**Flood Control Project Maintenance
Levee Inspections**

Maintenance Issue Types Only, Levee Inspection Report By Mile - Fall 2016

Reclamation District No. 0556 Upper Andrus

Waterway	Bank	Unit Miles	Inspection Start/End	Inspector
Unit No. 01 Georgiana Slough	Right	5.48	09/23/2016 09/23/2016	Herman Phillips

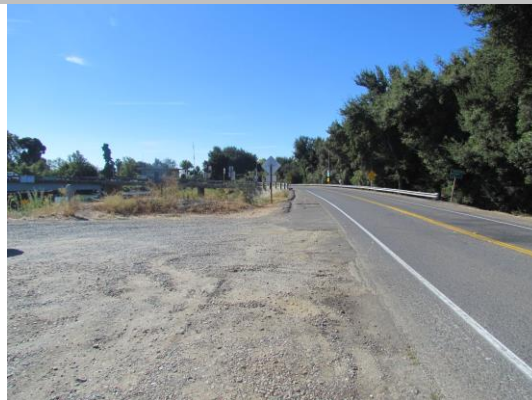
Photo 1 of 1 : FA_2016_RD0556_18_21_20161025_00056.jpg

LM Start	0.08	Rating **	A	Issue No.	21
LM End	0.40	Issue Type +	Ma	Location *	WS
Category	Earthen Levee		GPS Latitude/Longitude		
			Start	End	
Item	Vegetation		38.237977°	38.233935°	
			-121.518112°	-121.520094°	
DWR ID	DWR_RD0556_01_f_2016_21				
Comment Code					
V1 : Control annual grass and weeds on the levee slopes and easements.					
Inspector Comment					
No unwanted vegetation on the waterside from levee mile 0.08-0.40.

RD 556 Unit 1 levee mile 0.08-0.40.

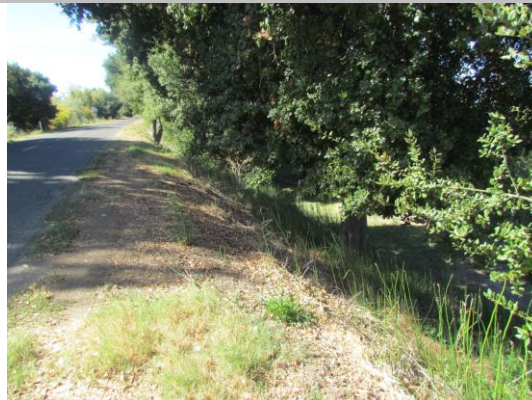
Photo 1 of 1 : FA_2016_RD0556_18_26_20161025_00050.jpg

LM Start	0.24	Rating **	U	Issue No.	26
LM End	0.73	Issue Type +	Ma	Location *	LS
Category	Earthen Levee		GPS Latitude/Longitude		
			Start	End	
Item	Trim / Thin Trees		38.235807°	38.230273°	
			-121.518278°	-121.523907°	
DWR ID	DWR_RD0556_01_f_2015_26				
Comment Code					
T1 : Trim trees to at least five feet above ground level.					
Inspector Comment					
Trim the trees two at least five foot above ground.

RD 556 Unit 1 landside levee miles 0.24-0.73 looking downstream.

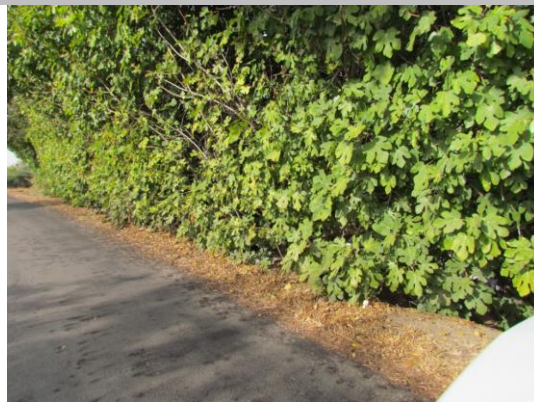
Photo 1 of 1 : FA_2016_RD0556_18_376_20160919_00016.jpg

LM Start	0.68	Rating **	U	Issue No.	376
LM End	0.90	Issue Type +	Ma	Location *	LS
Category	Earthen Levee			GPS Latitude/Longitude	
				Start	End
Item	Vegetation			38.230785 °	38.228602 °
				-121.523470 °	-121.526289 °
DWR ID	DWR_RD0556_01_s_2014_376				
Comment Code					
V7 : Trees / Woody Vegetation					
Inspector Comment					
District should remove these unwanted fig trees from the landside slope, unable to see ground.

Remove unwanted fig trees present on the landside slope.

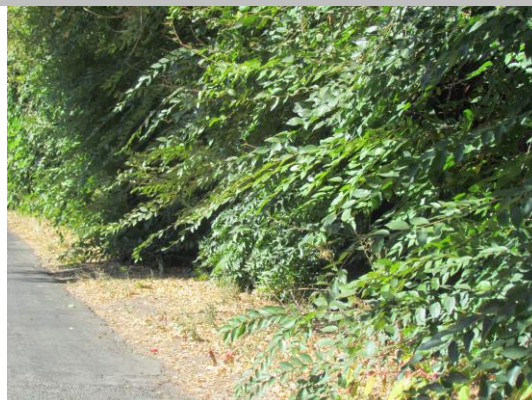
Photo 1 of 1 : FA_2016_RD0556_18_10_20161025_00051.jpg

LM Start	0.93	Rating **	U	Issue No.	10
LM End	1.54	Issue Type +	Ma	Location *	LS
Category	Earthen Levee			GPS Latitude/Longitude	
				Start	End
Item	Trim / Thin Trees			38.228295 °	38.225368 °
				-121.526688 °	-121.534677 °
DWR ID	DWR_RD0556_01_f_2015_10				
Comment Code					
T1 : Trim trees to at least five feet above ground level.					
Inspector Comment					
Remove the woody tree growth from the landside levee section.

RD 556 Unit 1 levee miles 0.93-1.54 looking downstream landside slope.

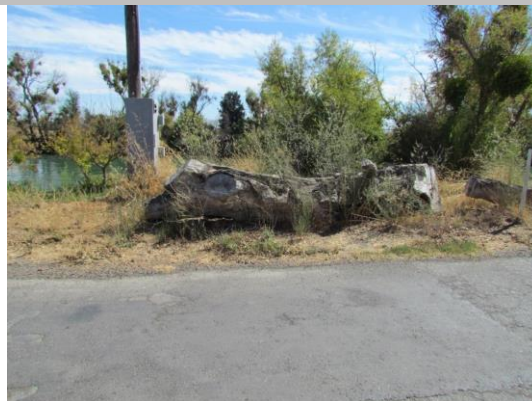
Photo 1 of 1 : FA_2016_RD0556_18_9_20160919_00002.jpg

LM Start	1.55	Rating **	U	Issue No.	9
LM End	1.57	Issue Type +	Ma	Location *	WS
Category	Earthen Levee			GPS Latitude/Longitude	
				Start	End
Item	Encroachments			38.225191°	38.224976°
				-121.534799°	-121.535043°
DWR ID	DWR_RD0556_01_s_2012_9				
Comment Code					
TR : Tree or limb					
Inspector Comment					
These cut up tree sections remain on the waterward slope. The owner is on the Reclamation District's Board, Mr. Silva said he will ask him to remove the encroachment.

Unsatisfactory dumping of cut up tree sections on the waterside levee shoulder.

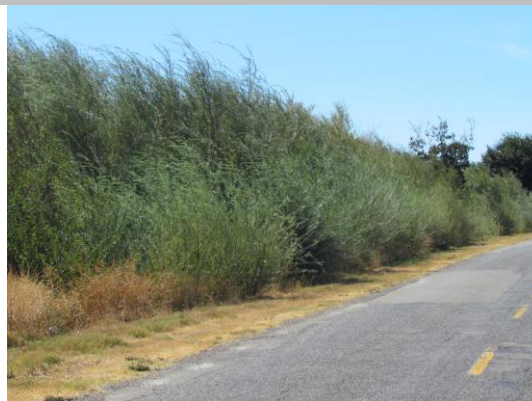
Photo 1 of 1 : FA_2016_RD0556_18_74_20161101_00057.jpg

LM Start	1.74	Rating **	U	Issue No.	74
LM End	2.29	Issue Type +	Ma	Location *	WS
Category	Earthen Levee			GPS Latitude/Longitude	
				Start	End
Item	Vegetation			38.224198°	38.220317°
				-121.537987°	-121.544172°
DWR ID	DWR_RD0556_01_f_2015_74				
Comment Code					
V7 : Trees / Woody Vegetation					
Inspector Comment					
This arundo needs to be removed, this vegetation completely blocks the view of the waterside slope, shoulder and toe.

RD 556 Unit 1 waterside levee mile 1.74-2.29.

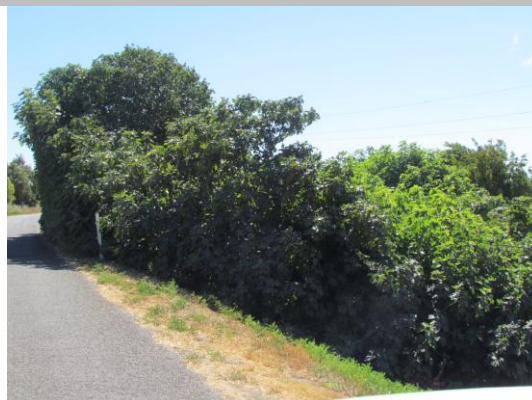
Photo 1 of 1 : FA_2016_RD0556_18_47_20161025_00055.jpg

LM Start	2.38	Rating **	U	Issue No.	47
LM End	2.42	Issue Type +	Ma	Location *	LS
Category	Earthen Levee			GPS Latitude/Longitude	
				Start	End
Item	Vegetation			38.219065 °	38.218458 °
				-121.543855 °	-121.543838 °
DWR ID	DWR_RD0556_01_f_2012_47				
Comment Code					
V7 : Trees / Woody Vegetation					
Inspector Comment					
This section of trees need to be removed from levee section, visibility completely blocked.

RD 556 Unit 1 levee miles 2.38-2.42 landside slope.

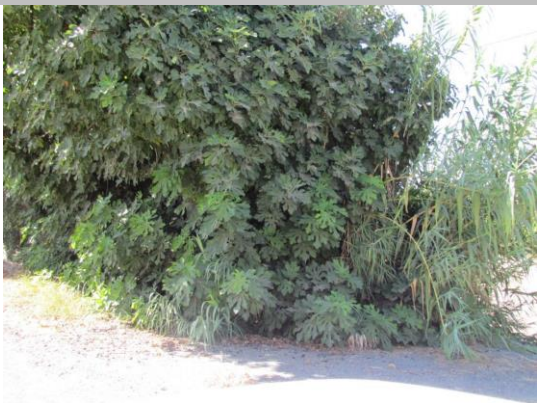
Photo 1 of 1 : FA_2016_RD0556_18_79_20160919_00013.jpg

Unsatisfactory woody tree growth and arondo blocking view of roadside levee shoulder and slope.

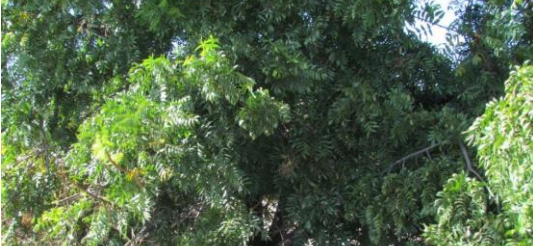
Photo 1 of 1 : FA_2016_RD0556_18_83_20160919_00015.jpg

Looking downstream from the landside slope unsatisfactory woody tree growth blocking view of levee section.

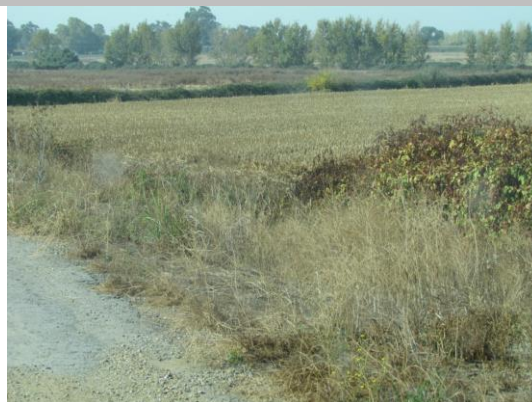
Photo 1 of 1 : FA_2016_RD0556_18_66_20160919_00008.jpg

LM Start	4.07	Rating **	U	Issue No.	66
LM End	5.47	Issue Type +	Ma	Location *	LS
Category	Earthen Levee			GPS Latitude/Longitude	
				Start	End
Item	Vegetation			38.200659 °	38.186542 °
				-121.544711 °	-121.562411 °
DWR ID	DWR_RD0556_01_s_2013_66				
Comment Code					
V2 : Remove the wild growth other than native grasses from the levee slopes.					
Inspector Comment					
Remove the wild berries from the slope and toe of the levee section along with the tall weeds.

Unwanted tall weeds and berries growing on the landside slope and toe.

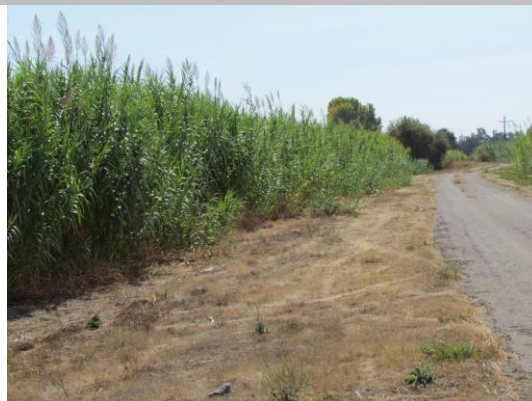
Photo 1 of 1 : FA_2016_RD0556_18_67_20160919_00009.jpg

LM Start	4.07	Rating **	U	Issue No.	67
LM End	5.48	Issue Type +	Ma	Location *	WS
Category	Earthen Levee			GPS Latitude/Longitude	
				Start	End
Item	Vegetation			38.200658 °	38.186464 °
				-121.544711 °	-121.562550 °
DWR ID	DWR_RD0556_01_s_2013_67				
Comment Code					
V2 : Remove the wild growth other than native grasses from the levee slopes.					
Inspector Comment					
Remove the wild weed growth and Arundo from the waterside levee section.

Looking downstream on waterside the arundo completely covering the levee section.

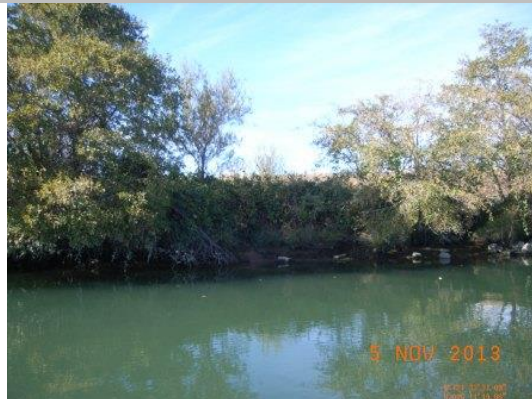
Photo 1 of 1 : FA_2016_RD0556_18_1_20160919_00001.jpg

LM Start	5.12	Rating **	M	Issue No.	1
LM End	5.27	Issue Type +	Ma	Location *	WS
Category	Supplemental			GPS Latitude/Longitude	
				Start	End
Item	2015 USACE Erosion Survey, DRAFT			38.189775 °	38.188121 °
				-121.557729 °	-121.559413 °
DWR ID	DWR_RD0556_01_f_2016_1				
Comment Code					
Inspector Comment					
1997 - Toe damaged rock. 1999 - One pocket filled with gravel. 2000 - Eroding beach with some biotech rolls and stakes; some gravel on slope. 2001 - Staked, low fascine walls at bankline. 2005 - Stone revetment in between pockets. 2006 - New rock on upper slope behind brush boxes at the upstream end, Stone is sliding off the hard toe. 2015: Last observed in 2013. [2015 Site ID: GEO_7-0_R]

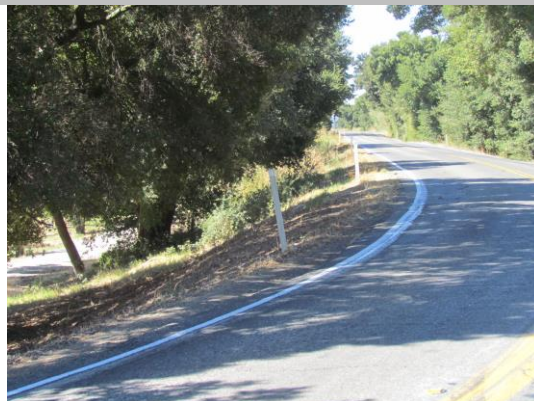
Photo 1 of 1 : FA_2016_RD0556_19_29_20161031_00052.jpg

LM Start	0.00	Rating **	U	Issue No.	29
LM End	1.35	Issue Type +	Ma	Location *	LS
Category	Earthen Levee			GPS Latitude/Longitude	
				Start	End
Item	Vegetation			38.200550 °	38.239821 °
				-121.544190 °	-121.542440 °
DWR ID	DWR_RD0556_02_f_2016_29				
Comment Code					
V1 : Control annual grass and weeds on the levee slopes and easements.					
Inspector Comment					
Control the wild vegetation and wild tree growth from the landside slope and shoulder heading downstream

RD 556 Unit 2 looking downstream landside levee mile 0.00-1.35.

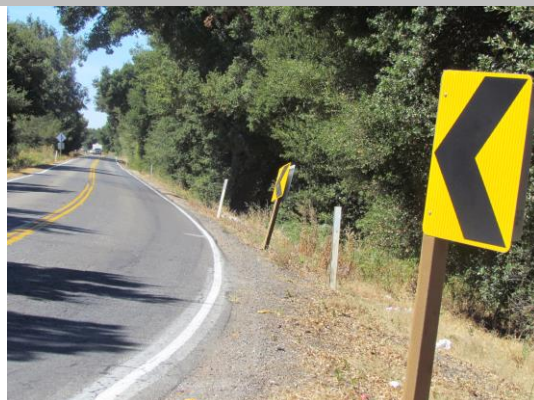
Photo 1 of 1 : FA_2016_RD0556_19_82_20161031_00051.jpg

LM Start	0.00	Rating **	U	Issue No.	82
LM End	1.82	Issue Type +	Ma	Location *	WS
Category	Earthen Levee			GPS Latitude/Longitude	
				Start	End
Item	Vegetation			38.200550 °	38.240999 °
				-121.544190 °	-121.551002 °
DWR ID	DWR_RD0556_02_s_2013_82				
Comment Code					
V2 : Remove the wild growth other than native grasses from the levee slopes.					
Inspector Comment					
Waterside levee slope and shoulder is covered with wild tree growth and other unsatisfactory vegetation.

RD 556 Unit 2 looking downstream of waterside slope.

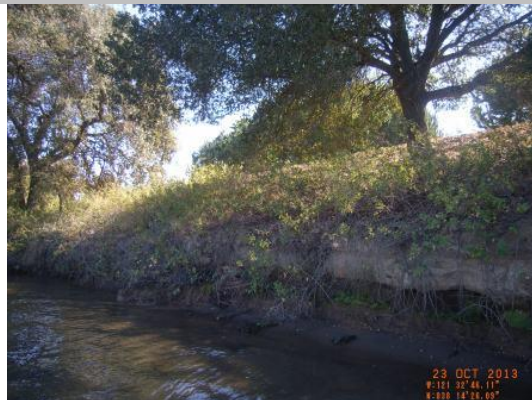
Photo 1 of 1 : FA_2016_RD0556_19_5_20160919_00005.jpg

LM Start	1.45	Rating **	M	Issue No.	5
LM End	1.59	Issue Type +	Ma	Location *	WS
Category	Supplemental			GPS Latitude/Longitude	
				Start	End
Item	2015 USACE Erosion Survey, DRAFT			38.240401 °	38.240772 °
				-121.544106 °	-121.546791 °
DWR ID	DWR_RD0556_02_f_2016_5				
Comment Code					
Inspector Comment					
1997 - Slow erosion of the berm at the waterline; bench below water. 2005 - Brush boxes present. 2010 - Minor new erosion. 2013 - There is little to no berm remaining at downstream end of this site. 2015: No observed changes. [2015 Site ID: SAC_24-8_L]

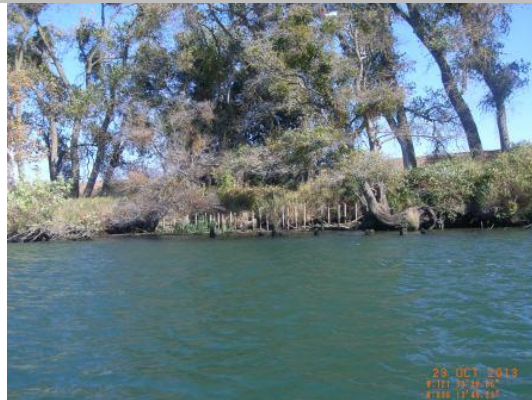
Photo 1 of 1 : FA_2016_RD0556_19_11_20160919_00009.jpg

LM Start	2.93	Rating **	M	Issue No.	11
LM End	3.04	Issue Type +	Ma	Location *	WS
Category	Supplemental			GPS Latitude/Longitude	
				Start	End
Item	2015 USACE Erosion Survey, DRAFT			38.228202 °	38.226601 °
				-121.555502 °	-121.555605 °
DWR ID	DWR_RD0556_02_f_2016_11				
Comment Code					
Inspector Comment					
1997 - Few scallops in berm, some getting close to levee toe. 2005 - Brush boxes present. 2012 - More erosion of the toe since last year. 2015: No observed changes. [2015 Site ID: SAC_23-3_L]

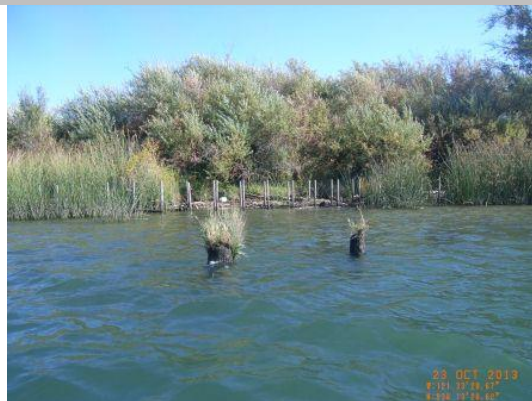
Photo 1 of 1 : FA_2016_RD0556_19_10_20160919_00008.jpg

LM Start	3.17	Rating **	M	Issue No.	10
LM End	3.28	Issue Type +	Ma	Location *	WS
Category	Supplemental			GPS Latitude/Longitude	
				Start	End
Item	2015 USACE Erosion Survey, DRAFT			38.224850 °	38.223233 °
				-121.555641 °	-121.555687 °
DWR ID	DWR_RD0556_02_f_2016_10				
Comment Code					
Inspector Comment					
2000 - Recently fallen cottonwood at the downstream end. 2005 - Empty brush boxes. 2011 - A few trees have fallen since last year. 2012 - Potential new tree popout since last year. 2013 - New erosion at downstream end of site and a recent tree pop-out observed. 2015: No observed changes. [2015 Site ID: SAC_23-2_L]

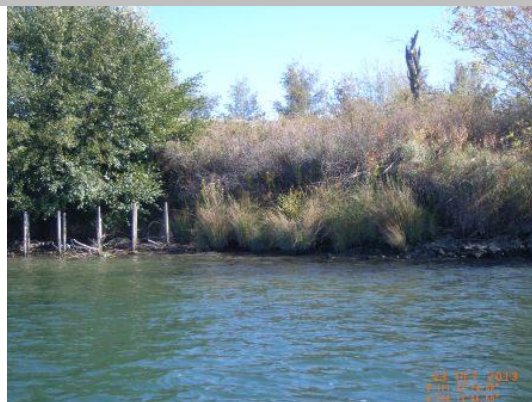
Photo 1 of 1 : FA_2016_RD0556_19_8_20160919_00007.jpg

LM Start	3.58	Rating **	M	Issue No.	8
LM End	3.64	Issue Type +	Ma	Location *	WS
Category	Supplemental			GPS Latitude/Longitude	
				Start	End
Item	2015 USACE Erosion Survey, DRAFT			38.218951 °	38.218104 °
				-121.556689 °	-121.556819 °
DWR ID	DWR_RD0556_02_f_2016_8				
Comment Code					
Inspector Comment					
1997 - Scallops into berm and very close to levee toe. 2005 - Brush boxes present. 2011 - New toe scour and freshly fallen tree. 2012 - New tree popout has taken significant portion of soil out of the levee. 2015: No observed changes. [2015 Site ID: SAC_22-7_L]

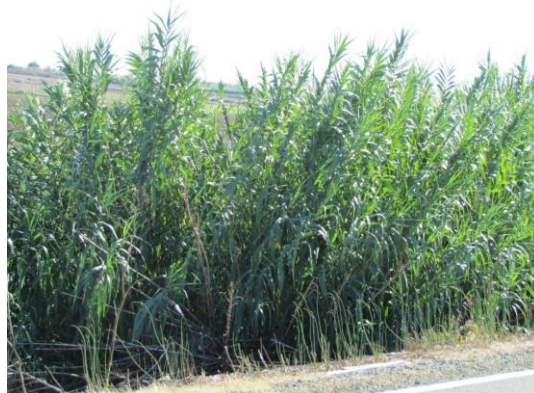
Photo 1 of 1 : FA_2016_RD0556_19_87_20160919_00014.jpg

LM Start	4.21	Rating **	U	Issue No.	87
LM End	4.22	Issue Type +	Ma	Location *	LS
Category	Earthen Levee			GPS Latitude/Longitude	
				Start	End
Item	Vegetation			38.209818 °	38.209638 °
				-121.556818 °	-121.556835 °
DWR ID	DWR_RD0556_02_f_2015_87				
Comment Code					
V2 : Remove the wild growth other than native grasses from the levee slopes.					
Inspector Comment					
Remove the unsatisfactory patch of bamboo from the landside levee shoulder and slope.

RD 556 Unit 2 looking downstream from the landside shoulder levee miles 4.21-4.22.

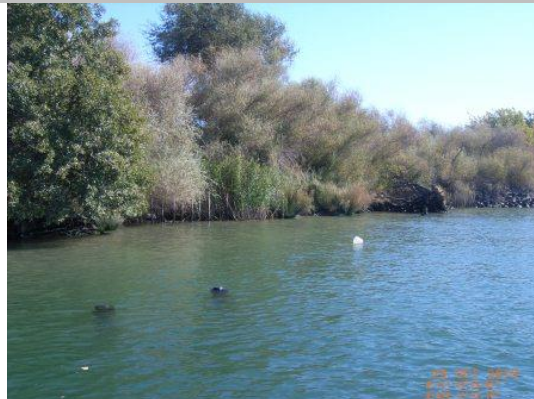
Photo 1 of 1 : FA_2016_RD0556_19_7_20160919_00006.jpg

LM Start	4.45	Rating **	M	Issue No.	7
LM End	4.49	Issue Type +	Ma	Location *	WS
Category	Supplemental			GPS Latitude/Longitude	
				Start	End
Item	2015 USACE Erosion Survey, DRAFT			38.206377°	38.205729°
				-121.557184°	-121.557108°
DWR ID	DWR_RD0556_02_f_2016_7				
Comment Code					
Inspector Comment					
2013 - Erosion pockets encroaching on levee foundation. 2015: No observed changes. [2015 Site ID: SAC_21-9_L]
