**Flood Control Project Maintenance
Levee Inspections**

Maintenance Issue Types Only, Levee Inspection Report By Mile - Fall 2017

Reclamation District No. 0556 Upper Andrus

Waterway	Bank	Unit Miles	Inspection Start/End	Inspector
Unit No. 01 Georgiana Slough	Right	5.48	11/01/2017 11/01/2017	Keith Millard

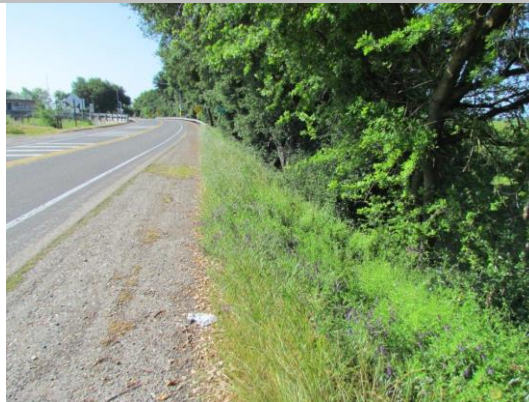
Photo 1 of 1 : FA_2017_RD0556_18_21_20171002_00004.jpg

LM Start	0.08	Rating **	U	Issue No.	21
LM End	0.84	Issue Type +	Ma	Location *	LS
Category	Earthen Levee			GPS Latitude/Longitude	
				Start	End
Item	Vegetation			38.238037 °	38.229105 °
				-121.518067 °	-121.525352 °
DWR ID	DWR_RD0556_01_s_2017_21				
Comment Code					
V7 : Trees / Woody Vegetation					
Inspector Comment					
Control the wild growth and trim the trees so the slope can be seen.

Looking downstream from levee mile 0.09 woody tree growth and wild weeds covering the levee slope and shoulder landside levee section.

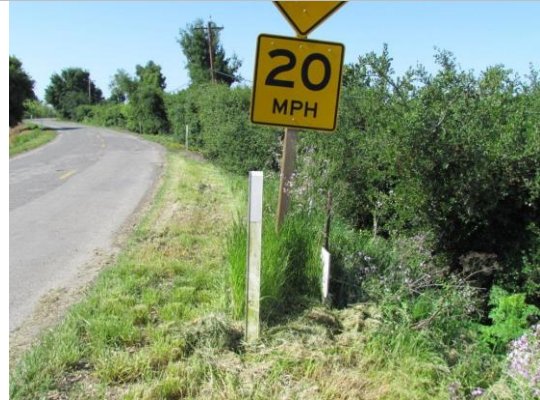
Photo 1 of 1 : FA_2017_RD0556_18_10_20171002_00003.jpg

LM Start	0.93	Rating **	U	Issue No.	10
LM End	1.54	Issue Type +	Ma	Location *	LS
Category	Earthen Levee			GPS Latitude/Longitude	
				Start	End
Item	Trim / Thin Trees			38.228295 °	38.225368 °
				-121.526688 °	-121.534677 °
DWR ID	DWR_RD0556_01_f_2015_10				
Comment Code					
T3 : Trim and thin trees to allow visibility of the ground and room to flood fight.					
Inspector Comment					
Thin out and remove the wild tree growth and vegetation on the landside levee slope and shoulder.

RD 556 Unit 1 levee miles 0.93-1.54 looking downstream landside slope.

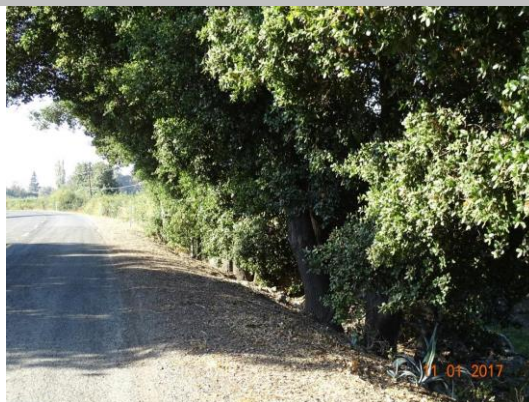
Photo 1 of 1 : FA_2017_RD0556_18_386_20171117_00061.jpg

LM Start	1.57	Rating **	M	Issue No.	386
LM End	1.65	Issue Type +	Ma	Location *	LS
Category	Earthen Levee			GPS Latitude/Longitude	
				Start	End
Item	Vegetation			38.224995 °	38.224623 °
				-121.535094 °	-121.536320 °
DWR ID	DWR_RD0556_01_f_2013_386				
Comment Code					
V2 : Remove the wild growth other than native grasses from the levee slopes.					
Inspector Comment

Remove the wild growth and trim trees from the landside levee slope.

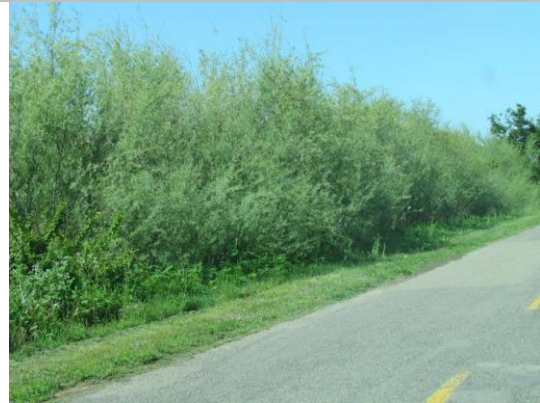
Photo 1 of 1 : FA_2017_RD0556_18_74_20171002_00024.jpg

LM Start	1.74	Rating **	U	Issue No.	74
LM End	2.29	Issue Type +	Ma	Location *	WS
Category	Earthen Levee			GPS Latitude/Longitude	
				Start	End
Item	Vegetation			38.224198 °	38.220317 °
				-121.537987 °	-121.544172 °
DWR ID	DWR_RD0556_01_f_2015_74				
Comment Code					
V7 : Trees / Woody Vegetation					
Inspector Comment					
Arundo and willows need to be removed. This vegetation completely blocks the view of the waterside slope, shoulder and toe.

RD 556 Unit 1 waterside levee mile 1.74-2.29.

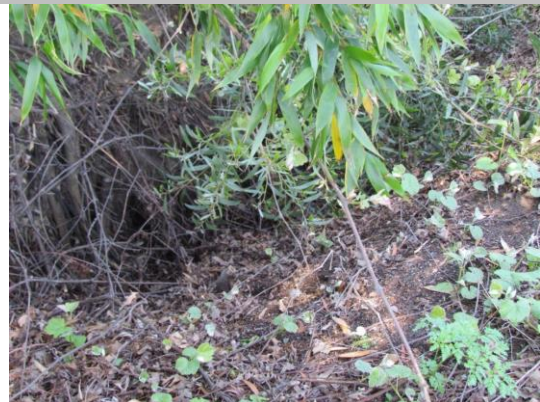
Photo 1 of 2 : FA_2017_RD0556_18_33_20171002_00010.jpg

LM Start	2.72	Rating **	U	Issue No.	33
LM End	2.72	Issue Type +	Ma	Location *	LS
Category	Earthen Levee			GPS Latitude/Longitude	
				Start	End
Item	Slope Stability			38.215107 °	38.215107 °
				-121.540677 °	-121.540677 °
DWR ID	DWR_RD0556_01_s_2017_33				
Comment Code					
S1 : Repair slope instability.					
Inspector Comment					
Fallen tree on landside. Remove the fallen tree and repair the levee damage.

RD 556 Unit 1 levee mile 2.72 fallen tree damage to shoulder and slope.

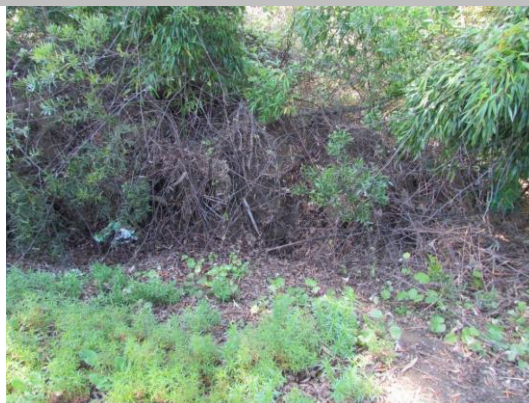
Photo 2 of 2 : FA_2017_RD0556_18_33_20171002_00011.jpg

LM Start	2.72	Rating **	U	Issue No.	33 (cont)	
LM End	2.72	Issue Type +	Ma	Location *	LS	
Category	Earthen Levee			GPS Latitude/Longitude		
				Start		End
Item	Slope Stability			38.215107 °		38.215107 °
				-121.540677 °		-121.540677 °
DWR ID	DWR_RD0556_01_s_2017_33					
Comment Code						
S1 : Repair slope instability.						
Inspector Comment						
Fallen tree on landside. Remove the fallen tree and repair the levee damage.

RD 349 Unut 1 levee mile 2.72 the root ball of the fallen tree on slope landward.

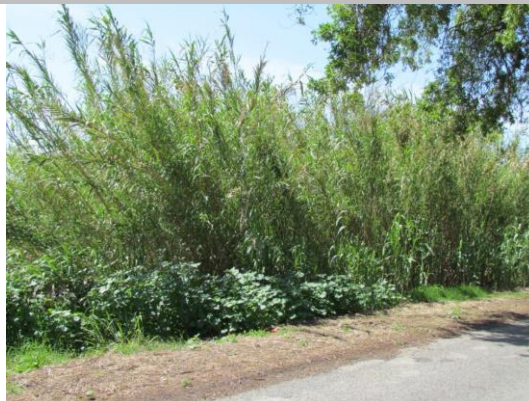
Photo 1 of 1 : FA_2017_RD0556_18_35_20171002_00012.jpg

LM Start	3.12	Rating **	U	Issue No.	35
LM End	3.14	Issue Type +	Ma	Location *	WS
Category	Earthen Levee			GPS Latitude/Longitude	
				Start	End
Item	Vegetation			38.211103 °	38.210970 °
				-121.537993 °	-121.538370 °
DWR ID	DWR_RD0556_01_s_2017_35				
Comment Code					
V2 : Remove the wild growth other than native grasses from the levee slopes.					
Inspector Comment					
Remove the unwanted wild growth from the waterside slope.

RD 556 Unit 1 levee mile 3.12-3.14 waterside shoulder and slope.

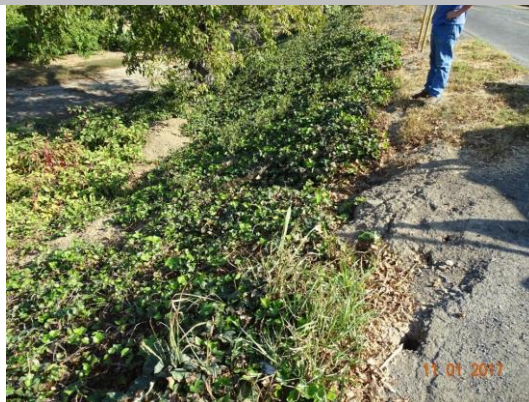
Photo 1 of 1 : FA_2017_RD0556_18_28_20171117_00065.jpg

LM Start	3.14	Rating **	U	Issue No.	28
LM End	3.26	Issue Type +	Ma	Location *	LS
Category	Earthen Levee			GPS Latitude/Longitude	
				Start	End
Item	Animal Control			38.210985 °	38.210160 °
				-121.538372 °	-121.540300 °
DWR ID	DWR_RD0556_01_f_2017_28				
Comment Code					
A1 : Exterminate rodents and backfill and compact or grout burrows.					
Inspector Comment

Significant rodent activity in this area must be stopped. Holes should be backfilled.

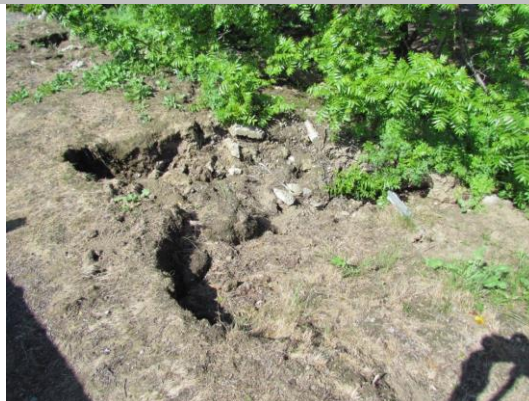
Photo 1 of 2 : FA_2017_RD0556_18_36_20171002_00013.jpg

LM Start	3.22	Rating **	U	Issue No.	36
LM End	3.22	Issue Type +	Ma	Location *	LS
Category	Earthen Levee			GPS Latitude/Longitude	
				Start	End
Item	Slope Stability			38.210528 °	38.210528 °
				-121.539678 °	-121.539678 °
DWR ID	DWR_RD0556_01_s_2017_36				
Comment Code					
S1 : Repair slope instability.					
Inspector Comment					
Repair the erosion sites.

556 Unit 1 levee mile 3.22 landside slope erosion.

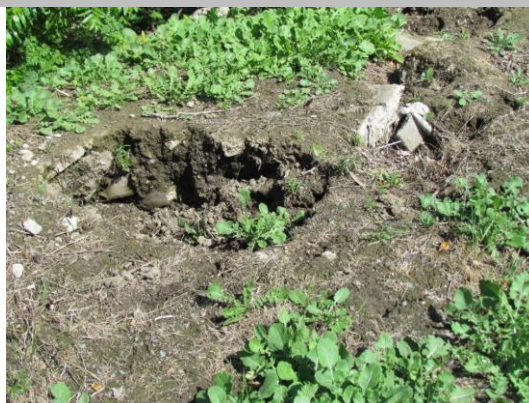
Photo 2 of 2 : FA_2017_RD0556_18_36_20171002_00014.jpg

LM Start	3.22	Rating **	U	Issue No.	36 (cont)
LM End	3.22	Issue Type +	Ma	Location *	LS

556 Unit 1 slope erosion levee mile 3.22.

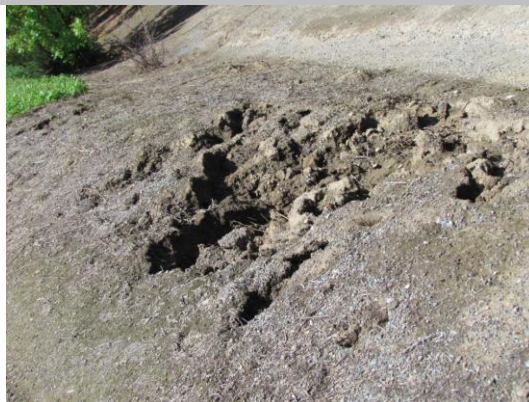
Photo 1 of 1 : FA_2017_RD0556_18_37_20171002_00015.jpg

LM Start	3.24	Rating **	M	Issue No.	37
LM End	3.24	Issue Type +	Ma	Location *	LS
Category	Earthen Levee			GPS Latitude/Longitude	
				Start	End
Item	Slope Stability			38.210365 °	38.210365 °
				-121.540002 °	-121.540002 °
DWR ID	DWR_RD0556_01_s_2017_37				
Comment Code					
S1 : Repair slope instability.					
Inspector Comment					
Repair the erosion on the slope.

556 Unit 1 levee mile 3.24 landside slope.

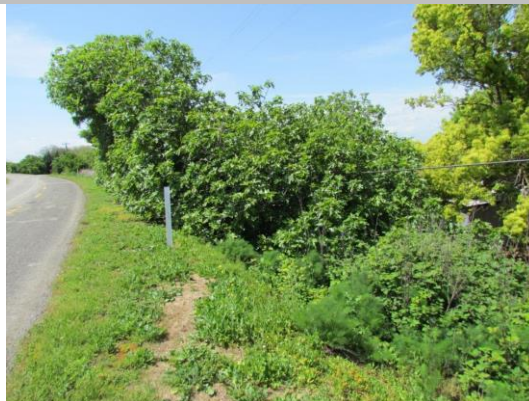
Photo 1 of 1 : FA_2017_RD0556_18_38_20171002_00016.jpg

LM Start	3.25	Rating **	U	Issue No.	38
LM End	3.29	Issue Type +	Ma	Location *	LS
Category	Earthen Levee			GPS Latitude/Longitude	
				Start	End
Item	Vegetation			38.210250 °	38.209842 °
				-121.540207 °	-121.540658 °
DWR ID	DWR_RD0556_01_s_2017_38				
Comment Code					
V7 : Trees / Woody Vegetation					
Inspector Comment					
Remove the wild tree growth and vegetation from the landside levee slope and toe so the ground can be seen.

556 Unit 1 levee mile 3.25-3.29 woody tree growth and vegetation blocking the view of the levee slope and toe.

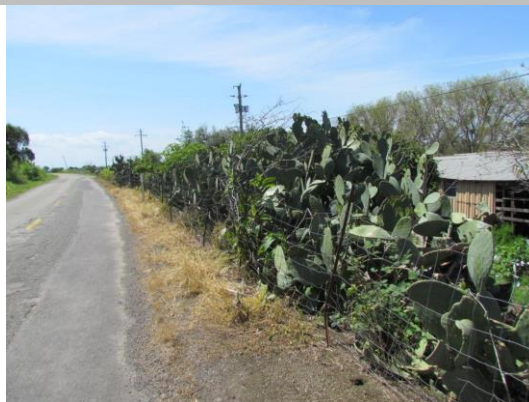
Photo 1 of 1 : FA_2017_RD0556_18_41_20171002_00017.jpg

LM Start	3.42	Rating **	M	Issue No.	41
LM End	3.93	Issue Type +	Ma	Location *	LS
Category	Earthen Levee			GPS Latitude/Longitude	
				Start	End
Item	Vegetation			38.208113 °	38.201603 °
				-121.541582 °	-121.542352 °
DWR ID	DWR_RD0556_01_s_2017_41				
Comment Code					
V2 : Remove the wild growth other than native grasses from the levee slopes.					
Inspector Comment					
Remove the wild growth other than annual grasses from the levee slope.

556 Unit 1 levee mile 3.42-5.47 landside shoulder and slope.

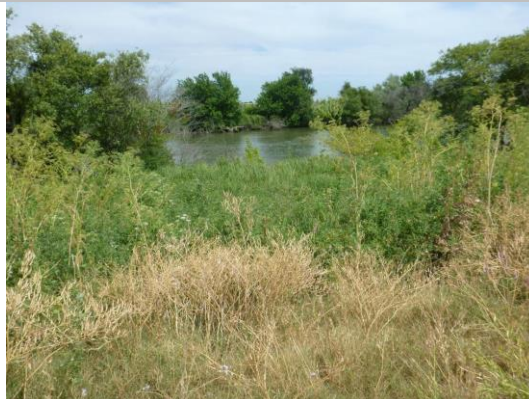
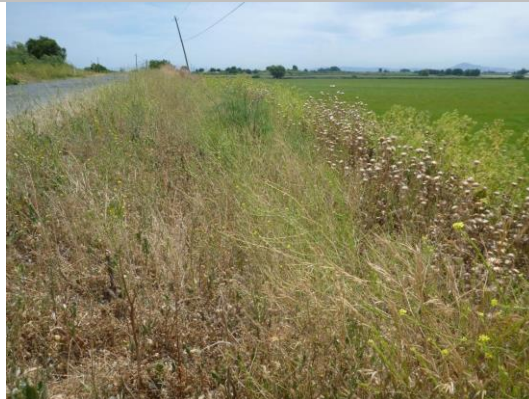
LM Start	3.43	Rating **	A/W	Issue No.	23
LM End	3.75	Issue Type +	Ma	Location *	
Category	Supplemental		GPS Latitude/Longitude		
			Start	End	
Item	2017 Storm Damage		38.208070 °	38.203400 °	
			-121.541700 °	-121.540990 °

Notes: inactive ditch on landside toe, slope covered in heavy vegetation, minor landside lower slope sloughing observed,

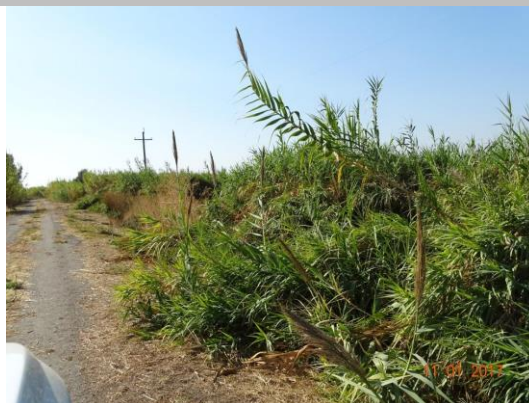
Photo 1 of 1 : FA_2017_RD0556_18_39_20171117_00069.jpg

LM Start	3.98	Rating **	U	Issue No.	39
LM End	5.48	Issue Type +	Ma	Location *	LS
Category	Earthen Levee			GPS Latitude/Longitude	
				Start	End
Item	Vegetation			38.201273 °	38.186464 °
				-121.543328 °	-121.562550 °
DWR ID	DWR_RD0556_01_f_2017_39				
Comment Code					
V2 : Remove the wild growth other than native grasses from the levee slopes.					
Inspector Comment

Control dense growth of wild vegetation, berry vines and arundo on landside to allow inspection and access.

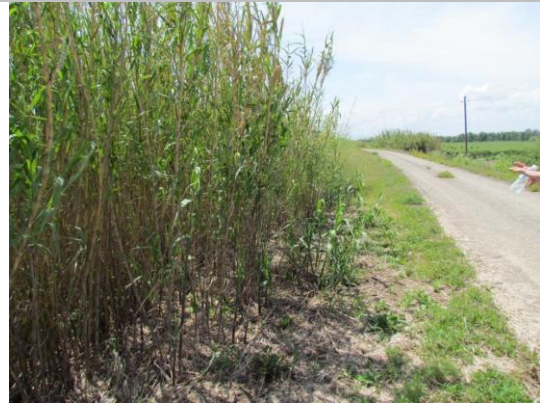
Photo 1 of 1 : FA_2017_RD0556_18_67_20171002_00021.jpg

LM Start	4.07	Rating **	U	Issue No.	67
LM End	5.48	Issue Type +	Ma	Location *	WS
Category	Earthen Levee			GPS Latitude/Longitude	
				Start	End
Item	Vegetation			38.200658 °	38.186464 °
				-121.544711 °	-121.562550 °
DWR ID	DWR_RD0556_01_s_2013_67				
Comment Code					
V2 : Remove the wild growth other than native grasses from the levee slopes.					
Inspector Comment					
Remove the wild weed growth and Arundo from the waterside levee section.

Looking downstream on the waterside arundo completely blocking view of the slope and shoulder.

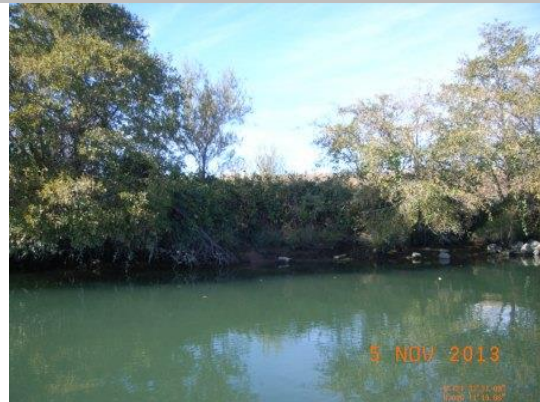
Photo 1 of 1 : FA_2017_RD0556_18_1_20171002_00001.jpg

LM Start	5.12	Rating **	M	Issue No.	1
LM End	5.27	Issue Type +	Ma	Location *	WS
Category	Supplemental			GPS Latitude/Longitude	
				Start	End
Item	2015 USACE Erosion Survey, DRAFT			38.189775 °	38.188121 °
				-121.557729 °	-121.559413 °
DWR ID	DWR_RD0556_01_f_2016_1				
Comment Code					
Inspector Comment					
1997 - Toe damaged rock. 1999 - One pocket filled with gravel. 2000 - Eroding beach with some biotech rolls and stakes; some gravel on slope. 2001 - Staked, low fascine walls at bankline. 2005 - Stone revetment in between pockets. 2006 - New rock on upper slope behind brush boxes at the upstream end. Stone is sliding off the hard toe. 2015: Last observed in 2013. [2015 Site ID: GEO_7-0_R]

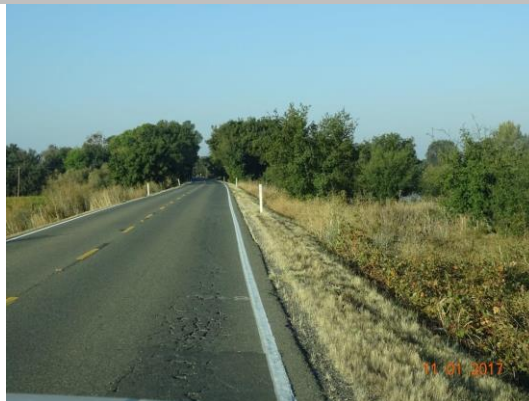
Photo 1 of 2 : FA_2017_RD0556_19_82_20171117_00051.jpg

LM Start	0.00	Rating **	A/W	Issue No.	82
LM End	5.71	Issue Type +	Ma	Location *	WS
Category	Earthen Levee			GPS Latitude/Longitude	
				Start	End
Item	Vegetation			38.200550 °	38.191937 °
				-121.544190 °	-121.567510 °
DWR ID	DWR_RD0556_02_s_2013_82				
Comment Code					
V2 : Remove the wild growth other than native grasses from the levee slopes.					
Inspector Comment

Waterside levee slope and shoulder have been mowed to 20' from

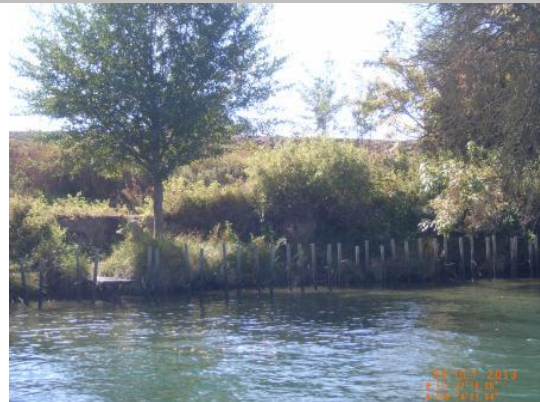
Photo 1 of 1 : FA_2017_RD0556_19_2_20171002_00002.jpg

LM Start	1.03	Rating **	M	Issue No.	2
LM End	1.15	Issue Type +	Ma	Location *	WS
Category	Supplemental			GPS Latitude/Longitude	
				Start	End
Item	2015 USACE Erosion Survey, DRAFT			38.238772 °	38.239265 °
				-121.536788 °	-121.538845 °
DWR ID	DWR_RD0556_02_f_2016_2				
Comment Code					
Inspector Comment					
1997 - Rock is in poor condition and has failed in many places. Scallops in berm with remnants of old rock in the toe area. 2005 - Brush boxes present. 2013 - Site extended upstream approximately 300 ft to include new erosion pockets. 2015: Minor new erosion at toe. [2015 Site ID: SAC 25-2 L]

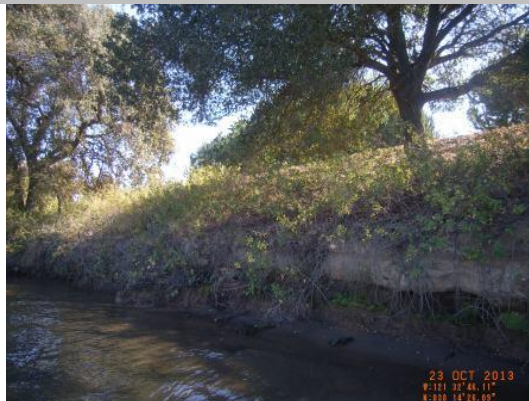
Photo 1 of 1 : FA_2017_RD0556_19_5_20171002_00005.jpg

LM Start	1.45	Rating **	M	Issue No.	5
LM End	1.59	Issue Type +	Ma	Location *	WS
Category	Supplemental			GPS Latitude/Longitude	
				Start	End
Item	2015 USACE Erosion Survey, DRAFT			38.240401 °	38.240772 °
				-121.544106 °	-121.546791 °
DWR ID	DWR_RD0556_02_f_2016_5				
Comment Code					
Inspector Comment					
1997 - Slow erosion of the berm at the waterline; bench below water. 2005 - Brush boxes present. 2010 - Minor new erosion. 2013 - There is little to no berm remaining at downstream end of this site. 2015: No observed changes. [2015 Site ID: SAC_24-8_L]

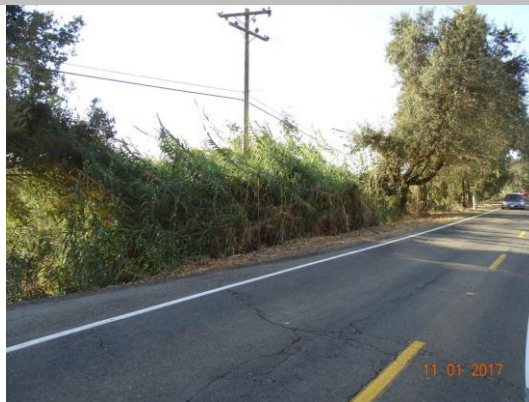
Photo 1 of 1 : FA_2017_RD0556_19_32_20171117_00057.jpg

LM Start	2.06	Rating **	U	Issue No.	32
LM End	2.06	Issue Type +	Ma	Location *	LS
Category	Earthen Levee			GPS Latitude/Longitude	
				Start	End
Item	Vegetation			38.239470 °	38.239470 °
				-121.554845 °	-121.554845 °
DWR ID	DWR_RD0556_02_f_2017_32				
Comment Code					
V2 : Remove the wild growth other than native grasses from the levee slopes.					
Inspector Comment

Arundo growth should be removed to allow inspection and access to landside slope and toe.

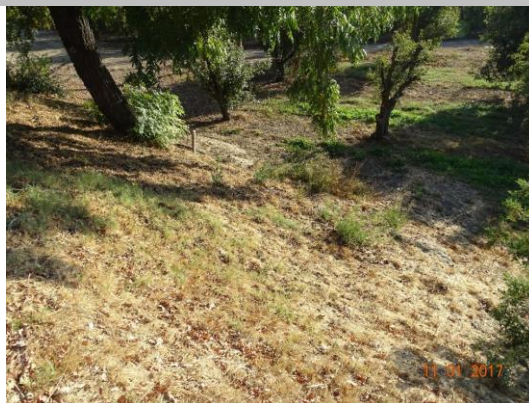
Photo 1 of 1 : FA_2017_RD0556_19_34_20171117_00059.jpg

Rodent burrows observed near the base of large nut tree on landside slope. Exterminate rodents and backfill burrows.

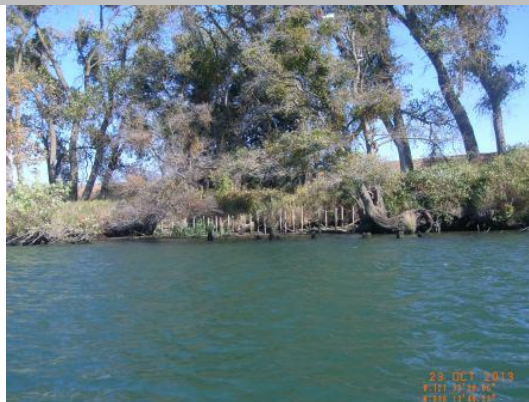
Photo 1 of 1 : FA_2017_RD0556_19_11_20171002_00009.jpg

LM Start	2.93	Rating **	A/W	Issue No.	11
LM End	3.04	Issue Type +	Ma	Location *	WS
Category	Supplemental			GPS Latitude/Longitude	
				Start	End
Item	2015 USACE Erosion Survey, DRAFT			38.228202 °	38.226601 °
				-121.555502 °	-121.555605 °
DWR ID	DWR_RD0556_02_f_2016_11				
Comment Code					
Inspector Comment					
1997 - Few scallops in berm, some getting close to levee toe. 2005 - Brush boxes present. 2012 - More erosion of the toe since last year. 2015: No observed changes. [2015 Site ID: SAC_23-3_L]

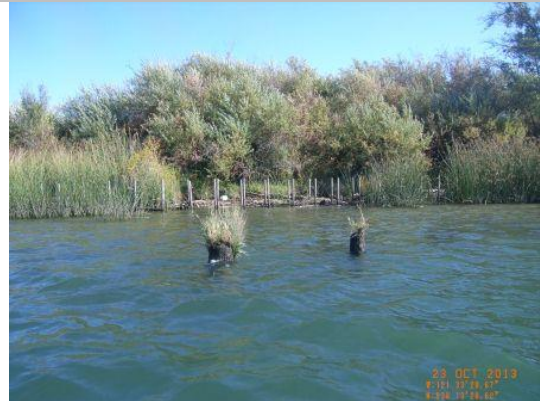
Photo 1 of 1 : FA_2017_RD0556_19_10_20171002_00008.jpg

LM Start	3.17	Rating **	M	Issue No.	10
LM End	3.28	Issue Type +	Ma	Location *	WS
Category	Supplemental			GPS Latitude/Longitude	
				Start	End
Item	2015 USACE Erosion Survey, DRAFT			38.224850 °	38.223233 °
				-121.555641 °	-121.555687 °
DWR ID	DWR_RD0556_02_f_2016_10				
Comment Code					
Inspector Comment					
2000 - Recently fallen cottonwood at the downstream end. 2005 - Empty brush boxes. 2011 - A few trees have fallen since last year. 2012 - Potential new tree popout since last year. 2013 - New erosion at downstream end of site and a recent tree pop-out observed. 2015: No observed changes. [2015 Site ID: SAC_23-2_L]

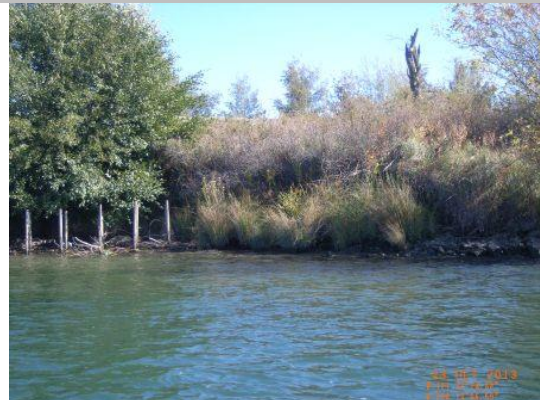
Photo 1 of 1 : FA_2017_RD0556_19_8_20171002_00007.jpg

LM Start	3.58	Rating **	M	Issue No.	8
LM End	3.64	Issue Type +	Ma	Location *	WS
Category	Supplemental			GPS Latitude/Longitude	
				Start	End
Item	2015 USACE Erosion Survey, DRAFT			38.218951 °	38.218104 °
				-121.556689 °	-121.556819 °
DWR ID	DWR_RD0556_02_f_2016_8				
Comment Code					
Inspector Comment					
1997 - Scallops into berm and very close to levee toe. 2005 - Brush boxes present. 2011 - New toe scour and freshly fallen tree. 2012 - New tree popout has taken significant portion of soil out of the levee. 2015: No observed changes. [2015 Site ID: SAC_22-7_L]

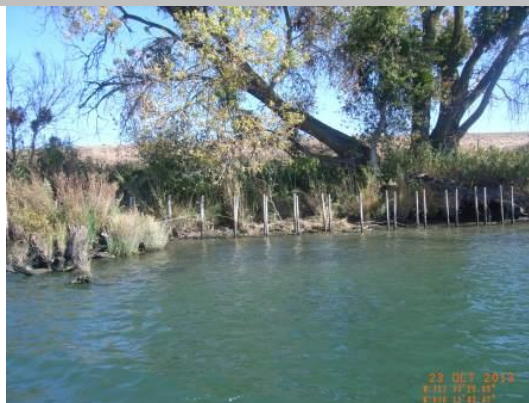
Photo 1 of 1 : FA_2017_RD0556_19_4_20171002_00004.jpg

LM Start	3.95	Rating **	M	Issue No.	4
LM End	4.12	Issue Type +	Ma	Location *	WS
Category	Supplemental			GPS Latitude/Longitude	
				Start	End
Item	2015 USACE Erosion Survey, DRAFT			38.213581 °	38.211112 °
				-121.557197 °	-121.557042 °
DWR ID	DWR_RD0556_02_f_2016_4				
Comment Code					
Inspector Comment					
2002 - Spot rock along berm, but not in the erosion pockets. 2005 - Some new minor stone revetment at the upstream end. Brush boxes present. 2006 - Currently installing new brush in downstream brush boxes. 2007 - Rock in middle portion for about 150 ft. 2010 - Some attempt at repairs but still has pockets of erosion. 2012 - More erosion along the toe. 2015: No observed changes. [2015 Site ID: SAC_22-5_L]

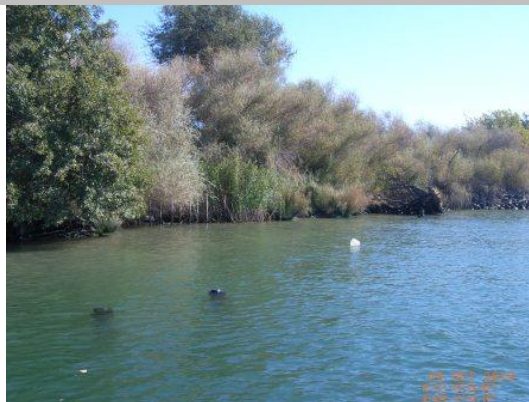
Photo 1 of 1 : FA_2017_RD0556_19_7_20171002_00006.jpg

LM Start	4.45	Rating **	M	Issue No.	7
LM End	4.49	Issue Type +	Ma	Location *	WS
Category	Supplemental			GPS Latitude/Longitude	
				Start	End
Item	2015 USACE Erosion Survey, DRAFT			38.206377 °	38.205729 °
				-121.557184 °	-121.557108 °
DWR ID	DWR_RD0556_02_f_2016_7				
Comment Code					
Inspector Comment					
2013 - Erosion pockets encroaching on levee foundation. 2015: No observed changes. [2015 Site ID: SAC_21-9_L]

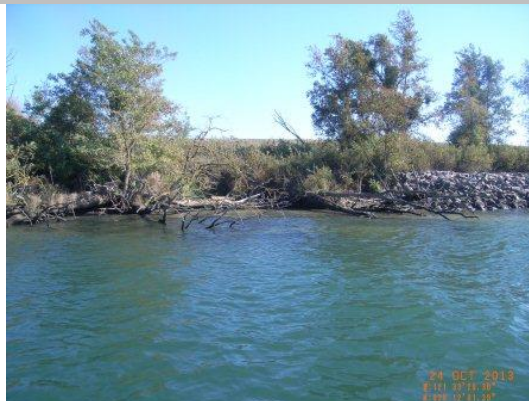
Photo 1 of 1 : FA_2017_RD0556_19_3_20171002_00003.jpg

LM Start	4.77	Rating **	A/W	Issue No.	3
LM End	4.88	Issue Type +	Ma	Location *	WS
Category	Supplemental			GPS Latitude/Longitude	
				Start	End
Item	2015 USACE Erosion Survey, DRAFT			38.201687 °	38.200225 °
				-121.557305 °	-121.557749 °
DWR ID	DWR_RD0556_02_f_2016_3				
Comment Code					
Inspector Comment					
1999 - Downstream 140 ft repaired with rock. 2010 - Lots of woody debris, but no changes to site. 2015: Site extended upstream due to erosion pockets. [2015 Site ID: SAC_21-5_L]
