**Flood Control Project Maintenance
Levee Inspections**

Maintenance Issue Types Only, Levee Inspection Report By Mile - Fall 2018

Reclamation District No. 0556 Upper Andrus

Waterway	Bank	Unit Miles	Inspection Start/End	Inspector
Unit No. 01 Georgiana Slough	Right	5.48	10/05/2018 10/05/2018	David Julian

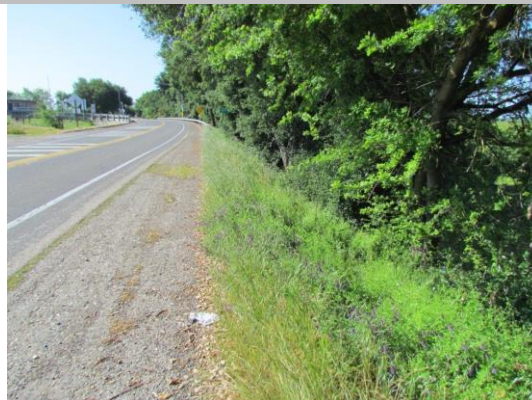
Photo 1 of 1 : FA_2018_RD0556_18_21_20180925_00003.jpg

LM Start	0.08	Rating **	U	Issue No.	21
LM End	0.58	Issue Type +	Ma	Location *	LS
Category	Earthen Levee			GPS Latitude/Longitude	
				Start	End
Item	Vegetation			38.238037°	38.231927°
				-121.518067°	-121.522215°
DWR ID	DWR_RD0556_01_s_2017_21				
Comment Code					
V7 : Trees / Woody Vegetation					
Inspector Comment					
Control the wild growth and trim the trees so the slope can be seen.

Looking downstream from levee mile 0.09 woody tree growth and wild weeds covering the levee slope and shoulder landside levee section.

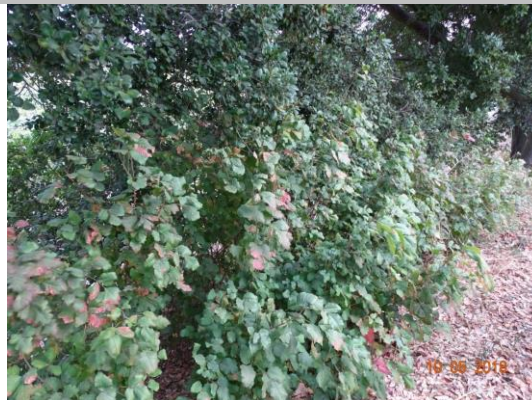
Photo 1 of 1 : FA_2018_RD0556_18_52_20181009_00066.jpg

View of poison oak at the top of the water land side slope (October 2018).

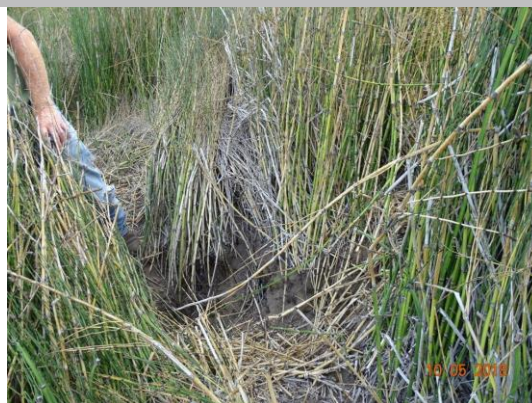
Photo 1 of 1 : FA_2018_RD0556_18_40_20181009_00067.jpg

View of erosion that is covered by vegetation on the land side slope (October 2018).

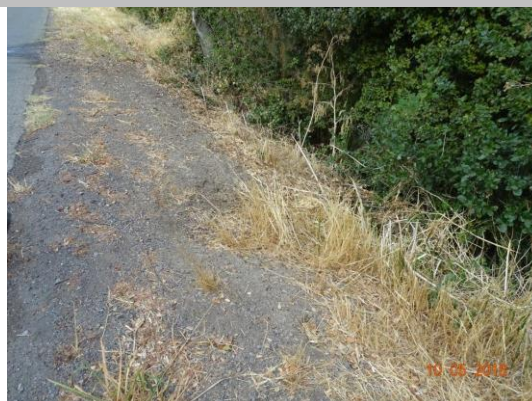
Photo 1 of 1 : FA_2018_RD0556_18_22_20181009_00068.jpg

View of dip at the top of the land side slope (October 2018).

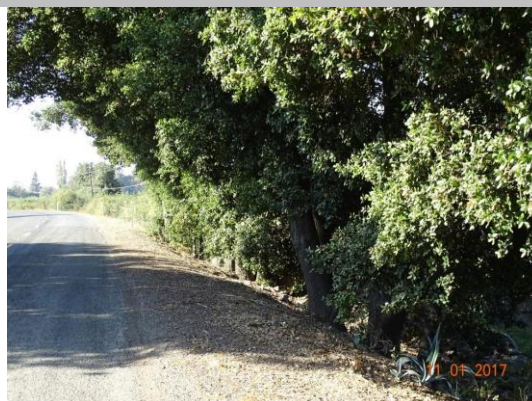
Photo 1 of 1 : FA_2018_RD0556_18_386_20180925_00032.jpg

LM Start	1.57	Rating **	M	Issue No.	386
LM End	1.65	Issue Type +	Ma	Location *	LS
Category	Earthen Levee			GPS Latitude/Longitude	
				Start	End
Item	Vegetation			38.224995 °	38.224623 °
				-121.535094 °	-121.536320 °
DWR ID	DWR_RD0556_01_f_2013_386				
Comment Code					
V2 : Remove the wild growth other than native grasses from the levee slopes.					
Inspector Comment

Remove the wild growth and trim trees from the landside levee slope.

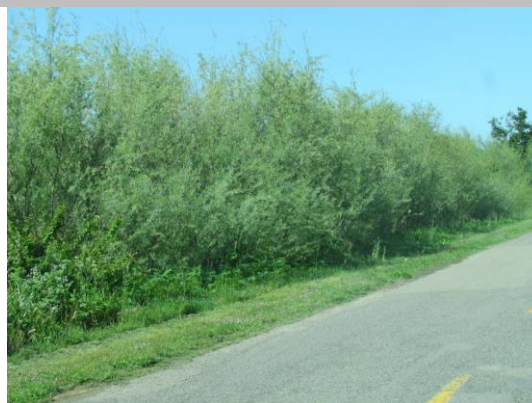
Photo 1 of 1 : FA_2018_RD0556_18_74_20180925_00031.jpg

RD 556 Unit 1 waterside levee mile 1.74-2.29.

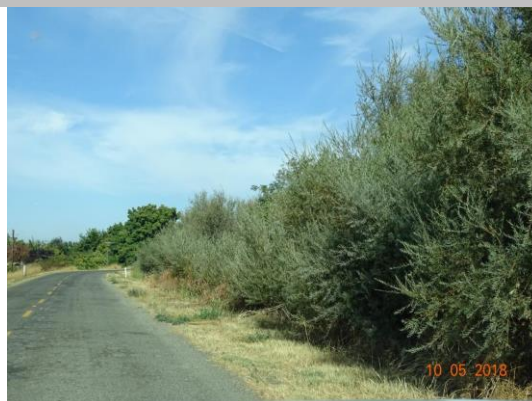
Photo 1 of 1 : FA_2018_RD0556_18_64_20181009_00073.jpg

View of vegetation on the water side slope (October 2018).

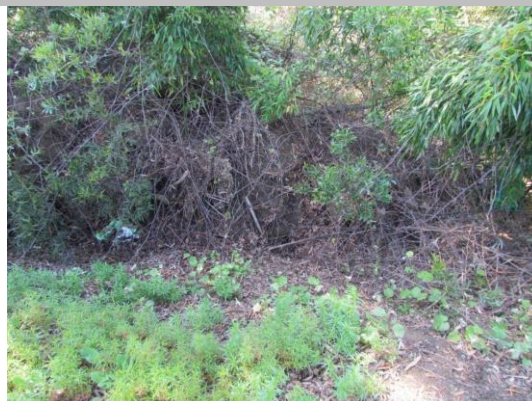
Photo 2 of 2 : FA_2018_RD0556_18_33_20180925_00018.jpg

RD 349 Unut 1 levee mile 2.72 the root ball of the fallen tree on slope landward.

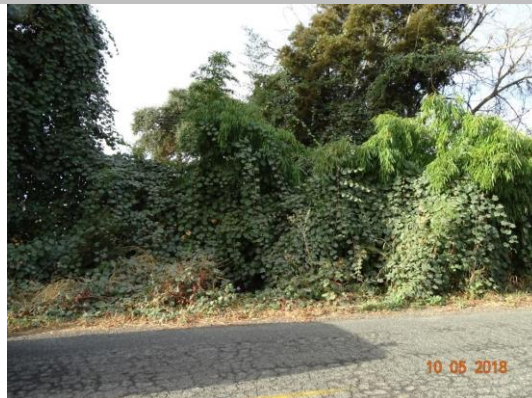
Photo 1 of 1 : FA_2018_RD0556_18_48_20181009_00070.jpg

View of thick vegetation on the land side slope (October 2018).

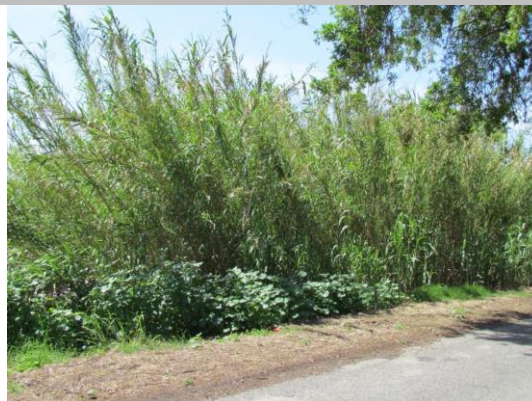
Photo 1 of 1 : FA_2018_RD0556_18_35_20180925_00020.jpg

RD 556 Unit 1 levee mile 3.12-3.14 waterside shoulder and slope.

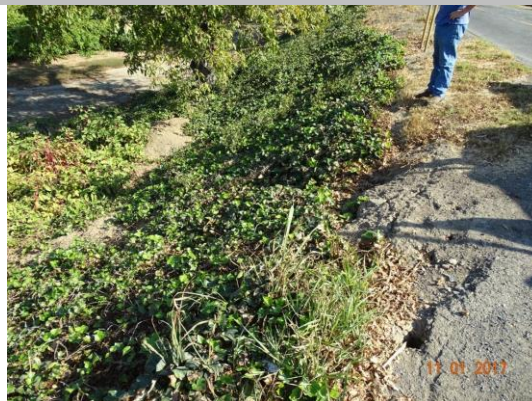
Photo 1 of 1 : FA_2018_RD0556_18_28_20180925_00012.jpg

Significant rodent activity in this area must be stopped. Holes should be backfilled.

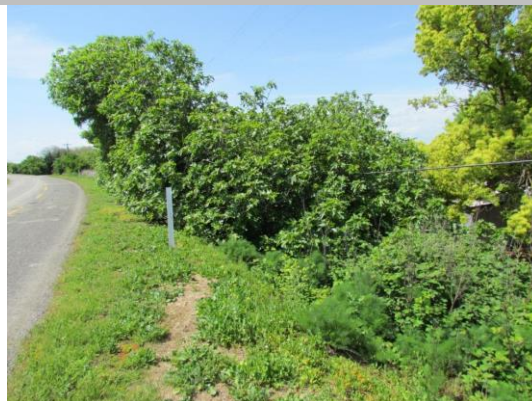
Photo 1 of 1 : FA_2018_RD0556_18_38_20180925_00021.jpg

556 Unit 1 levee mile 3.25-3.29 woody tree growth and vegetation blocking the view of the levee slope and toe.

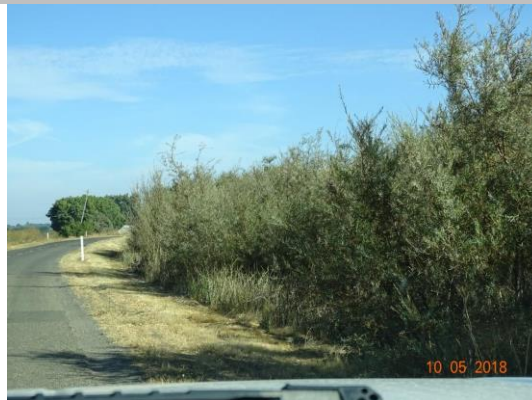
Photo 1 of 1 : FA_2018_RD0556_18_61_20181009_00071.jpg

LM Start	3.31	Rating **	U	Issue No.	61
LM End	3.84	Issue Type +	Ma	Location *	WS
Category	Earthen Levee			GPS Latitude/Longitude	
				Start	End
Item	Vegetation			38.209553 °	38.202133 °
				-121.540752 °	-121.540957 °
DWR ID	DWR_RD0556_01_f_2018_61				
Comment Code					
V2 : Remove the wild growth other than native grasses from the levee slopes.					
Inspector Comment					
Remove vegetation 20' from crown

View looking upstream on the water side slope (October 2018).

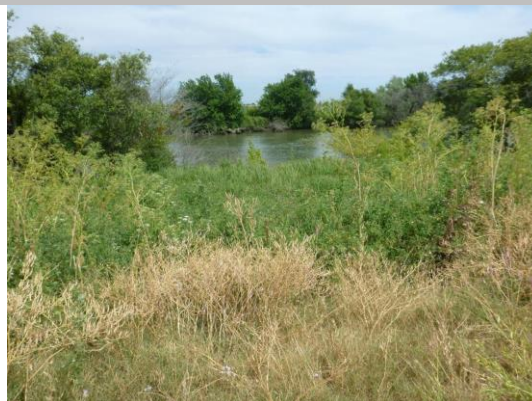
Photo 1 of 2 : FA_2018_RD0556_18_23_20180925_00004.jpg

LM Start	3.43	Rating **	A/W	Issue No.	23
LM End	3.75	Issue Type +	Ma	Location *	
Category	Supplemental			GPS Latitude/Longitude	
				Start	End
Item	2017 Storm Damage			38.208070 °	38.203400 °
				-121.541700 °	-121.540990 °
DWR ID	DWR_RD0556_01_f_2017_23				
Comment Code					
Inspector Comment					
Levee Evaluation Comments					
Description:					
Site ID No:67					
Site Designation:USACE_CESPK_UPA1_2011_p_0143					
Repair Type: Stability					
Rating:Area of Concern					
Field Date:2/7/2017					
Notes: inactive ditch on landside toe, slope covered in heavy vegetation, minor landside lower slope sloughing observed,

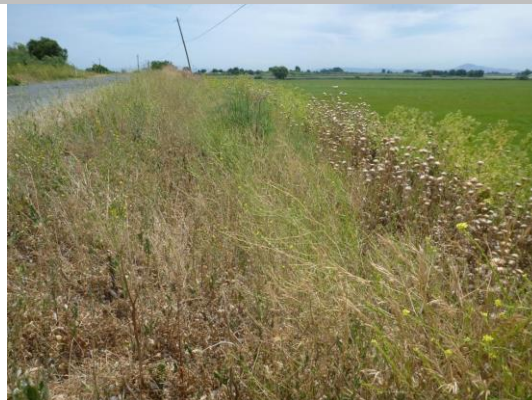
Photo 2 of 2 : FA_2018_RD0556_18_23_20180925_00005.jpg

LM Start	3.43	Rating **	A/W	Issue No.	23 (cont)	
LM End	3.75	Issue Type +	Ma	Location *		
Category	Supplemental			GPS Latitude/Longitude		
				Start		End
Item	2017 Storm Damage			38.208070 °		38.203400 °
				-121.541700 °		-121.540990 °
DWR ID	DWR_RD0556_01_f_2017_23					
Comment Code						
Inspector Comment						
Levee Evaluation Comments						
Description:						
Site ID No:67						
Site Designation:USACE_CESPK_UPA1_2011_p_0143						
Repair Type: Stability						
Rating:Area of Concern						
Field Date:2/7/2017						
Notes: inactive ditch on landside toe, slope covered in heavy vegetation, minor landside lower slope sloughing observed,

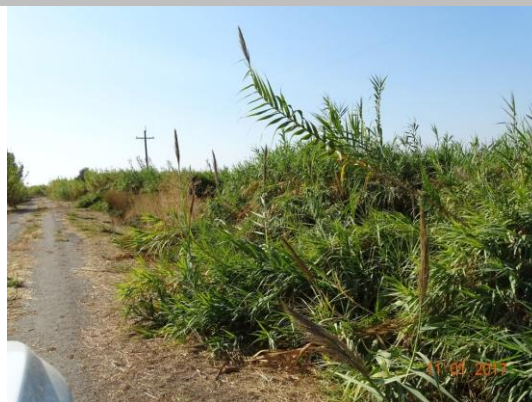
Photo 1 of 1 : FA_2018_RD0556_18_39_20180925_00022.jpg

LM Start	3.98	Rating **	U	Issue No.	39
LM End	5.48	Issue Type +	Ma	Location *	LS
Category	Earthen Levee			GPS Latitude/Longitude	
				Start	End
Item	Vegetation			38.201273 °	38.186464 °
				-121.543328 °	-121.562550 °
DWR ID	DWR_RD0556_01_f_2017_39				
Comment Code					
V2 : Remove the wild growth other than native grasses from the levee slopes.					
Inspector Comment					
Remove wild growth and arundo from landside slope and toe.

Control dense growth of wild vegetation, berry vines and arundo on landside to allow inspection and access.

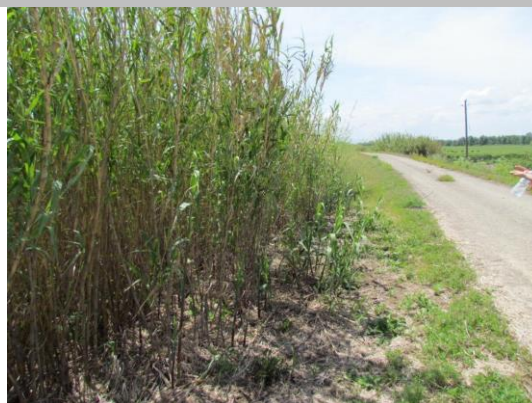
Photo 1 of 1 : FA_2018_RD0556_18_67_20180925_00030.jpg

Looking downstream on the wateside arundo completely blocking view of the slope and shoulder.

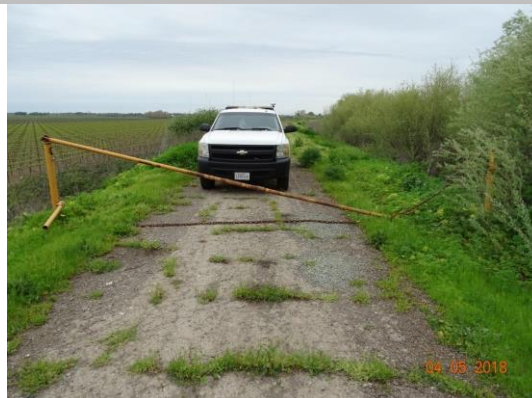
Photo 1 of 1 : FA_2018_RD0556_18_56_20180925_00029.jpg

LM Start	5.10	Rating **	U	Issue No.	56
LM End	5.10	Issue Type +	Ma	Location *	CR
Category	Earthen Levee			GPS Latitude/Longitude	
				Start	End
Item	Repair Gates			38.190157°	38.190157°
				-121.557555°	-121.557555°
DWR ID	DWR_RD0556_01_s_2018_56				
Comment Code					
Inspector Comment					
Gate needs repair or replacement.

Repair or replace broken gate.

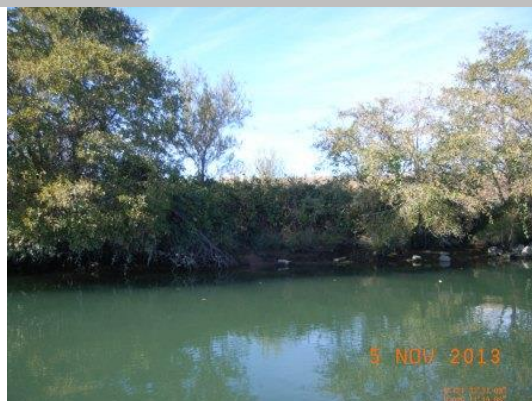
Photo 1 of 1 : FA_2018_RD0556_18_37_20181023_00008.jpg

LM Start	5.12	Rating **	M	Issue No.	37
LM End	5.34	Issue Type +	Ma	Location *	WS
Category	Supplemental			GPS Latitude/Longitude	
				Start	End
Item	2017 USACE Erosion Survey, DRAFT			38.189775°	38.187369°
				-121.557729°	-121.560247°
DWR ID	DWR_RD0556_01_f_2018_37				
Comment Code					
Inspector Comment					
2017 Site ID: GEO 7.0 R					
Status: Eroding					
2017 Field Notes: Site extended downstream. Large erosion pockets and significant toe erosion.					
Site History: 1997 - Toe damaged rock. 1999 - One pocket filled with gravel. 2000 - Eroding beach with some biotech rolls and stakes; some gravel on slope. 2001 - Staked, low fascine walls at bankline. 2005 - Stone revetment in between pockets. 2006 - New rock on upper slope behind brush boxes at the upstream end, Stone is sliding off the hard toe. 2016 - Fresh erosion observed.

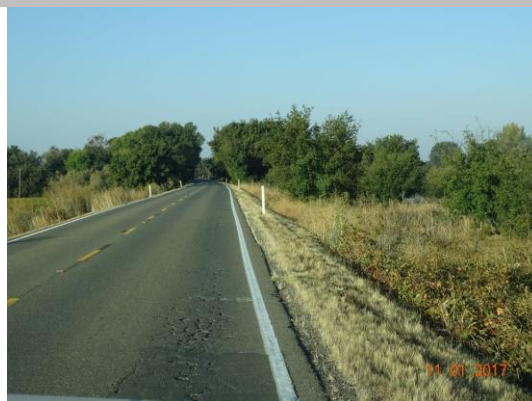
Photo 4 of 4 : FA_2018_RD0556_19_82_20180925_00023.jpg

Waterside levee slope and shoulder have been mowed to 20' from

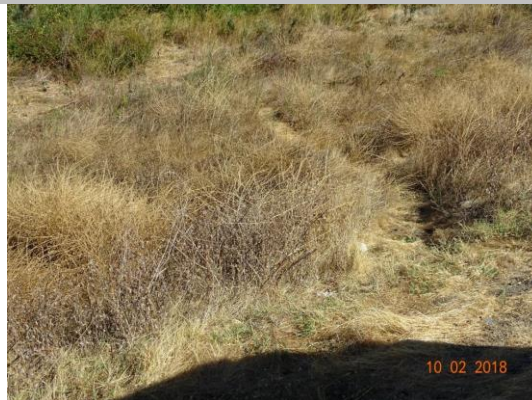
Photo 1 of 1 : FA_2018_RD0556_19_22_20181003_00061.jpg

LM Start	0.39	Rating **	A/W	Issue No.	22
LM End	0.39	Issue Type +	Ma	Location *	WS
Category	Earthen Levee			GPS Latitude/Longitude	
				Start	End
Item	Slope Stability			38.238292°	38.238292°
				-121.525362°	-121.525362°
DWR ID	DWR_RD0556_02_f_2018_22				
Comment Code					
S1 : Repair slope instability.					
Inspector Comment					
Foot path digging into levee should be monitored

View of footpath down the water side slope that is beginning to dig into levee (October 2018).

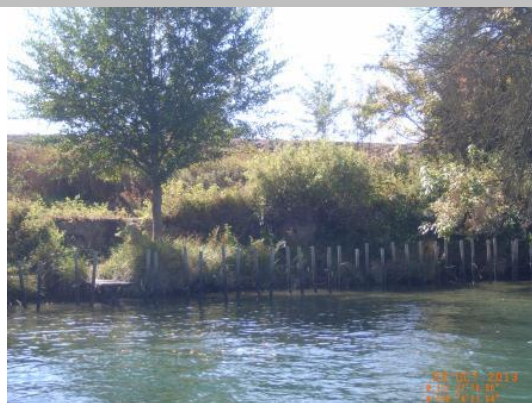
Photo 1 of 1 : FA_2018_RD0556_19_19_20181023_00081.jpg

LM Start	1.03	Rating **	M	Issue No.	19
LM End	1.15	Issue Type +	Ma	Location *	WS
Category	Supplemental			GPS Latitude/Longitude	
				Start	End
Item	2017 USACE Erosion Survey, DRAFT			38.238772 °	38.239265 °
				-121.536788 °	-121.538845 °
DWR ID	DWR_RD0556_02_f_2018_19				
Comment Code					
Inspector Comment					
2017 Site ID: SAC 25.2 L					
Status: Eroding					
2017 Field Notes: Minor new erosion observed.					
Site History: 1997 - Rock is in poor condition and has failed in many places. Scallops in berm with remnants of old rock in the toe area.					
2005 - Brush boxes present. 2013 - Site extended upstream approximately 300 ft to include new erosion pockets. 2015 - Minor new erosion at toe.

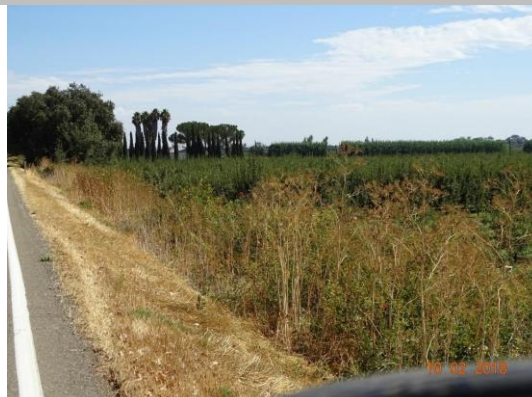
Photo 1 of 1 : FA_2018_RD0556_19_88_20181003_00076.jpg

LM Start	1.50	Rating **	M	Issue No.	88
LM End	1.68	Issue Type +	Ma	Location *	LS
Category	Earthen Levee			GPS Latitude/Longitude	
				Start	End
Item	Vegetation			38.240255 °	38.240832 °
				-121.545255 °	-121.548440 °
DWR ID	DWR_RD0556_02_f_2018_88				
Comment Code					
V1 : Control annual grass and weeds on the levee slopes and easements.					
Inspector Comment					
Remove vegetation from land side slope.

View looking downstream at vegetation on the land side slope (October 2018).

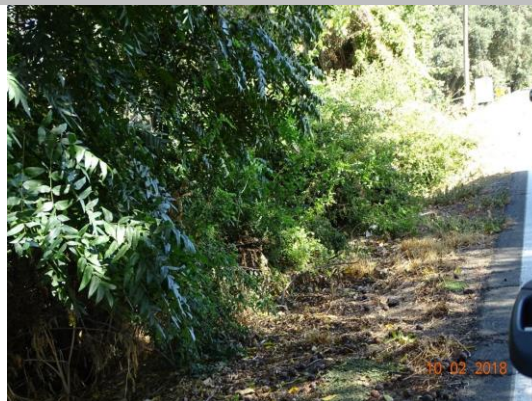
Photo 1 of 1 : FA_2018_RD0556_19_71_20181003_00064.jpg

View looking upstream at vegetation on water side slope (October 2018).

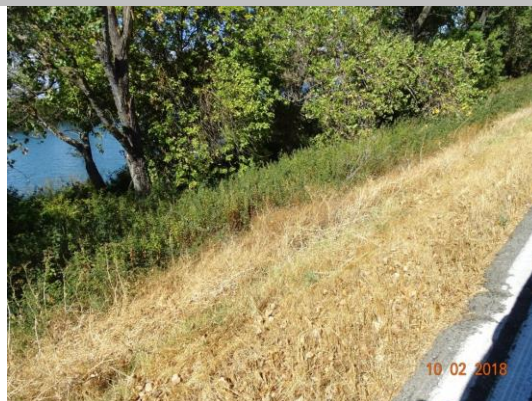
Photo 1 of 1 : FA_2018_RD0556_19_76_20181003_00065.jpg

View looking upstream at vegetation on the water side slope (October 2018).

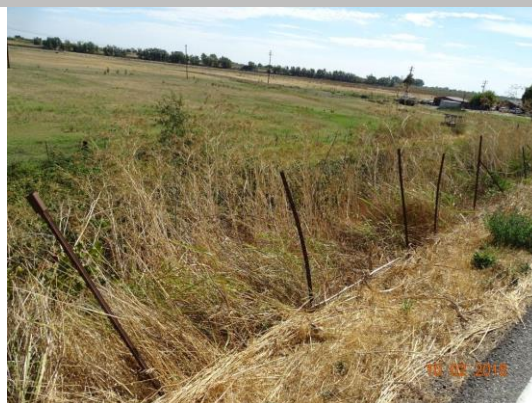
Photo 1 of 1 : FA_2018_RD0556_19_81_20181003_00071.jpg

View looking slightly downstream at vegetation on the land side slope (October 2018).

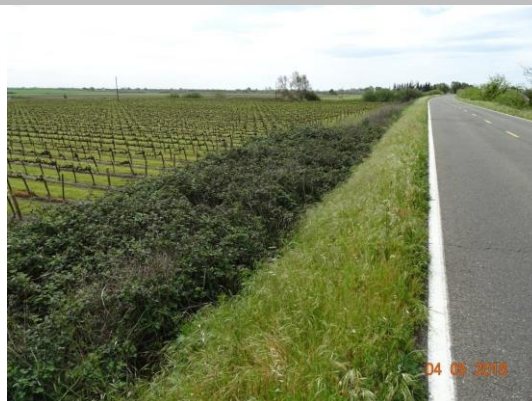
Photo 1 of 1 : FA_2018_RD0556_19_52_20180925_00016.jpg

LM Start	4.01	Rating **	U	Issue No.	52
LM End	4.38	Issue Type +	Ma	Location *	LS
Category	Earthen Levee			GPS Latitude/Longitude	
				Start	End
Item	Vegetation			38.212662 °	38.207293 °
				-121.556808 °	-121.556837 °
DWR ID	DWR_RD0556_02_s_2018_52

Berry vines on landside should be removed to allow inspection and access.

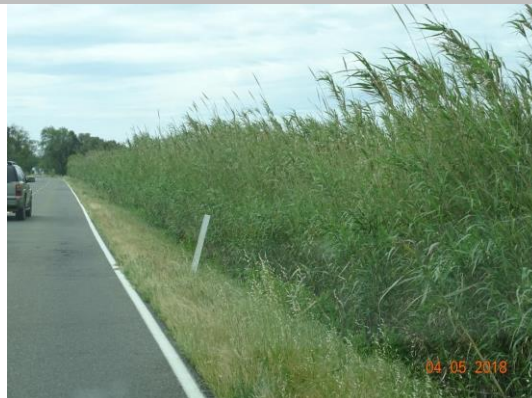
Photo 1 of 1 : FA_2018_RD0556_19_53_20180925_00017.jpg

Waterside arundo should be removed.

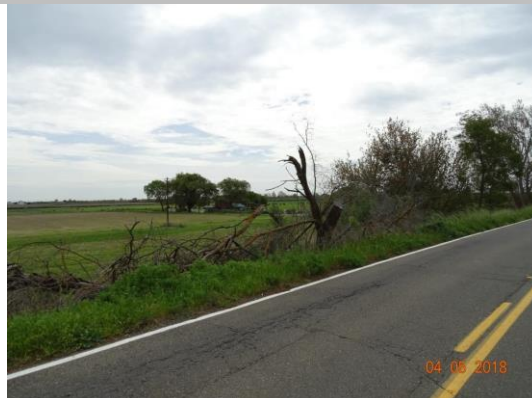
Photo 1 of 1 : FA_2018_RD0556_19_56_20180925_00019.jpg

Fallen tree on landside should be removed.

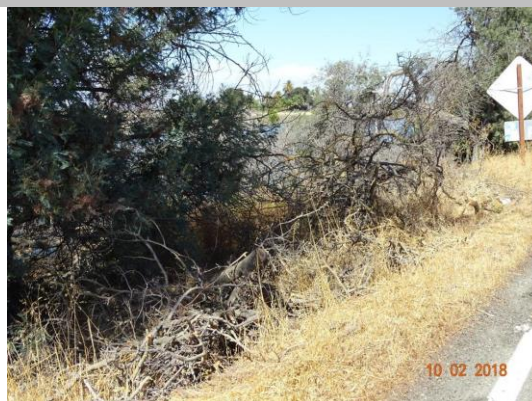
Photo 1 of 1 : FA_2018_RD0556_19_27_20181003_00068.jpg

LM Start	4.65	Rating **	M	Issue No.	27
LM End	4.65	Issue Type +	Ma	Location *	WS
Category	Earthen Levee			GPS Latitude/Longitude	
				Start	End
Item	Encroachments			38.203425 °	38.203425 °
				-121.556845 °	-121.556845 °
DWR ID	DWR_RD0556_02_s_2017_27				
Comment Code					
TR : Tree or limb					
Inspector Comment					
Remove fallen tree.

View of fallen tree on the water side slope (October 2018).

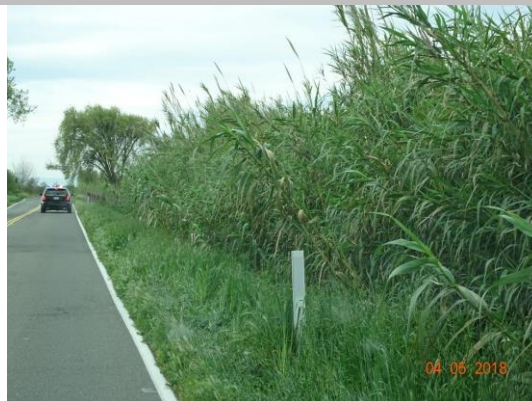
Photo 1 of 1 : FA_2018_RD0556_19_59_20180925_00020.jpg

Remove waterside arundo.

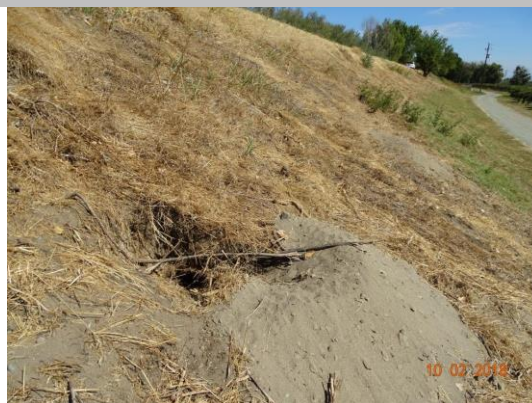
Photo 1 of 1 : FA_2018_RD0556_19_79_20181003_00069.jpg

View looking upstream at burrow holes on land side slope. More than cubic feet of soil was removed between the two burrow holes (October 2018).
