**Flood Control Project Maintenance  
Levee Inspections**

## Maintenance Issue Types Only, Levee Inspection Report By Mile - Fall 2019

### Reclamation District No. 0556 Upper Andrus

Waterway	Bank	Unit Miles	Inspection Start/End	Inspector
Unit No. 01 Georgiana Slough	Right	5.48	10/18/2019 10/18/2019	David Julian

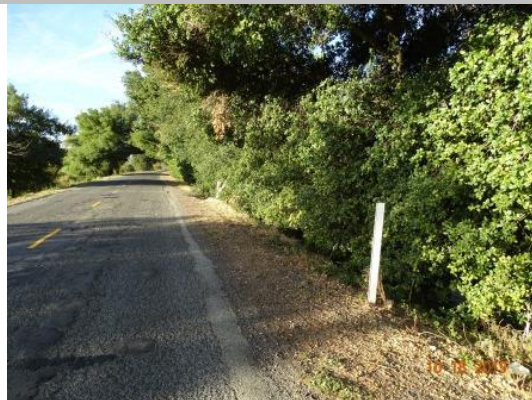
Photo 1 of 1 : FA\_2019\_RD0556\_18\_21\_20191021\_00063.jpg

LM Start	0.08	Rating **	U	Issue No.	21
LM End	0.58	Issue Type +	Ma	Location *	LS
Category	Earthen Levee			GPS Latitude/Longitude	
				Start	End
Item	Trim / Thin Trees			38.238037°	38.231927°
				-121.518067°	-121.522215°
DWR ID	DWR_RD0556_01_s_2017_21				
Comment Code					
T2 : Thin trees to allow visibility of the ground and room to flood fight.					
Inspector Comment					
Control the wild growth and trim the trees so the slope can be seen.

View looking downstream at thick trees on the landside slope (Fall 2019).

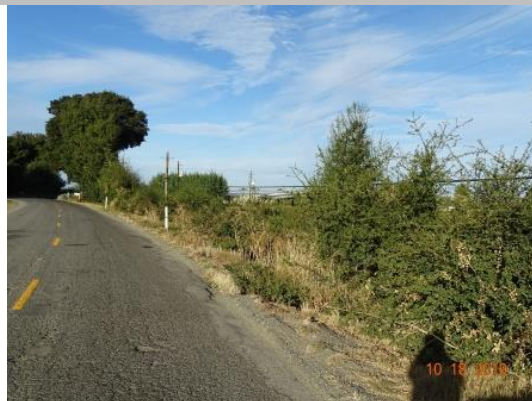
Photo 1 of 1 : FA\_2019\_RD0556\_18\_49\_20191021\_00064.jpg

LM Start	1.26	Rating **	U	Issue No.	49
LM End	1.58	Issue Type +	Ma	Location *	LS
Category	Earthen Levee			GPS Latitude/Longitude	
				Start	End
Item	Vegetation			38.228020 °	38.224923 °
				-121.530930 °	-121.535153 °
DWR ID	DWR_RD0556_01_f_2019_49				
Comment Code					
V2 : Remove the wild growth other than native grasses from the levee slopes.					
Inspector Comment

View looking downstream at thick vegetation the landside slope (Fall 2019).

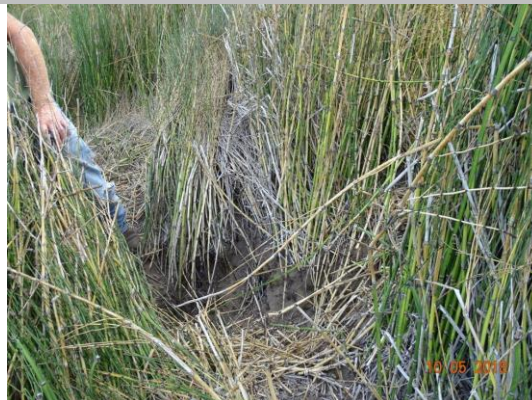
Photo 1 of 1 : FA\_2019\_RD0556\_18\_40\_20190826\_00024.jpg

LM Start	1.43	Rating **	M	Issue No.	40
LM End	1.43	Issue Type +	Ma	Location *	LS
Category	Earthen Levee			GPS Latitude/Longitude	
				Start	End
Item	Erosion / Bank Caving			38.226537 °	38.226537 °
				-121.533512 °	-121.533512 °
DWR ID	DWR_RD0556_01_f_2012_40				
Comment Code					
E1 : Note and monitor erosion site.					
Inspector Comment					
Erosion is covered by vegetation.

View of erosion that is covered by vegetation on the landside slope (October 2018).

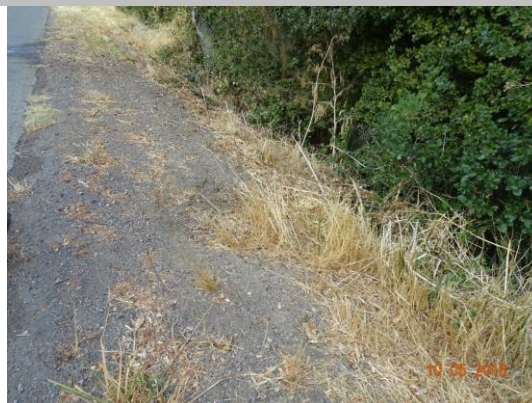
Photo 1 of 1 : FA\_2019\_RD0556\_18\_22\_20190826\_00003.jpg

LM Start	1.50	Rating **	M	Issue No.	22
LM End	1.50	Issue Type +	Ma	Location *	LS
Category	Earthen Levee			GPS Latitude/Longitude	
				Start	End
Item	Erosion / Bank Caving			38.225840 °	38.225840 °
				-121.534157 °	-121.534157 °
DWR ID	DWR_RD0556_01_s_2012_22				
Comment Code					
E1 : Note and monitor erosion site.					
Inspector Comment					
Dip at the top of the landside slope is greater than 3".

View of dip at the top of the landside slope (October 2018).

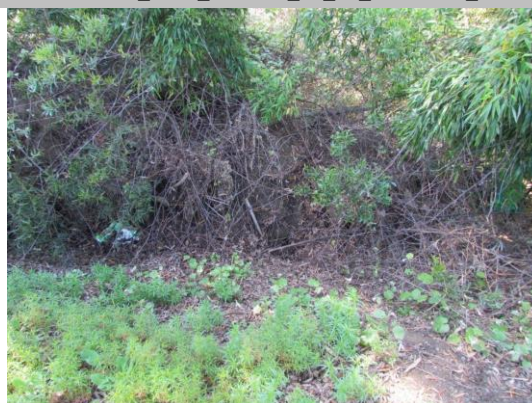
Photo 2 of 2 : FA\_2019\_RD0556\_18\_33\_20190826\_00018.jpg

View of the root ball of the fallen tree on slope landward.

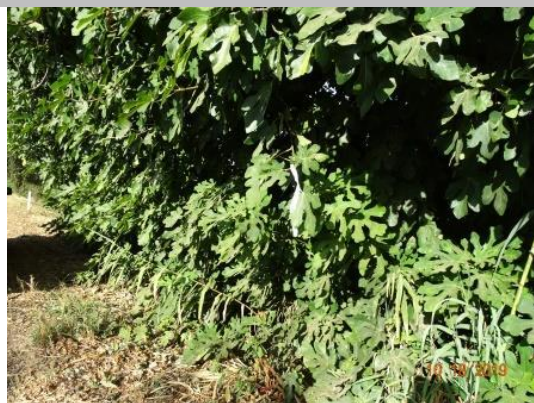
Photo 1 of 1 : FA\_2019\_RD0556\_18\_55\_20191021\_00069.jpg

View of fig tree on the landside slope (Fall 2019).

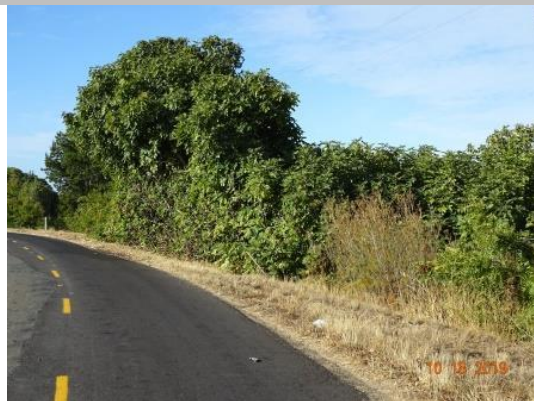
Photo 1 of 1 : FA\_2019\_RD0556\_18\_38\_20191021\_00070.jpg

LM Start	3.22	Rating **	U	Issue No.	38
LM End	3.29	Issue Type +	Ma	Location *	LS
Category	Earthen Levee			GPS Latitude/Longitude	
				Start	End
Item	Trim / Thin Trees			38.210493 °	38.209842 °
				-121.539760 °	-121.540658 °
DWR ID	DWR_RD0556_01_s_2017_38				
Comment Code					
T2 : Thin trees to allow visibility of the ground and room to flood fight.					
Inspector Comment					
Remove the wild tree growth and vegetation from the landside levee slope and toe so the ground can be seen.

View looking downstream at thick tree growth on the landside slope (Fall 2019).

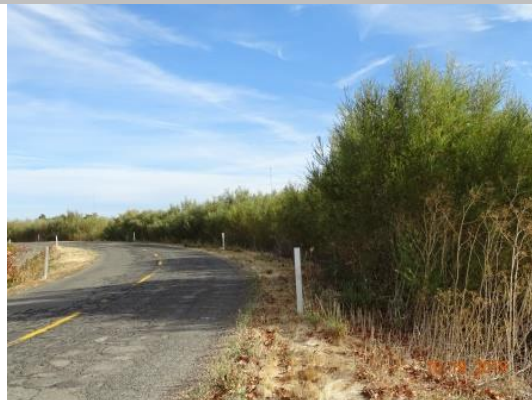
Photo 1 of 1 : FA\_2019\_RD0556\_18\_57\_20191021\_00076.jpg

View looking upstream at thick vegetation on the waterside slope (Fall 2019).

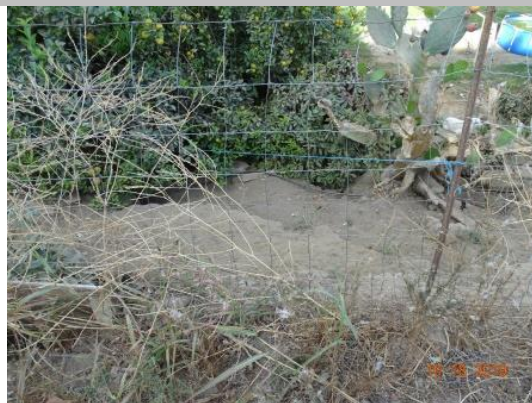
Photo 1 of 2 : FA\_2019\_RD0556\_18\_56\_20191021\_00072.jpg

LM Start	3.41	Rating **	U	Issue No.	56
LM End	3.41	Issue Type +	Ma	Location *	LS
Category	Earthen Levee			GPS Latitude/Longitude	
				Start	End
Item	Slope Stability			38.208210 °	38.208210 °
				-121.541588 °	-121.541588 °
DWR ID	DWR_RD0556_01_f_2019_56				
Comment Code					
S2 : Repair the levee slope damaged by foot traffic and prevent access where possible.					
Inspector Comment					
Slope worn down by goats

View looking downslope at levee terracing on the landside slope due to goats (Fall 2019).

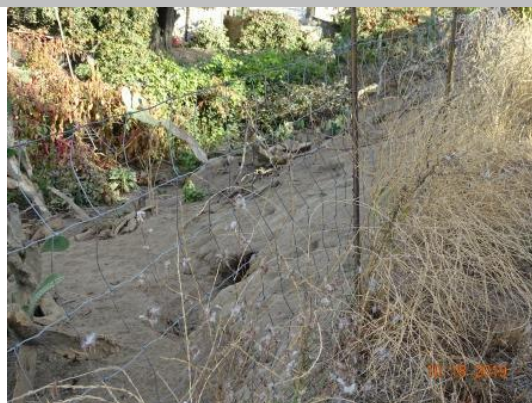
Photo 2 of 2 : FA\_2019\_RD0556\_18\_56\_20191021\_00073.jpg

View looking upstream at levee terracing on the landside slope due to goats (Fall 2019).

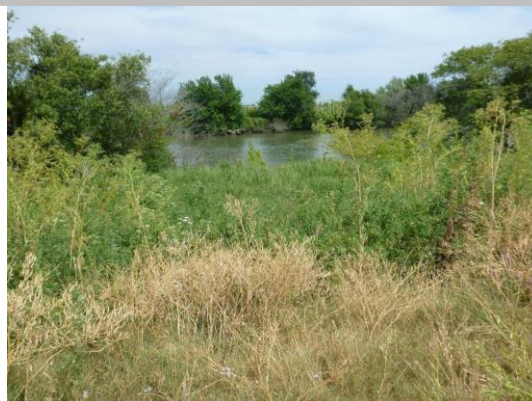
Photo 1 of 2 : FA\_2019\_RD0556\_18\_23\_20190826\_00004.jpg

LM Start	3.43	Rating **	A/W	Issue No.	23
LM End	3.75	Issue Type +	Ma	Location *	LS
Category	Supplemental			GPS Latitude/Longitude	
				Start	End
Item	2017 Storm Damage			38.208070 °	38.203400 °
				-121.541700 °	-121.540990 °
DWR ID	USACE_CESPK_UPA1_2011_p_0143				
Comment Code					
Inspector Comment					
Levee Evaluation Comments					
Description:					
Site ID No:67					
Site Designation:USACE_CESPK_UPA1_2011_p_0143					
Repair Type: Stability					
Rating:Area of Concern					
Field Date:2/7/2017					
Notes: inactive ditch on landside toe, slope covered in heavy vegetation, minor landside lower slope sloughing observed.

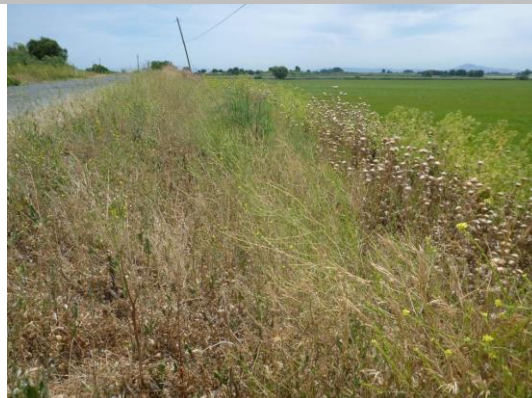
Photo 2 of 2 : FA\_2019\_RD0556\_18\_23\_20190826\_00005.jpg

LM Start	3.43	Rating **	A/W	Issue No.	23 (cont)
LM End	3.75	Issue Type +	Ma	Location *	LS
Category	Supplemental			GPS Latitude/Longitude	
				Start	End
Item	2017 Storm Damage			38.208070 °	38.203400 °
				-121.541700 °	-121.540990 °
DWR ID	USACE_CESPK_UPA1_2011_p_0143				
Comment Code					
Inspector Comment					
Levee Evaluation Comments					
Description:					
Site ID No:67					
Site Designation:USACE_CESPK_UPA1_2011_p_0143					
Repair Type: Stability					
Rating:Area of Concern					
Field Date:2/7/2017					
Notes: inactive ditch on landside toe, slope covered in heavy vegetation, minor landside lower slope sloughing observed,

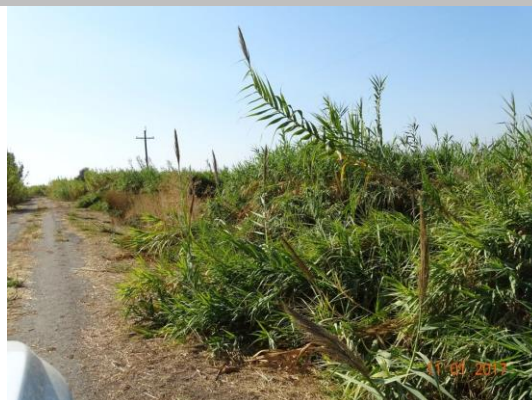
Photo 1 of 1 : FA\_2019\_RD0556\_18\_39\_20190826\_00023.jpg

LM Start	3.98	Rating **	U	Issue No.	39
LM End	5.10	Issue Type +	Ma	Location *	LS
Category	Earthen Levee			GPS Latitude/Longitude	
				Start	End
Item	Vegetation			38.201273 °	38.190115 °
				-121.543328 °	-121.557642 °
DWR ID	DWR_RD0556_01_f _ 2017_39				
Comment Code					
V2 : Remove the wild growth other than native grasses from the levee slopes.					
Inspector Comment					
Remove wild growth including berry vines and arundo from landside slope and toe to allow for inspection and access.

View of dense growth of wild vegetation, berry vines and arundo on landside slope and toe

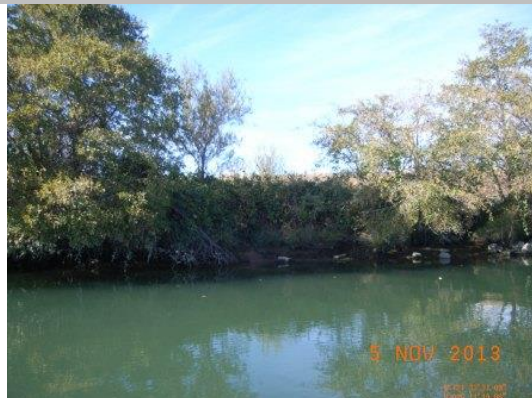
Photo 1 of 1 : FA\_2019\_RD0556\_18\_37\_20190826\_00021.jpg

LM Start	5.12	Rating **	M	Issue No.	37
LM End	5.34	Issue Type +	Ma	Location *	WS
Category	Supplemental			GPS Latitude/Longitude	
				Start	End
Item	2017 USACE Erosion Survey			38.189775°	38.187369°
				-121.557729°	-121.560247°
DWR ID	DWR_RD0556_01_f_2018_37				
Comment Code					
Inspector Comment					
2017 Site ID: GEO 7.0 R					
Status: Eroding					
2017 Field Notes: Site extended downstream. Large erosion pockets and significant toe erosion.					
Site History: 1997 - Toe damaged rock. 1999 - One pocket filled with gravel. 2000 - Eroding beach with some biotech rolls and stakes; some gravel on slope. 2001 - Staked, low fascine walls at bankline. 2005 - Stone revetment in between pockets. 2006 - New rock on upper slope behind brush boxes at the upstream end, Stone is sliding off the hard toe. 2016 - Fresh erosion observed.

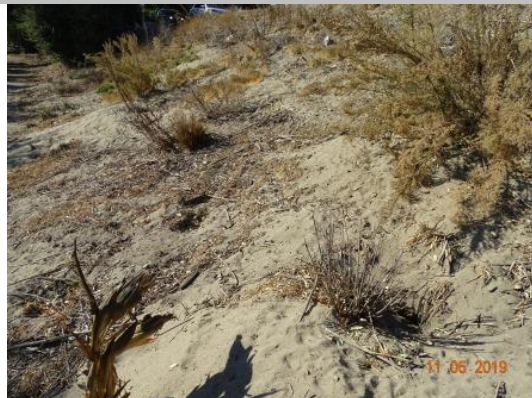
Photo 1 of 1 : FA\_2019\_RD0556\_19\_92\_20191107\_00103.jpg

View of multiple fresh squirrel holes in the landside slope (Fall 2019).

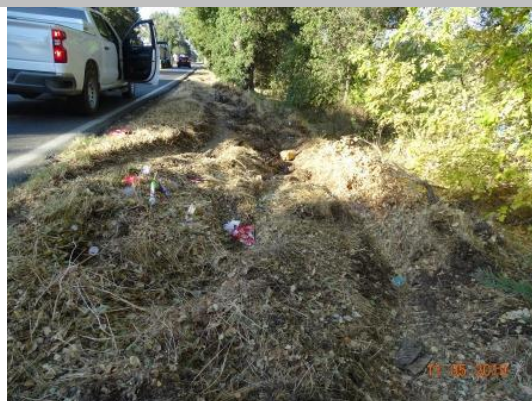
Photo 1 of 1 : FA\_2019\_RD0556\_19\_20\_20191107\_00080.jpg

LM Start	0.04	Rating **	U	Issue No.	20
LM End	0.04	Issue Type +	Ma	Location *	WS
Category	Earthen Levee			GPS Latitude/Longitude	
				Start	End
Item	Slope Stability			38.239167°	38.239167°
				-121.519040°	-121.519040°
DWR ID	DWR_RD0556_02_f_2019_20				
Comment Code					
S3 : Repair the levee slope damaged by vehicle traffic and prevent access where possible.					
Inspector Comment

View looking downstream at vehicle damage to the waterside slope (Fall 2019).

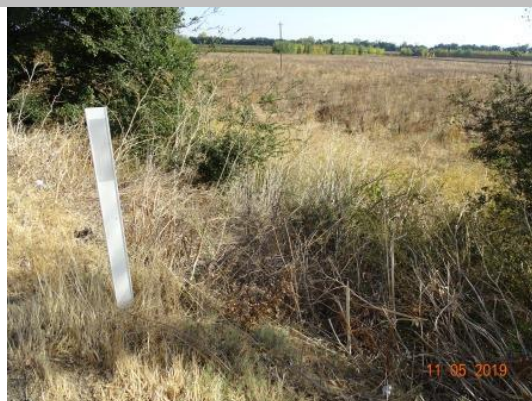
Photo 1 of 1 : FA\_2019\_RD0556\_19\_91\_20191107\_00102.jpg

View of thick vegetation on the landside slope (Fall 2019).

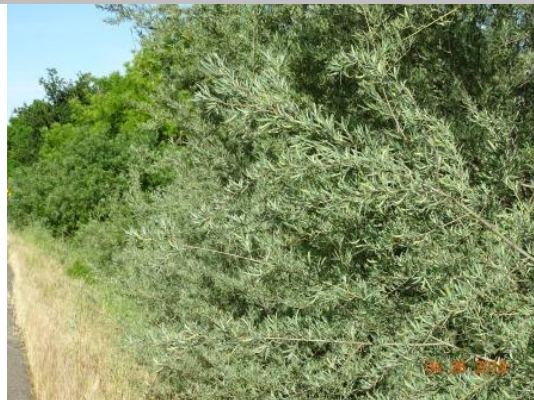
Photo 1 of 1 : FA\_2019\_RD0556\_19\_51\_20190826\_00030.jpg

View looking downstream at wildgrowth on the waterside slope (Spring 2019).

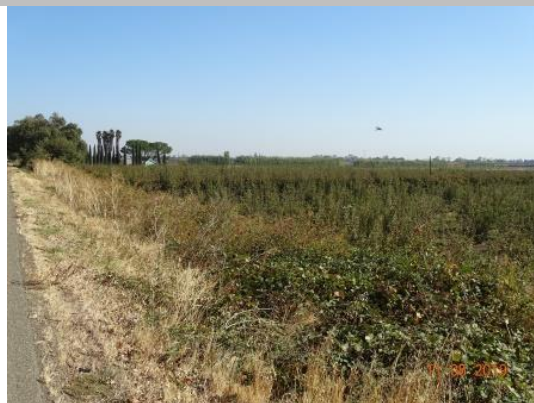
Photo 1 of 1 : FA\_2019\_RD0556\_19\_90\_20191107\_00101.jpg

View looking upstream at thick vegetation on the landside slope (Fall 2019).

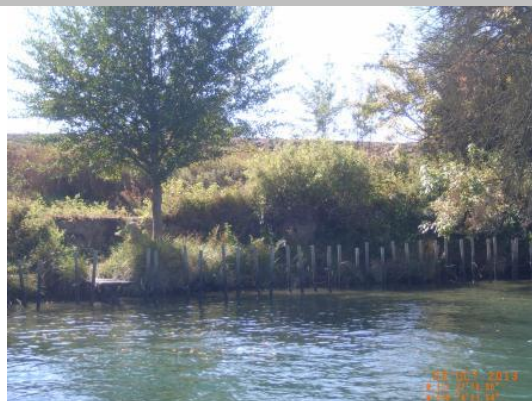
Photo 1 of 1 : FA\_2019\_RD0556\_19\_19\_20190826\_00007.jpg

LM Start	1.03	Rating **	M	Issue No.	19
LM End	1.15	Issue Type +	Ma	Location *	WS
Category	Supplemental			GPS Latitude/Longitude	
				Start	End
Item	2017 USACE Erosion Survey			38.238772 °	38.239265 °
				-121.536788 °	-121.538845 °
DWR ID	DWR_RD0556_02_f_2018_19				
Comment Code					
Inspector Comment					
2017 Site ID: SAC 25.2 L					
Status: Eroding					
2017 Field Notes: Minor new erosion observed.					
Site History: 1997 - Rock is in poor condition and has failed in many places. Scallops in berm with remnants of old rock in the toe area.					
2005 - Brush boxes present. 2013 - Site extended upstream approximately 300 ft to include new erosion pockets. 2015 - Minor new erosion at toe.

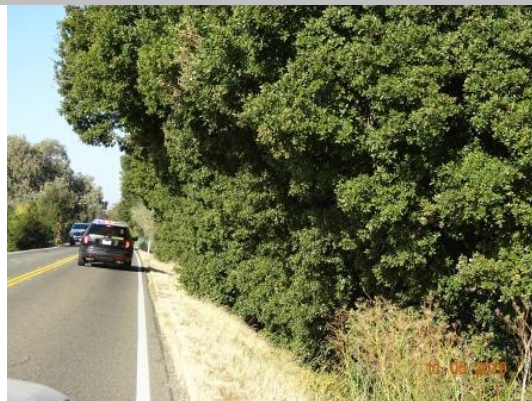
Photo 1 of 1 : FA\_2019\_RD0556\_19\_65\_20191107\_00082.jpg

View looking downstream at thick trees on the waterside slope (Fall 2019).

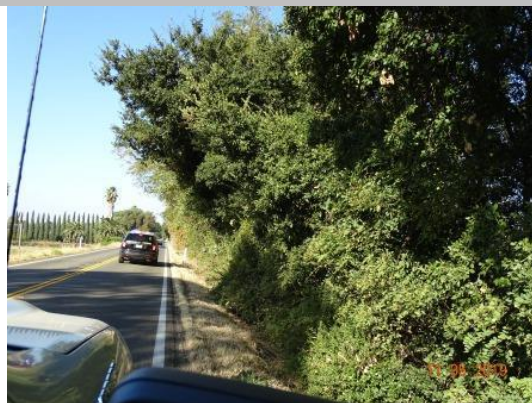
Photo 1 of 1 : FA\_2019\_RD0556\_19\_66\_20191107\_00083.jpg

LM Start	1.37	Rating **	U	Issue No.	66
LM End	1.43	Issue Type +	Ma	Location *	WS
Category	Earthen Levee			GPS Latitude/Longitude	
				Start	End
Item	Trim / Thin Trees			38.239888°	38.240080°
				-121.542833°	-121.543942°
DWR ID	DWR_RD0556_02_f_2019_66				
Comment Code					
T1 : Trim trees to at least five feet above ground level.					
Inspector Comment

View looking downstream at thick trees on the waterside slope (Fall 2019).

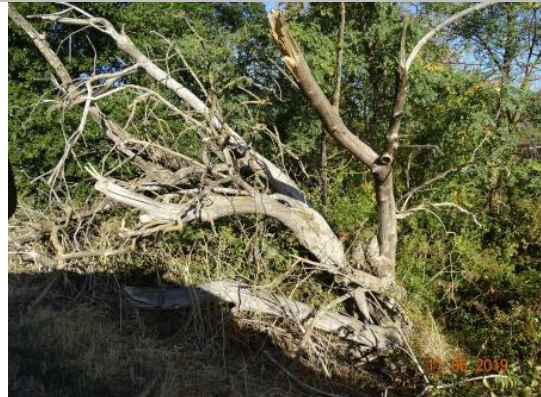
Photo 1 of 1 : FA\_2019\_RD0556\_19\_48\_20191107\_00084.jpg

LM Start	1.46	Rating **	U	Issue No.	48
LM End	1.46	Issue Type +	Ma	Location *	WS
Category	Earthen Levee			GPS Latitude/Longitude	
				Start	End
Item	Encroachments			38.240157 °	38.240157 °
				-121.544530 °	-121.544530 °
DWR ID	DWR_RD0556_02_f _ 2019_48				
Comment Code					
TR : Tree or limb					
Inspector Comment					
Remove down dead tree on waterside slope

View of downed dead tree on the waterside slope (Fall 2019).

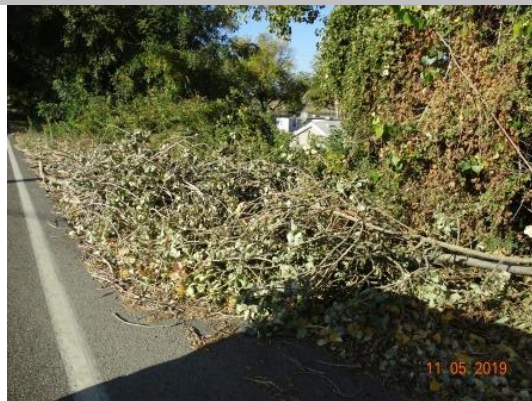
Photo 1 of 1 : FA\_2019\_RD0556\_19\_50\_20191107\_00085.jpg

View of down tree limbs on the waterside shoulder (Fall 2019).

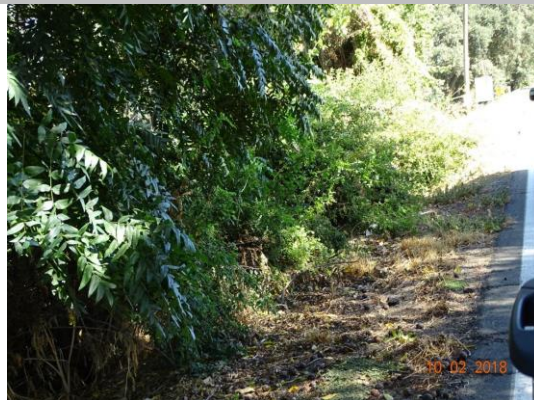
Photo 1 of 1 : FA\_2019\_RD0556\_19\_71\_20190826\_00038.jpg

View looking upstream at vegetation on waterside slope (October 2018).

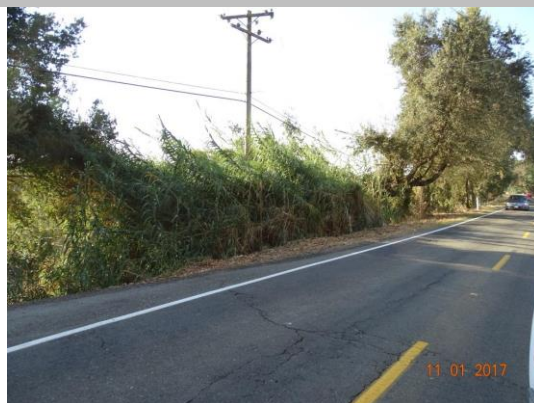
Photo 1 of 1 : FA\_2019\_RD0556\_19\_32\_20190826\_00017.jpg

LM Start	2.06	Rating **	U	Issue No.	32
LM End	2.06	Issue Type +	Ma	Location *	LS
Category	Earthen Levee			GPS Latitude/Longitude	
				Start	End
Item	Vegetation			38.239470 °	38.239470 °
				-121.554845 °	-121.554845 °
DWR ID	DWR_RD0556_02_f_2017_32				
Comment Code					
V2 : Remove the wild growth other than native grasses from the levee slopes.					
Inspector Comment					
Arundo growth should be removed to allow inspection and access to the landside slope and toe.

View of arundo on the landside slope and toe.

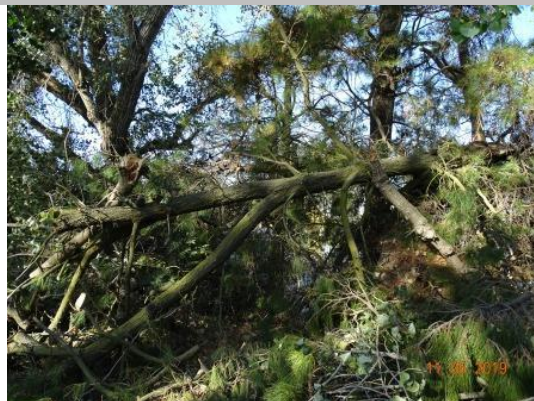
Photo 1 of 1 : FA\_2019\_RD0556\_19\_57\_20191107\_00086.jpg

LM Start	2.12	Rating **	U	Issue No.	57
LM End	2.12	Issue Type +	Ma	Location *	WS
Category	Earthen Levee			GPS Latitude/Longitude	
				Start	End
Item	Encroachments			38.238887 °	38.238887 °
				-121.555570 °	-121.555570 °
DWR ID	DWR_RD0556_02_f_2019_57				
Comment Code					
TR : Tree or limb					
Inspector Comment					
Remove downed tree.

Down tree on the waterside shoulder (Fall 2019).

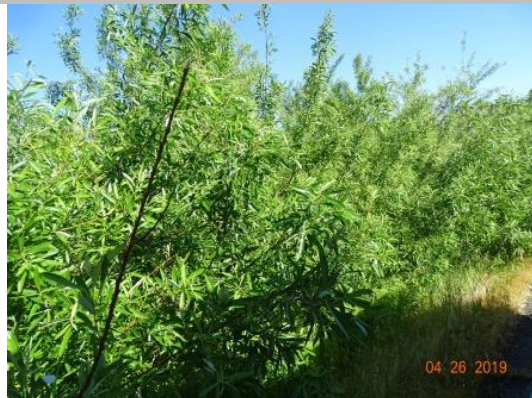
Photo 2 of 2 : FA\_2019\_RD0556\_19\_76\_20190826\_00040.jpg

View looking upstream at thick wildgrowth on the waterside slope (Spring 2019).

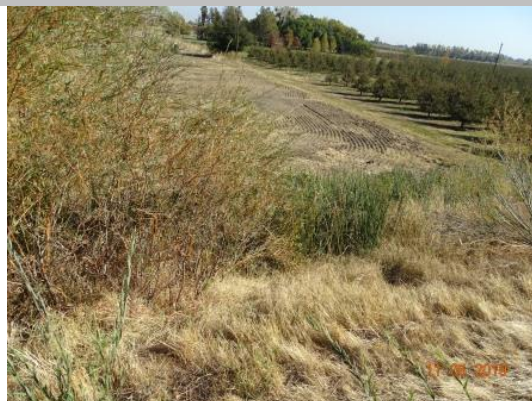
Photo 1 of 1 : FA\_2019\_RD0556\_19\_86\_20191107\_00098.jpg

LM Start	2.90	Rating **	U	Issue No.	86
LM End	3.26	Issue Type +	Ma	Location *	LS
Category	Earthen Levee			GPS Latitude/Longitude	
				Start	End
Item	Vegetation			38.228627 °	38.223450 °
				-121.555220 °	-121.555398 °
DWR ID	DWR_RD0556_02_f_2019_86				
Comment Code					
V2 : Remove the wild growth other than native grasses from the levee slopes.					
Inspector Comment

View of thick vegetation on the landside slope (Fall 2019).

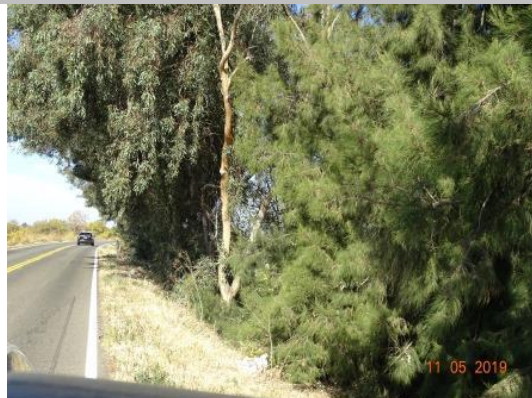
Photo 1 of 1 : FA\_2019\_RD0556\_19\_84\_20191107\_00097.jpg

View looking upstream at thick trees on the landside slope (Fall 2019).

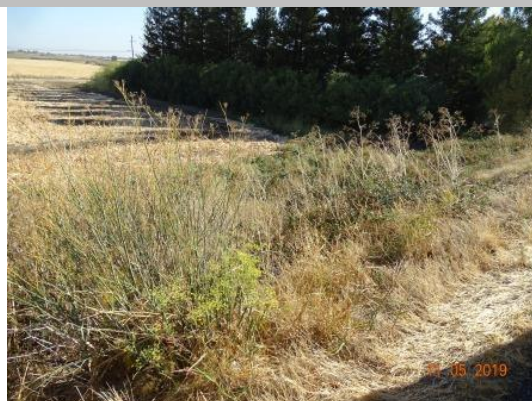
Photo 1 of 1 : FA\_2019\_RD0556\_19\_52\_20191107\_00096.jpg

View of vegetation on the landside slope. Weeds are obscuring the large blackberry vines at the landside toe (Fall 2019).

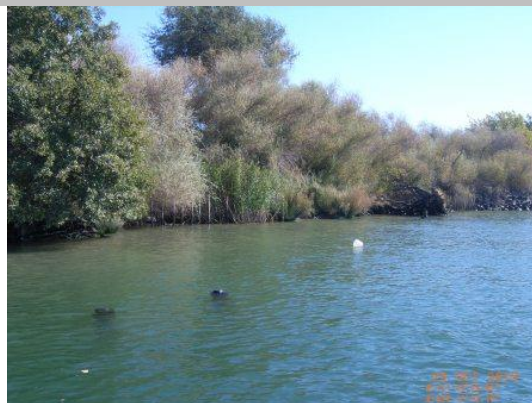
Photo 1 of 1 : FA\_2019\_RD0556\_19\_14\_20190826\_00002.jpg

LM Start	4.45	Rating **	M	Issue No.	14
LM End	4.49	Issue Type +	Ma	Location *	WS
Category	Supplemental			GPS Latitude/Longitude	
				Start	End
Item	2017 USACE Erosion Survey			38.206377°	38.205729°
				-121.557184°	-121.557108°
DWR ID	DWR_RD0556_02_f_2018_14				
Comment Code					
Inspector Comment					
2017 Site ID: SAC 21.9 L					
Status: Eroding					
2017 Field Notes: No observed change..					
Site History: 2013 - Erosion pockets encroaching on levee foundation.

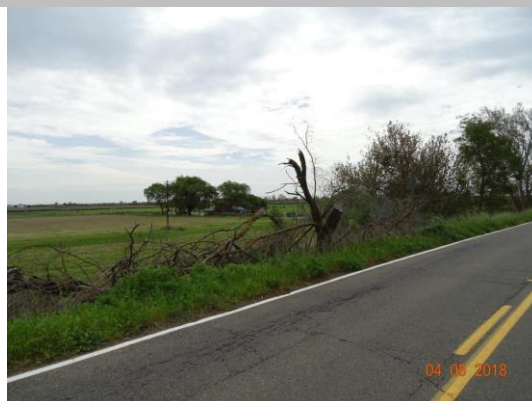
Photo 1 of 1 : FA\_2019\_RD0556\_19\_56\_20190826\_00033.jpg

Fallen tree on landside should be removed.

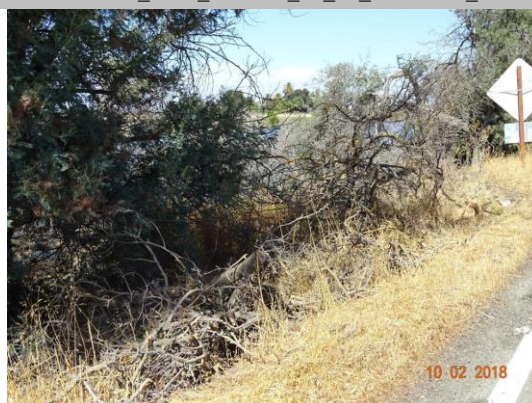
Photo 1 of 1 : FA\_2019\_RD0556\_19\_27\_20190826\_00012.jpg

View of fallen tree on the waterside slope (October 2018).

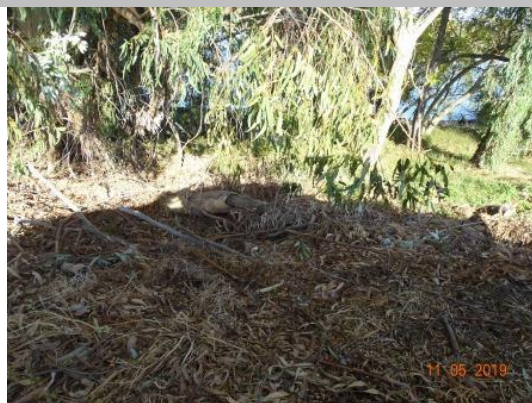
Photo 1 of 1 : FA\_2019\_RD0556\_19\_69\_20191107\_00090.jpg

View of large fallen tree limbs on the waterside shoulder. Leaves are obscuring the largest branches (Fall 2019).

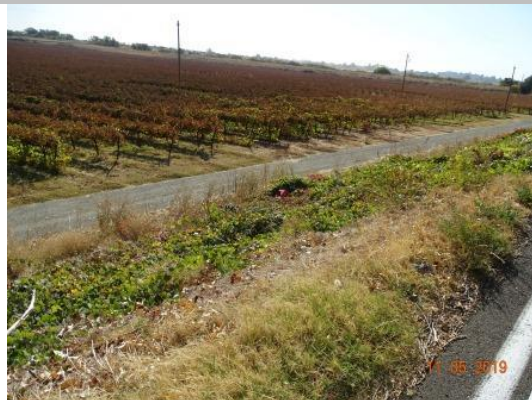
Photo 1 of 1 : FA\_2019\_RD0556\_19\_81\_20191107\_00093.jpg

View looking downstream at blackberries at the landside toe (Fall 2019).

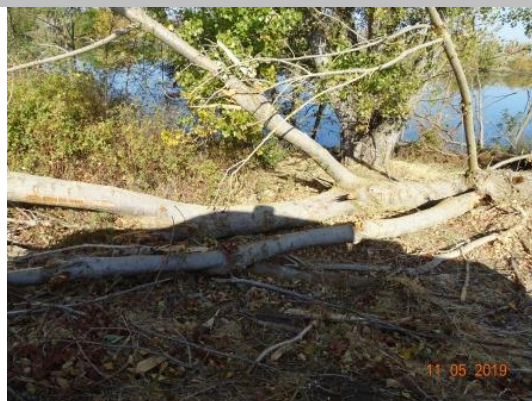
Photo 1 of 1 : FA\_2019\_RD0556\_19\_74\_20191107\_00091.jpg

View of large fallen tree on the waterside slope (Fall 2019).

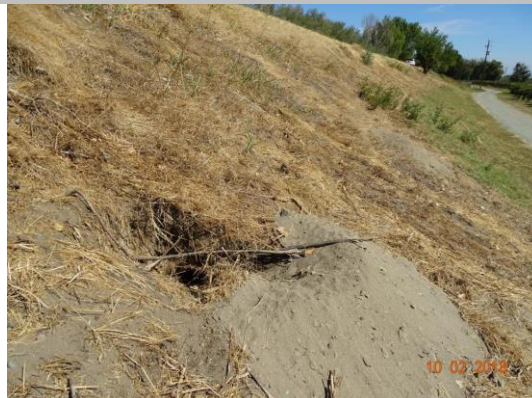
Photo 1 of 1 : FA\_2019\_RD0556\_19\_79\_20190826\_00042.jpg

View looking upstream at burrow holes on landside slope. (October 2018).
