**Flood Control Project Maintenance
Levee Inspections**

Maintenance Issue Types Only, Levee Inspection Report By Mile - Fall 2020

Reclamation District No. 0556 Upper Andrus

Waterway	Bank	Unit Miles	Inspection Start/End	Inspector
Unit No. 01 Georgiana Slough	Right	5.48	09/15/2020 09/15/2020	David Julian

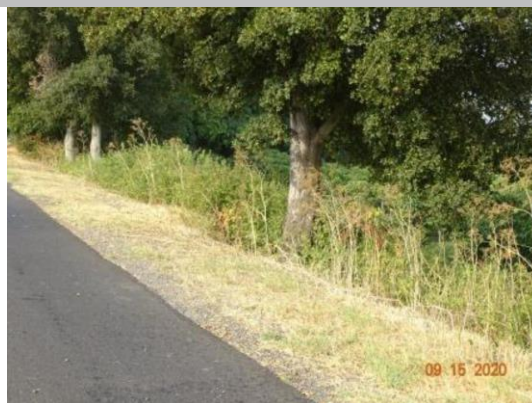
Photo 1 of 1 : FA_2020_RD0556_18_65_20200915_00090.jpg

LM Start	0.82	Rating **	U	Issue No.	65
LM End	0.85	Issue Type +	Ma	Location *	LS
Category	Earthen Levee			GPS Latitude/Longitude	
				Start	End
Item	Vegetation			38.229278 °	38.229013 °
				-121.525103 °	-121.525562 °
DWR ID	DWR_RD0556_01_f_2020_65				
Comment Code					
V2 : Remove the wild growth other than native grasses from the levee slopes.					
Inspector Comment

View looking downstream at vegetation on the landside slope (Fall 2020).

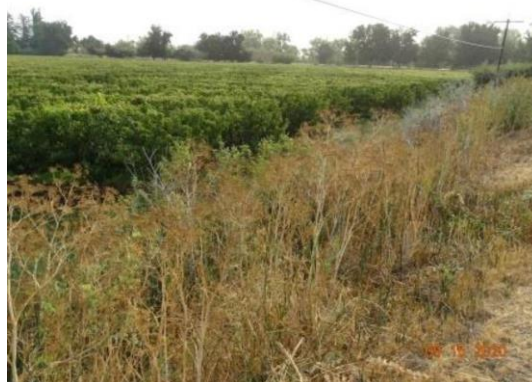
Photo 1 of 1 : FA_2020_RD0556_18_66_20200915_00091.jpg

LM Start	0.98	Rating **	U	Issue No.	66
LM End	1.57	Issue Type +	Ma	Location *	LS
Category	Earthen Levee			GPS Latitude/Longitude	
				Start	End
Item	Vegetation			38.227653 °	38.225012 °
				-121.527032 °	-121.535035 °
DWR ID	DWR_RD0556_01_f_2020_66				
Comment Code					
V2 : Remove the wild growth other than native grasses from the levee slopes.					
Inspector Comment

View looking upstream at annual vegetation on the landside slope (Fall 2020).

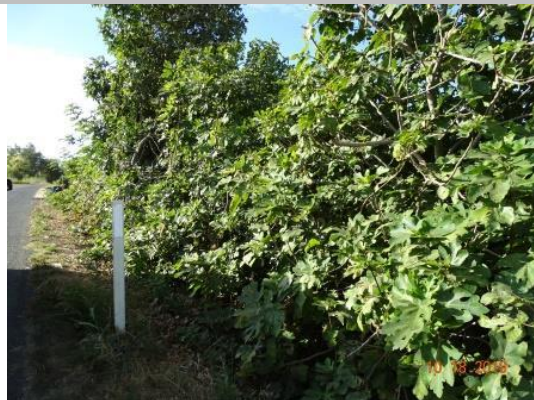
Photo 1 of 1 : FA_2020_RD0556_18_53_20200910_00034.jpg

LM Start	2.32	Rating **	U	Issue No.	53
LM End	2.32	Issue Type +	Ma	Location *	LS
Category	Earthen Levee			GPS Latitude/Longitude	
				Start	End
Item	Trim / Thin Trees			38.219813 °	38.219813 °
				-121.544032 °	-121.544032 °
DWR ID	DWR_RD0556_01_f_2019_53				
Comment Code					
T2 : Thin trees to allow visibility of the ground and room to flood fight.					
Inspector Comment

View looking downstream at fig tree on the landside slope (Fall 2019).

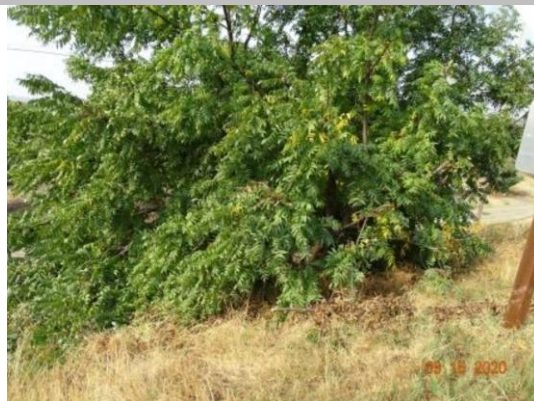
Photo 1 of 1 : FA_2020_RD0556_18_68_20200915_00089.jpg

LM Start	2.63	Rating **	U	Issue No.	68
LM End	2.63	Issue Type +	Ma	Location *	LS
Category	Earthen Levee			GPS Latitude/Longitude	
				Start	End
Item	Trim / Thin Trees			38.215850 °	38.215850 °
				-121.542045 °	-121.542045 °
DWR ID	DWR_RD0556_01_f_2020_68				
Comment Code					
T1 : Trim trees to at least five feet above ground level.					
Inspector Comment

View of thick tree on the landside slope (Fall 2020).

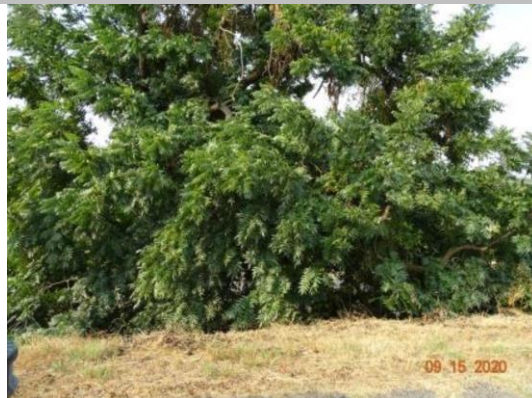
Photo 1 of 1 : FA_2020_RD0556_18_69_20200915_00097.jpg

LM Start	2.69	Rating **	U	Issue No.	69
LM End	2.69	Issue Type +	Ma	Location *	LS
Category	Earthen Levee			GPS Latitude/Longitude	
				Start	End
Item	Trim / Thin Trees			38.215382 °	38.215382 °
				-121.541247 °	-121.541247 °
DWR ID	DWR_RD0556_01_f _ 2020_69				
Comment Code					
T1 : Trim trees to at least five feet above ground level.					
Inspector Comment

View of thick tree on the landside slope (Fall 2020).

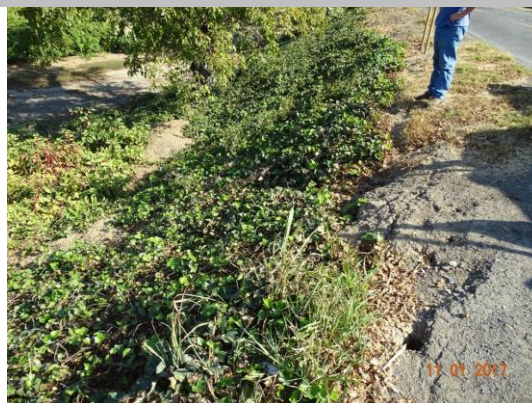
Photo 1 of 1 : FA_2020_RD0556_18_28_20200910_00013.jpg

Significant rodent activity in this area must be stopped. Holes should be backfilled.

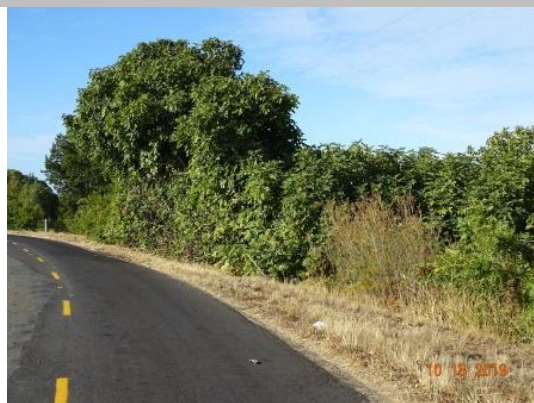
Photo 1 of 1 : FA_2020_RD0556_18_38_20200910_00022.jpg

LM Start	3.22	Rating **	U	Issue No.	38
LM End	3.29	Issue Type +	Ma	Location *	LS
Category	Earthen Levee			GPS Latitude/Longitude	
				Start	End
Item	Trim / Thin Trees			38.210493 °	38.209842 °
				-121.539760 °	-121.540658 °
DWR ID	DWR_RD0556_01_s_2017_38				
Comment Code					
T2 : Thin trees to allow visibility of the ground and room to flood fight.					
Inspector Comment					
Remove the wild tree growth and vegetation from the landside levee slope and toe so the ground can be seen.

View looking downstream at thick tree growth on the landside slope (Fall 2019).

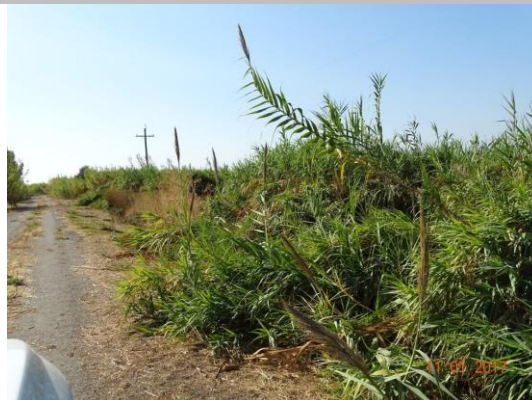
Photo 1 of 1 : FA_2020_RD0556_18_39_20200910_00023.jpg

View of dense growth of wild vegetation, berry vines and arundo on landside slope and toe

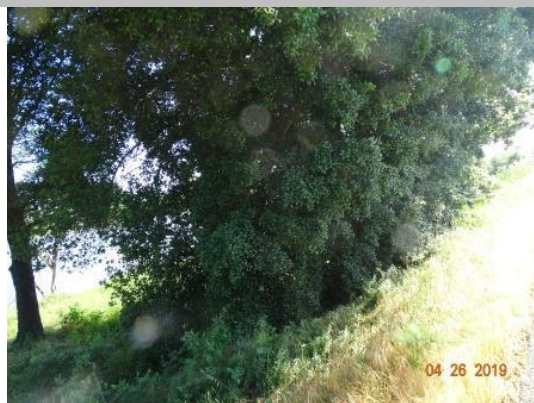
Photo 1 of 1 : FA_2020_RD0556_19_40_20200909_00023.jpg

View looking upstream at thick trees on the waterside slope (Spring 2019).

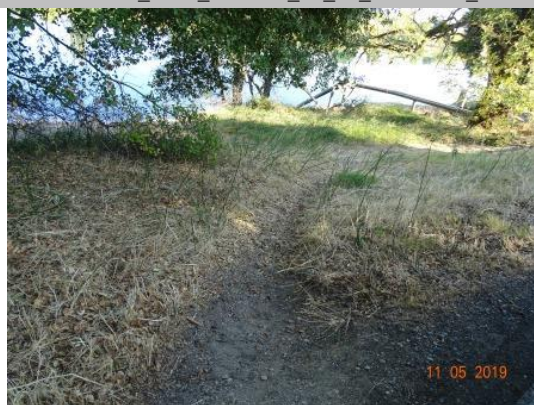
Photo 1 of 1 : FA_2020_RD0556_19_43_20200909_00025.jpg

LM Start	0.50	Rating **	A/W	Issue No.	43
LM End	0.50	Issue Type +	Ma	Location *	WS
Category	Earthen Levee			GPS Latitude/Longitude	
				Start	End
Item	Slope Stability			38.237963 °	38.237963 °
				-121.527372 °	-121.527372 °
DWR ID	DWR_RD0556_02_f_2019_43				
Comment Code					
S2 : Repair the levee slope damaged by foot traffic and prevent access where possible.					
Inspector Comment					
Fishermen trail is on slope.

View of fishermen trail digging into levee on the waterside slope (Fall 2019).

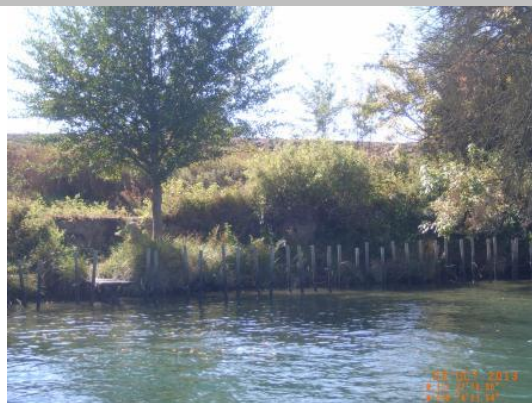
Photo 1 of 1 : FA_2020_RD0556_19_19_20200909_00007.jpg

LM Start	1.03	Rating **	M	Issue No.	19
LM End	1.15	Issue Type +	Ma	Location *	WS
Category	Supplemental			GPS Latitude/Longitude	
				Start	End
Item	2017 USACE Erosion Survey			38.238772 °	38.239265 °
				-121.536788 °	-121.538845 °
DWR ID	DWR_RD0556_02_f_2018_19				
Comment Code					
Inspector Comment					
2017 Site ID: SAC 25.2 L					
Status: Eroding					
2017 Field Notes: Minor new erosion observed.					
Site History: 1997 - Rock is in poor condition and has failed in many places. Scallops in berm with remnants of old rock in the toe area.					
2005 - Brush boxes present. 2013 - Site extended upstream approximately 300 ft to include new erosion pockets. 2015 - Minor new erosion at toe.

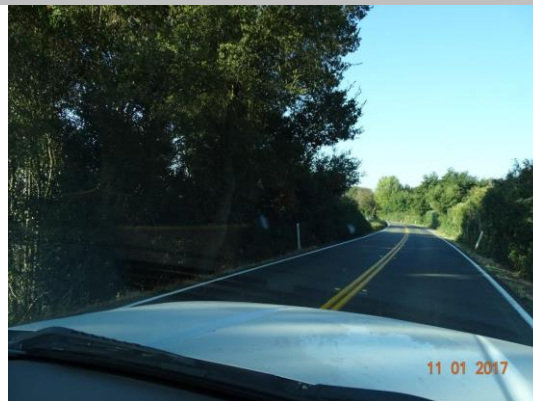
Photo 1 of 1 : FA_2020_RD0556_19_30_20200909_00015.jpg

Trim/thin oleanders on landside slope.

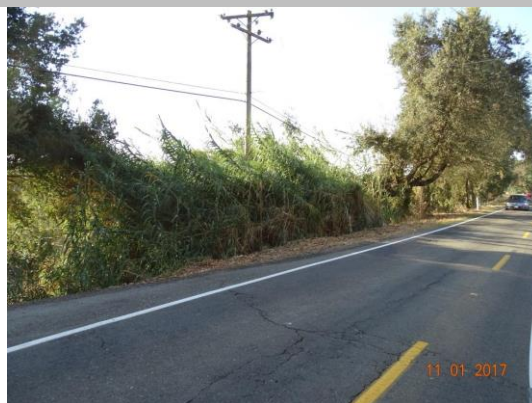
Photo 1 of 1 : FA_2020_RD0556_19_32_20200909_00017.jpg

View of arundo on the landside slope and toe.

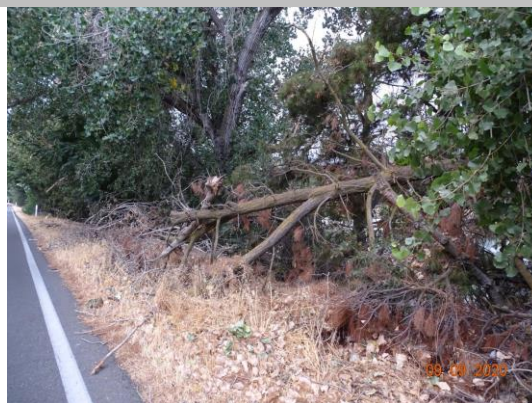
Photo 1 of 1 : FA_2020_RD0556_19_57_20200911_00062.jpg

LM Start	2.12	Rating **	U	Issue No.	57
LM End	2.12	Issue Type +	Ma	Location *	WS
Category	Earthen Levee			GPS Latitude/Longitude	
				Start	End
Item	Encroachments			38.238887 °	38.238887 °
				-121.555570 °	-121.555570 °
DWR ID	DWR_RD0556_02_f _ 2019_57				
Comment Code					
TR : Tree or limb					
Inspector Comment					
Remove downed tree.

View looking downstream at down tree on waterside shoulder (Fall 2020).

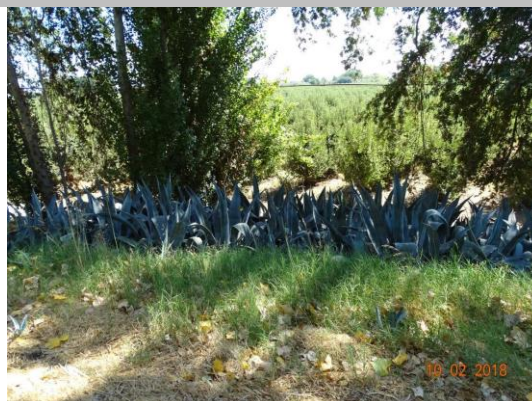
Photo 1 of 1 : FA_2020_RD0556_19_87_20200909_00057.jpg

View of cactus on the landside slope (October 2018).

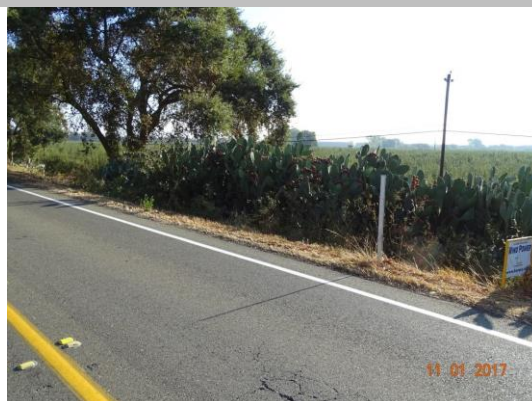
Photo 1 of 1 : FA_2020_RD0556_19_33_20200909_00018.jpg

LM Start	2.19	Rating **	U	Issue No.	33
LM End	2.22	Issue Type +	Ma	Location *	LS
Category	Earthen Levee			GPS Latitude/Longitude	
				Start	End
Item	Vegetation			38.238172 °	38.237883 °
				-121.556502 °	-121.556958 °
DWR ID	DWR_RD0556_02_f_2017_33				
Comment Code					
V7 : Trees / Woody Vegetation					
Inspector Comment					
Large growth of prickly pear cactus should be removed to allow inspection and access.

View of large growth of prickly pear cactus.

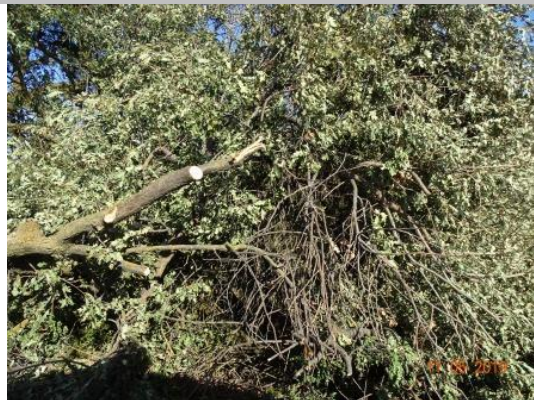
Photo 1 of 1 : FA_2020_RD0556_19_88_20200909_00058.jpg

LM Start	2.75	Rating **	U	Issue No.	88
LM End	2.75	Issue Type +	Ma	Location *	LS
Category	Earthen Levee			GPS Latitude/Longitude	
				Start	End
Item	Encroachments			38.230752 °	38.230752 °
				-121.556007 °	-121.556007 °
DWR ID	DWR_RD0556_02_f_2019_88				
Comment Code					
TR : Tree or limb					
Inspector Comment					
Broken tree limb blocking view of landside slope.

View of broken tree limb blocking the view of the landside slope (Fall 2019).

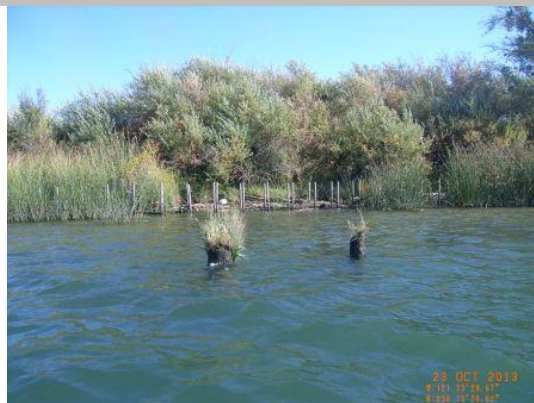
Photo 1 of 1 : FA_2020_RD0556_19_17_20200909_00005.jpg

LM Start	3.17	Rating **	M	Issue No.	17	
LM End	3.28	Issue Type +	Ma	Location *	WS	
Category	Supplemental			GPS Latitude/Longitude		
				Start	End	
Item	2017 USACE Erosion Survey			38.224850 °	38.223233 °	
				-121.555641 °	-121.555687 °	
DWR ID	DWR_RD0556_02_f_2018_17					
Comment Code						
Inspector Comment						
2017 Site ID: SAC 23.2 L Status: Eroding 2017 Field Notes: New erosion along lower bank. Site History: 2000 - Recently fallen cottonwood at the downstream end. 2005 - Empty brush boxes. 2011 - A few trees have fallen since last year. 2012 - Potential new tree popout since last year. 2013 - New erosion at downstream end of site and a recent tree pop-out observed. 2016 - New erosion at the toe.

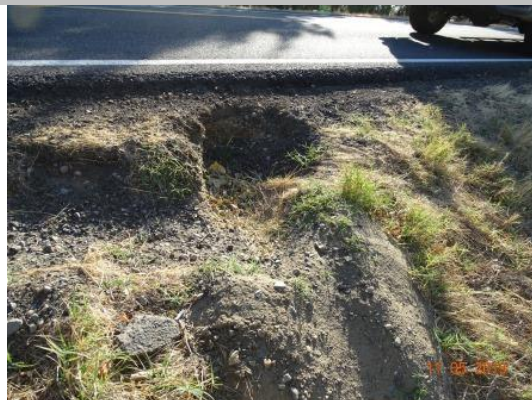
Photo 1 of 1 : FA_2020_RD0556_19_63_20200909_00044.jpg

LM Start	3.68	Rating **	M	Issue No.	63
LM End	3.68	Issue Type +	Ma	Location *	WS
Category	Earthen Levee			GPS Latitude/Longitude	
				Start	End
Item	Erosion / Bank Caving			38.217462 °	38.217462 °
				-121.556647 °	-121.556647 °
DWR ID	DWR_RD0556_02_f_2019_63				
Comment Code					
E2 : Schedule repair of erosion site prior to the next inspection.					
Inspector Comment					
Repair erosion on waterside shoulder

View of erosion on the waterside shoulder (Fall 2019).

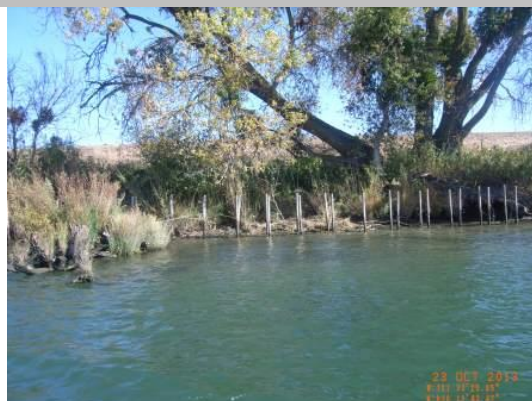
Photo 1 of 1 : FA_2020_RD0556_19_15_20200909_00003.jpg

LM Start	3.95	Rating **	M	Issue No.	15
LM End	4.12	Issue Type +	Ma	Location *	WS
Category	Supplemental			GPS Latitude/Longitude	
				Start	End
Item	2017 USACE Erosion Survey			38.213581 °	38.211112 °
				-121.557197 °	-121.557042 °
DWR ID	DWR_RD0556_02_f_2018_15				
Comment Code					
Inspector Comment					
2017 Site ID: SAC 22.5 L					
Status: Eroding					
2017 Field Notes: New lower bank erosion at the upstream end. Locals placed rock in some erosion pockets.					
Site History: 2002 - Spot rock along berm, but not in the erosion pockets. 2005 - Some new minor stone revetment at the upstream end. Brush boxes present. 2006 - Currently installing new brush in downstream brush boxes. 2007 - Rock in middle portion for about 150 ft. 2010 - Some attempt at repairs but still has pockets of erosion. 2012 - More erosion along the toe.

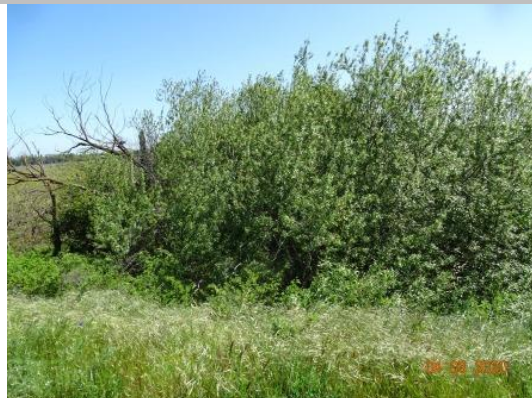
Photo 1 of 1 : FA_2020_RD0556_19_55_20200909_00036.jpg

View of thick tree on the landside slope (Spring 2020).

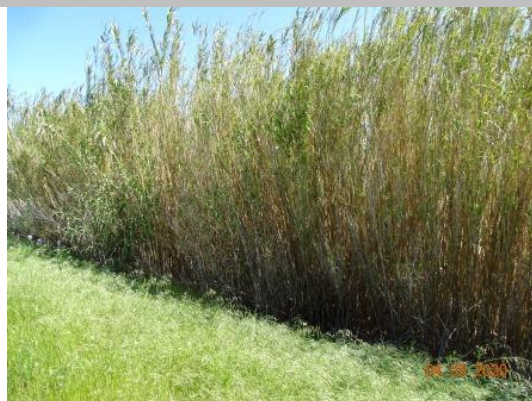
Photo 1 of 1 : FA_2020_RD0556_19_51_20200909_00032.jpg

LM Start	4.22	Rating **	U	Issue No.	51
LM End	4.22	Issue Type +	Ma	Location *	LS
Category	Earthen Levee			GPS Latitude/Longitude	
				Start	End
Item	Vegetation			38.209629 °	38.209629 °
				-121.556757 °	-121.556757 °
DWR ID	DWR_RD0556_02_s _ 2020_51				
Comment Code					
V7 : Trees / Woody Vegetation					
Inspector Comment					
Remove arundo from landside slope

View of thick arundo on the landside slope (Spring 2020).

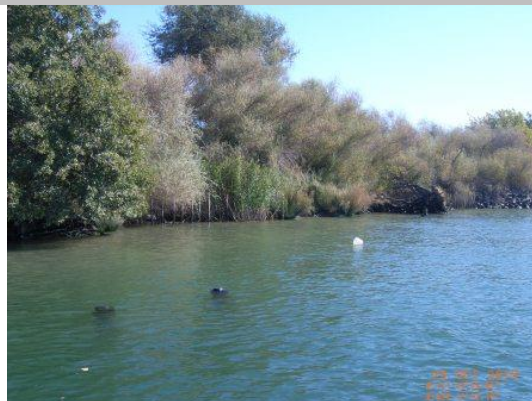
Photo 1 of 1 : FA_2020_RD0556_19_14_20200909_00002.jpg

LM Start	4.45	Rating **	M	Issue No.	14
LM End	4.49	Issue Type +	Ma	Location *	WS
Category	Supplemental			GPS Latitude/Longitude	
				Start	End
Item	2017 USACE Erosion Survey			38.206377 °	38.205729 °
				-121.557184 °	-121.557108 °
DWR ID	DWR_RD0556_02_f _ 2018_14				
Comment Code					
Inspector Comment					
2017 Site ID: SAC 21.9 L					
Status: Eroding					
2017 Field Notes: No observed change..					
Site History: 2013 - Erosion pockets encroaching on levee foundation.

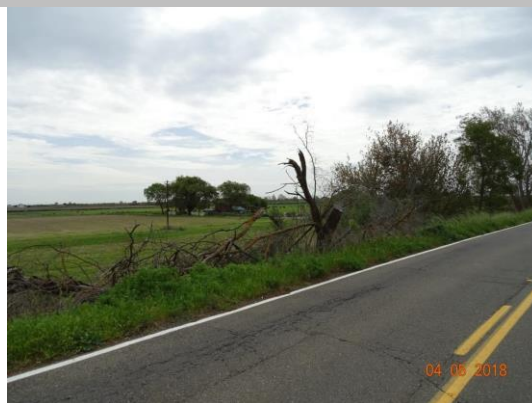
Photo 1 of 1 : FA_2020_RD0556_19_56_20200909_00037.jpg

Fallen tree on landside should be removed.

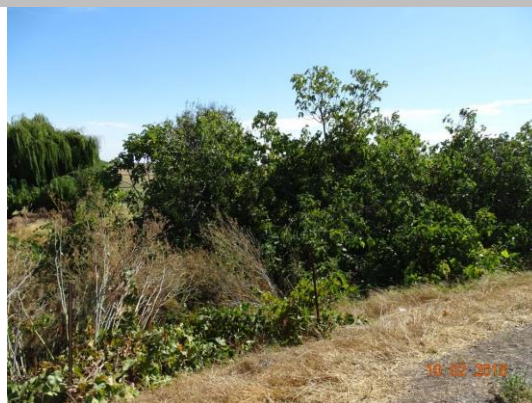
Photo 1 of 1 : FA_2020_RD0556_19_58_20200909_00039.jpg

View of fig tree on landside slope (October 2018).

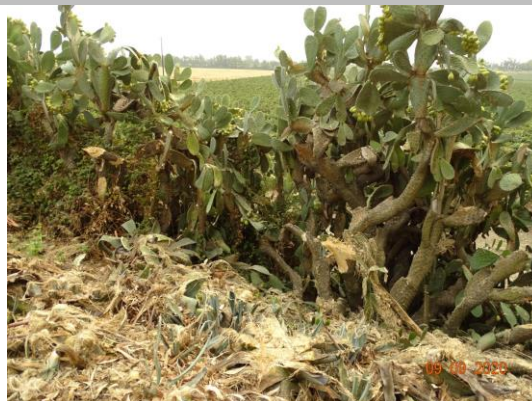
Photo 1 of 1 : FA_2020_RD0556_19_37_20200911_00069.jpg

View looking upstream at cactus partway down the landside slope (Fall 2020).

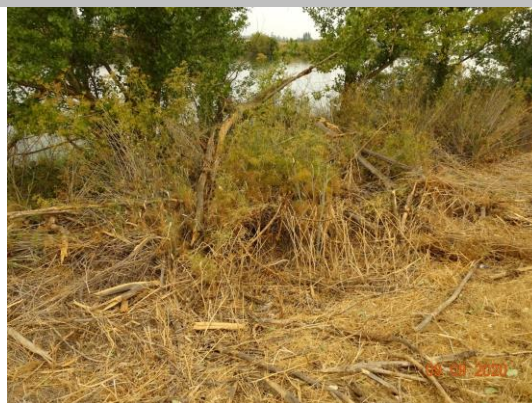
Photo 1 of 1 : FA_2020_RD0556_19_74_20200911_00066.jpg

View of fallen tree on the waterside slope (Fall 2020).

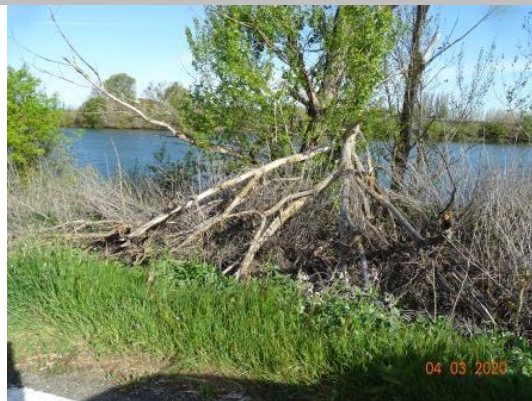
Photo 1 of 1 : FA_2020_RD0556_19_75_20200909_00051.jpg

View of down tree on the waterside slope (Spring 2020).

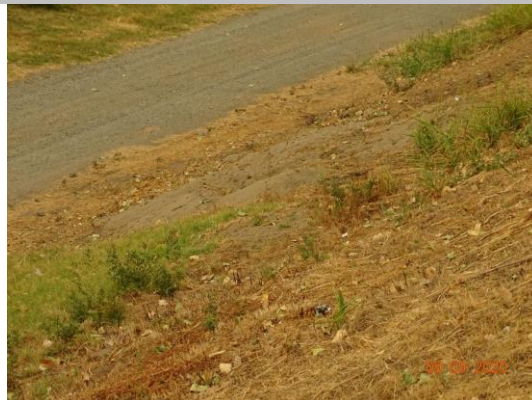
Photo 1 of 1 : FA_2020_RD0556_19_79_20200911_00067.jpg

View looking downstream at burrow holes on the landside slope (Fall 2020).
