**Flood Control Project Maintenance
Levee Inspections**

Maintenance Issue Types Only, Levee Inspection Report By Mile - Fall 2021

Reclamation District No. 0556 Upper Andrus

Waterway	Bank	Unit Miles	Inspection Start/End	Inspector
Unit No. 01 Georgiana Slough	Right	5.48	09/01/2021 09/01/2021	David Julian

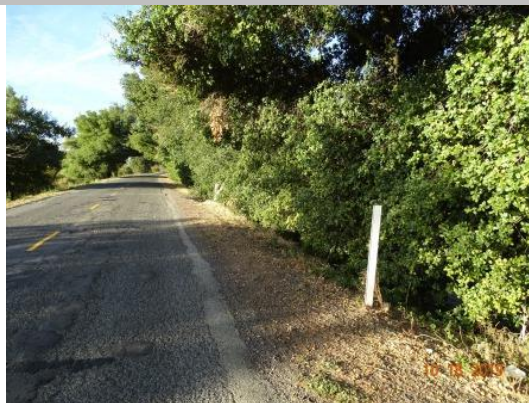
Photo 1 of 1 : FA_2021_RD0556_18_21_20210830_00005.jpg

LM Start	0.00	Rating **	U	Issue No.	21
LM End	0.57	Issue Type +	Ma	Location *	LS
Category	Earthen Levee			GPS Latitude/Longitude	
				Start	End
Item	Trim / Thin Trees			38.239100 °	38.232070 °
				-121.518250 °	-121.522067 °
DWR ID	DWR_RD0556_01_s_2017_21				
Comment Code					
T2 : Thin trees to allow visibility of the ground and room to flood fight.					
Inspector Comment

View looking downstream at thick trees on the landside slope (Fall 2019).

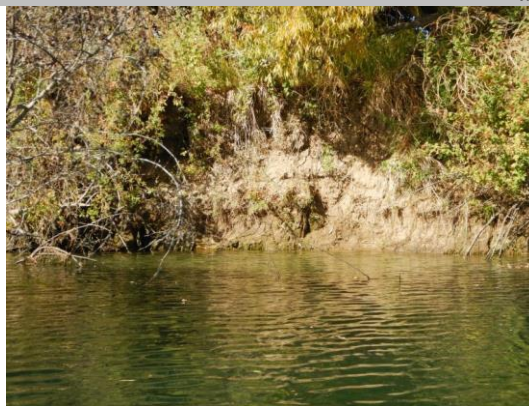
Photo 1 of 2 : FA_2021_RD0556_18_43_20211218_40.jpg

LM Start	0.38	Rating **	M	Issue No.	43
LM End	0.58	Issue Type +	Ma	Location *	WS
Category	Supplemental			GPS Latitude/Longitude	
				Start	End
Item	2018 USACE Erosion Survey			38.234038 °	38.231879 °
				-121.519817 °	-121.522003 °
DWR ID					
Comment Code					
Inspector Comment					
2018 Site ID: GEO 11.8 R					
Status: Eroding					
2018 Field Notes: No observed change.					
Site History: 2017 - Tree popout popouts eminent , significant toe erosion and whole bank failure in sections

USACE 2018 Erosion Photo #1

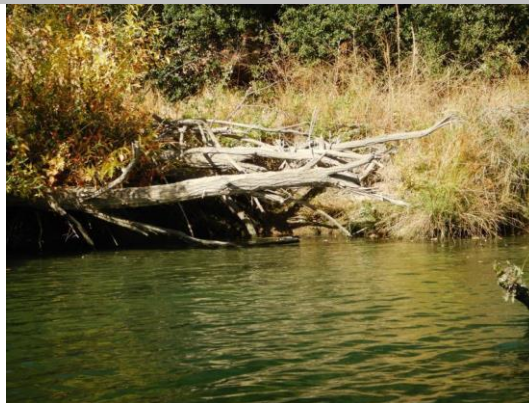
Photo 2 of 2 : FA_2021_RD0556_18_43_20211218_41.jpg

USACE 2018 Erosion Photo #2

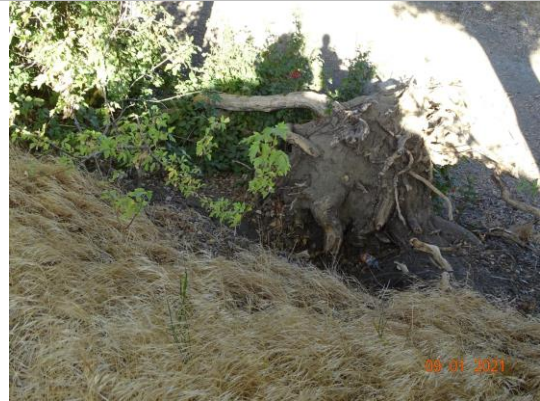
Photo 1 of 1 : FA_2021_RD0556_18_84_20211004_00158.jpg

View of fallen tree root ball and large hole in the landside slope (Fall 2021).

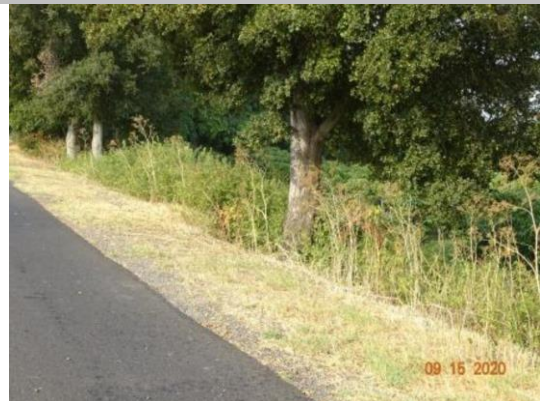
Photo 1 of 1 : FA_2021_RD0556_18_65_20210830_00035.jpg

LM Start	0.82	Rating **	U	Issue No.	65
LM End	0.85	Issue Type +	Ma	Location *	LS
Category	Earthen Levee			GPS Latitude/Longitude	
				Start	End
Item	Vegetation			38.229278 °	38.229013 °
				-121.525103 °	-121.525562 °
DWR ID	DWR_RD0556_01_f_2020_65				
Comment Code					
V2 : Remove the wild growth other than native grasses from the levee slopes.					
Inspector Comment

View looking downstream at vegetation on the landside slope (Fall 2020).

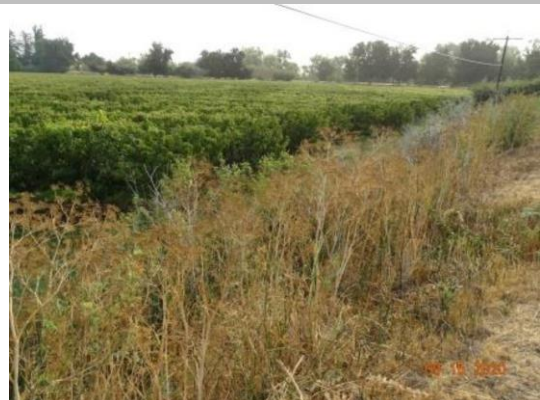
Photo 1 of 1 : FA_2021_RD0556_18_66_20210830_00036.jpg

LM Start	0.98	Rating **	U	Issue No.	66
LM End	1.17	Issue Type +	Ma	Location *	LS
Category	Earthen Levee			GPS Latitude/Longitude	
				Start	End
Item	Vegetation			38.227653 °	38.227574 °
				-121.527032 °	-121.529479 °
DWR ID	DWR_RD0556_01_f_2020_66				
Comment Code					
V2 : Remove the wild growth other than native grasses from the levee slopes.					
Inspector Comment

View looking upstream at annual vegetation on the landside slope (Fall 2020).

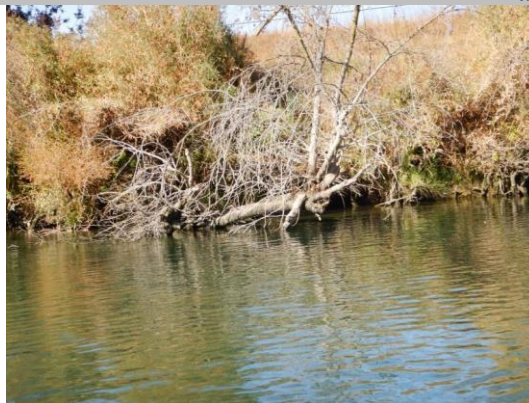
Photo 1 of 2 : FA_2021_RD0556_18_42_20211218_38.jpg

LM Start	1.20	Rating **	M	Issue No.	42
LM End	1.53	Issue Type +	Ma	Location *	WS
Category	Supplemental			GPS Latitude/Longitude	
				Start	End
Item	2018 USACE Erosion Survey			38.227615 °	38.225374 °
				-121.529894 °	-121.534406 °
DWR ID					
Comment Code					
Inspector Comment					
2018 Site ID: GEO 10.9 R Status: Eroding 2018 Field Notes: New erosion throughout site. Site History: 2017 - Significant toe erosion and whole bank failure in sections, large pockets from tree popouts.

USACE 2018 Erosion Photo #1

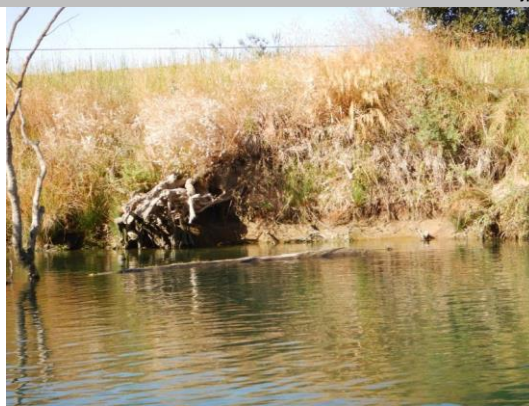
Photo 2 of 2 : FA_2021_RD0556_18_42_20211218_39.jpg

USACE 2018 Erosion Photo #2

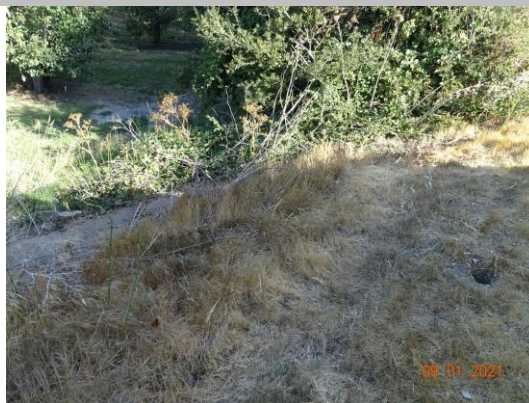
Photo 1 of 1 : FA_2021_RD0556_18_82_20210901_00157.jpg

View of animal holes in landside hinge and slope (Fall 2021).

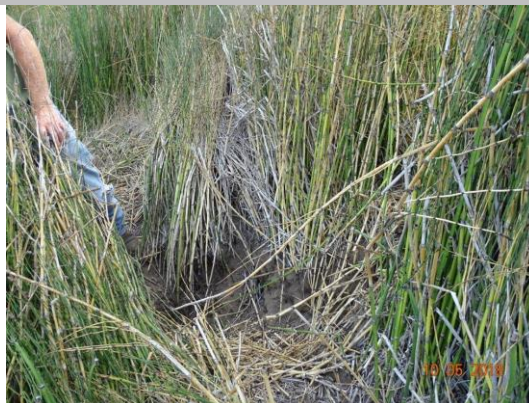
Photo 1 of 1 : FA_2021_RD0556_18_40_20210830_00020.jpg

View of erosion that is covered by vegetation on the landside slope (October 2018).

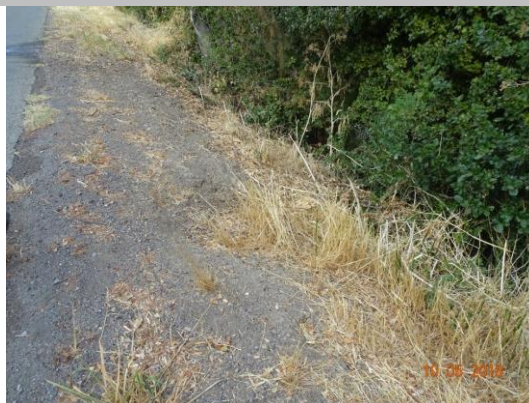
Photo 1 of 1 : FA_2021_RD0556_18_22_20210830_00006.jpg

LM Start	1.50	Rating **	M	Issue No.	22
LM End	1.50	Issue Type +	Ma	Location *	LS
Category	Earthen Levee			GPS Latitude/Longitude	
				Start	End
Item	Erosion / Bank Caving			38.225840 °	38.225840 °
				-121.534157 °	-121.534157 °
DWR ID	DWR_RD0556_01_s_2012_22				
Comment Code					
E1 : Note and monitor erosion site.					
Inspector Comment					
Dip at the top of the landside slope is greater than 3".

View of dip at the top of the landside slope (October 2018).

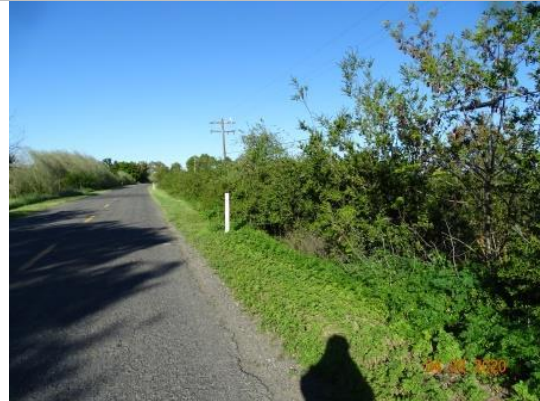
Photo 1 of 1 : FA_2021_RD0556_18_19_20210830_00003.jpg

View looking downstream at thick wild vegetation on the landside slope (Spring 2020).

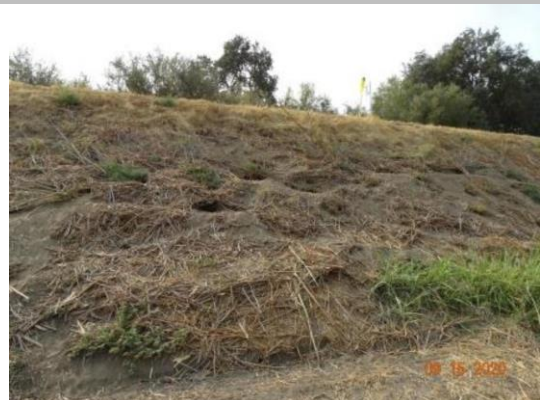
Photo 1 of 1 : FA_2021_RD0556_18_61_20210830_00034.jpg

View of multiple squirrel holes in the landside slope (Fall 2020).

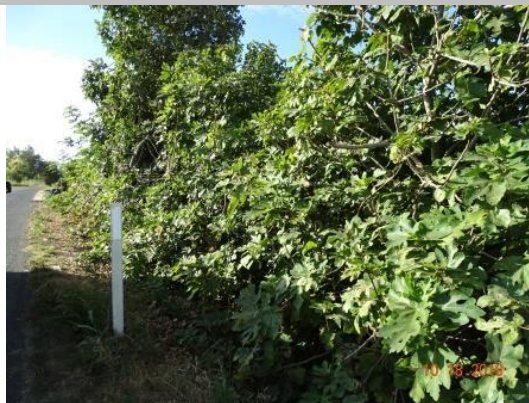
Photo 1 of 1 : FA_2021_RD0556_18_53_20210830_00030.jpg

View looking downstream at fig tree on the landside slope (Fall 2019).

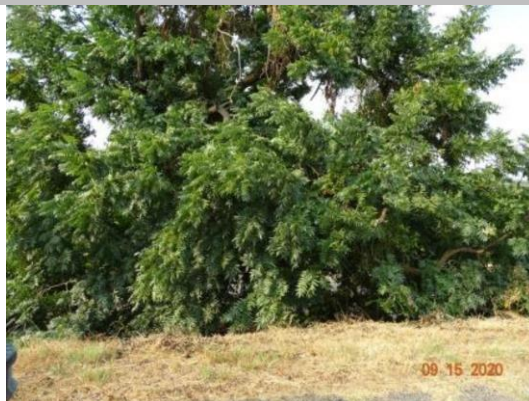
Photo 1 of 1 : FA_2021_RD0556_18_69_20210830_00037.jpg

LM Start	2.63	Rating **	M	Issue No.	68
LM End	2.63	Issue Type +	Ma	Location *	LS
Category	Earthen Levee			GPS Latitude/Longitude	
				Start	End
Item	Trim / Thin Trees			38.215850 °	38.215850 °
				-121.542045 °	-121.542045 °
DWR ID	DWR_RD0556_01_f_2020_68				
Comment Code					
T1 : Trim trees to at least five feet above ground level.					
Inspector Comment

View of thick tree on the landside slope (Fall 2020).

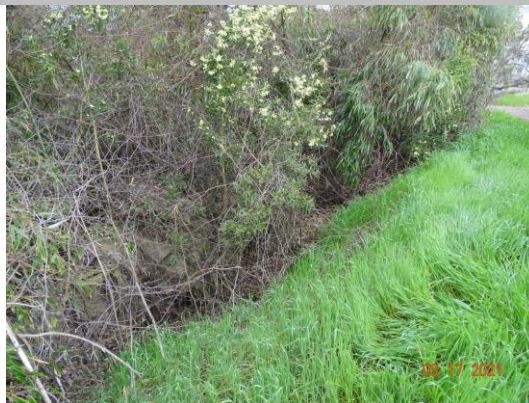
Photo 1 of 1 : FA_2021_RD0556_18_33_20210830_00015.jpg

LM Start	2.72	Rating **	U	Issue No.	33
LM End	2.72	Issue Type +	Ma	Location *	LS
Category	Earthen Levee			GPS Latitude/Longitude	
				Start	End
Item	Slope Stability			38.215107 °	38.215107 °
				-121.540677 °	-121.540677 °
DWR ID	DWR_RD0556_01_s_2017_33				
Comment Code					
S1 : Repair slope instability.					
Inspector Comment					
Fallen tree on landside. Remove the fallen tree and repair the levee damage.

View of hole in landside slope caused by down tree (Spring 2021).

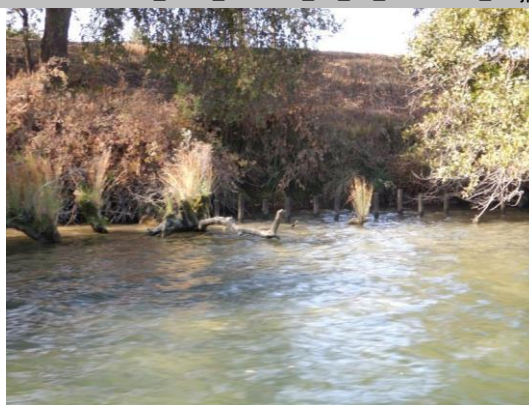
Photo 1 of 2 : FA_2021_RD0556_18_37_20211218_22.jpg

USACE 2018 Erosion Photo #1

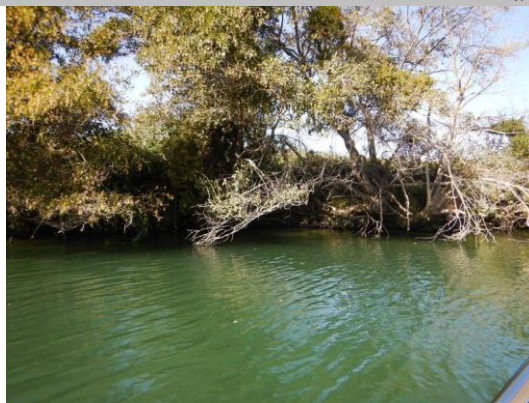
Photo 1 of 2 : FA_2021_RD0556_18_36_20211218_9.jpg

LM Start	3.18	Rating **	M	Issue No.	36
LM End	3.50	Issue Type +	Ma	Location *	WS
Category	Supplemental			GPS Latitude/Longitude	
				Start	End
Item	2018 USACE Erosion Survey			38.210674 °	38.206919 °
				-121.538854 °	-121.541559 °
DWR ID					
Comment Code					
Inspector Comment					
2018 Site ID: GEO 9.0 R					
Status: Eroding					
2018 Field Notes: Site extended downstream.					
Site History: 2017 - Toe erosion and failed revetment.

USACE 2018 Erosion Photo #1

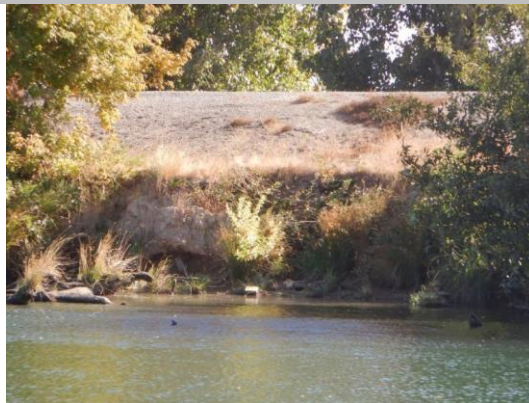
Photo 2 of 2 : FA_2021_RD0556_18_36_20211218_17.jpg

USACE 2018 Erosion Photo #2

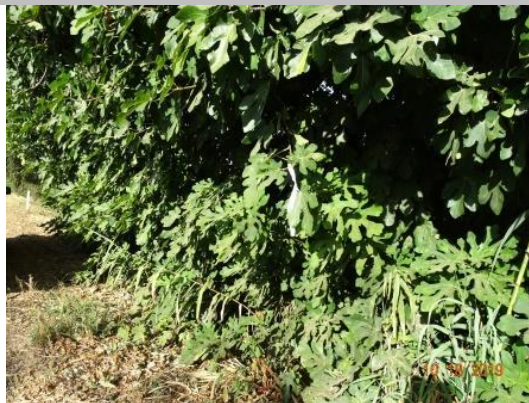
Photo 1 of 1 : FA_2021_RD0556_18_55_20210830_00032.jpg

View of fig tree on the landside slope (Fall 2019).

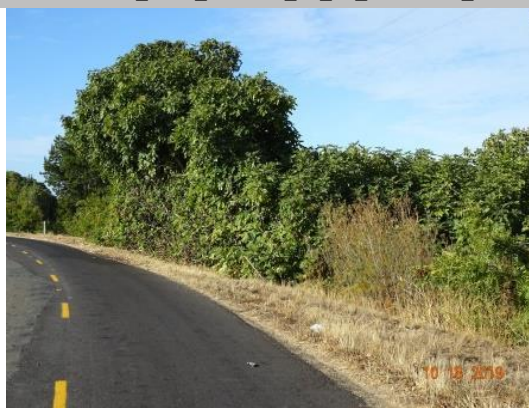
Photo 1 of 1 : FA_2021_RD0556_18_38_20210830_00018.jpg

View looking downstream at thick tree growth on the landside slope (Fall 2019).

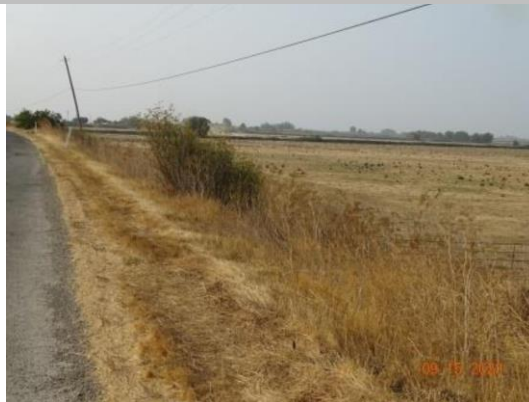
Photo 1 of 1 : FA_2021_RD0556_18_41_20210830_00021.jpg

View looking downstream at vegetation on the landside slope (Fall 2020).

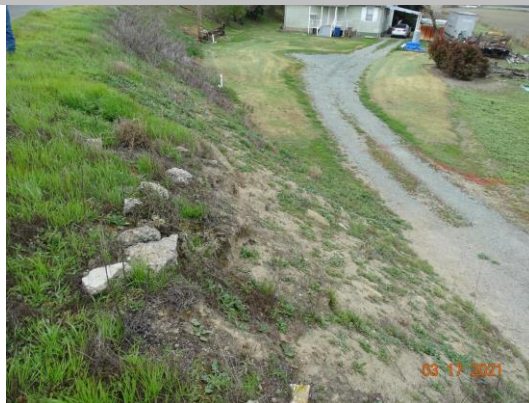
Photo 1 of 1 : FA_2021_RD0556_18_86_20211004_00160.jpg

LM Start	3.82	Rating **	M	Issue No.	86
LM End	3.82	Issue Type +	Ma	Location *	LS
Category	Earthen Levee			GPS Latitude/Longitude	
				Start	End
Item	Erosion / Bank Caving			38.202481 °	38.202481 °
				-121.540839 °	-121.540839 °
DWR ID	DWR_RD0556_01_f_2021_86				
Comment Code					
E2 : Schedule repair of erosion site prior to the next inspection.					
Inspector Comment					
Exposed slope eroding, most likely due to runoff.

View of erosion rivulets in the landside slope (Spring 2021).

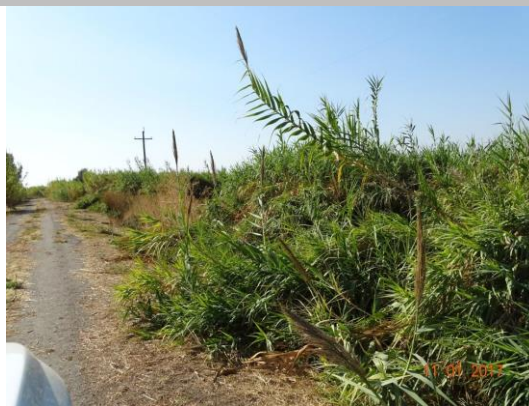
Photo 1 of 1 : FA_2021_RD0556_18_39_20210830_00019.jpg

View of dense growth of wild vegetation, berry vines and arundo on landside slope and toe.

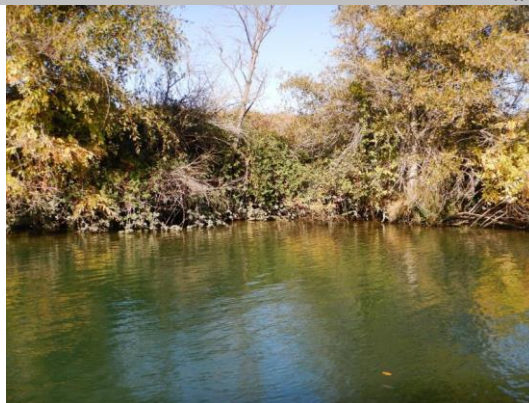
Photo 1 of 2 : FA_2021_RD0556_18_20_20211218_4.jpg

2018 Site ID: GEO 7.0 R
 Status: Eroding
 2018 Field Notes: Minor new toe erosion.
 Site History: 1997 - Toe damaged rock. 1999 - One pocket filled with gravel. 2000 - Eroding beach with some biotech rolls and stakes; some gravel on slope. 2001 - Staked, low fascine walls at bankline. 2005 - Stone revetment in between pockets. 2006 - New rock on upper slope behind brush boxes at the upstream end, Stone is sliding off the hard toe. 2016 - Fresh erosion observed. 2017 - Site extended downstream. Large erosion pockets and significant toe erosion.

USACE 2018 Erosion Photo #1

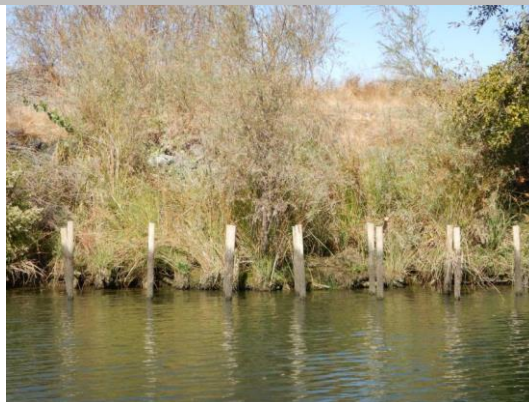
Photo 2 of 2 : FA_2021_RD0556_18_20_20211218_8.jpg

USACE 2018 Erosion Photo #2

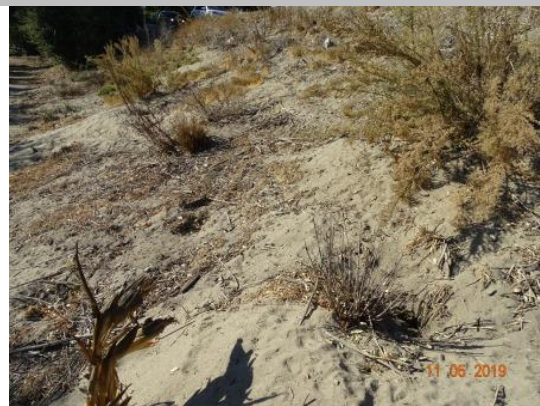
Photo 1 of 1 : FA_2021_RD0556_19_92_20210830_00057.jpg

View of multiple fresh squirrel holes in the landside slope (Fall 2019).

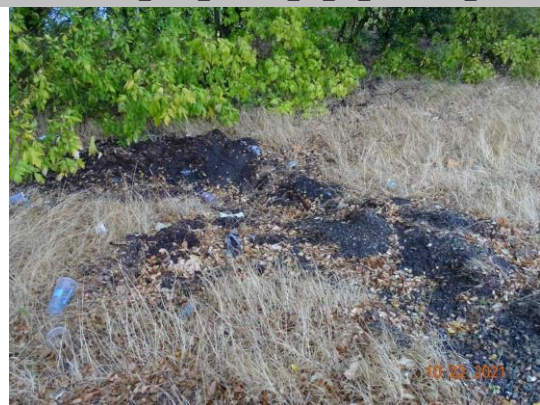
Photo 1 of 1 : FA_2021_RD0556_19_20_20211022_00094.jpg

LM Start	0.04	Rating **	U	Issue No.	20
LM End	0.04	Issue Type +	Ma	Location *	WS
Category	Earthen Levee			GPS Latitude/Longitude	
				Start	End
Item	Slope Stability			38.239167 °	38.239167 °
				-121.519040 °	-121.519040 °
DWR ID	DWR_RD0556_02_f_2019_20				
Comment Code					
S3 : Repair the levee slope damaged by vehicle traffic and prevent access where possible.					
Inspector Comment

View of depression caused by vehicle on the waterside slope (Fall 2021).

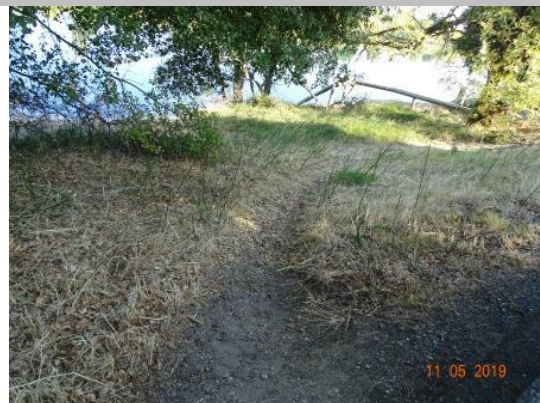
Photo 1 of 1 : FA_2021_RD0556_19_43_20210830_00024.jpg

LM Start	0.50	Rating **	M	Issue No.	43
LM End	0.50	Issue Type +	Ma	Location *	WS
Category	Earthen Levee			GPS Latitude/Longitude	
				Start	End
Item	Slope Stability			38.237963 °	38.237963 °
				-121.527372 °	-121.527372 °
DWR ID	DWR_RD0556_02_f_2019_43				
Comment Code					
S2 : Repair the levee slope damaged by foot traffic and prevent access where possible.					
Inspector Comment					
Fishermen trail is on slope.

View of fishermen trail digging into levee on the waterside slope (Fall 2019).

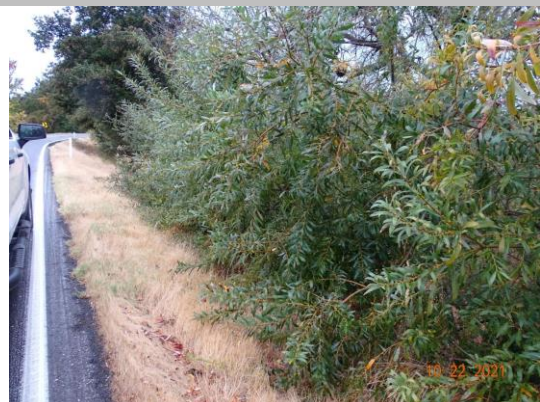
Photo 1 of 1 : FA_2021_RD0556_19_34_20211022_00095.jpg

View looking downstream at thick tree on the waterside slope (Fall 2021).

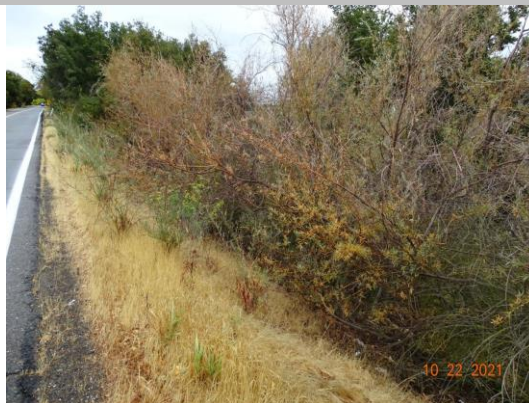
Photo 1 of 1 : FA_2021_RD0556_19_81_20211022_00108.jpg

View looking upstream at thick vegetation on the landside slope (Fall 2021).

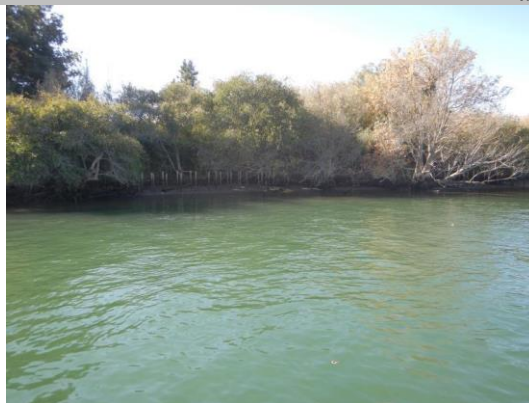
Photo 1 of 2 : FA_2021_RD0556_19_19_20211218_61.jpg

LM Start	1.03	Rating **	M	Issue No.	19
LM End	1.15	Issue Type +	Ma	Location *	WS
Category	Supplemental			GPS Latitude/Longitude	
				Start	End
Item	2018 USACE Erosion Survey			38.238772 °	38.239265 °
				-121.536788 °	-121.538845 °
DWR ID					
Comment Code					
Inspector Comment					
2018 Site ID: SAC 25.2 L					
Status: Eroding					
2018 Field Notes: Additional erosion along toe. Site extended upstream.					
Site History: 1997 - Rock is in poor condition and has failed in many places. Scallops in berm with remnants of old rock in the toe area.					
2005 - Brush boxes present. 2013 - Site extended upstream					
approximately 300 ft to include new erosion pockets. 2015 - Minor new					
erosion at toe. 2017 - Minor new erosion observed.

USACE 2018 Erosion Photo #1

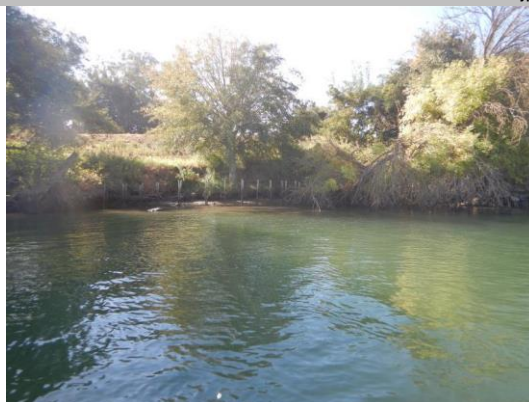
Photo 2 of 2 : FA_2021_RD0556_19_19_20211218_62.jpg

USACE 2018 Erosion Photo #2

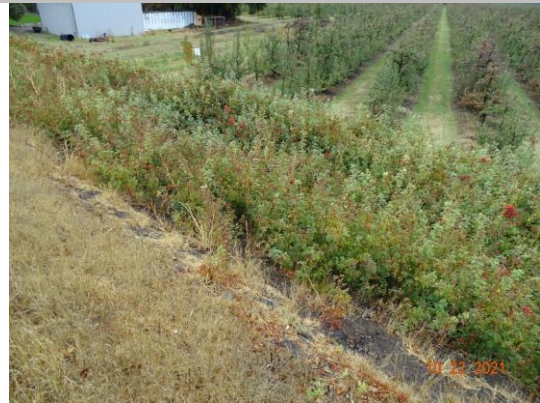
Photo 1 of 1 : FA_2021_RD0556_19_116_20211022_00107.jpg

View of thick vegetation on the landside slope (Fall 2021).

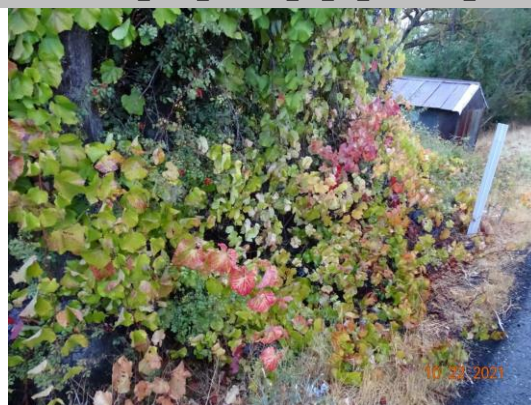
Photo 1 of 1 : FA_2021_RD0556_19_40_20211022_00096.jpg

View looking upstream at thick vegetation on the waterside slope (Fall 2021).

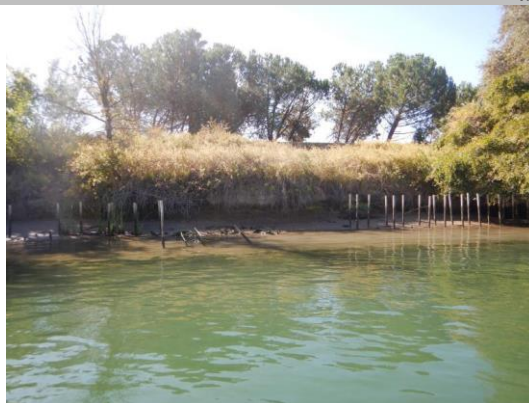
Photo 1 of 2 : FA_2021_RD0556_19_18_20211218_59.jpg

USACE 2018 Erosion Photo #1

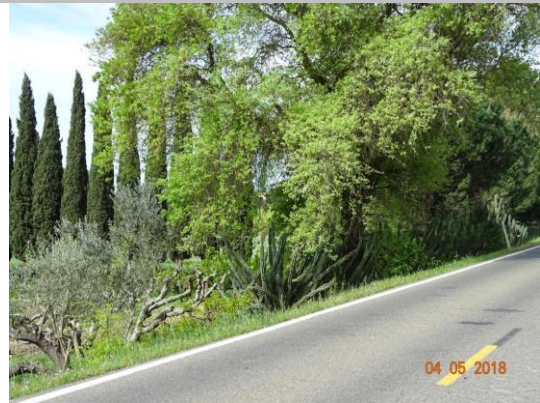
Photo 1 of 1 : FA_2021_RD0556_19_41_20210830_00023.jpg

View of cactus and other landscaping.

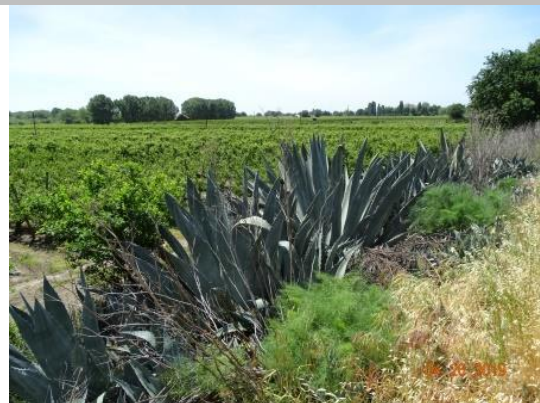
Photo 1 of 1 : FA_2021_RD0556_19_47_20210830_00028.jpg

View looking downstream at cactus on the landside slope (Spring 2019).

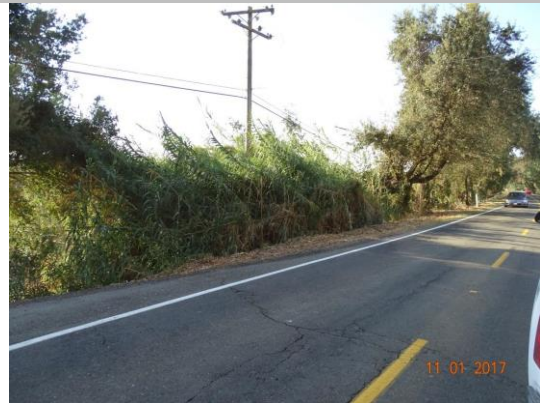
Photo 1 of 1 : FA_2021_RD0556_19_32_20210830_00017.jpg

View of arundo on the landside slope and toe.

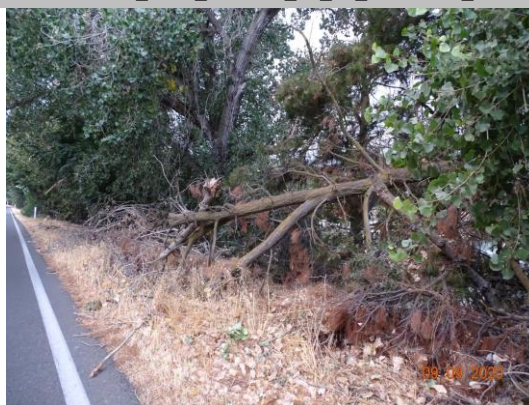
Photo 1 of 1 : FA_2021_RD0556_19_57_20210830_00037.jpg

View looking downstream at down tree on waterside shoulder (Fall 2020).

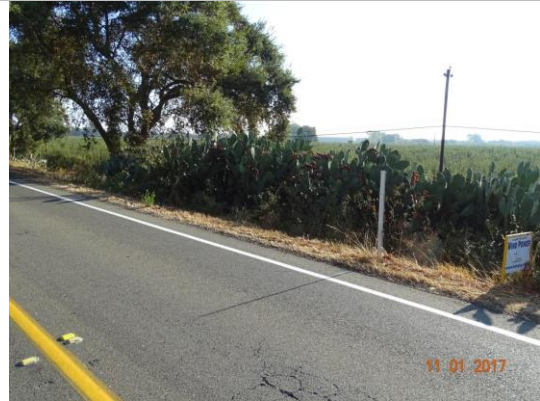
Photo 1 of 1 : FA_2021_RD0556_19_33_20210830_00018.jpg

View of large growth of prickly pear cactus.

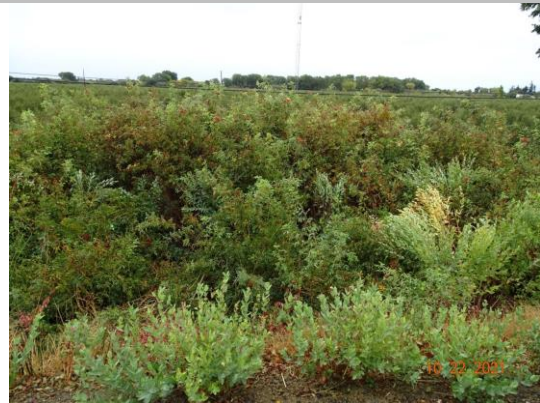
Photo 1 of 1 : FA_2021_RD0556_19_111_20211022_00105.jpg

View of thick vegetation on the landside slope (Fall 2021).

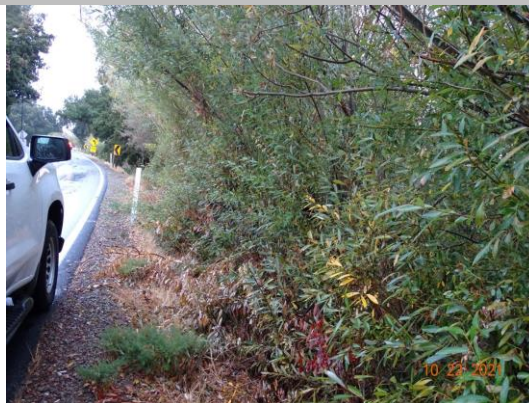
Photo 1 of 1 : FA_2021_RD0556_19_89_20211022_00098.jpg

View looking downstream at thick trees on the landside slope (Fall 2021).

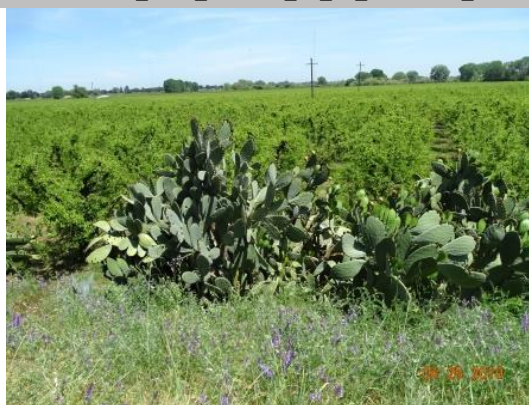
Photo 1 of 1 : FA_2021_RD0556_19_45_20210830_00026.jpg

View of cactus on the landside slope (Spring 2019).

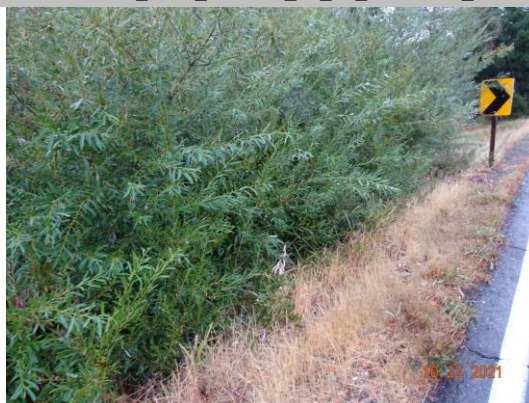
Photo 1 of 1 : FA_2021_RD0556_19_90_20211022_00099.jpg

View looking upstream at thick vegetation on the waterside slope (Fall 2021).

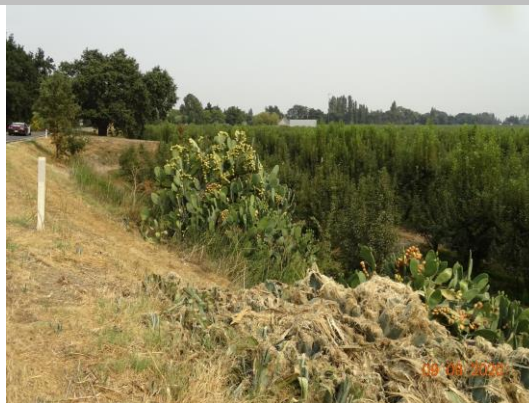
Photo 1 of 1 : FA_2021_RD0556_19_76_20210830_00049.jpg

View of large cactus on the landside slope (Fall 2020).

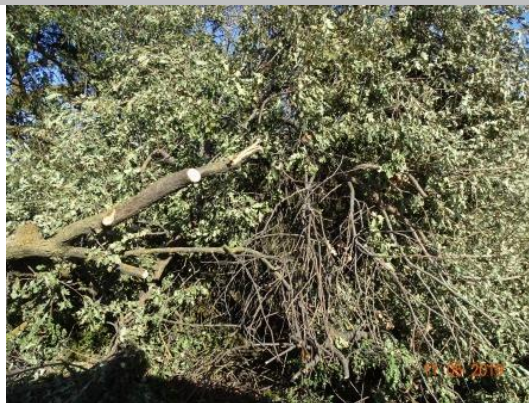
Photo 1 of 1 : FA_2021_RD0556_19_88_20210830_00056.jpg

View of broken tree limb blocking the view of the landside slope (Fall 2019).

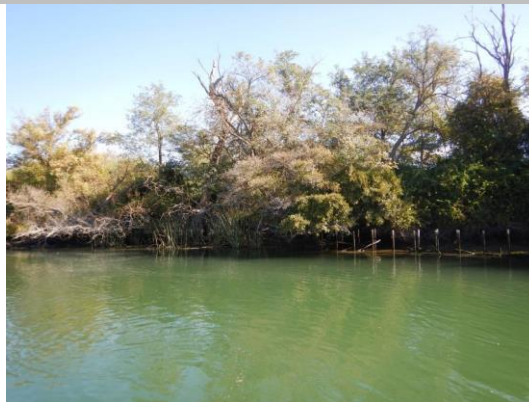
Photo 2 of 2 : FA_2021_RD0556_19_17_20211218_58.jpg

USACE 2018 Erosion Photo #2

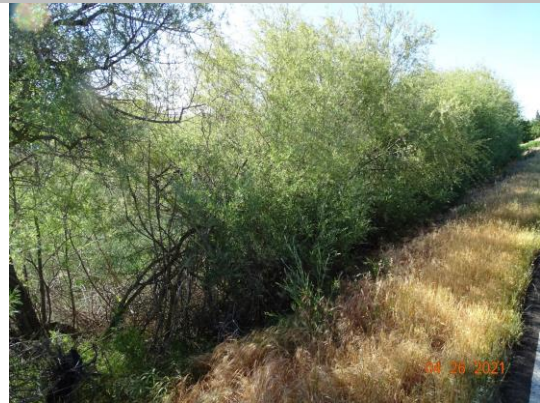
Photo 1 of 1 : FA_2021_RD0556_19_61_20210830_00040.jpg

View looking downstream at willows on the landside slope (Spring 2021).

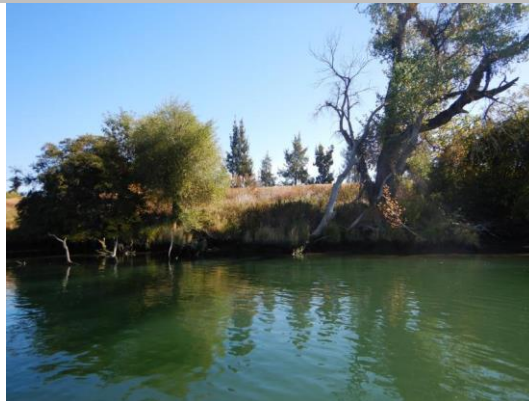
Photo 1 of 2 : FA_2021_RD0556_19_16_20211218_8.jpg

USACE 2018 Erosion Photo #1

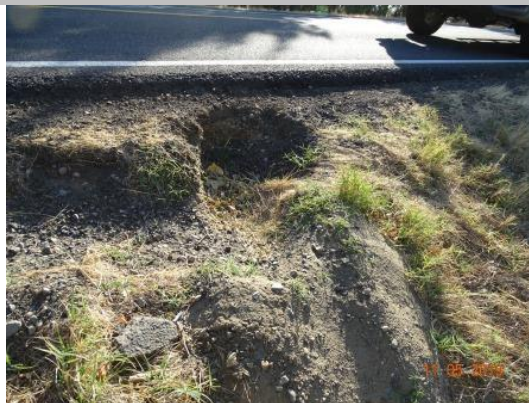
Photo 1 of 1 : FA_2021_RD0556_19_63_20210830_00042.jpg

View of erosion on the waterside shoulder (Fall 2019).

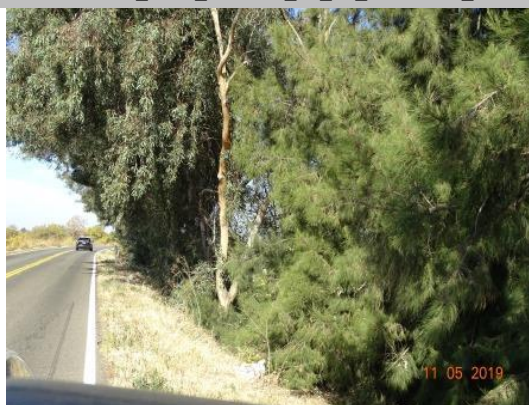
Photo 1 of 1 : FA_2021_RD0556_19_84_20210830_00053.jpg

View looking upstream at thick trees on the landside slope (Fall 2019).

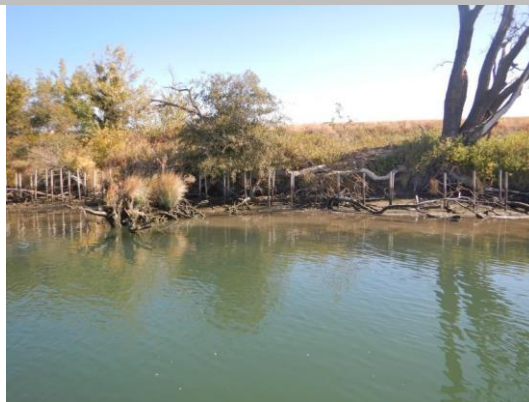
Photo 2 of 2 : FA_2021_RD0556_19_15_20211218_7.jpg

USACE 2018 Erosion Photo #2

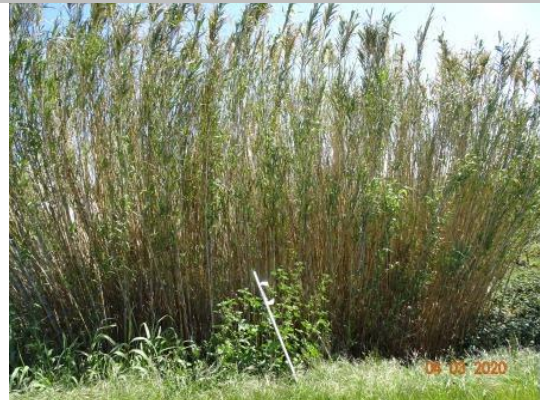
Photo 1 of 1 : FA_2021_RD0556_19_71_20210830_00046.jpg

View of thick arundo on the landside slope (Spring 2020).

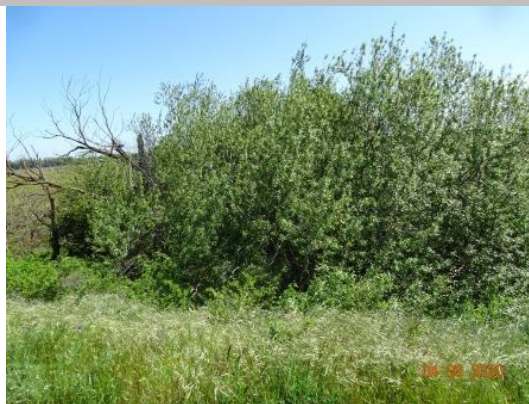
Photo 1 of 1 : FA_2021_RD0556_19_55_20210830_00035.jpg

View of thick tree on the landside slope (Spring 2020).

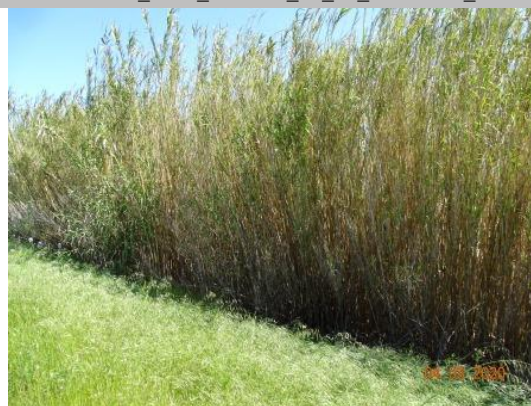
Photo 1 of 1 : FA_2021_RD0556_19_51_20210830_00031.jpg

View of thick arundo on the landside slope (Spring 2020).

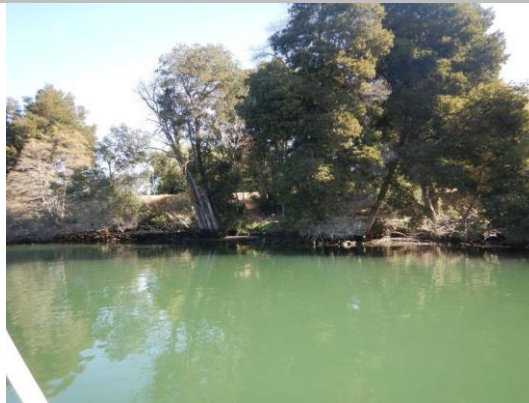
Photo 1 of 2 : FA_2021_RD0556_19_14_20211218_4.jpg

USACE 2018 Erosion Photo #1

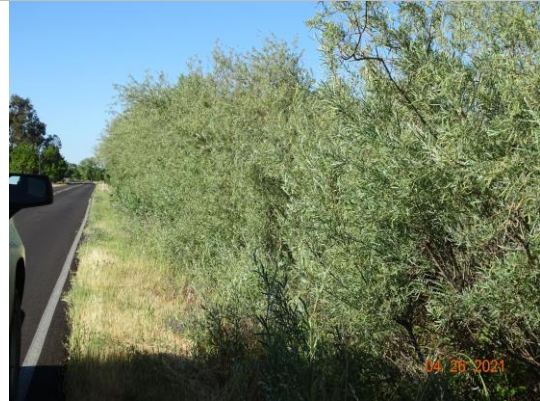
Photo 1 of 1 : FA_2021_RD0556_19_67_20210830_00044.jpg

View looking downstream at willows on the waterside slope (Spring 2021).

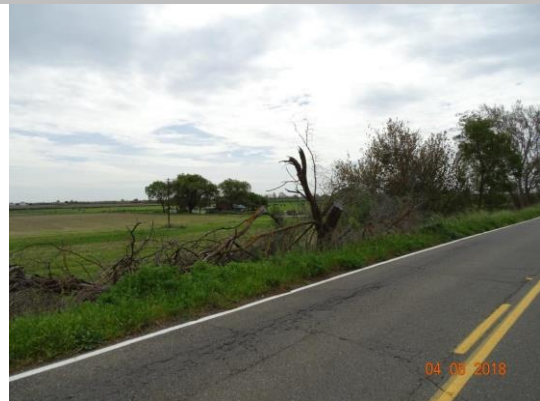
Photo 1 of 1 : FA_2021_RD0556_19_56_20210830_00036.jpg

Fallen tree on landside should be removed.

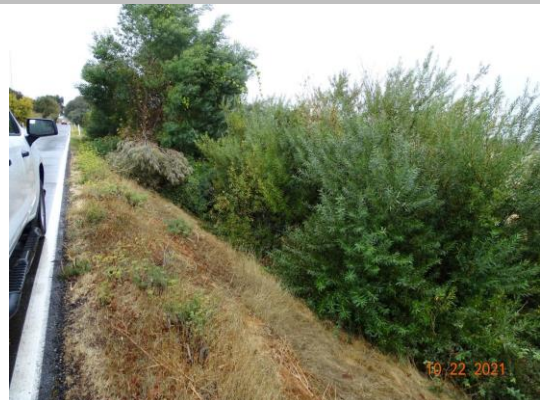
Photo 1 of 1 : FA_2021_RD0556_19_60_20211022_00103.jpg

View looking upstream at thick trees on the landside slope (Fall 2021).

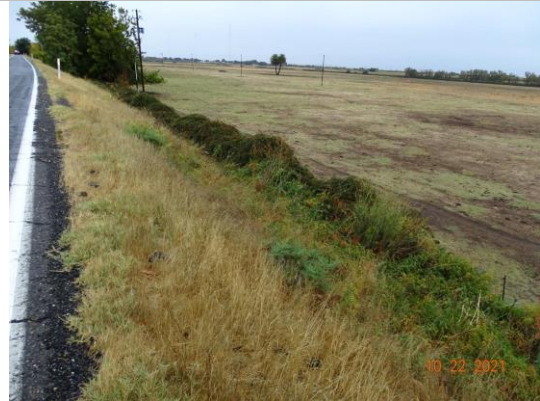
Photo 1 of 1 : FA_2021_RD0556_19_102_20211022_00102.jpg

View looking upstream at blackberries on the landside slope (Fall 2021).

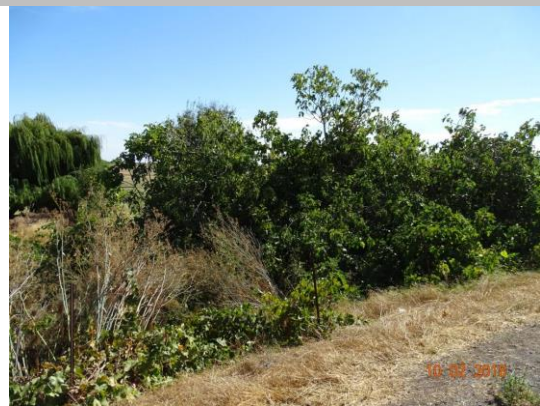
Photo 1 of 1 : FA_2021_RD0556_19_58_20210830_00038.jpg

View of fig tree on landside slope (October 2018).

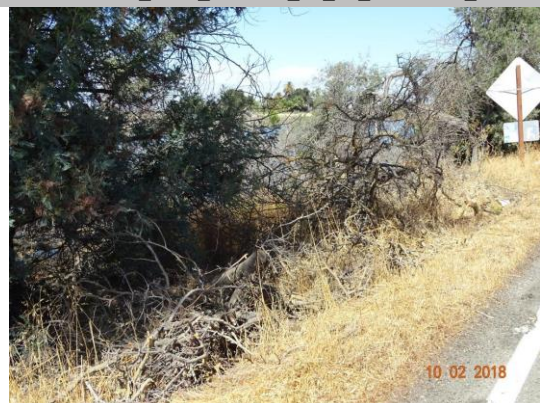
Photo 1 of 1 : FA_2021_RD0556_19_27_20210830_00013.jpg

View of fallen tree on the waterside slope (October 2018).

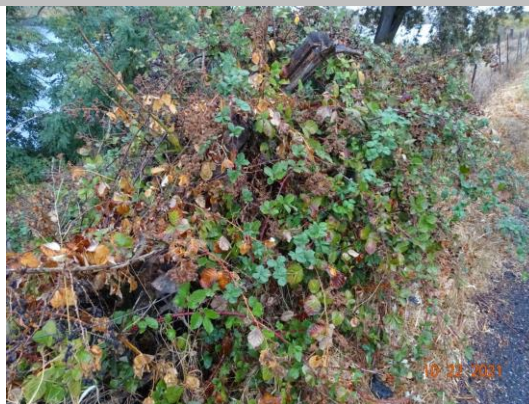
Photo 1 of 1 : FA_2021_RD0556_19_94_20211022_00100.jpg

View looking upstream at vegetation on the waterside slope (Fall 2021).

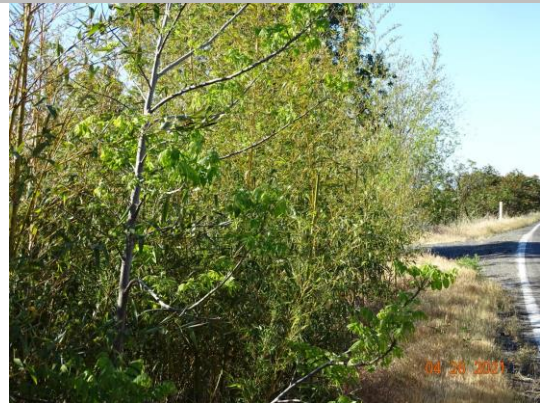
Photo 1 of 1 : FA_2021_RD0556_19_52_20210830_00032.jpg

View looking downstream at bamboo and trees of heaven on landside slope (Spring 2021).

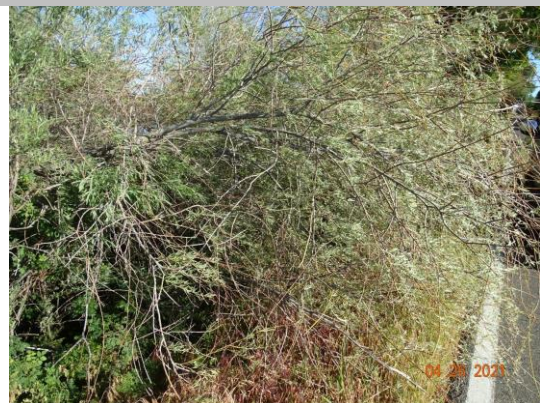
Photo 1 of 1 : FA_2021_RD0556_19_66_20210830_00043.jpg

View looking upstream at willows on the waterside slope (Spring 2021).

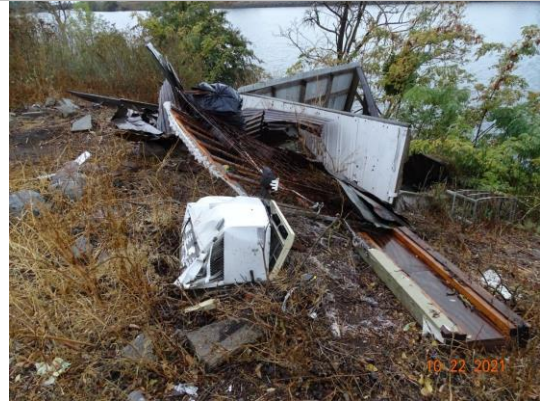
Photo 1 of 1 : FA_2021_RD0556_19_95_20211022_00101.jpg

View of garbage on the waterside slope (Fall 2021).

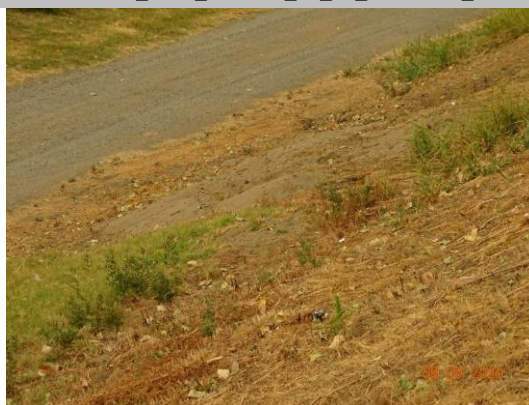
Photo 1 of 1 : FA_2021_RD0556_19_79_20210830_00051.jpg

View looking downstream at burrow holes on the landside slope (Fall 2020).
