**Flood Control Project Maintenance
Levee Inspections**

Maintenance Issue Types Only, Levee Inspection Report By Mile - Fall 2022

Reclamation District No. 0556 Upper Andrus

Waterway	Bank	Unit Miles	Inspection Start/End	Inspector
Unit No. 01 Georgiana Slough	Right	5.48	09/22/2022 09/22/2022	Saskia Donovan

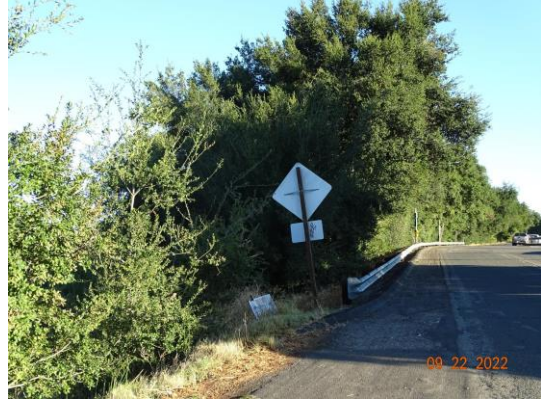
Photo 1 of 1 : FA_2022_RD0556_18_21_20221004_00171.jpg

LM Start	0.00	Rating **	U	Issue No.	21
LM End	0.57	Issue Type +	Ma	Location *	LS
Category	Earthen Levee			GPS Latitude/Longitude	
				Start	End
Item	Trim / Thin Trees			38.239100 °	38.232070 °
				-121.518250 °	-121.522067 °
DWR ID	DWR_RD0556_01_s_2017_21				
Comment Code					
T1 : Trim and thin trees to at least five feet above ground level to allow visibility of the ground and room to flood fight.					
Inspector Comment

View of the vegetation on the LS slope (Fall 2022).

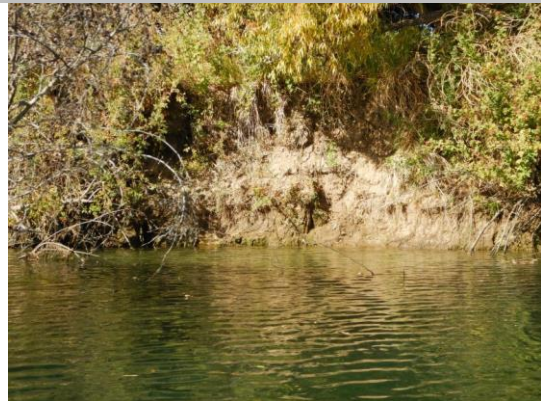
Photo 1 of 2 : FA_2022_RD0556_18_43_20220831_00027.jpg

LM Start	0.38	Rating **	M	Issue No.	43
LM End	0.58	Issue Type +	Ma	Location *	WS
Category	Supplemental			GPS Latitude/Longitude	
				Start	End
Item	2018 USACE Erosion Survey			38.234038 °	38.231879 °
				-121.519817 °	-121.522003 °
DWR ID	DWR_RD0556_01_s_2022_43				
Comment Code					
Inspector Comment					
2018 Site ID: GEO 11.8 R					
Status: Eroding					
2018 Field Notes: No observed change.					
Site History: 2017 - Tree popout popouts eminent , significant toe erosion and whole bank failure in sections

USACE 2018 Erosion Photo #1

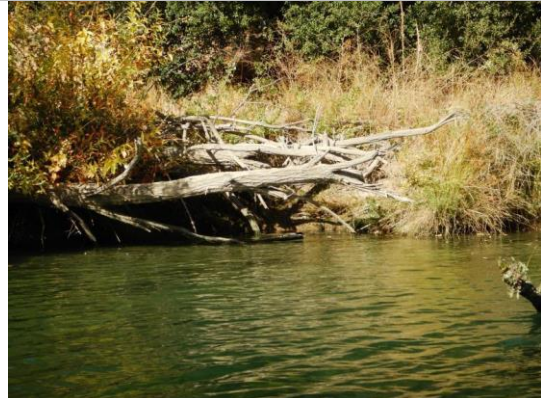
Photo 2 of 2 : FA_2022_RD0556_18_43_20220831_00028.jpg

LM Start	0.38	Rating **	M	Issue No.	43 (cont)
LM End	0.58	Issue Type +	Ma	Location *	WS

USACE 2018 Erosion Photo #2

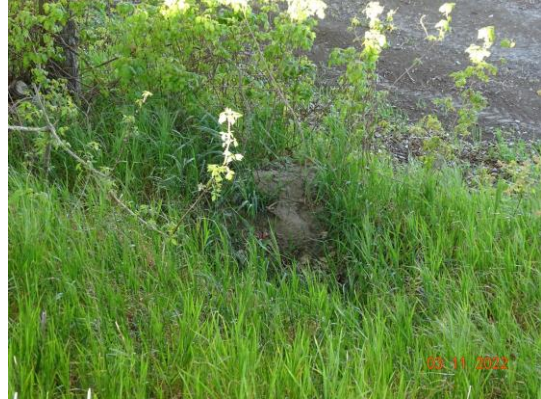
Photo 1 of 1 : FA_2022_RD0556_18_84_20220831_00046.jpg

LM Start	0.63	Rating **	U	Issue No.	84
LM End	0.63	Issue Type +	Ma	Location *	LS
Category	Earthen Levee			GPS Latitude/Longitude	
				Start	End
Item	Slope Stability			38.231428 °	38.231428 °
				-121.522772 °	-121.522772 °
DWR ID	DWR_RD0556_01_f _ 2021_84				
Comment Code					
S1 : Repair slope instability.					
Inspector Comment					
Tree fell over and created large hole in landside slope. Tree was removed but hole remains.

View of hole in the landside slope where root ball had been (Spring 2022).

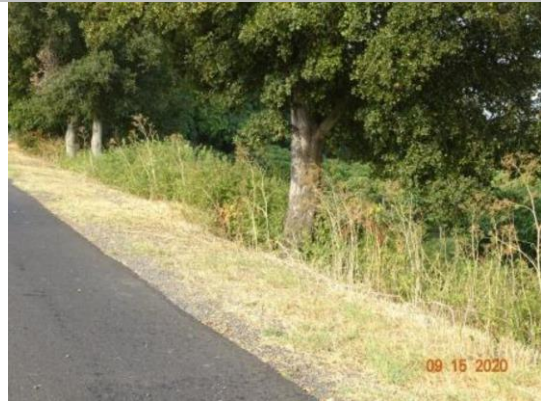
Photo 1 of 1 : FA_2022_RD0556_18_65_20220831_00041.jpg

LM Start	0.82	Rating **	U	Issue No.	65
LM End	0.85	Issue Type +	Ma	Location *	LS
Category	Earthen Levee			GPS Latitude/Longitude	
				Start	End
Item	Vegetation			38.229278 °	38.229013 °
				-121.525103 °	-121.525562 °
DWR ID	DWR_RD0556_01_f_2020_65				
Comment Code					
V2 : Remove the wild growth and woody vegetation other than native grasses from the levee slopes.					
Inspector Comment

View looking downstream at vegetation on the landside slope (Fall 2020).

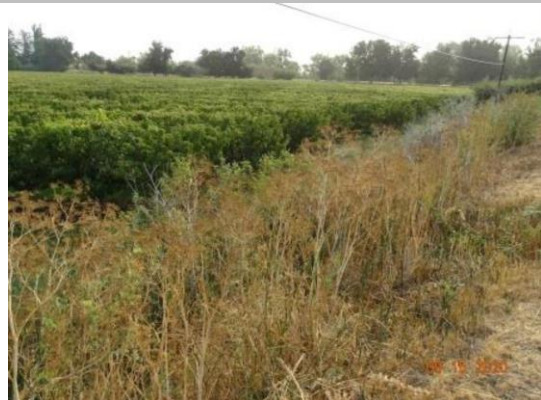
Photo 1 of 1 : FA_2022_RD0556_18_66_20220831_00042.jpg

LM Start	0.98	Rating **	U	Issue No.	66
LM End	1.17	Issue Type +	Ma	Location *	LS
Category	Earthen Levee			GPS Latitude/Longitude	
				Start	End
Item	Vegetation			38.227653 °	38.227574 °
				-121.527032 °	-121.529479 °
DWR ID	DWR_RD0556_01_f_2020_66				
Comment Code					
V2 : Remove the wild growth and woody vegetation other than native grasses from the levee slopes.					
Inspector Comment

View looking upstream at annual vegetation on the landside slope (Fall 2020).

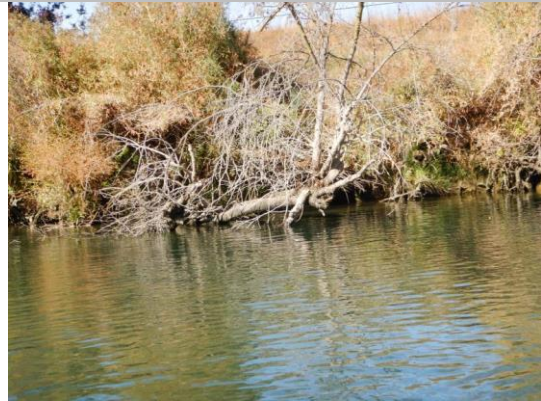
Photo 1 of 2 : FA_2022_RD0556_18_42_20220831_00025.jpg

LM Start	1.20	Rating **	M	Issue No.	42
LM End	1.53	Issue Type +	Ma	Location *	WS
Category	Supplemental			GPS Latitude/Longitude	
				Start	End
Item	2018 USACE Erosion Survey			38.227615 °	38.225374 °
				-121.529894 °	-121.534406 °
DWR ID	DWR_RD0556_01_s_2022_42				
Comment Code					
Inspector Comment					
2018 Site ID: GEO 10.9 R					
Status: Eroding					
2018 Field Notes: New erosion throughout site.					
Site History: 2017 - Significant toe erosion and whole bank failure in sections, large pockets from tree popouts.

USACE 2018 Erosion Photo #1

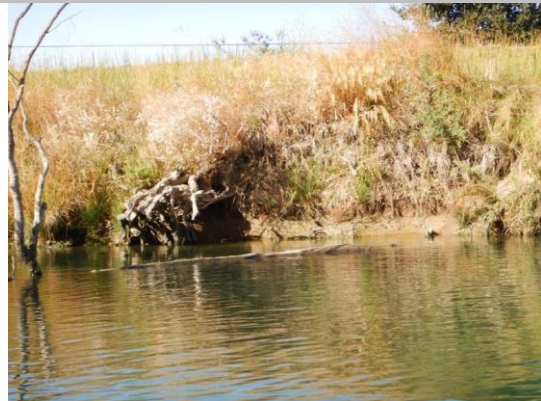
Photo 2 of 2 : FA_2022_RD0556_18_42_20220831_00026.jpg

USACE 2018 Erosion Photo #2

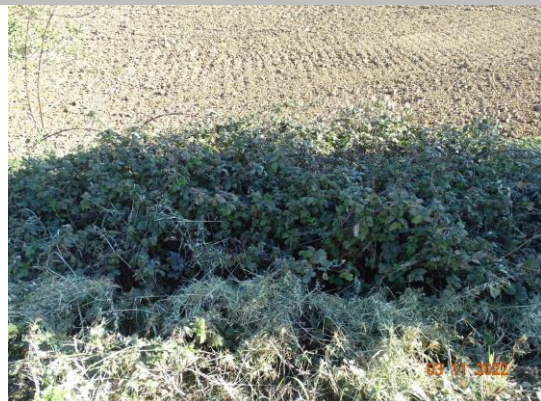
Photo 1 of 1 : FA_2022_RD0556_18_81_20220831_00044.jpg

LM Start	1.21	Rating **	U	Issue No.	81
LM End	1.21	Issue Type +	Ma	Location *	LS
Category	Earthen Levee			GPS Latitude/Longitude	
				Start	End
Item	Vegetation			38.227783 °	38.227783 °
				-121.530067 °	-121.530067 °
DWR ID	DWR_RD0556_01_s_2022_81				
Comment Code					
V2 : Remove the wild growth and woody vegetation other than native grasses from the levee slopes.					
Inspector Comment					
Blackberries on the landside slope.

View of blackberries on the landside slope (Spring 2022).

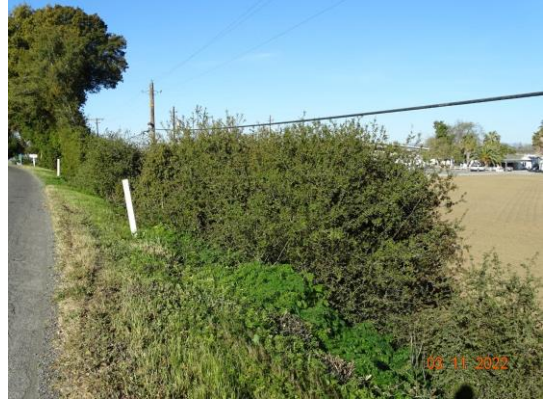
Photo 1 of 1 : FA_2022_RD0556_18_87_20220831_00049.jpg

View looking downstream at trees on the landside slope (Spring 2022).

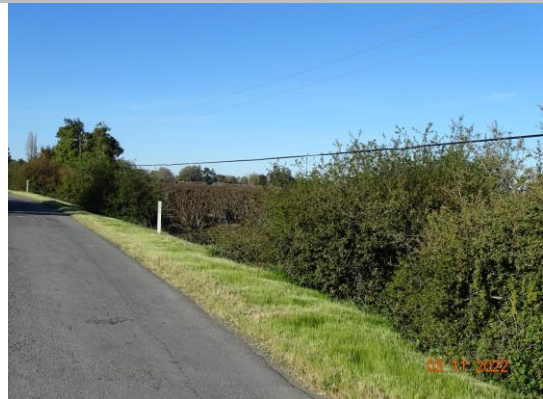
Photo 1 of 1 : FA_2022_RD0556_18_88_20220831_00050.jpg

LM Start	1.37	Rating **	U	Issue No.	88
LM End	1.54	Issue Type +	Ma	Location *	LS
Category	Earthen Levee			GPS Latitude/Longitude	
				Start	End
Item	Trim / Thin Trees			38.227286 °	38.225374 °
				-121.532724 °	-121.534665 °
DWR ID	DWR_RD0556_01_s_2022_88				
Comment Code					
T1 : Trim and thin trees to at least five feet above ground level to allow visibility of the ground and room to flood fight.					
Inspector Comment

View looking downstream at trees on the landside slope (Spring 2022).

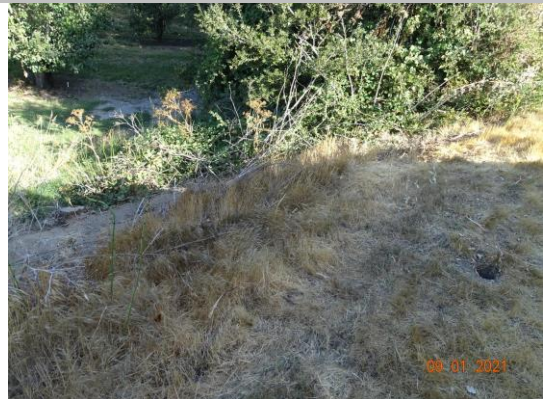
Photo 1 of 1 : FA_2022_RD0556_18_82_20220831_00045.jpg

LM Start	1.43	Rating **	M	Issue No.	82
LM End	1.43	Issue Type +	Ma	Location *	LS
Category	Earthen Levee			GPS Latitude/Longitude	
				Start	End
Item	Animal Control			38.226537 °	38.226537 °
				-121.533351 °	-121.533351 °
DWR ID	DWR_RD0556_01_f_2021_82				
Comment Code					
A1 : Exterminate rodents and backfill and compact or grout burrows.					
Inspector Comment

View of animal holes in landside hinge and slope (Fall 2021).

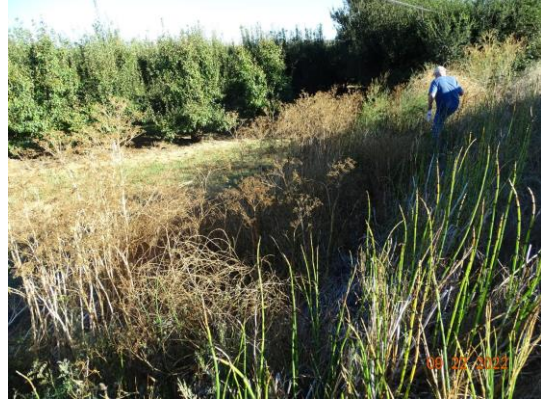
Photo 1 of 1 : FA_2022_RD0556_18_40_20221004_00175.jpg

View of the erosion on the LS slope (Fall 2022).

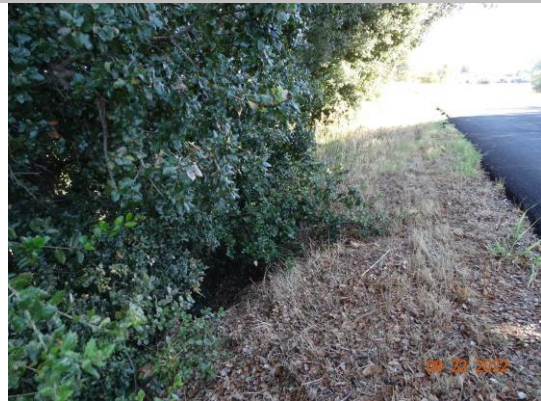
Photo 1 of 1 : FA_2022_RD0556_18_22_20221004_00176.jpg

LM Start	1.50	Rating **	M	Issue No.	22
LM End	1.50	Issue Type +	Ma	Location *	LS
Category	Earthen Levee			GPS Latitude/Longitude	
				Start	End
Item	Erosion / Rills			38.225840 °	38.225840 °
				-121.534157 °	-121.534157 °
DWR ID	DWR_RD0556_01_s_2012_22				
Comment Code					
E5 : Schedule repair of rills prior to the next inspection.					
Inspector Comment					
Dip at the top of the landside slope is greater than 3". Erosion seems to be caused by surface runoff.

View of the erosion on the upper LS slope (Fall 2022).

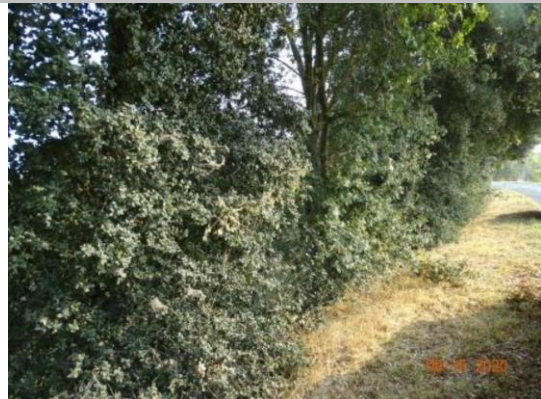
Photo 1 of 1 : FA_2022_RD0556_18_46_20220831_00031.jpg

View looking upstream at thick trees on the landside slope (Fall 2020).

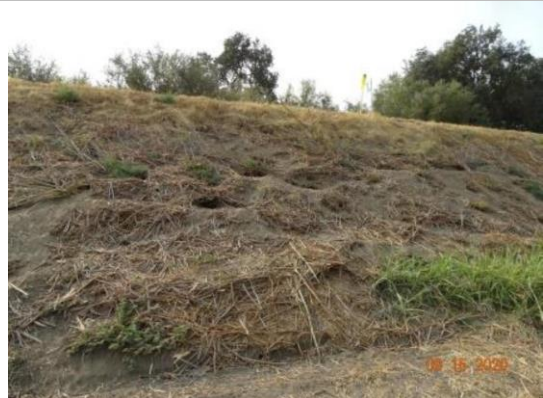
Photo 1 of 1 : FA_2022_RD0556_18_61_20220831_00039.jpg

View of multiple squirrel holes in the landside slope (Fall 2020).

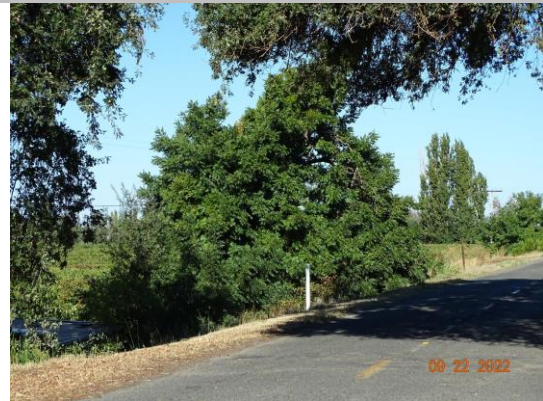
Photo 1 of 1 : FA_2022_RD0556_18_69_20221004_00184.jpg

View of the tree on the LS slope (Fall 2022).

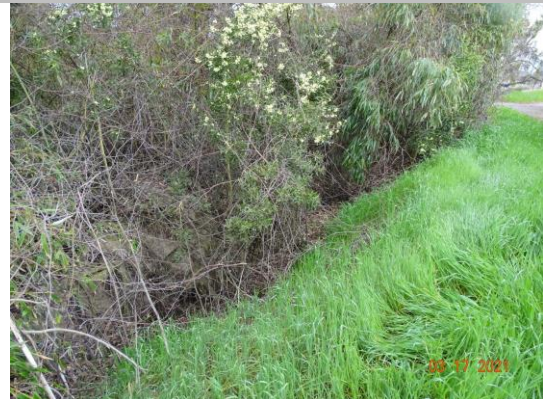
Photo 1 of 1 : FA_2022_RD0556_18_33_20220831_00015.jpg

LM Start	2.72	Rating **	U	Issue No.	33
LM End	2.72	Issue Type +	Ma	Location *	LS
Category	Earthen Levee			GPS Latitude/Longitude	
				Start	End
Item	Trim / Thin Trees			38.215107 °	38.215107 °
				-121.540677 °	-121.540677 °
DWR ID	DWR_RD0556_01_s_2017_33				
Comment Code					
T3 : Fallen tree with root ball.					
Inspector Comment					
Fallen tree on landside. Remove the fallen tree and repair the levee damage.

View of hole in landside slope caused by down tree (Spring 2021).

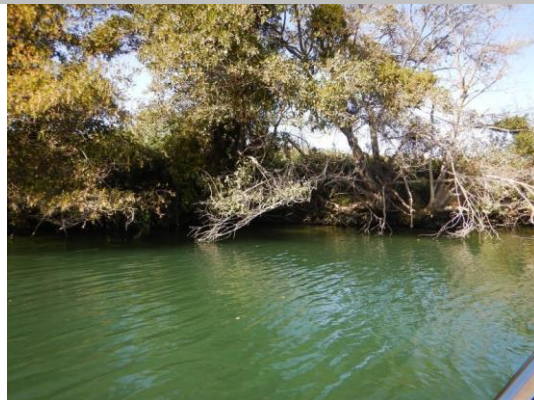
Photo 1 of 2 : FA_2022_RD0556_18_36_20220831_00017.jpg

LM Start	3.18	Rating **	M	Issue No.	36
LM End	3.50	Issue Type +	Ma	Location *	WS
Category	Supplemental			GPS Latitude/Longitude	
				Start	End
Item	2018 USACE Erosion Survey			38.210674 °	38.206919 °
				-121.538854 °	-121.541559 °
DWR ID	DWR_RD0556_01_s_2022_36				
Comment Code					
Inspector Comment					
2018 Site ID: GEO 9.0 R					
Status: Eroding					
2018 Field Notes: Site extended downstream.					
Site History: 2017 - Toe erosion and failed revetment.

USACE 2018 Erosion Photo #1

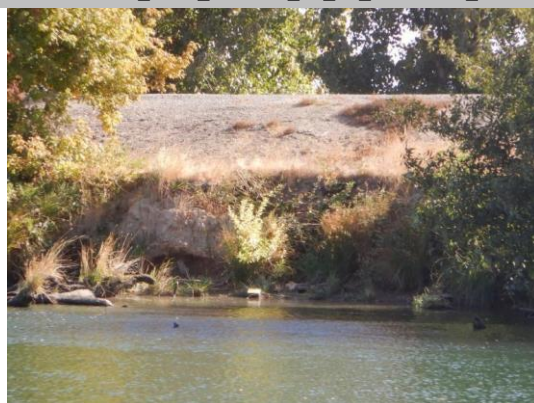
Photo 2 of 2 : FA_2022_RD0556_18_36_20220831_00018.jpg

LM Start	3.18	Rating **	M	Issue No.	36 (cont)
LM End	3.50	Issue Type +	Ma	Location *	WS

USACE 2018 Erosion Photo #2

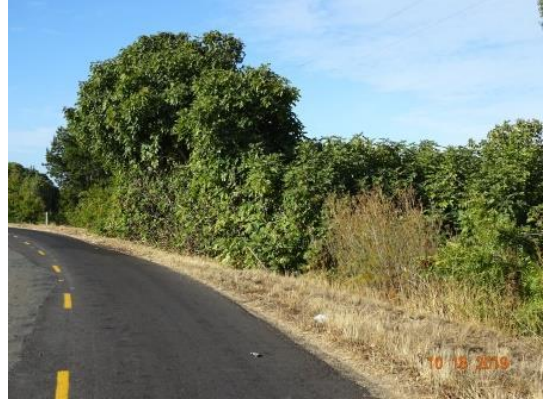
Photo 1 of 1 : FA_2022_RD0556_18_38_20220831_00021.jpg

View looking downstream at thick tree growth on the landside slope (Fall 2019).

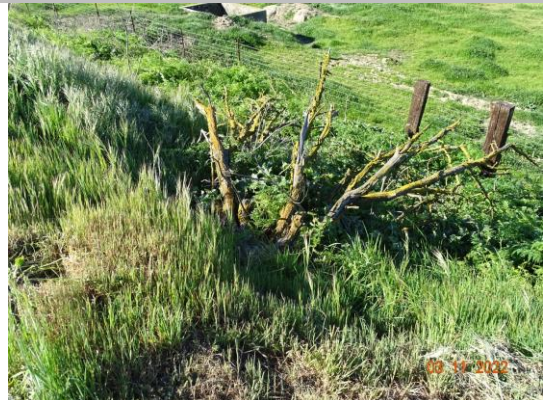
Photo 1 of 1 : FA_2022_RD0556_18_95_20220831_00052.jpg

View of down tree limbs on the landside slope (Spring 2022).

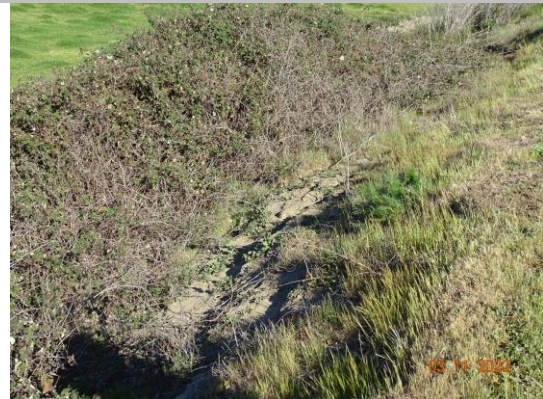
Photo 1 of 1 : FA_2022_RD0556_18_97_20220831_00053.jpg

LM Start	3.66	Rating **	M	Issue No.	97
LM End	3.71	Issue Type +	Ma	Location *	LS
Category	Earthen Levee			GPS Latitude/Longitude	
				Start	End
Item	Erosion / Livestock			38.204630 °	38.204020 °
				-121.541382 °	-121.541196 °
DWR ID	DWR_RD0556_01_s _ 2022_97				
Comment Code					
E4 : Repair the levee slope damaged by livestock and prevent large animal access.					
Inspector Comment					
Cow on levee creating path and holes in landside shoulder.

View of cow path digging into landside slope (Spring 2022).

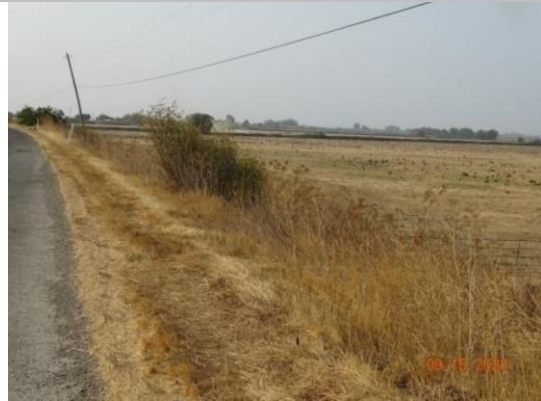
Photo 1 of 1 : FA_2022_RD0556_18_41_20220831_00024.jpg

View looking downstream at vegetation on the landside slope (Fall 2020).

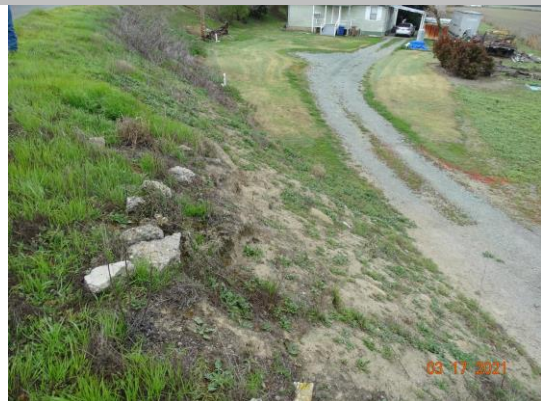
Photo 1 of 1 : FA_2022_RD0556_18_86_20220831_00048.jpg

LM Start	3.82	Rating **	M	Issue No.	86
LM End	3.82	Issue Type +	Ma	Location *	LS
Category	Earthen Levee			GPS Latitude/Longitude	
				Start	End
Item	Erosion / Rills			38.202481 °	38.202481 °
				-121.540839 °	-121.540839 °
DWR ID	DWR_RD0556_01_f_2021_86				
Comment Code					
E5 : Schedule repair of rills prior to the next inspection.					
Inspector Comment					
Exposed slope eroding, most likely due to runoff.

View of erosion rivulets in the landside slope (Spring 2021).

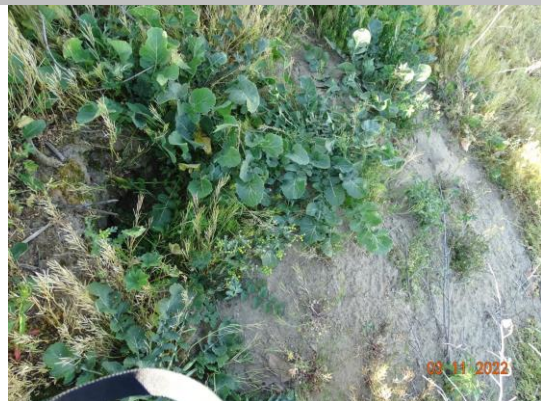
Photo 1 of 1 : FA_2022_RD0556_18_98_20220831_00054.jpg

View of large rodent hole in the landside slope (Spring 2022).

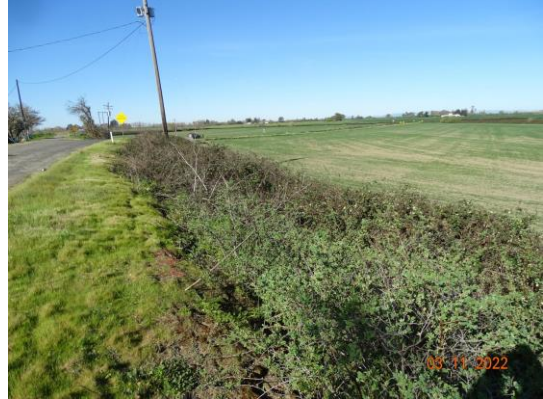
Photo 1 of 1 : FA_2022_RD0556_18_99_20220831_00055.jpg

View looking downstream at vegetation on the landside slope (Spring 2022).

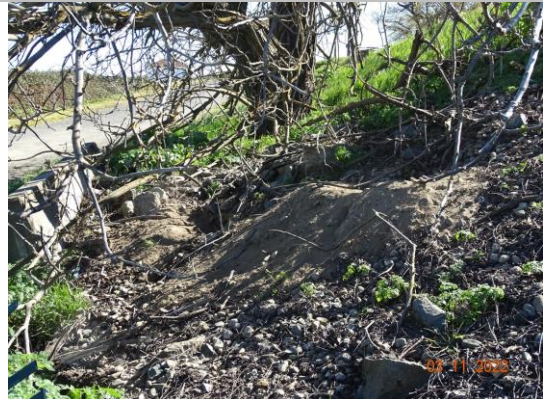
Photo 1 of 1 : FA_2022_RD0556_18_101_20220831_00057.jpg

View of multiple animal holes in the landside slope (Spring 2022).

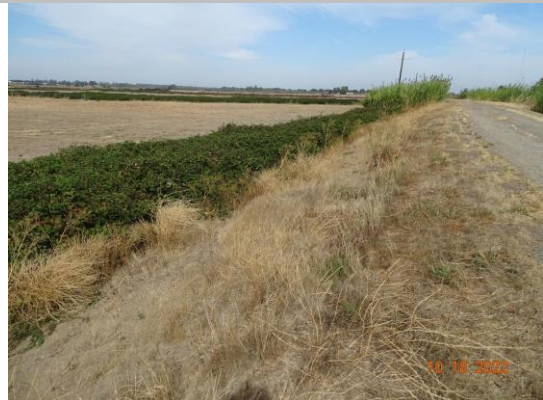
Photo 1 of 1 : FA_2022_RD0556_18_39_20221026_00195.jpg

View of the blackberries on the LS toe (Fall 2022).

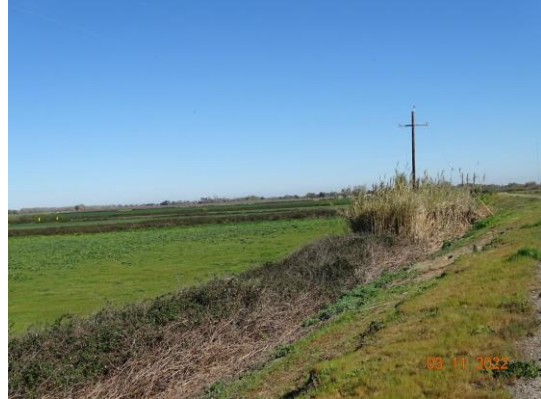
Photo 1 of 1 : FA_2022_RD0556_18_111_20220831_00059.jpg

LM Start	4.23	Rating **	M	Issue No.	111
LM End	4.25	Issue Type +	Ma	Location *	LS
Category	Earthen Levee			GPS Latitude/Longitude	
				Start	End
Item	Erosion / Livestock			38.198731 °	38.198510 °
				-121.546352 °	-121.546557 °
DWR ID	DWR_RD0556_01_s_2022_111				
Comment Code					
E4 : Repair the levee slope damaged by livestock and prevent large animal access.					
Inspector Comment

View looking upstream of erosion due to cow path on the landside slope (Spring 2022).

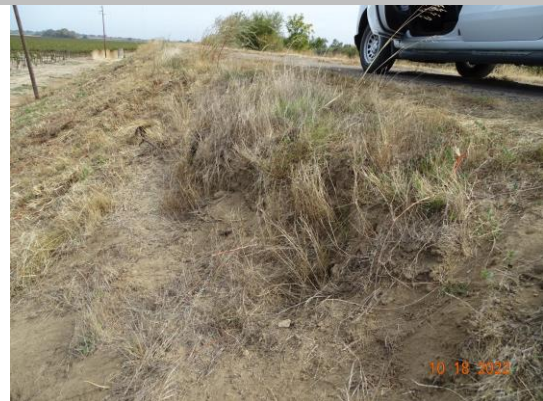
Photo 1 of 1 : FA_2022_RD0556_18_63_20221026_00192.jpg

LM Start	5.09	Rating **	M	Issue No.	63
LM End	5.21	Issue Type +	Ma	Location *	LS
Category	Earthen Levee			GPS Latitude/Longitude	
				Start	End
Item	Erosion / Livestock			38.190255 °	38.188928 °
				-121.557440 °	-121.558976 °
DWR ID	DWR_RD0556_01_s _ 2022_63				
Comment Code					
E4 : Repair the levee slope damaged by livestock and prevent large animal access.					
Inspector Comment

View of the erosion due to livestock on the upper LS slope (Fall 2022).

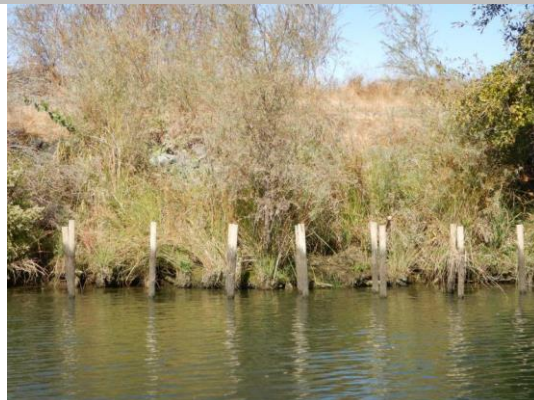
Photo 2 of 2 : FA_2022_RD0556_18_20_20220831_00005.jpg

2018 Site ID: GEO 7.0 R
Status: Eroding
2018 Field Notes: Minor new toe erosion.
Site History: 1997 - Toe damaged rock. 1999 - One pocket filled with gravel. 2000 - Eroding beach with some biotech rolls and stakes; some gravel on slope. 2001 - Staked, low fascine walls at bankline. 2005 - Stone revetment in between pockets. 2006 - New rock on upper slope behind brush boxes at the upstream end, Stone is sliding off the hard toe. 2016 - Fresh erosion observed. 2017 - Site extended downstream. Large erosion pockets and significant toe erosion.

USACE 2018 Erosion Photo #2

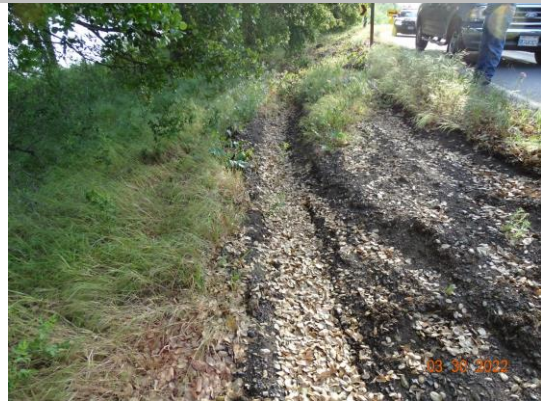
Photo 1 of 1 : FA_2022_RD0556_19_20_20220831_00017.jpg

LM Start	0.04	Rating **	U	Issue No.	20
LM End	0.04	Issue Type +	Ma	Location *	WS
Category	Earthen Levee			GPS Latitude/Longitude	
				Start	End
Item	Erosion / Vehicle Traffic			38.239167 °	38.239167 °
				-121.519040 °	-121.519040 °
DWR ID	DWR_RD0556_02_f_2019_20				
Comment Code					
E6 : Repair the levee slope damaged by vehicle traffic and prevent access where possible.					
Inspector Comment

View of damage to waterside slope due to a vehicle (Spring 2022).

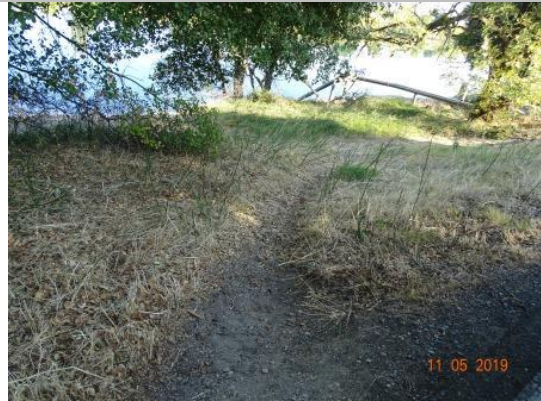
Photo 1 of 1 : FA_2022_RD0556_19_43_20220831_00031.jpg

LM Start	0.50	Rating **	M	Issue No.	43
LM End	0.50	Issue Type +	Ma	Location *	WS
Category	Earthen Levee			GPS Latitude/Longitude	
				Start	End
Item	Erosion / Foot Traffic			38.237963 °	38.237963 °
				-121.527372 °	-121.527372 °
DWR ID	DWR_RD0556_02_f _ 2019_43				
Comment Code					
E3 : Repair the levee slope damaged by foot traffic and prevent access where possible.					
Inspector Comment					
Fishermen trail is on slope. Concrete blocks on the shoulder just downstream of the erosion help with preventing access.

View of fishermen trail digging into levee on the waterside slope (Fall 2019).

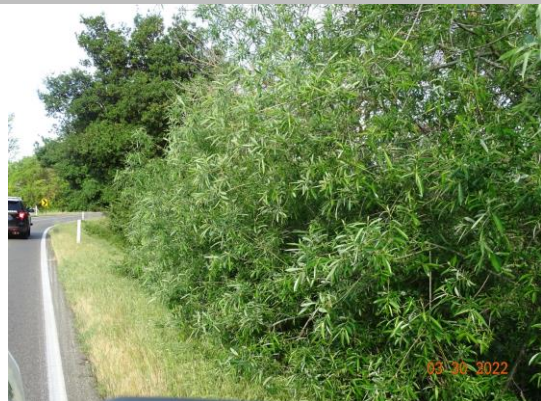
Photo 1 of 1 : FA_2022_RD0556_19_34_20220831_00025.jpg

View looking downstream at thick tree on the waterside slope (Spring 2022).

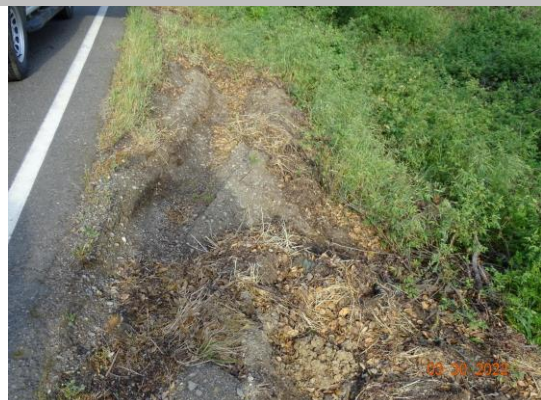
Photo 1 of 1 : FA_2022_RD0556_19_48_20220831_00035.jpg

LM Start	0.73	Rating **	U	Issue No.	48
LM End	0.73	Issue Type +	Ma	Location *	WS
Category	Earthen Levee			GPS Latitude/Longitude	
				Start	End
Item	Erosion / Vehicle Traffic			38.237588 °	38.237588 °
				-121.531453 °	-121.531453 °
DWR ID	DWR_RD0556_02_s_2022_48				
Comment Code					
E6 : Repair the levee slope damaged by vehicle traffic and prevent access where possible.					
Inspector Comment

View of damage to the waterside slope due to vehicle (Spring 2022).

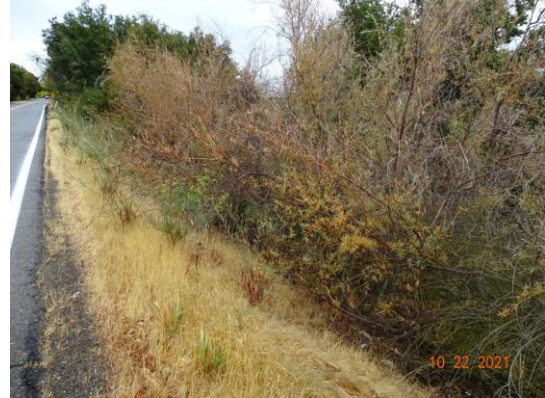
Photo 1 of 1 : FA_2022_RD0556_19_81_20220831_00058.jpg

View looking upstream at thick vegetation on the landside slope (Fall 2021).

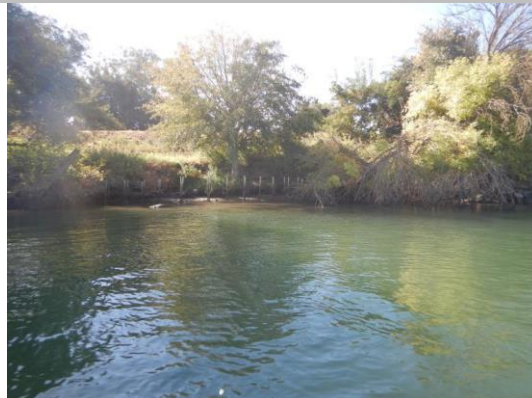
Photo 2 of 2 : FA_2022_RD0556_19_19_20220831_00016.jpg

USACE 2018 Erosion Photo #2

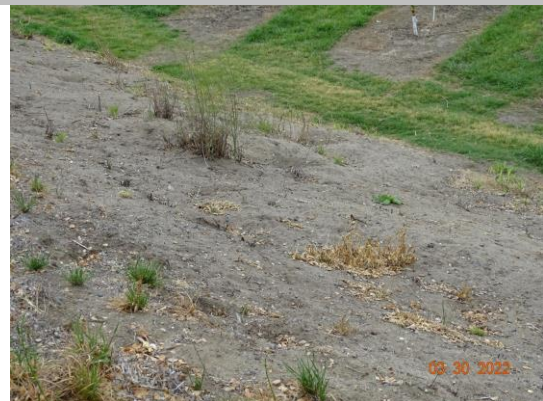
Photo 1 of 1 : FA_2022_RD0556_19_75_20220831_00053.jpg

View of animal holes in the landside slope (Spring 2022).

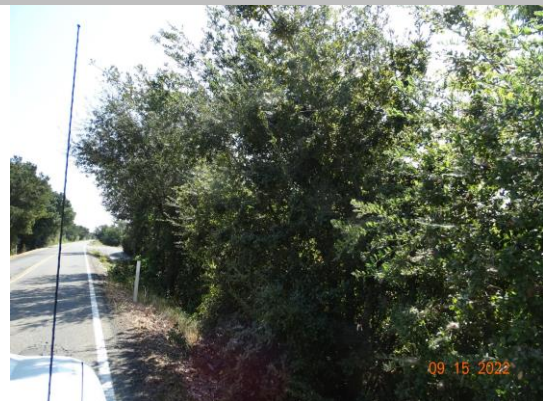
Photo 1 of 1 : FA_2022_RD0556_19_115_20221003_00086.jpg

View of the trees on the LS slope (Fall 2022).

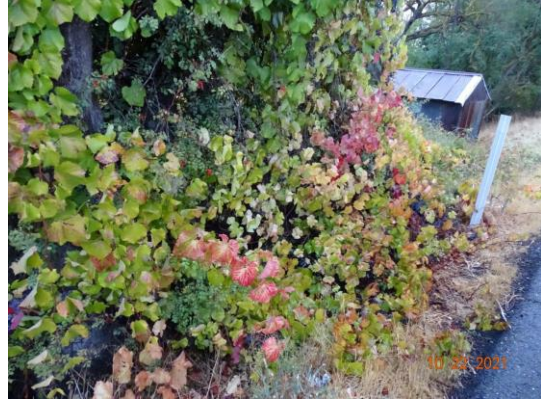
Photo 1 of 1 : FA_2022_RD0556_19_40_20220831_00029.jpg

View looking upstream at thick vegetation on the waterside slope (Fall 2021).

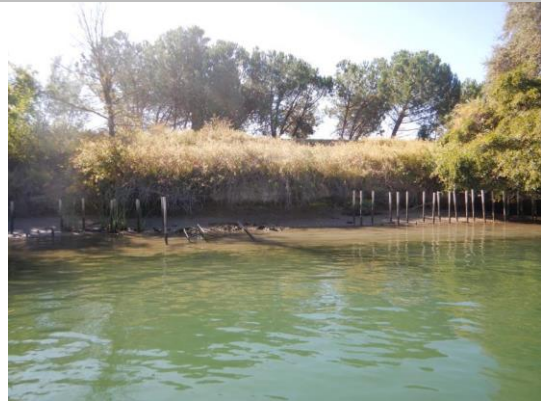
Photo 1 of 2 : FA_2022_RD0556_19_18_20220831_00013.jpg

USACE 2018 Erosion Photo #1

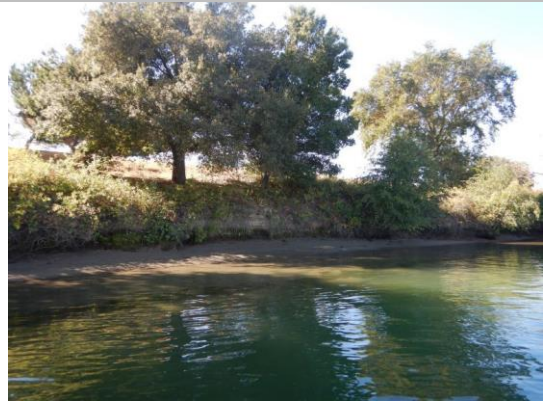
Photo 2 of 2 : FA_2022_RD0556_19_18_20220831_00014.jpg

USACE 2018 Erosion Photo #2

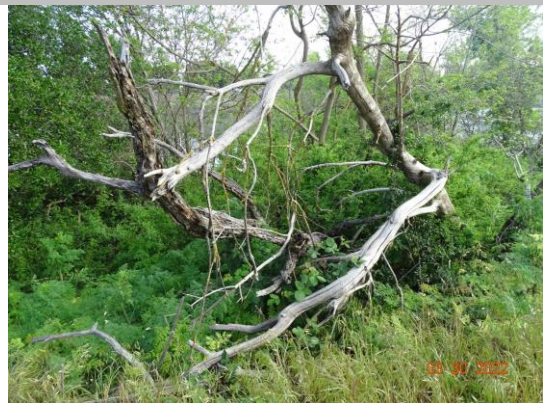
Photo 1 of 1 : FA_2022_RD0556_19_50_20220831_00036.jpg

View of down tree on the landside slope (Spring 2022).

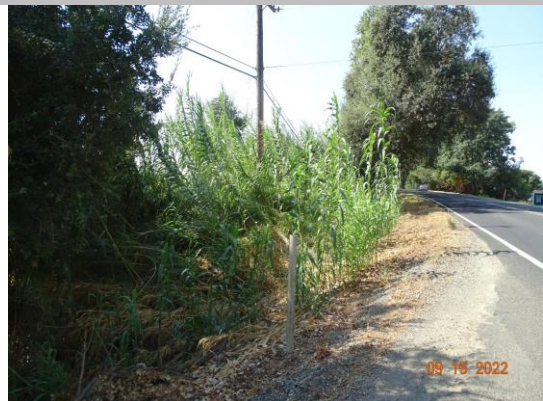
Photo 1 of 1 : FA_2022_RD0556_19_32_20221003_00083.jpg

View of the arundo on the LS slope (Fall 2022).

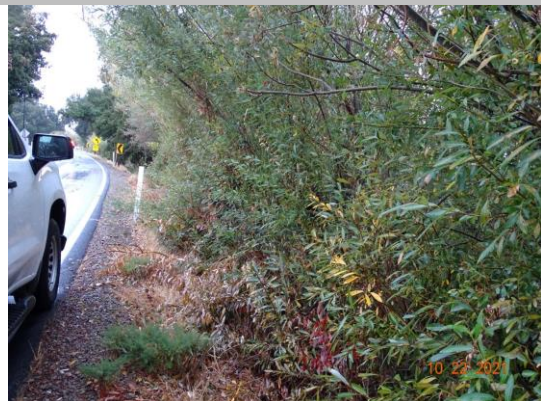
Photo 1 of 1 : FA_2022_RD0556_19_89_20220831_00062.jpg

View looking downstream at thick trees on the waterside slope (Fall 2021).

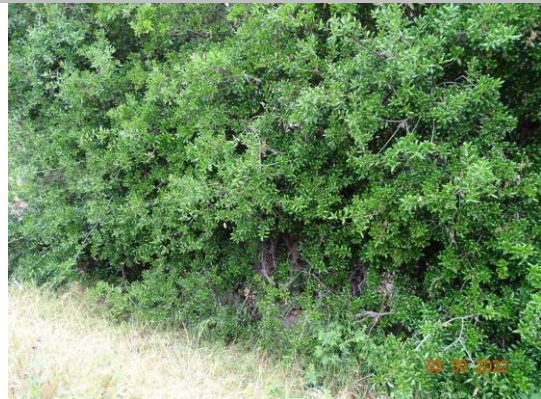
Photo 1 of 1 : FA_2022_RD0556_19_67_20220831_00048.jpg

View of thick trees needing trimming on the landside slope (Spring 2022).

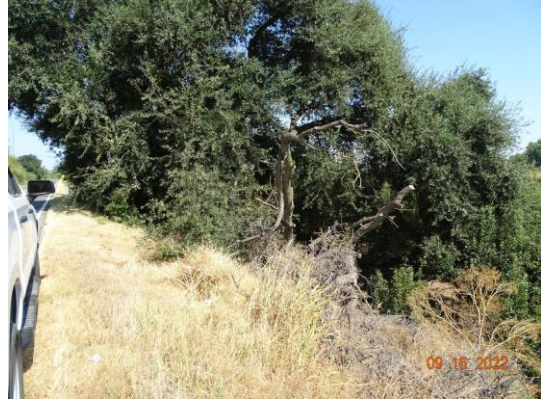
Photo 1 of 1 : FA_2022_RD0556_19_88_20221003_00080.jpg

View of the tree limb on the LS slope (Fall 2022).

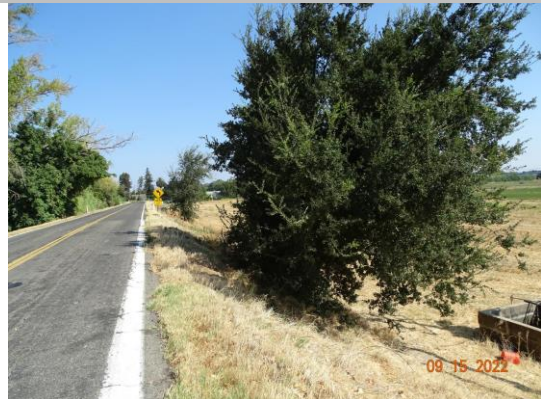
Photo 1 of 1 : FA_2022_RD0556_19_62_20221003_00078.jpg

View of the tree on the LS slope (Fall 2022).

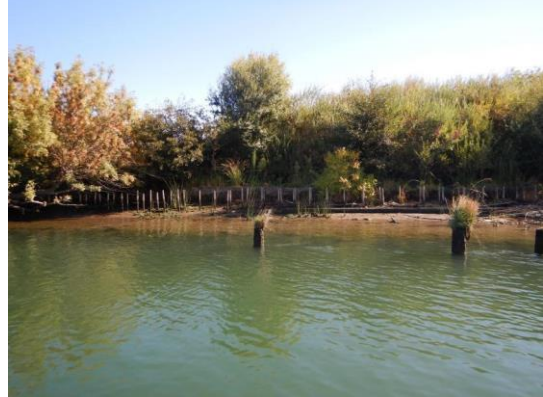
Photo 1 of 2 : FA_2022_RD0556_19_17_20220831_00011.jpg

USACE 2018 Erosion Photo #1

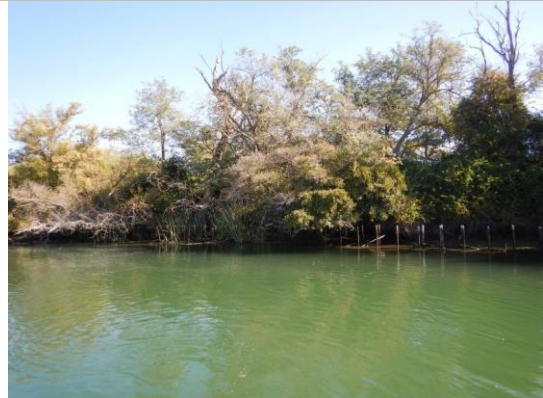
Photo 2 of 2 : FA_2022_RD0556_19_17_20220831_00012.jpg

USACE 2018 Erosion Photo #2

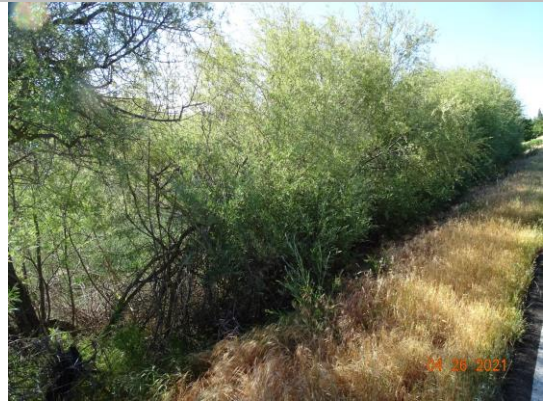
Photo 1 of 1 : FA_2022_RD0556_19_61_20220831_00045.jpg

View looking downstream at willows on the landside slope (Spring 2021).

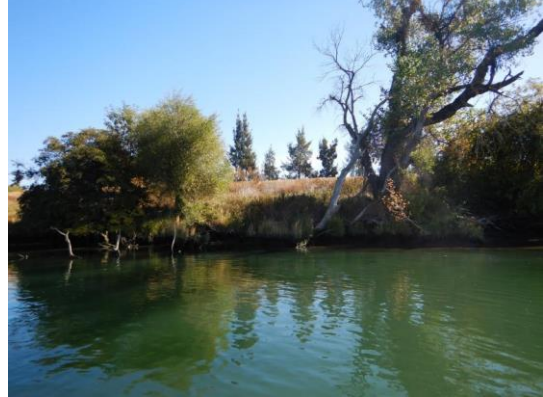
Photo 1 of 2 : FA_2022_RD0556_19_16_20220831_00009.jpg

USACE 2018 Erosion Photo #1

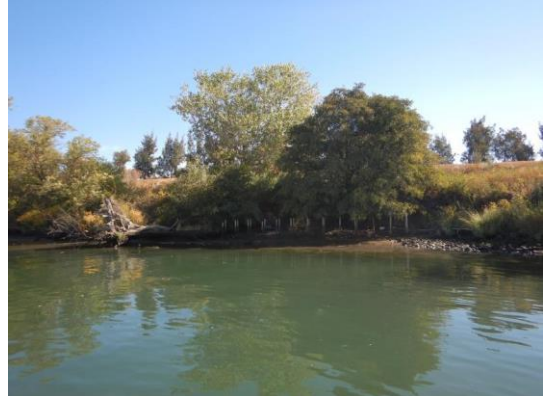
Photo 2 of 2 : FA_2022_RD0556_19_16_20220831_00010.jpg

USACE 2018 Erosion Photo #2

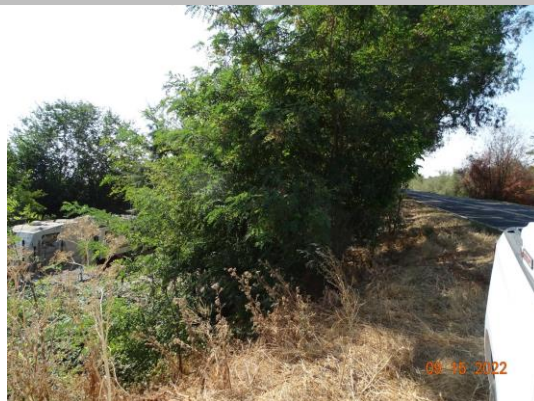
Photo 1 of 1 : FA_2022_RD0556_19_84_20221003_00075.jpg

View of the trees on the LS slope (Fall 2022).

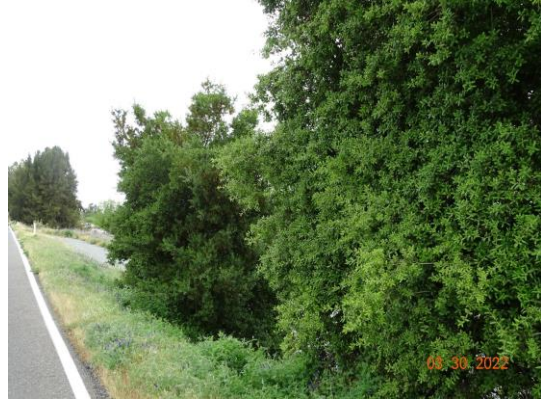
Photo 1 of 1 : FA_2022_RD0556_19_5_20220831_00004.jpg

View looking upstream at trees needing trimming on the landside slope (Spring 2022).

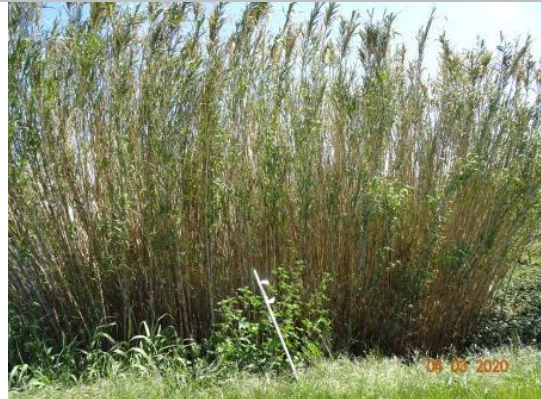
Photo 1 of 1 : FA_2022_RD0556_19_71_20220831_00051.jpg

View of thick arundo on the landside slope (Spring 2020).

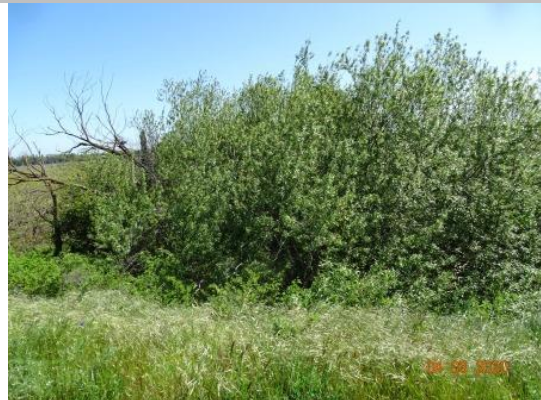
Photo 1 of 1 : FA_2022_RD0556_19_55_20220831_00039.jpg

View of thick tree on the landside slope (Spring 2020).

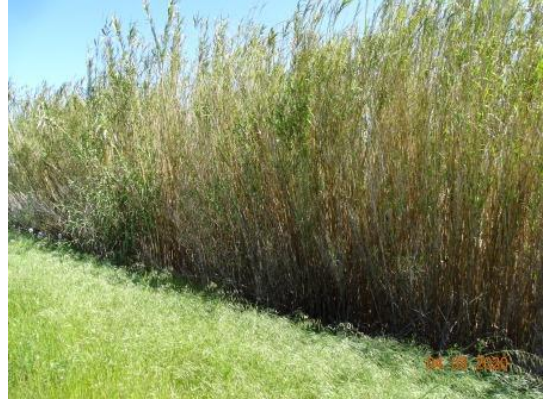
Photo 1 of 1 : FA_2022_RD0556_19_51_20220831_00037.jpg

View of thick arundo on the landside slope (Spring 2020).

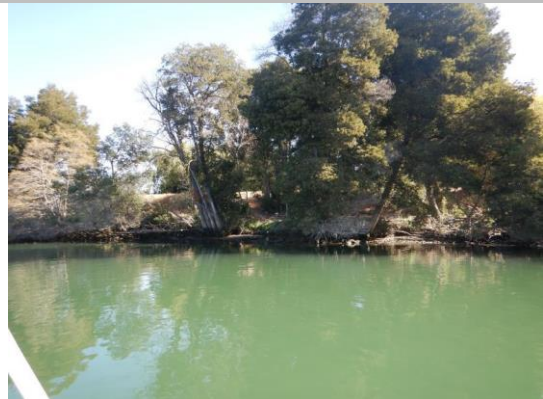
Photo 1 of 2 : FA_2022_RD0556_19_14_20220831_00005.jpg

USACE 2018 Erosion Photo #1

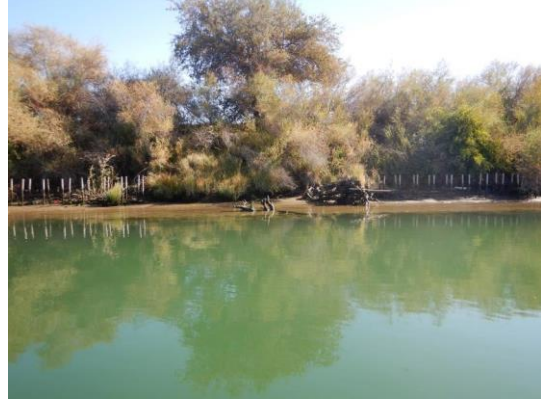
Photo 2 of 2 : FA_2022_RD0556_19_14_20220831_00006.jpg

USACE 2018 Erosion Photo #2

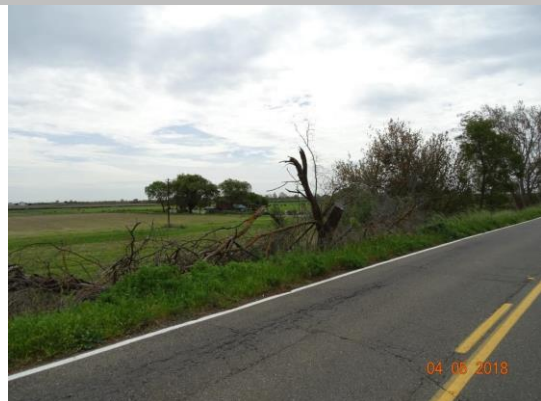
Photo 1 of 1 : FA_2022_RD0556_19_56_20220831_00040.jpg

Fallen tree on landside should be removed.

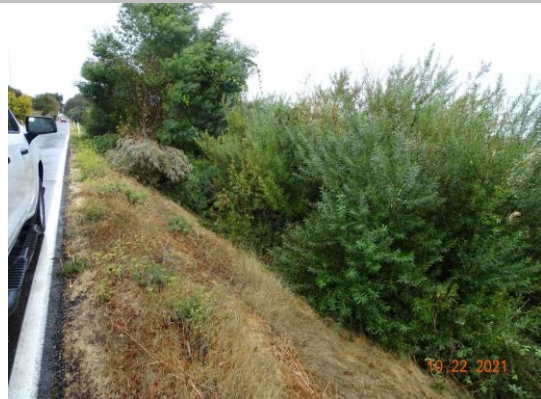
Photo 1 of 1 : FA_2022_RD0556_19_60_20220831_00044.jpg

View looking upstream at thick trees on the landside slope (Fall 2021).

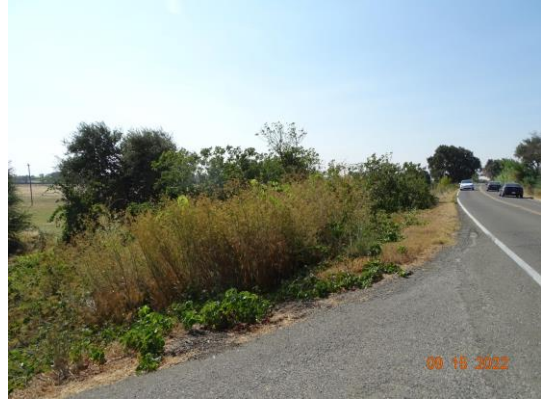
Photo 1 of 1 : FA_2022_RD0556_19_58_20221003_00073.jpg

View of the LS vegetation and fig tree in the background (Fall 2022).

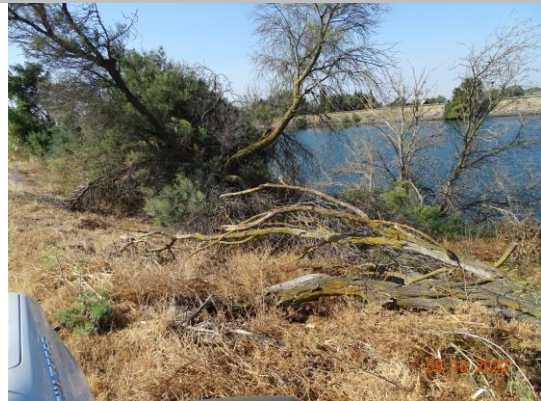
Photo 1 of 1 : FA_2022_RD0556_19_27_20221003_00071.jpg

View of the fallen tree on the WS slope (Fall 2022).

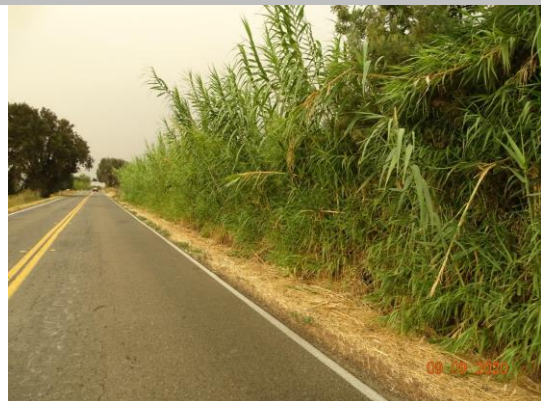
Photo 1 of 1 : FA_2022_RD0556_19_3_20220831_00003.jpg

View looking downstream at arundo on the waterside slope (Fall 2020).

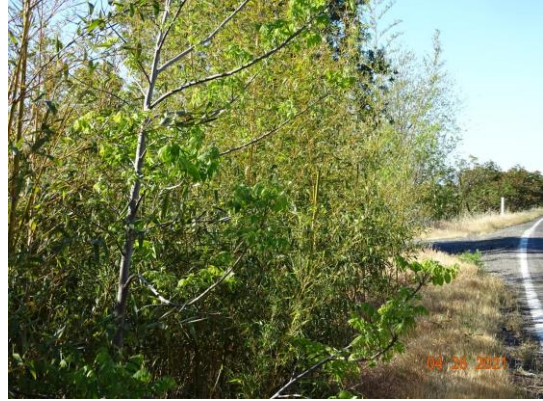
Photo 1 of 1 : FA_2022_RD0556_19_52_20220831_00038.jpg

View looking downstream at bamboo and trees of heaven on landside slope (Spring 2021).

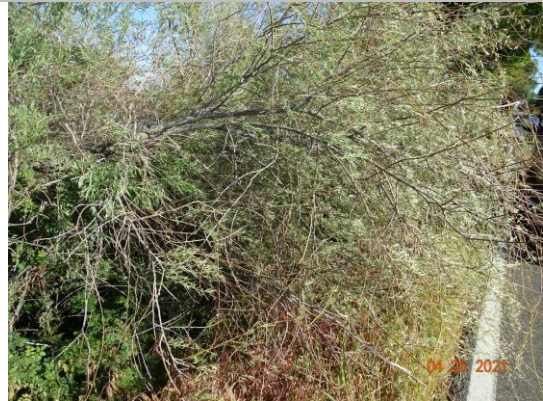
Photo 1 of 1 : FA_2022_RD0556_19_66_20220831_00047.jpg

View looking upstream at willows on the waterside slope (Spring 2021).
