**Flood Control Project Maintenance
Levee Inspections**

Maintenance Issue Types Only, Levee Inspection Report By Mile - Fall 2023

Reclamation District No. 0556 Upper Andrus

Waterway	Bank	Unit Miles	Inspection Start/End	Inspector
Unit No. 01 Georgiana Slough	Right	5.48	10/30/2023 10/30/2023	Zach Jojola

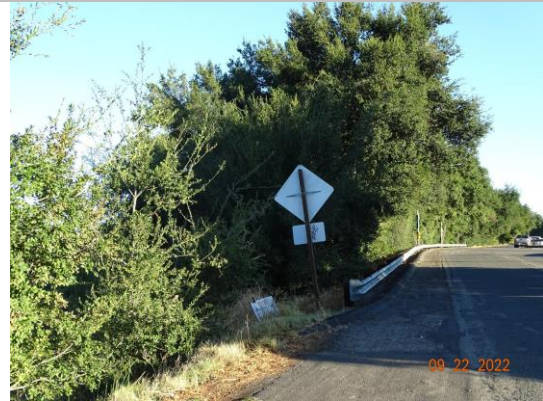
Photo 1 of 1 : FA_2023_RD0556_18_21_20231019_00006.jpg

LM Start	0.17	Rating **	U	Issue No.	21
LM End	0.57	Issue Type +	Ma	Location *	LS
Category	Earthen Levee			GPS Latitude/Longitude	
				Start	End
Item	Trim / Thin Trees			38.236723°	38.232070°
				-121.518079°	-121.522067°
DWR ID	DWR_RD0556_01_s_2017_21				
Comment Code					
T1 : Trim and thin trees to at least five feet above ground level to allow visibility of the ground and room to flood fight.					
Inspector Comment

View of the vegetation on the LS slope (Fall 2022).

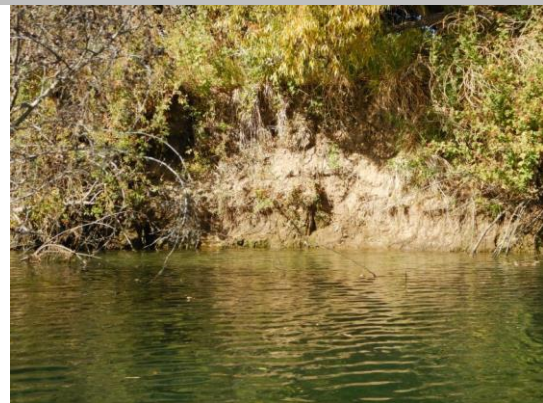
Photo 1 of 2 : FA_2023_RD0556_18_43_20231019_00026.jpg

LM Start	0.38	Rating **	M	Issue No.	43
LM End	0.58	Issue Type +	Ma	Location *	WS
Category	Supplemental			GPS Latitude/Longitude	
				Start	End
Item	2018 USACE Erosion Survey			38.234038°	38.231879°
				-121.519817°	-121.522003°
DWR ID	DWR_RD0556_01_s_2022_43				
Comment Code					
Inspector Comment					
2018 Site ID: GEO 11.8 R					
Status: Eroding					
2018 Field Notes: No observed change.					
Site History: 2017 - Tree popout popouts eminent , significant toe erosion and whole bank failure in sections

USACE 2018 Erosion Photo #1

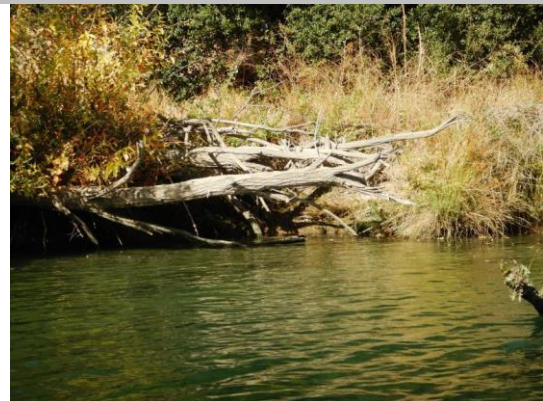
Photo 2 of 2 : FA_2023_RD0556_18_43_20231019_00027.jpg

USACE 2018 Erosion Photo #2

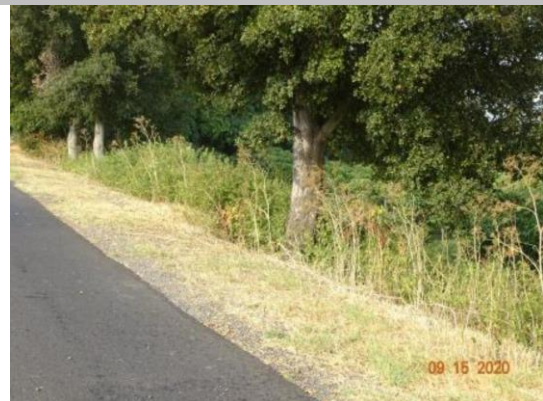
Photo 1 of 1 : FA_2023_RD0556_18_65_20231019_00038.jpg

View looking downstream at vegetation on the landside slope (Fall 2020).

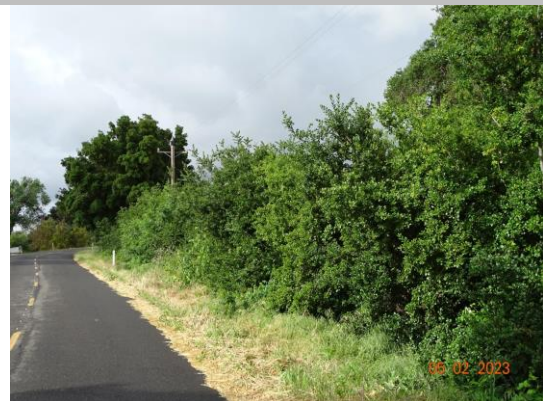
Photo 1 of 1 : FA_2023_RD0556_18_66_20231019_00039.jpg

LM Start	0.98	Rating **	U	Issue No.	66
LM End	1.17	Issue Type +	Ma	Location *	LS
Category	Earthen Levee			GPS Latitude/Longitude	
				Start	End
Item	Vegetation			38.227653°	38.227574°
				-121.527032°	-121.529479°
DWR ID	DWR_RD0556_01_f_2020_66				
Comment Code					
V2 : Remove the wild growth and woody vegetation other than native grasses from the levee slopes.					
Inspector Comment

View of the wild growth on the LS slope (Spring 2023).

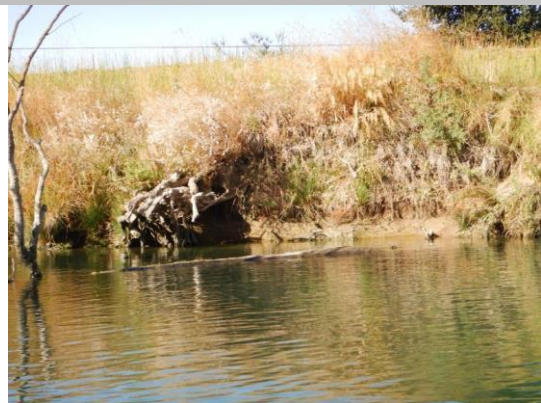
Photo 2 of 2 : FA_2023_RD0556_18_42_20231019_00025.jpg

USACE 2018 Erosion Photo #2

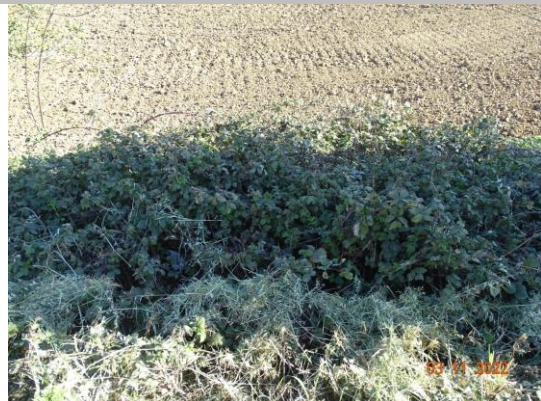
Photo 1 of 1 : FA_2023_RD0556_18_81_20231019_00041.jpg

LM Start	1.21	Rating **	U	Issue No.	81
LM End	1.21	Issue Type +	Ma	Location *	LS
Category	Earthen Levee			GPS Latitude/Longitude	
				Start	End
Item	Vegetation			38.227783°	38.227783°
				-121.530067°	-121.530067°
DWR ID	DWR_RD0556_01_f_2023_81				
Comment Code					
V2 : Remove the wild growth and woody vegetation other than native grasses from the levee slopes.					
Inspector Comment					
Blackberries on the landside slope.

View of blackberries on the landside slope (Spring 2022).

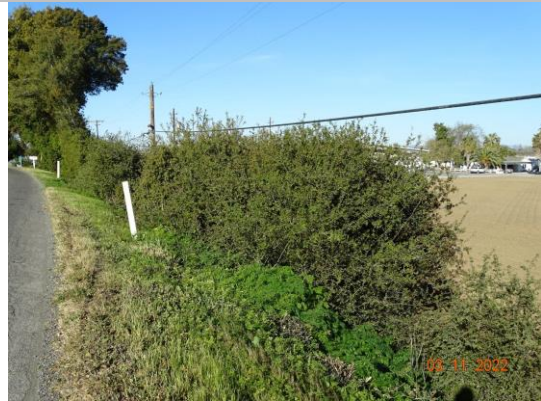
Photo 1 of 1 : FA_2023_RD0556_18_87_20231019_00045.jpg

View looking downstream at trees on the landside slope (Spring 2022).

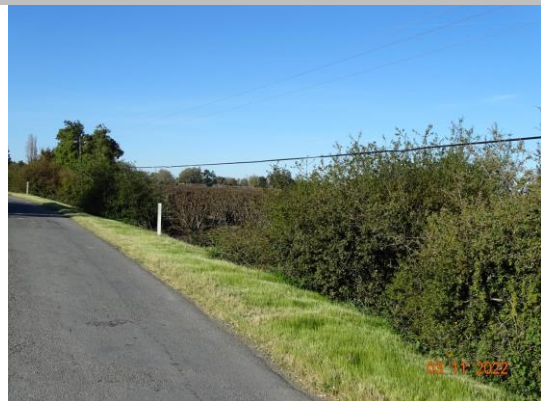
Photo 1 of 1 : FA_2023_RD0556_18_88_20231019_00046.jpg

LM Start	1.37	Rating **	U	Issue No.	88
LM End	1.54	Issue Type +	Ma	Location *	LS
Category	Earthen Levee			GPS Latitude/Longitude	
				Start	End
Item	Vegetation			38.227286°	38.225374°
				-121.532724°	-121.534665°
DWR ID	DWR_RD0556_01_s_2022_88				
Comment Code					
V2 : Remove the wild growth and woody vegetation other than native grasses from the levee slopes.					
Inspector Comment

View looking downstream at trees on the landside slope (Spring 2022).

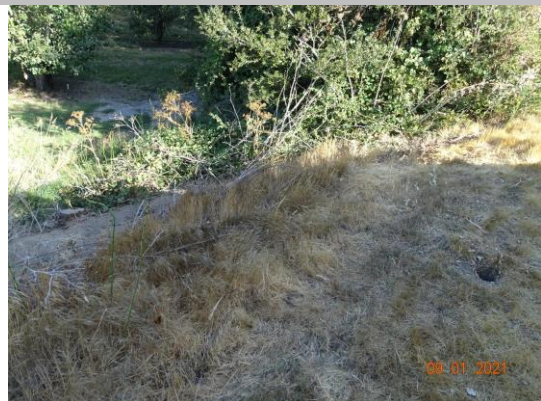
Photo 1 of 1 : FA_2023_RD0556_18_82_20231019_00042.jpg

LM Start	1.43	Rating **	M	Issue No.	82
LM End	1.43	Issue Type +	Ma	Location *	LS
Category	Earthen Levee			GPS Latitude/Longitude	
				Start	End
Item	Animal Control			38.226537°	38.226537°
				-121.533351°	-121.533351°
DWR ID	DWR_RD0556_01_f_2021_82				
Comment Code					
A1 : Exterminate rodents and backfill and compact or grout burrows.					
Inspector Comment

View of animal holes in landside hinge and slope (Fall 2021).

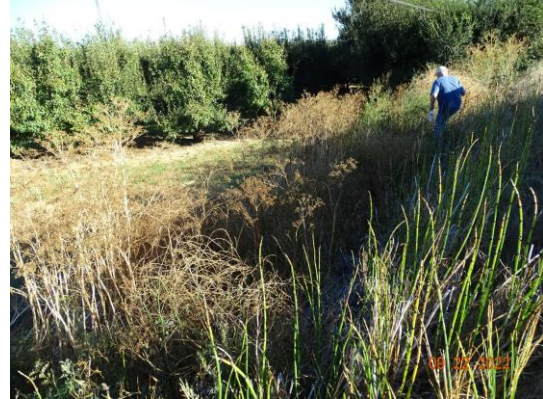
Photo 1 of 1 : FA_2023_RD0556_18_40_20231019_00022.jpg

View of the erosion on the LS slope (Fall 2022).

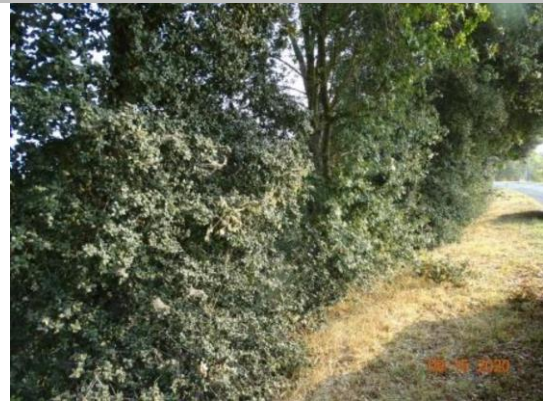
Photo 1 of 1 : FA_2023_RD0556_18_46_20231019_00030.jpg

LM Start	1.55	Rating **	U	Issue No.	46
LM End	1.64	Issue Type +	Ma	Location *	LS
Category	Earthen Levee			GPS Latitude/Longitude	
				Start	End
Item	Trim / Thin Trees			38.225268°	38.224587°
				-121.534733°	-121.536129°
DWR ID	DWR_RD0556_01_s_2018_46				
Comment Code					
T1 : Trim and thin trees to at least five feet above ground level to allow visibility of the ground and room to flood fight.					
Inspector Comment

View looking upstream at thick trees on the landside slope (Fall 2020).

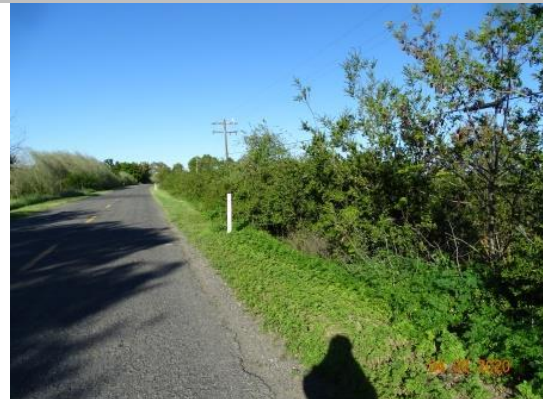
Photo 1 of 1 : FA_2023_RD0556_18_19_20231019_00003.jpg

LM Start	1.71	Rating **	U	Issue No.	19
LM End	1.80	Issue Type +	Ma	Location *	LS
Category	Earthen Levee			GPS Latitude/Longitude	
				Start	End
Item	Vegetation			38.224301°	38.223965°
				-121.537367°	-121.539080°
DWR ID	DWR_RD0556_01_s_2020_19				
Comment Code					
V2 : Remove the wild growth and woody vegetation other than native grasses from the levee slopes.					
Inspector Comment

View looking downstream at thick wild vegetation on the landside slope (Spring 2020).

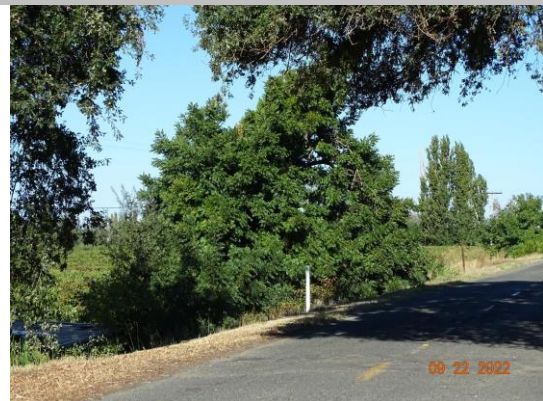
Photo 1 of 1 : FA_2023_RD0556_18_69_20231019_00040.jpg

View of the tree on the LS slope (Fall 2022).

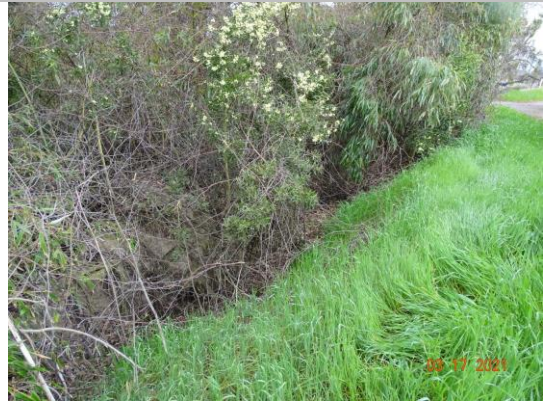
Photo 1 of 1 : FA_2023_RD0556_18_33_20231019_00014.jpg

LM Start	2.72	Rating **	U	Issue No.	33
LM End	2.72	Issue Type +	Ma	Location *	LS
Category	Earthen Levee			GPS Latitude/Longitude	
				Start	End
Item	Trim / Thin Trees			38.215107°	38.215107°
				-121.540677°	-121.540677°
DWR ID	DWR_RD0556_01_s_2017_33				
Comment Code					
T3 : Fallen tree with root ball.					
Inspector Comment					
Fallen trees on landside. Remove the fallen tree and repair the levee damage.

View of hole in landside slope caused by down tree (Spring 2021).

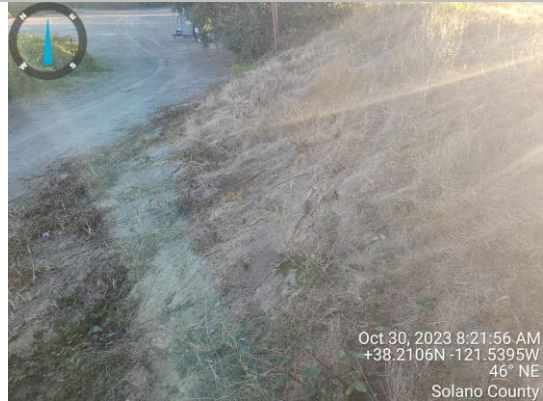
Photo 1 of 1 : FA_2023_RD0556_18_28_20231030_00092.jpg

View of rodent holes on the landside slope. Fall 2023.

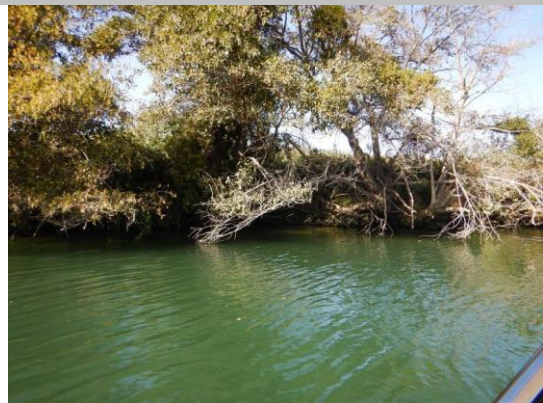
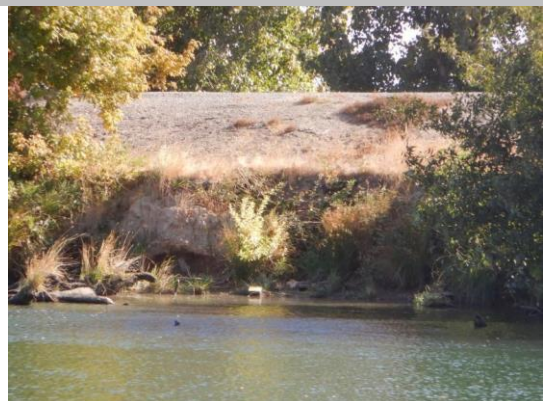
LM Start	3.18	Rating **	M	Issue No.	36
LM End	3.50	Issue Type +	Ma	Location *	WS
Category	Supplemental			GPS Latitude/Longitude	
				Start	End
Item	2018 USACE Erosion Survey			38.210674°	38.206919°
				-121.538854°	-121.541559°
DWR ID	DWR_RD0556_01_s_2022_36				
Comment Code					
Inspector Comment					
2018 Site ID: GEO 9.0 R					
Status: Eroding					
2018 Field Notes: Site extended downstream.					
Site History: 2017 - Toe erosion and failed revetment.

USACE 2018 Erosion Photo #1

USACE 2018 Erosion Photo #2

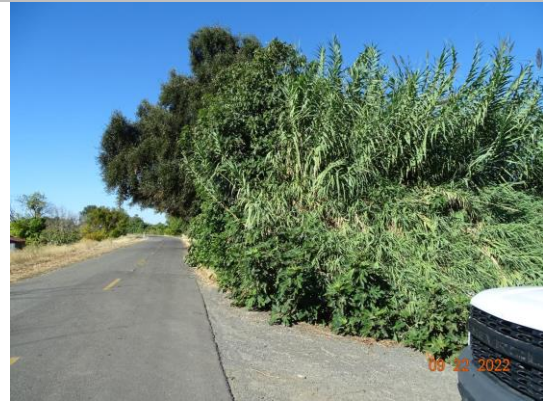
Photo 1 of 1 : FA_2023_RD0556_18_55_20231019_00036.jpg

View of the trees on the LS slope (Fall 2022).

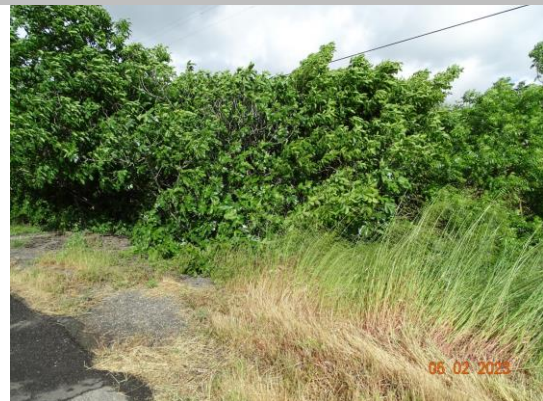
Photo 1 of 1 : FA_2023_RD0556_18_38_20231019_00020.jpg

View of the wild growth on the LS slope (Spring 2023).

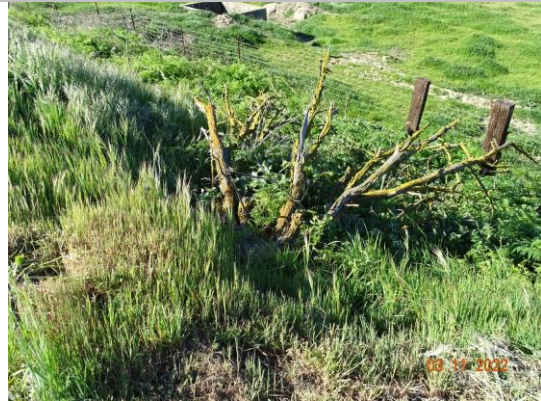
Photo 1 of 1 : FA_2023_RD0556_18_95_20231019_00048.jpg

View of down tree limbs on the landside slope (Spring 2022).

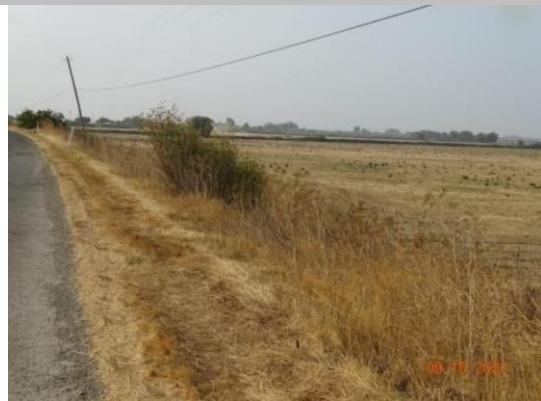
Photo 1 of 1 : FA_2023_RD0556_18_41_20231019_00023.jpg

View looking downstream at vegetation on the landside slope (Fall 2020).

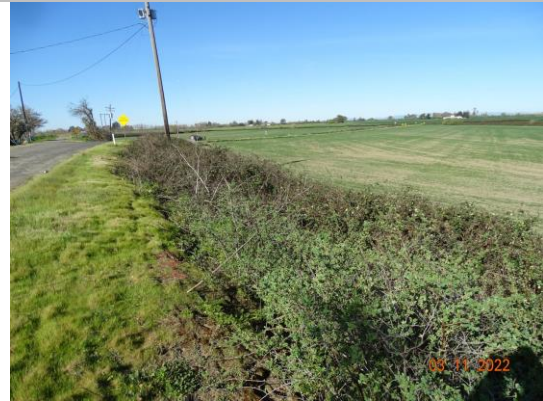
Photo 1 of 1 : FA_2023_RD0556_18_99_20231019_00049.jpg

View looking downstream at vegetation on the landside slope (Spring 2022).

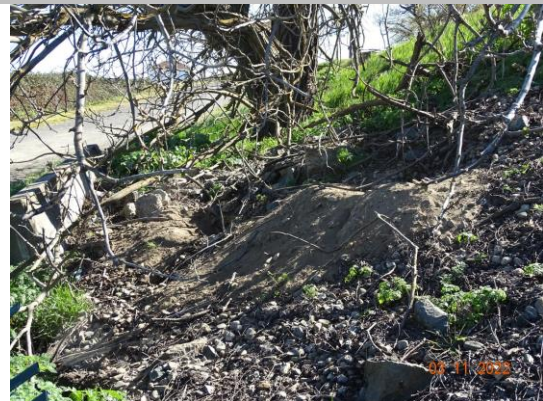
Photo 1 of 1 : FA_2023_RD0556_18_101_20231019_00051.jpg

View of multiple animal holes in the landside slope (Spring 2022).

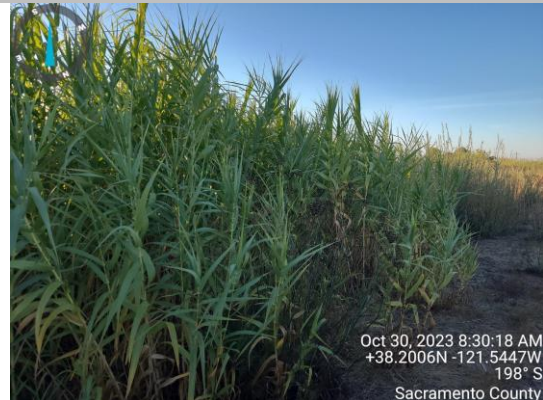
Photo 1 of 1 : FA_2023_RD0556_18_22_20231030_00093.jpg

View of arundo on the waterside shoulder. Fall 2023.

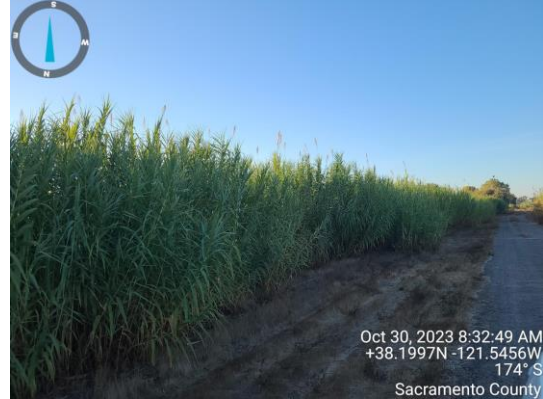
Photo 1 of 1 : FA_2023_RD0556_18_23_20231030_00094.jpg

View of arundo on the waterside shoulder. Fall 2023.

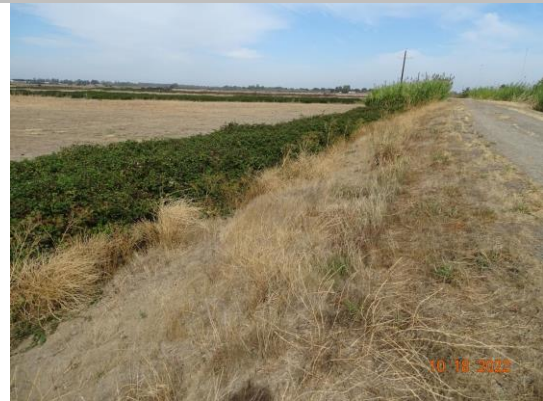
Photo 1 of 1 : FA_2023_RD0556_18_39_20231019_00021.jpg

View of the blackberries on the LS toe (Fall 2022).

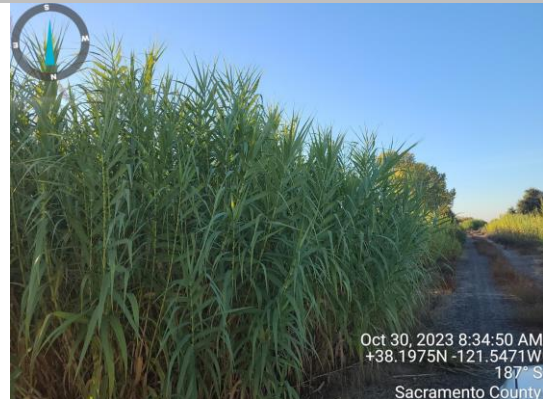
Photo 1 of 1 : FA_2023_RD0556_18_26_20231030_00095.jpg

View of arundo on the waterside shoulder. Fall 2023.

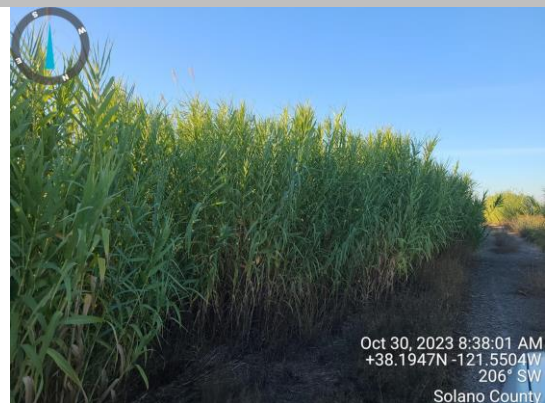
Photo 1 of 1 : FA_2023_RD0556_18_35_20231030_00096.jpg

View of arundo on the waterside shoulder. Fall 2023.

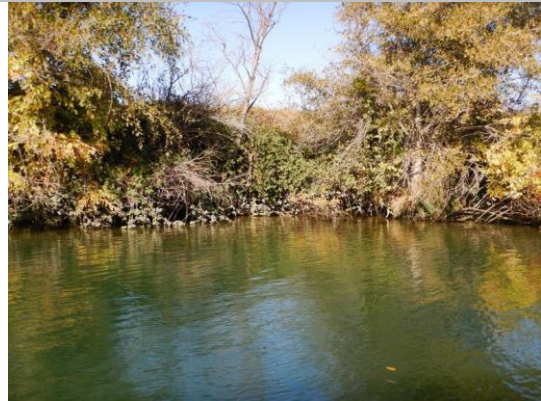
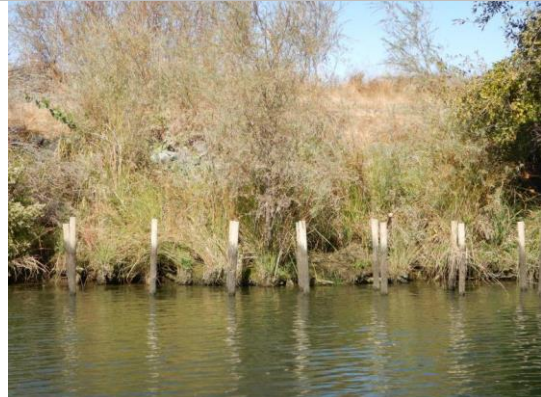
2018 Site ID: GEO 7.0 R
 Status: Eroding
 2018 Field Notes: Minor new toe erosion.
 Site History: 1997 - Toe damaged rock. 1999 - One pocket filled with gravel. 2000 - Eroding beach with some biotech rolls and stakes; some gravel on slope. 2001 - Staked, low fascine walls at bankline. 2005 - Stone revetment in between pockets. 2006 - New rock on upper slope behind brush boxes at the upstream end, Stone is sliding off the hard toe. 2016 - Fresh erosion observed. 2017 - Site extended downstream. Large erosion pockets and significant toe erosion.

USACE 2018 Erosion Photo #1

USACE 2018 Erosion Photo #2

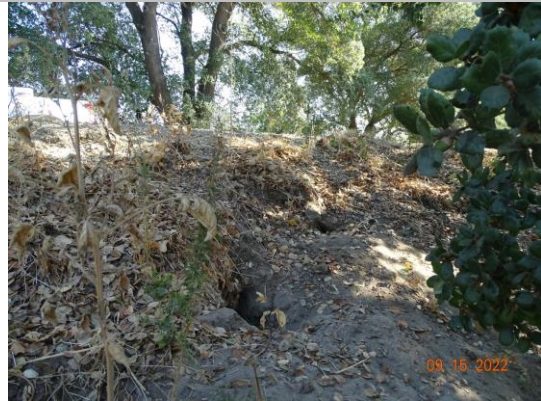
Photo 1 of 1 : FA_2023_RD0556_19_92_20231019_00063.jpg

View of the rodent holes looking up the LS slope (Fall 2022).

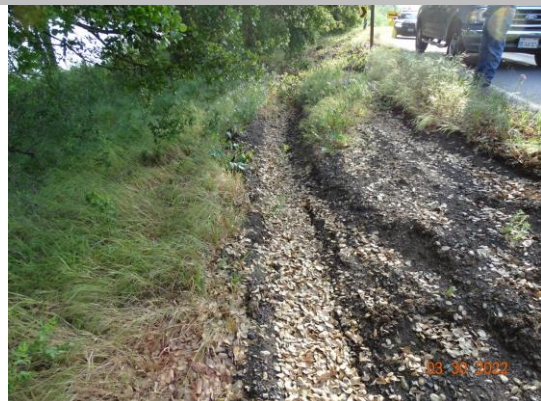
Photo 1 of 1 : FA_2023_RD0556_19_20_20231019_00017.jpg

LM Start	0.04	Rating **	U	Issue No.	20
LM End	0.04	Issue Type +	Ma	Location *	WS
Category	Earthen Levee			GPS Latitude/Longitude	
				Start	End
Item	Erosion / Vehicle Traffic			38.239167°	38.239167°
				-121.519040°	-121.519040°
DWR ID	DWR_RD0556_02_f_2019_20				
Comment Code					
E6 : Repair the levee slope damaged by vehicle traffic and prevent access where possible.					
Inspector Comment

View of damage to waterside slope due to a vehicle (Spring 2022).

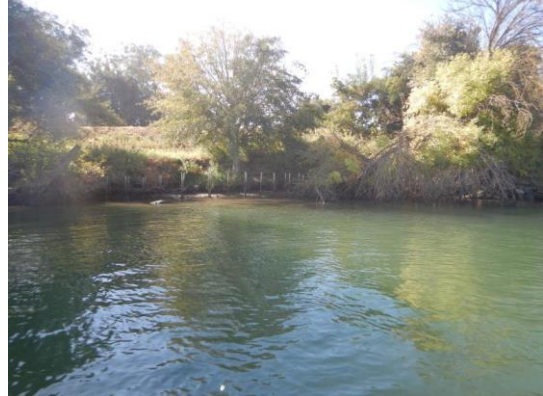
Photo 2 of 2 : FA_2023_RD0556_19_19_20231019_00016.jpg

LM Start	1.03	Rating **	M	Issue No.	19
LM End	1.15	Issue Type +	Ma	Location *	WS
Category	Supplemental			GPS Latitude/Longitude	
				Start	End
Item	2018 USACE Erosion Survey			38.238772°	38.239265°
				-121.536788°	-121.538845°
DWR ID	DWR_RD0556_02_s_2022_19				
Comment Code					
Inspector Comment					
2018 Site ID: SAC 25.2 L					
Status: Eroding					
2018 Field Notes: Additional erosion along toe. Site extended upstream.					
Site History: 1997 - Rock is in poor condition and has failed in many places. Scallops in berm with remnants of old rock in the toe area.					
2005 - Brush boxes present. 2013 - Site extended upstream approximately 300 ft to include new erosion pockets. 2015 - Minor new erosion at toe. 2017 - Minor new erosion observed.

USACE 2018 Erosion Photo #2

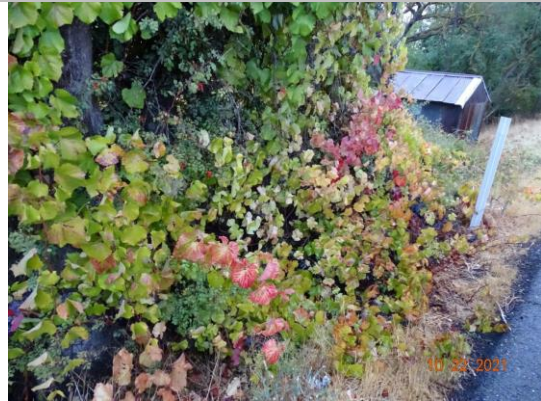
Photo 1 of 1 : FA_2023_RD0556_19_40_20231019_00029.jpg

View looking upstream at thick vegetation on the waterside slope (Fall 2021).

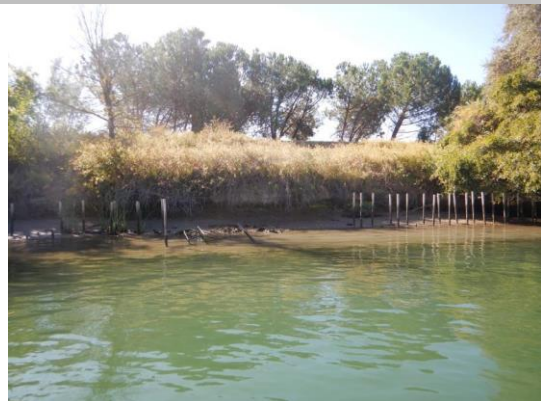
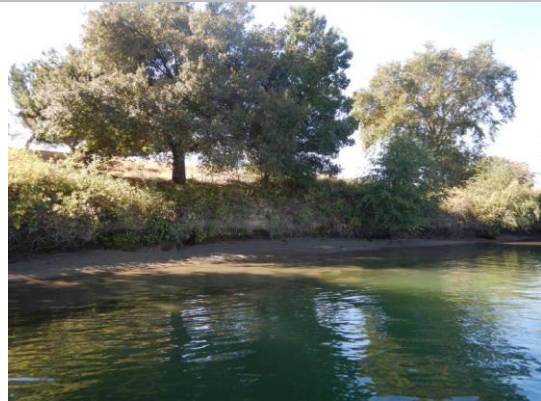
USACE 2018 Erosion Photo #1

USACE 2018 Erosion Photo #2

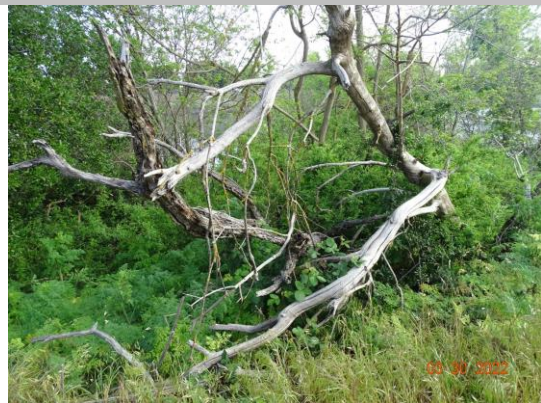
Photo 1 of 1 : FA_2023_RD0556_19_50_20231019_00036.jpg

View of down tree on the landside slope (Spring 2022).

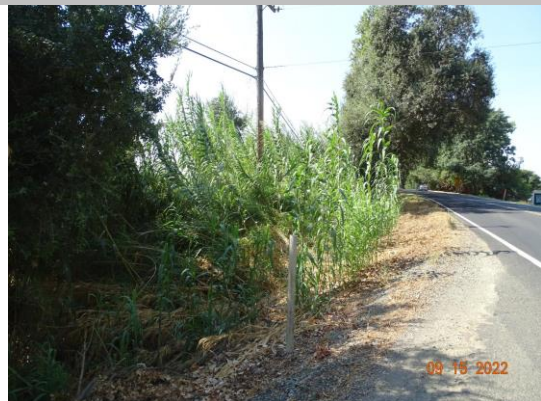
Photo 1 of 1 : FA_2023_RD0556_19_32_20231019_00023.jpg

View of the arundo on the LS slope (Fall 2022).

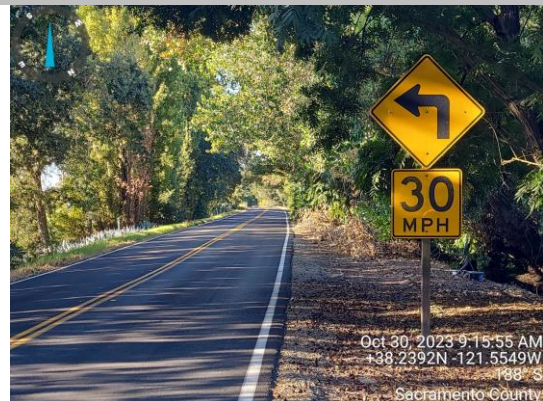
Photo 1 of 1 : FA_2023_RD0556_19_29_20231030_00105.jpg

View of limbs on the waterside shoulder. Fall 2023.

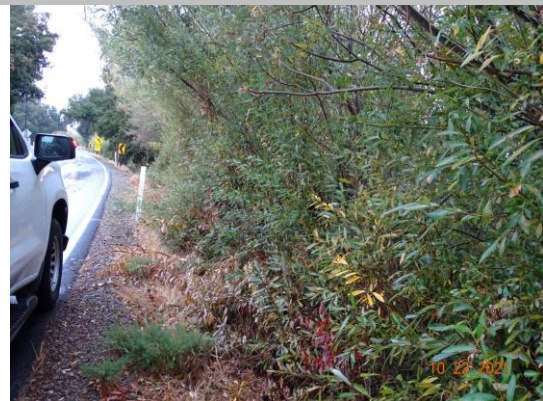
Photo 1 of 1 : FA_2023_RD0556_19_89_20231019_00061.jpg

View looking downstream at thick trees on the waterside slope (Fall 2021).

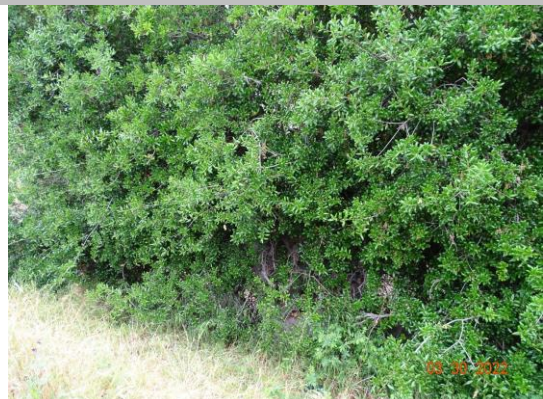
Photo 1 of 1 : FA_2023_RD0556_19_67_20231019_00047.jpg

View of thick trees needing trimming on the landside slope (Spring 2022).

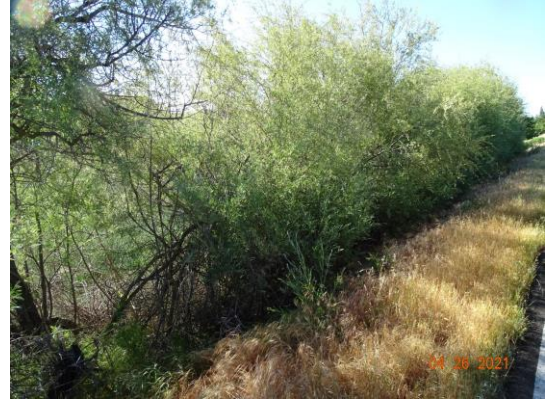
Photo 1 of 1 : FA_2023_RD0556_19_61_20231019_00044.jpg

View looking downstream at willows on the landside slope (Spring 2021).

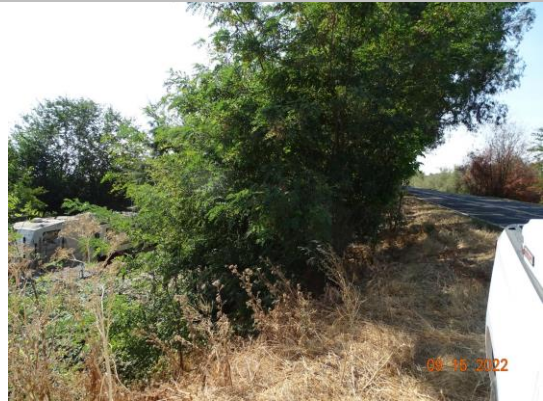
Photo 1 of 1 : FA_2023_RD0556_19_84_20231019_00058.jpg

View of the trees on the LS slope (Fall 2022).

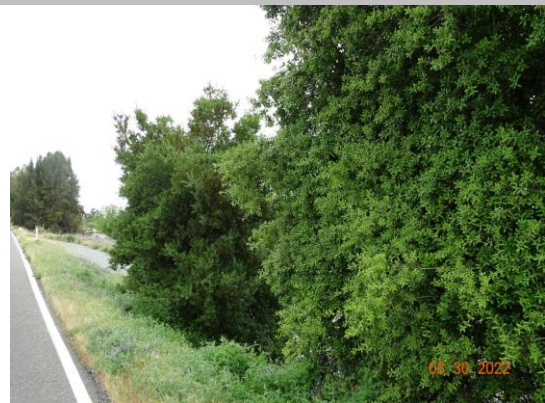
Photo 1 of 1 : FA_2023_RD0556_19_5_20231019_00004.jpg

View looking upstream at trees needing trimming on the landside slope (Spring 2022).

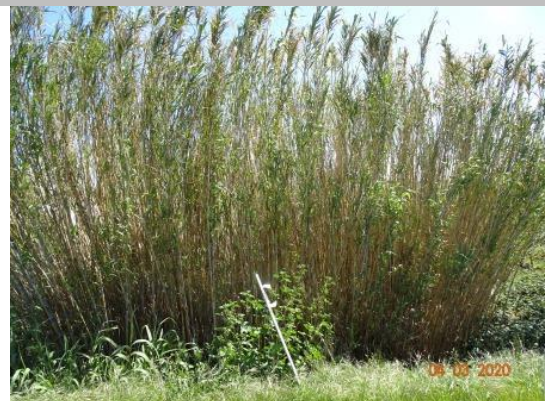
Photo 1 of 1 : FA_2023_RD0556_19_71_20231019_00050.jpg

View of thick arundo on the landside slope (Spring 2020).

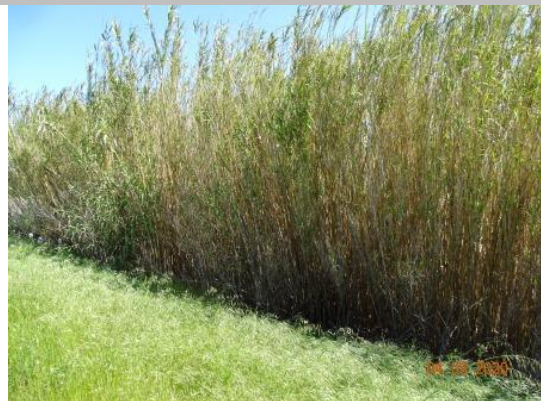
Photo 1 of 1 : FA_2023_RD0556_19_51_20231019_00037.jpg

View of thick arundo on the landside slope (Spring 2020).

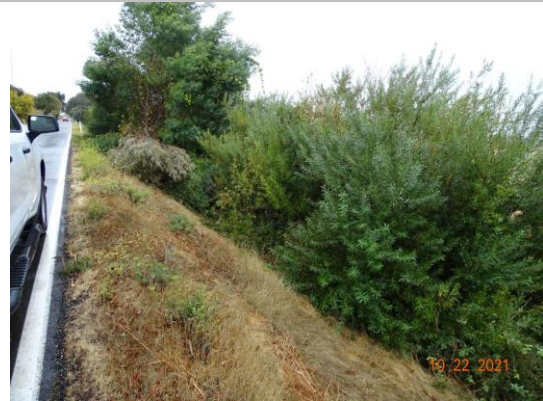
Photo 1 of 1 : FA_2023_RD0556_19_60_20231019_00043.jpg

View looking upstream at thick trees on the landside slope (Fall 2021).

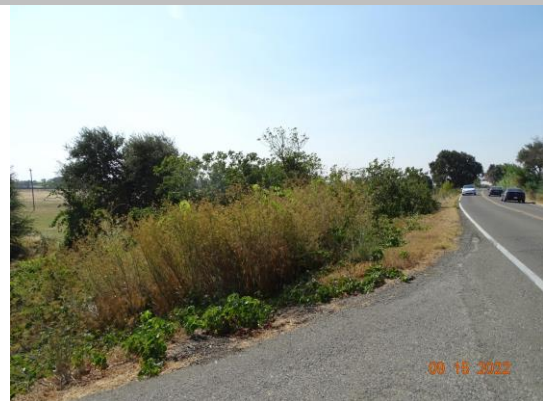
Photo 1 of 1 : FA_2023_RD0556_19_58_20231019_00041.jpg

View of the LS vegetation and fig tree in the background (Fall 2022).

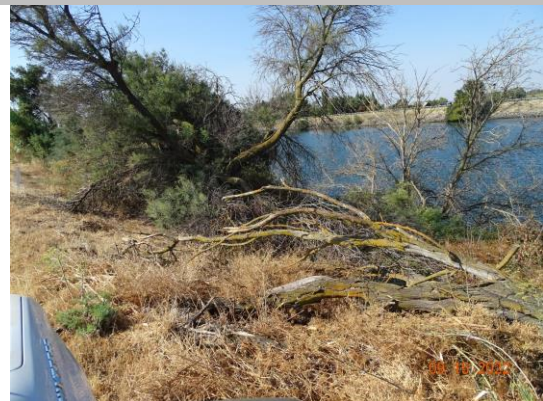
Photo 1 of 1 : FA_2023_RD0556_19_27_20231019_00020.jpg

View of the fallen tree on the WS slope (Fall 2022).

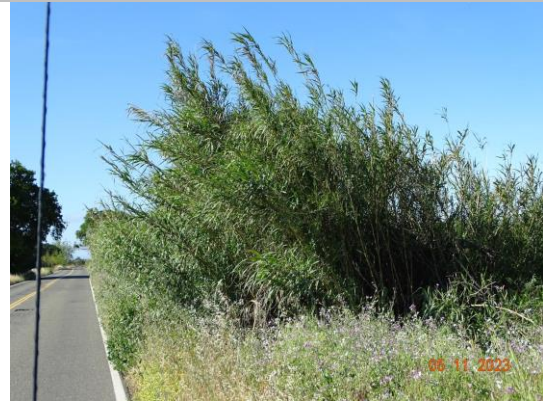
Photo 1 of 1 : FA_2023_RD0556_19_3_20231019_00003.jpg

View of the arundo on the WS slope (Spring 2023).

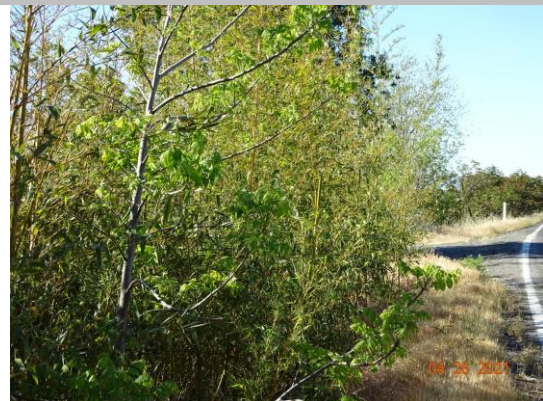
Photo 1 of 1 : FA_2023_RD0556_19_52_20231019_00038.jpg

View looking downstream at bamboo and trees of heaven on landside slope (Spring 2021).

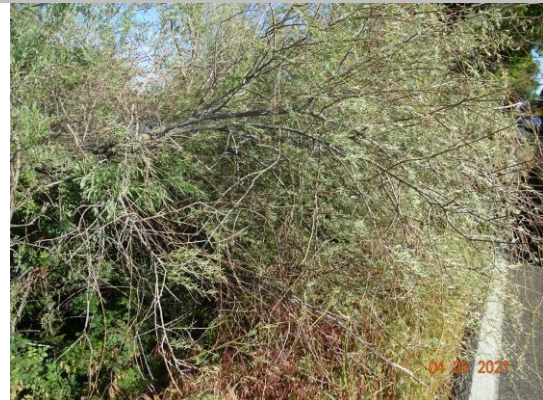
Photo 1 of 1 : FA_2023_RD0556_19_66_20231019_00046.jpg

View looking upstream at willows on the waterside slope (Spring 2021).

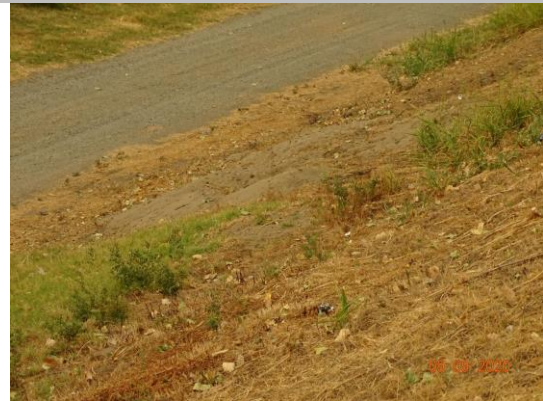
Photo 1 of 1 : FA_2023_RD0556_19_79_20231019_00055.jpg

View looking downstream at burrow holes on the landside slope (Fall 2020).
