**Flood Control Project Maintenance
Levee Inspections**

Maintenance Issue Types Only, Levee Inspection Report By Mile - Fall 2024

Reclamation District No. 0556 Upper Andrus

Waterway	Bank	Unit Miles	Inspection Start/End	Inspector
Unit No. 01 Georgiana Slough	Right	5.48	10/22/2024 10/22/2024	Gregg McMillon

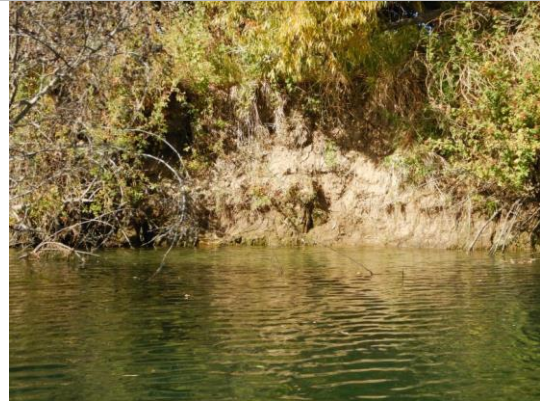
Photo 1 of 2 : FA_2024_RD0556_18_43_20241001_00024.jpg

LM Start	0.38	Rating **	M	Issue No.	43
LM End	0.58	Issue Type +	Ma	Location *	WS
Category	Supplemental			GPS Latitude/Longitude	
				Start	End
Item	2018 USACE Erosion Survey			38.234038°	38.231879°
				-121.519817°	-121.522003°
DWR ID	DWR_RD0556_01_s _ 2022_43				
Comment Code					
Inspector Comment					
2018 Site ID: GEO 11.8 R					
Status: Eroding					
2018 Field Notes: No observed change.					
Site History: 2017 - Tree popout popouts eminent , significant toe erosion and whole bank failure in sections

USACE 2018 Erosion Photo #1

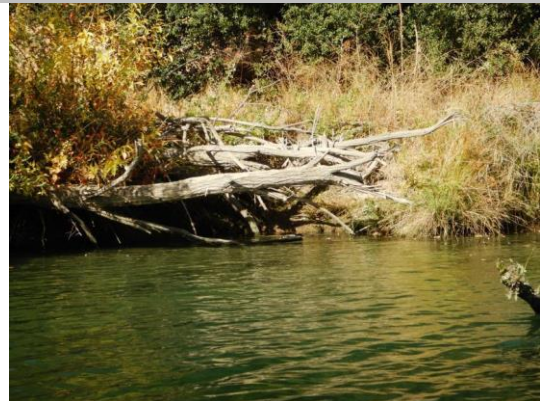
Photo 2 of 2 : FA_2024_RD0556_18_43_20241001_00025.jpg

USACE 2018 Erosion Photo #2

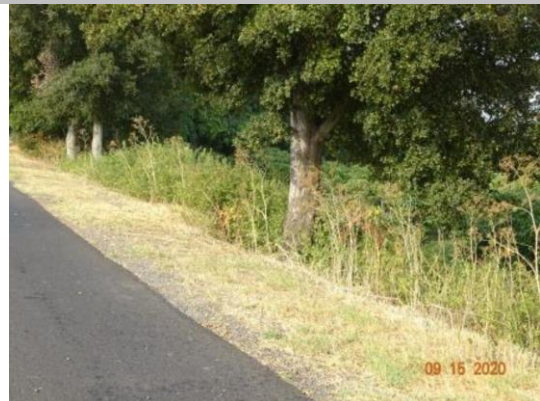
Photo 1 of 1 : FA_2024_RD0556_18_65_20241001_00038.jpg

LM Start	0.75	Rating **	M	Issue No.	65
LM End	0.84	Issue Type +	Ma	Location *	LS
Category	Earthen Levee			GPS Latitude/Longitude	
				Start	End
Item	Vegetation			38.230046°	38.229088°
				-121.524167°	-121.525347°
DWR ID	DWR_RD0556_01_f_2020_65				
Comment Code					
V2 : Remove the wild growth and woody vegetation other than native grasses from the levee slopes.					
Inspector Comment

View looking downstream at vegetation on the landside slope (Fall 2020).

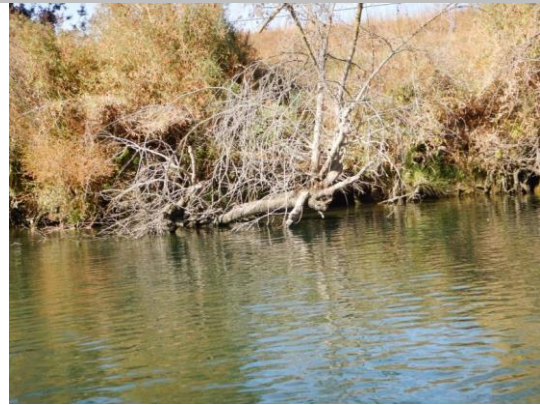
Photo 1 of 2 : FA_2024_RD0556_18_42_20241001_00022.jpg

LM Start	1.20	Rating **	M	Issue No.	42
LM End	1.53	Issue Type +	Ma	Location *	WS
Category	Supplemental			GPS Latitude/Longitude	
				Start	End
Item	2018 USACE Erosion Survey			38.227615°	38.225374°
				-121.529894°	-121.534406°
DWR ID	DWR_RD0556_01_s_2022_42				
Comment Code					
Inspector Comment					
2018 Site ID: GEO 10.9 R					
Status: Eroding					
2018 Field Notes: New erosion throughout site.					
Site History: 2017 - Significant toe erosion and whole bank failure in sections, large pockets from tree popouts.

USACE 2018 Erosion Photo #1

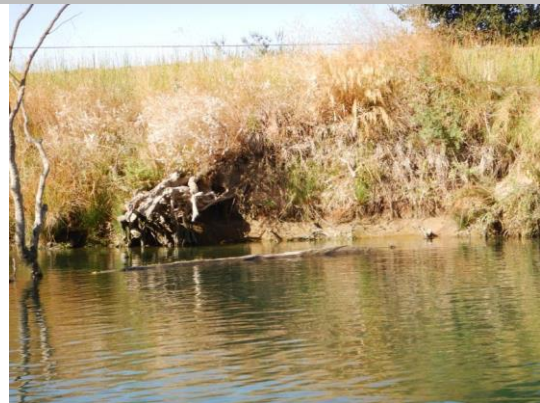
Photo 2 of 2 : FA_2024_RD0556_18_42_20241001_00023.jpg

USACE 2018 Erosion Photo #2

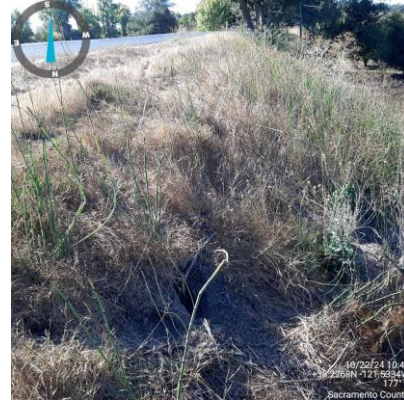
Photo 1 of 1 : FA_2024_RD0556_18_82_20241023_00089.jpg

View of animal holes in landside hinge and slope. (Fall 2024)

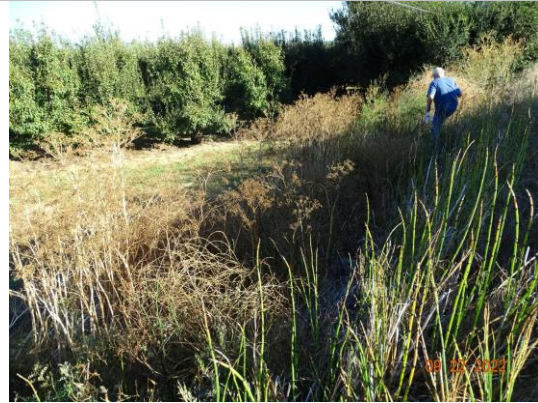
Photo 1 of 1 : FA_2024_RD0556_18_40_20241001_00020.jpg

LM Start	1.43	Rating **	A/W	Issue No.	40
LM End	1.43	Issue Type +	Ma	Location *	LS
Category	Earthen Levee			GPS Latitude/Longitude	
				Start	End
Item	Erosion / Bank Caving			38.226537°	38.226537°
				-121.533512°	-121.533512°
DWR ID	DWR_RD0556_01_f_2012_40				
Comment Code					
E1 : Note and monitor erosion site.					
Inspector Comment					
Erosion is covered by vegetation.

View of the erosion on the LS slope (Fall 2022).

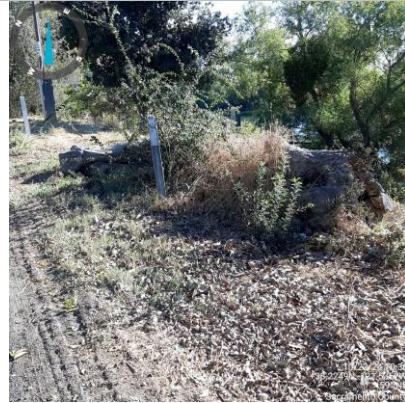
Photo 1 of 1 : FA_2024_RD0556_18_59_20241023_00092.jpg

View of log sitting on the waterside shoulder. (Fall 2024)

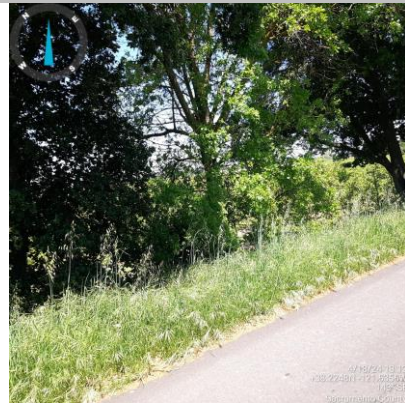
Photo 1 of 1 : FA_2024_RD0556_18_46_20241001_00028.jpg

LM Start	1.61	Rating **	U	Issue No.	46
LM End	1.63	Issue Type +	Ma	Location *	LS
Category	Earthen Levee			GPS Latitude/Longitude	
				Start	End
Item	Trim / Thin Trees			38.224700°	38.224582°
				-121.535631°	-121.536075°
DWR ID	DWR_RD0556_01_s_2018_46				
Comment Code					
T1 : Trim and thin trees to at least five feet above ground level to allow visibility of the ground and room to flood fight.					
Inspector Comment

View looking upstream at thick trees on the landside slope (Spring 2024).

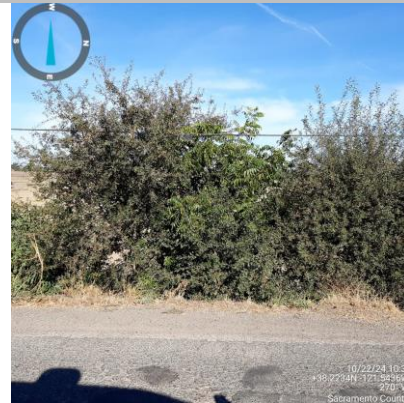
Photo 1 of 1 : FA_2024_RD0556_18_50_20241023_00093.jpg

View of tall shrubs to be trimmed back on the landside shoulder. (Fall 2024)

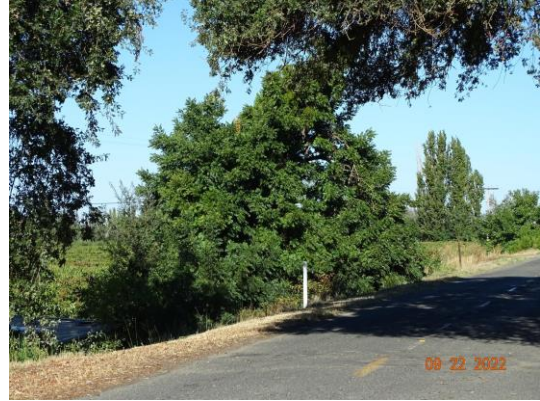
Photo 1 of 1 : FA_2024_RD0556_18_69_20241001_00039.jpg

View of the tree on the LS slope (Fall 2022).

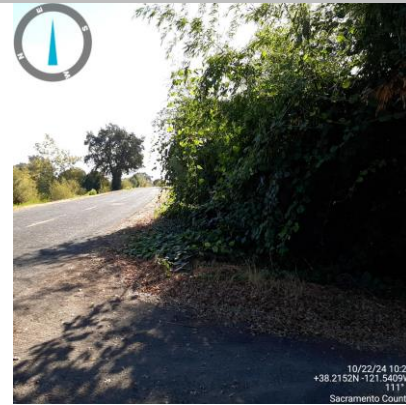
Photo 1 of 2 : FA_2024_RD0556_18_33_20241023_00094.jpg

LM Start	2.72	Rating **	U	Issue No.	33
LM End	2.72	Issue Type +	Ma	Location *	LS
Category	Earthen Levee			GPS Latitude/Longitude	
				Start	End
Item	Trim / Thin Trees			38.215107°	38.215107°
				-121.540677°	-121.540677°
DWR ID	DWR_RD0556_01_s_2017_33				
Comment Code					
T3 : Fallen tree with root ball.					
Inspector Comment					
Fallen trees on landside. Remove the fallen tree and repair the levee damage. Ivy to be trimmed back to provide access to the fallen tree.

View of ivy and trees to be trimmed to expose fallen tree on the landside shoulder. (Fall 2024)

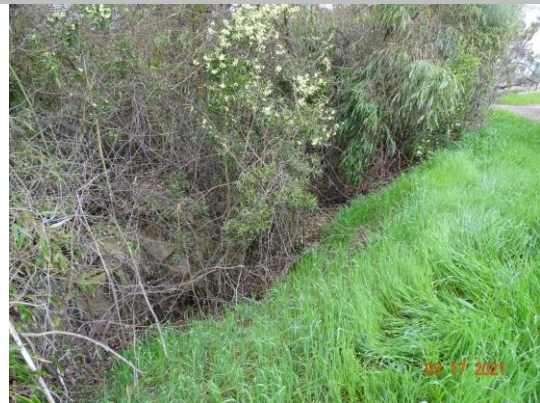
Photo 2 of 2 : FA_2024_RD0556_18_33_20241001_00012.jpg

View of hole in landside slope caused by down tree (Spring 2021).

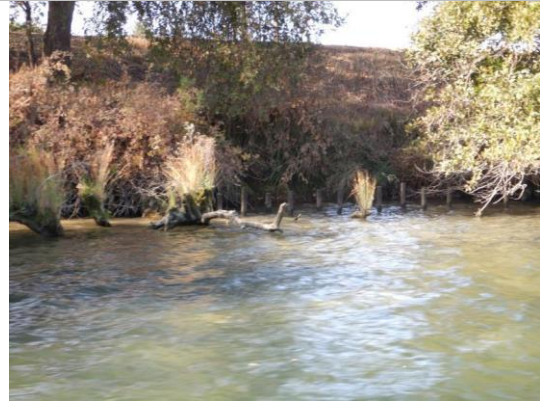
Photo 1 of 2 : FA_2024_RD0556_18_37_20241001_00017.jpg

USACE 2018 Erosion Photo #1

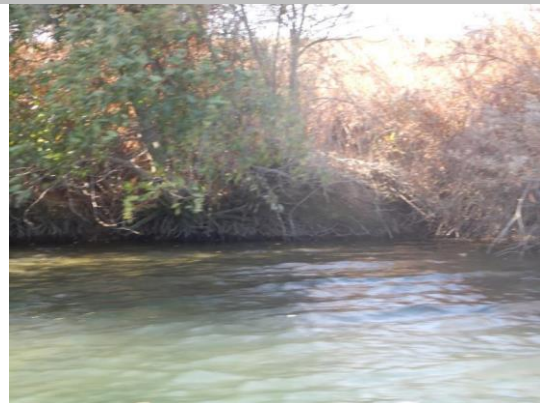
Photo 2 of 2 : FA_2024_RD0556_18_37_20241001_00018.jpg

USACE 2018 Erosion Photo #2

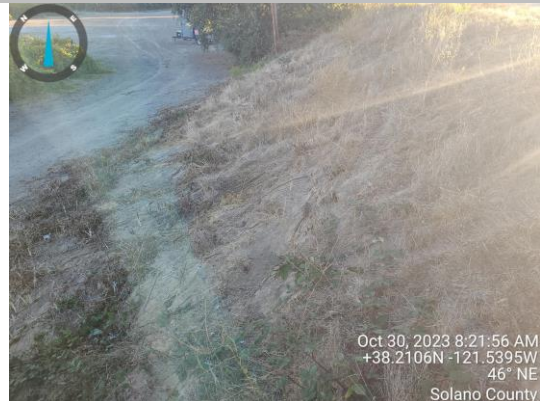
Photo 1 of 1 : FA_2024_RD0556_18_28_20241001_00008.jpg

LM Start	3.14	Rating **	A/W	Issue No.	28
LM End	3.26	Issue Type +	Ma	Location *	LS
Category	Earthen Levee			GPS Latitude/Longitude	
				Start	End
Item	Animal Control			38.210985°	38.210160°
				-121.538372°	-121.540300°
DWR ID	DWR_RD0556_01_f_2017_28				
Comment Code					
A1 : Exterminate rodents and backfill and compact or grout burrows.					
Inspector Comment					
Monitor area for reinfestation of rodents.

View of rodent holes on the landside slope. Fall 2023.

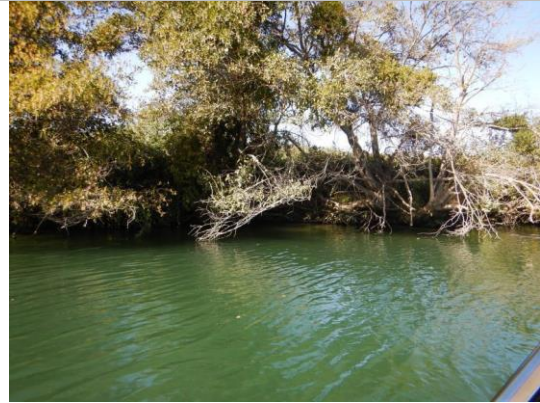
Photo 1 of 2 : FA_2024_RD0556_18_36_20241001_00015.jpg

LM Start	3.18	Rating **	M	Issue No.	36
LM End	3.50	Issue Type +	Ma	Location *	WS
Category	Supplemental			GPS Latitude/Longitude	
				Start	End
Item	2018 USACE Erosion Survey			38.210674°	38.206919°
				-121.538854°	-121.541559°
DWR ID	DWR_RD0556_01_s_2022_36				
Comment Code					
Inspector Comment					
2018 Site ID: GEO 9.0 R					
Status: Eroding					
2018 Field Notes: Site extended downstream.					
Site History: 2017 - Toe erosion and failed revetment.

USACE 2018 Erosion Photo #1

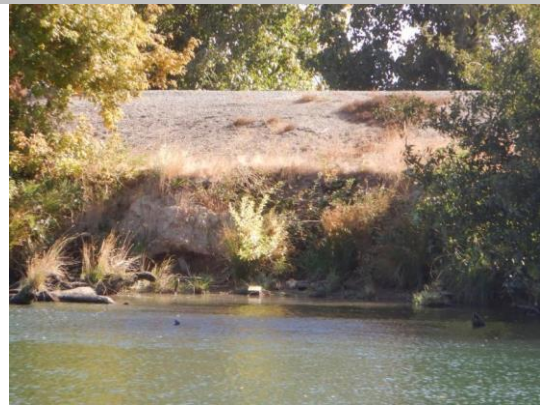
Photo 2 of 2 : FA_2024_RD0556_18_36_20241001_00016.jpg

USACE 2018 Erosion Photo #2

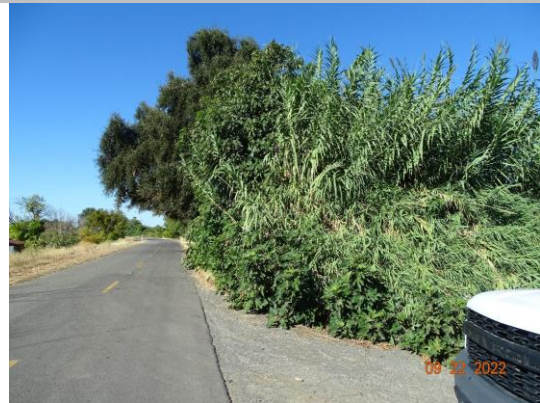
Photo 1 of 1 : FA_2024_RD0556_18_55_20241001_00034.jpg

LM Start	3.18	Rating **	U	Issue No.	55
LM End	3.18	Issue Type +	Ma	Location *	LS
Category	Earthen Levee			GPS Latitude/Longitude	
				Start	End
Item	Trim / Thin Trees			38.210745°	38.210745°
				-121.538967°	-121.538967°
DWR ID	DWR_RD0556_01_f_2019_55				
Comment Code					
T1 : Trim and thin trees to at least five feet above ground level to allow visibility of the ground and room to flood fight.					
Inspector Comment					
Some trimming was done but more work is needed.

View of the trees on the LS slope (Fall 2022).

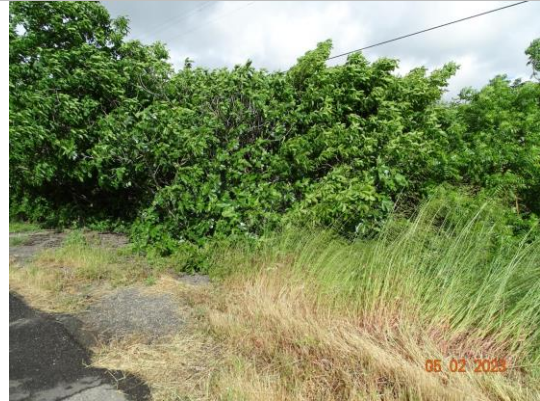
Photo 1 of 1 : FA_2024_RD0556_18_38_20241001_00019.jpg

View of the wild growth on the LS slope (Spring 2023).

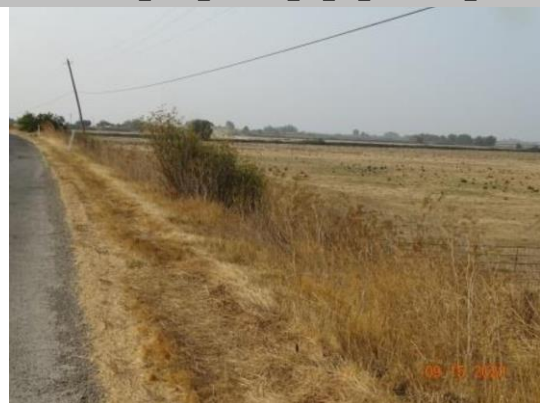
Photo 1 of 1 : FA_2024_RD0556_18_41_20241001_00021.jpg

View looking downstream at vegetation on the landside slope (Fall 2020).

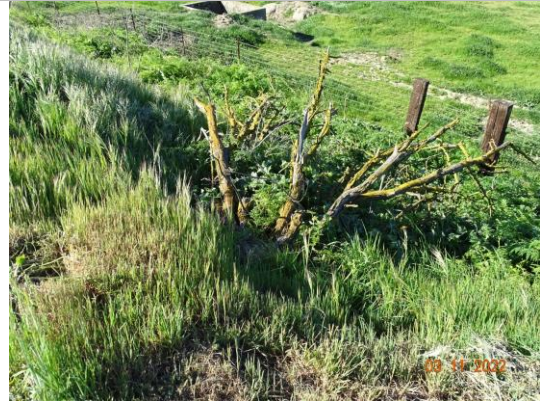
Photo 1 of 1 : FA_2024_RD0556_18_95_20241001_00045.jpg

View of down tree limbs on the landside slope (Spring 2022).

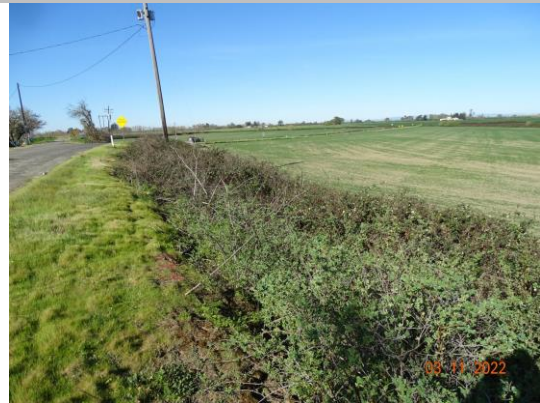
Photo 1 of 1 : FA_2024_RD0556_18_99_20241001_00046.jpg

View looking downstream at vegetation on the landside slope (Spring 2022).

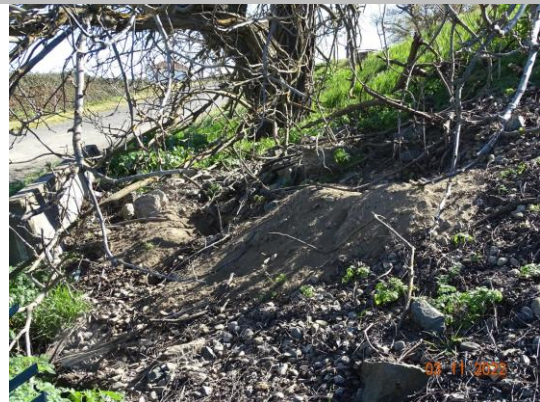
Photo 1 of 1 : FA_2024_RD0556_18_101_20241001_00048.jpg

View of multiple animal holes in the landside slope (Spring 2022).

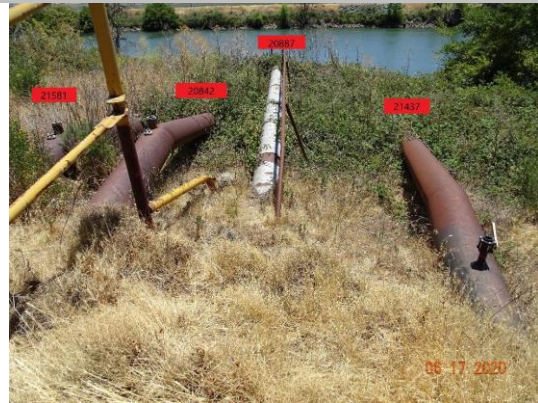
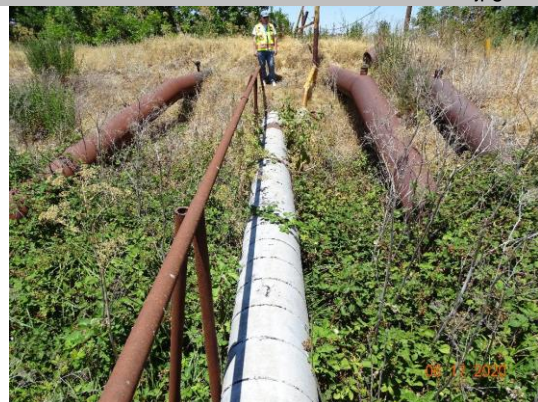
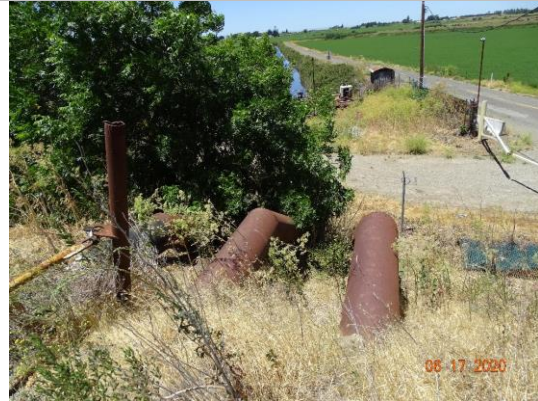
Comment Code						
Inspector Comment						
DS_ID:21581 FS_ID:61315 EP_NO: 13030 Repair Type: Non-Urgent EVAL Issue: 10, Unauthorized Modification or Non-Compliant Permit Crossing Status: Found UCIP Comments: 06/17/2020 Record is Non-Urgent. Pipe diameter field measured as 20-inch on both slopes. On landside berm pipe diameter changes from 20 inch to 18 inch. Unable to find a permit for modification of this crossing. No permit has been identified authorizing original O&M pipe through the levee. (O.Yakimov - DWR UCIP) FIELD_STRUCT_DESC: 18-inch steel drainage pipes through levee, 4.3 feet below crown. Pumps on landward side and 4-inch air valve. (18-inch pipe [HLM 4.01] authorized under Automatic Board Order (ABO) issued as Permit No. 11175, 1975 - RD0556). [Additional Reference(s): DWR Levee Log, unk.yr. (HLM 4.01). USACE Sacramento O&M Manual, Unit 103, June 1954, Revised 29 December 2016, (Station 397+36.3), listed as 20-inch pipe]. USACE As-Built Drawing No. 50-04-2631, Sheet 10, Station 397+36.3, March 1950, Revised 16 Dec.1952, listed as 20-inch pipe]. FS Date: 6/17/2020

Water-Side: Pipes on waterside berm

Water-Side: Pipes on waterside berm and levee slope on background

Land-Side: View of levee shoulder

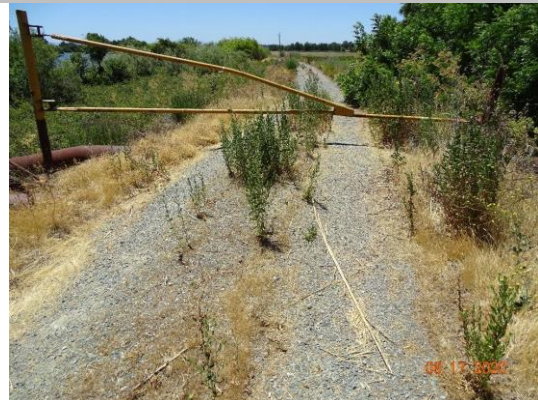
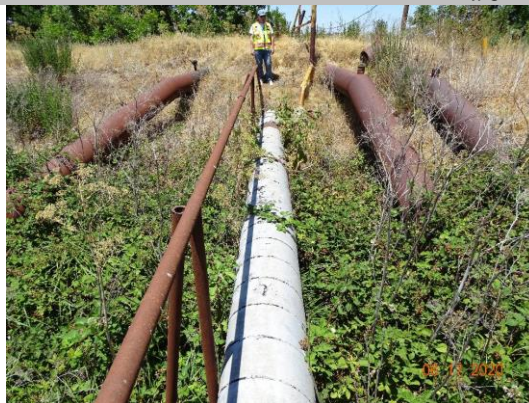
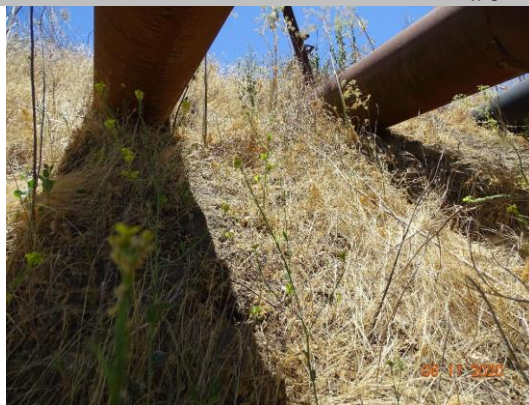
DS_ID:20842
FS_ID:61303
EP_NO: 13030
Repair Type: Non-Urgent
EVAL Issue: 10, Unauthorized Modification or Non-Compliant Permit
Crossing Status: Found
UCIP Comments: 06/17/2020 Record is Non-Urgent. Pipe diameter field measured as 20-inch on both slopes. On landside berm pipe diameter changes from 20 inch to 18 inch. Debris of 20-inch pipe welded to 16-inch pipe with open end found next to this crossing on landside berm. Unable to find a permit for modification of this crossing. No permit has been identified authorizing original O&M pipe through the levee. (O.Yakimov - DWR UCIP)
FIELD_STRUCT_DESC: 16-inch steel drainage pipe through levee, 4.3 feet below crown. Pump on landward side and 4-inch air valve. (16-inch pipe [HLM 4.01] authorized under Automatic Board Order (ABO) issued as Permit No. 11175, 1975 - RD0556). [Additional Reference(s): DWR Levee Log, unk.yr. (HLM 4.01). USACE Sacramento O&M Manual, Unit 103, June 1954, Revised 29 December 2016, (Station 397+20.5), listed as 16-inch pipe. USACE As-Built Drawing No. 50-04-2631, Sheet 10, Station 397+20.5, March 1950, Revised 16 Dec.1952, listed as 12-inch pipe].

Top of Levee: View of levee crown looking downstream

Water-Side: Pipes on waterside berm looking from riverbank

Land-Side: View of levee slope looking from toe

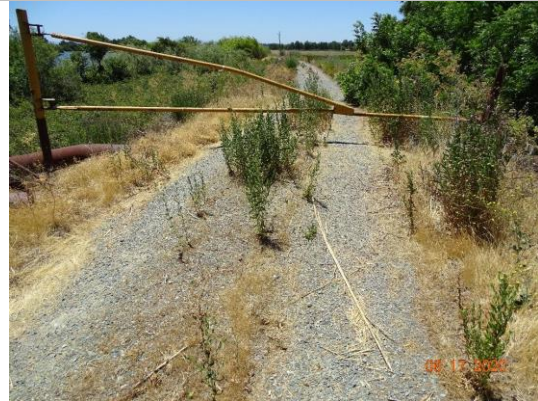
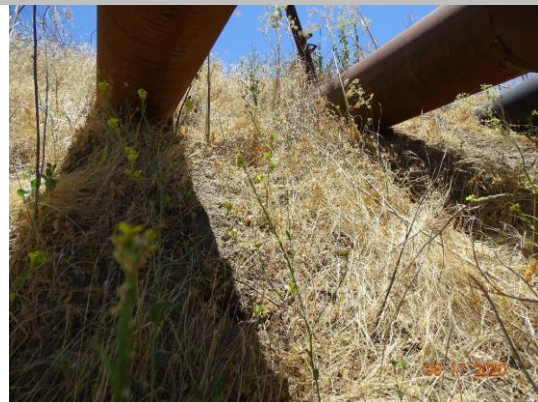
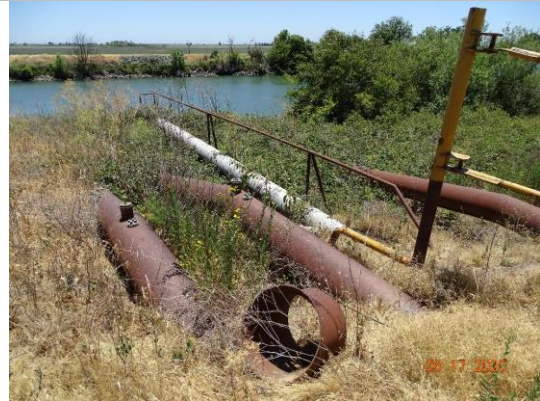
Comment Code						
Inspector Comment						
DS_ID:21437 FS_ID:61311 EP_NO: 10526 Repair Type: Non-Urgent EVAL Issue: 10, Unauthorized Modification or Non-Compliant Permit Crossing Status: Found UCIP Comments: 06/17/2020 Record is Non-Urgent. Pipe diameter field measured as 20-inch on both slopes. Unable to find a permit for modification of this crossing. (O.Yakimov - DWR UCIP) FIELD_STRUCT_DESC: 24-inch steel drainage pipes 3.5 ft below levee crown. Pumping plant on landside. 6" air valve, concrete saddle & wood beam on waterside. This crossing replaces 24-inch pipe (see DSID 25634). (24-inch pipe authorized under Permit No. 10526, 1975 - Reclamation District 556). [Additional Reference(s): USACE Sacramento O&M Manual, Unit 103, June 1954, Revised 29 December 2016, (Station 397+36.3), listed as 24-inch pipe. USACE As-Built Drawing No. 50-04-2631, Sheet 10, Station 397+36.3, March 1950, Revised 16 Dec.1952]. FS Date: 6/17/2020

Top of Levee: View of levee crown looking downstream

Land-Side: View of levee slope looking from toe

Water-Side: View of levee slope looking from crown

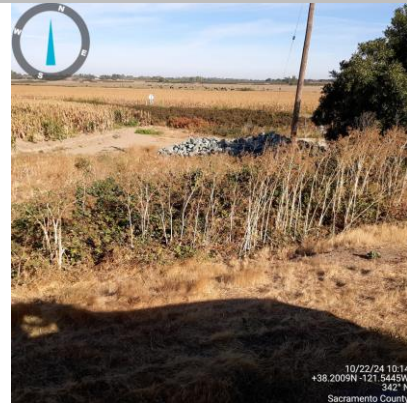
Photo 1 of 1 : FA_2024_RD0556_18_23_20241023_00095.jpg

View of vegetation on the landside slope. (Fall 2024)

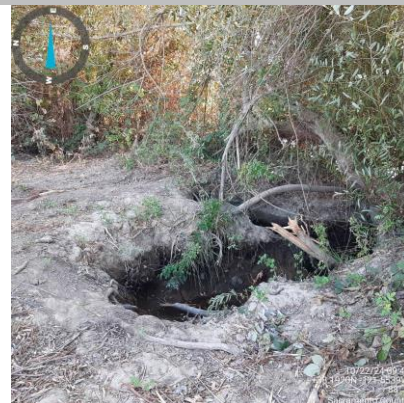
Photo 1 of 1 : FA_2024_RD0556_18_21_20241023_00096.jpg

View of erosion at the edge of the waterside berm. (Fall 2024)

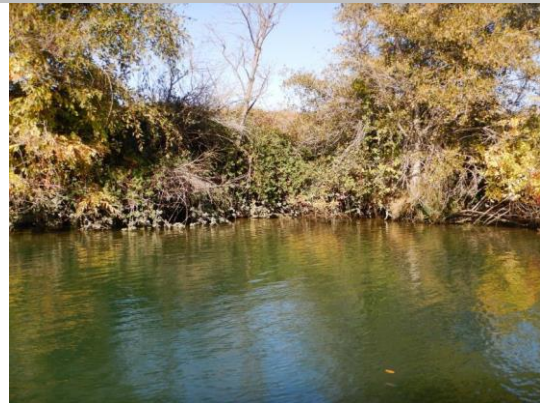
Photo 1 of 2 : FA_2024_RD0556_18_20_20241001_00003.jpg

LM Start	5.12	Rating **	M	Issue No.	20
LM End	5.34	Issue Type +	Ma	Location *	WS
Category	Supplemental			GPS Latitude/Longitude	
				Start	End
Item	2018 USACE Erosion Survey			38.189775°	38.187369°
				-121.557729°	-121.560247°
DWR ID	DWR_RD0556_01_s _ 2022_20				
Comment Code					
Inspector Comment					
2018 Site ID: GEO 7.0 R Status: Eroding 2018 Field Notes: Minor new toe erosion. Site History: 1997 - Toe damaged rock. 1999 - One pocket filled with gravel. 2000 - Eroding beach with some biotech rolls and stakes; some gravel on slope. 2001 - Staked, low fascine walls at bankline. 2005 - Stone revetment in between pockets. 2006 - New rock on upper slope behind brush boxes at the upstream end, Stone is sliding off the hard toe. 2016 - Fresh erosion observed. 2017 - Site extended downstream. Large erosion pockets and significant toe erosion.

USACE 2018 Erosion Photo #1

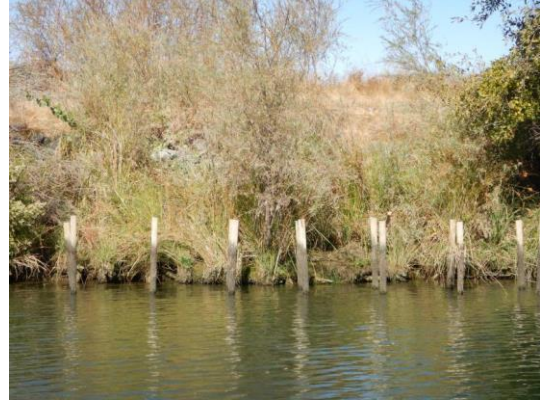
Photo 2 of 2 : FA_2024_RD0556_18_20_20241001_00004.jpg

USACE 2018 Erosion Photo #2

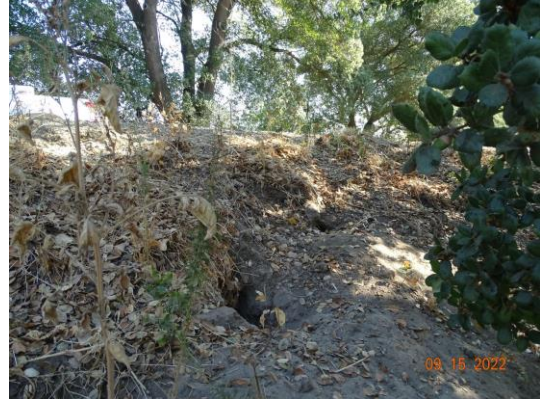
Photo 1 of 1 : FA_2024_RD0556_19_92_20241001_00057.jpg

View of the rodent holes looking up the LS slope (Fall 2022).

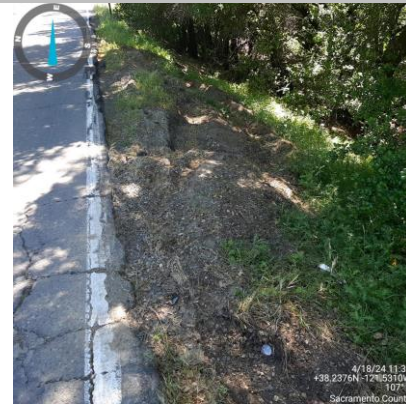
Photo 1 of 1 : FA_2024_RD0556_19_38_20241001_00028.jpg

LM Start	0.70	Rating **	U	Issue No.	38
LM End	0.70	Issue Type +	Ma	Location *	LS
Category	Earthen Levee			GPS Latitude/Longitude	
				Start	End
Item	Erosion / Vehicle Traffic			38.237444°	38.237444°
				-121.530852°	-121.530852°
DWR ID	DWR_RD0556_02_s_2024_38				
Comment Code					
E6 : Repair the levee slope damaged by vehicle traffic and prevent access where possible.					
Inspector Comment					
LS slope needs to be backfilled and regraded to fix vehicle ruts.

View of vehicle rut on LS slope. (Spring 2024)

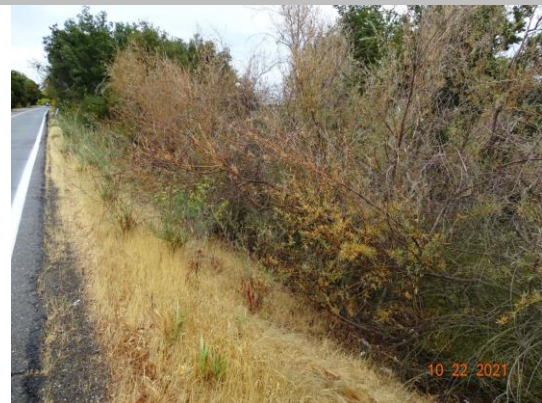
Photo 1 of 1 : FA_2024_RD0556_19_81_20241001_00051.jpg

View looking upstream at thick vegetation on the landside slope (Fall 2021).

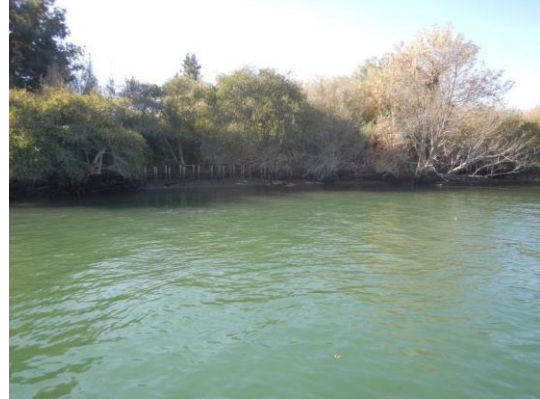
Photo 1 of 2 : FA_2024_RD0556_19_19_20241001_00015.jpg

LM Start	1.03	Rating **	M	Issue No.	19
LM End	1.15	Issue Type +	Ma	Location *	WS
Category	Supplemental			GPS Latitude/Longitude	
				Start	End
Item	2018 USACE Erosion Survey			38.238772°	38.239265°
				-121.536788°	-121.538845°
DWR ID	DWR_RD0556_02_s_2022_19				
Comment Code					
Inspector Comment					
2018 Site ID: SAC 25.2 L					
Status: Eroding					
2018 Field Notes: Additional erosion along toe. Site extended upstream.					
Site History: 1997 - Rock is in poor condition and has failed in many places. Scallops in berm with remnants of old rock in the toe area.					
2005 - Brush boxes present. 2013 - Site extended upstream					
approximately 300 ft to include new erosion pockets. 2015 - Minor new					
erosion at toe. 2017 - Minor new erosion observed.

USACE 2018 Erosion Photo #1

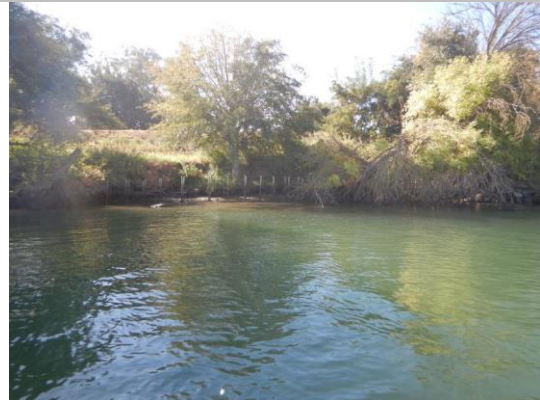
Photo 2 of 2 : FA_2024_RD0556_19_19_20241001_00016.jpg

USACE 2018 Erosion Photo #2

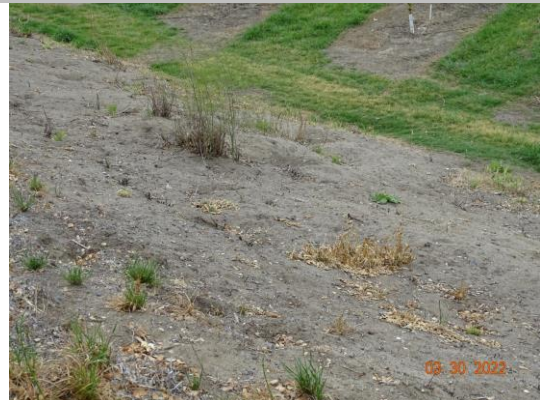
Photo 1 of 1 : FA_2024_RD0556_19_75_20241001_00046.jpg

View of animal holes in the landside slope (Spring 2022).

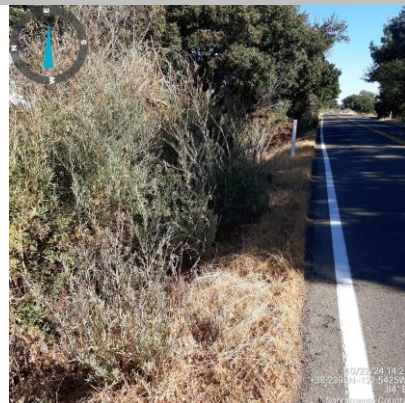
Photo 1 of 1 : FA_2024_RD0556_19_48_20241106_00094.jpg

View of tall vegetation on the waterside hinge. (Fall 2024)

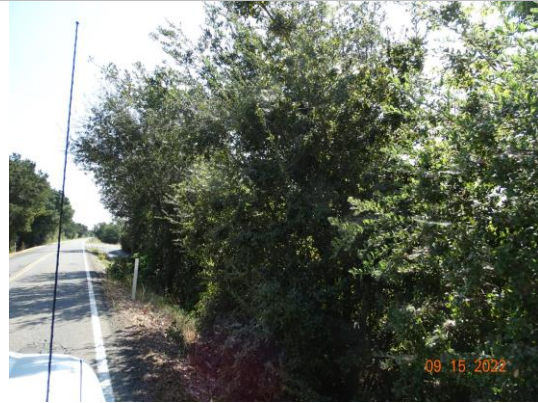
Photo 1 of 1 : FA_2024_RD0556_19_115_20241001_00060.jpg

View of the trees on the LS slope (Fall 2022).

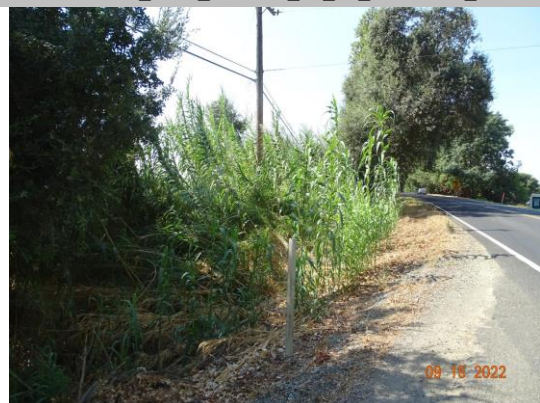
Photo 1 of 1 : FA_2024_RD0556_19_32_20241001_00023.jpg

View of the arundo on the LS slope (Fall 2022).

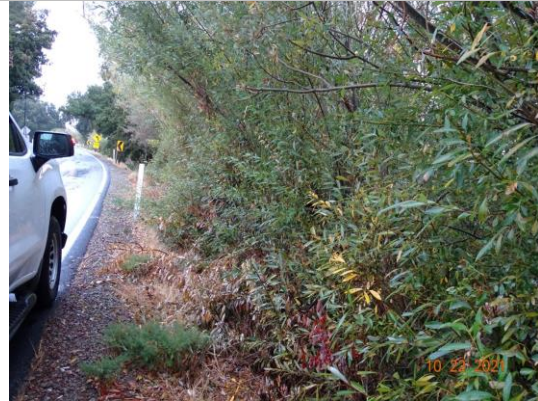
Photo 1 of 1 : FA_2024_RD0556_19_89_20241001_00054.jpg

View looking downstream at thick trees on the waterside slope (Fall 2021).

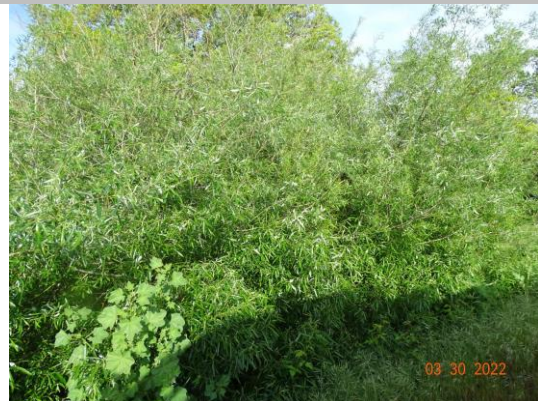
Photo 1 of 1 : FA_2024_RD0556_19_90_20241001_00055.jpg

View of thick willows on the waterside slope (Spring 2022).

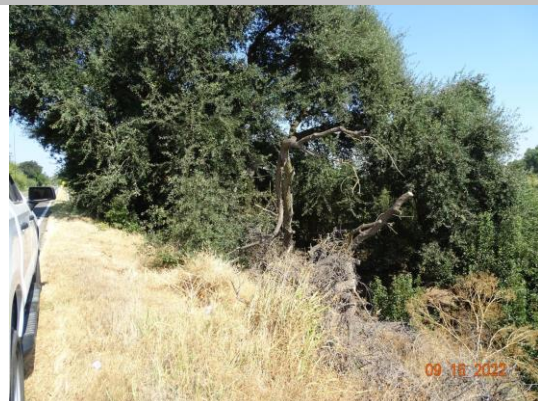
Photo 1 of 1 : FA_2024_RD0556_19_88_20241001_00053.jpg

View of the tree limb on the LS slope (Fall 2022).

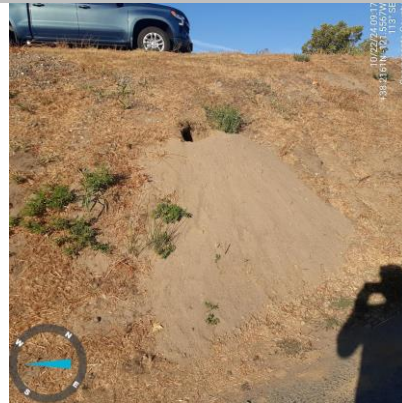
Photo 1 of 1 : FA_2024_RD0556_19_40_20241106_00102.jpg

View of large rodent hole on the landside slope. (Fall 2024)

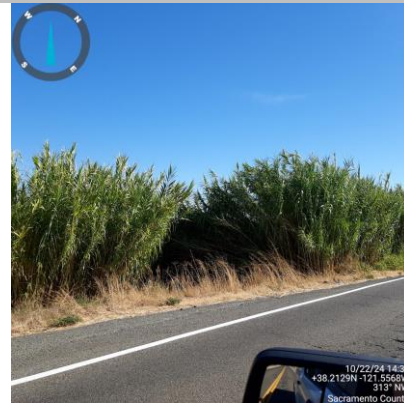
Photo 1 of 1 : FA_2024_RD0556_19_71_20241106_00103.jpg

View of thick arundo on the landside slope. (Fall 2024)

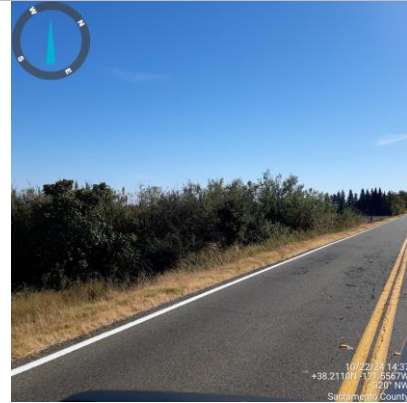
Photo 1 of 1 : FA_2024_RD0556_19_55_20241106_00104.jpg

View of thick trees on the landside slope. (Fall 2024)

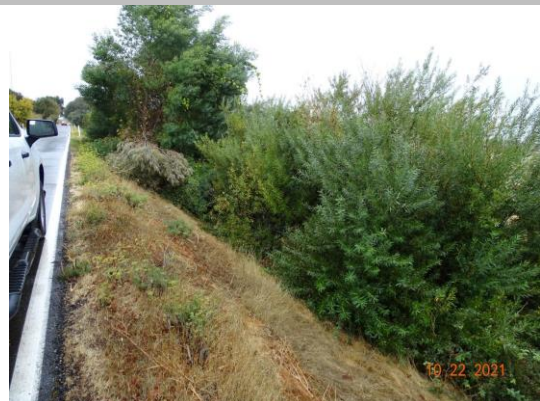
Photo 1 of 1 : FA_2024_RD0556_19_60_20241001_00038.jpg

View looking upstream at trees on the landside slope (Fall 2021).

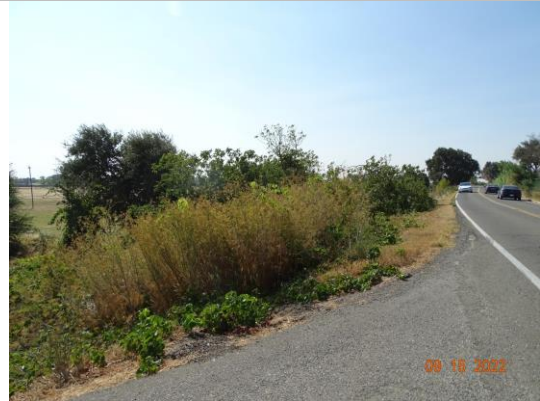
Photo 1 of 1 : FA_2024_RD0556_19_58_20241001_00036.jpg

View of the LS vegetation and fig tree in the background (Fall 2022).

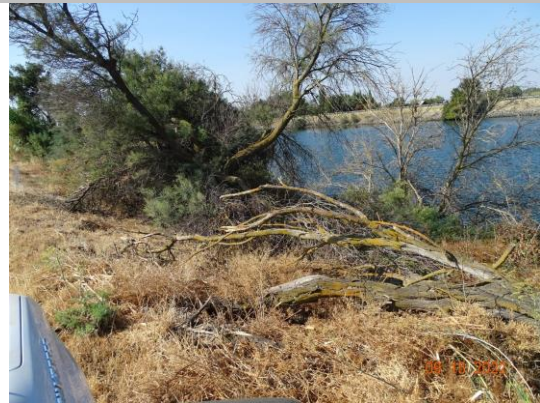
Photo 1 of 1 : FA_2024_RD0556_19_27_20241001_00019.jpg

View of overgrown and fallen trees on the WS slope (Fall 2022).

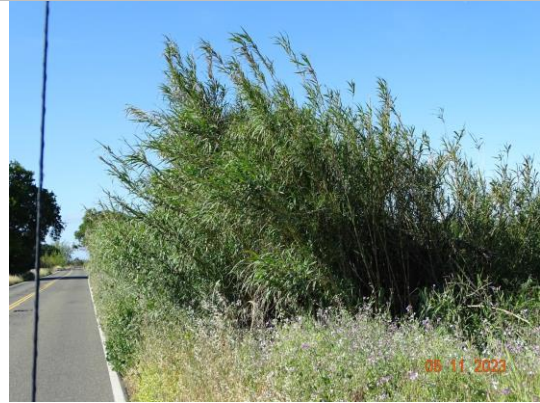
Photo 1 of 1 : FA_2024_RD0556_19_3_20241001_00003.jpg

View of the arundo on the WS slope (Spring 2023).

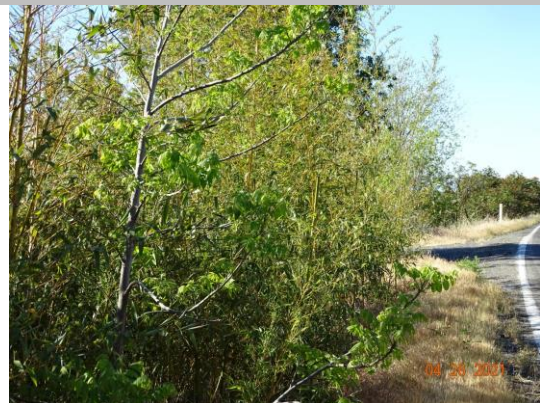
Photo 1 of 1 : FA_2024_RD0556_19_52_20241001_00034.jpg

View looking downstream at bamboo and trees of heaven on landside slope (Spring 2021).

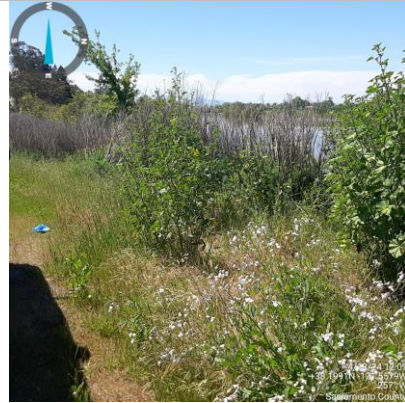
Photo 1 of 1 : FA_2024_RD0556_19_91_20241001_00056.jpg

View of tall vegetation on WS slope. (Spring 2024)

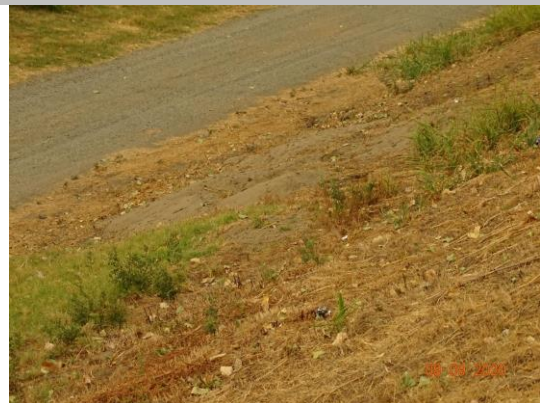
Photo 1 of 1 : FA_2024_RD0556_19_79_20241001_00049.jpg

View looking downstream at burrow holes on the landside slope (Fall 2020).
