**Flood Control Project Maintenance
Levee Inspections**
LMA District Cover Sheet
Spring 2011 Levee Inspection Results

Reclamation District No. 0556 Upper Andrus

Levee Inspection Report By Mile - Spring 2011

Waterway		Bank	Unit Miles	Inspection Start/End	Inspector
Unit No. 01 Georgiana Slough		Right	5.47	03/29/2011 03/29/2011	Herman Phillips

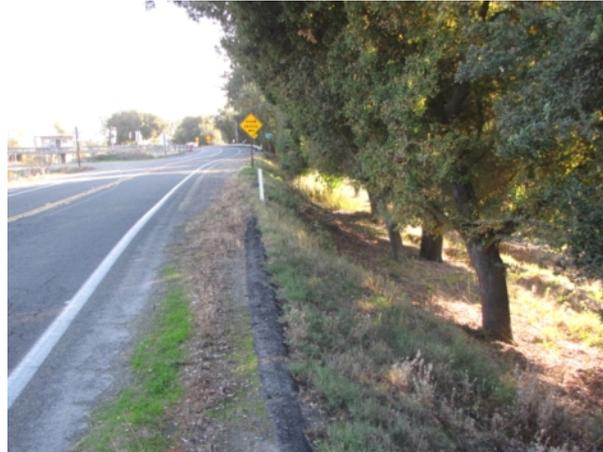
Levee Mile Report Line	1
Start Levee Mile	0.00
End Levee Mile	0.00
Location	Land Side
Category	Earthen Levee
Item	Vegetation
Standing on land side looking downstream from levee mile 0.00 Unit 1 RD 556. Photo taken 11-17-2010	
phillips_s_20110228_106.jpg

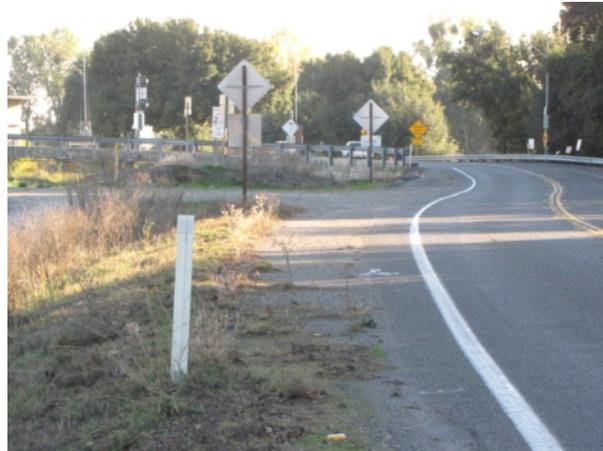
Levee Mile Report Line	2
Start Levee Mile	0.00
End Levee Mile	0.00
Location	Water Side
Category	Earthen Levee
Item	Vegetation
Standing on water side from levee mile 0.00 looking downstream of RD 556 Unit 1. Photo taken 11-17-2010.	
phillips_s_20110228_107.jpg

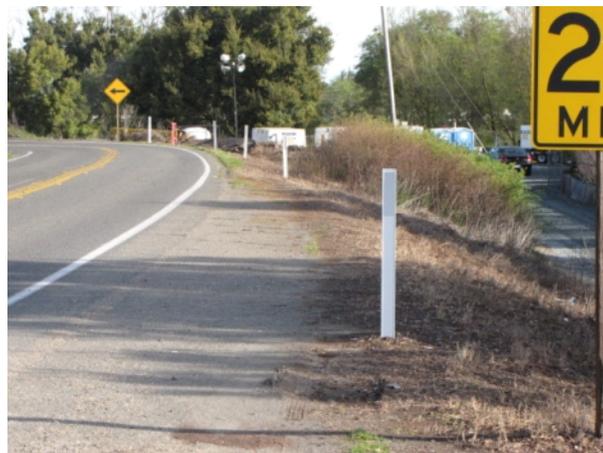
Levee Mile Report Line	3
Start Levee Mile	0.00
End Levee Mile	0.07
Location	Water Side
Category	Earthen Levee
Item	Vegetation
Standing on waterside levee mile 0.07 looking upstream to levee mile 0.00. Photo taken 03-29-2011.	
phillips_s_20110329_217.jpg

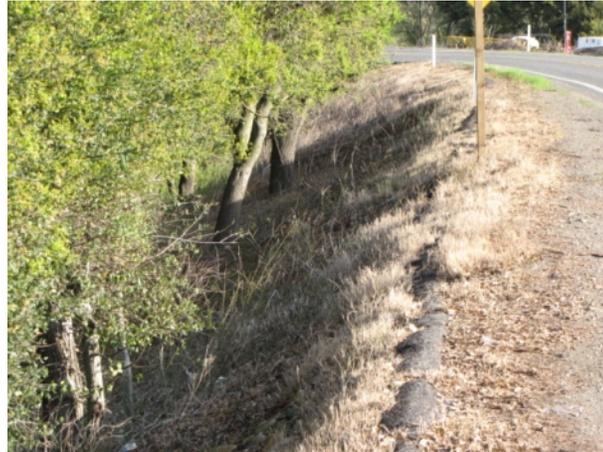
Levee Mile Report Line	4
Start Levee Mile	0.00
End Levee Mile	0.08
Location	Land Side
Category	Earthen Levee
Item	Vegetation
<p>Standing on landside levee mile 0.08 looking upstream to levee mile 0.00. Photo taken 3-29-2011.</p>	
<p>phillips_s_20110329_218.jpg</p>

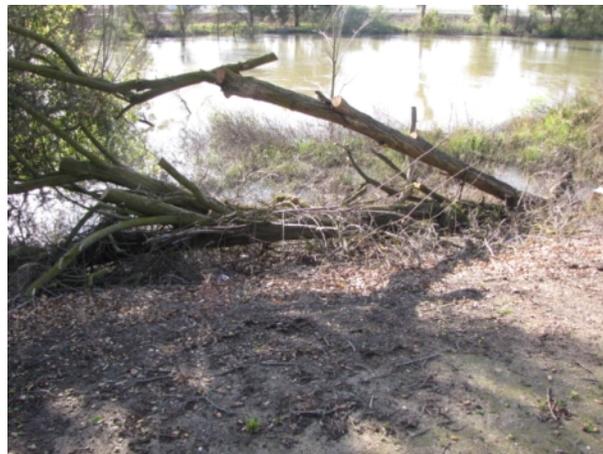
Levee Mile Report Line	8
Start Levee Mile	0.42
End Levee Mile	0.42
Location	Water Side
Category	Earthen Levee
Item	Encroachments
<p>Looking downstream from levee mile 0.42 two fallen trees on waterward slope. Photo taken 3-29-2011</p>	
<p>phillips_s_20110330_229.jpg</p>

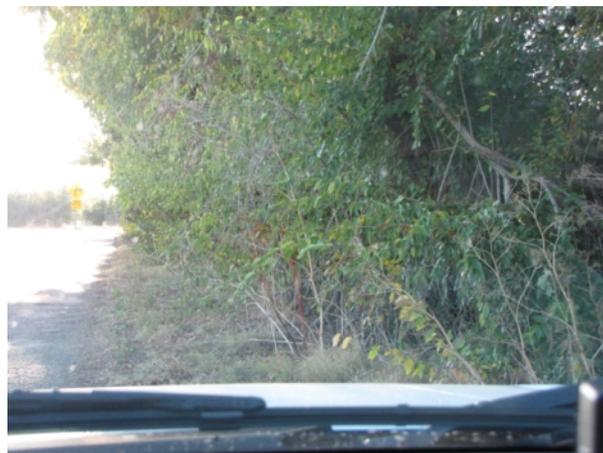
Levee Mile Report Line	10
Start Levee Mile	0.90
End Levee Mile	0.91
Location	Land Side
Category	Earthen Levee
Item	Trim / Thin Trees
<p>Standing on landside from levee mile 0.90 looking downstream to levee mile 0.91 unsatisfactory wild growth on shoulder and slope of Unit 1 RD 556</p>	
<p>phillips_s_20110228_105.jpg</p>

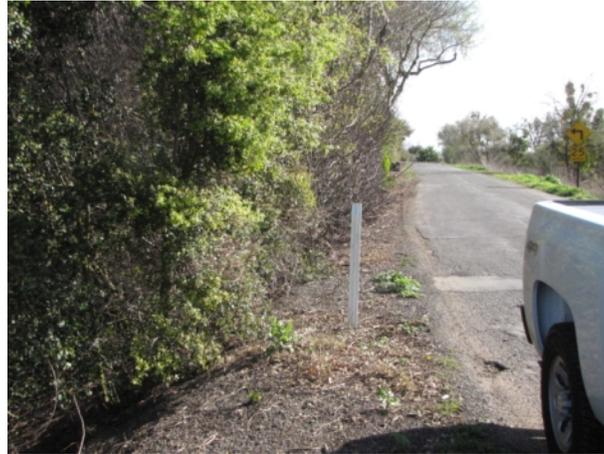
Levee Mile Report Line	10
Start Levee Mile	0.90
End Levee Mile	0.91
Location	Land Side
Category	Earthen Levee
Item	Trim / Thin Trees
<p>Standing downstream from levee mile 0.93 looking upstream toward 0.90. new photo taken 3-29-2011</p>	
<p>phillips_s_20110330_231.jpg</p>

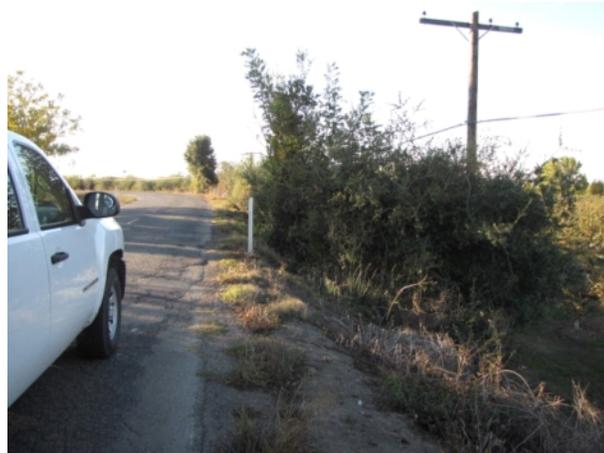
Levee Mile Report Line	11
Start Levee Mile	1.20
End Levee Mile	1.31
Location	Land Side
Category	Earthen Levee
Item	Trim / Thin Trees
<p>Standing on landside from levee mile 1.20 looking downstream at wild growth on landside shoulder and slope of Unit 1 RD 556. Photo taken 11-17-2010</p>	
<p>phillips_s_20110228_109.jpg</p>

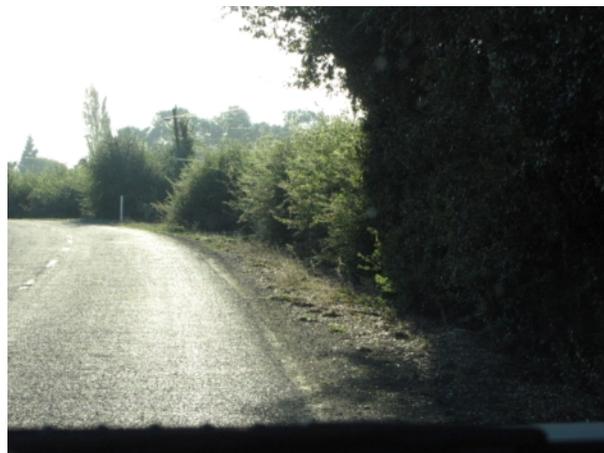
Levee Mile Report Line	13
Start Levee Mile	1.32
End Levee Mile	1.42
Location	Land Side
Category	Earthen Levee
Item	Trim / Thin Trees
<p>Standing on landside Unit 1 RD 556 from levee mile 1.32 looking downstream to levee mile 1.42 unsatisfactory growth remains on levee section. Photo taken 11-17-2010</p>	
<p>phillips_s_20110228_110.jpg</p>

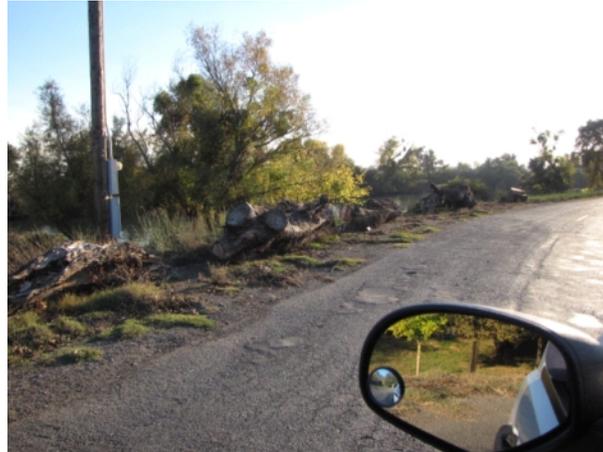
Levee Mile Report Line	15
Start Levee Mile	1.55
End Levee Mile	1.57
Location	Water Side
Category	Earthen Levee
Item	Encroachments
<p>Standing on land side from levee mile 1.55 looking at water side shoulder unauthorized dumping of cut up trees has been placed on levee section to levee mile 1.57. District need to remove this encroachment from the levee section. Photo taken 11-17-2010</p>	
<p>phillips_s_20110228_108.jpg</p>

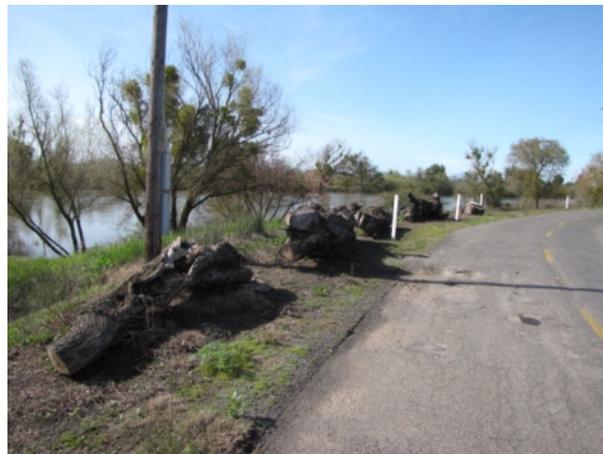
Levee Mile Report Line	15
Start Levee Mile	1.55
End Levee Mile	1.57
Location	Water Side
Category	Earthen Levee
Item	Encroachments
<p>The land owner stated that he would have these trees removed from levee section next month (April). Photo taken 3-29-2011.</p>	
<p>phillips_s_20110330_232.jpg</p>

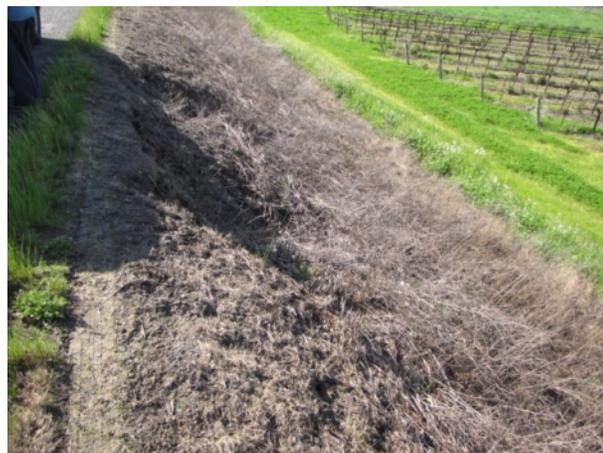
Levee Mile Report Line	21
Start Levee Mile	2.32
End Levee Mile	2.32
Location	Land Side
Category	Earthen Levee
Item	Erosion / Bank Caving
<p>Looking at new erosion site levee mile 2.32 landside slope UNIT # 1 RD 556. Photo taken 3-29-2011.</p>	
<p>phillips_s_20110330_233.jpg</p>

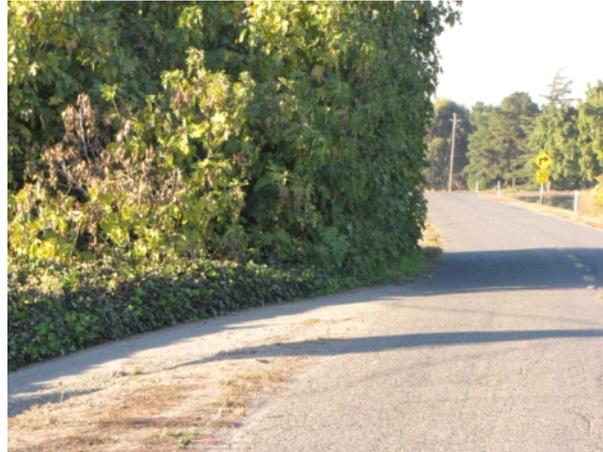
Levee Mile Report Line	22
Start Levee Mile	2.32
End Levee Mile	2.34
Location	Land Side
Category	Earthen Levee
Item	Trim / Thin Trees
<p>Standing on waterside of Unit 1 RD 556 from levee miles 2.34 looking back upstream to levee 2.32 unauthorized tree growth remains on levee section. Phot taken 11-17-2010</p>	
<p>phillips_s_20110228_111.jpg</p>

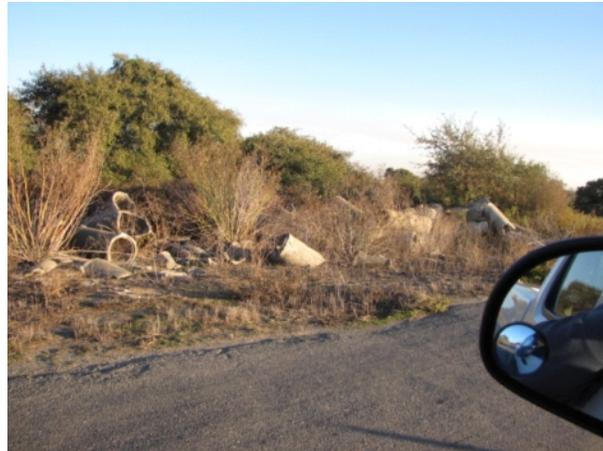
Levee Mile Report Line	41
Start Levee Mile	3.44
End Levee Mile	3.46
Location	Water Side
Category	Earthen Levee
Item	Encroachments
<p>Unit 1 RD 556 Un authorized dumping of concrete pipe and blocks of water side shoulder and berm. Photo taken 11-17-2010 (Unsatisfactory).</p>	
<p>phillips_s_20110228_112.jpg</p>

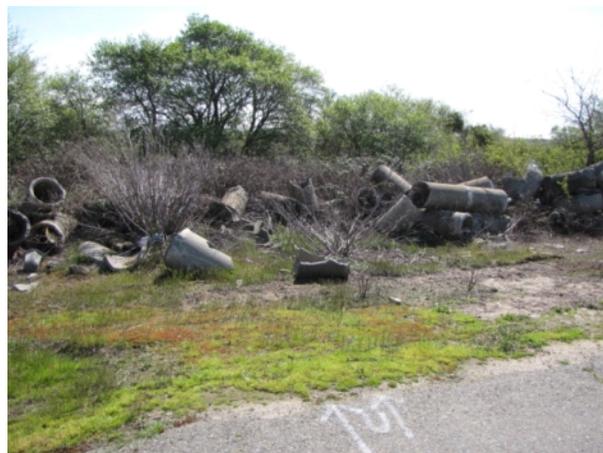
Levee Mile Report Line	41
Start Levee Mile	3.44
End Levee Mile	3.46
Location	Water Side
Category	Earthen Levee
Item	Encroachments
<p>This pipe continue to be on waterward side of RD 556 Unit 1. New photo taken 3-29-2011. Unsatisfactory.</p>	
<p>phillips_s_20110330_230.jpg</p>

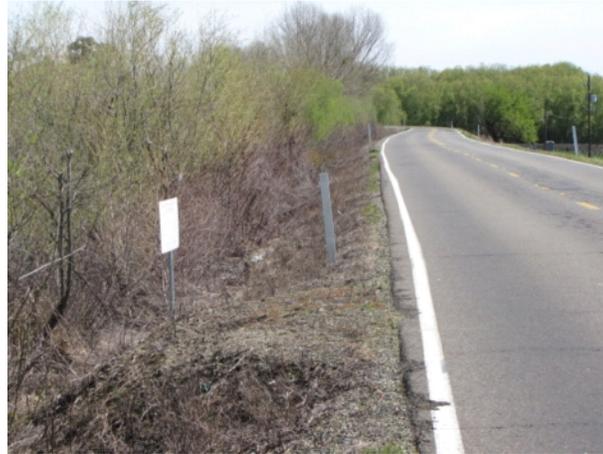
Levee Mile Report Line	1
Start Levee Mile	0.00
End Levee Mile	0.00
Location	Water Side
Category	Earthen Levee
Item	Vegetation
Looking downstream from levee mile 0.00 Unit # 2 RD 556. Re-vegetation and Rock site on waterward slope. Photo taken 03-29-2011.	
phillips_s_20110330_234.jpg
