**Flood Control Project Maintenance  
Levee Inspections**

**Fall 2011 Levee Maintenance Deficiency Summary Report**

**Reclamation District No. 0563 Tyler Island**

Waterway	Bank	Unit Miles
Unit No. 01 Georgiana Slough (Tyler Island)	Left	12.38

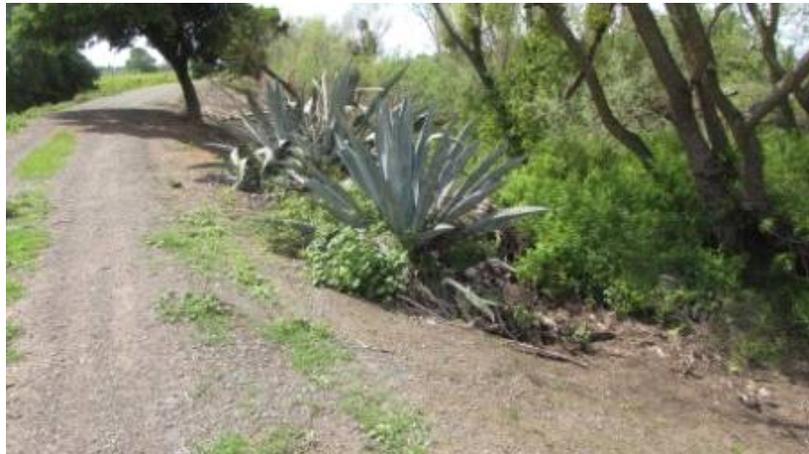
Levee Mile Report Line	26
Start Levee Mile	1.77
End Levee Mile	1.77
Location	Land Side
Category	Earthen Levee
Item	Animal Control
Looking west at rodent hole on landside slope.	
richard_f_20111006_581.jpg

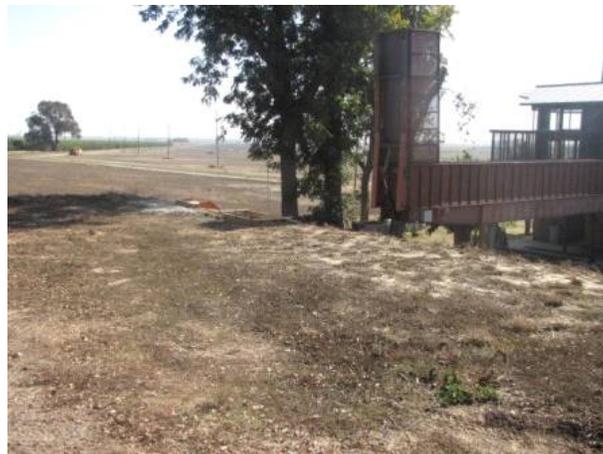
Levee Mile Report Line	27
Start Levee Mile	1.86
End Levee Mile	1.86
Location	Land Side
Category	Earthen Levee
Item	Encroachments
Looking north at deadman for metal walkway on earthen pad on landside shoulder.	
richard_f_20110922_407.jpg

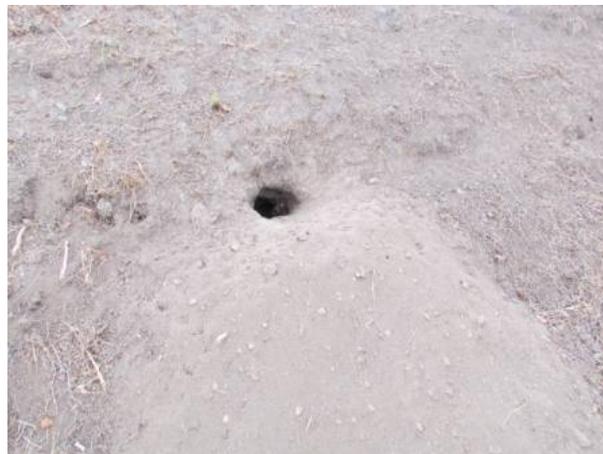
Levee Mile Report Line	37
Start Levee Mile	2.58
End Levee Mile	2.61
Location	Land Side
Category	Earthen Levee
Item	Animal Control
Looking northeast at rodent holes on landside slope.	
richard_f_20111006_584.jpg

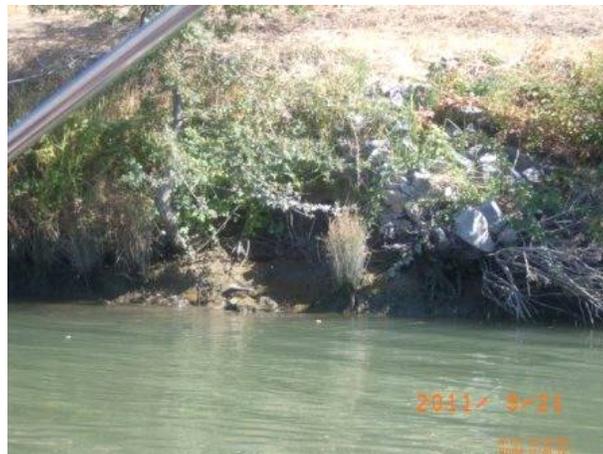
Levee Mile Report Line	44
Start Levee Mile	2.90
End Levee Mile	2.90
Location	Water Side
Category	Earthen Levee
Item	Encroachments
Looking southwest at fencing on waterside shoulder.	
richard_f_20111006_587.jpg

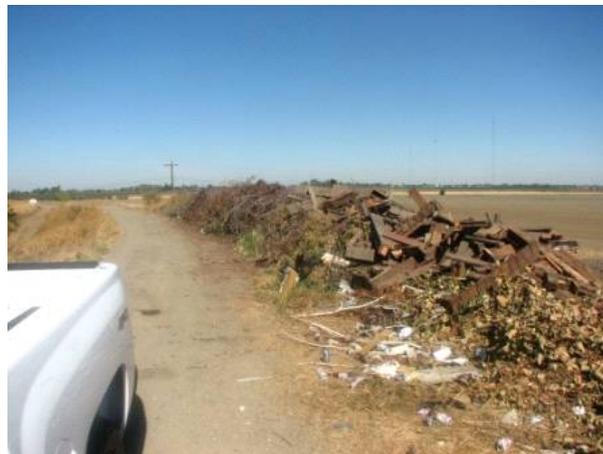
Levee Mile Report Line	45
Start Levee Mile	2.94
End Levee Mile	2.94
Location	Land Side
Category	Earthen Levee
Item	Encroachments
Looking south at pruning and garbage pile on landside slope	
richard_f_20110922_374.jpg

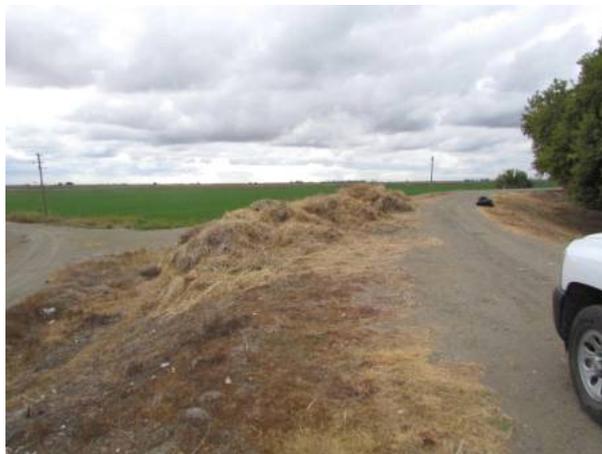
Levee Mile Report Line	47
Start Levee Mile	3.06
End Levee Mile	3.12
Location	Land Side
Category	Earthen Levee
Item	Vegetation
Bamboo at landward toe at LM 3.05	
richard_f_20110922_376.jpg

LMIR No.	Levee Mile		Category	Item	Location *	Rating **	Action/Comment	GPS Latitude/Longitude		Issue No. Photo
	Start	End						Start	End	
47	3.06	3.12	Earthen Levee	Vegetation	LS	W	Remove the wild growth other than native grasses from the levee slopes. Inspector Comments: Bamboo and vines (Berry or wildroses) along landside toe.	38.210230 ° -121.536342 °	38.210251 ° -121.537290 °	17 Y
48	3.09	3.28	Earthen Levee	Vegetation	LS	U	Remove the wild growth other than native grasses from the levee slopes. Inspector Comments: Berryvines at landside toe.	38.210212 ° -121.536728 °	38.209165 ° -121.539920 °	74 Y
49	3.13	3.13	Earthen Levee	Slope Stability	LS	M	Repair slope instability.	38.210240 ° -121.537517 °	38.210240 ° -121.537517 °	78 Y
50	3.28	3.28	Earthen Levee	Trim / Thin Trees	LS	M	Thin trees to allow visibility of the ground and room to flood fight.	38.209217 ° -121.539823 °	38.209217 ° -121.539823 °	68 Y

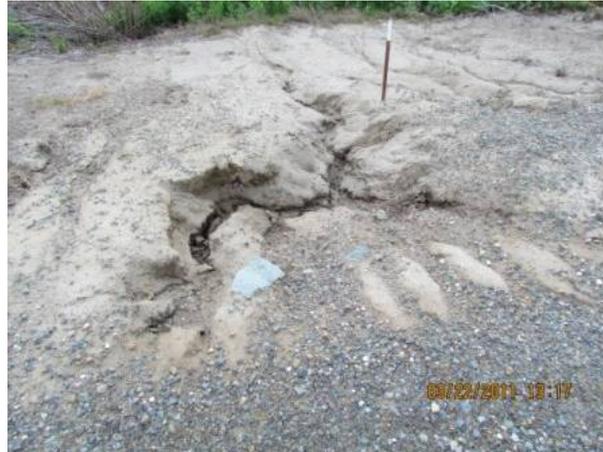
Levee Mile Report Line	49
Start Levee Mile	3.13
End Levee Mile	3.13
Location	Land Side
Category	Earthen Levee
Item	Slope Stability
Looking west at slope erosion cause by runoff on landside slope.	
richard_f_20110922_428.jpg

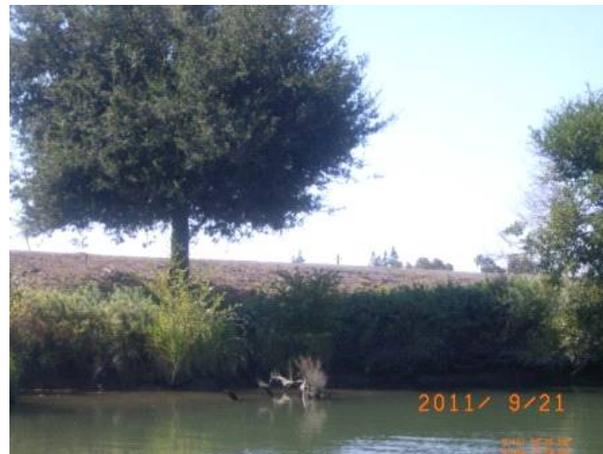
Levee Mile Report Line	57
Start Levee Mile	6.03
End Levee Mile	6.03
Location	Land Side
Category	Earthen Levee
Item	Encroachments
Looking southeast at garbage and prunings on landside slope.	
richard_f_20110922_418.jpg

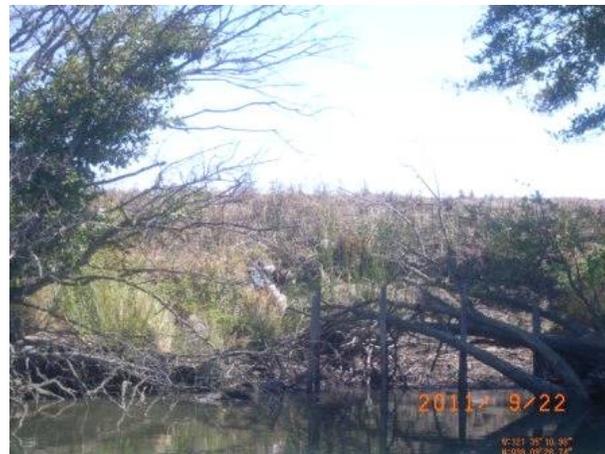
Levee Mile Report Line	74
Start Levee Mile	8.18
End Levee Mile	8.63
Location	Water Side
Category	Supplemental
Item	USACE Erosion Survey
USACE 2011 Photo #1	
USACE2011_GEO_3-8_L_1.jpg

74	8.18	8.63	Supplemental	USACE Erosion Survey	WS	U	Inspector Comments: 1997 - Pockets of erosion into the levee at the water line. Alders are being undercut and rotating out into the channel. Damaged rock at upstream end. 2000 - New minor erosion. 2001 - Staked low fascine walls at bankline. 2002 - New "Brush Boxes" along the bank toe. 2003 - New erosion pockets in the middle of the site. 2005 - Some new bundles in the brush boxes. 2011: Site upgraded to CRITICAL. Significant new erosion. Sites 3.6, 3.7, 3.71, and 4.0 were combined. [2011 Site ID: GEO_3-8_L]	38.156987 ° -121.587427 °	38.152919 ° -121.591129 °	48 Y

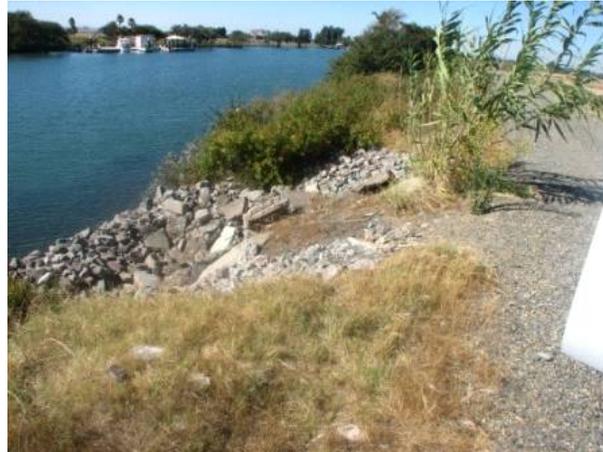
Levee Mile Report Line	86
Start Levee Mile	10.90
End Levee Mile	10.90
Location	Water Side
Category	Earthen Levee
Item	Slope Stability
Uncompleted slope stability repair on waterside slope.	
richard_f_20110922_429.jpg
