**Flood Control Project Maintenance
Levee Inspections**

Fall 2009 Levee Maintenance Deficiency Summary Report

Reclamation District No. 0563 Tyler Island

Waterway	Bank	Unit Miles
Unit No. 01 Georgiana Slough (Tyler Island)	Left	12.38

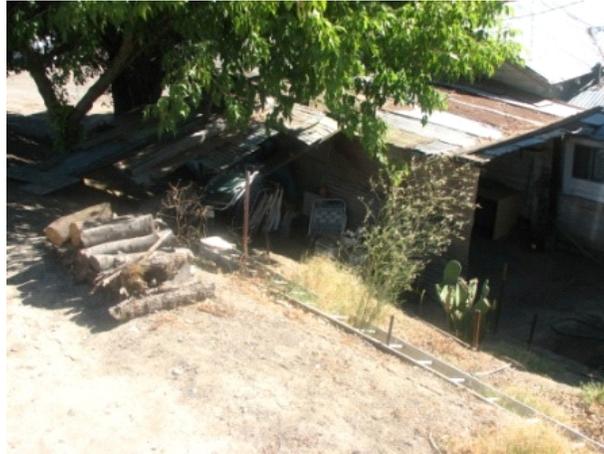
Levee Mile Report Line	10
Start Levee Mile	1.25
End Levee Mile	1.25
Location	Land Side
Category	Earthen Levee
Item	Encroachments
Looking at shed at landside toe.	
richard_20091104_64.jpg

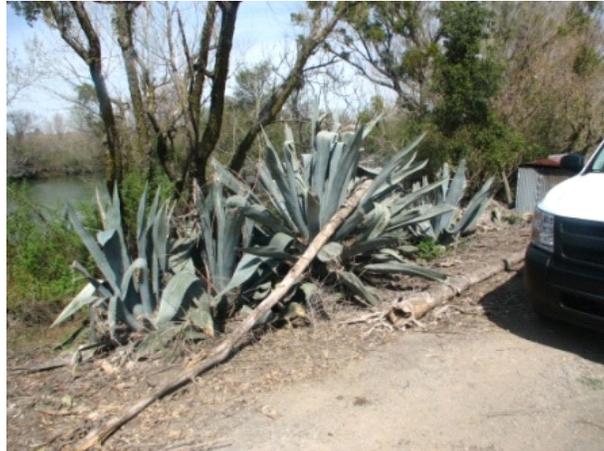
Levee Mile Report Line	11
Start Levee Mile	1.44
End Levee Mile	1.48
Location	Water Side
Category	Earthen Levee
Item	Vegetation
Century plant on waterward shoulder at LM 1.42	
richard_20091104_57.jpg

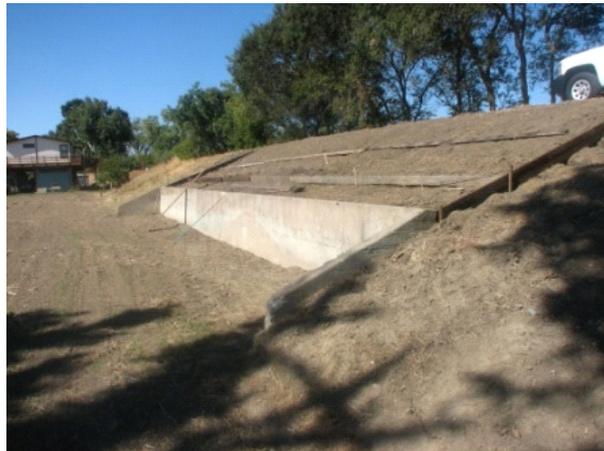
Levee Mile Report Line	12
Start Levee Mile	1.86
End Levee Mile	1.86
Location	Land Side
Category	Earthen Levee
Item	Encroachments
Unauthorized retaining wall on landside toe.	
richard_20091104_65.jpg

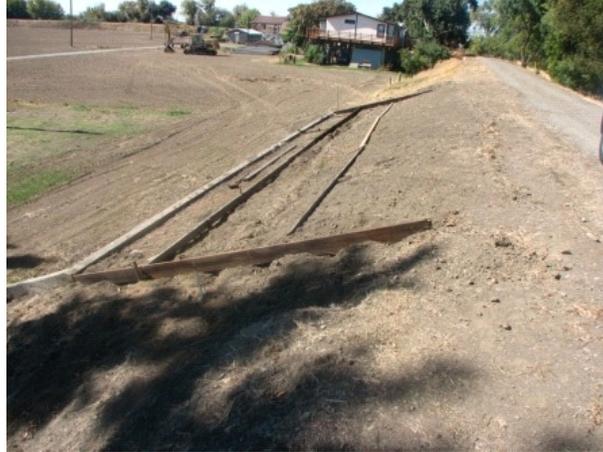
Levee Mile Report Line	12
Start Levee Mile	1.86
End Levee Mile	1.86
Location	Land Side
Category	Earthen Levee
Item	Encroachments
Flower box above retaining wall on landside slope	
richard_20091104_66.jpg

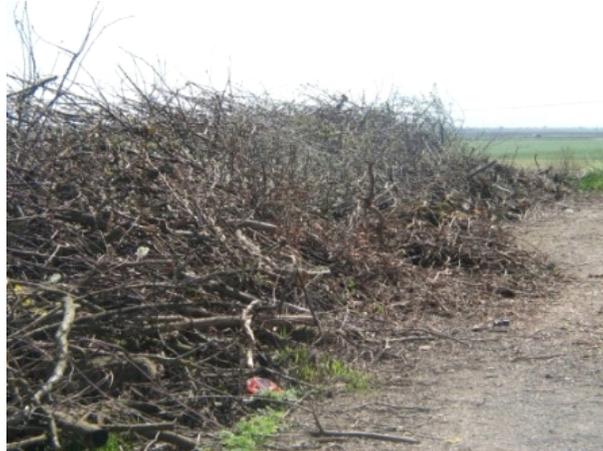
Levee Mile Report Line	19
Start Levee Mile	2.94
End Levee Mile	2.95
Location	Land Side
Category	Earthen Levee
Item	Encroachments
Prunings on landward shoulder from LM 2.93 to 2.95	
richard_20091104_58.jpg

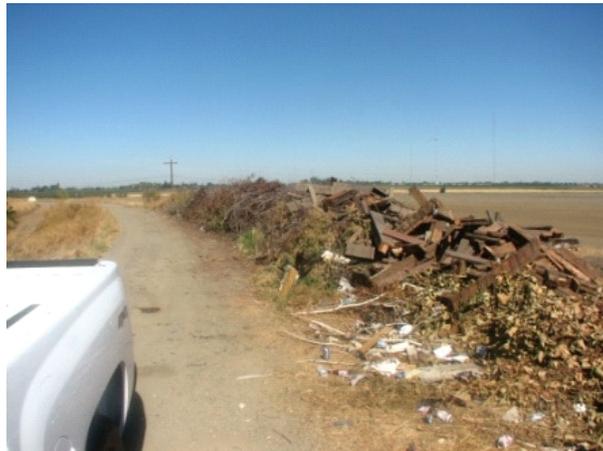
Levee Mile Report Line	19
Start Levee Mile	2.94
End Levee Mile	2.95
Location	Land Side
Category	Earthen Levee
Item	Encroachments
View looking upstream at pruning pile.	
richard_20091104_59.jpg

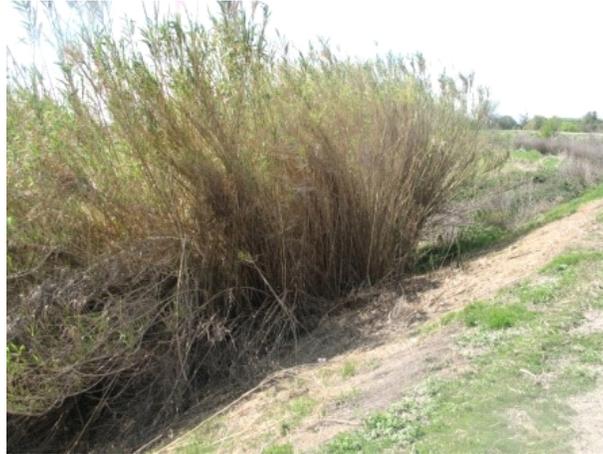
Levee Mile Report Line	20
Start Levee Mile	3.06
End Levee Mile	3.12
Location	Land Side
Category	Earthen Levee
Item	Vegetation
Bamboo at landward toe at LM 3.05	
richard_20091104_60.jpg

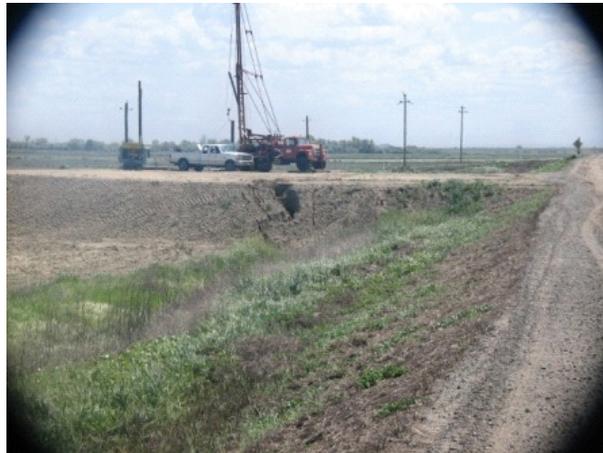
24	3.63	3.65	Earthen Levee	Encroachments	LS	PO	Buildings Inspector Comments: Landowner building house pad for new home 100'x 100'	38.204600 ° -121.540232 °	38.204300 ° -121.540133 °	940 Y
25	4.00	4.01	Supplemental	USACE Erosion Survey	LS	M	Inspector Comments: slumping	38.200804 ° -121.542592 °	38.200702 ° -121.542843 °	931
26	5.61	5.68	Supplemental	USACE Erosion Survey	LS	M	Inspector Comments: tree hazards, caves	38.185539 ° -121.563353 °	38.185166 ° -121.564469 °	930
27	5.72	5.84	Earthen Levee	Vegetation	WS	U	Remove the wild growth other than native grasses from the levee slopes.	38.184602 ° -121.565112 °	38.183667 ° -121.566794 °	941
28	5.90	5.98	Supplemental	USACE Erosion Survey	WS	M	Inspector Comments: tree hazards, caves	38.183382 ° -121.567878 °	38.182680 ° -121.568970 °	929
29	6.04	6.08	Earthen Levee	Vegetation	LS	U	Remove the wild growth other than native grasses from the levee slopes. Inspector Comments: Large Cactus on landward slope.	38.181965 ° -121.569913 °	38.181763 ° -121.570447 °	22 Y

Levee Mile Report Line	24
Start Levee Mile	3.63
End Levee Mile	3.65
Location	Land Side
Category	Earthen Levee
Item	Encroachments
Looking upstream at building pad at landside slope. Pad is approx. 100' x 100'	
richard_20091104_69.jpg

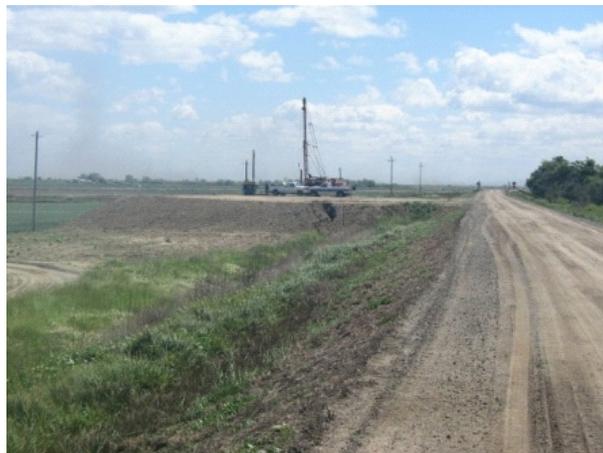
Levee Mile Report Line	24
Start Levee Mile	3.63
End Levee Mile	3.65
Location	Land Side
Category	Earthen Levee
Item	Encroachments
Looking upstream at house pad on landside slope.	
richard_20091104_70.jpg

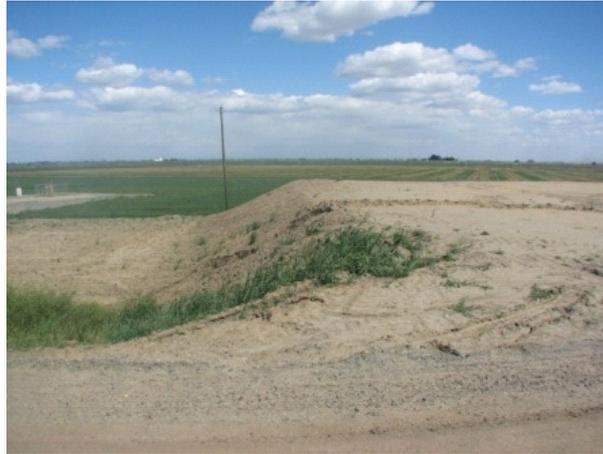
Levee Mile Report Line	24
Start Levee Mile	3.63
End Levee Mile	3.65
Location	Land Side
Category	Earthen Levee
Item	Encroachments
Looking east at left corner of house pad.	
richard_20091104_71.jpg

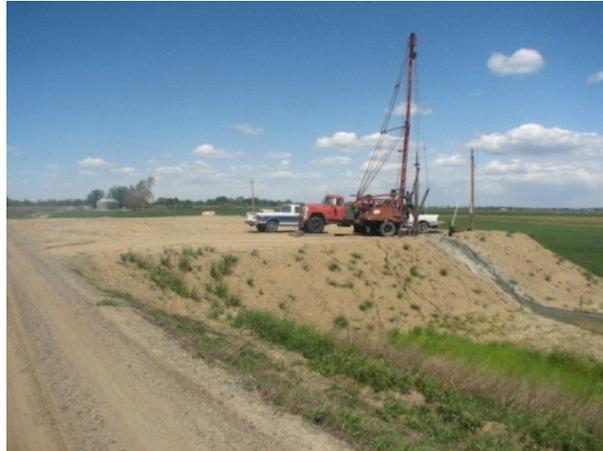
Levee Mile Report Line	24
Start Levee Mile	3.63
End Levee Mile	3.65
Location	Land Side
Category	Earthen Levee
Item	Encroachments
Looking downstream at house pad with utility pole and drilling rig on the landside of levee.	
richard_20091104_72.jpg

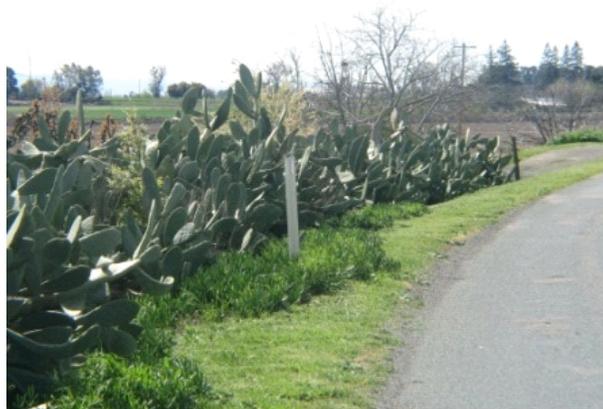
Levee Mile Report Line	29
Start Levee Mile	6.04
End Levee Mile	6.08
Location	Land Side
Category	Earthen Levee
Item	Vegetation
Large Cactus plant on landward slope from LM 6.04 to 6.08	
richard_20091104_61.jpg

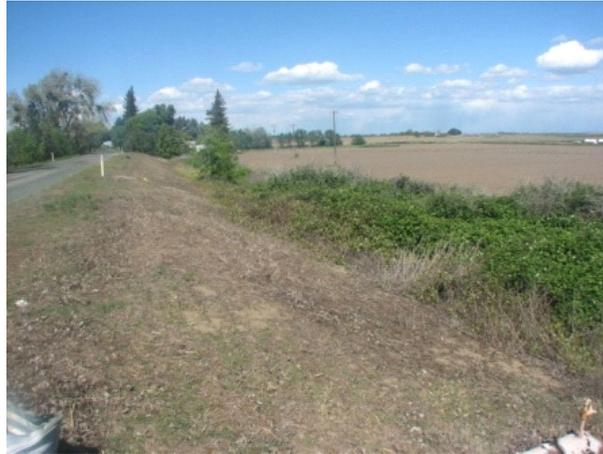
Levee Mile Report Line	36
Start Levee Mile	6.75
End Levee Mile	7.05
Location	Land Side
Category	Earthen Levee
Item	Vegetation
Side view of dense berryvines on landside toe.	
richard_20091104_67.jpg

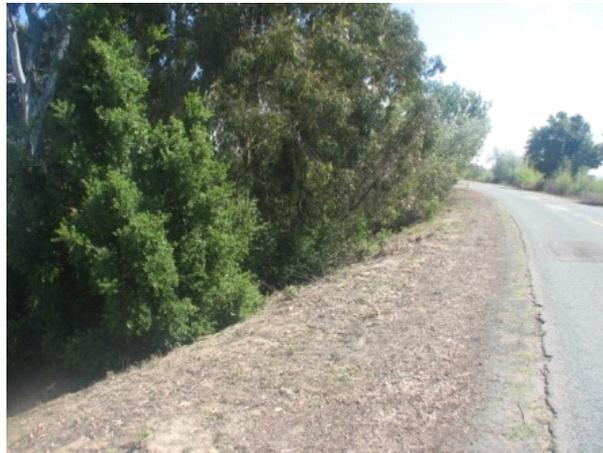
Levee Mile Report Line	38
Start Levee Mile	6.90
End Levee Mile	6.94
Location	Land Side
Category	Earthen Levee
Item	Trim / Thin Trees
Side view of dense trees along landside slope and shoulder.	
richard_20091104_62.jpg

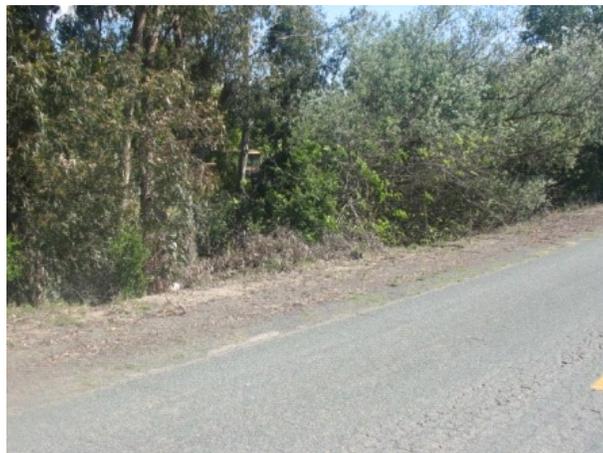
Levee Mile Report Line	38
Start Levee Mile	6.90
End Levee Mile	6.94
Location	Land Side
Category	Earthen Levee
Item	Trim / Thin Trees
Front view of dense trees along landside shoulder and slope.	
richard_20091104_63.jpg

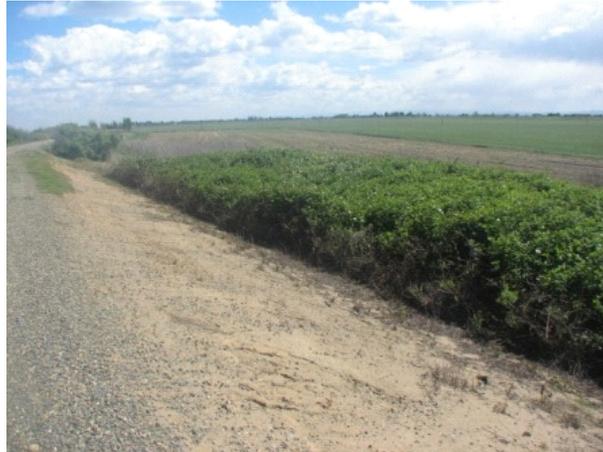
Levee Mile Report Line	53
Start Levee Mile	9.85
End Levee Mile	9.98
Location	Land Side
Category	Earthen Levee
Item	Vegetation
Looking downstream at dense wildroses at landside toe.	
richard_20091104_73.jpg

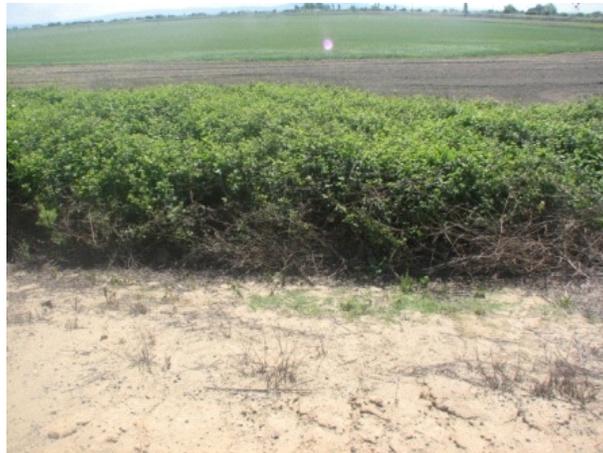
Levee Mile Report Line	53
Start Levee Mile	9.85
End Levee Mile	9.98
Location	Land Side
Category	Earthen Levee
Item	Vegetation
Front view of dense wildroses at landside toe.	
richard_20091104_74.jpg

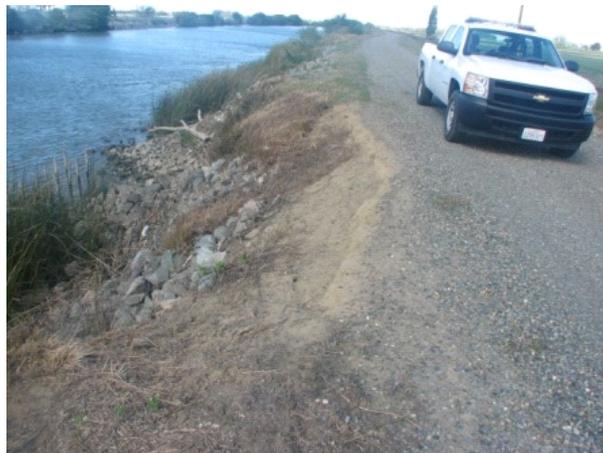
Levee Mile Report Line	58
Start Levee Mile	10.44
End Levee Mile	10.44
Location	Water Side
Category	Earthen Levee
Item	Erosion / Bank Caving
Looking downstream at erosion site on waterside slope and shoulder.	
richard_20091104_75.jpg

57	10.13	10.34	Earthen Levee	Encroachments	LS	M	Prunings	38.149990 ° -121.597478 °	38.147271 ° -121.599406 °	948
58	10.44	10.44	Earthen Levee	Erosion / Bank Caving	WS	U	Schedule repair of erosion site prior to the next inspection.	38.146102 ° -121.600342 °	38.146102 ° -121.600342 °	949 Y
59	10.58	10.66	Earthen Levee	Encroachments	LS	M	Prunings	38.144212 ° -121.599983 °	38.143295 ° -121.599223 °	950
60	10.63	10.89	Supplemental	USACE Erosion Survey	WS	M	Inspector Comments: tree hazards, caves	38.143473 ° -121.599758 °	38.140302 ° -121.597228 °	918
61	10.90	10.90	Earthen Levee	Slope Stability	WS	U	Repair slope instability. Inspector Comments: Site is not completely repaired	38.140307 ° -121.596957 °	38.140307 ° -121.596957 °	79 Y
62	11.36	11.36	Earthen Levee	Encroachments	LS	M	Prunings	38.134902 ° -121.592201 °	38.134902 ° -121.592201 °	951
63	11.49	11.59	Earthen Levee	Encroachments	WS	M	Prunings	38.133556 ° -121.590641 °	38.132462 ° -121.589452 °	952

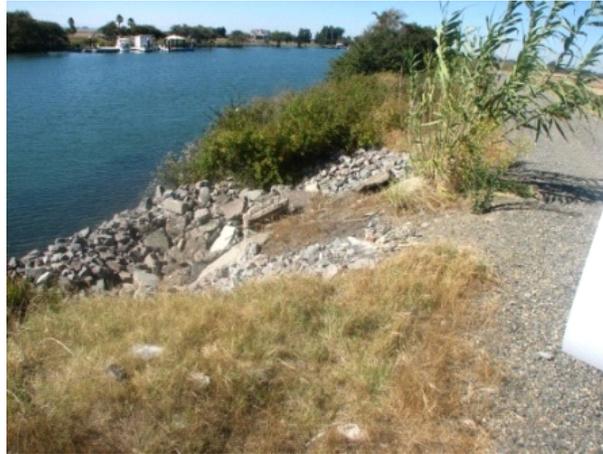
Levee Mile Report Line	61
Start Levee Mile	10.90
End Levee Mile	10.90
Location	Water Side
Category	Earthen Levee
Item	Slope Stability
Uncompleted slope stability repair on waterside slope.	
richard_20091104_68.jpg

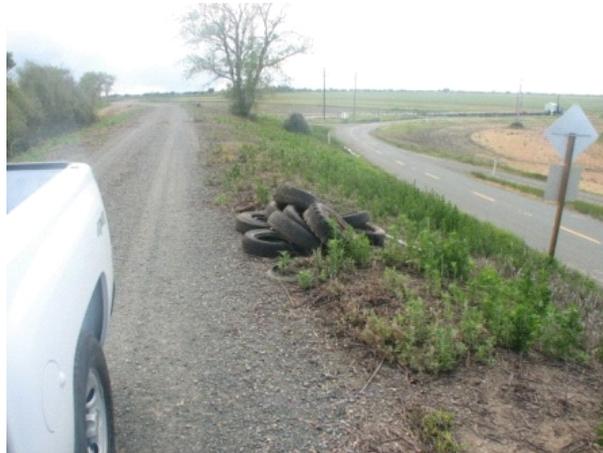
Levee Mile Report Line	67
Start Levee Mile	12.26
End Levee Mile	12.26
Location	Land Side
Category	Earthen Levee
Item	Encroachments
Rubber tires on landside shoulder.	
richard_20091104_76.jpg
