**Flood Control Project Maintenance
Levee Inspections**

Fall 2014 Levee Maintenance Deficiency Summary Report

Reclamation District No. 0563 Tyler Island

Waterway		Bank	Unit Miles	
Unit No. 01 Georgiana Slough (Tyler Island)		Left	12.11	
	Spring (March - May)	Summer (June - August)	(September - November) Fall	Winter (December - February)
Unit Maintenance Rating (Fall Only)			U	
Date of Inspection	03/25/2014 - 03/26/2014		10/09/2014 - 10/09/2014	
DWR Inspector	Richard Willoughby		Richard Willoughby	
Accompanied By	Steve Mello RD 563		Steve Mello RD 563

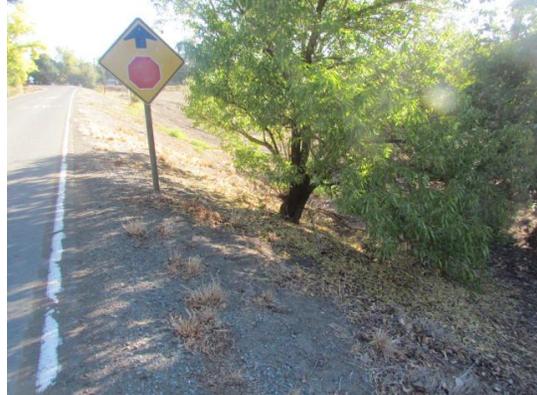
Photo 1 of 1 : FA_2014_RD0563_210_59_20141010_00165.jpg

Looking north at untrimmed tree on landward toe.

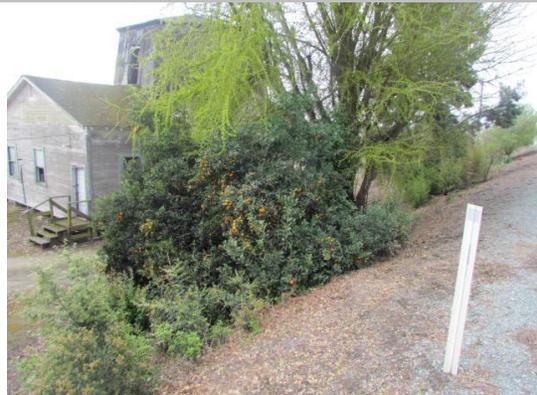
Photo 2 of 2 : FA_2014_RD0563_210_28_20141006_00033.jpg

Looking southeast at landscaping on landside slope and toe.

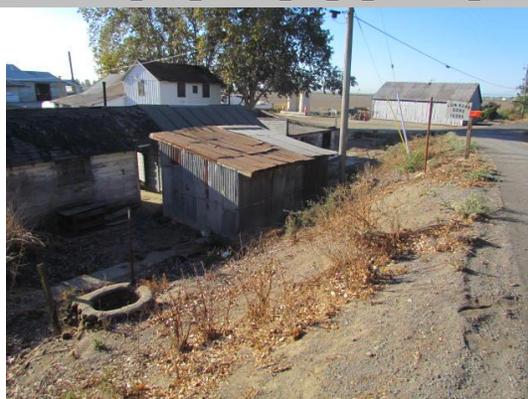
Photo 3 of 3 : FA_2014_RD0563_210_10_20141006_00014.jpg

Looking southeast at storage shed at landward toe.

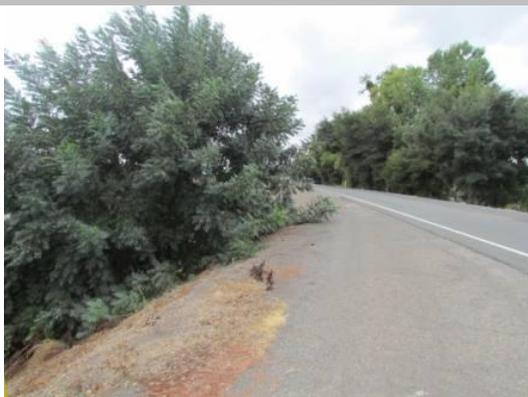
Photo 1 of 1 : FA_2014_RD0563_210_18_20141006_00023.jpg

Looking southwest at overgrown trees on landside slope.

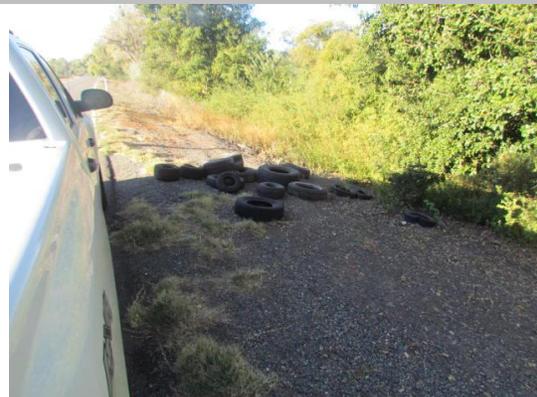
Photo 1 of 2 : FA_2014_RD0563_210_139_20141010_00166.jpg

Looking south at tires dumped on waterward slope.

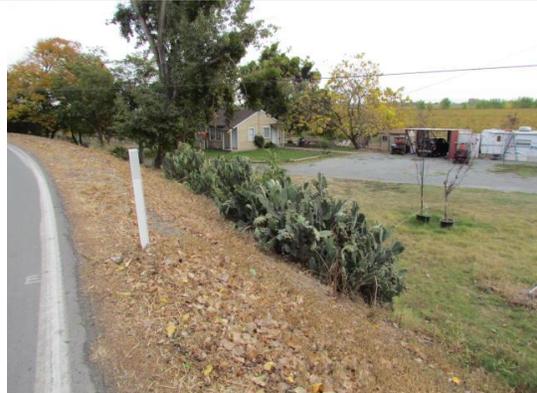
Photo 1 of 1 : FA_2014_RD0563_210_61_20141006_00068.jpg

Looking northwest at cactus along landside toe.

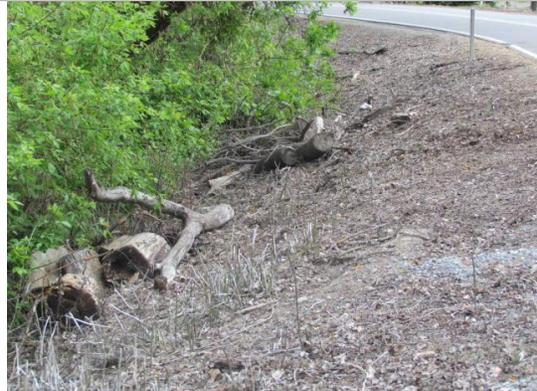
Photo 1 of 2 : FA_2014_RD0563_210_9_20141006_00010.jpg

LM Start	0.86	Rating **	M	Issue No.	9
LM End	0.86	Issue Type +	Ma	Location *	WS
Category	Earthen Levee		GPS Latitude/Longitude		
			Start	End	
Item	Encroachments		38.225685 °	38.225685 °	
			-121.526288 °	-121.526288 °	
DWR ID	DWR_RD0563_01_s_2012_9				
Action/Comments					
Prunings Inspector Comments: Prunings on waterside slope should be burned or removed.

Looking northeast at tree limbs on waterward slope.

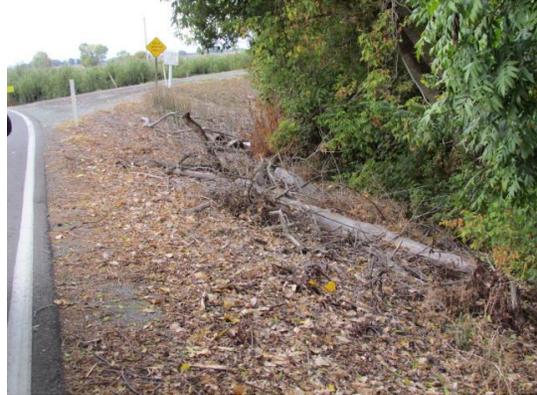
Photo 2 of 2 : FA_2014_RD0563_210_9_20141006_00011.jpg

LM Start	0.86	Rating **	M	Issue No.	9 (cont)
LM End	0.86	Issue Type +	Ma	Location *	WS
Category	Earthen Levee		GPS Latitude/Longitude		
			Start	End	
Item	Encroachments		38.225685 °	38.225685 °	
			-121.526288 °	-121.526288 °	
DWR ID	DWR_RD0563_01_s_2012_9				
Action/Comments					
Prunings Inspector Comments: Prunings on waterside slope should be burned or removed.

Looking southwest at tree limbs on waterside slope.

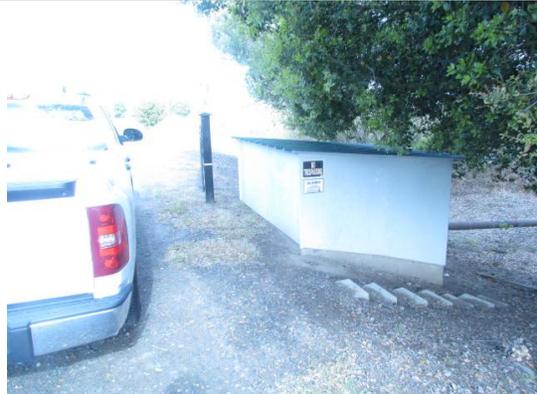
Photo 1 of 1 : FA_2014_RD0563_210_13_20141006_00018.jpg

Looking south at pump shed on waterside slope and gate across levee crown.

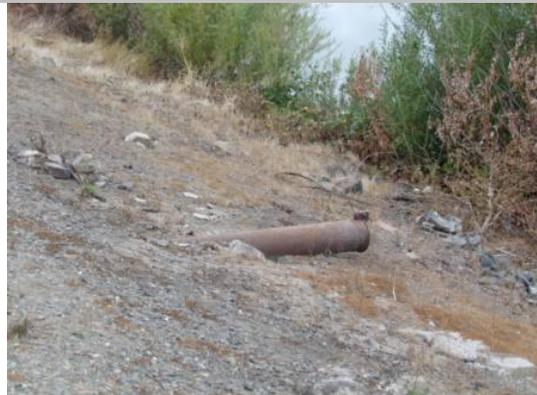
Photo 2 of 2 : FA_2014_RD0563_210_937_20141006_00136.jpg

Looking southwest at pipe on waterside slope.

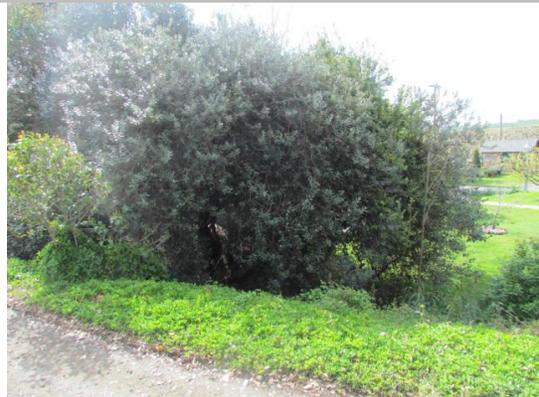
Photo 1 of 1 : FA_2014_RD0563_210_54_20141006_00052.jpg

Looking east at landscaping on landside slope.

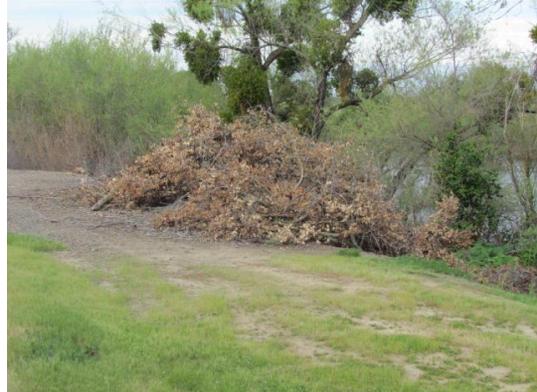
Photo 1 of 1 : FA_2014_RD0563_210_69_20141006_00075.jpg

LM Start	1.21	Rating **	M	Issue No.	69
LM End	1.21	Issue Type +	En	Location *	WS
Category	Earthen Levee		GPS Latitude/Longitude		
			Start	End	
Item	Encroachments		38.226748 °	38.226748 °	
			-121.531756 °	-121.531756 °	
DWR ID	DWR_RD0563_01_f_2013_69				
Action/Comments					
Prunings Inspector Comments: Pruning pile should be burned or removed from waterward slope.

Looking west at pruning pile on waterward slope.

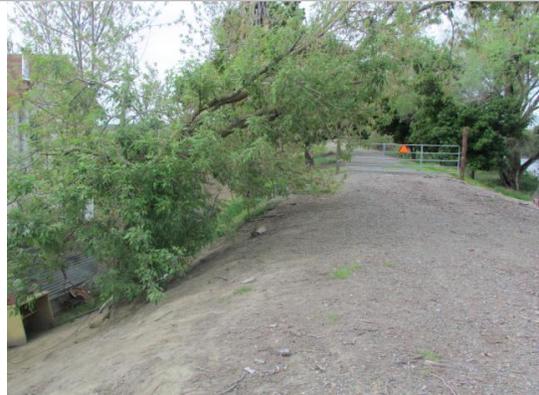
Photo 1 of 1 : FA_2014_RD0563_210_5_20141006_00004.jpg

Looking south at untrimmed trees on landward slope.

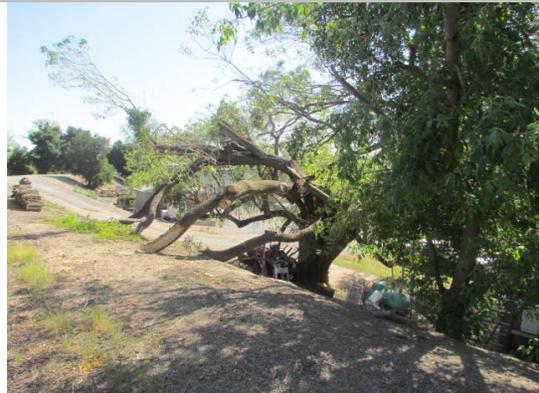
Photo 1 of 1 : FA_2014_RD0563_210_103_20141006_00124.jpg

LM Start	1.25	Rating **	A/W	Issue No.	103
LM End	1.25	Issue Type +	Ma	Location *	LS
Category	Earthen Levee		GPS Latitude/Longitude		
			Start	End	
Item	Encroachments				
DWR ID	DWR_RD0563_01_s_2013_103				
Action/Comments					
Tree or limb Inspector Comments: Broken tree branches on landward slope.

Looking northeast at broken tree branch on landward slope.

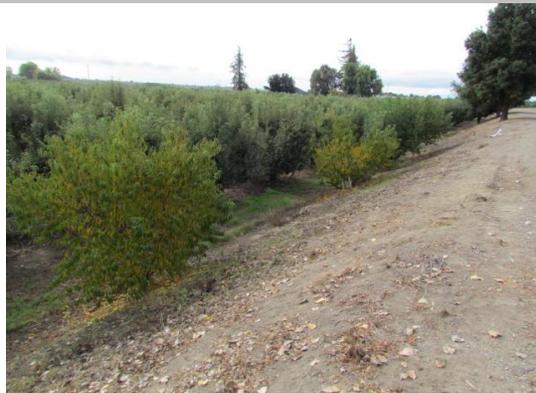
Photo 1 of 1 : FA_2014_RD0563_210_64_20141006_00071.jpg

Looking southeast at fruit trees on landside toe.

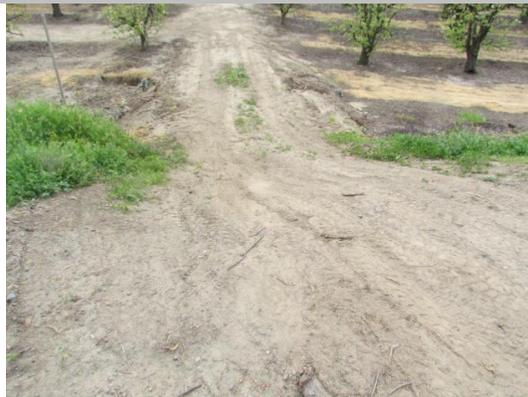
Photo 2 of 2 : FA_2014_RD0563_210_141_20141006_00129.jpg

Looking east at ramp on landward slope.

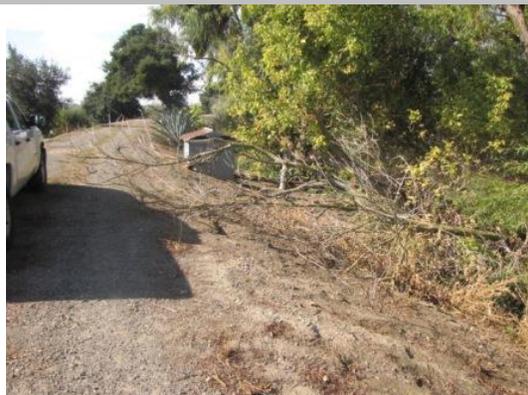
Photo 1 of 1 : FA_2014_RD0563_210_19_20141006_00024.jpg

LM Start	1.42	Rating **	A/W	Issue No.	19
LM End	1.42	Issue Type +	Ma	Location *	WS
Category	Earthen Levee		GPS Latitude/Longitude		
			Start	End	
Item	Encroachments		38.224367 °	38.224367 °	
			-121.534165 °	-121.534165 °	
DWR ID	DWR_RD0563_01_s_2012_19				
Action/Comments					
Tree or limb Inspector Comments: Broken tree along waterside slope.

Looking south at a downed tree on waterside slope.

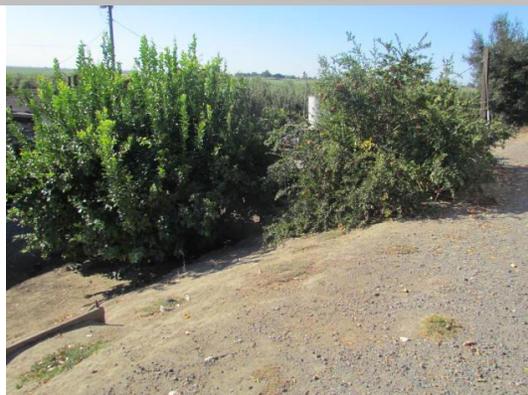
Photo 1 of 2 : FA_2014_RD0563_210_86_20141006_00102.jpg

Looking southeast at dense landscaping on the landward slope.

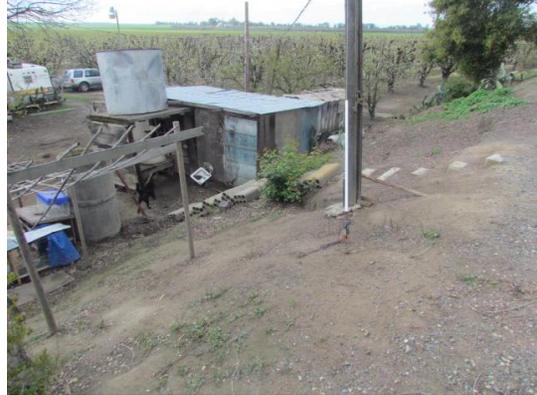
Photo 3 of 3 : FA_2014_RD0563_210_8_20141006_00009.jpg

Looking southeast at a tool shed at the landside toe.

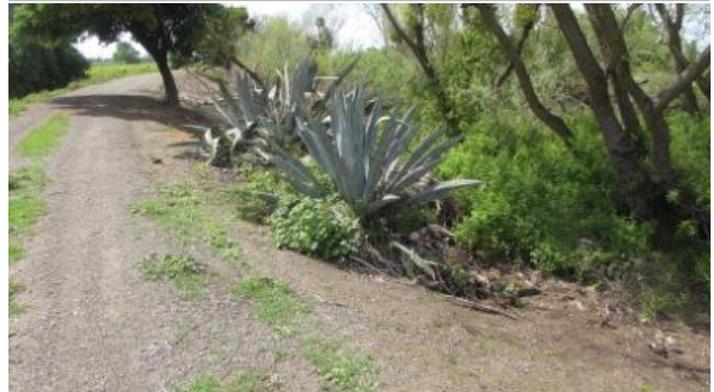
Photo 1 of 2 : FA_2014_RD0563_210_6_20141006_00005.jpg

Updated view looking upstream at a century plant on waterside shoulder slope.

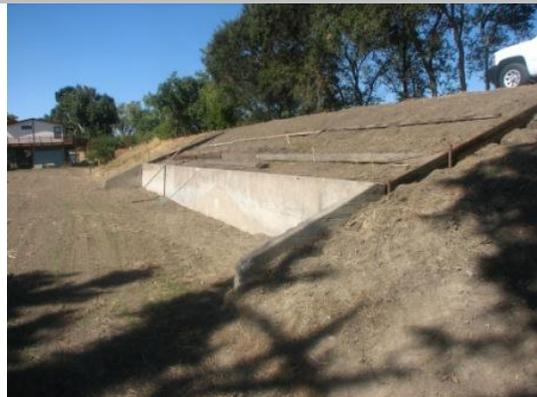
Photo 1 of 12 : FA_2014_RD0563_210_60_20141006_00056.jpg

Unauthorized retaining wall on landside toe.

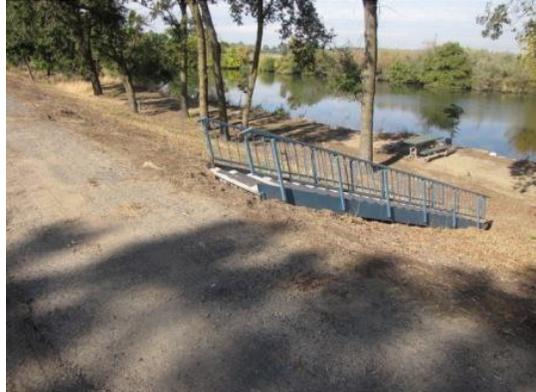
Photo 4 of 12 : FA_2014_RD0563_210_60_20141006_00059.jpg

Looking west at metal stairs on waterside slope.

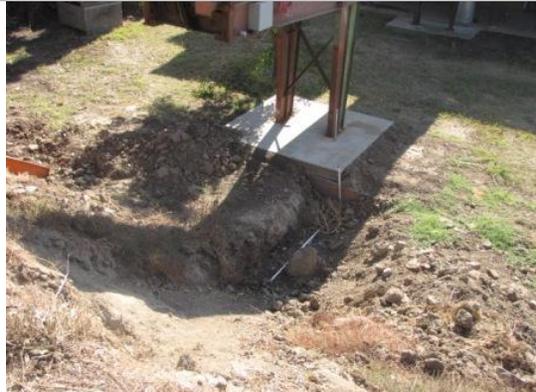
Photo 7 of 12 : FA_2014_RD0563_210_60_20141006_00062.jpg

Looking east at electrical conduit in trench on landside toe and concrete pad for walkway.

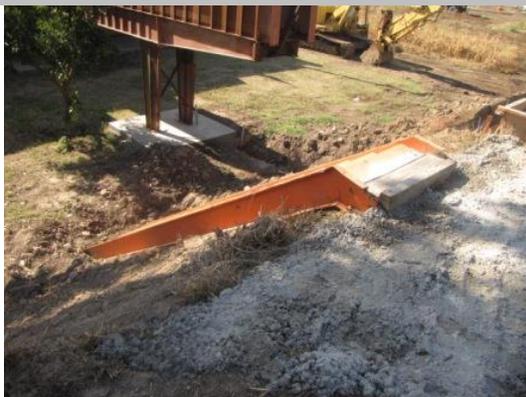
Photo 10 of 12 : FA_2014_RD0563_210_60_20141006_00065.jpg

Looking southeast at temporary metal stairs on landside slope.

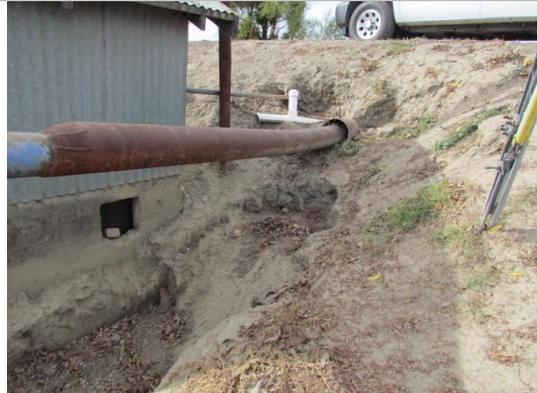
Photo 1 of 2 : FA_2014_RD0563_210_71_20141006_00076.jpg

Looking west at erosion at landside toe and slope next to pump house.

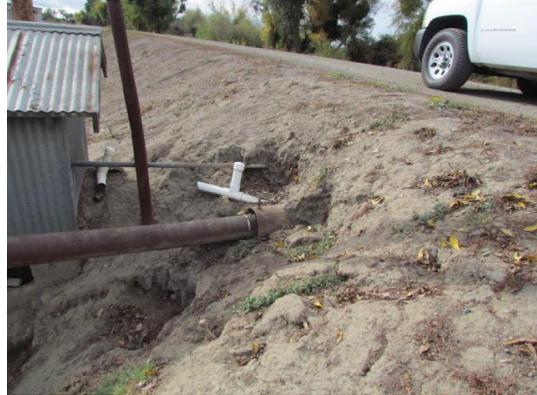
Photo 2 of 2 : FA_2014_RD0563_210_71_20141006_00077.jpg

Looking southwest at erosion around irrigation pipe on landside slope and toe.

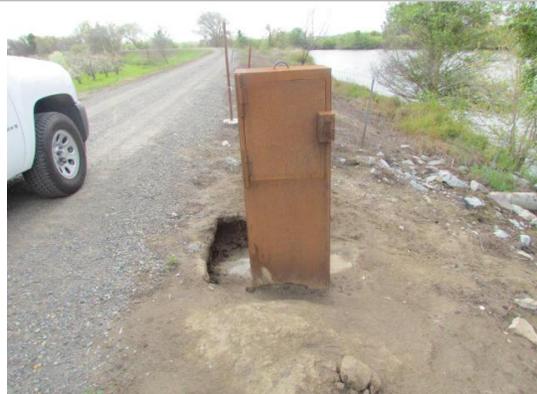
Photo 1 of 1 : FA_2014_RD0563_210_15_20141006_00019.jpg

Looking south at siphon box installed on waterside shoulder.

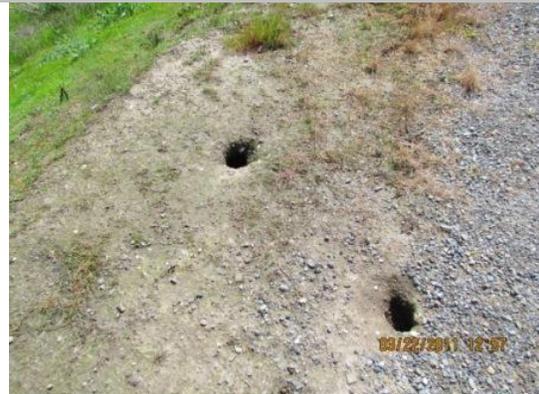
Photo 1 of 1 : FA_2014_RD0563_210_33_20141006_00035.jpg

Looking southeast at squirrel holes on landside shoulder.

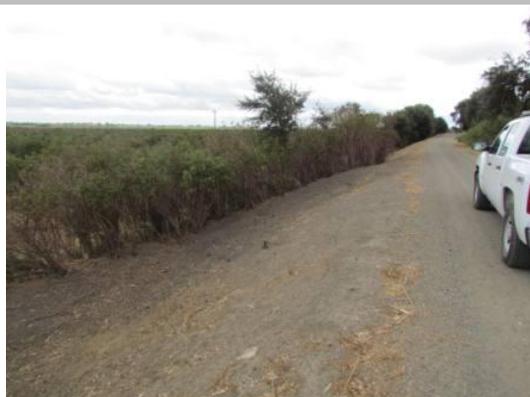
Photo 1 of 2 : FA_2014_RD0563_210_11_20141006_00015.jpg

Look southeast at updated (10/11) view of elderberries on landside slope.

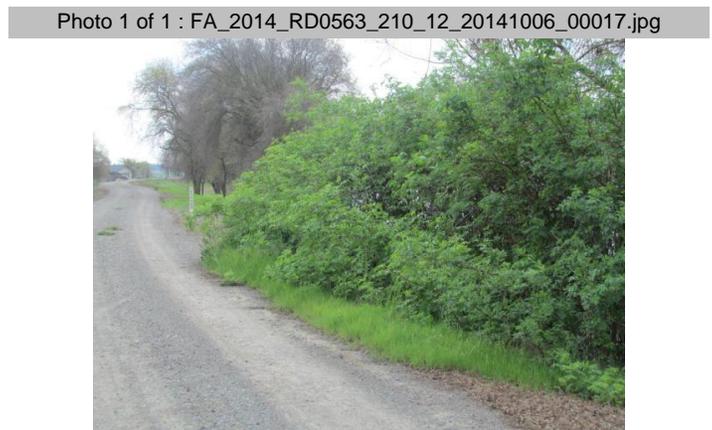
LM Start	2.46	Rating **	M	Issue No.	12
LM End	2.46	Issue Type +	Ma	Location *	WS
Category	Earthen Levee		GPS Latitude/Longitude		
			Start	End	
Item	Vegetation		38.216122 °	38.216047 °	
			-121.540555 °	-121.540415 °	
DWR ID	DWR_RD0563_01_s_2012_12				
Action/Comments					
Elderberries are blocking visibility and flood fight capability.

Looking southwest at dense elderberry brush on waterside shoulder and slope.

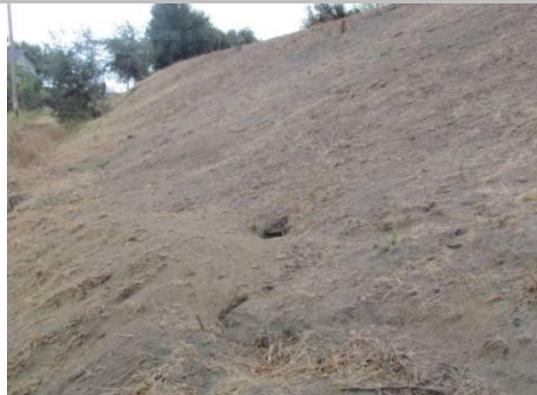
Photo 3 of 4 : FA_2014_RD0563_210_85_20141006_00100.jpg

Looking southwest at rodent holes on landside slope.

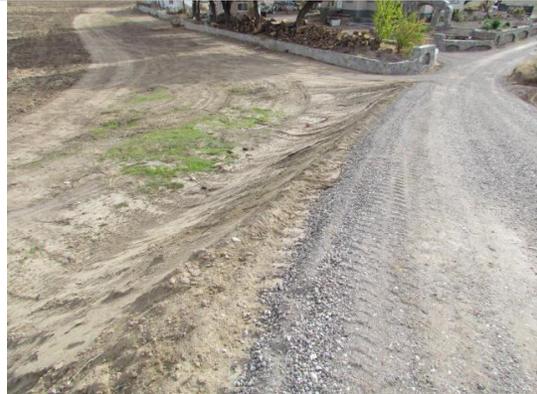
Photo 1 of 2 : FA_2014_RD0563_210_80_20141006_00092.jpg

Looking east at unauthorized ramp on landside slope.

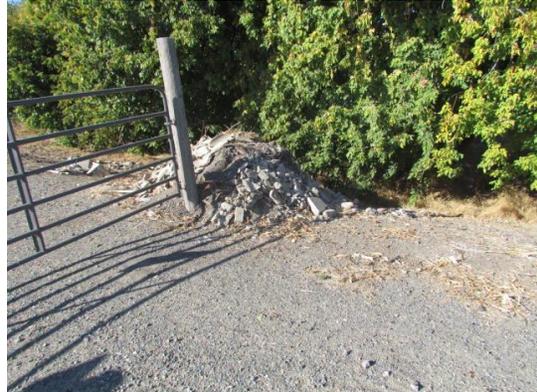
Photo 1 of 2 : FA_2014_RD0563_210_104_20141006_00125.jpg

Looking west at concrete rubble on waterward shoulder and slope.

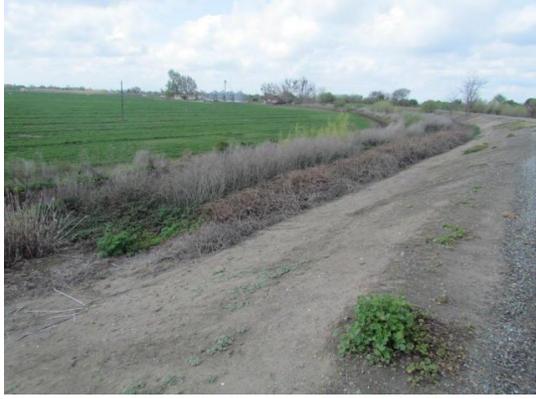
Photo 1 of 2 : FA_2014_RD0563_210_74_20141006_00081.jpg

Looking southeast at dead berryvine on landside toe.

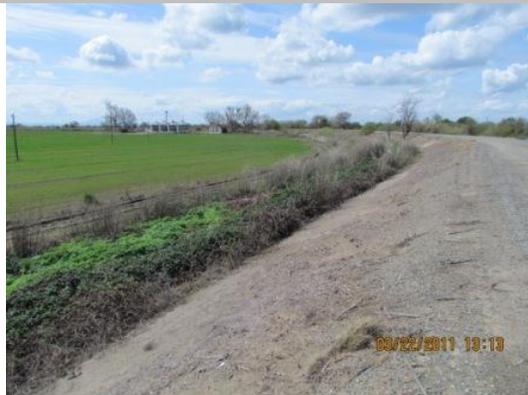
Photo 2 of 2 : FA_2014_RD0563_210_74_20141006_00082.jpg

Looking southeast at berryvines on landside toe.

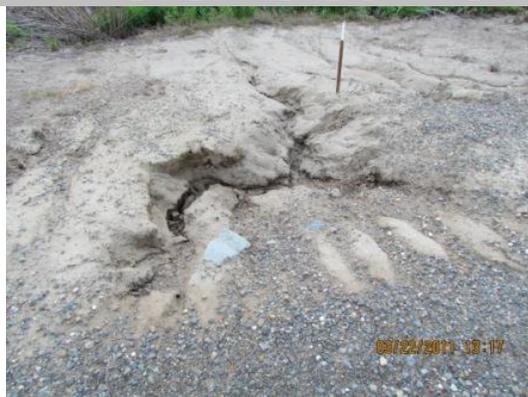
Photo 1 of 4 : FA_2014_RD0563_210_78_20141006_00088.jpg

Looking east at slope erosion cause by runoff on landside slope.

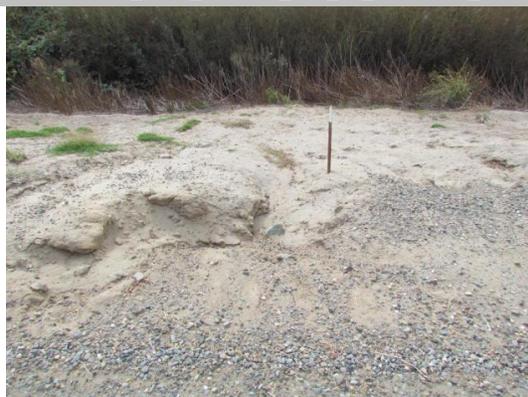
Photo 2 of 4 : FA_2014_RD0563_210_78_20141006_00089.jpg

Looking east at slope damage on 10/31/2012, no change in status.

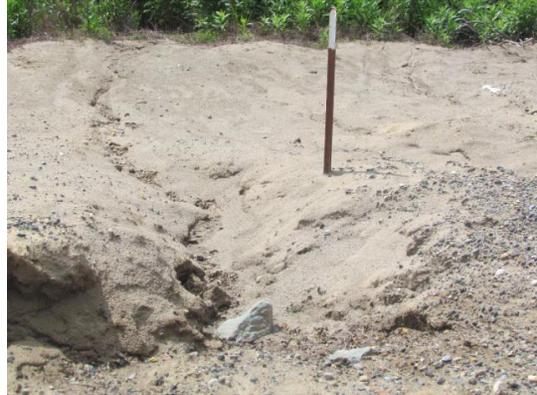
Photo 3 of 4 : FA_2014_RD0563_210_78_20141006_00090.jpg

Looking east at slope erosion. (Updated Spring 2012)

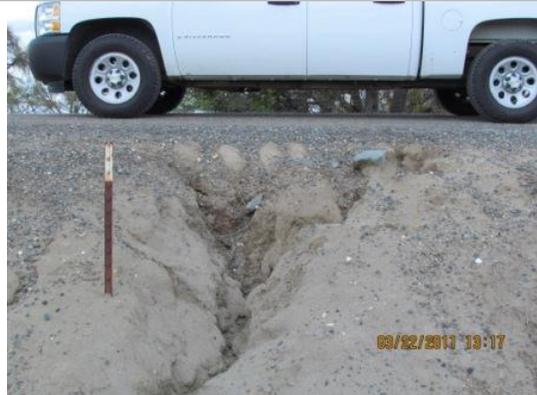
Photo 4 of 4 : FA_2014_RD0563_210_78_20141006_00091.jpg

Looking west at slope erosion cause by runoff on landside slope.

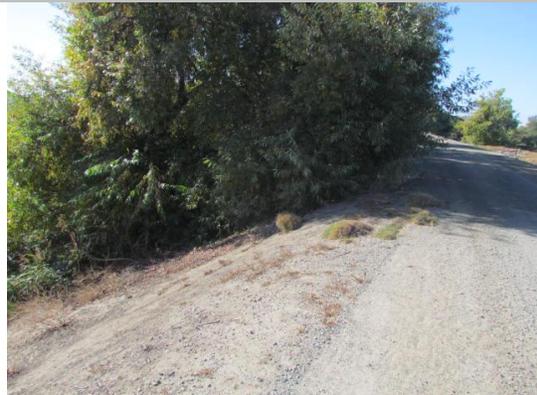
Photo 1 of 2 : FA_2014_RD0563_210_68_20141006_00073.jpg

Looking south at dense trees on landward slope.

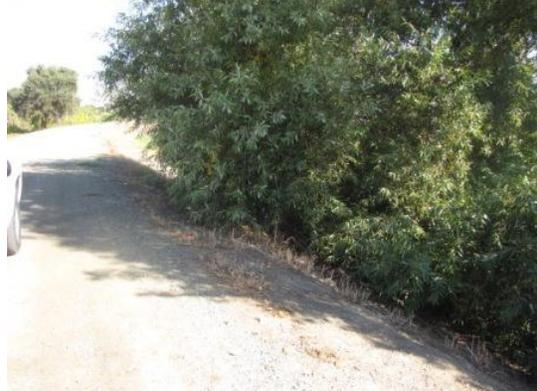
Photo 2 of 2 : FA_2014_RD0563_210_68_20141006_00074.jpg

Looking southeast at dense trees on landside slope and toe.

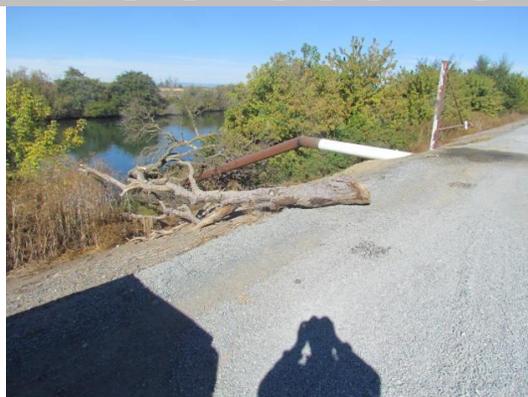
Photo 1 of 1 : FA_2014_RD0563_210_150_20141010_00171.jpg

Looking northwest at tree branch on waterward shoulder.

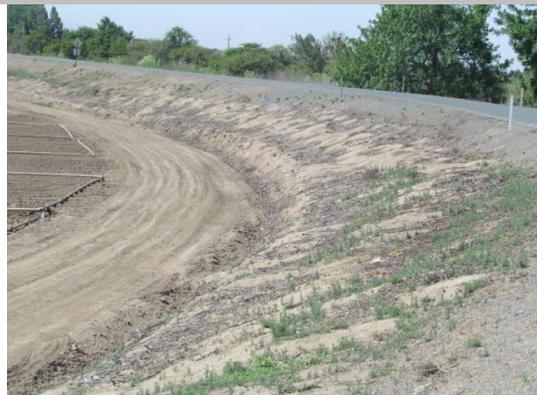
Photo 2 of 2 : FA_2014_RD0563_210_17_20141006_00022.jpg

Looking southwest at irrigation ditch on landward toe.

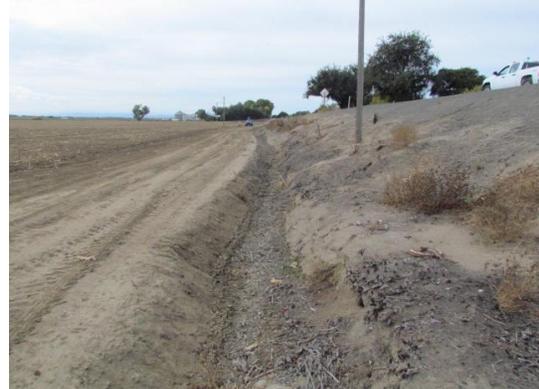
Photo 1 of 1 : FA_2014_RD0563_210_93_20141006_00113.jpg

Looking south at irrigation ditch at landside toe.

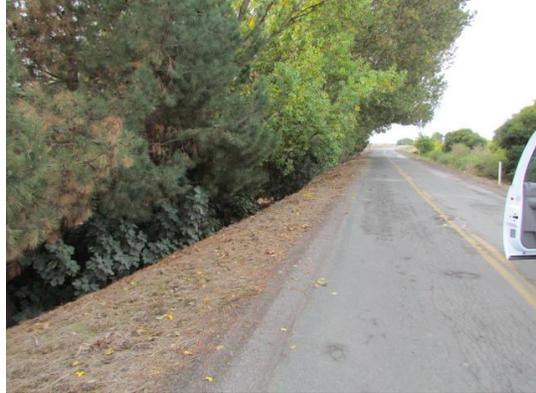
Photo 1 of 1 : FA_2014_RD0563_210_88_20141006_00104.jpg

Looking south at dense trees on landside slope and toe.

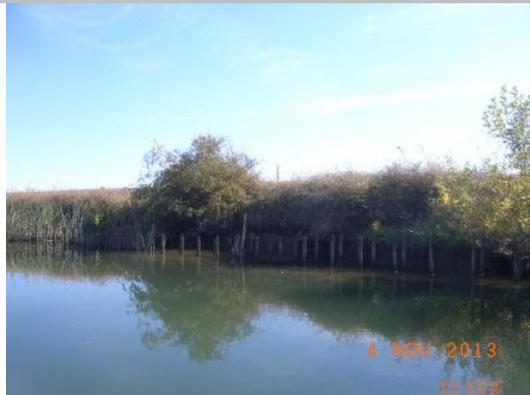
Photo 1 of 1 : FA_2014_RD0563_210_46_20141006_00045.jpg

Action/Comments
 Inspector Comments: 1997 - Deep pockets of erosion and narrow berm. Reach is characterized by lots of pockets into the existing berm and/or levee slope. 1999 - Some pockets filled with rock riprap. 2000 - Exposed fabric. 2001 - Staked, low fascine walls at bankline. 2002 - New spot of rock at upstream end. Some new brush boxes. 2005 - Some stone sliding off the underlying geotextile fabric. Some new brush bundles in the brush boxes; some with missing bundles. Some boxes too low relative to high tide. 2009 - Minimal new erosion, site length extended. 2010 - New erosion on downstream end, site extended downstream. 2011 - Sites 6.1, 6.4 and 6.6 were combined. New erosion pockets, site extended to include the erosion in between the old sites. 2012 - Rock has been placed in portions of the bank since last year. 2013: No observed changes. [2013 Site ID: GEO_6-3_L]

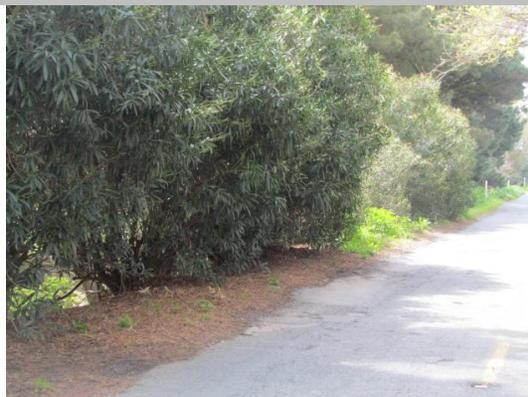
Photo 1 of 1 : FA_2014_RD0563_210_25_20141006_00028.jpg

Looking southeast at dense landscaping on landside shoulder and slope.

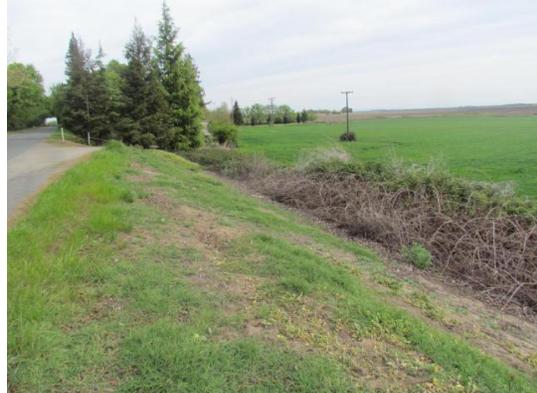
Photo 2 of 2 : FA_2014_RD0563_210_145_20141006_00133.jpg

Looking north at dense dead berryvines at landward toe.

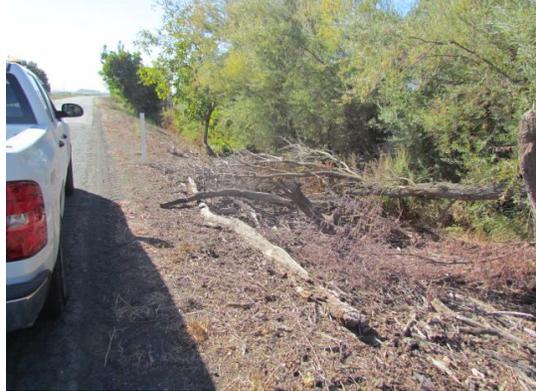
Photo 1 of 1 : FA_2014_RD0563_210_82_20141006_00094.jpg

Looking south at tree limbs on waterward slope.

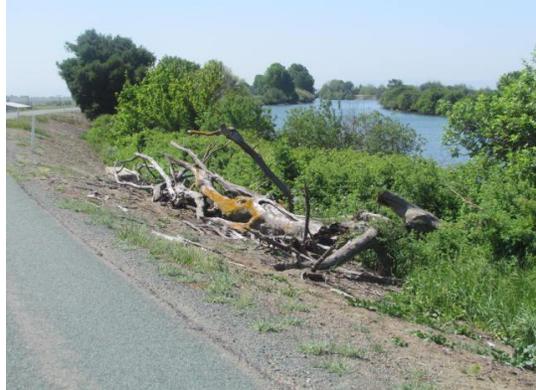
Photo 1 of 1 : FA_2014_RD0563_210_95_20141006_00114.jpg

Looking southwest at prunings on waterward slope.

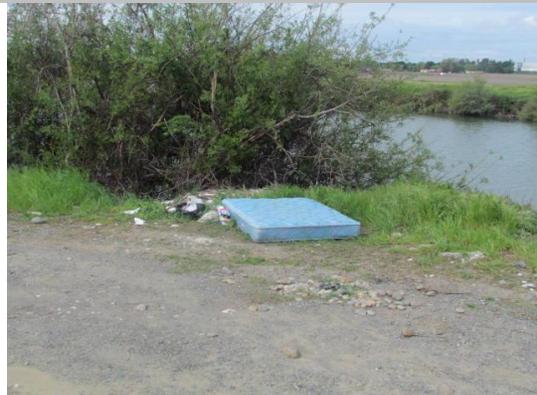
Photo 1 of 1 : FA_2014_RD0563_210_146_20141006_00134.jpg

Looking west at garbage on waterward slope and toe.

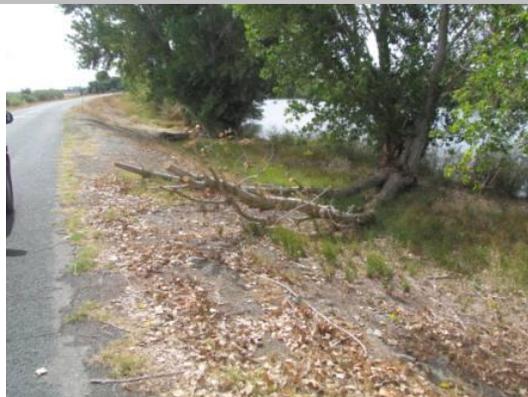
Photo 1 of 1 : FA_2014_RD0563_210_89_20141006_00105.jpg

Looking southwest at downed limbs on waterside slope.

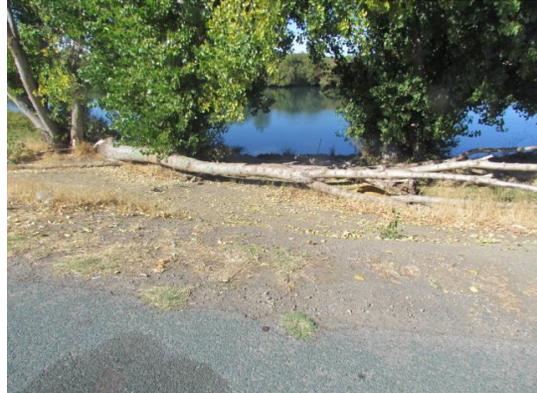
Photo 1 of 1 : FA_2014_RD0563_210_152_20141010_00172.jpg

Looking west at tree branch on waterward slope.

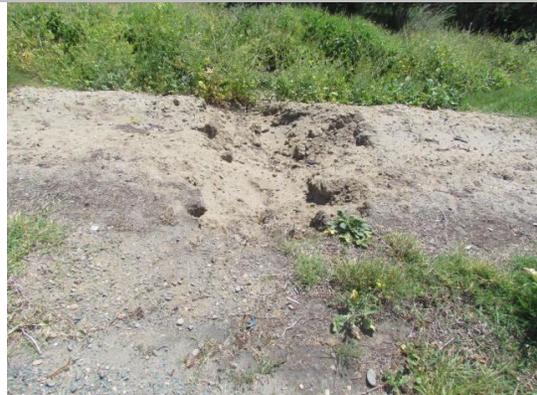
Photo 1 of 1 : FA_2014_RD0563_210_97_20141006_00119.jpg

Looking east at slope erosion on landward shoulder and slope.

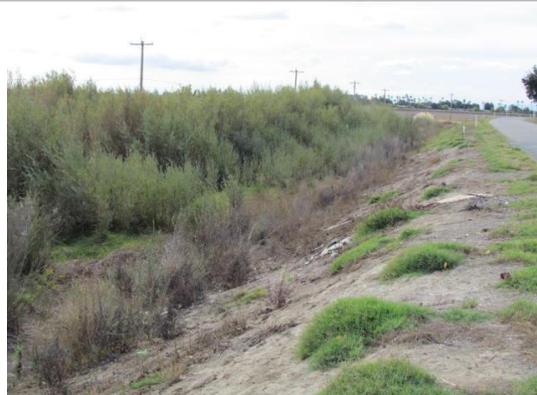
Photo 2 of 4 : FA_2014_RD0563_210_90_20141006_00107.jpg

Looking south at dense vegetation on landside toe. (2012 Fall)

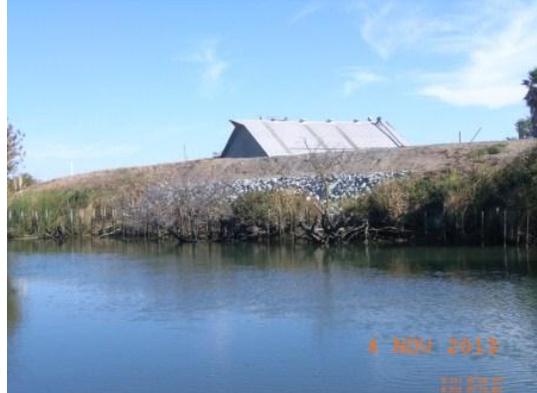
Photo 1 of 1 : FA_2014_RD0563_210_41_20141006_00040.jpg

Action/Comments
 Inspector Comments: 1997 - Pockets of erosion into the levee at the water line. Alders are being undercut and rotating out into the channel. Damaged rock at upstream end. 2000 - New minor erosion. 2001 - Staked low fascine walls at bankline. 2002 - New "Brush Boxes" along the bank toe. 2003 - New erosion pockets in the middle of the site. 2005 - Some new bundles in the brush boxes. 2011 - Site upgraded to CRITICAL. Significant new erosion. Sites 3.6, 3.7, 3.71, and 4.0 were combined. 2012 - Rock has been placed in some of the erosion pockets since last year, however site remains critical. 2013: Site no longer critical. The worst pockets were filled with rock by the local RD. [2013 Site ID: GEO_3-8_L]

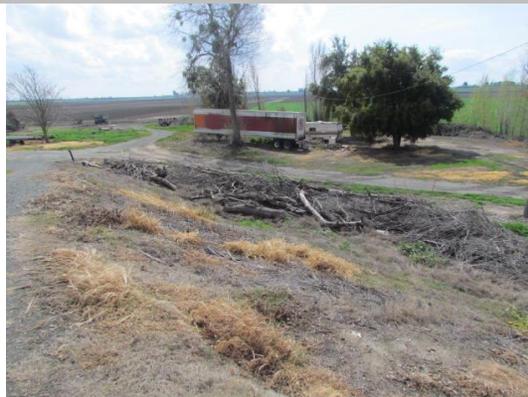
Photo 2 of 2 : FA_2014_RD0563_210_73_20141006_00080.jpg

Looking east at prunings on landside slope and toe.

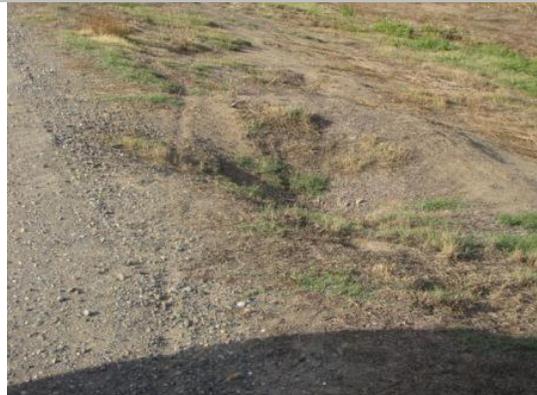
Photo 1 of 4 : FA_2014_RD0563_210_76_20141006_00083.jpg

Looking northeast a depression on landside shoulder and slope above 10" irrigation pipe four feet below crown.

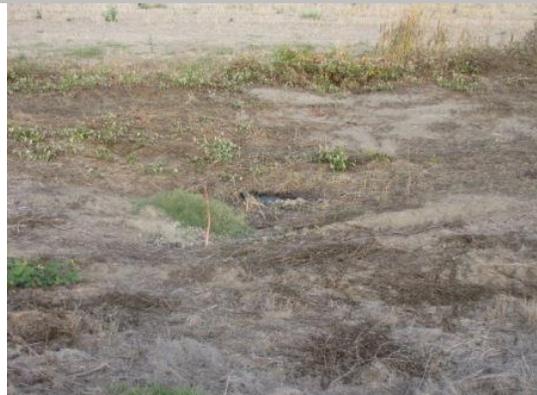
Photo 2 of 4 : FA_2014_RD0563_210_76_20141006_00084.jpg

Looking east at water ponding at landside toe just above 10" irrigation pipe.

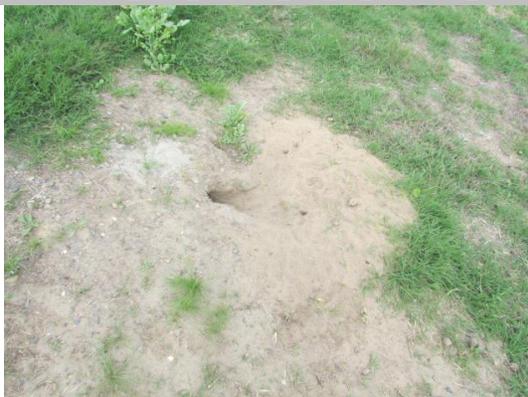
Photo 1 of 1 : FA_2014_RD0563_210_77_20141006_00087.jpg

Looking at typical rodent holes on landward slope.

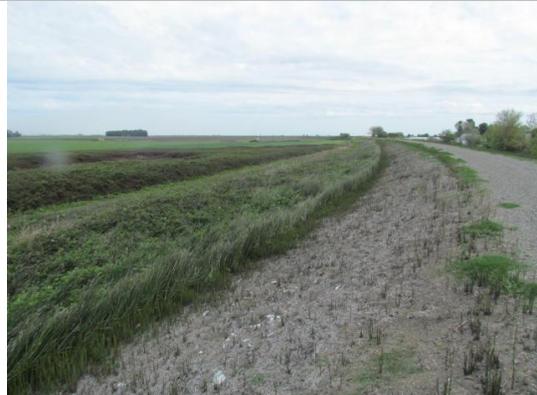
Photo 1 of 2 : FA_2014_RD0563_210_100_20141006_00122.jpg

Looking south at additional dense vegetation at landward toe.

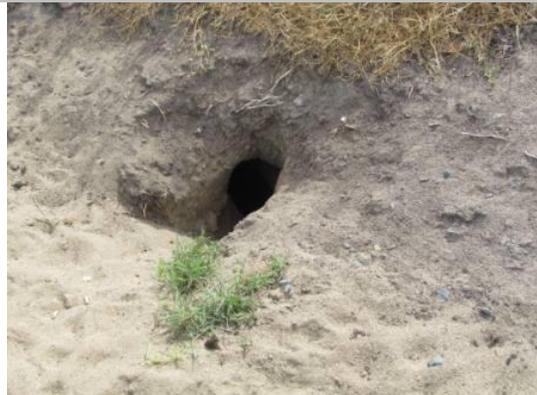
Photo 2 of 3 : FA_2014_RD0563_210_91_20141006_00111.jpg

Looking west at rodent hole on landside slope.
