**Flood Control Project Maintenance
Levee Inspections**
LMA District Cover Sheet
Spring 2011 Levee Inspection Results

Reclamation District No. 0563 Tyler Island

Levee Inspection Report By Mile - Spring 2011

Waterway	Bank	Unit Miles	Inspection Start/End	Inspector
Unit No. 01 Georgiana Slough (Tyler Island)	Left	12.38	03/22/2011 03/28/2011	Richard Willoughby

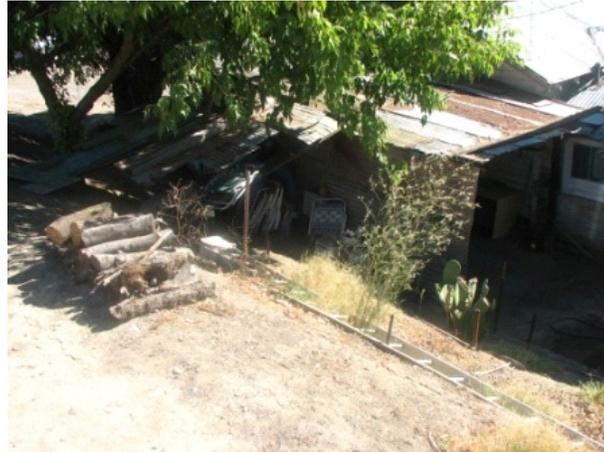
Levee Mile Report Line	17
Start Levee Mile	1.42
End Levee Mile	1.42
Location	Water Side
Category	Earthen Levee
Item	Encroachments

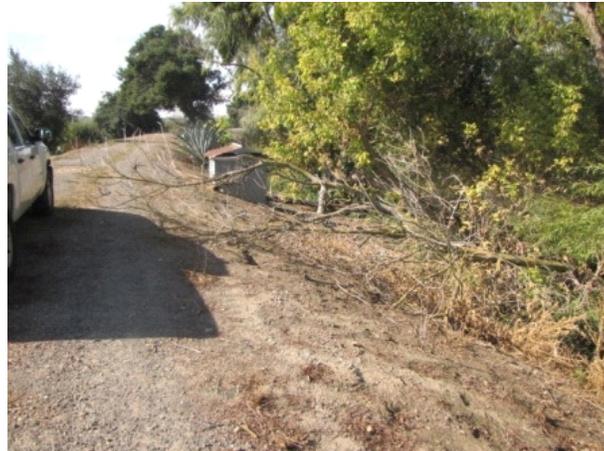
Levee Mile Report Line	18
Start Levee Mile	1.44
End Levee Mile	1.48
Location	Water Side
Category	Earthen Levee
Item	Vegetation

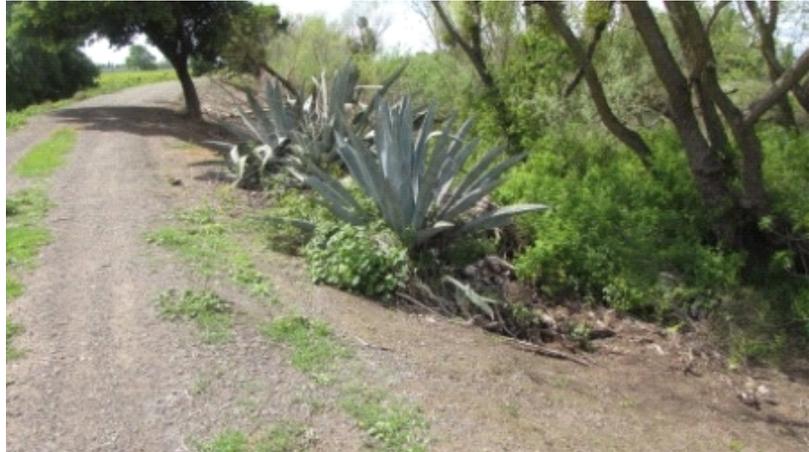
LMR No.	Levee Mile		Category	Item	Location	Rating	Action/Comment	GPS Latitude/Longitude		Issue No. Photo
	Start	End						Start	End	
19	1.45	1.45	Earthen Levee	Encroachments	WS	M	Tree or limb Inspector Comments: Down tree across waterside slope.	38.224147 ° -121.534610 °	38.224147 ° -121.534610 °	24 Y
20	1.46	1.46	Earthen Levee	Encroachments	WS	M	Tree or limb Inspector Comments: Tree limb down.	38.224092 ° -121.534717 °	38.224092 ° -121.534717 °	8 Y
21	1.47	1.47	Earthen Levee	Trim / Thin Trees	LS	M	Trim trees to at least five feet above ground level.	38.224072 ° -121.534827 °	38.224072 ° -121.534827 °	30
22	1.54	1.54	Earthen Levee	Trim / Thin Trees	LS	W	Trim trees to at least five feet above ground level.	38.223700 ° -121.536157 °	38.223700 ° -121.536157 °	52
23	1.63	1.63	Earthen Levee	Trim / Thin Trees	LS	W	Trim trees to at least five feet above ground level.	38.223332 ° -121.537635 °	38.223332 ° -121.537635 °	56

Levee Mile Report Line	19
Start Levee Mile	1.45
End Levee Mile	1.45
Location	Water Side
Category	Earthen Levee
Item	Encroachments
Looking south at down tree on waterside slope.	
richard_s_20110215_249.jpg

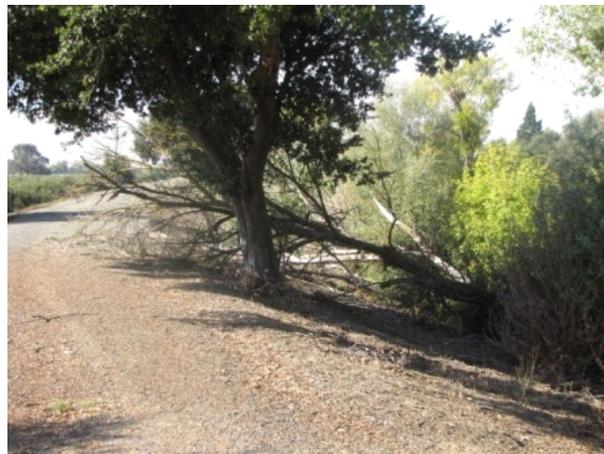
Levee Mile Report Line	20
Start Levee Mile	1.46
End Levee Mile	1.46
Location	Water Side
Category	Earthen Levee
Item	Encroachments
Looking at tree limb on waterside slope.	
richard_s_20110215_236.jpg

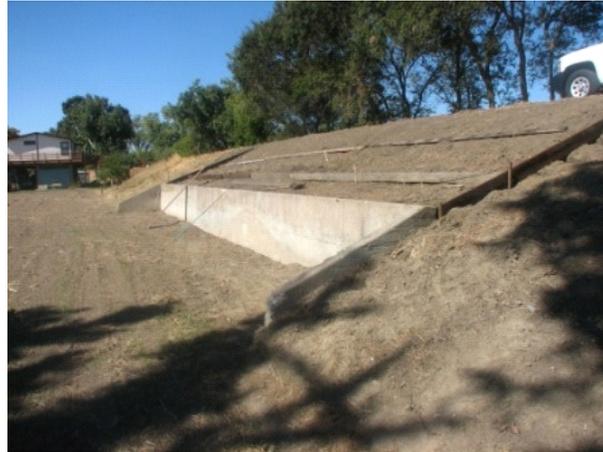
24	1.86	1.86	Earthen Levee	Encroachments	LS	U	Stairways Inspector Comments: Landowner has built pad on landside shoulder 60' x 15' for metal walkway leading from house to pad with a concrete deadman. Also install an temporary stairway on landside slope and stairway on waterside slope. Electrical conduit on landside toe.	38.222702 ° -121.541678 °	38.222702 ° -121.541678 °	60 Y
25	1.94	1.94	Earthen Levee	Encroachments	WS	PO	Buildings Inspector Comments: Landowner has built shed on waterside berm.	38.222655 ° -121.543068 °	38.222655 ° -121.543068 °	15 Y
26	1.96	1.98	Earthen Levee	Encroachments	LS	M	Equipment Inspector Comments: Material and equipment at landside toe.	38.222370 ° -121.543297 °	38.222101 ° -121.543409 °	10 Y
27	2.24	2.24	Earthen Levee	Animal Control	WS	M	Exterminate rodents and backfill and compact or grout burrows.	38.218494 ° -121.542646 °	38.218494 ° -121.542646 °	14
28	2.24	2.24	Earthen Levee	Animal Control	LS	M	Exterminate rodents and backfill and compact or grout burrows. Inspector Comments: Rodent holes on landside shoulder.	38.218463 ° -121.542650 °	38.218463 ° -121.542650 °	33 Y

Levee Mile Report Line	24
Start Levee Mile	1.86
End Levee Mile	1.86
Location	Land Side
Category	Earthen Levee
Item	Encroachments
Looking southeast at top of retaining wall.	
richard_s_20110215_267.jpg

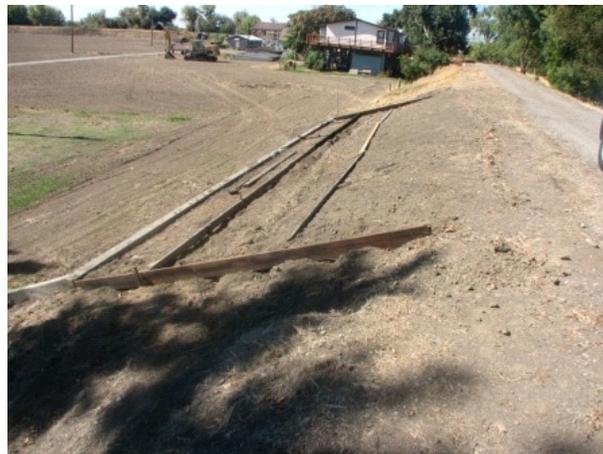
Levee Mile Report Line	24
Start Levee Mile	1.86
End Levee Mile	1.86
Location	Land Side
Category	Earthen Levee
Item	Encroachments
Looking southeast at earthen pad on landside shoulder covering retaining wall.	
richard_s_20110215_268.jpg

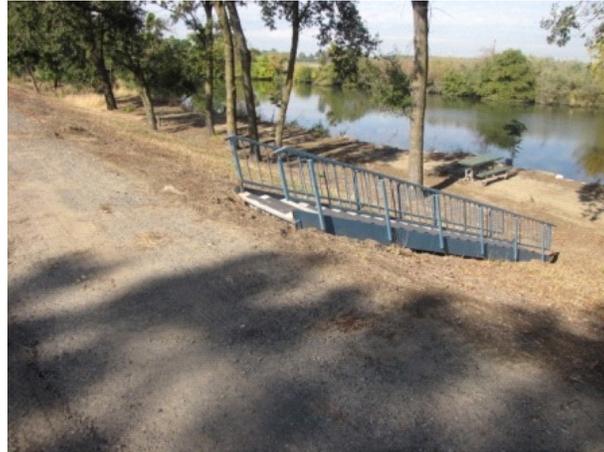
Levee Mile Report Line	24
Start Levee Mile	1.86
End Levee Mile	1.86
Location	Land Side
Category	Earthen Levee
Item	Encroachments
Looking northeast metal walkway on landside of levee.	
richard_s_20110215_270.jpg

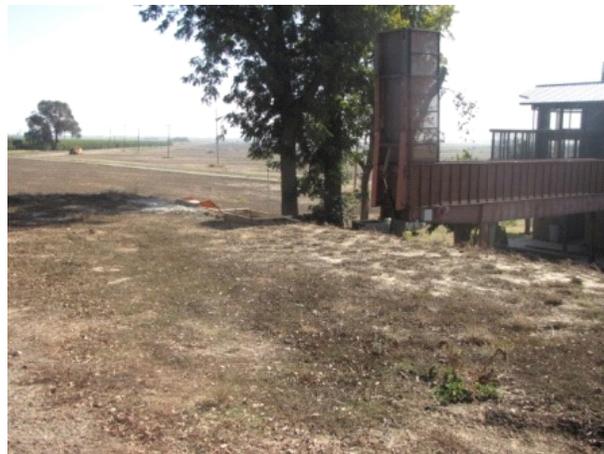
Levee Mile Report Line	24
Start Levee Mile	1.86
End Levee Mile	1.86
Location	Land Side
Category	Earthen Levee
Item	Encroachments
Looking north at deadman for metal walkway on earthen pad on landside shoulder.	
richard_s_20110215_271.jpg

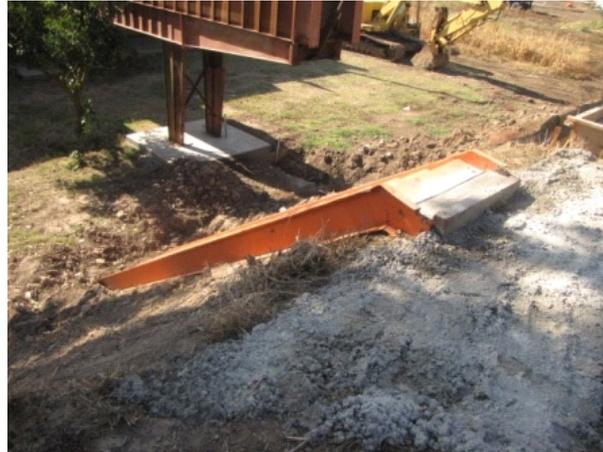
Levee Mile Report Line	24
Start Levee Mile	1.86
End Levee Mile	1.86
Location	Land Side
Category	Earthen Levee
Item	Encroachments
Looking southeast at framing for footings on landside shoulder.	
richard_s_20110330_461.jpg

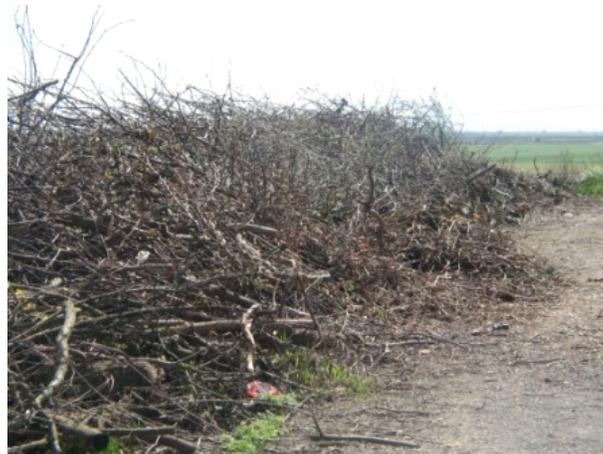
Levee Mile Report Line	38
Start Levee Mile	2.94
End Levee Mile	2.94
Location	Land Side
Category	Earthen Levee
Item	Encroachments
View looking upstream at pruning pile.	
richard_s_20110215_242.jpg

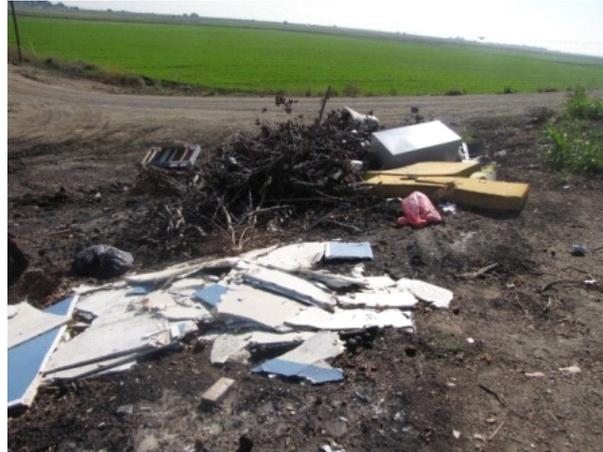
Levee Mile Report Line	38
Start Levee Mile	2.94
End Levee Mile	2.94
Location	Land Side
Category	Earthen Levee
Item	Encroachments
Looking southeast at garbage on landside shoulder as of 03/22/11	
richard_s_20110330_465.jpg

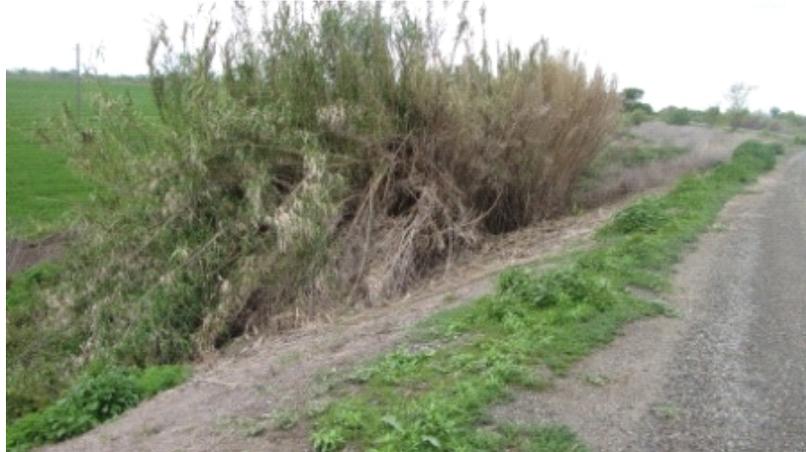
Levee Mile Report Line	40
Start Levee Mile	3.06
End Levee Mile	3.12
Location	Land Side
Category	Earthen Levee
Item	Vegetation
Looking southeast after bamboo has been removed. Great Job!!	
richard_s_20110330_466.jpg

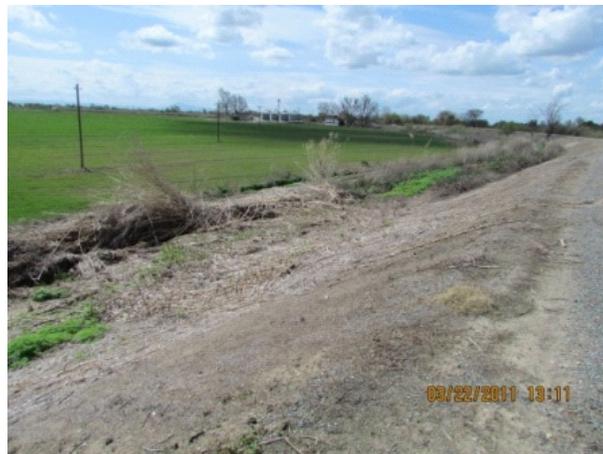
Levee Mile Report Line	41
Start Levee Mile	3.09
End Levee Mile	3.13
Location	Land Side
Category	Earthen Levee
Item	Vegetation
Looking southeast at berryvines on landside toe.	
richard_s_20110330_467.jpg

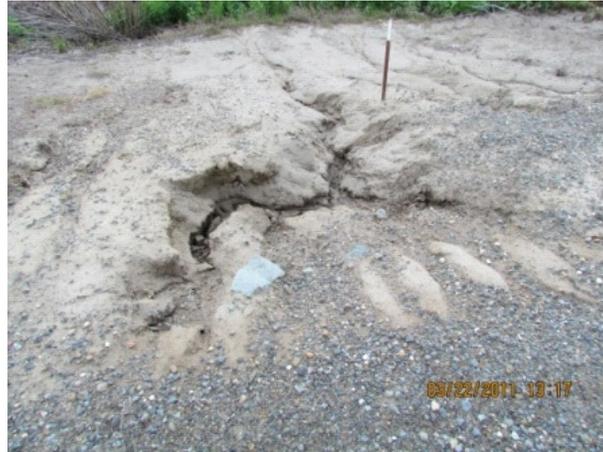
Levee Mile Report Line	42
Start Levee Mile	3.13
End Levee Mile	3.13
Location	Land Side
Category	Earthen Levee
Item	Slope Stability
Looking west at slope erosion cause by runoff on landside slope.	
richard_s_20110330_469.jpg

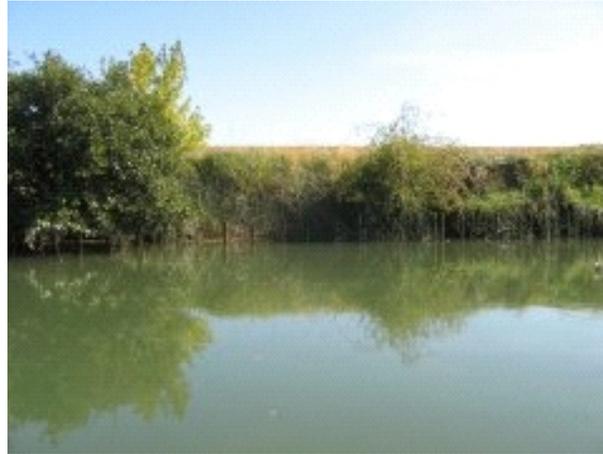
46	5.12	5.16	Supplemental	USACE Erosion Survey	WS	M	Inspector Comments: 2009: no berm, 2:1 slope, no stability issues, clays and silts, 3.71 ft/s [2009 SiteID:GEO_7-2_L]	38.189886 ° -121.556686 °	38.189522 ° -121.557228 °	43 Y
47	5.29	5.52	Supplemental	USACE Erosion Survey	WS	M	Inspector Comments: 2009: 10 ft berm, 1.5:1 slope, tree hazards and holes, clays and silts, 3.78 ft/s [2009 SiteID:GEO_6-8_L]	38.187975 ° -121.558844 °	38.186022 ° -121.561736 °	44 Y
48	6.03	6.03	Earthen Levee	Encroachments	LS	M	Garbage	38.182102 ° -121.569602 °	38.182102 ° -121.569602 °	69 Y

Levee Mile Report Line	46
Start Levee Mile	5.12
End Levee Mile	5.16
Location	Water Side
Category	Supplemental
Item	USACE Erosion Survey
2009: no berm, 2:1 slope, no stability issues, clays and silts, 3.71 ft/s [2009 SiteID:GEO_7-2_L]	
richard_s_20110215_254.JPG

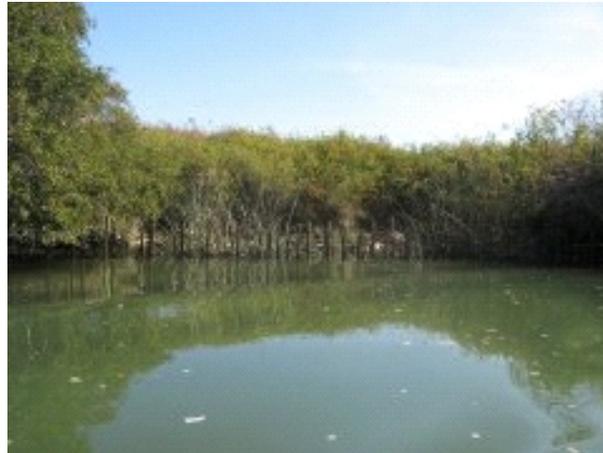
Levee Mile Report Line	47
Start Levee Mile	5.29
End Levee Mile	5.52
Location	Water Side
Category	Supplemental
Item	USACE Erosion Survey
2009: 10 ft berm, 1.5:1 slope, tree hazards and holes, clays and silts, 3.78 ft/s [2009 SiteID:GEO_6-8_L]	
richard_s_20110215_255.JPG

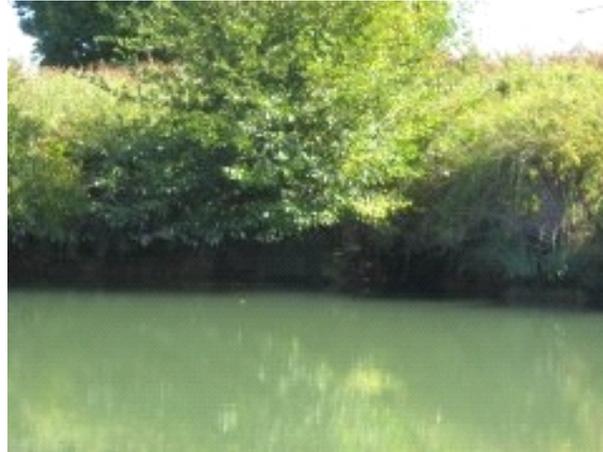
Levee Mile Report Line	56
Start Levee Mile	6.83
End Levee Mile	7.44
Location	Water Side
Category	Supplemental
Item	USACE Erosion Survey
2009: 5 ft berm, 1.5:1 slope, tree hazards and holes, clays and silts, 3.95 ft/s [2009 SiteID:GEO_5-3_L]	
richard_s_20110215_257.JPG

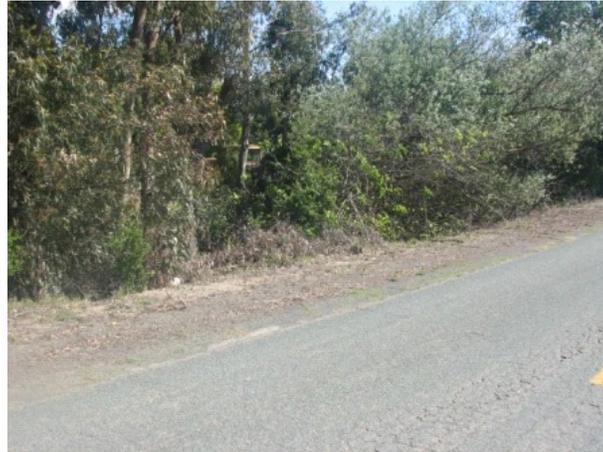
Levee Mile Report Line	59
Start Levee Mile	7.54
End Levee Mile	7.54
Location	Land Side
Category	Earthen Levee
Item	Encroachments
Looking east at garbage on landside toe.	
richard_s_20110215_282.jpg

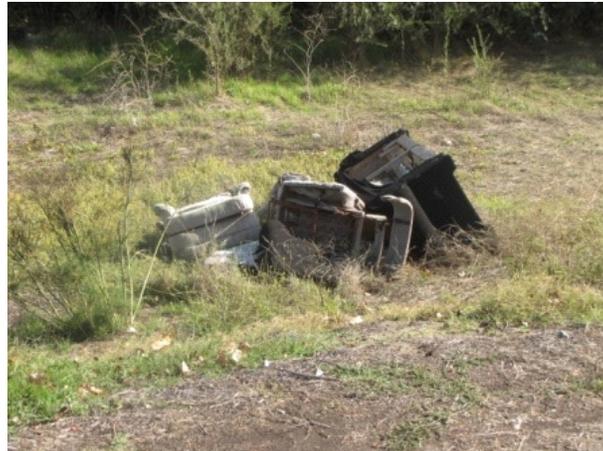
Levee Mile Report Line	60
Start Levee Mile	7.54
End Levee Mile	7.54
Location	Water Side
Category	Earthen Levee
Item	Encroachments
Looking west at garbage on waterside shoulder.	
richard_s_20110215_281.jpg

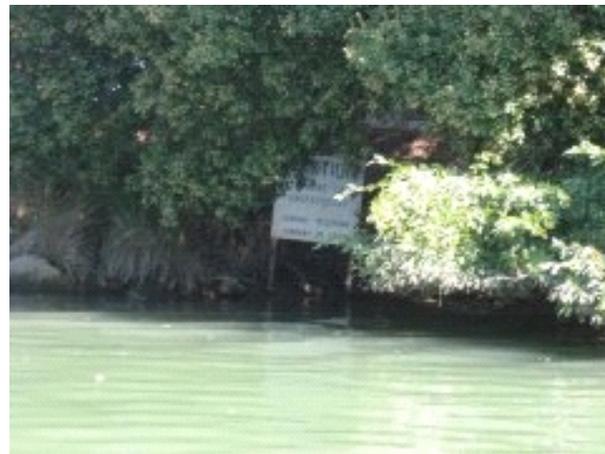
Levee Mile Report Line	63
Start Levee Mile	7.93
End Levee Mile	7.97
Location	Water Side
Category	Supplemental
Item	USACE Erosion Survey
2009: 5 ft berm, 1.5:1 slope, tree hazards, clays and silts, 4.01 ft/s [2009 SiteID:GEO_4-5_L]	
richard_s_20110215_259.JPG

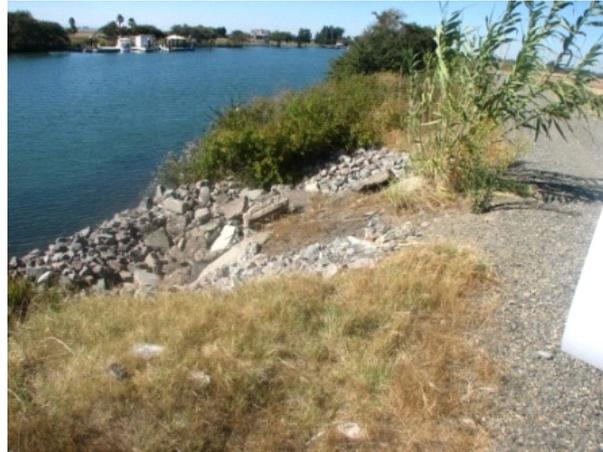
Levee Mile Report Line	83
Start Levee Mile	11.69
End Levee Mile	12.04
Location	Water Side
Category	Supplemental
Item	USACE Erosion Survey
2009: 5 ft berm, 1.5:1 slope, tree hazards and slumping, clays and silts, 4.63 ft/s [2009 SiteID:GEO_0-3_L]	
richard_s_20110215_279.JPG
