**Flood Control Project Maintenance
Levee Inspections**
LMA District Cover Sheet
Spring 2015 Levee Inspection Results

Reclamation District No. 0563 Tyler Island

Spring 2015 Levee Inspection Results

Waterway	Bank	Unit Miles
Unit No. 01 Georgiana Slough (Tyler Island)	Left	12.11

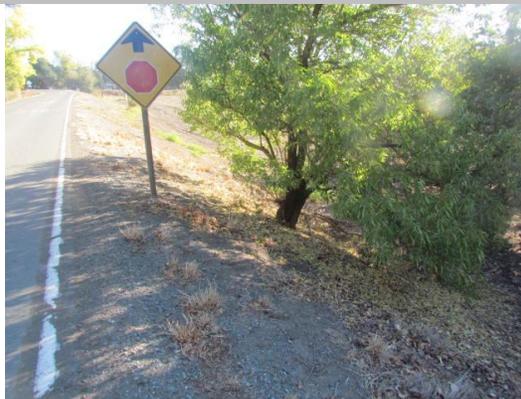
Photo 1 of 1 : SP_2015_RD0563_210_59_20150309_00056.jpg

Looking north at untrimmed tree on landward toe.

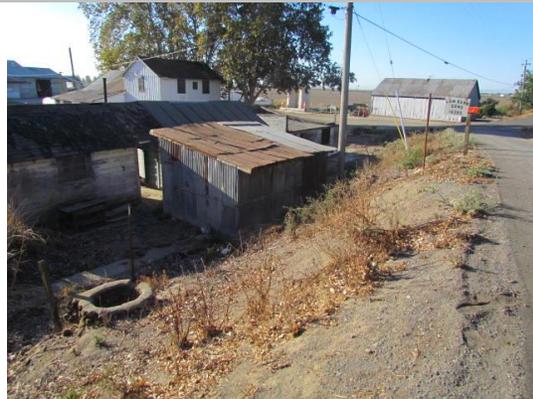
Photo 3 of 3 : SP_2015_RD0563_210_10_20150309_00014.jpg

Looking southeast at storage shed at landward toe.

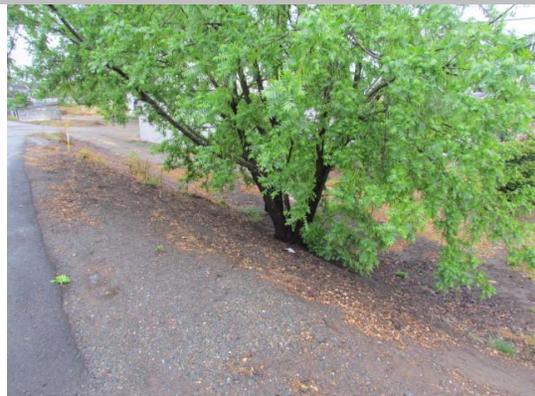
Photo 1 of 1 : SP_2015_RD0563_210_18_20150409_00965.jpg

Looking northeast at untrimmed tree on landward slope.

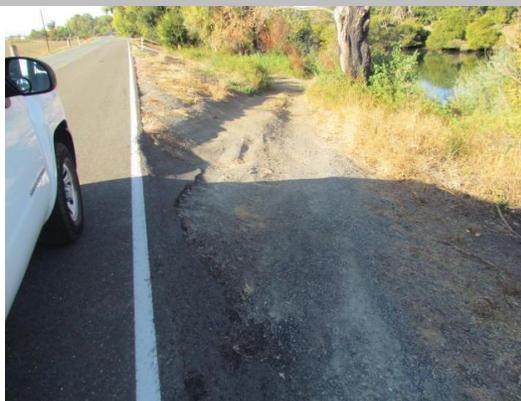
Photo 1 of 1 : SP_2015_RD0563_210_16_20150309_00020.jpg

LM Start	0.39	Rating **	M	Issue No.	16
LM End	0.39	Issue Type +	Ma	Location *	WS
Category	Earthen Levee			GPS Latitude/Longitude	
				Start	End
Item	Slope Stability			38.230841 °	38.230841 °
				-121.521898 °	-121.521898 °
DWR ID	DWR_RD0563_01_f_2013_16				
Action/Comments					
Repair the levee slope damaged by vehicle traffic and prevent access where possible. Inspector Comments: Slope damage is due to fishermen vehicle traffic.

Looking southwest at slope damage caused by vehicle traffic.

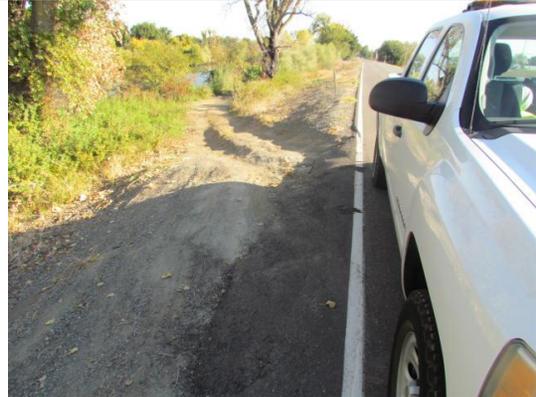
Photo 1 of 1 : SP_2015_RD0563_210_26_20150309_00029.jpg

LM Start	0.43	Rating **	M	Issue No.	26
LM End	0.43	Issue Type +	Ma	Location *	WS
Category	Earthen Levee			GPS Latitude/Longitude	
				Start	End
Item	Slope Stability			38.230460 °	38.230460 °
				-121.522324 °	-121.522324 °
DWR ID	DWR_RD0563_01_f_2013_26				
Action/Comments					
Repair the levee slope damaged by vehicle traffic and prevent access where possible. Inspector Comments: Slope damage due to fishermen vehicle traffic.

Looking northwest at slope damage caused by vehicle traffic.

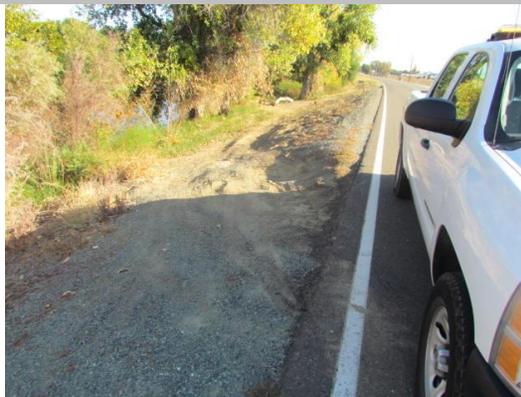
Photo 1 of 1 : SP_2015_RD0563_210_34_20150309_00036.jpg

LM Start	0.56	Rating **	M	Issue No.	34
LM End	0.56	Issue Type +	Ma	Location *	WS
Category	Earthen Levee			GPS Latitude/Longitude	
				Start	End
Item	Slope Stability			38.228948 °	38.228948 °
				-121.523904 °	-121.523904 °
DWR ID	DWR_RD0563_01_f_2013_34				
Action/Comments					
Repair the levee slope damaged by vehicle traffic and prevent access where possible. Inspector Comments: Slope damage is due to fishermen vehicle traffic.

Looking northwest at slope damage caused by vehicle traffic.

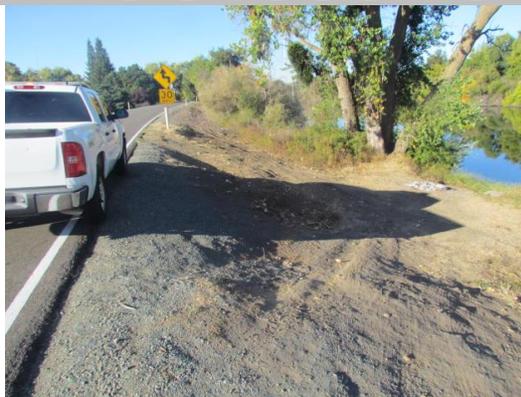
Photo 1 of 2 : SP_2015_RD0563_210_143_20150309_00128.jpg

LM Start	0.61	Rating **	M	Issue No.	143
LM End	0.61	Issue Type +	Ma	Location *	WS
Category	Earthen Levee			GPS Latitude/Longitude	
				Start	End
Item	Slope Stability			38.228507 °	38.228507 °
				-121.524543 °	-121.524543 °
DWR ID	DWR_RD0563_01_f_2014_143				
Action/Comments					
Repair the levee slope damaged by vehicle traffic and prevent access where possible. Inspector Comments: Slope damage due to vehicle traffic.

Looking southeast at slope damage on waterward slope.

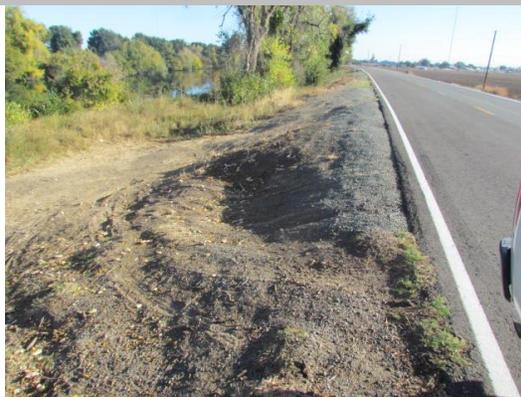
Photo 2 of 2 : SP_2015_RD0563_210_143_20150309_00129.jpg

Looking northwest at slope damage on waterward slope.

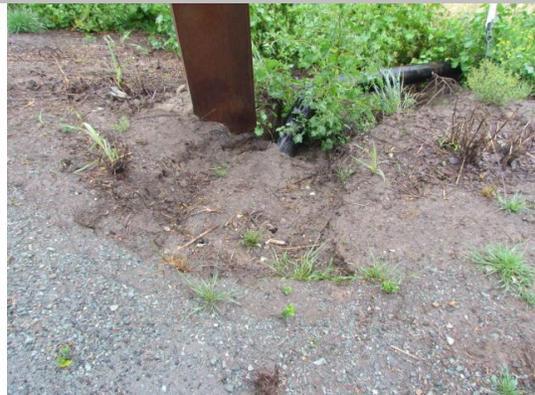
Photo 1 of 2 : SP_2015_RD0563_210_62_20150409_00966.jpg

Looking east at depression above newly installed black steel pipe.

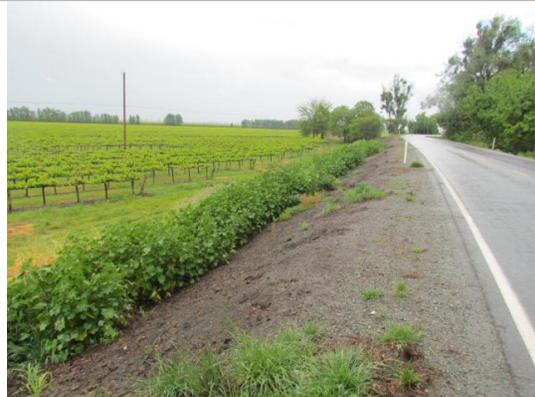
Photo 1 of 1 : SP_2015_RD0563_210_754_20150409_00968.jpg

Looking southeast at dense vegetation at landward toe.

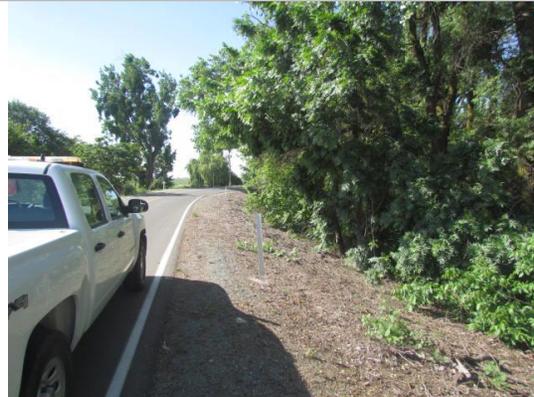
Photo 1 of 2 : SP_2015_RD0563_210_3_20150309_00001.jpg

Looking south at trimmed trees on waterward slope. (Spring 2013)

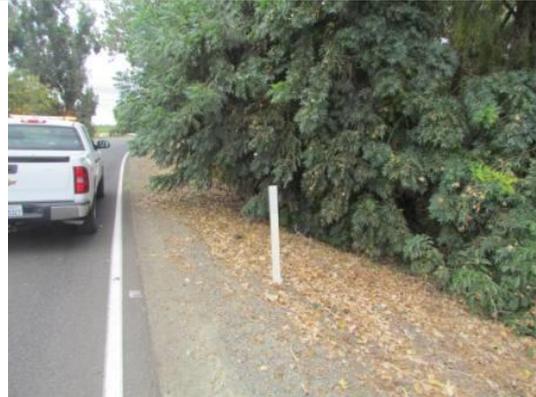
Photo 2 of 2 : SP_2015_RD0563_210_3_20150309_00002.jpg

Looking southwest at overgrown trees on waterside slope.

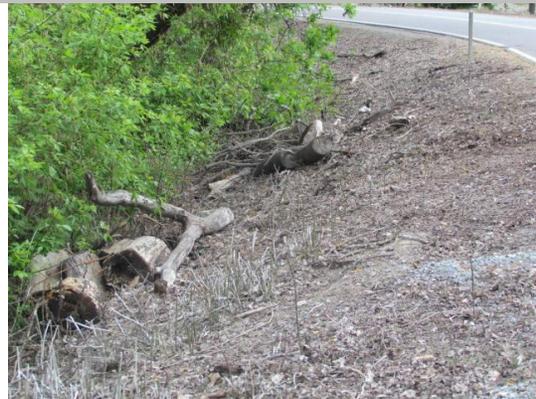
Photo 1 of 2 : SP_2015_RD0563_210_9_20150309_00010.jpg

Looking northeast at tree limbs on waterward slope.

LM Start	0.84	Rating **	M	Issue No.	9
LM End	0.84	Issue Type +	Ma	Location *	WS
Category	Earthen Levee			GPS Latitude/Longitude	
				Start	End
Item	Encroachments			38.225685 °	38.225685 °
				-121.526288 °	-121.526288 °
DWR ID	DWR_RD0563_01_s_2012_9				
Action/Comments					
Prunings Inspector Comments: Prunings on waterside slope should be burned or removed.

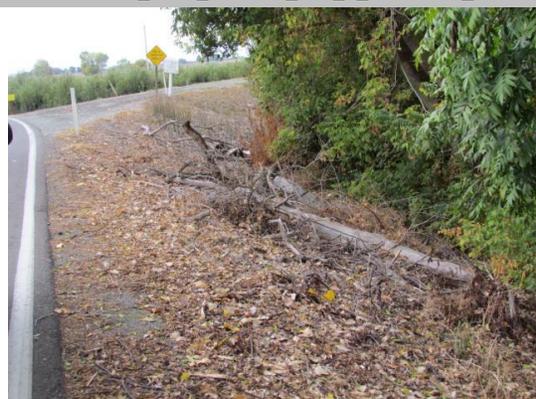
Photo 2 of 2 : SP_2015_RD0563_210_9_20150309_00011.jpg

Looking southwest at tree limbs on waterside slope.

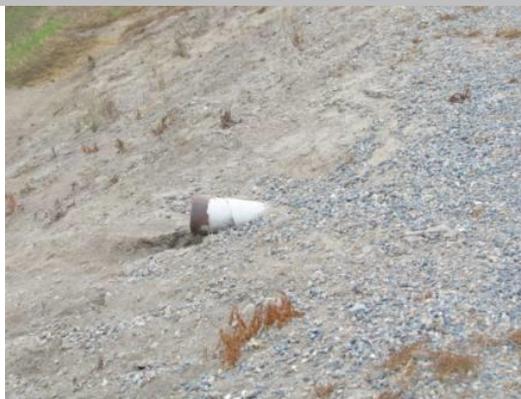
Photo 1 of 2 : SP_2015_RD0563_210_937_20150309_00135.jpg

Looking southwest at abandoned pipe on landside slope.

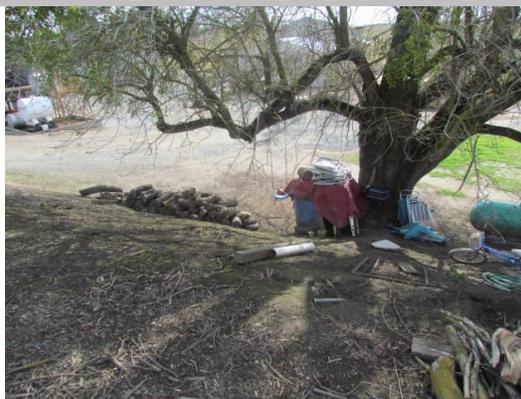
Photo 1 of 2 : SP_2015_RD0563_210_57_20150309_00054.jpg

Looking east at firewood and other materials stored on landside slope and toe.

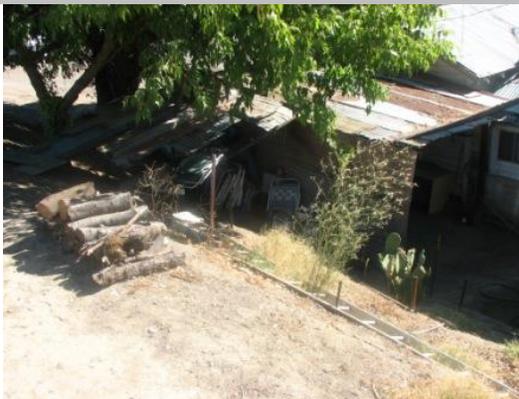
Photo 2 of 2 : SP_2015_RD0563_210_57_20150309_00055.jpg

Looking at a shed at landside toe.

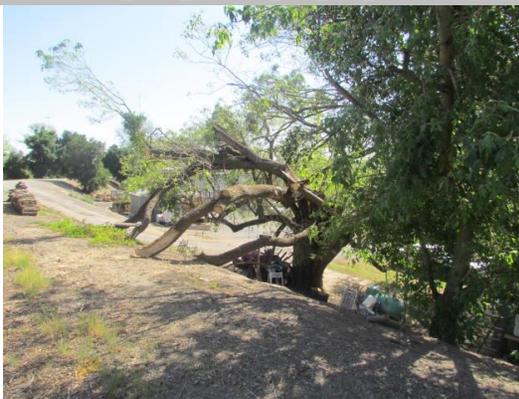
Photo 1 of 1 : SP_2015_RD0563_210_103_20150309_00118.jpg

LM Start	1.25	Rating **	A/W	Issue No.	103
LM End	1.25	Issue Type +	Ma	Location *	LS
Category	Earthen Levee			GPS Latitude/Longitude	
				Start	End
Item	Encroachments				
DWR ID	DWR_RD0563_01_s_2013_103				
Action/Comments					
Tree or limb Inspector Comments: Broken tree branches on landward slope.

Looking northeast at broken tree branch on landward slope.

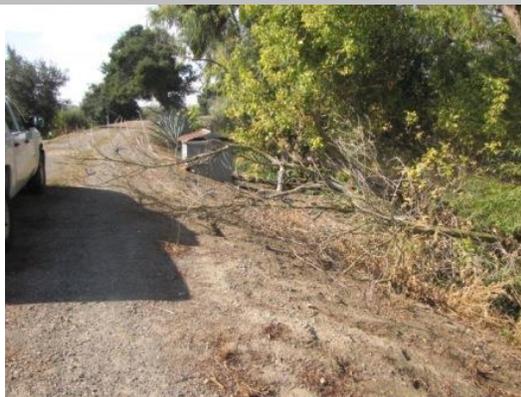
Photo 1 of 1 : SP_2015_RD0563_210_19_20150309_00024.jpg

LM Start	1.39	Rating **	A/W	Issue No.	19
LM End	1.39	Issue Type +	Ma	Location *	WS
Category	Earthen Levee		GPS Latitude/Longitude		
			Start	End	
Item	Encroachments		38.224367 °	38.224367 °	
			-121.534165 °	-121.534165 °	
DWR ID	DWR_RD0563_01_s_2012_19				
Action/Comments					
Tree or limb Inspector Comments: Broken tree along waterside slope.

Looking south at a downed tree on waterside slope.

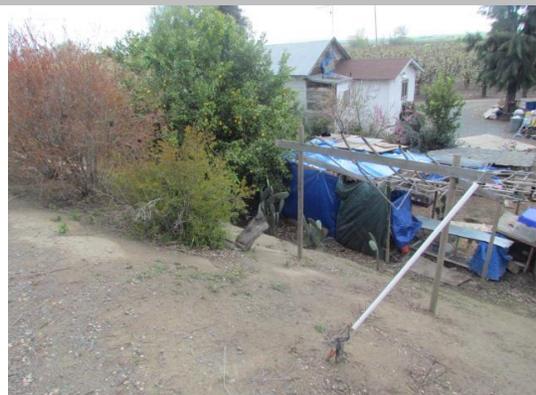
Photo 1 of 3 : SP_2015_RD0563_210_8_20150309_00007.jpg

Looking east at landscaping and animal containers on the landside slope and toe.

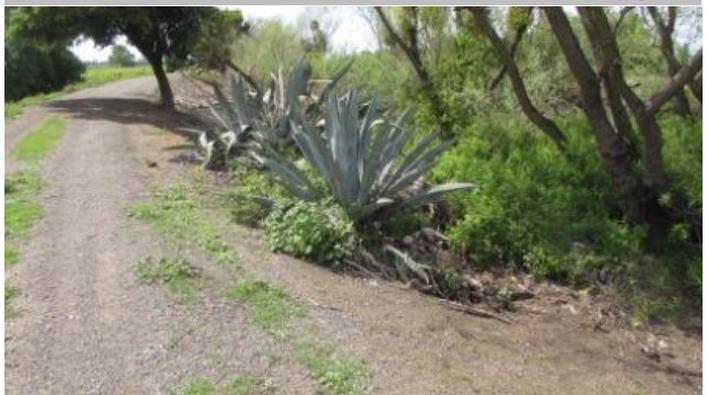
Photo 1 of 2 : SP_2015_RD0563_210_6_20150309_00005.jpg

Updated view looking upstream at a century plant on waterside shoulder slope.

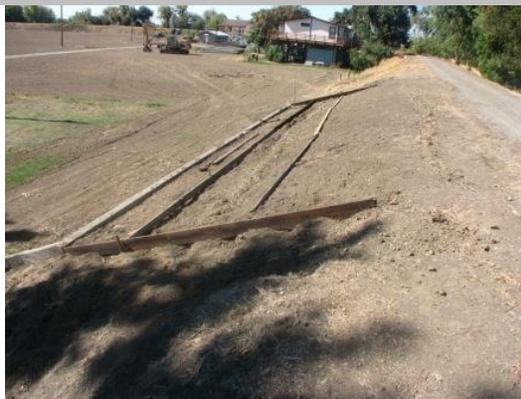
Photo 2 of 12 : SP_2015_RD0563_210_60_20150309_00058.jpg

Looking southeast at top of retaining wall.

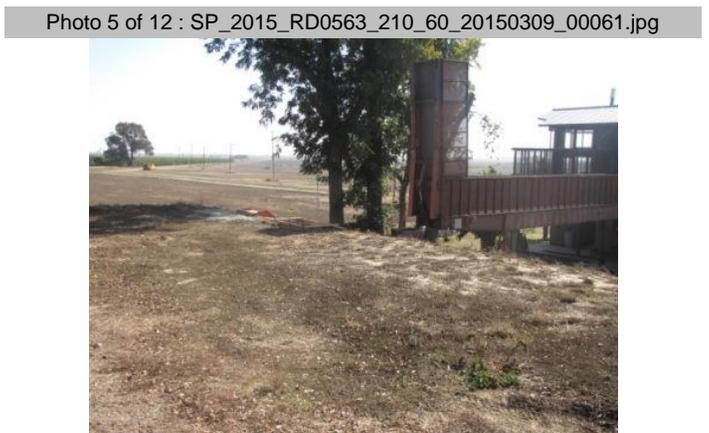
Looking northeast metal walkway on landside of levee.

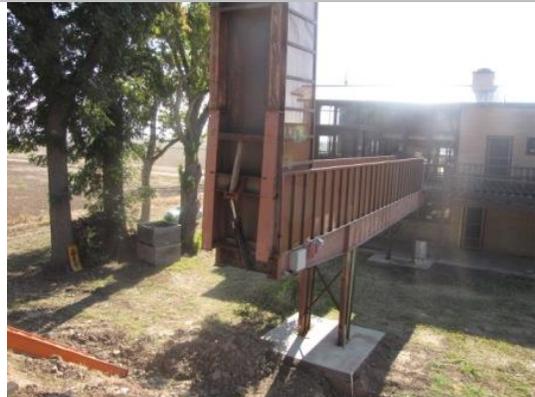
Photo 8 of 12 : SP_2015_RD0563_210_60_20150309_00064.jpg

Looking east at metal walkway on landside.

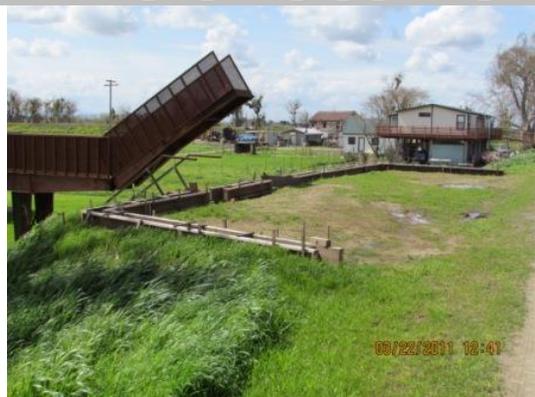
Photo 11 of 12 : SP_2015_RD0563_210_60_20150309_00067.jpg

Looking southeast at framing for footings on landside shoulder.

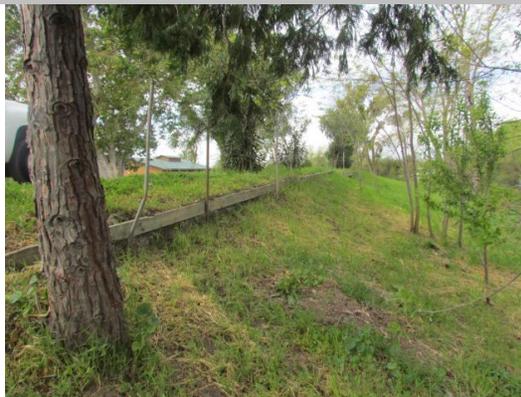
Photo 1 of 2 : SP_2015_RD0563_210_142_20150309_00126.jpg

Looking southeast at planting box on waterward shoulder.

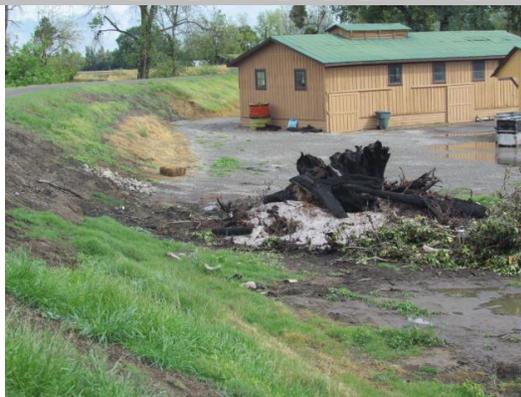
Photo 1 of 1 : SP_2015_RD0563_210_96_20150409_00971.jpg

Looking north at partially burned pruning pile at landward toe.

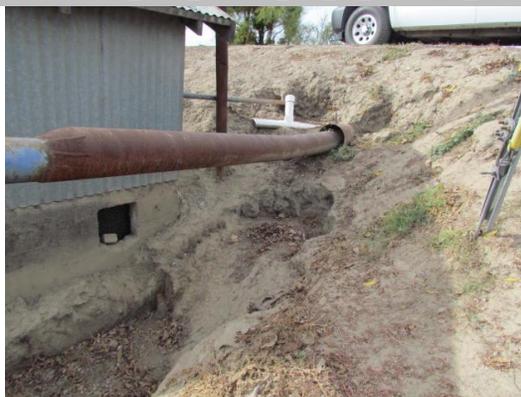
Photo 1 of 2 : SP_2015_RD0563_210_71_20150309_00074.jpg

Looking west at erosion at landside toe and slope next to pump house.

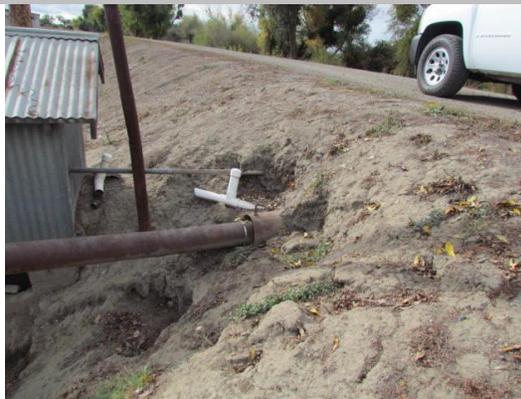
Photo 2 of 2 : SP_2015_RD0563_210_71_20150309_00075.jpg

Looking southwest at erosion around irrigation pipe on landside slope and toe.

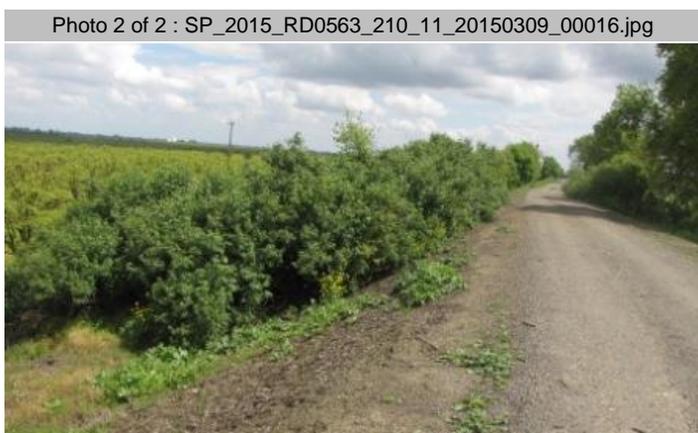
Looking southeast at elderberry on the landside slope and toe.

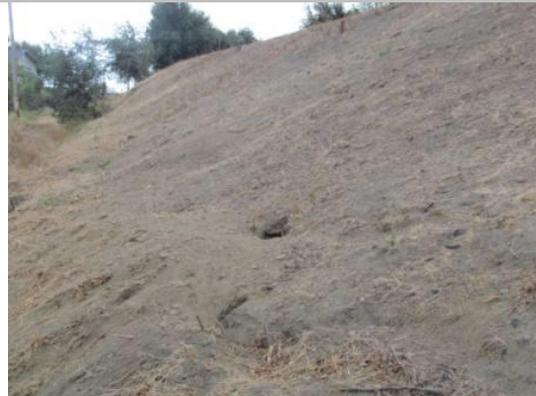
Photo 3 of 4 : SP_2015_RD0563_210_85_20150309_00097.jpg

Looking southwest at rodent holes on landside slope.

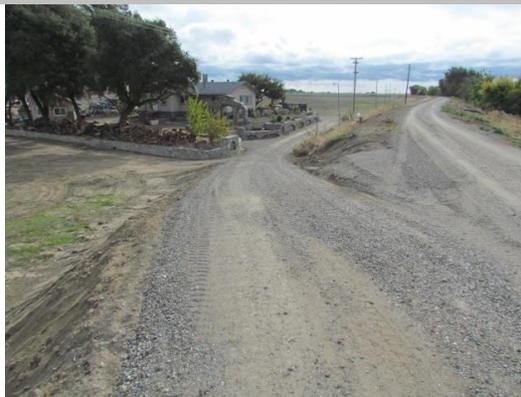
Photo 2 of 2 : SP_2015_RD0563_210_80_20150309_00090.jpg

Looking southeast at unauthorized ramp on landside slope.

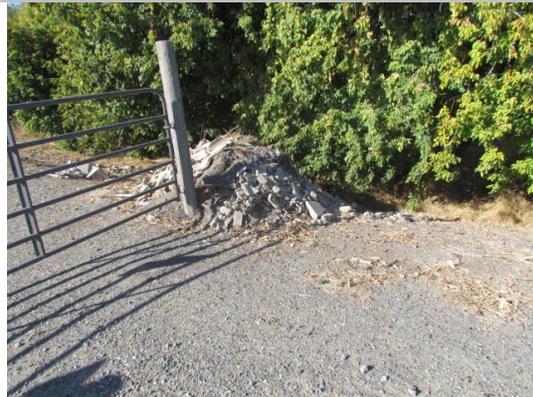
Photo 1 of 2 : SP_2015_RD0563_210_104_20150309_00119.jpg

Looking west at concrete rubble on waterward shoulder and slope.

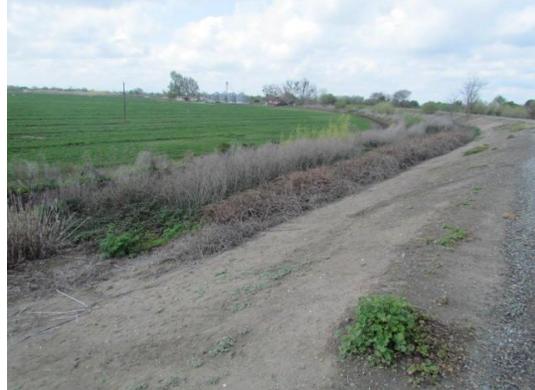
Photo 2 of 3 : SP_2015_RD0563_210_74_20150309_00078.jpg

Looking southeast at dead berryvine on landside toe. (Fall 2014)

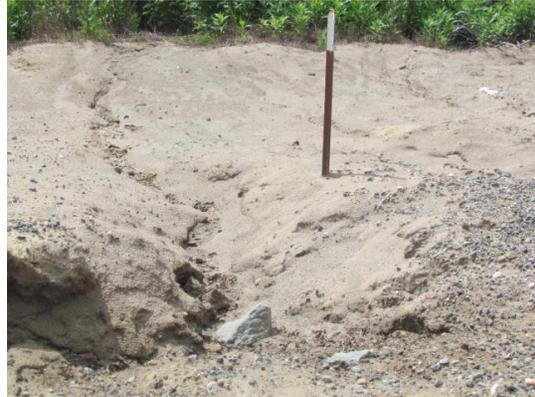
Photo 3 of 4 : SP_2015_RD0563_210_78_20150309_00087.jpg

Looking east at slope erosion. (Updated Spring 2012)

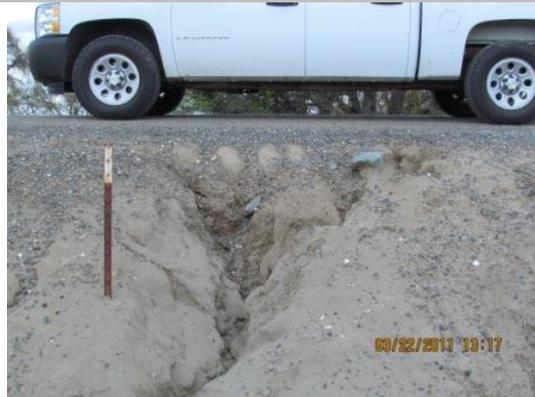
Photo 4 of 4 : SP_2015_RD0563_210_78_20150309_00088.jpg

Looking west at slope erosion cause by runoff on landside slope.

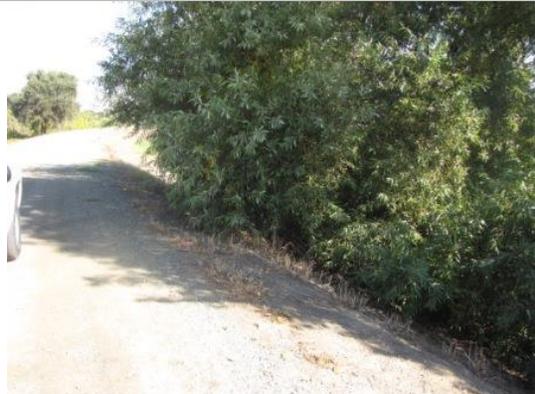
Photo 2 of 2 : SP_2015_RD0563_210_68_20150309_00072.jpg

Looking southeast at dense trees on landside slope and toe.

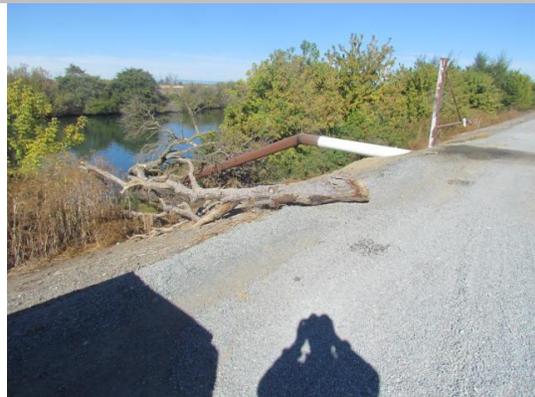
Photo 1 of 1 : SP_2015_RD0563_210_150_20150309_00133.jpg

Looking northwest at tree branch on waterward shoulder.

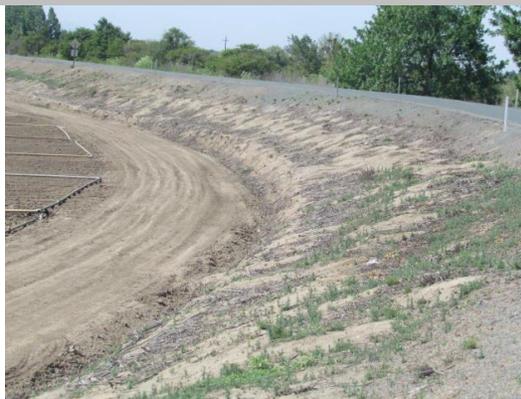
Photo 2 of 2 : SP_2015_RD0563_210_17_20150309_00022.jpg

Looking southwest at irrigation ditch on landward toe.

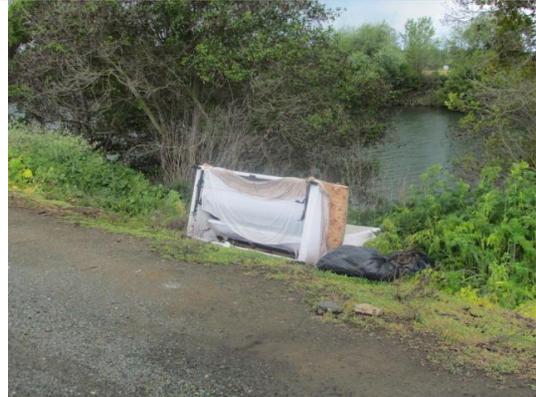
Photo 1 of 1 : SP_2015_RD0563_210_765_20150409_00976.jpg

Looking west at garbage on waterward slope. (Spring 2015)

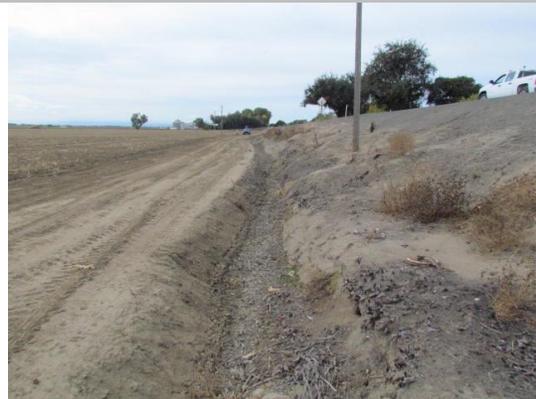
Photo 1 of 1 : SP_2015_RD0563_210_93_20150309_00110.jpg

Looking south at irrigation ditch at landside toe.

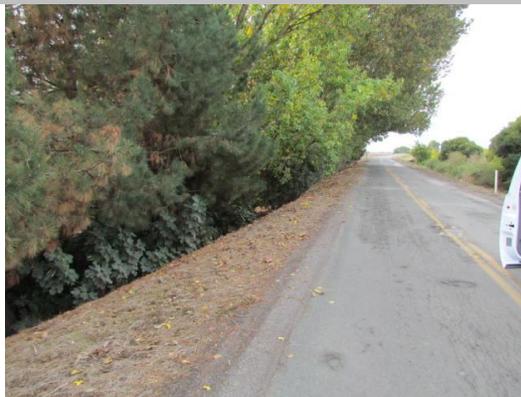
Photo 1 of 1 : SP_2015_RD0563_210_88_20150309_00101.jpg

Looking south at dense trees on landside slope and toe.

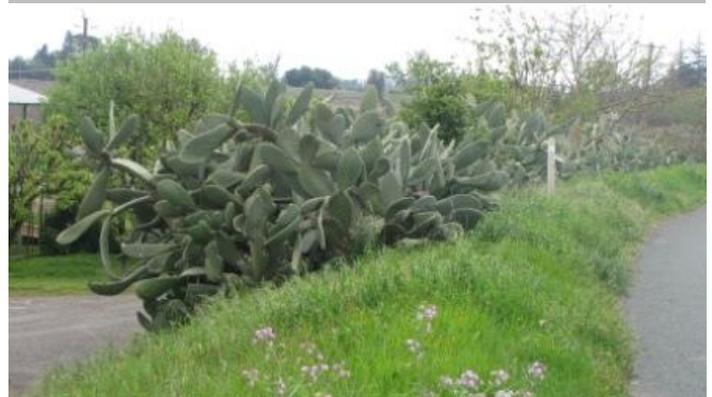
Photo 1 of 2 : SP_2015_RD0563_210_22_20150309_00025.jpg

Looking at north end of cactus on the landside slope.

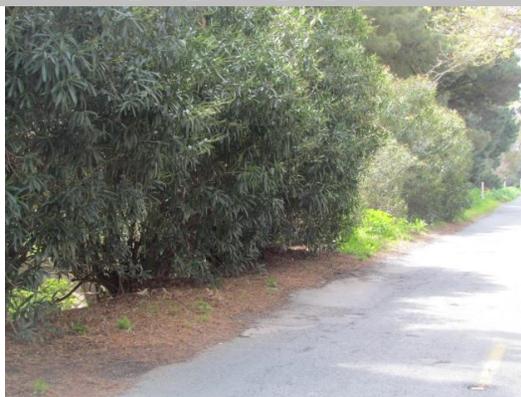
Photo 1 of 1 : SP_2015_RD0563_210_25_20150309_00028.jpg

Looking southeast at dense landscaping on landside shoulder and slope.

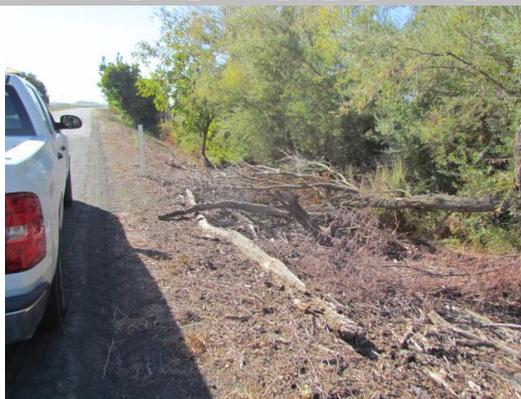
Photo 1 of 1 : SP_2015_RD0563_210_82_20150309_00091.jpg

Looking south at tree limbs on waterward slope.

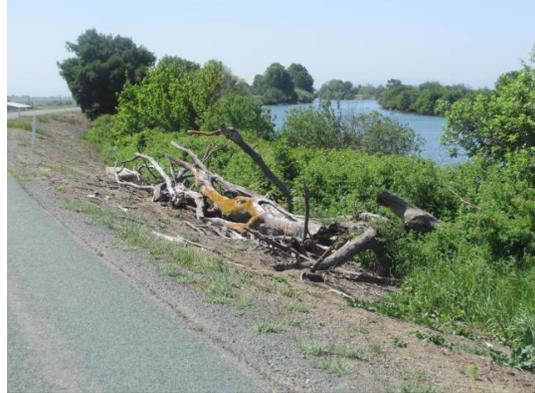
Photo 1 of 1 : SP_2015_RD0563_210_95_20150309_00111.jpg

Looking southwest at prunings on waterward slope.

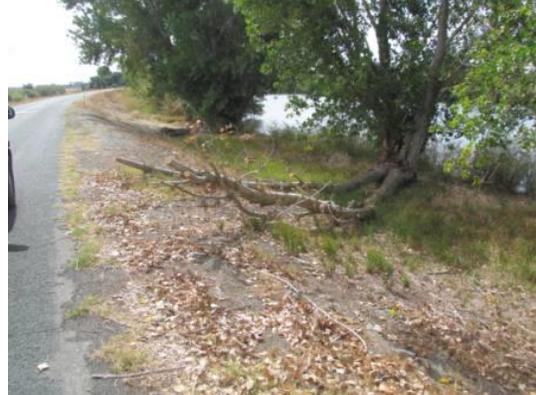
Photo 1 of 1 : SP_2015_RD0563_210_89_20150309_00102.jpg

Looking southwest at downed limbs on waterside slope.

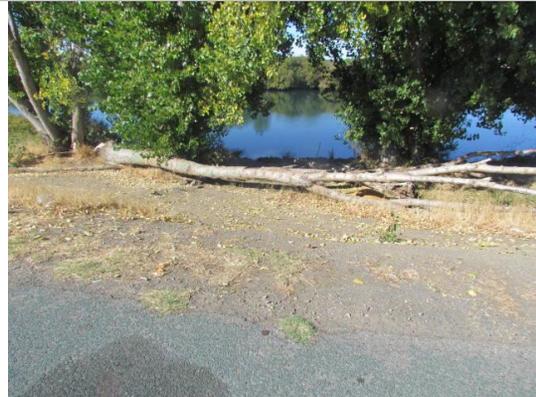
Photo 1 of 1 : SP_2015_RD0563_210_152_20150309_00134.jpg

Looking west at tree branch on waterward slope.

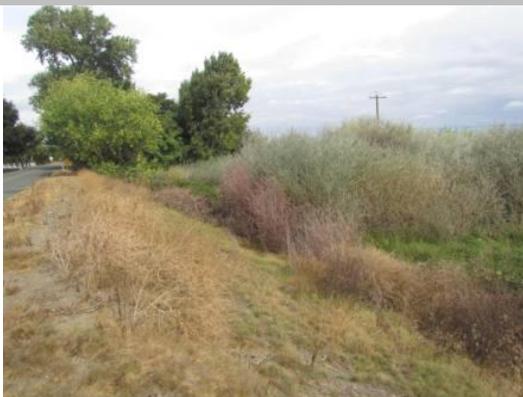
Photo 2 of 5 : SP_2015_RD0563_210_90_20150309_00103.jpg

Looking northeast at dense vegetation on landside toe.

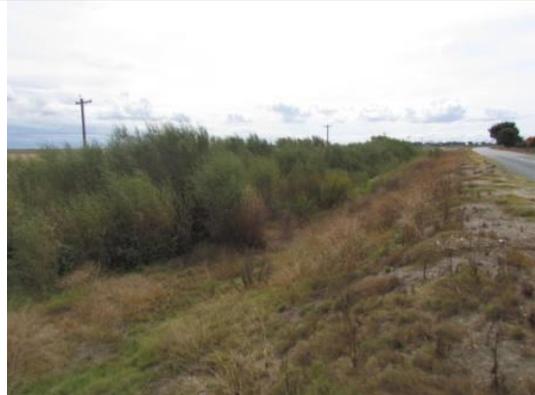
Photo 5 of 5 : SP_2015_RD0563_210_90_20150309_00106.jpg

Looking southwest at dense vegetation on landside toe.

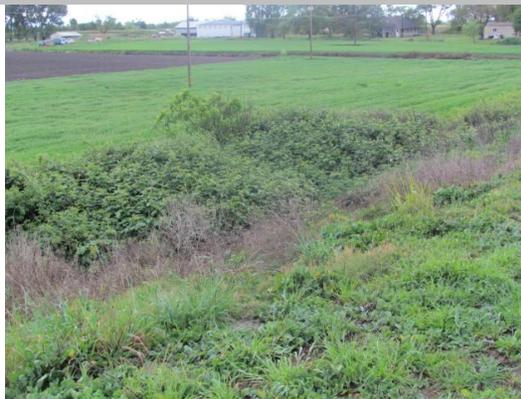
Photo 1 of 1 : SP_2015_RD0563_210_767_20150409_00981.jpg

Looking east at dense wild vines at landward toe.

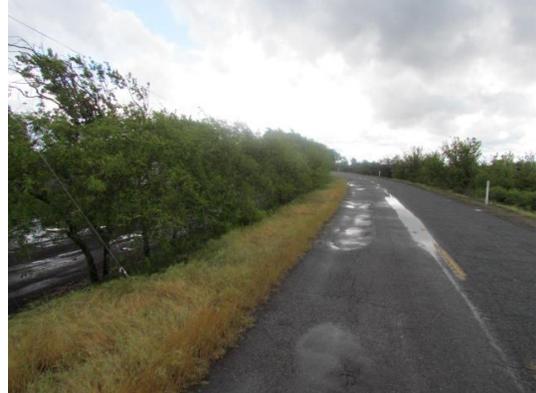
Photo 1 of 1 : SP_2015_RD0563_210_31_20150409_00982.jpg

Looking south at untrimmed trees at landward toe.

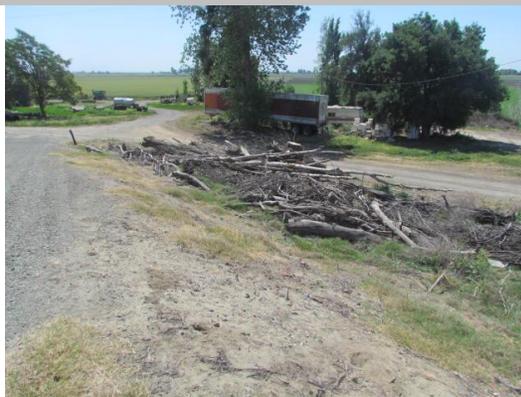
Photo 2 of 2 : SP_2015_RD0563_210_73_20150309_00076.jpg

Looking east at prunings on landward slope. (Spring 2013)

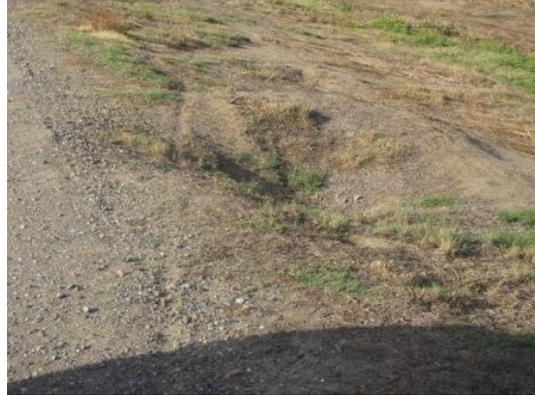
Photo 1 of 4 : SP_2015_RD0563_210_76_20150309_00080.jpg

Looking northeast a depression on landside shoulder and slope above 10" irrigation pipe four feet below crown.

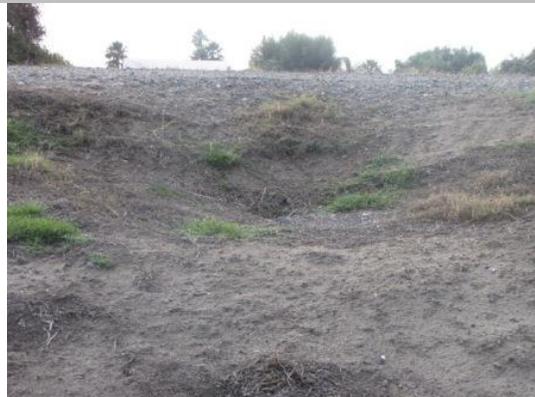
Photo 3 of 4 : SP_2015_RD0563_210_76_20150309_00082.jpg

Looking west at depression on landside shoulder and slope from landside toe.

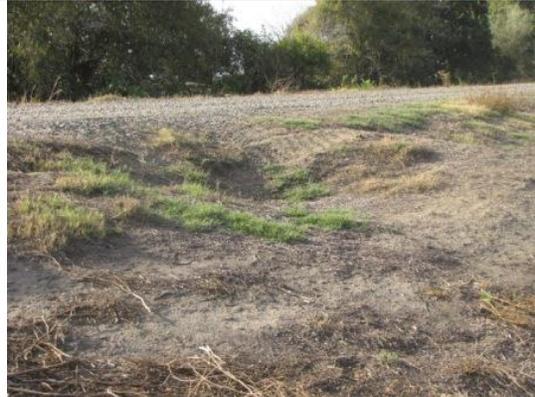
Photo 4 of 4 : SP_2015_RD0563_210_76_20150309_00083.jpg

Looking west at depression on landside shoulder and slope.

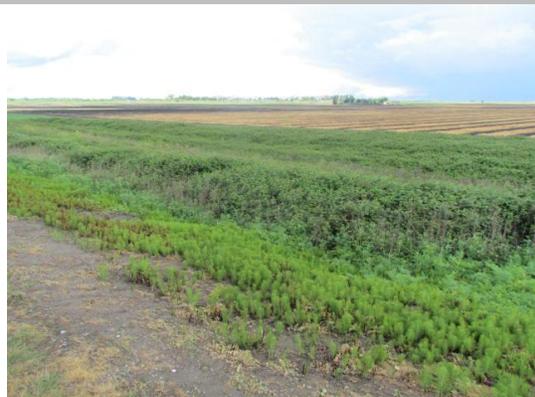
Photo 1 of 3 : SP_2015_RD0563_210_100_20150409_00987.jpg

Looking northeast at dense vegetation at landward toe. (Spring 2015)

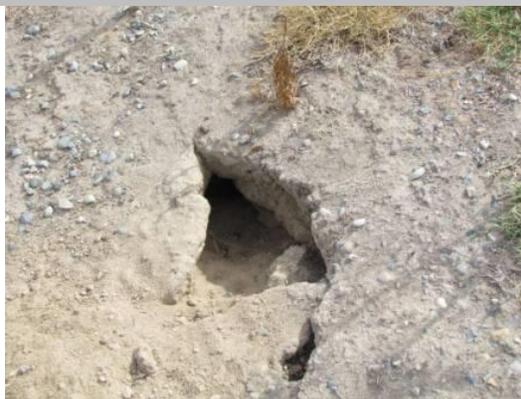
Photo 1 of 3 : SP_2015_RD0563_210_91_20150309_00107.jpg

Looking east at rodent hole on landside slope.

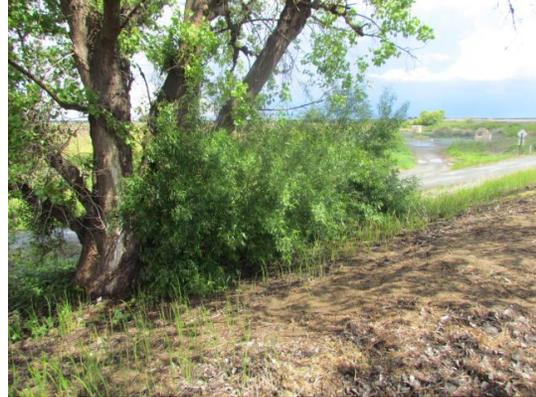
Photo 1 of 1 : SP_2015_RD0563_210_47_20150409_00989.jpg

Looking east at untrimmed tree at landward slope. (Spring 2015)
