**Flood Control Project Maintenance
Levee Inspections**
LMA District Cover Sheet
Spring 2016 Levee Inspection Results

Reclamation District No. 0563 Tyler Island

Spring 2016 Levee Inspection Results

Waterway	Bank	Unit Miles
Unit No. 01 Georgiana Slough (Tyler Island)	Left	12.11

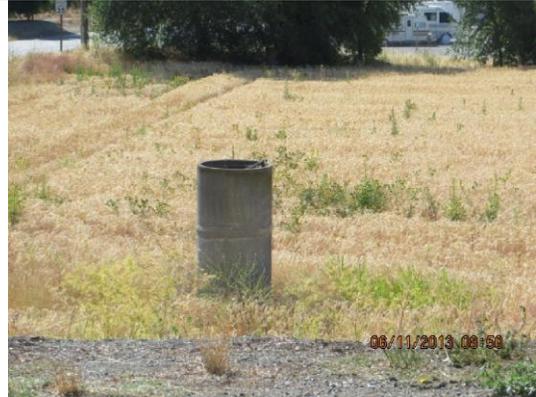
Photo 1 of 1 : UCIP_SP_2016_14864_24503.jpg

LM Start	0.02	Rating **	M	Issue No.	958
LM End	0.02	Issue Type +	En	Location *	LS
Category	Supplemental			GPS Latitude/Longitude	
				Start	End
Item	DWR UCIP Field Study			38.234936 °	38.234936 °
				-121.517528 °	-121.517528 °
DWR ID					
Comment Code					
Inspector Comment					
FS_ID:14864 DS_ID:20199 EP_NO: N/A Repair Type: Non-Urgent Crossing Status: Indicator Found UCIP Comments: Need to determine disposition of pipe. Was it abandoned properly? FIELD_STRUCT_DESC: 10-inch pipe through levee unknown feet below crown. 36-inch concrete stand pipe at landward toe. Originally included in the 1954 O&M manual. (Unable to located pipe 6/11/2013). FS Date: 6/11/2013

36-inch concrete standpipe on LS toe.

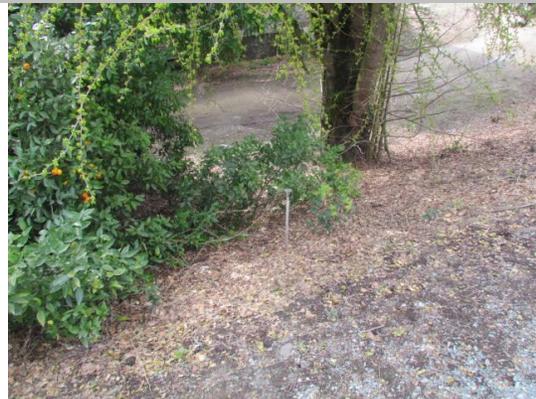
Photo 1 of 2 : SP_2016_RD0563_210_28_20160308_00029.jpg

Looking east at sprinklers on landside slope.

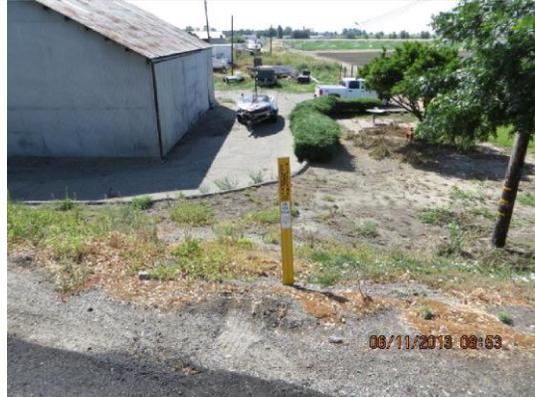
Photo 1 of 2 : UCIP_SP_2016_14865_24505.jpg

LM Start	0.20	Rating **	M	Issue No.	959
LM End	0.20	Issue Type +	En	Location *	WS
Category	Supplemental			GPS Latitude/Longitude	
				Start	End
Item	DWR UCIP Field Study			38.233027 °	38.233027 °
				-121.519631 °	-121.519631 °
DWR ID					
Comment Code					
Inspector Comment					
FS_ID:14865 DS_ID:20129 EP_NO: 3448 Repair Type: Non-Urgent Crossing Status: Indicator Found UCIP Comments: Sign on waterside slope should be cleared of vegetation. FIELD_STRUCT_DESC: 4.5-inch gas line through levee 4.0 feet below crown and across channel (Permit No. 3448, 1961). Large warning sign on WS slope. FS Date: 6/11/2013

Gasline marker on LS shoulder.

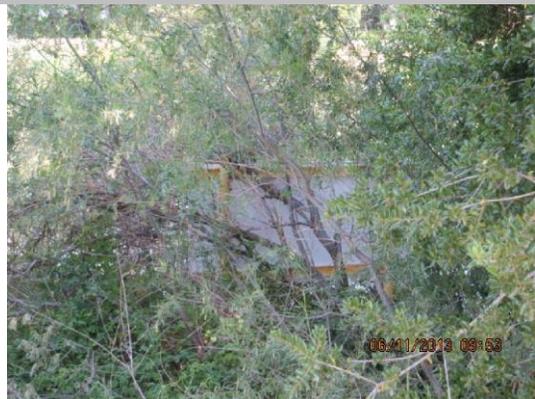
Photo 2 of 2 : UCIP_SP_2016_14865_24504.jpg

Gasline warning sign covered in vegetation on WS slope.

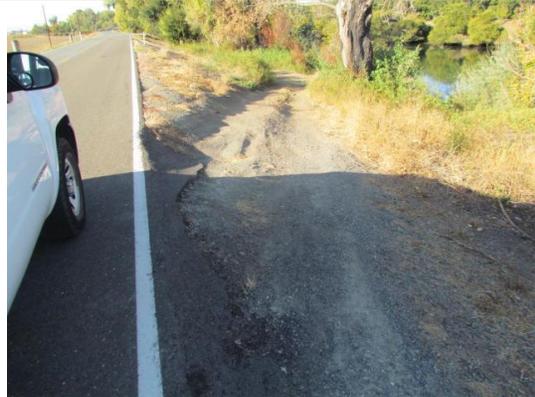
Photo 1 of 1 : SP_2016_RD0563_210_16_20160308_00020.jpg

LM Start	0.39	Rating **	M	Issue No.	16
LM End	0.39	Issue Type +	Ma	Location *	WS
Category	Earthen Levee		GPS Latitude/Longitude		
			Start	End	
Item	Slope Stability		38.230841 °	38.230841 °	
			-121.521898 °	-121.521898 °	
DWR ID	DWR_RD0563_01_f_2013_16				
Comment Code					
S3 : Repair the levee slope damaged by vehicle traffic and prevent access where possible.					
Inspector Comment					
Slope damage is due to fishermen vehicle traffic.

Looking southwest at slope damage caused by vehicle traffic.

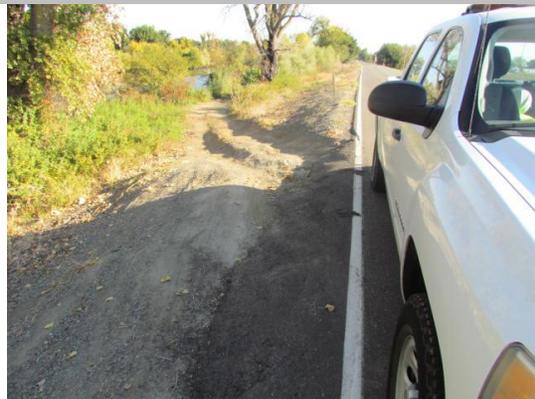
Photo 1 of 1 : SP_2016_RD0563_210_26_20160308_00027.jpg

LM Start	0.43	Rating **	M	Issue No.	26
LM End	0.43	Issue Type +	Ma	Location *	WS
Category	Earthen Levee		GPS Latitude/Longitude		
			Start	End	
Item	Slope Stability		38.230460 °	38.230460 °	
			-121.522324 °	-121.522324 °	
DWR ID	DWR_RD0563_01_f_2013_26				
Comment Code					
S3 : Repair the levee slope damaged by vehicle traffic and prevent access where possible.					
Inspector Comment					
Slope damage due to fishermen vehicle traffic.

Looking northwest at slope damage caused by vehicle traffic.

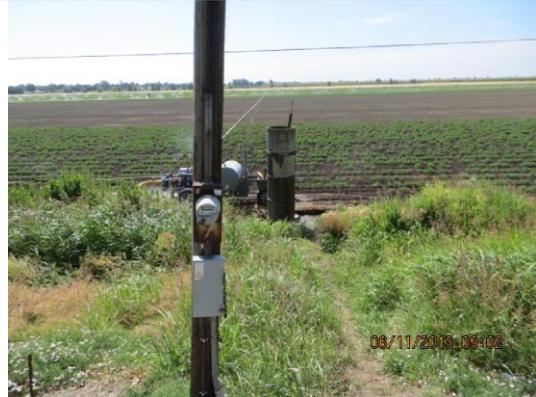
Photo 1 of 2 : UCIP_SP_2016_14866_24508.jpg

LM Start	0.45	Rating **	M	Issue No.	960
LM End	0.45	Issue Type +	En	Location *	WS
Category	Supplemental			GPS Latitude/Longitude	
				Start	End
Item	DWR UCIP Field Study			38.230185 °	38.230185 °
				-121.522631 °	-121.522631 °
DWR ID					
Comment Code					
Inspector Comment					
FS_ID:14866 DS_ID:20130 EP_NO: 11218 Repair Type: Non-Urgent Crossing Status: Found UCIP Comments: Pipe leaking at various points on WS berm. Failure on berm may indicate potential for failure within the levee. Good candidate for video inspection. FIELD_STRUCT_DESC: 12-inch steel pipe through the levee 5.0 feet below the crown. Walkway to pump on pile structure in stream. Siphon breaker in a 24-inch CMP riser on the waterward shoulder. 1" air and vacuum valve and a 15' tall by 36" diameter concrete standpipe at the LS toe (ABO No. 11218, 1975). Originally included in the 1954 O&M manual. FS Date: 6/11/2013

JP on LS slope with 36-inch concrete standpip on LS toe.

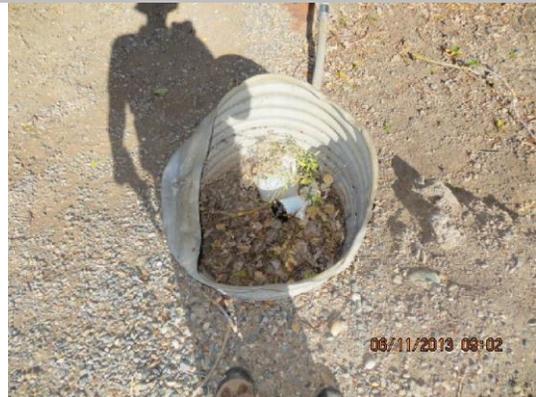
Photo 2 of 2 : UCIP_SP_2016_14866_24507.jpg

Siphon breaker not visible in 24-inch CMP riser on WS shoulder.

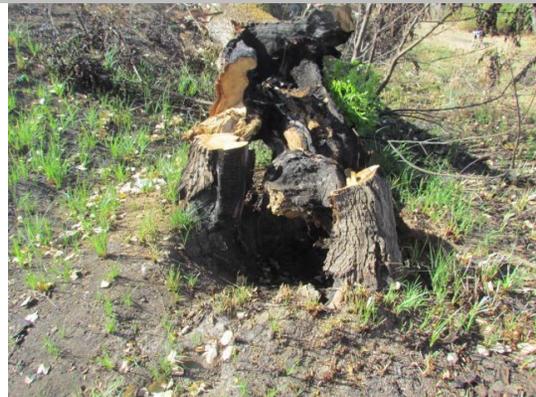
Photo 3 of 5 : SP_2016_RD0563_210_139_20160308_00122.jpg

Looking at stump of fallen tree on waterward berm.

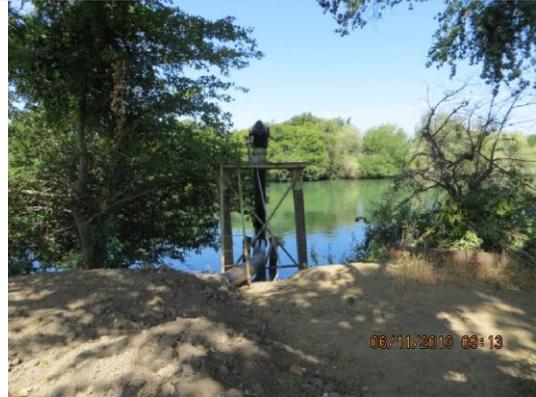
Photo 1 of 2 : UCIP_SP_2016_14867_24512.jpg

LM Start	0.73	Rating **	U	Issue No.	961
LM End	0.73	Issue Type +	En	Location *	LS
Category	Supplemental			GPS Latitude/Longitude	
				Start	End
Item	DWR UCIP Field Study			38.227262 °	38.227262 °
				-121.525844 °	-121.525844 °
DWR ID					
Comment Code					
Inspector Comment					
FS_ID:14867 DS_ID:20131 EP_NO: 11203 Repair Type: Urgent Crossing Status: Found UCIP Comments: Signs of leak in pipe at levee slope on both LS and WS where pipe enters levee. Moist soil at LS toe indicates possible internal leak. Evidence of recent pipe repair on WS. Pipe debris on WS toe should be removed. FIELD_STRUCT_DESC: 12-inch steel irrigation pipe through the levee 5.0 feet below the crown. Slant pump on bank. Siphon breaker and switch box on waterward slope. Service pole on landward slope. (ABO No. 11203, 1971) FS Date: 6/11/2013

Slant pump on WS berm.

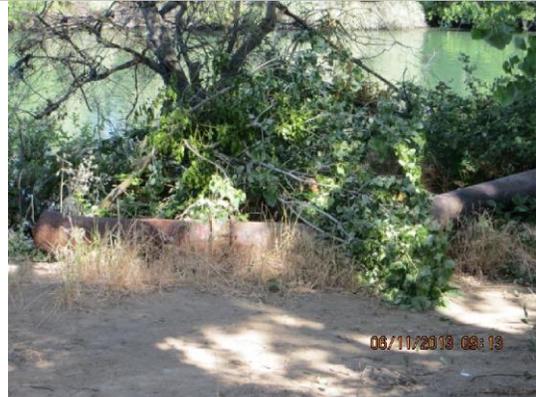
Photo 2 of 2 : UCIP_SP_2016_14867_24511.jpg

Pipe debris on WS berm.

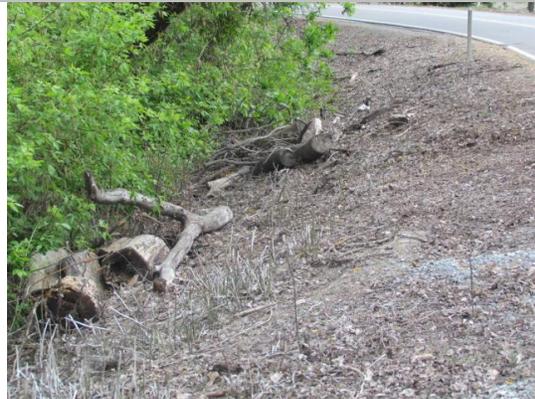
Photo 1 of 2 : SP_2016_RD0563_210_9_20160308_00009.jpg

LM Start	0.84	Rating **	A/W	Issue No.	9
LM End	0.84	Issue Type +	Ma	Location *	WS
Category	Earthen Levee		GPS Latitude/Longitude		
			Start	End	
Item	Encroachments		38.225685 °	38.225685 °	
			-121.526288 °	-121.526288 °	
DWR ID	DWR_RD0563_01_s_2012_9				
Comment Code					
PR : Prunings					
Inspector Comment					
Prunings on waterside slope should be burned or removed.

Looking northeast at tree limbs on waterward slope.

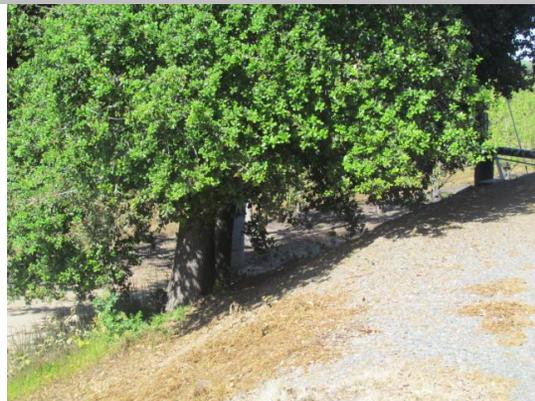
Photo 1 of 1 : SP_2016_RD0563_210_755_20160330_00229.jpg

Looking southeast at untrimmed tree on landward slope.

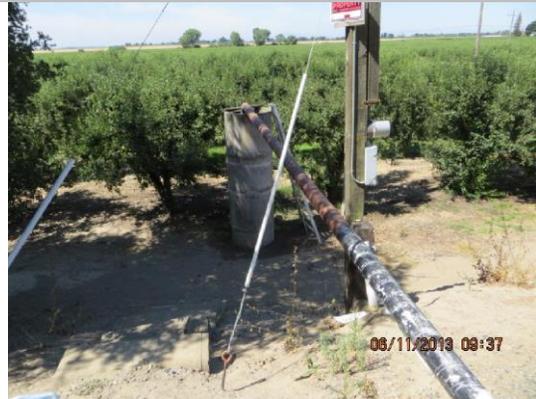
Photo 1 of 2 : UCIP_SP_2016_14870_24517.jpg

LM Start	0.93	Rating **	M	Issue No.	962
LM End	0.93	Issue Type +	En	Location *	LS
Category	Supplemental			GPS Latitude/Longitude	
				Start	End
Item	DWR UCIP Field Study			38.225595 °	38.225595 °
				-121.527813 °	-121.527813 °
DWR ID					
Comment Code					
Inspector Comment					
FS_ID:14870 DS_ID:20132 EP_NO: 11210 Repair Type: Non-Urgent Crossing Status: Found UCIP Comments: Pipe does not have sufficient cover at crown. FIELD_STRUCT_DESC: 1 of 2: 6-inch pipe through the levee 3-inches below the crown. Pump and gate valve in pump house on waterward slope. Service pole on landward slope. (ABO No. 11210, 1971). 1-inch PVC electrical conduit through levee at same location. Originally included in 1954 O&M manual. FS Date: 6/11/2013

6-inch pipe and concrete standpipe on LS. Electrical conduit runs parallel to pipe to pumphouse on WS.

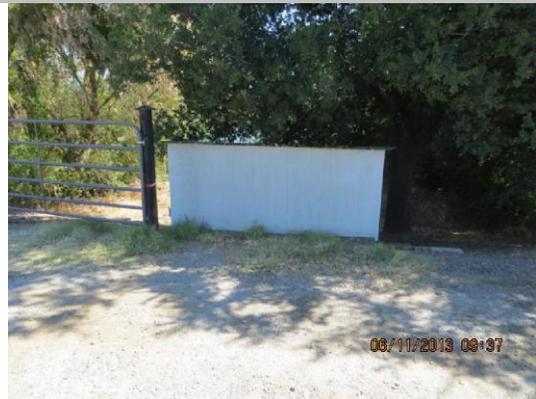
Photo 2 of 2 : UCIP_SP_2016_14870_24516.jpg

Pumphouse on WS shoulder.

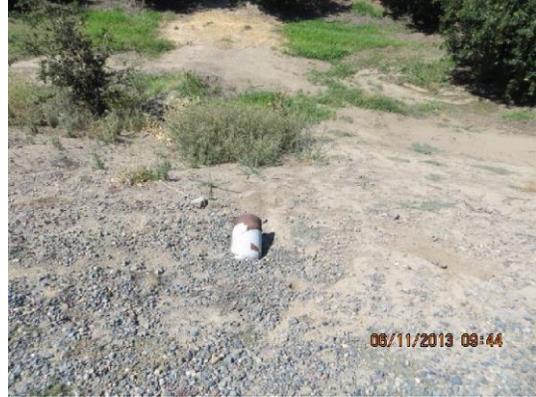
Photo 1 of 2 : UCIP_SP_2016_41248_24525.jpg

LM Start	0.96	Rating **	U	Issue No.	985
LM End	0.96	Issue Type +	En	Location *	LS
Category	Supplemental			GPS Latitude/Longitude	
				Start	End
Item	DWR UCIP Field Study			38.225830 °	38.225830 °
				-121.528201 °	-121.528201 °
DWR ID					
Comment Code					
Inspector Comment					
FS_ID:41248 DS_ID:20133 EP_NO: 11210 Repair Type: Urgent Crossing Status: Found UCIP Comments: Flap gate rusted in closed position. FIELD_STRUCT_DESC: 2 of 2: 8-inch pipe through the levee 3.0 feet below the crown. Flap gate on waterward end. Landward end open (ABO No. 11210, 1971). FS Date: 6/11/2013

Pipe open on LS slope.

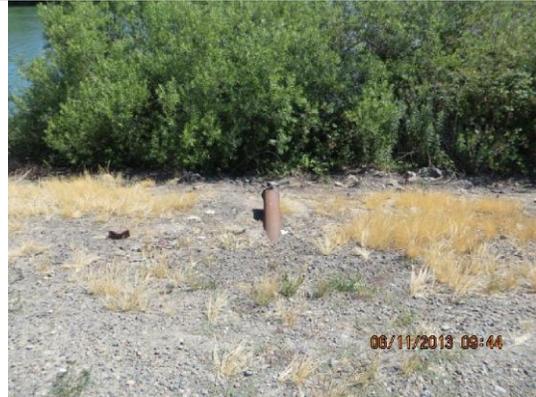
Photo 2 of 2 : UCIP_SP_2016_41248_24524.jpg

Pipe and flapgate on WS slope.

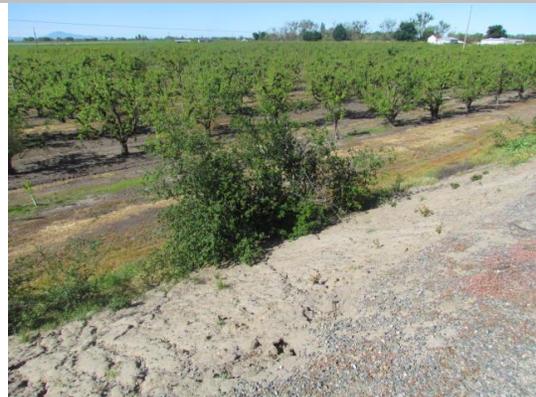
Photo 1 of 1 : SP_2016_RD0563_210_132_20160330_00231.jpg

Looking southeast at several small trees at landward toe.

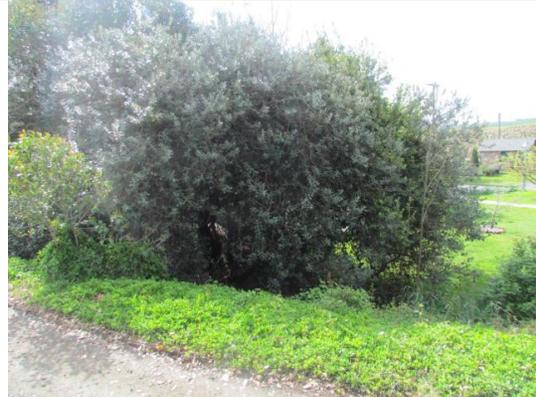
Photo 1 of 1 : SP_2016_RD0563_210_54_20160308_00052.jpg

Looking South at landscaping on landside slope.

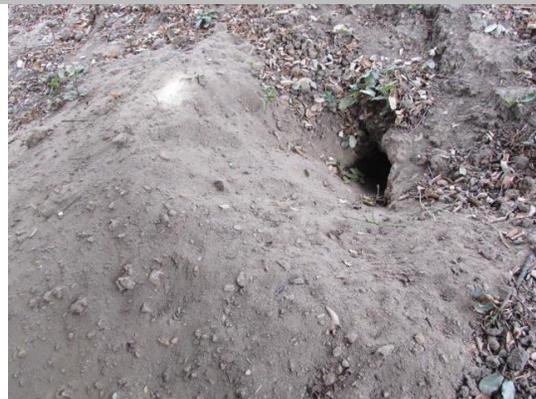
Photo 1 of 1 : SP_2016_RD0563_210_153_20160308_00135.jpg

LM Start	1.15	Rating **	U	Issue No.	153
LM End	1.15	Issue Type +	Ma	Location *	LS
Category	Earthen Levee		GPS Latitude/Longitude		
			Start	End	
Item	Animal Control		38.226910 °	38.226910 °	
			-121.531294 °	-121.531294 °	
DWR ID	DWR_RD0563_01_f_2015_153				
Comment Code					
A3 : No rodents visible, but rodent burrows visible; need to backfill and compact or grout burrows.					
Inspector Comment					
Several large to medium rodent holes noted.

Looking at typical view of several rodent holes on landward slope.

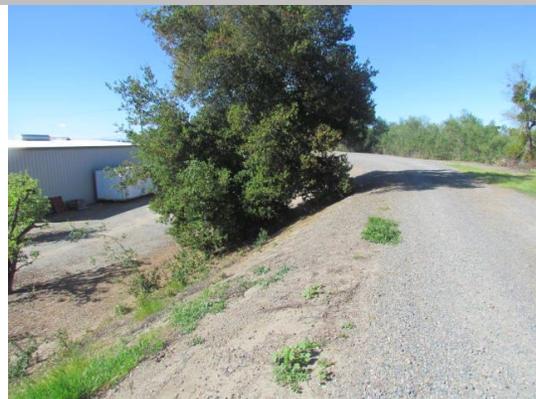
Photo 1 of 1 : SP_2016_RD0563_210_140_20160330_00232.jpg

Looking southeast at untrimmed tree at landward toe.

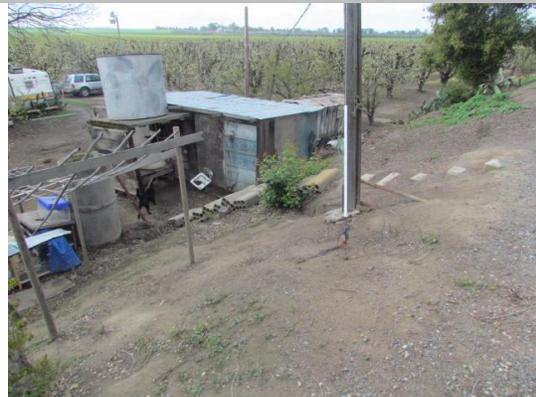
Photo 3 of 3 : SP_2016_RD0563_210_8_20160308_00008.jpg

Looking southeast at a tool shed at the landside toe.

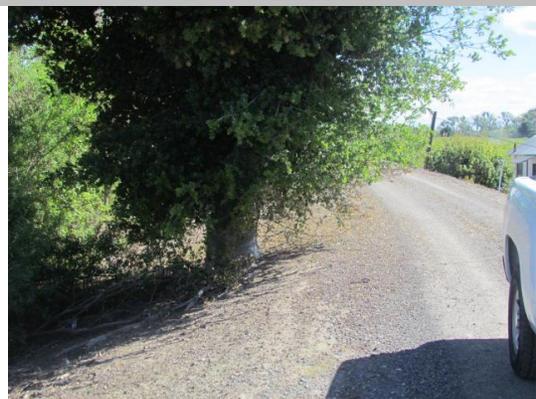
Photo 1 of 1 : SP_2016_RD0563_210_759_20160330_00240.jpg

Looking northwest at untrimmed trees on waterward slope and toe.

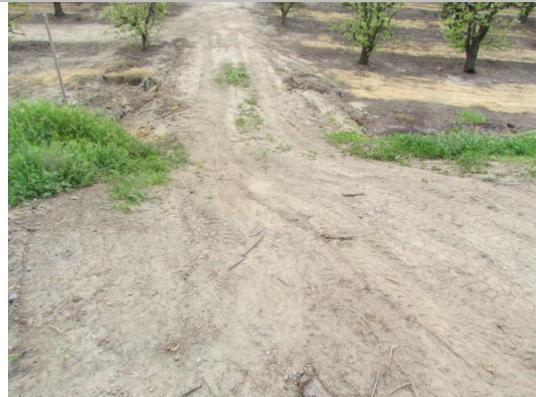
Photo 2 of 2 : SP_2016_RD0563_210_141_20160308_00126.jpg

Looking east at ramp on landward slope.

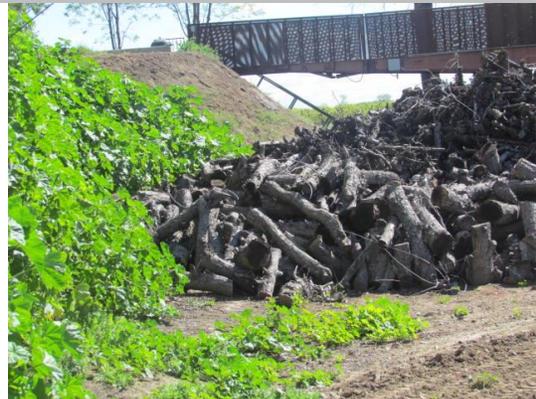
Photo 1 of 1 : SP_2016_RD0563_210_161_20160330_00241.jpg

Looking north at fireward at landward toe.

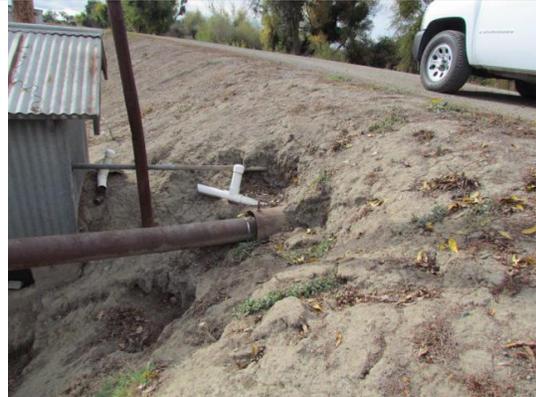
Photo 2 of 2 : SP_2016_RD0563_210_71_20160308_00064.jpg

Looking southwest at erosion around irrigation pipe on landside slope and toe.

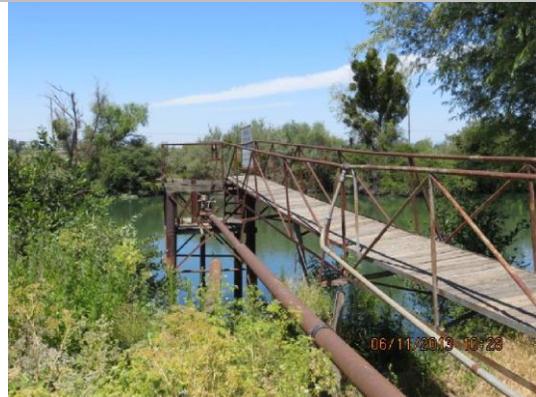
Photo 1 of 2 : UCIP_SP_2016_14878_24537.jpg

Pump on pile structure with walkway structurally failing. WS berm.

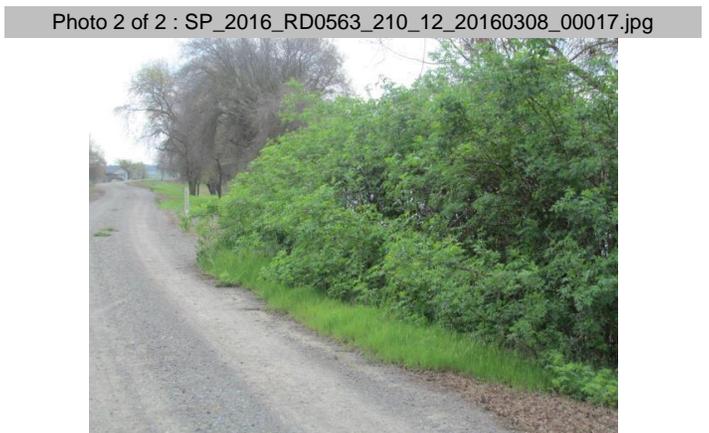
Looking southwest at dense elderberry on waterside shoulder and slope. (Fall 2014)

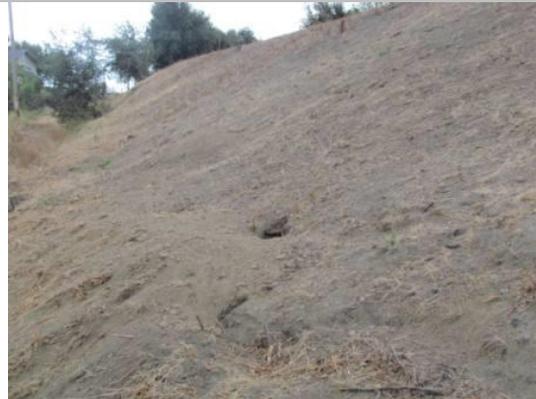
Photo 3 of 4 : SP_2016_RD0563_210_85_20160308_00089.jpg

Looking southwest at rodent holes on landside slope.

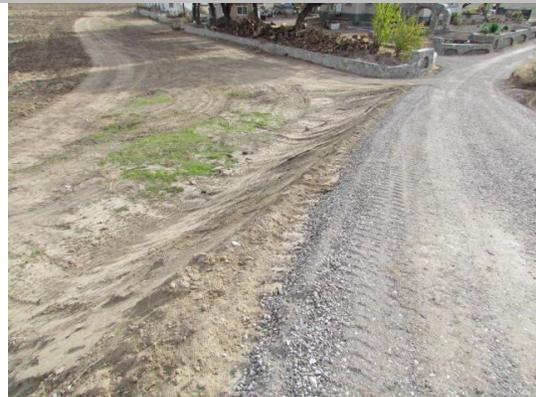
Photo 1 of 2 : SP_2016_RD0563_210_80_20160308_00081.jpg

Looking east at unauthorized ramp on landside slope.

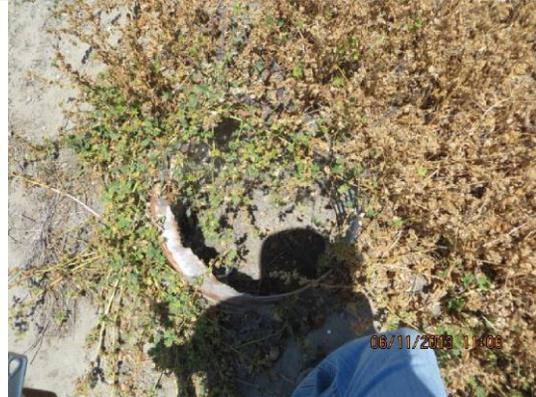
Photo 1 of 1 : UCIP_SP_2016_14885_24548.jpg

24-inch CMP standpipe on LS slope.

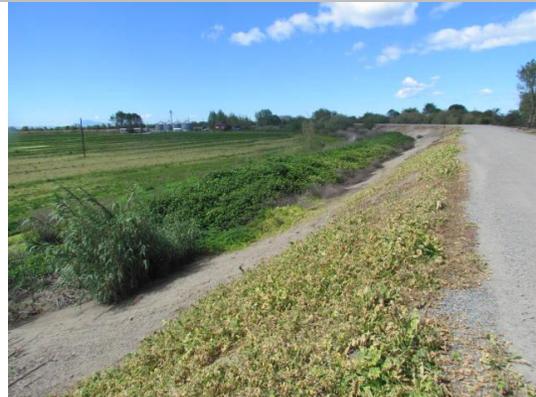
Photo 1 of 4 : SP_2016_RD0563_210_74_20160330_00244.jpg

Looking southeast at berryvines at landward toe., (Spring 2016)

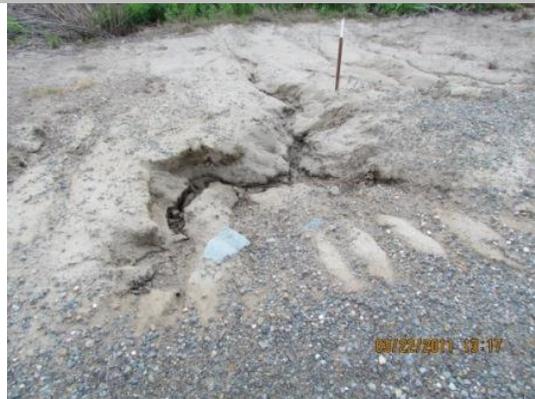
Photo 2 of 5 : SP_2016_RD0563_210_78_20160308_00077.jpg

Looking east at slope erosion cause by runoff on landside slope.

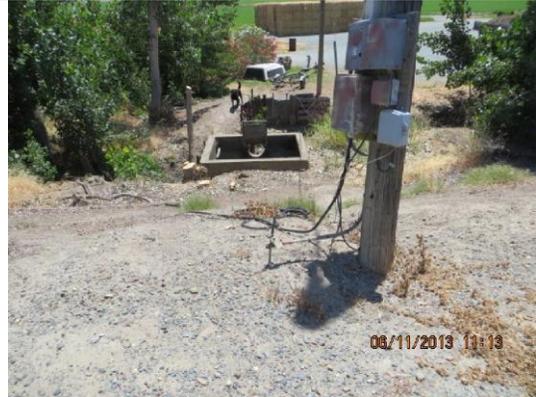
Photo 1 of 2 : UCIP_SP_2016_14887_24550.jpg

Distribution box and JP on LS.

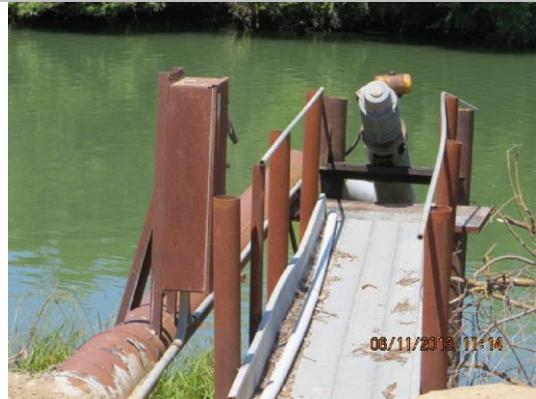
Photo 2 of 2 : UCIP_SP_2016_14887_24549.jpg

Pump and walkway on WS.

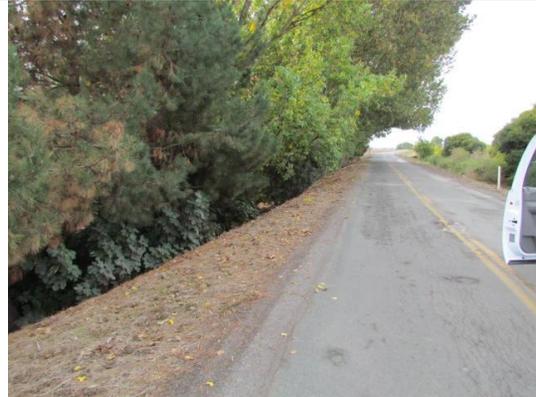
Photo 1 of 1 : SP_2016_RD0563_210_88_20160308_00093.jpg

Looking south at dense trees on landside slope and toe.

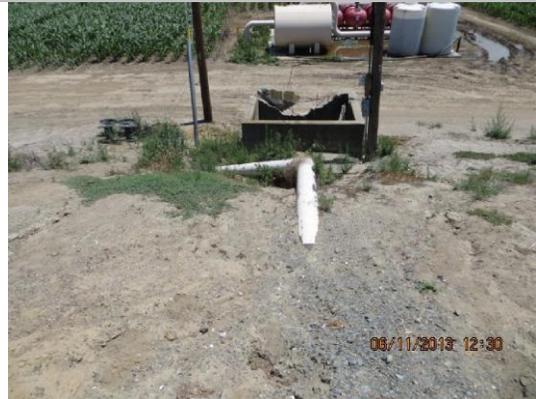
Photo 1 of 2 : UCIP_SP_2016_14927_24590.jpg

Pipe, distribution box, JP, electrical conduit, and booster/filter system on LS.

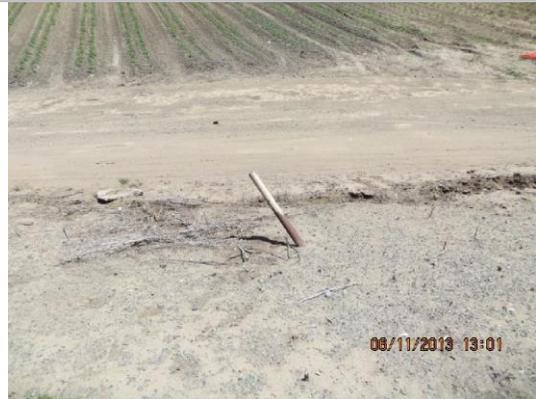
Photo 1 of 2 : UCIP_SP_2016_16289_27439.jpg

Pipe visible on LS slope.

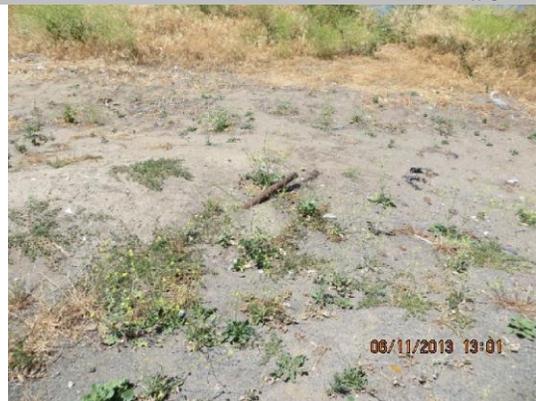
Photo 2 of 2 : UCIP_SP_2016_16289_27438.jpg

Pipe visible on WS shoulder.

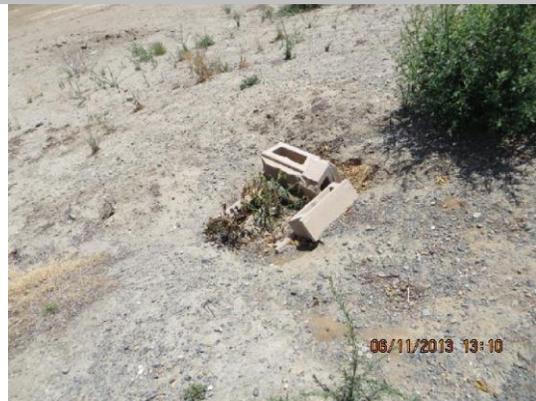
Photo 1 of 2 : UCIP_SP_2016_14950_24607.jpg

Vent/filler pipe exposed on LS shoulder.

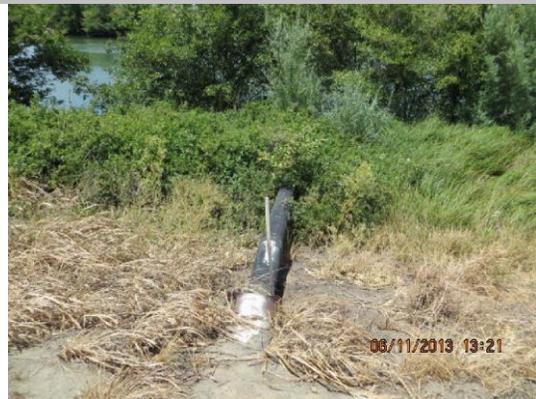
Photo 1 of 2 : UCIP_SP_2016_14963_24622.jpg

10-inch pipe sleeved through 18-inch conduit.

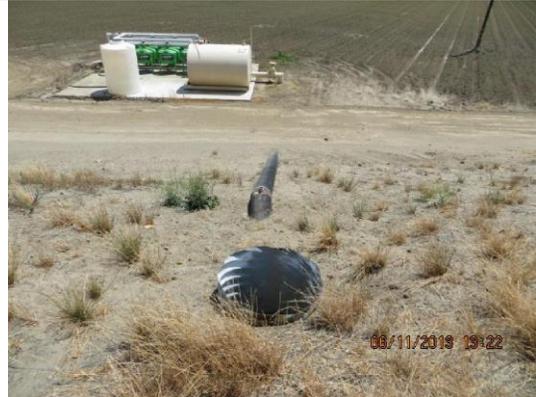
Photo 2 of 2 : UCIP_SP_2016_14963_24621.jpg

Siphon breaker in 24-inch CMP riser on LS shoulder.

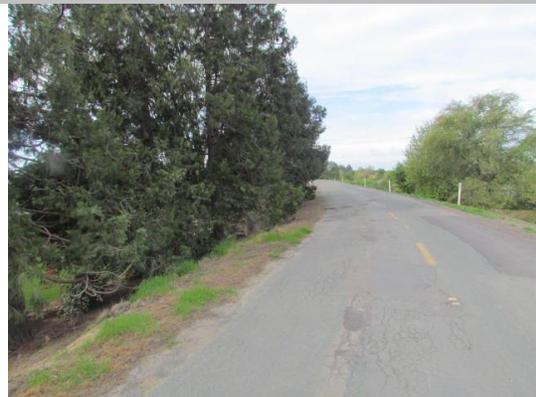
Photo 1 of 1 : SP_2016_RD0563_210_23_20160308_00025.jpg

Looking south at trees on landward shoulder.

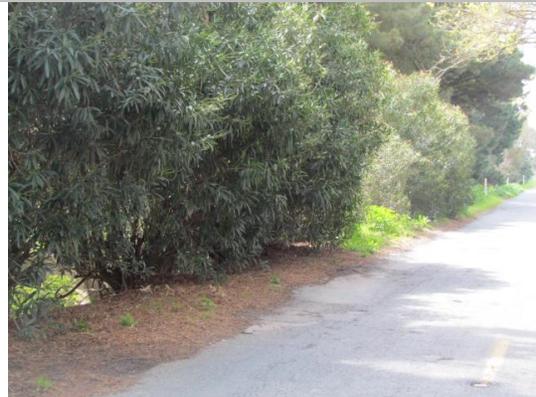
Photo 1 of 1 : SP_2016_RD0563_210_25_20160308_00026.jpg

Looking southeast at dense landscaping on landside shoulder and slope.

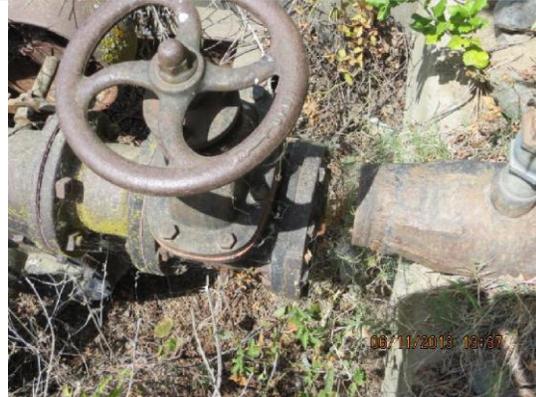
Photo 1 of 2 : UCIP_SP_2016_14966_24628.jpg

No connection to pump on WS shoulder.

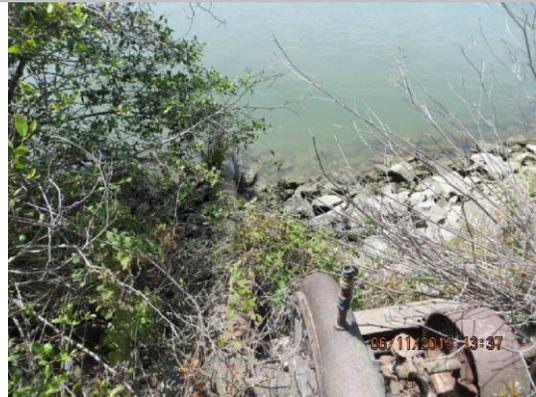
Photo 2 of 2 : UCIP_SP_2016_14966_24627.jpg

Pump and pipe on WS slope.

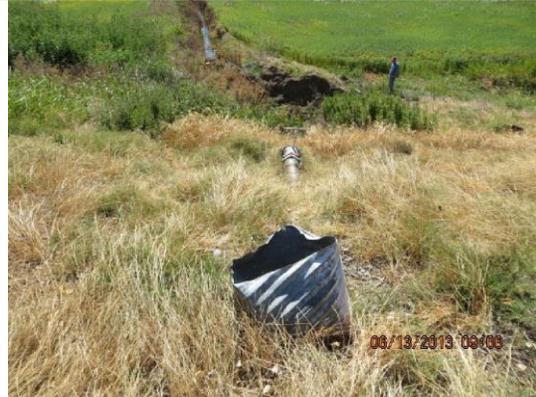
Photo 2 of 2 : UCIP_SP_2016_40790_24632.jpg

24-inch CMP standpipe with vent/filler pipe on LS shoulder.

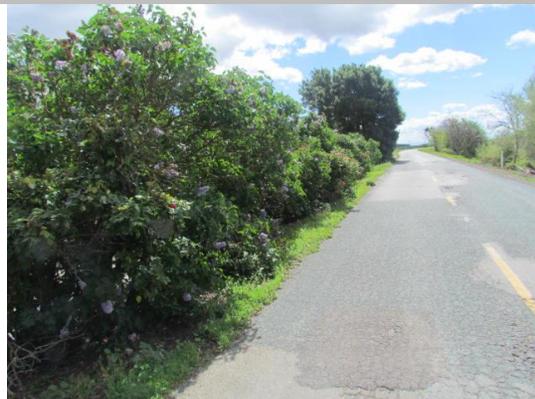
Photo 1 of 1 : SP_2016_RD0563_210_75_20160330_00251.jpg

Looking south at dense landscaping on landward shoulder and slope. (Spring 2016)

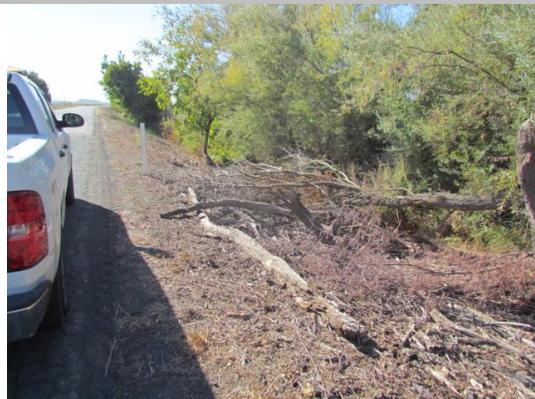
Photo 1 of 1 : SP_2016_RD0563_210_82_20160308_00083.jpg

Looking south at tree limbs on waterward slope.

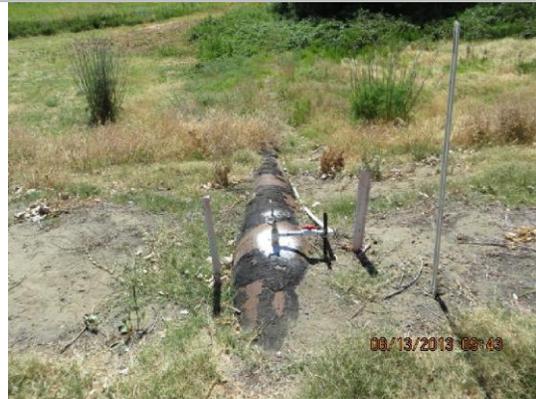
Photo 2 of 2 : UCIP_SP_2016_42743_24640.jpg

Pipe, vent, and filler valve on LS shoulder.

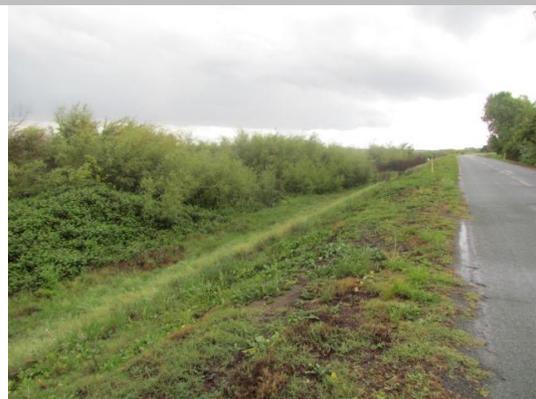
Photo 1 of 1 : SP_2016_RD0563_210_27_20160308_00028.jpg

Looking southeast at dense vegetation within landward right away.

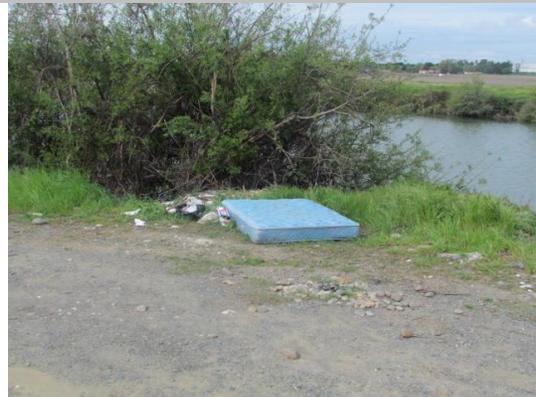
Photo 1 of 1 : SP_2016_RD0563_210_146_20160308_00133.jpg

Looking west at garbage on waterward slope and toe.

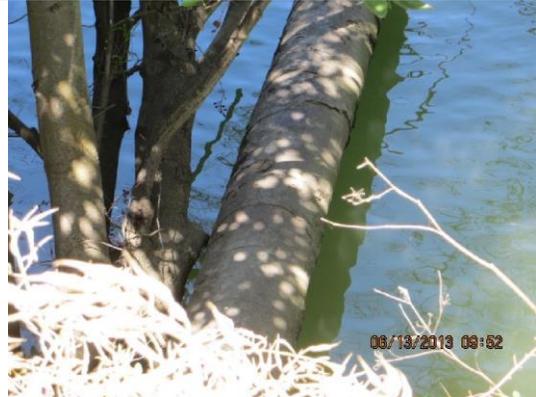
Photo 1 of 2 : UCIP_SP_2016_16304_27464.jpg

Pipe visible on WS toe.

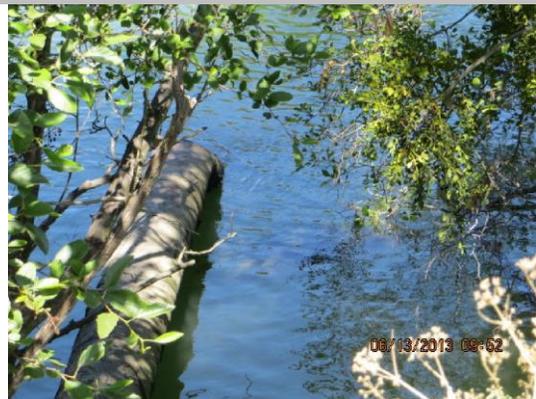
Photo 2 of 2 : UCIP_SP_2016_16304_27463.jpg

Pipe visible on WS toe.

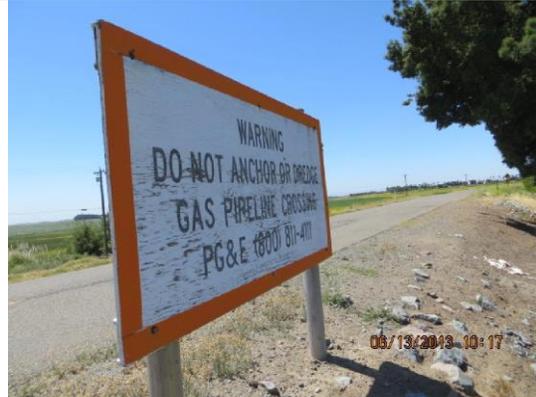
Photo 1 of 2 : UCIP_SP_2016_16265_27407.jpg

Sign on WS shoulder.

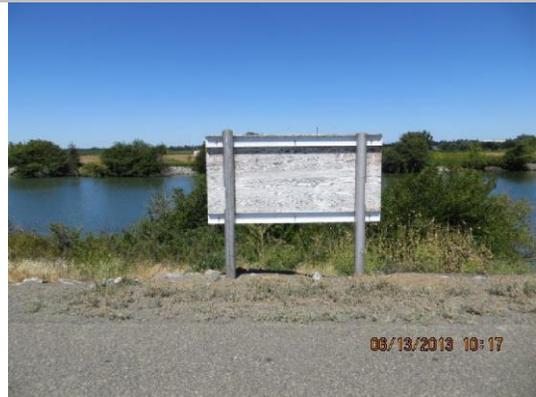
Photo 2 of 2 : UCIP_SP_2016_16265_27406.jpg

Sign on WS shoulder.

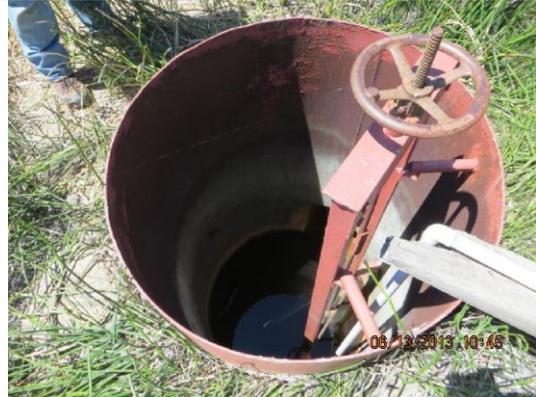
Photo 2 of 2 : UCIP_SP_2016_14988_24669.jpg

Slide gate in steel riser on LS toe.

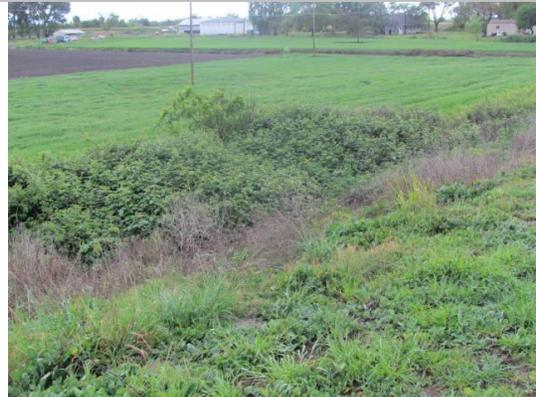
Photo 1 of 1 : SP_2016_RD0563_210_767_20160308_00142.jpg

Looking east at dense wild vines at landward toe.

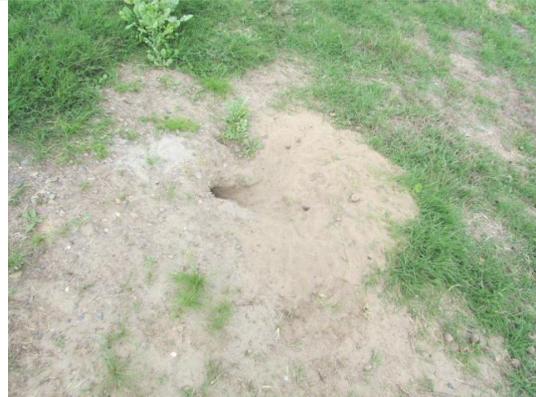
Photo 4 of 4 : SP_2016_RD0563_210_77_20160308_00076.jpg

Looking at typical rodent holes on landward slope.

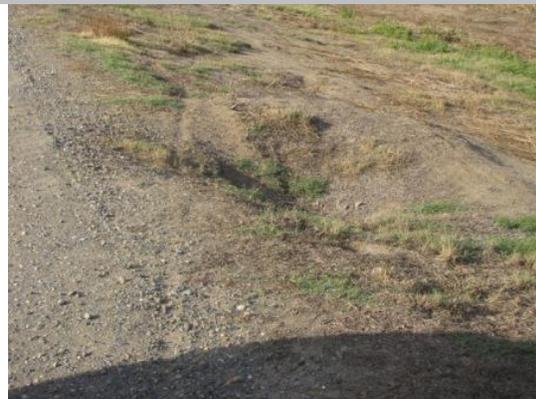
Photo 1 of 4 : SP_2016_RD0563_210_76_20160308_00070.jpg

Looking northeast a depression on landside shoulder and slope above 10" irrigation pipe four feet below crown.

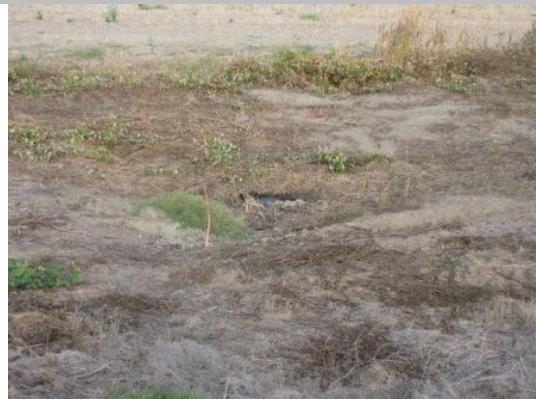
Photo 2 of 4 : SP_2016_RD0563_210_76_20160308_00071.jpg

Looking east at water ponding at landside toe just above 10" irrigation pipe.

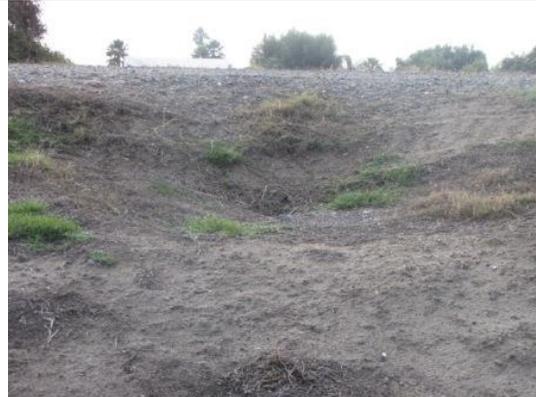
Photo 3 of 4 : SP_2016_RD0563_210_76_20160308_00072.jpg

Looking west at depression on landside shoulder and slope from landside toe.

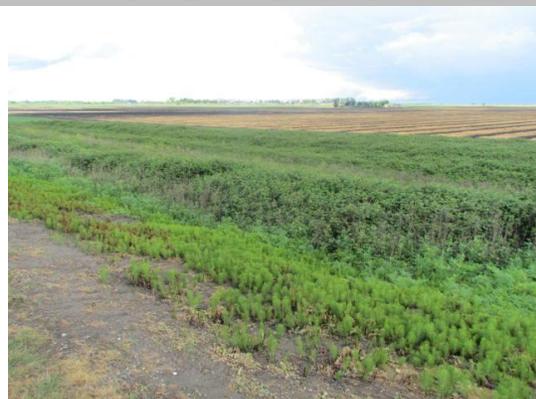
Photo 1 of 3 : SP_2016_RD0563_210_100_20160308_00111.jpg

Looking northeast at dense vegetation at landward toe. (Spring 2015)

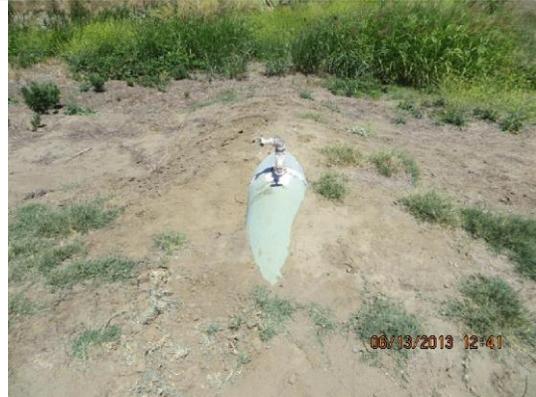
Photo 1 of 2 : UCIP_SP_2016_15002_24691.jpg

Vent/filler on pipe at LS shoulder.

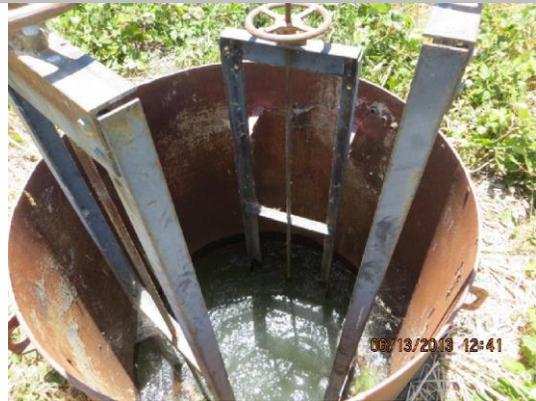
Photo 2 of 2 : UCIP_SP_2016_15002_24690.jpg

slide gate in steel riser on LS toe.

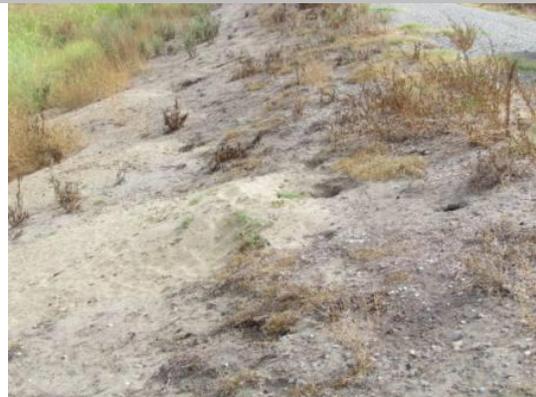
Photo 3 of 3 : SP_2016_RD0563_210_91_20160308_00102.jpg

Looking south at rodent holes on landside slope.

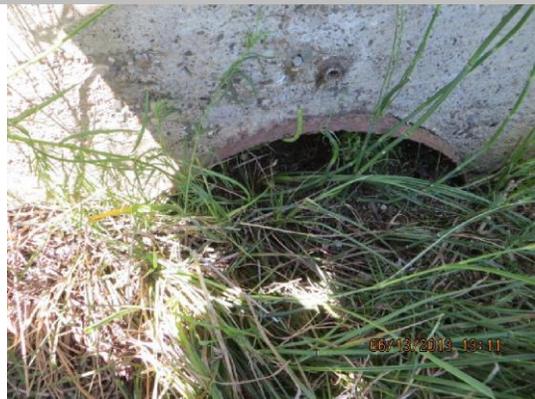
Photo 2 of 2 : UCIP_SP_2016_15028_24735.jpg

Pipe at concrete headwall on WS slope.

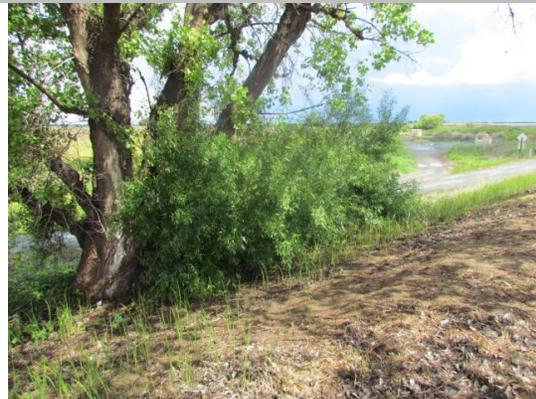
Photo 1 of 1 : SP_2016_RD0563_210_47_20160308_00046.jpg

Looking east at untrimmed tree at landward slope. (Spring 2015)
