**Flood Control Project Maintenance
Levee Inspections**

Maintenance Issue Types Only, Levee Inspection Report By Mile - Fall 2015

Reclamation District No. 0563 Tyler Island

Waterway	Bank	Unit Miles	Inspection Start/End	Inspector
Unit No. 01 Georgiana Slough (Tyler Island)	Left	12.11	09/16/2015 09/16/2015	Richard Willoughby

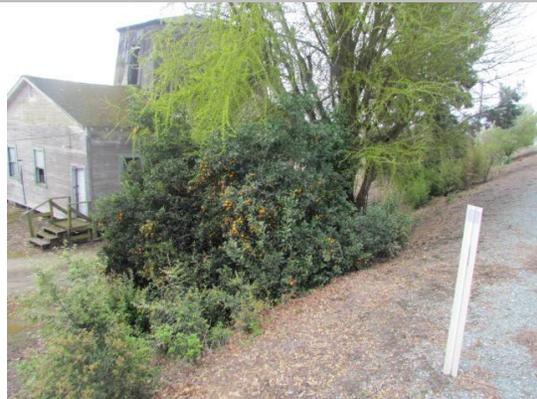
Photo 2 of 2 : FA_2015_RD0563_210_28_20150914_00032.jpg

LM Start	0.12	Rating **	A/W	Issue No.	28
LM End	0.14	Issue Type +	Ma	Location *	LS
Category	Earthen Levee		GPS Latitude/Longitude		
			Start	End	
Item	Trim / Thin Trees		38.233910 °	38.233655 °	
			-121.518722 °	-121.519000 °	
DWR ID	DWR_RD0563_01_s_2012_28				
Action/Comments					
Trim trees to at least five feet above ground level.

Looking southeast at landscaping on landside slope and toe.

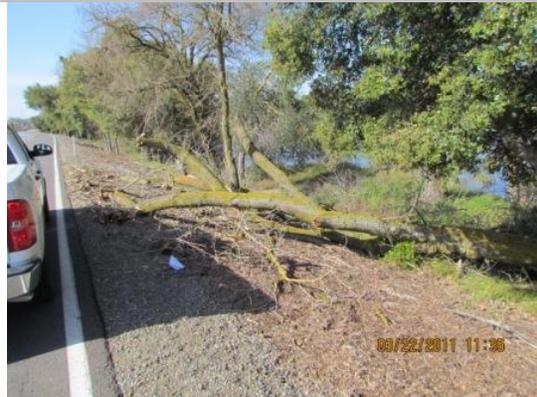
Photo 1 of 1 : FA_2015_RD0563_210_32_20150914_00035.jpg

LM Start	0.17	Rating **	M	Issue No.	32
LM End	0.17	Issue Type +	Ma	Location *	WS
Category	Earthen Levee		GPS Latitude/Longitude		
			Start	End	
Item	Encroachments		38.233315 °	38.233315 °	
			-121.519360 °	-121.519360 °	
DWR ID	DWR_RD0563_01_s_2012_32				
Action/Comments					
Tree or limb Inspector Comments: Tree fallen across waterward slope.

Looking south (downstream) at fallen tree limb on waterside slope.

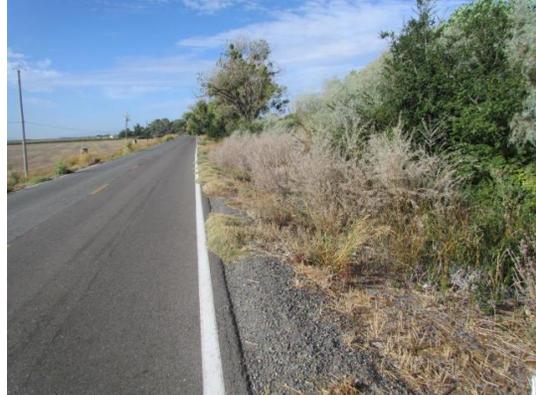
Photo 1 of 1 : FA_2015_RD0563_210_136_20150917_00180.jpg

Looking at young willows on waterward slope.

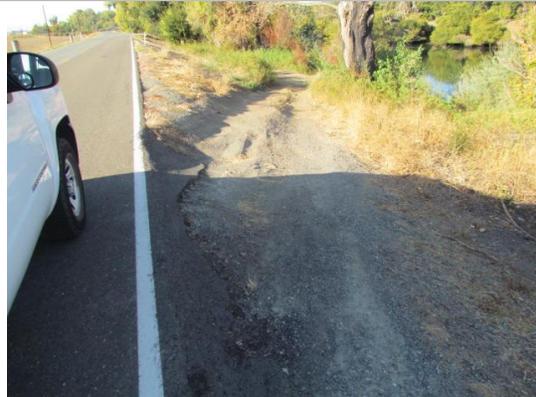
Photo 1 of 1 : FA_2015_RD0563_210_16_20150914_00020.jpg

LM Start	0.39	Rating **	M	Issue No.	16
LM End	0.39	Issue Type +	Ma	Location *	WS
Category	Earthen Levee		GPS Latitude/Longitude		
			Start	End	
Item	Slope Stability		38.230841 °	38.230841 °	
			-121.521898 °	-121.521898 °	
DWR ID	DWR_RD0563_01_f_2013_16				
Action/Comments					
Repair the levee slope damaged by vehicle traffic and prevent access where possible. Inspector Comments: Slope damage is due to fishermen vehicle traffic.

Looking southwest at slope damage caused by vehicle traffic.

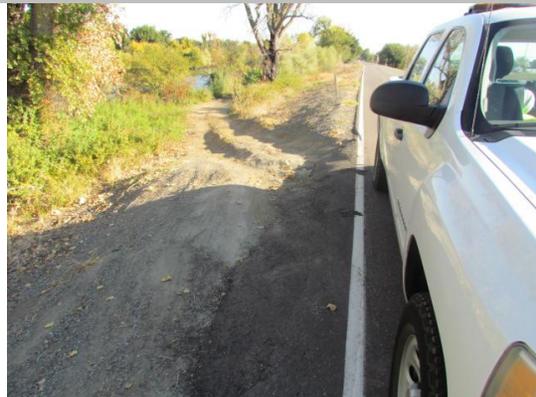
Photo 1 of 1 : FA_2015_RD0563_210_26_20150914_00029.jpg

LM Start	0.43	Rating **	M	Issue No.	26
LM End	0.43	Issue Type +	Ma	Location *	WS
Category	Earthen Levee		GPS Latitude/Longitude		
			Start	End	
Item	Slope Stability		38.230460 °	38.230460 °	
			-121.522324 °	-121.522324 °	
DWR ID	DWR_RD0563_01_f_2013_26				
Action/Comments					
Repair the levee slope damaged by vehicle traffic and prevent access where possible. Inspector Comments: Slope damage due to fishermen vehicle traffic.

Looking northwest at slope damage caused by vehicle traffic.

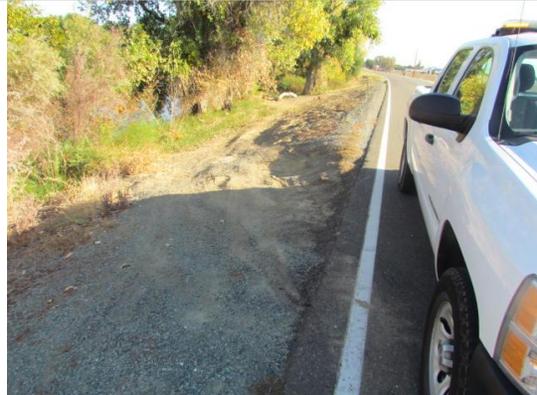
Photo 1 of 1 : FA_2015_RD0563_210_34_20150914_00037.jpg

LM Start	0.56	Rating **	M	Issue No.	34
LM End	0.56	Issue Type +	Ma	Location *	WS
Category	Earthen Levee		GPS Latitude/Longitude		
			Start	End	
Item	Slope Stability		38.228948 °	38.228948 °	
			-121.523904 °	-121.523904 °	
DWR ID	DWR_RD0563_01_f_2013_34				
Action/Comments					
Repair the levee slope damaged by vehicle traffic and prevent access where possible. Inspector Comments: Slope damage is due to fishermen vehicle traffic.

Looking northwest at slope damage caused by vehicle traffic.

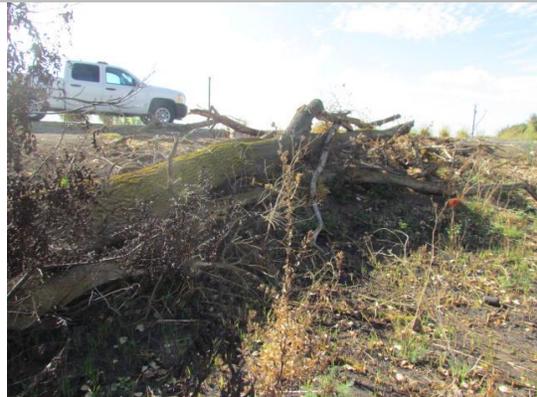
Photo 1 of 5 : FA_2015_RD0563_210_139_20150917_00182.jpg

LM Start	0.60	Rating **	U	Issue No.	139
LM End	0.60	Issue Type +	Ma	Location *	WS
Category	Earthen Levee		GPS Latitude/Longitude		
			Start	End	
Item	Encroachments		38.228605 °	38.228605 °	
			-121.524364 °	-121.524364 °	
DWR ID	DWR_RD0563_01_f_2015_139				
Action/Comments					
Tree or limb Inspector Comments: Large fallen tree on waterward slope. Fallen tree left large hole on waterward berm.

Looking southeast at fallen tree on waterward slope.

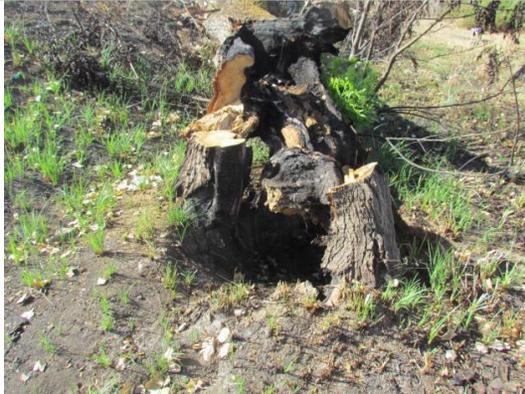
Photo 4 of 5 : FA_2015_RD0563_210_139_20150917_00185.jpg

Looking at stump of fallen tree on waterward berm.

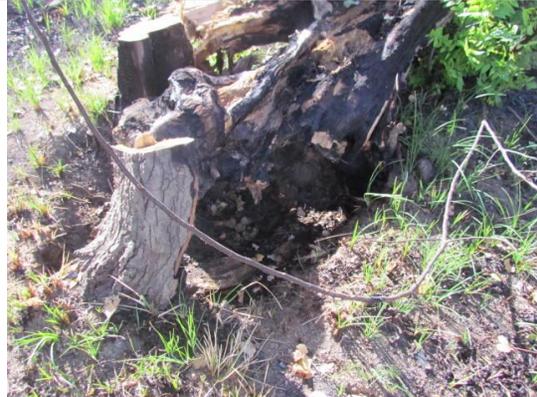
Photo 5 of 5 : FA_2015_RD0563_210_139_20150917_00186.jpg

Looking at large hole left by fallen tree on waterward berm.

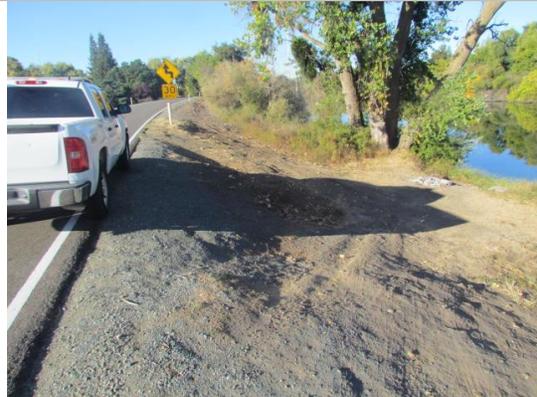
Photo 1 of 2 : FA_2015_RD0563_210_143_20150914_00136.jpg

LM Start	0.61	Rating **	M	Issue No.	143
LM End	0.61	Issue Type +	Ma	Location *	WS
Category	Earthen Levee			GPS Latitude/Longitude	
				Start	End
Item	Slope Stability			38.228507 °	38.228507 °
				-121.524543 °	-121.524543 °
DWR ID	DWR_RD0563_01_f_2014_143				
Action/Comments					
Repair the levee slope damaged by vehicle traffic and prevent access where possible. Inspector Comments: Slope damage due to vehicle traffic.

Looking southeast at slope damage on waterward slope.

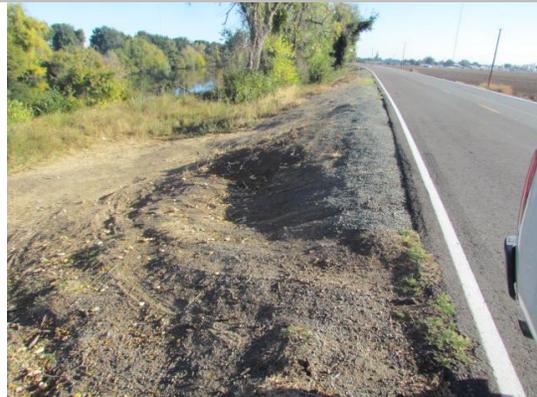
Photo 2 of 2 : FA_2015_RD0563_210_143_20150914_00137.jpg

Looking northwest at slope damage on waterward slope.

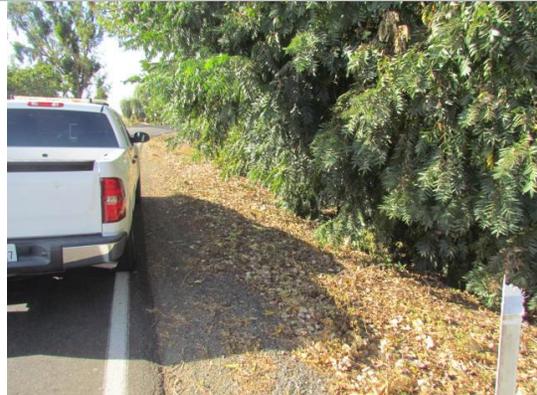
Photo 1 of 1 : FA_2015_RD0563_210_3_20150917_00187.jpg

Looking south at untrimmed trees on waterward slope and toe.

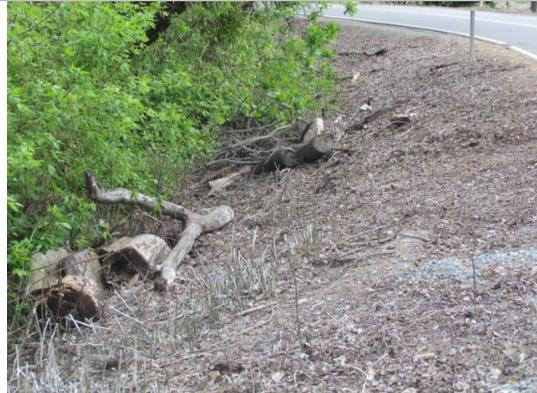
Photo 1 of 2 : FA_2015_RD0563_210_9_20150914_00010.jpg

LM Start	0.84	Rating **	M	Issue No.	9
LM End	0.84	Issue Type +	Ma	Location *	WS
Category	Earthen Levee		GPS Latitude/Longitude		
			Start	End	
Item	Encroachments		38.225685 °	38.225685 °	
			-121.526288 °	-121.526288 °	
DWR ID	DWR_RD0563_01_s_2012_9				
Action/Comments					
Prunings Inspector Comments: Prunings on waterside slope should be burned or removed.

Looking northeast at tree limbs on waterward slope.

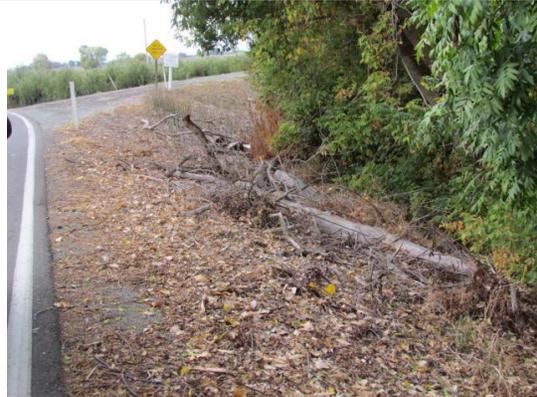
Photo 2 of 2 : FA_2015_RD0563_210_9_20150914_00011.jpg

LM Start	0.84	Rating **	M	Issue No.	9 (cont)
LM End	0.84	Issue Type +	Ma	Location *	WS
Category	Earthen Levee		GPS Latitude/Longitude		
			Start	End	
Item	Encroachments		38.225685 °	38.225685 °	
			-121.526288 °	-121.526288 °	
DWR ID	DWR_RD0563_01_s_2012_9				
Action/Comments					
Prunings Inspector Comments: Prunings on waterside slope should be burned or removed.

Looking southwest at tree limbs on waterside slope.

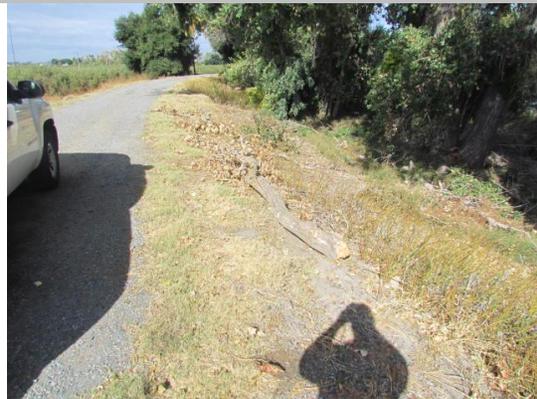
Photo 1 of 1 : FA_2015_RD0563_210_144_20150917_00188.jpg

Looking at tree limbs on waterward shoulder and slope.

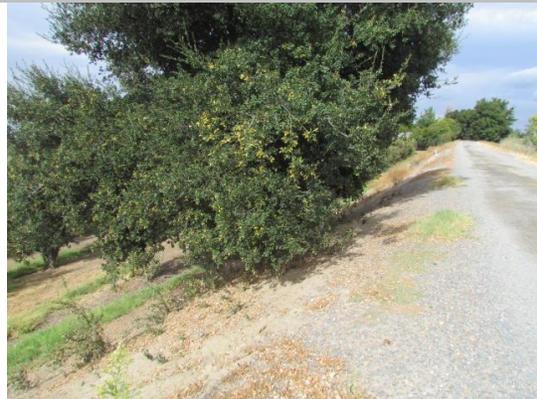
Photo 1 of 1 : FA_2015_RD0563_210_757_20150917_00189.jpg

Looking at untrimmed trees on landward slope.

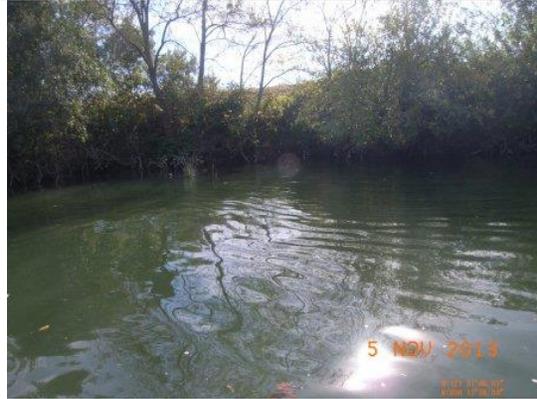
Photo 1 of 1 : USACE2013A_GEO_11-0_L_6.jpg

LM Start	1.02	Rating **	M	Issue No.	48
LM End	1.11	Issue Type +	Ma	Location *	WS
Category	Supplemental			GPS Latitude/Longitude	
				Start	End
Item	2015 USACE Erosion Survey, DRAFT			38.226522 °	38.227157 °
				-121.529094 °	-121.530432 °
DWR ID					
Action/Comments					
Inspector Comments: 2011 - Short sections of eroding bank at the waterline and holes in toe of levee. 2012 - Site extended upstream. 2013 - Erosion pockets filled with an insufficient amounts of revetment. 2015: Last observed in 2013. [2015 Site ID: GEO_11-0_L]

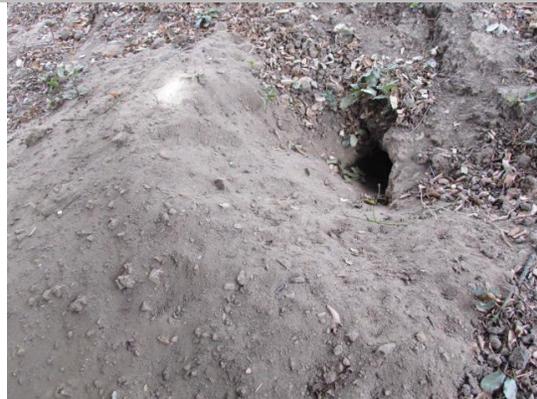
Photo 1 of 1 : FA_2015_RD0563_210_153_20150917_00190.jpg

LM Start	1.15	Rating **	U	Issue No.	153
LM End	1.15	Issue Type +	Ma	Location *	LS
Category	Earthen Levee			GPS Latitude/Longitude	
				Start	End
Item	Animal Control			38.226910 °	38.226910 °
				-121.531294 °	-121.531294 °
DWR ID	DWR_RD0563_01_f_2015_153				
Action/Comments					
No rodents visible, but rodent burrows visible; need to backfill and compact or grout burrows. Inspector Comments: Several large to medium rodent holes noted.

Looking at typical view of several rodent holes on landward slope.

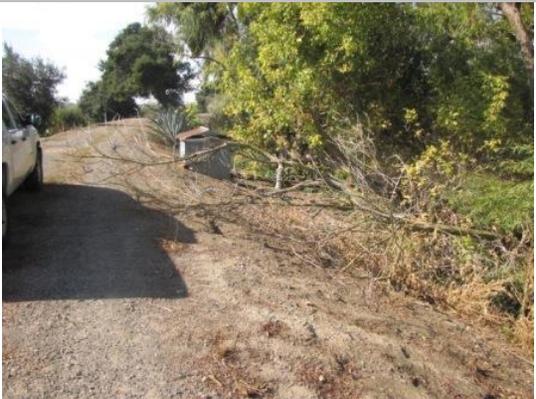
Photo 1 of 1 : FA_2015_RD0563_210_19_20150914_00024.jpg

LM Start	1.39	Rating **	M	Issue No.	19
LM End	1.39	Issue Type +	Ma	Location *	WS
Category	Earthen Levee		GPS Latitude/Longitude		
			Start	End	
Item	Encroachments		38.224367 °	38.224367 °	
			-121.534165 °	-121.534165 °	
DWR ID	DWR_RD0563_01_s_2012_19				
Action/Comments					
Tree or limb Inspector Comments: Broken tree along waterside slope.

Looking south at a downed tree on waterside slope.

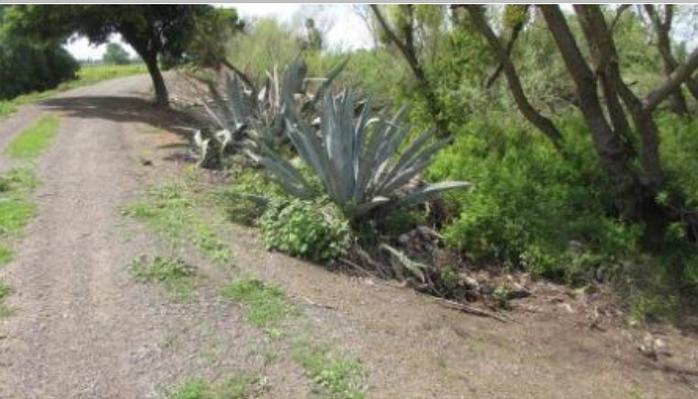
Photo 1 of 2 : FA_2015_RD0563_210_6_20150914_00005.jpg

Updated view looking upstream at a century plant on waterside shoulder slope.

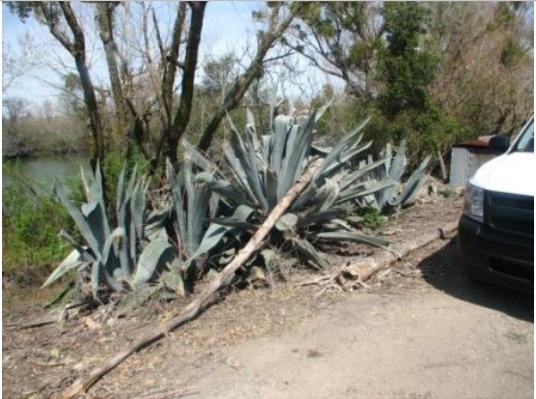
Photo 2 of 2 : FA_2015_RD0563_210_6_20150914_00006.jpg

Century plant on waterward shoulder at LM 1.42

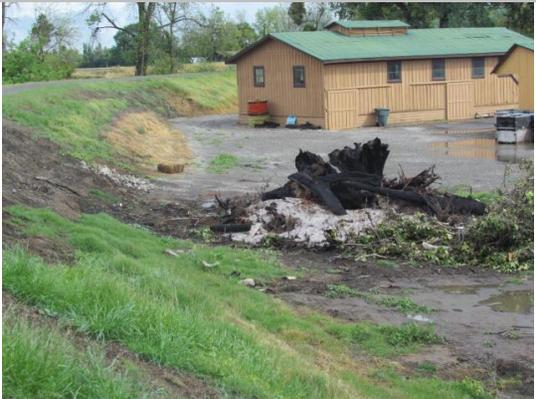
Photo 2 of 2 : FA_2015_RD0563_210_96_20150914_00120.jpg

LM Start	1.94	Rating **	M	Issue No.	96 (cont)
LM End	1.94	Issue Type +	Ma	Location *	LS
Category	Earthen Levee		GPS Latitude/Longitude		
			Start	End	
Item	Encroachments		38.222094 °	38.222094 °	
			-121.543435 °	-121.543435 °	
DWR ID	DWR_RD0563_01_f_2013_96				
Action/Comments					
Prunings Inspector Comments: Large pruning pile at landward toe. Landowner has burned pile, but pile is still within right away.

Looking north at partially burned pruning pile at landward toe. (Spring 2015)

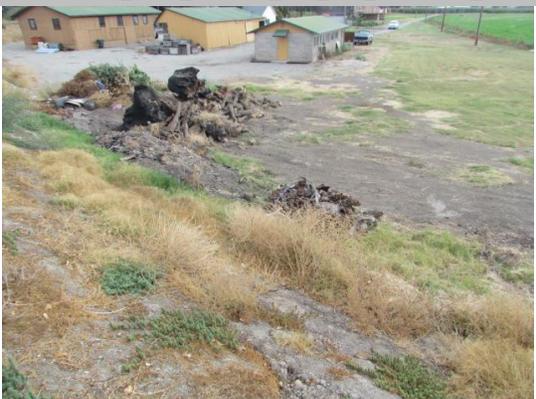
Photo 1 of 1 : FA_2015_RD0563_210_157_20150917_00192.jpg

Looking at garbage stockpile at landward toe.

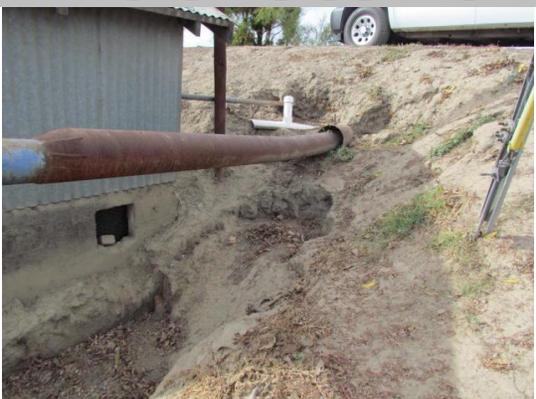
Photo 1 of 2 : FA_2015_RD0563_210_71_20150914_00080.jpg

Looking west at erosion at landside toe and slope next to pump house.

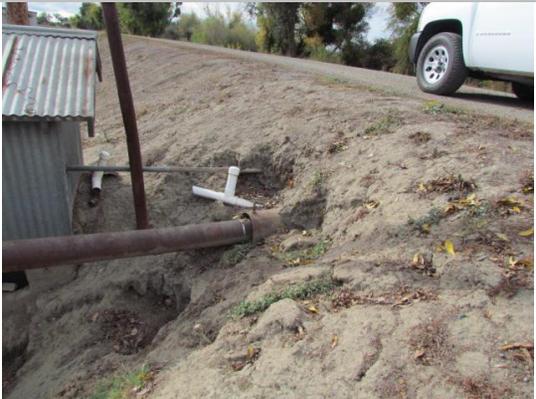
Photo 2 of 2 : FA_2015_RD0563_210_71_20150914_00081.jpg

Looking southwest at erosion around irrigation pipe on landside slope and toe.

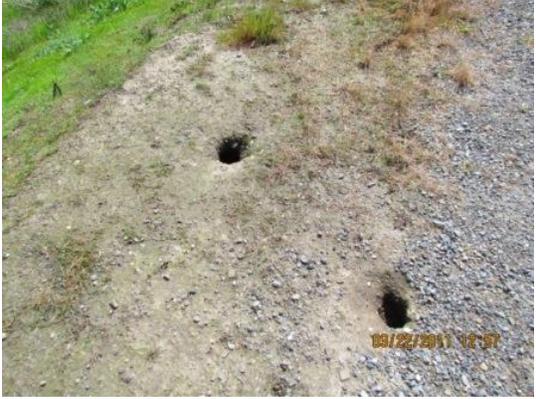
Photo 1 of 1 : FA_2015_RD0563_210_33_20150914_00036.jpg

Looking southeast at squirrel holes on landside shoulder.

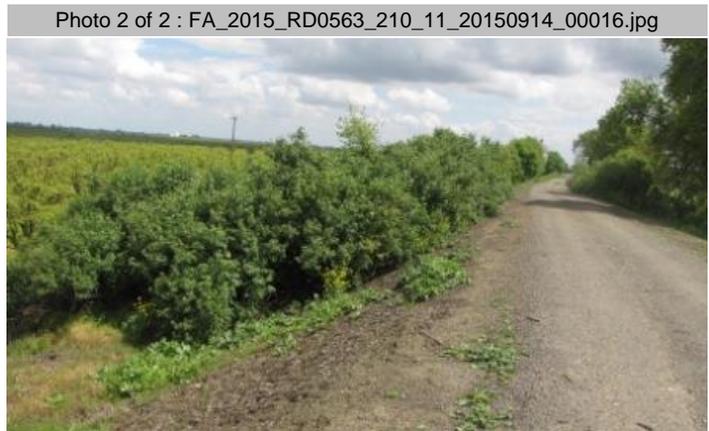
LM Start	2.39	Rating **	A/W	Issue No.	11 (cont)
LM End	2.40	Issue Type +	Ma	Location *	LS
Category	Earthen Levee		GPS Latitude/Longitude		
			Start	End	
Item	Vegetation		38.216242 °	38.216147 °	
			-121.540835 °	-121.540612 °	
DWR ID	DWR_RD0563_01_s_2012_11				
Action/Comments					
Elderberries are blocking visibility and flood fight capability. Inspector Comments: District is controlling the elderberry.

Looking southeast at elderberry on the landside slope and toe.

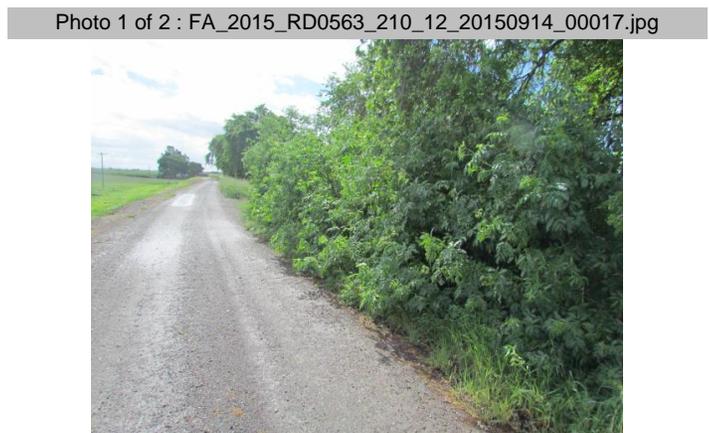
LM Start	2.40	Rating **	U	Issue No.	12
LM End	2.41	Issue Type +	Ma	Location *	WS
Category	Earthen Levee		GPS Latitude/Longitude		
			Start	End	
Item	Vegetation		38.216122 °	38.216047 °	
			-121.540555 °	-121.540415 °	
DWR ID	DWR_RD0563_01_s_2012_12				
Action/Comments					
Elderberries are blocking visibility and flood fight capability.

Looking south at dense elderberry on waterward shoulder and slope. (Spring 2015)

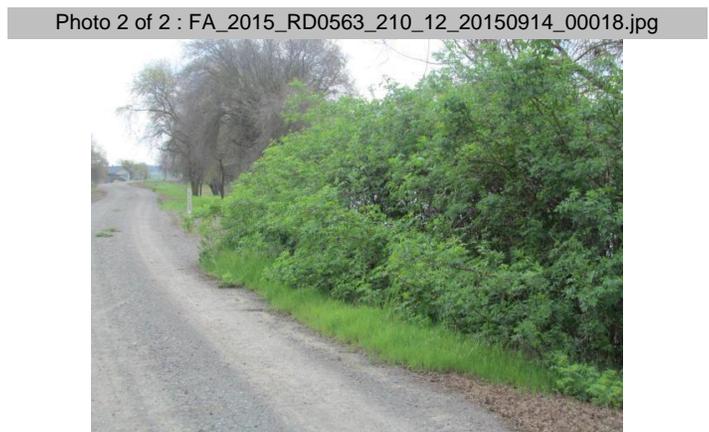
Looking southwest at dense elderberry on waterside shoulder and slope. (Fall 2014)

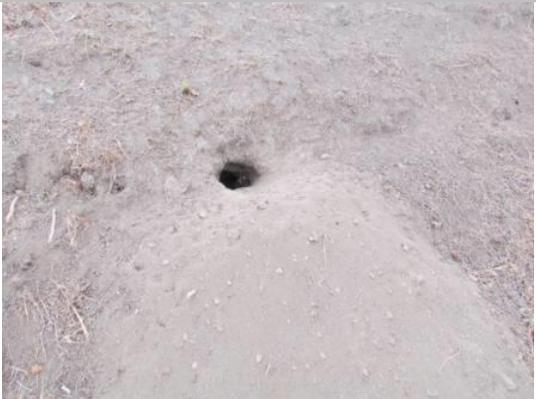
Photo 1 of 4 : FA_2015_RD0563_210_85_20150914_00102.jpg

Looking west at rodent hole on landside slope.

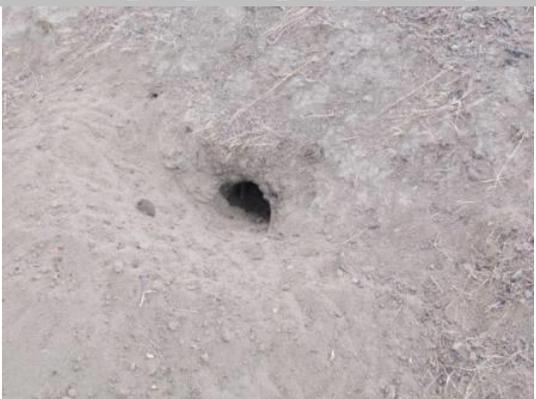
Photo 2 of 4 : FA_2015_RD0563_210_85_20150914_00103.jpg

Looking east at rodent hole on landside slope.

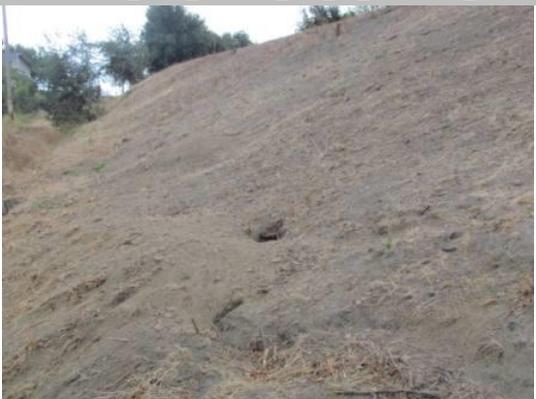
Photo 3 of 4 : FA_2015_RD0563_210_85_20150914_00104.jpg

Looking southwest at rodent holes on landside slope.

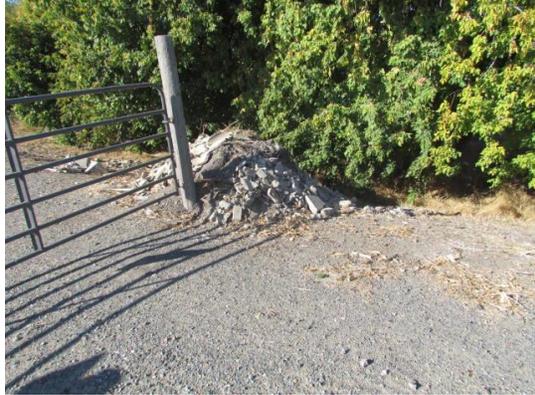
Photo 1 of 2 : FA_2015_RD0563_210_104_20150914_00129.jpg

LM Start	2.89	Rating **	M	Issue No.	104
LM End	2.89	Issue Type +	Ma	Location *	LS
Category	Earthen Levee		GPS Latitude/Longitude		
			Start	End	
Item	Encroachments		38.210966 °	38.210966 °	
			-121.534813 °	-121.534813 °	
DWR ID	DWR_RD0563_01_f_2013_104				
Action/Comments					
Material Inspector Comments: Landowner stockpiled concrete rubble on landward and waterward slope to stop trespassers. Landowner should replace the stockpile with a proper fence.

Looking west at concrete rubble on waterward shoulder and slope.

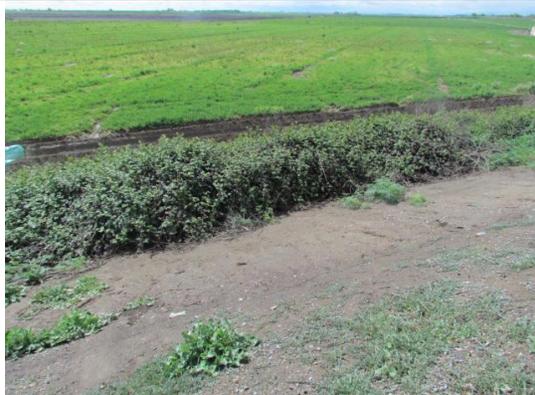
Photo 1 of 1 : FA_2015_RD0563_210_67_20150914_00076.jpg

Looking east at dense vegetation at landward toe.

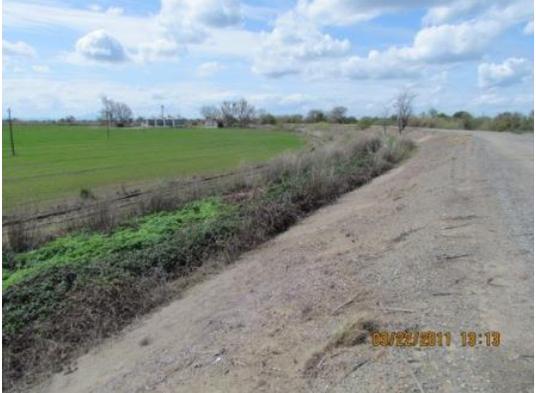
Photo 3 of 3 : FA_2015_RD0563_210_74_20150914_00086.jpg

Looking southeast at berryvines on landside toe. (Fall 2014)

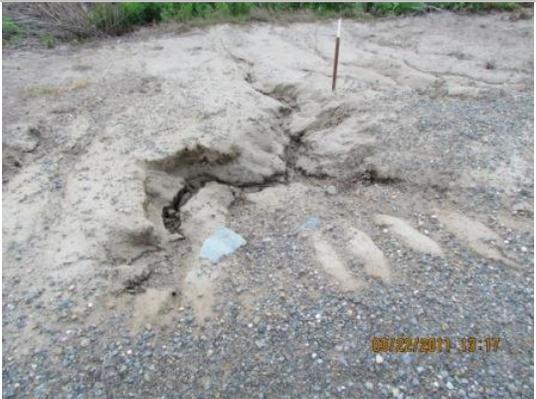
Photo 1 of 4 : FA_2015_RD0563_210_78_20150914_00092.jpg

LM Start	3.06	Rating **	M	Issue No.	78
LM End	3.06	Issue Type +	Ma	Location *	LS
Category	Earthen Levee		GPS Latitude/Longitude		
			Start	End	
Item	Slope Stability		38.210240 °	38.210240 °	
			-121.537517 °	-121.537517 °	
DWR ID	DWR_RD0563_01_s_2012_78				
Action/Comments					
Repair slope instability. Inspector Comments: Slope damage on landward shoulder and slope.

Looking east at slope erosion cause by runoff on landside slope.

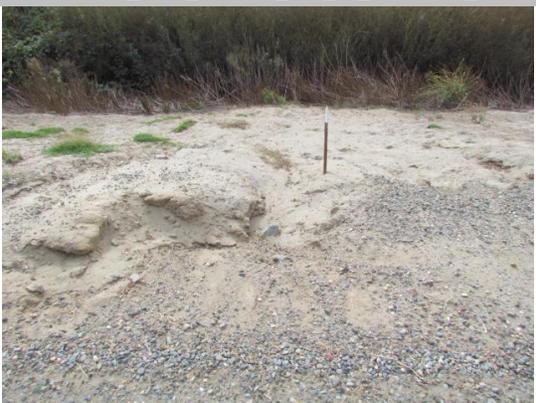
Photo 2 of 4 : FA_2015_RD0563_210_78_20150914_00093.jpg

Looking east at slope damage on 10/31/2012, no change in status.

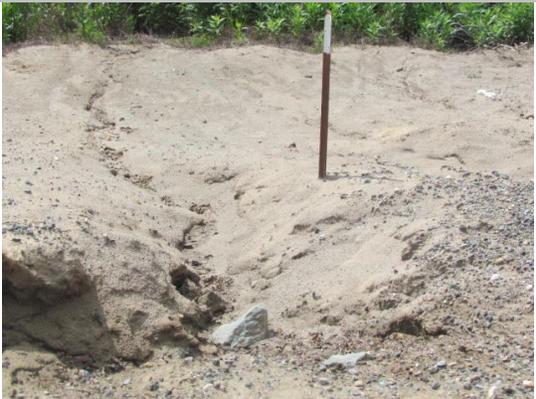
Photo 3 of 4 : FA_2015_RD0563_210_78_20150914_00094.jpg

Looking east at slope erosion. (Updated Spring 2012)

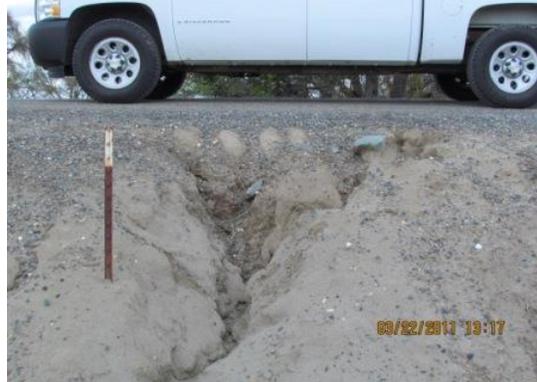
Photo 4 of 4 : FA_2015_RD0563_210_78_20150914_00095.jpg

LM Start	3.06	Rating **	M	Issue No.	78 (cont)
LM End	3.06	Issue Type +	Ma	Location *	LS
Category	Earthen Levee		GPS Latitude/Longitude		
			Start	End	
Item	Slope Stability		38.210240 °	38.210240 °	
			-121.537517 °	-121.537517 °	
DWR ID	DWR_RD0563_01_s_2012_78				
Action/Comments					
Repair slope instability. Inspector Comments: Slope damage on landward shoulder and slope.

Looking west at slope erosion cause by runoff on landside slope.

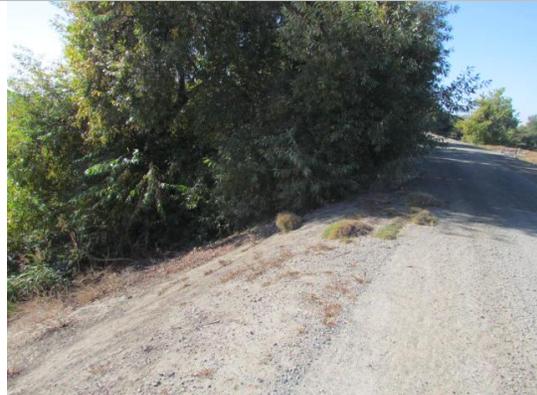
Photo 1 of 2 : FA_2015_RD0563_210_68_20150914_00077.jpg

Looking south at dense trees on landward slope.

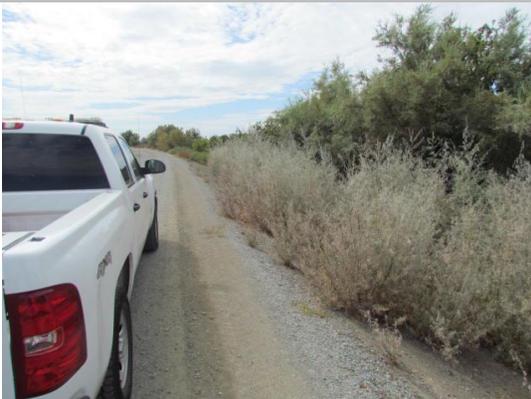
Photo 1 of 1 : FA_2015_RD0563_210_159_20150917_00193.jpg

Looking south at dense willows on waterward slope.

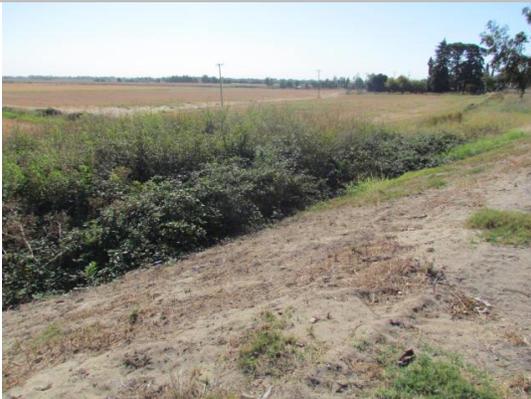
Photo 2 of 2 : FA_2015_RD0563_210_84_20150914_00101.jpg

Looking southeast at dense berryvines on landward toe.

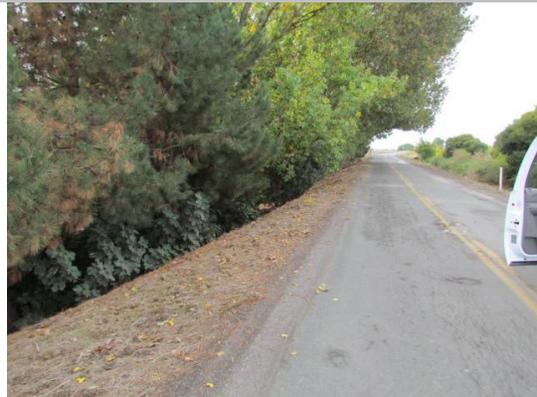
Photo 1 of 1 : FA_2015_RD0563_210_88_20150914_00108.jpg

Looking south at dense trees on landside slope and toe.

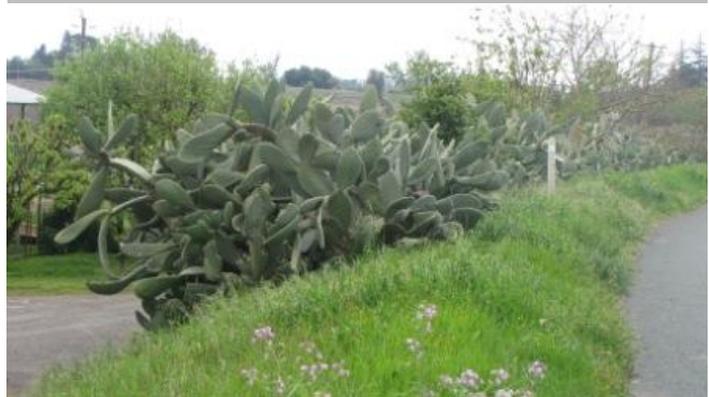
Photo 1 of 2 : FA_2015_RD0563_210_22_20150914_00025.jpg

Looking at north end of cactus on the landside slope.

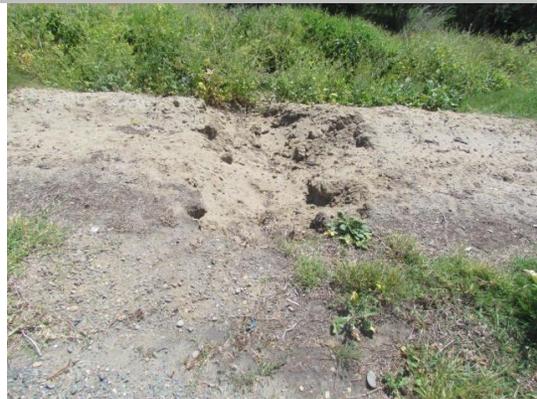
Photo 1 of 1 : FA_2015_RD0563_210_97_20150914_00121.jpg

Looking east at slope erosion on landward shoulder and slope.

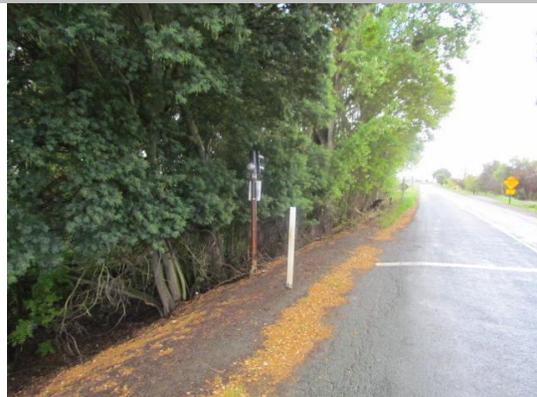
Photo 1 of 1 : FA_2015_RD0563_210_29_20150914_00033.jpg

Looking southeast at dense trees on landward slope and toe.

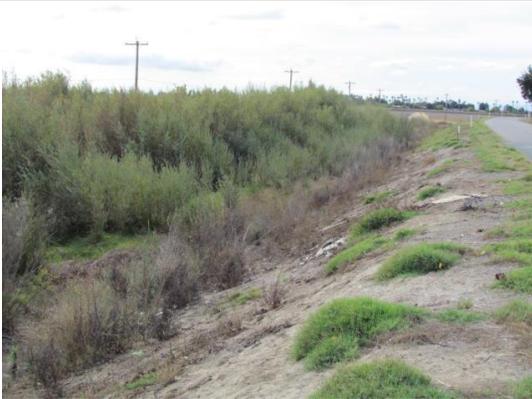
Photo 3 of 5 : FA_2015_RD0563_210_90_20150914_00112.jpg

Looking south at dense vegetation on landside toe. (2012 Fall)

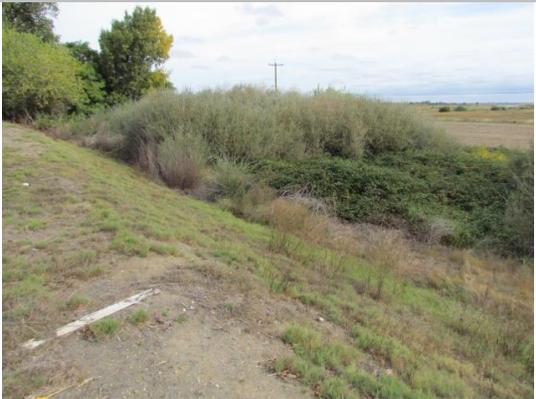
Photo 4 of 5 : FA_2015_RD0563_210_90_20150914_00113.jpg

Looking northeast at dense vegetation on landside toe. (2012 Fall Inspection)

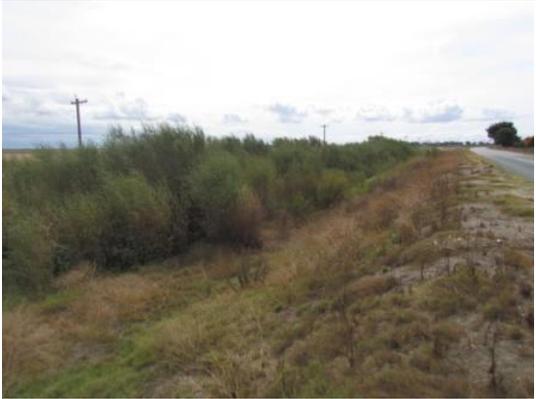
Photo 5 of 5 : FA_2015_RD0563_210_90_20150914_00114.jpg

Looking southwest at dense vegetation on landside toe.

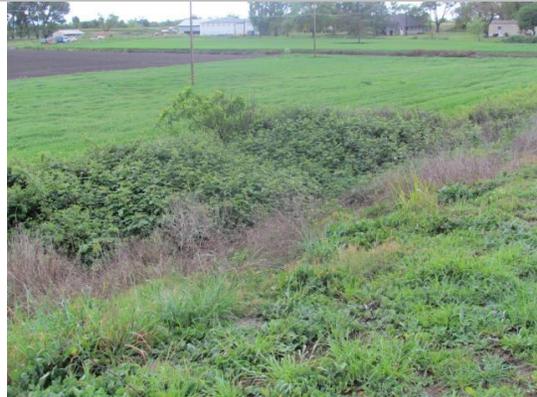
Photo 1 of 1 : FA_2015_RD0563_210_767_20150914_00145.jpg

Looking east at dense wild vines at landward toe.

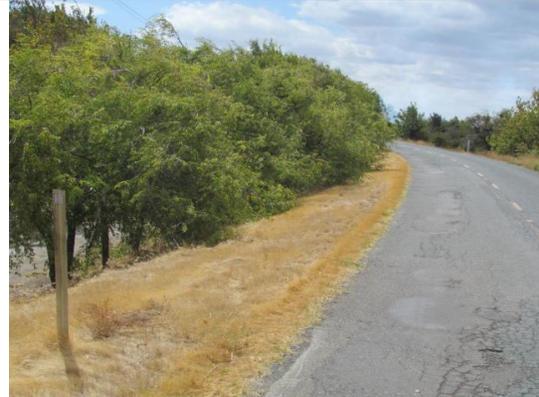
Photo 1 of 1 : FA_2015_RD0563_210_31_20150917_00194.jpg

Looking southeast at untrimmed trees on landward slope and toe.

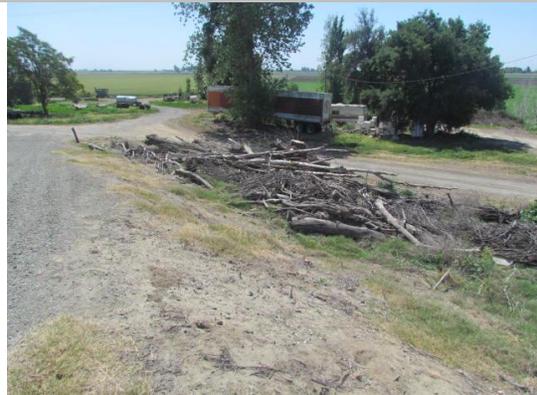
Photo 2 of 2 : FA_2015_RD0563_210_73_20150914_00083.jpg

Looking east at prunings on landward slope. (Spring 2013)

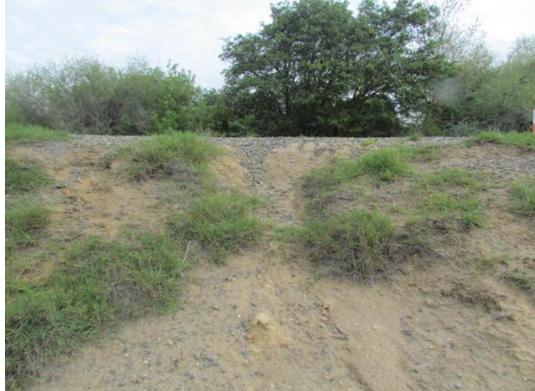
Photo 1 of 2 : FA_2015_RD0563_210_99_20150914_00123.jpg

Looking west at minor erosion on landward shoulder and slope.

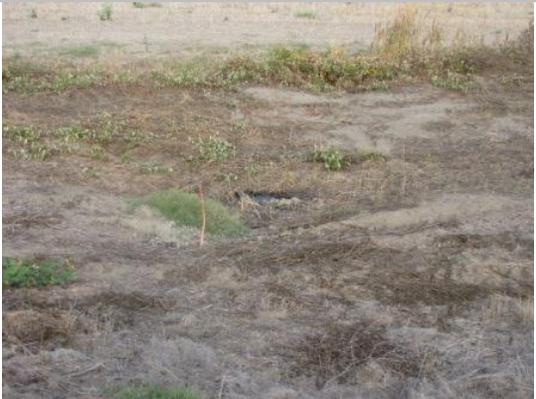
Photo 2 of 4 : FA_2015_RD0563_210_76_20150914_00088.jpg

Looking east at water ponding at landside toe just above 10" irrigation pipe.

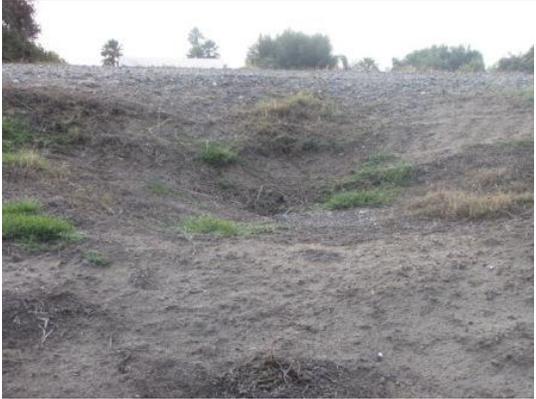
Photo 3 of 4 : FA_2015_RD0563_210_76_20150914_00089.jpg

Looking west at depression on landside shoulder and slope from landside toe.

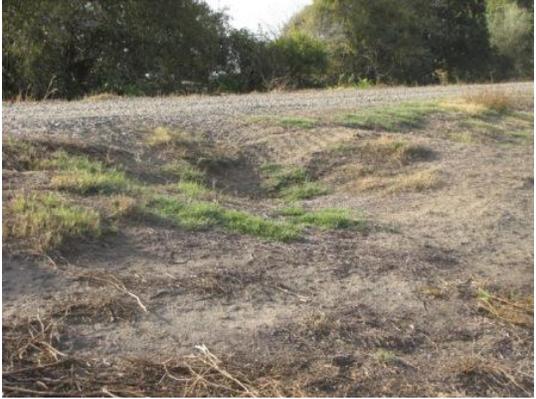
Photo 4 of 4 : FA_2015_RD0563_210_76_20150914_00090.jpg

Looking west at depression on landside shoulder and slope.

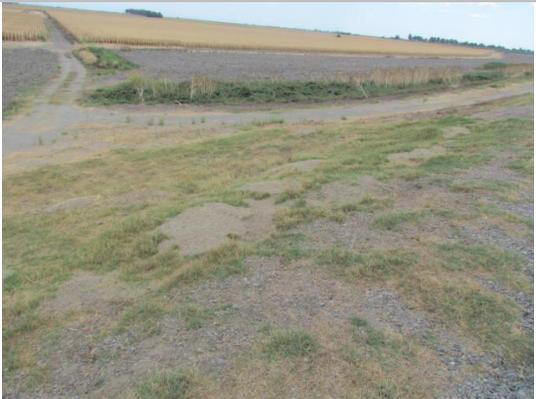
Photo 1 of 3 : FA_2015_RD0563_210_77_20150917_00195.jpg

Looking southeast at several rodent holes on landward slope.

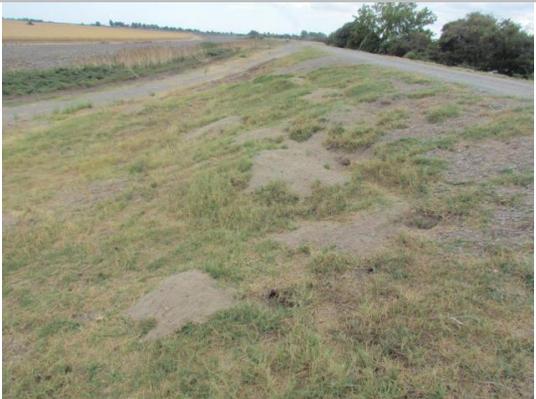
Photo 2 of 3 : FA_2015_RD0563_210_77_20150917_00196.jpg

Looking south at several rodent holes on landward slope.

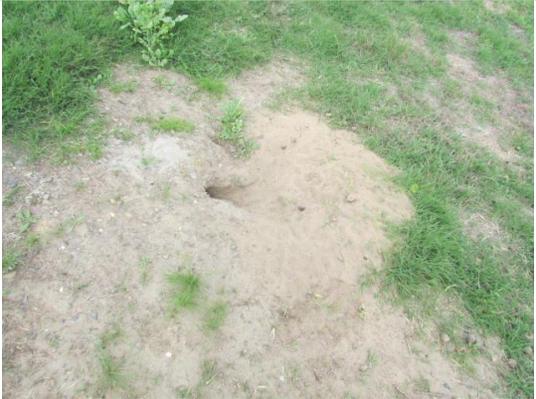
Photo 3 of 3 : FA_2015_RD0563_210_77_20150914_00091.jpg

Looking at typical rodent holes on landward slope.

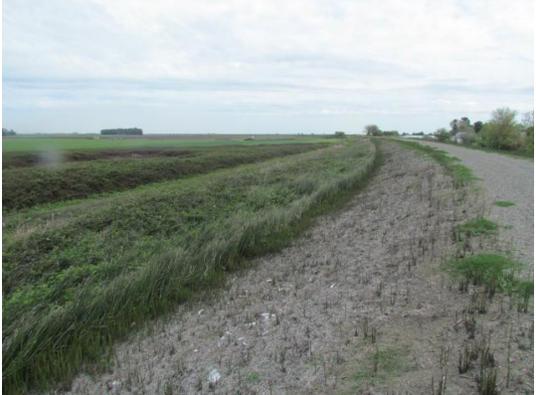
Photo 3 of 3 : FA_2015_RD0563_210_100_20150914_00127.jpg

Looking south at additional dense vegetation at landward toe.

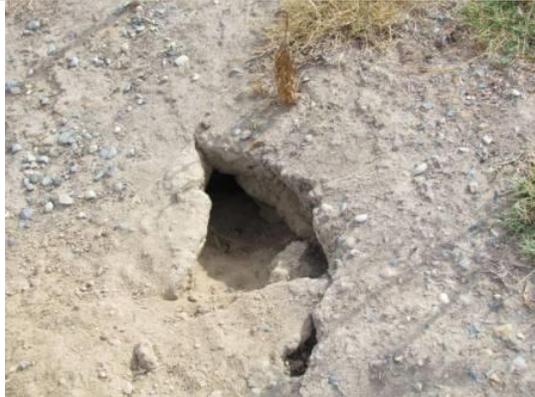
Photo 1 of 3 : FA_2015_RD0563_210_91_20150914_00115.jpg

Looking east at rodent hole on landside slope.

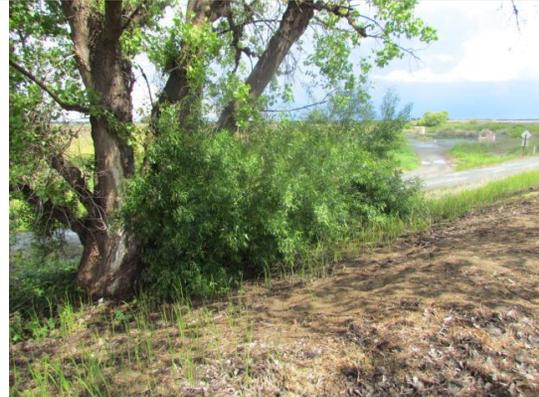
Photo 1 of 1 : FA_2015_RD0563_210_47_20150914_00048.jpg

Looking east at untrimmed tree at landward slope. (Spring 2015)
