**Flood Control Project Maintenance  
Levee Inspections**

**Fall 2010 Levee Maintenance Deficiency Summary Report**

**Reclamation District No. 0755 Randall**

**Levee Inspection Report By Mile - Fall 2010**

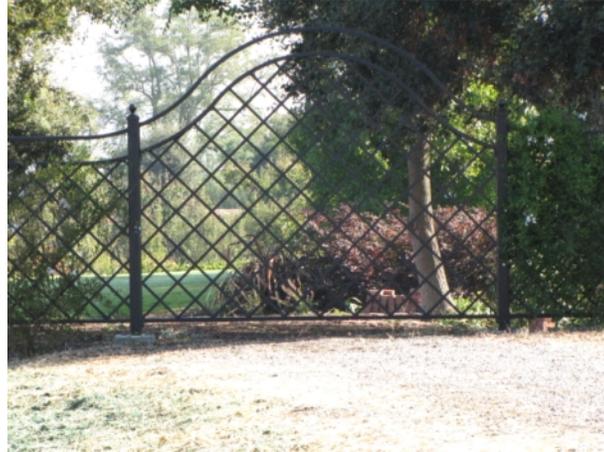
LWR No.	Levee Mile		Category	Item	* Location	** Rating	Action/Comment	GPS Latitude/Longitude		Issue No. Photo
	Start	End						Start	End	
1	0.02	0.02	Earthen Levee	Encroachments	LS	PO	Fences Inspector Comments: The land owner has installed the fence without PERMIT, I met with owner 10-16-2009. An application is being prepared for submittal todote. Photos were taken.	38.347517 ° -121.535943 °	38.347517 ° -121.535943 °	23 Y
2	0.26	0.26	Earthen Levee	Vegetation	LS	M	Remove the wild growth other than native grasses from the levee slopes.	38.346450 ° -121.540260 °	38.346450 ° -121.540260 °	1 Y
3	0.26	0.26	Earthen Levee	Vegetation	WS	M	Remove the wild growth other than native grasses from the levee slopes.	38.346450 ° -121.540260 °	38.346450 ° -121.540260 °	2 Y
4	0.43	0.43	Earthen Levee	Trim / Thin Trees	LS	N	Tree stumps.	38.345653 ° -121.542942 °	38.345653 ° -121.542942 °	3
5	0.55	1.78	Earthen Levee	Animal Control	LS	M	Exterminate rodents and backfill and compact or grout burrows.	38.345637 ° -121.545270 °	38.337432 ° -121.564027 °	4

Levee Mile Report Line	1
Start Levee Mile	0.02
End Levee Mile	0.02
Location	Land Side
Category	Earthen Levee
Item	Encroachments
This is the gate Mr. Hemley has installed without a Permit.	
phillips_f_20100923_148.jpg

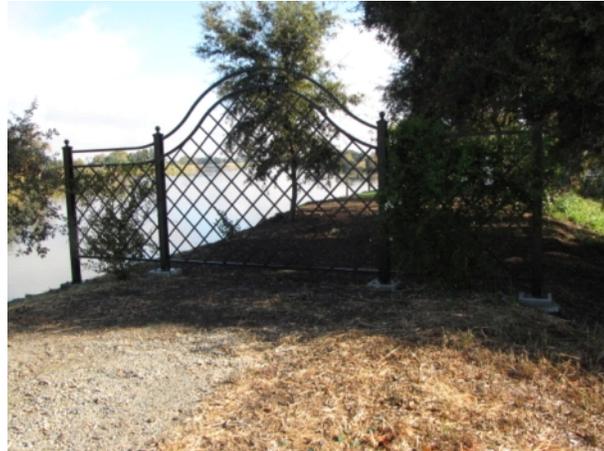
Levee Mile Report Line	1
Start Levee Mile	0.02
End Levee Mile	0.02
Location	Land Side
Category	Earthen Levee
Item	Encroachments
Hemley's gate	
phillips_f_20100923_149.jpg

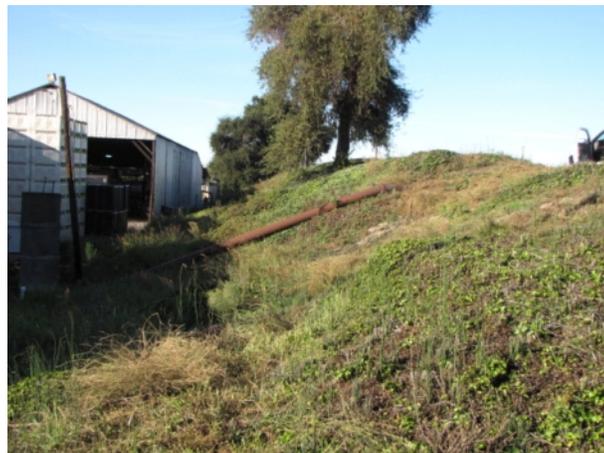
Levee Mile Report Line	2
Start Levee Mile	0.26
End Levee Mile	0.26
Location	Land Side
Category	Earthen Levee
Item	Vegetation
Standing downstream from levee mile 0.26 RD 755 looking downstream landside. Photo taken 11-09-2010	
phillips_f_20101130_356.jpg

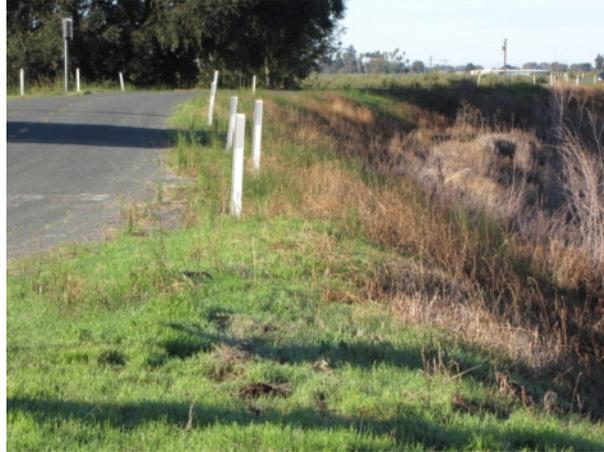
Levee Mile Report Line	3
Start Levee Mile	0.26
End Levee Mile	0.26
Location	Water Side
Category	Earthen Levee
Item	Vegetation
Standing downstream from levee mile 0.26 water side of RD 755 looking downstream. Photo taken 11-09-2010	
phillips_f_20101130_357.jpg
