**Flood Control Project Maintenance
Levee Inspections**

Fall 2014 Levee Maintenance Deficiency Summary Report

Reclamation District No. 0755 Randall

Levee Inspection Report By Mile - Fall 2014

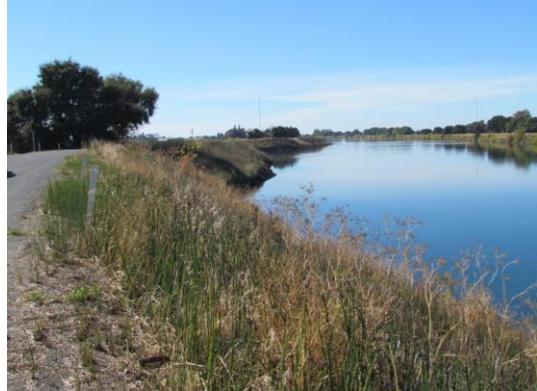
Photo 1 of 1 : FA_2014_RD0755_177_2_20141124_00003.jpg

LM Start	0.18	Rating **	U	Issue No.	2
LM End	0.59	Issue Type +	Ma	Location *	WS
Category	Earthen Levee		GPS Latitude/Longitude		
			Start	End	
Item	Vegetation		38.346768 °	38.345555 °	
			-121.538667 °	-121.545965 °	
DWR ID	DWR_RD0755_01_f_2014_2				
Action/Comments					
Control annual grass and weeds on the levee slopes and easements. Inspector Comments: Control the wild growth on the waterside levee slope.

Looking downstream from levee mile 0.18 along the waterside at unwanted tall weeds blocking the view of the waterside slope.

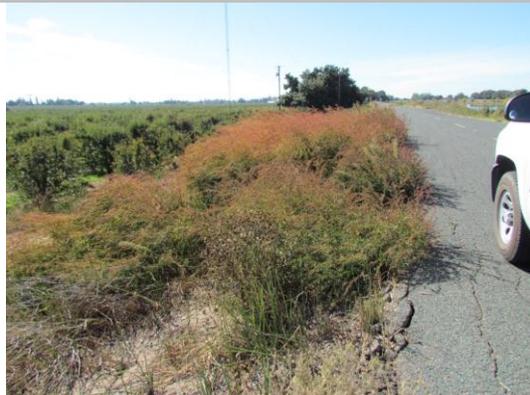
Photo 1 of 1 : FA_2014_RD0755_177_11_20141124_00002.jpg

LM Start	0.64	Rating **	U	Issue No.	11
LM End	0.92	Issue Type +	Ma	Location *	LS
Category	Earthen Levee		GPS Latitude/Longitude		
			Start	End	
Item	Vegetation		38.345383 °	38.344197 °	
			-121.546740 °	-121.551710 °	
DWR ID	DWR_RD0755_01_f_2014_11				
Action/Comments					
Control annual grass and weeds on the levee slopes and easements. Inspector Comments: Remove the unwanted tall weeds from the levee section.

Looking downstream from levee mile 0.64 at unwanted tall weeds on the landside levee shoulder and slope.

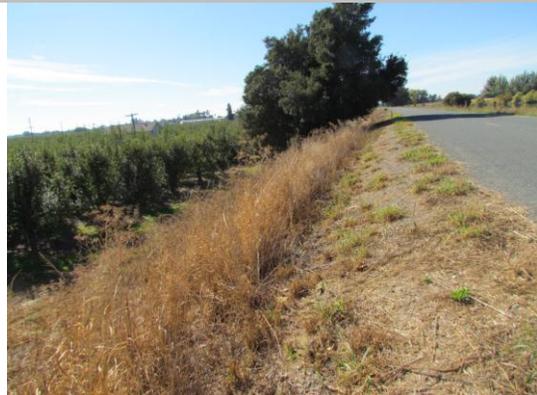
Photo 1 of 1 : FA_2014_RD0755_177_7_20141124_00004.jpg

LM Start	1.14	Rating **	U	Issue No.	7
LM End	1.26	Issue Type +	Ma	Location *	LS
Category	Earthen Levee		GPS Latitude/Longitude		
			Start	End	
Item	Vegetation		38.343302 °	38.342810 °	
			-121.555538 °	-121.557687 °	
DWR ID	DWR_RD0755_01_f_2014_7				
Action/Comments					
Control annual grass and weeds on the levee slopes and easements. Inspector Comments: Remove tall weeds from the landside levee slope.

Tall weeds on slope and toe landside.
