**Flood Control Project Maintenance  
Levee Inspections  
LMA District Cover Sheet  
Spring 2010 Levee Inspection Results**

**Reclamation District No. 0755 Randall**

**Levee Inspection Report By Mile - Spring 2010**

Waterway	Bank	Unit Miles	Inspection Start/End	Inspector
Unit No. 01 Sacramento River	Left	1.86	03/26/2010 03/26/2010	Herman Phillips

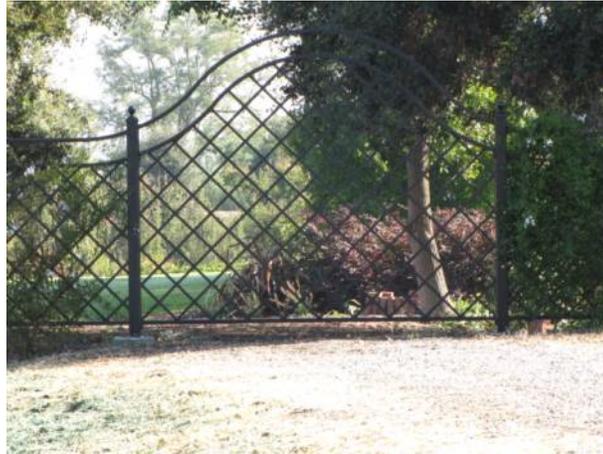
LMIR No	Levee Mile		Category	Item	Location *	Rating **	Action/Comment	GPS Latitude/Longitude		Issue No. Photo
	Start	End						Start	End	
1	0.02	0.02	Earthen Levee	Encroachments	LS	PO	Fences Inspector Comments: The land owner has installed the fence without PERMIT, I met with owner 10-16-2009. An application is being prepared for submittal todade. Photos were taken.	38.347517 ° 121.535943 °	38.347517 ° -121.535943 °	23 Y
2	0.13	0.19	Earthen Levee	Vegetation	WS	M	Control annual grass and weeds on the levee slopes and easements.	38.346987 ° -121.537882 °	38.346685 ° -121.538758 °	2
3	0.14	0.15	Earthen Levee	Vegetation	LS	M	Control annual grass and weeds on the levee slopes and easements.	38.346855 ° -121.537947 °	38.346902 ° -121.538193 °	1
4	0.43	0.43	Earthen Levee	Trim / Thin Trees	LS	N	Tree stumps.	38.345653 ° -121.542942 °	38.345653 ° -121.542942 °	3
5	0.55	1.78	Earthen Levee	Animal Control	LS	M	Exterminate rodents and backfill and compact or grout burrows.	38.345637 ° -121.545270 °	38.337432 ° -121.564027 °	4

Levee Mile Report Line	1
Start Levee Mile	0.02
End Levee Mile	0.02
Location	Land Side
Category	Earthen Levee
Item	Encroachments
This is the gate Mr. Hemley has installed without a Permit.	
phillips_s_20100316_022.jpg

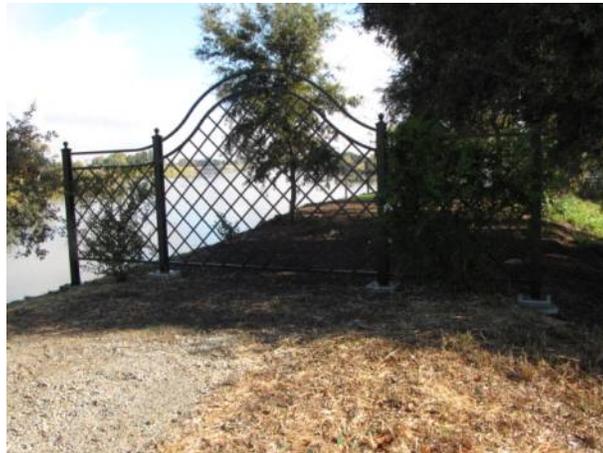
Levee Mile Report Line	1
Start Levee Mile	0.02
End Levee Mile	0.02
Location	Land Side
Category	Earthen Levee
Item	Encroachments
Hemley's gate	
phillips_s_20100316_023.jpg
