**Flood Control Project Maintenance  
Levee Inspections****LMA District Cover Sheet****Spring 2011 Levee Inspection Results****Reclamation District No. 0755 Randall**

**Levee Inspection Report By Mile - Spring 2011**

Waterway						Bank	Unit Miles	Inspection Start/End	Inspector	
Unit No. 01 Sacramento River						Left	1.86	03/30/2011 03/30/2011	Herman Phillips

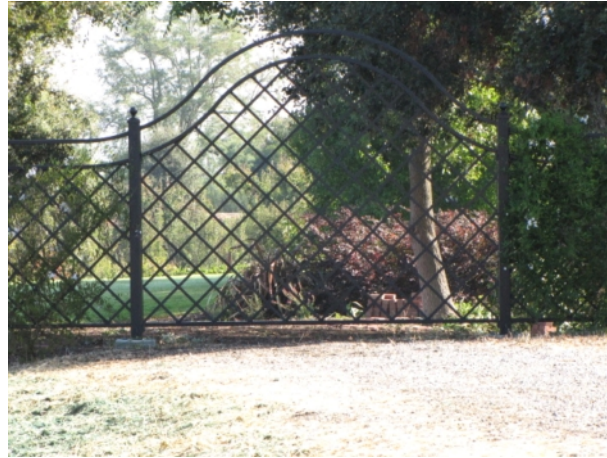
Levee Mile Report Line	1
Start Levee Mile	0.02
End Levee Mile	0.02
Location	Land Side
Category	Earthen Levee
Item	Encroachments

LMR No.	Levee Mile		Category	Item	Location	Rating	Action/Comment	GPS Latitude/Longitude		Issue No.
	Start	End						Start	End	Photo
1	0.02	0.02	Earthen Levee	Encroachments	LS	PO	Fences Inspector Comments: The land owner has installed the fence without PERMIT, I met with owner 10-16-2009. An application is being prepared for submittal todote. Photos were taken.	38.347517 ° -121.535943 °	38.347517 ° -121.535943 °	23 Y
2	0.03	0.03	Earthen Levee	Vegetation	LS	A	Control annual grass and weeds on the levee slopes and easements.	° °	° °	6 Y
3	0.03	0.03	Earthen Levee	Vegetation	WS	A	Control annual grass and weeds on the levee slopes and easements.	° °	° °	7 Y
4	0.26	0.26	Earthen Levee	Vegetation	LS	C	Remove the wild growth other than native grasses from the levee slopes.	38.346450 ° -121.540260 °	38.346450 ° -121.540260 °	1
5	0.26	0.26	Earthen Levee	Vegetation	WS	C	Remove the wild growth other than native grasses from the levee slopes.	38.346450 ° -121.540260 °	38.346450 ° -121.540260 °	2

This is the gate Mr. Hemley has installed without a Permit.

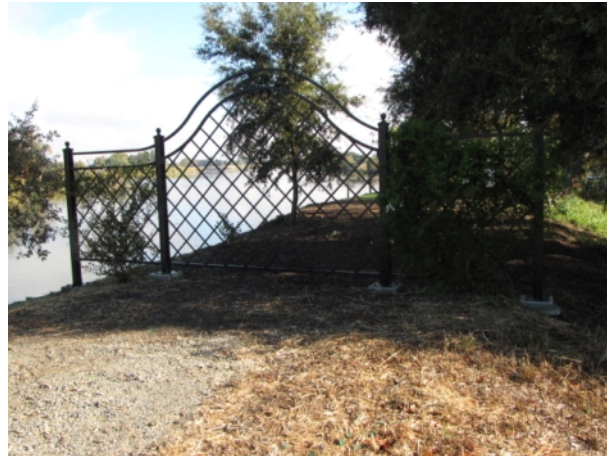
Levee Mile Report Line	1
Start Levee Mile	0.02
End Levee Mile	0.02
Location	Land Side
Category	Earthen Levee
Item	Encroachments

Hemley's gate

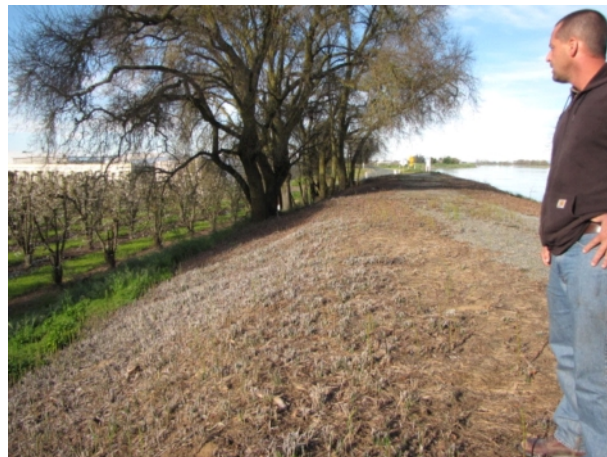
Levee Mile Report Line	2
Start Levee Mile	0.03
End Levee Mile	0.03
Location	Land Side
Category	Earthen Levee
Item	Vegetation

Landside levee mile 0.03 looking downstream in RD 755. Photo taken 03-30,-2011.

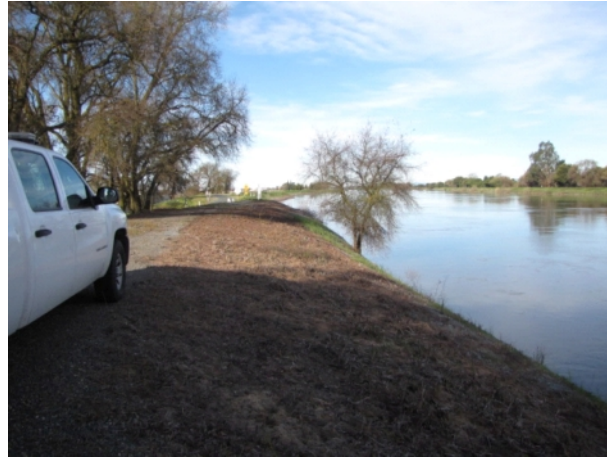
Levee Mile Report Line	3
Start Levee Mile	0.03
End Levee Mile	0.03
Location	Water Side
Category	Earthen Levee
Item	Vegetation

Looking downstream from levee mile 0.03 RD 755. Photo taken 03-30-2011.
