**Flood Control Project Maintenance  
Levee Inspections**  
**LMA District Cover Sheet**  
**Spring 2012 Levee Inspection Results**

**Reclamation District No. 0755 Randall**

**Levee Inspection Report By Mile - Spring 2012**

Waterway						Bank	Unit Miles	Inspection Start/End	Inspector	
Unit No. 01 Sacramento River						Left	1.86	03/27/2012 03/27/2012	Herman Phillips	
LMR No.	Levee Mile		Category	Item	Location * + Rating	Action/Comment	GPS Latitude/Longitude		Issue No.	Photo
	Start	End					Start	End		
1			Earthen Levee	Operations & Maintenance Manuals	LS M Ma		°	°	40	
DWR ID: DWR_RD0755_01_s_2012_40										
2			Earthen Levee	Emergency Supplies & Equipment	LS M Ma		°	°	41	
DWR ID: DWR_RD0755_01_s_2012_41										
3			Earthen Levee	Flood Preparedness & Training	LS M Ma		°	°	42	
DWR ID: DWR_RD0755_01_s_2012_42										
4	0.00	0.00	Earthen Levee	Vegetation	LS M Ma	V1 : Control annual grass and weeds on the levee slopes and easements.	38.347432 ° -121.536671 °	38.347432 ° -121.536671 °	1 Y	
DWR ID: DWR_RD0755_01_s_2012_1										
5	0.02	0.02	Earthen Levee	Encroachments	LS M En	FE : Fences Inspector Comments: The land owner has installed the fence without a permit, I met with owner

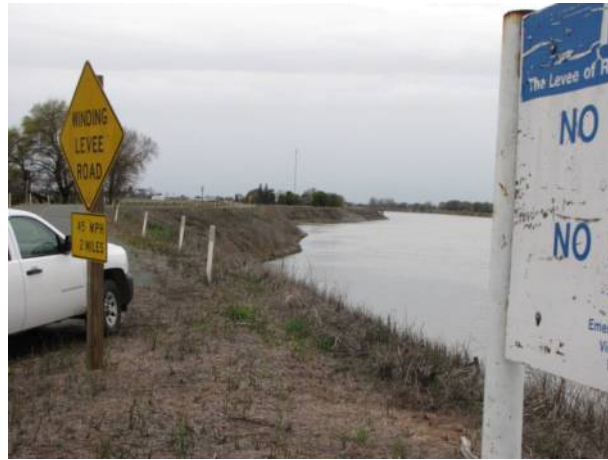
Levee Mile Report Line	4
Start Levee Mile	0.00
End Levee Mile	0.00
Location	Land Side
Category	Earthen Levee
Item	Vegetation

RD 755 Spring inspection. Photo taken 3-27-2012.

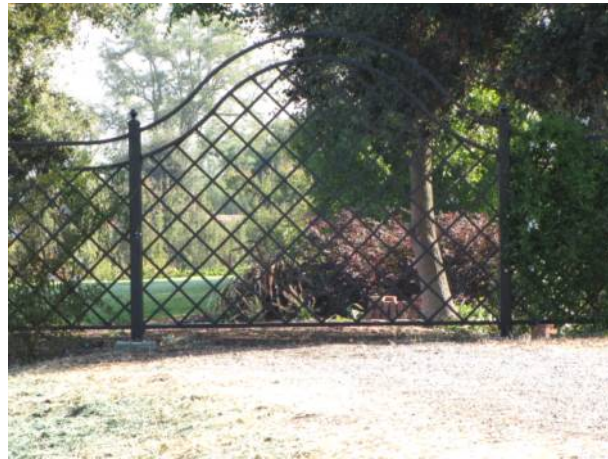
Levee Mile Report Line	5
Start Levee Mile	0.02
End Levee Mile	0.02
Location	Land Side
Category	Earthen Levee
Item	Encroachments

This is the gate Mr. Hemley has installed without a permit.

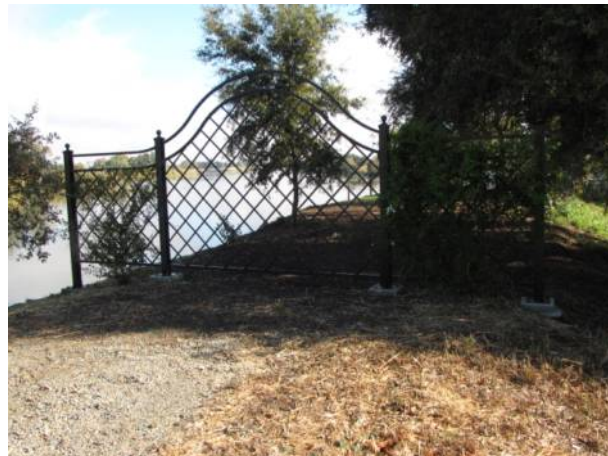
Levee Mile Report Line	5
Start Levee Mile	0.02
End Levee Mile	0.02
Location	Land Side
Category	Earthen Levee
Item	Encroachments

Hemley's gate

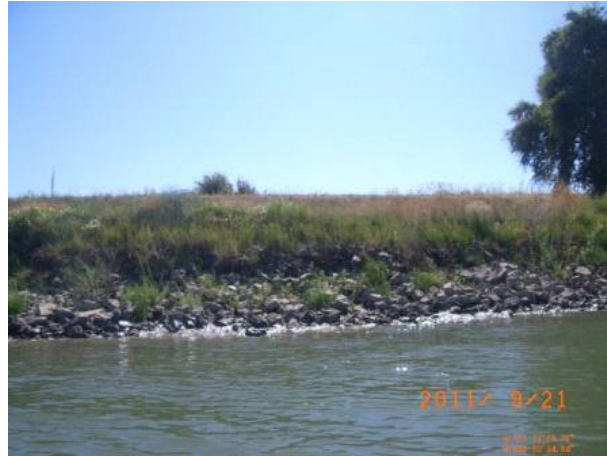
Levee Mile Report Line	7
Start Levee Mile	1.21
End Levee Mile	1.30
Location	Water Side
Category	Supplemental
Item	USACE Erosion Survey

USACE 2011 Photo #1

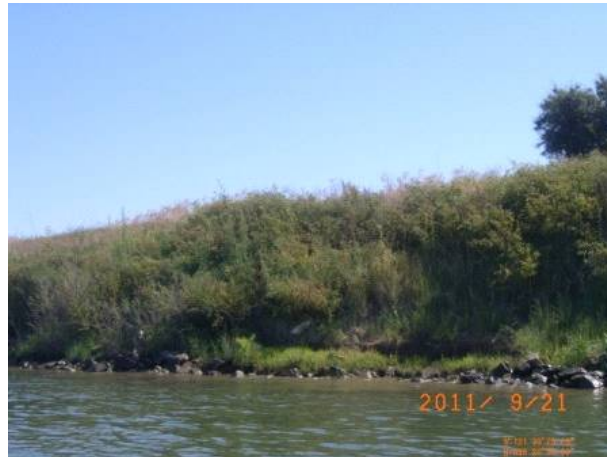
Levee Mile Report Line	7
Start Levee Mile	1.21
End Levee Mile	1.30
Location	Water Side
Category	Supplemental
Item	USACE Erosion Survey

USACE 2011 Photo #2

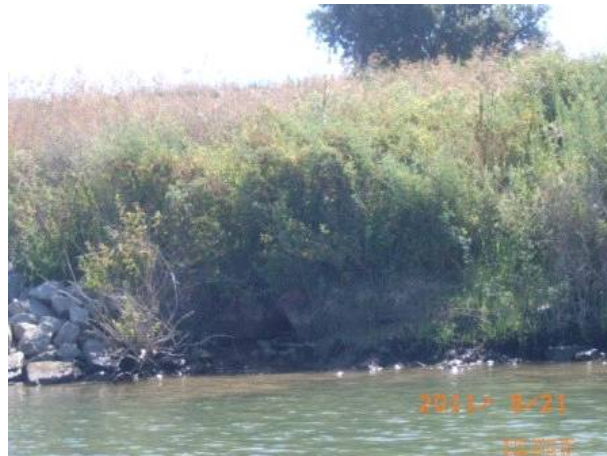
Levee Mile Report Line	7
Start Levee Mile	1.21
End Levee Mile	1.30
Location	Water Side
Category	Supplemental
Item	USACE Erosion Survey

USACE 2011 Photo #3
