**Flood Control Project Maintenance
Levee Inspections****LMA District Cover Sheet****Spring 2013 Levee Inspection Results****Reclamation District No. 0755 Randall**

Spring 2013 Levee Inspection Results

Reclamation District No. 0755 Randall

Waterway			Bank	Unit Miles
Unit No. 01 Sacramento River			Left	1.86
	Spring (March - May)	Summer (June - August)	(September - November) Fall	Winter (December - February)
Unit Maintenance Rating (Fall Only)				
Date of Inspection	03/29/2013 - 03/29/2013			
DWR Inspector	Herman Phillips			
Accompanied By	Mathew Hemly RD755

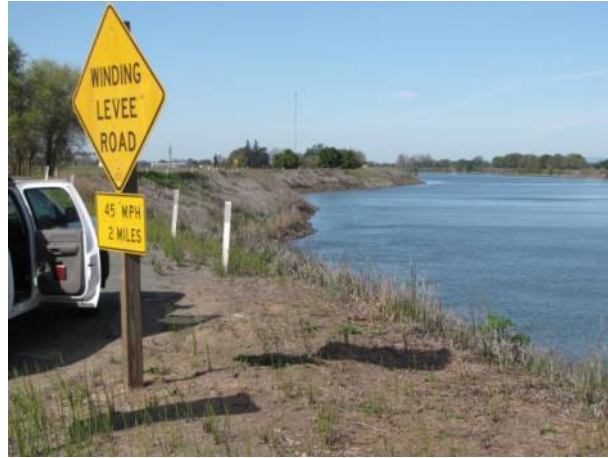
Levee Mile Report Line	5
Start Levee Mile	0.19
End Levee Mile	0.19
Location	Water Side
Category	
Item	Vegetation

RD 755 Standing on the waterside of the levee shoulder looking downstream from levee mile 0.19. Slopes has been sprayed . Photo taken 3-29-2013.

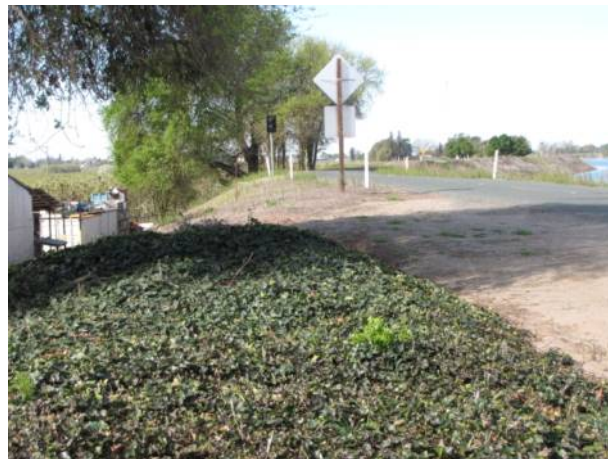
Levee Mile Report Line	6
Start Levee Mile	0.19
End Levee Mile	0.19
Location	Land Side
Category	
Item	Vegetation

RD 755 Looking downstream from levee mile 0.19 landside shoulder. Good spray job downstream. Photo taken 3-29-2013.
