**Flood Control Project Maintenance  
Levee Inspections****LMA District Cover Sheet****Spring 2014 Levee Inspection Results****Reclamation District No. 0755 Randall**

**Levee Inspection Report By Mile - Spring 2014**

**Reclamation District No. 0755 Randall**

Waterway	Bank	Unit Miles	Inspection Start/End	Inspector
Unit No. 01 Sacramento River	Left	1.86	04/01/2014 04/01/2014	Herman Phillips

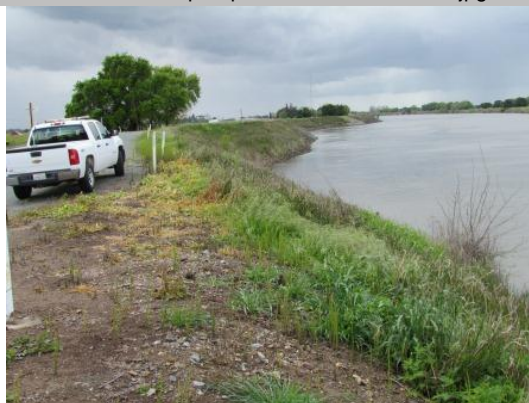
Photo 1 of 1 : phillips\_s\_20140527\_05945.jpg

LM Start	0.19	Rating **	U	Issue No.	9
LM End	0.73	Issue Type +	Ma	Location *	WS
Category	Earthen Levee			GPS Latitude/Longitude	
				Start	End
Item	Vegetation			38.346688 °	38.345050 °
				-121.538814 °	-121.548325 °
DWR ID	DWR_RD0755_01_s _ 2014_9				
Action/Comments					
Control annual grass and weeds on the levee slopes and easements.

RD 755 Looking downstream from waterside shoulder levee mile 0.19.  
Tall weeds to levee mile 0.19.

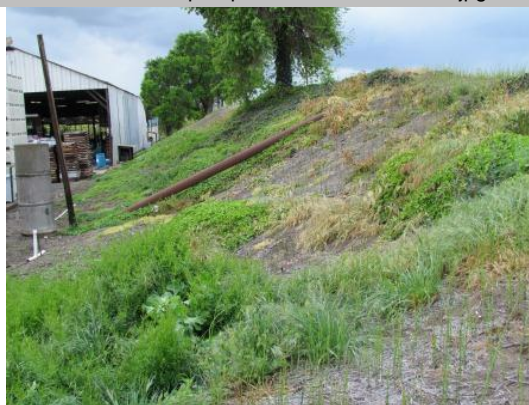
Photo 1 of 1 : phillips\_s\_20140527\_05946.jpg

LM Start	0.23	Rating **	M	Issue No.	15
LM End	1.67	Issue Type +	Ma	Location *	LS
Category	Earthen Levee			GPS Latitude/Longitude	
				Start	End
Item	Vegetation			38.346391 °	38.338604 °
				-121.539480 °	-121.562664 °
DWR ID	DWR_RD0755_01_f _ 2013_15				
Action/Comments					
Control annual grass and weeds on the levee slopes and easements.

RD 755 looking downstream from levee mile 0.23. Tall weeds on  
landside slope.

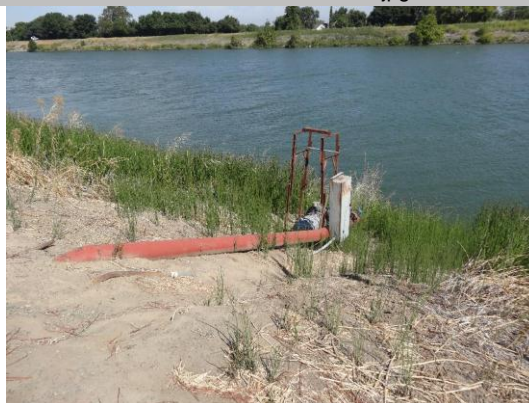
Photo 1 of 1 : UCIP\_1563.jpg

LM Start	0.45	Rating **	M	Issue No.	1
LM End	0.45	Issue Type +	En	Location *	LS
Category	Supplemental			GPS Latitude/Longitude	
				Start	End
Item	DWR UCIP Field Study			38.345640 °	38.345640 °
				-121.543277 °	-121.543277 °
DWR ID	DWR_RD0755_01_s_2014_1				
Action/Comments					
Inspector Comments: FS_ID:17123					
EP_NO: 4302					
Repair Type:					
Crossing Status:					
UCIP Comments: FBC about 2 feet. Power conduit also through the levee/wet ground on pump site/location. May need investigation about wet ground.					
FIELD_STRUCT_DESC: 8-inch steel pipe through levee, 2.0 feet below crown. Pump electrical box and control valve on waterward slope. Siphon breaker on landward slope. Service pole at landward toe. (App. No. 4302-Hemly) .					
FS Date: 8/6/2013

WS view: overview of pump and pipe.

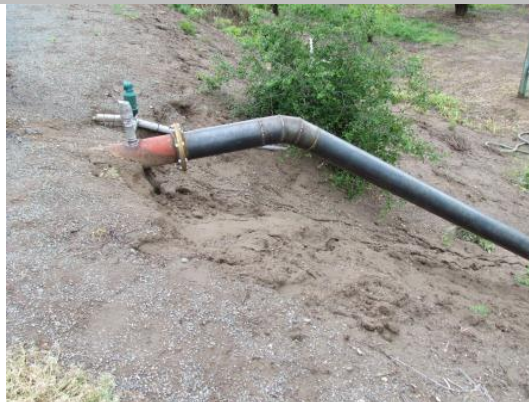
Photo 1 of 2 : phillips\_s\_20140527\_05948.jpg

LM Start	0.45	Rating **	U	Issue No.	11
LM End	0.45	Issue Type +	Ma	Location *	LS
Category	Earthen Levee			GPS Latitude/Longitude	
				Start	End
Item	Erosion / Bank Caving			38.345666 °	38.345666 °
				-121.543327 °	-121.543327 °
DWR ID	DWR_RD0755_01_s_2014_11				
Action/Comments					
Note and monitor erosion site.					
Inspector Comments: Erosion at pipe located at LM 0.45 on the landside. The erosion is on the slope and at toe.

The erosion is located under the pipe.

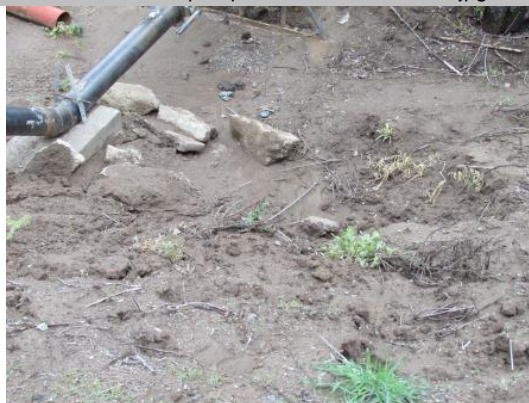
Photo 2 of 2 : phillips\_s\_20140527\_05949.jpg

LM Start	0.45	Rating **	U	Issue No.	11 (cont)
LM End	0.45	Issue Type +	Ma	Location *	LS
Category	Earthen Levee			GPS Latitude/Longitude	
				Start	End
Item	Erosion / Bank Caving			38.345666 °	38.345666 °
				-121.543327 °	-121.543327 °
DWR ID	DWR_RD0755_01_s _ 2014_11				
Action/Comments					
Note and monitor erosion site.					
Inspector Comments: Erosion at pipe located at LM 0.45 on the landside. The erosion is on the slope and at toe.

The erosion extend down to the toe of the levee slope.

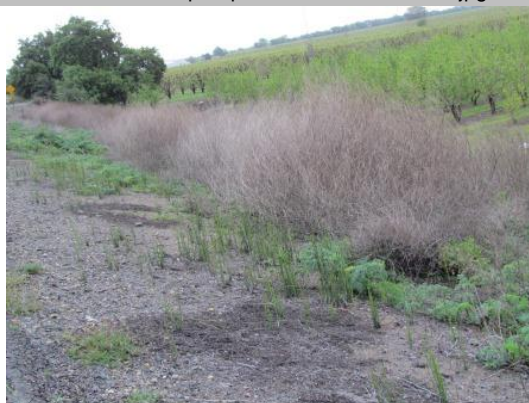
Photo 1 of 1 : phillips\_s\_20140527\_05947.jpg

LM Start	0.56	Rating **	U	Issue No.	18
LM End	0.79	Issue Type +	Ma	Location *	LS
Category	Earthen Levee			GPS Latitude/Longitude	
				Start	End
Item	Vegetation			38.345593 °	38.344711 °
				-121.545412 °	-121.549581 °
DWR ID	DWR_RD0755_01_f _ 2013_18				
Action/Comments					
Remove the wild growth other than native grasses from the levee slopes.					
Inspector Comments: Remove the tall weeds from levee section.

RD 755 Looking back upstream from levee mile 0.79 landside. Tall  
weeds on the slope and toe of levee section.

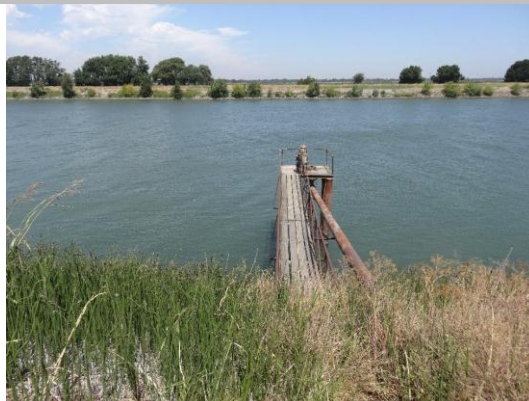
Photo 1 of 1 : UCIP\_1545.jpg

LM Start	0.94	Rating **	M	Issue No.	2
LM End	0.94	Issue Type +	En	Location *	LS
Category	Supplemental			GPS Latitude/Longitude	
				Start	End
Item	DWR UCIP Field Study			38.344103 °	38.344103 °
				-121.552119 °	-121.552119 °
DWR ID	DWR_RD0755_01_s_2014_2				
Action/Comments					
Inspector Comments: FS_ID:17063					
EP_NO: 11225					
Repair Type:					
Crossing Status:					
UCIP Comments: Abandoned pipe and pump service pole, power box lying on LS slope.					
FIELD_STRUCT_DESC: Abandoned 10-inch pipe and 1-inch conduit through levee, 5.6 feet below crown, pump on pile structure with walkway to pump. Abandoned service pole on landward slope. (ABO No. 11225- Wilson O&M Manual Sac 111, May 1959, Revision Year 2011.					
FS Date: 8/6/2013

WS view: overview of pipe and pump structure.

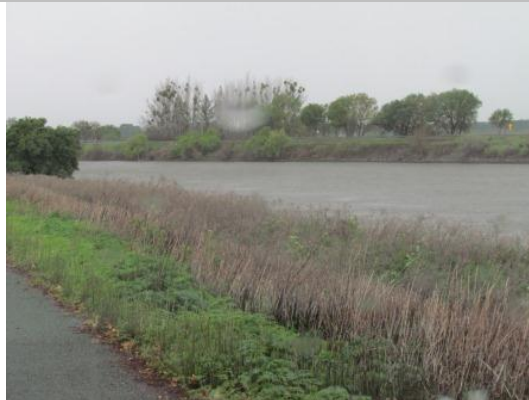
Photo 1 of 1 : phillips\_s\_20140527\_05950.jpg

LM Start	1.03	Rating **	U	Issue No.	14
LM End	1.40	Issue Type +	Ma	Location *	WS
Category	Earthen Levee			GPS Latitude/Longitude	
				Start	End
Item	Vegetation			38.343731 °	38.341669 °
				-121.553597 °	-121.559644 °
DWR ID	DWR_RD0755_01_s_2014_14				
Action/Comments					
Remove the wild growth other than native grasses from the levee slopes.

Tall weeds on waterside slope and toe.

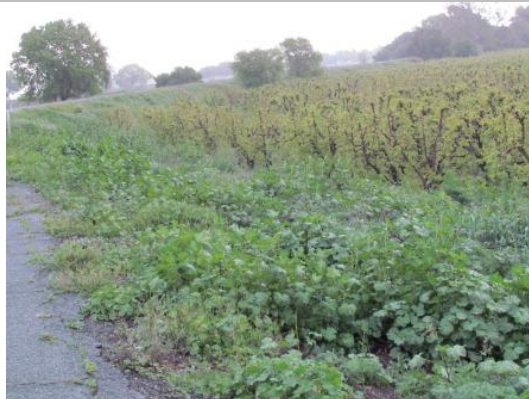
Photo 1 of 1 : phillips\_s\_20140527\_05951.jpg

LM Start	1.03	Rating **	U	Issue No.	24
LM End	1.40	Issue Type +	Ma	Location *	LS
Category	Earthen Levee			GPS Latitude/Longitude	
				Start	End
Item	Vegetation			38.343765 °	38.341670 °
				-121.553635 °	-121.559643 °
DWR ID	DWR_RD0755_01_s _ 2014_24				
Action/Comments					
Control annual grass and weeds on the levee slopes and easements.

Looking downstream from the landside shoulder at wild weeds covering the slope and toe.

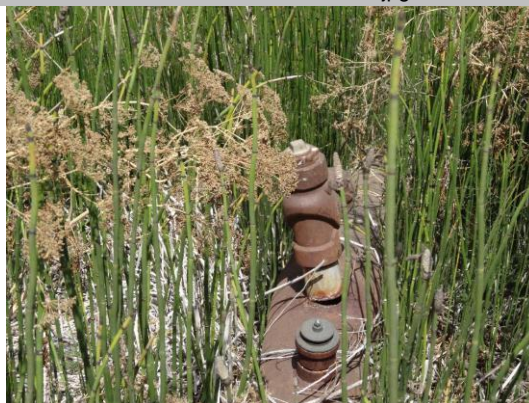
Photo 1 of 1 : UCIP\_1549.jpg

LM Start	1.06	Rating **	M	Issue No.	5
LM End	1.06	Issue Type +	En	Location *	LS
Category	Supplemental			GPS Latitude/Longitude	
				Start	End
Item	DWR UCIP Field Study			38.343625 °	38.343625 °
				-121.554145 °	-121.554145 °
DWR ID	DWR_RD0755_01_s_2014_5				
Action/Comments					
Inspector Comments: FS_ID:17064					
EP_NO: N/A					
Repair Type:					
Crossing Status:					
UCIP Comments: Needs properly abandoned.					
FIELD_STRUCT_DESC: Abandoned 12-inch pipe through levee, 5.0					
feet below crown. (Cat. IVA-Wilson). O&M Manual Sac 111, May 1959,					
Revision Year 2011.					
FS Date: 8/6/2013

WS view: steel pipe with siphon breaker on levee slope

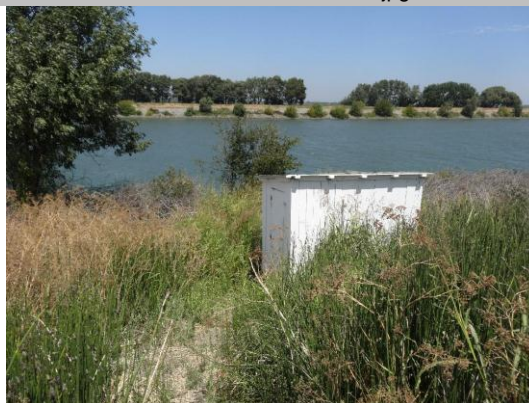
Photo 1 of 1 : UCIP\_1578.jpg

LM Start	1.14	Rating **	M	Issue No.	7
LM End	1.14	Issue Type +	En	Location *	LS
Category	Supplemental			GPS Latitude/Longitude	
				Start	End
Item	DWR UCIP Field Study			38.343305 °	38.343305 °
				-121.555538 °	-121.555538 °
DWR ID	DWR_RD0755_01_s_2014_7				
Action/Comments					
Inspector Comments: FS_ID:17144					
EP_NO: 11219					
Repair Type:					
Crossing Status:					
UCIP Comments: - requires cleaning of siphon breaker box.					
FIELD_STRUCT_DESC: 8-inch pipe through levee, 5.7 feet below crown. Siphon breaker inside CM Pipe riser on landside shoulder. Power pole on landside. Pump and power box in pump house on waterward slope. (ABO No. 11219- Elliott). O&M Manual Sac 111, May 1959, Revision Year 2011.					
FS Date: 8/6/2013

WS view: pump house on levee slope.

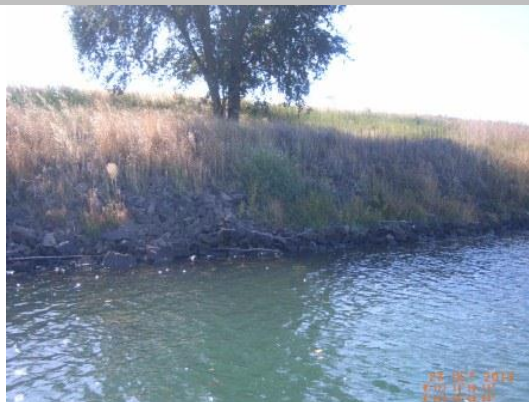
Photo 1 of 1 : USACE2013A\_SAC\_35-4\_L\_7.jpg

LM Start	1.21	Rating **	M	Issue No.	3
LM End	1.34	Issue Type +	Ma	Location *	WS
Category	Supplemental			GPS Latitude/Longitude	
				Start	End
Item	USACE Erosion Survey			38.343071 °	38.342426 °
				-121.557706 °	-121.559163 °
DWR ID					
Action/Comments					
Inspector Comments: 2003 - Toe and lower slope eroding, rock in water and a few pieces on the slope; rock at upstream and downstream ends. 2005 - Looks a little worse. Two major holes with vertical banks and smaller intermittent pockets in between. Stone is present upstream, downstream, and at toe. 2008 - Repaired at both ends (50 ft of new stone) but middle remains unrepaired. 2011 - Site extended downstream to include new scour. 2013: At the downstream end, behind tree, there is a new animal burrow. Tree have exposed roots. [2013 Site ID: SAC_35-4_L]

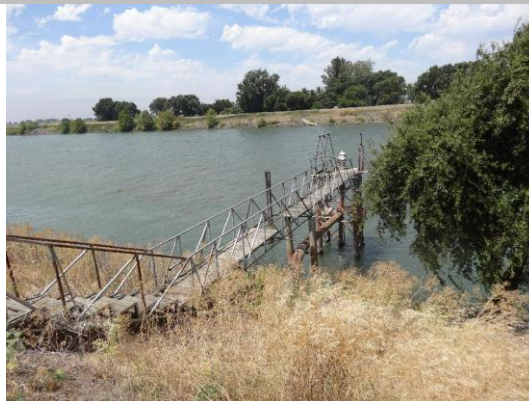
Photo 1 of 1 : UCIP\_1572.jpg

LM Start	1.66	Rating **	M	Issue No.	8
LM End	1.66	Issue Type +	En	Location *	WS
Category	Supplemental			GPS Latitude/Longitude	
				Start	End
Item	DWR UCIP Field Study			38.338714 °	38.338714 °
				-121.562560 °	-121.562560 °
DWR ID	DWR_RD0755_01_s_2014_8				
Action/Comments					
Inspector Comments: FS_ID:17143					
EP_NO: 11219					
Repair Type:					
Crossing Status:					
UCIP Comments: - Pump and walkway seem abandonedPower line is not connected with pumpA pump house like structure found on LS levee toe.					
FIELD_STRUCT_DESC: 16-inch pipe through levee, 8.5 feet below crown. Pump on pile structure in stream. Walkway to pump. Siphon breaker and power pole on landward slope. (ABO No. 11219-Elliott). O&M Manual Sac 111, May 1959, Revision Year 2011.					
FS Date: 8/6/2013

WS view: Overview of walkway, pump structure, and pipe.
