**Flood Control Project Maintenance
Levee Inspections****LMA District Cover Sheet****Spring 2015 Levee Inspection Results****Reclamation District No. 0755 Randall**

Reclamation District No. 0755 Randall

Waterway			Bank	Unit Miles
Unit No. 01 Sacramento River			Left	1.83
	Spring (March - May)	Summer (June - August)	(September - November) Fall	Winter (December - February)
Unit Maintenance Rating (Fall Only)				
Date of Inspection	04/16/2015 - 04/16/2015			
DWR Inspector	Herman Phillips			
Accompanied By

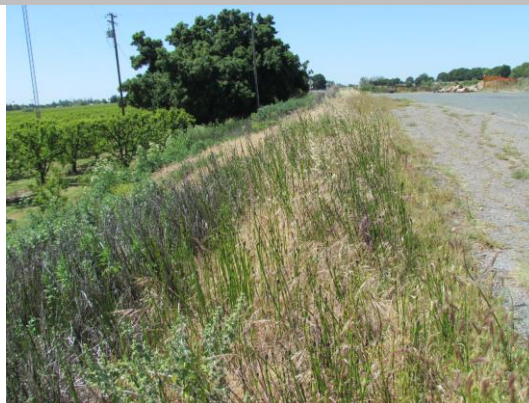
Photo 1 of 1 : SP_2015_RD0755_177_11_20150601_00012.jpg

LM Start	0.62	Rating **	U	Issue No.	11
LM End	0.90	Issue Type +	Ma	Location *	LS
Category	Earthen Levee			GPS Latitude/Longitude	
				Start	End
Item	Vegetation			38.345383 °	38.344197 °
				-121.546740 °	-121.551710 °
DWR ID	DWR_RD0755_01_f_2014_11				
Action/Comments					
Control annual grass and weeds on the levee slopes and easements. Inspector Comments: Remove the unwanted tall weeds from the levee section.

Looking downstream at tall weeds on the landside levee shoulder and slope.

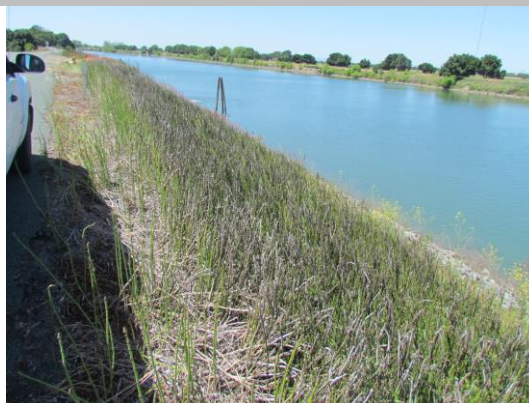
Photo 1 of 1 : SP_2015_RD0755_177_22_20150601_00010.jpg

LM Start	0.64	Rating **	U	Issue No.	22
LM End	0.87	Issue Type +	Ma	Location *	WS
Category	Earthen Levee			GPS Latitude/Longitude	
				Start	End
Item	Vegetation			38.345315 °	38.344330 °
				-121.547092 °	-121.551032 °
DWR ID	DWR_RD0755_01_s_2015_22				
Action/Comments					
Control annual grass and weeds on the levee slopes and easements. Inspector Comments: Snap grasses on waterward levee section unacceptable growth.

Looking downstream at tall snap grasses covering the waterward levee slope.

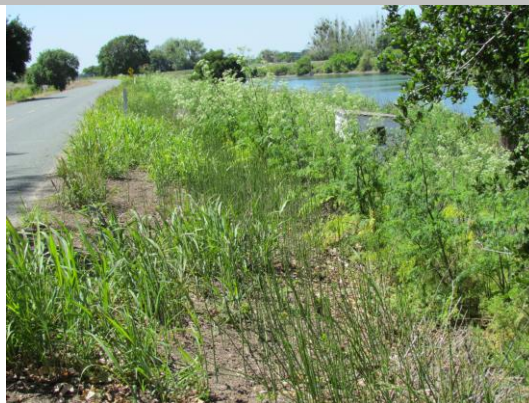
Photo 1 of 1 : SP_2015_RD0755_177_25_20150601_00009.jpg

LM Start	1.11	Rating **	U	Issue No.	25
LM End	1.57	Issue Type +	Ma	Location *	WS
Category	Earthen Levee			GPS Latitude/Longitude	
				Start	End
Item	Vegetation			38.343418 °	38.339530 °
				-121.555315 °	-121.561800 °
DWR ID	DWR_RD0755_01_s _ 2015_25				
Action/Comments					
Control annual grass and weeds on the levee slopes and easements. Inspector Comments: Control the wild growth on the waterside levee slope.

Looking downstream from the waterside shoulder at unacceptable tall weeds covering the waterward slope.
