**Flood Control Project Maintenance  
Levee Inspections**  
**LMA District Cover Sheet**  
**Spring 2016 Levee Inspection Results**

**Reclamation District No. 0755 Randall**

**Levee Inspection Report By Mile - Spring 2016**

Waterway	Bank	Unit Miles	Inspection Start/End	Inspector
Unit No. 01 Sacramento River	Left	1.83	03/17/2016 03/17/2016	Herman Phillips

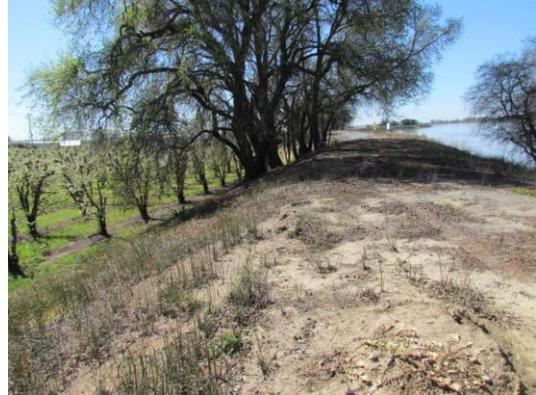
Photo 1 of 1 : SP\_2016\_RD0755\_177\_19\_20160321\_00024.jpg

LM Start	<b>0.11</b>	Rating **	A	Issue No.	<b>19</b>
LM End	<b>0.19</b>	Issue Type +	Ma	Location *	LS
Category	Earthen Levee		GPS Latitude/Longitude		
			Start	End	
Item	Vegetation		38.347080 °	38.346577 °	
			-121.537630 °	-121.539075 °	
DWR ID	DWR_RD0755_01_s_2016_19				
Comment Code					
V1 : Control annual grass and weeds on the levee slopes and easements.					
Inspector Comment					
Looking downstream st the landside slope form levee mile 0.11 the slope has been sprayed at this location.

Looking downstream from levee mile 0.11 landside slope.

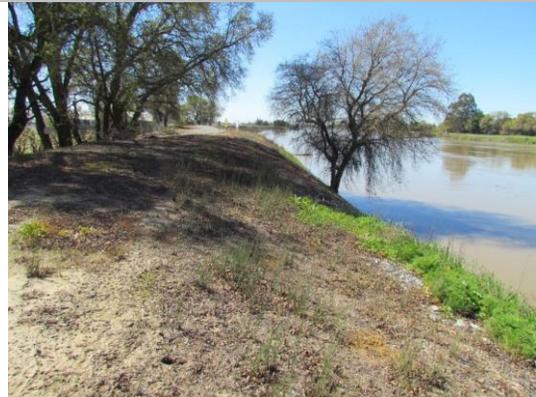
Photo 1 of 1 : SP\_2016\_RD0755\_177\_38\_20160321\_00025.jpg

LM Start	<b>0.11</b>	Rating **	A	Issue No.	<b>38</b>
LM End	<b>0.17</b>	Issue Type +	Ma	Location *	WS
Category	Earthen Levee		GPS Latitude/Longitude		
			Start	End	
Item	Vegetation		38.347080 °	38.346745 °	
			-121.537630 °	-121.538750 °	
DWR ID	DWR_RD0755_01_s_2016_38				
Comment Code					
V1 : Control annual grass and weeds on the levee slopes and easements.					
Inspector Comment					
This section along the waterside appears to have been sprayed.

Looking downstream from levee mile 0.11 waterside slope to levee mile 0.17.

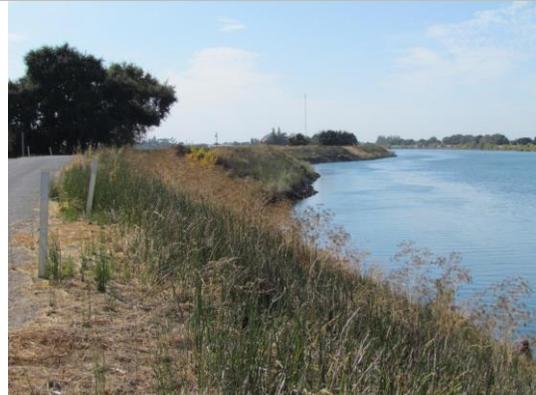
Photo 1 of 1 : SP\_2016\_RD0755\_177\_9\_20160223\_00003.jpg

LM Start	<b>0.17</b>	Rating **	U	Issue No.	<b>9</b>
LM End	<b>1.82</b>	Issue Type +	Ma	Location *	WS
Category	Earthen Levee		GPS Latitude/Longitude		
			Start	End	
Item	Vegetation		38.346752 °	38.336687 °	
			-121.538672 °	-121.564615 °	
DWR ID	DWR_RD0755_01_f_2015_9				
Comment Code					
V1 : Control annual grass and weeds on the levee slopes and easements.					
Inspector Comment					
Remove the unsatisfactory tall weeds from the waterside levee slope.

RD 755 Waterside levee mile 0.17-1.82 levee slope covered with tall weeds such as sweet anise, snap grass and other unsatisfactory weed growth.

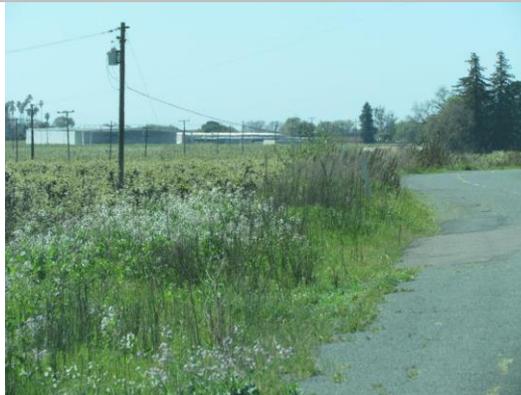
Photo 1 of 1 : SP\_2016\_RD0755\_177\_24\_20160321\_00026.jpg

LM Start	<b>0.25</b>	Rating **	U	Issue No.	<b>24</b>
LM End	<b>0.51</b>	Issue Type +	Ma	Location *	LS
Category	Earthen Levee		GPS Latitude/Longitude		
			Start	End	
Item	Vegetation		38.346262 °	38.345668 °	
			-121.540047 °	-121.544744 °	
DWR ID	DWR_RD0755_01_s_2016_24				
Comment Code					
V1 : Control annual grass and weeds on the levee slopes and easements.					
Inspector Comment					
Tall weed growth on the landside shoulder and slope need spraying.

Looking at tall weeds along the landside levee shoulder and slope.

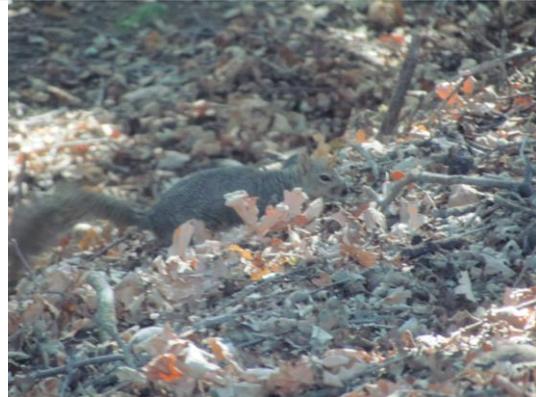
Photo 1 of 1 : SP\_2016\_RD0755\_177\_4\_20160223\_00002.jpg

LM Start	<b>0.43</b>	Rating **	M	Issue No.	<b>4</b>
LM End	<b>1.77</b>	Issue Type +	Ma	Location *	LS
Category	Earthen Levee			GPS Latitude/Longitude	
				Start	End
Item	Animal Control			38.345593 °	38.337197 °
				-121.543263 °	-121.564147 °
DWR ID	DWR_RD0755_01_f_2014_4				
Comment Code					
A1 : Exterminate rodents and backfill and compact or grout burrows.					
Inspector Comment					
There are bait station along the landside levee slope rodents are very active in this location near the walnut trees.

One of many active rodent observed during this inspection.

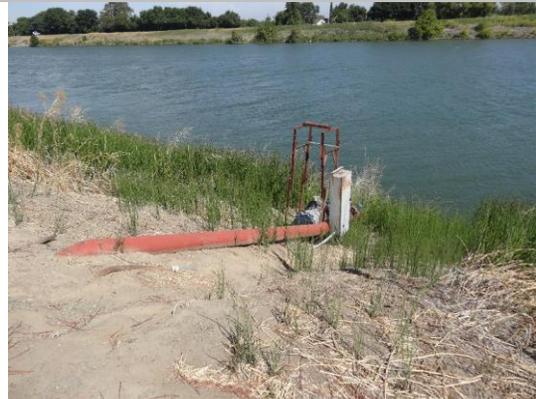
Photo 1 of 2 : UCIP\_SP\_2016\_17123\_29242.jpg

LM Start	<b>0.43</b>	Rating **	M	Issue No.	<b>39</b>
LM End	<b>0.43</b>	Issue Type +	En	Location *	LS
Category	Supplemental			GPS Latitude/Longitude	
				Start	End
Item	DWR UCIP Field Study			38.345640 °	38.345640 °
				-121.543277 °	-121.543277 °
DWR ID					
Comment Code					
Inspector Comment					
FS_ID:17123 DS_ID:18849 EP_NO: 4302 Repair Type: Non-Urgent Crossing Status: Found UCIP Comments: FBC about 2 feet.Power conduit also through the levee.Wet ground on pump site/location. May need investigation about wet ground. FIELD_STRUCT_DESC: 8-inch steel pipe through levee, 2.0 feet below crown. Pump electrical box and control valve on waterward slope. Siphon breaker on landward slope. Service pole at landward toe. (App. No. 4302-Hemly) . FS Date: 8/6/2013

WS view: overview of pump and pipe.

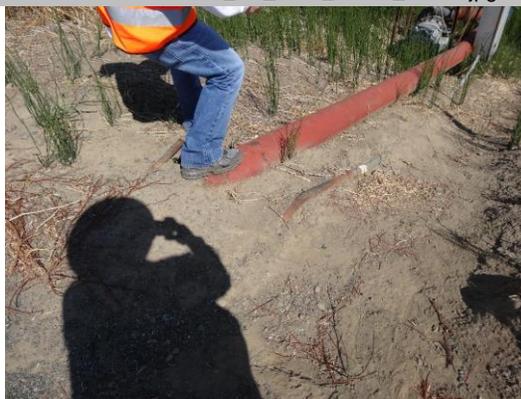
Photo 2 of 2 : UCIP\_SP\_2016\_17123\_29241.jpg

LM Start	<b>0.43</b>	Rating **	M	Issue No.	<b>39 (cont)</b>
LM End	<b>0.43</b>	Issue Type +	En	Location *	LS
Category	Supplemental			GPS Latitude/Longitude	
				Start	End
Item	DWR UCIP Field Study			38.345640 °	38.345640 °
				-121.543277 °	-121.543277 °
DWR ID					
Comment Code					
Inspector Comment					
FS_ID:17123 DS_ID:18849 EP_NO: 4302 Repair Type: Non-Urgent Crossing Status: Found UCIP Comments: FBC about 2 feet. Power conduit also through the levee. Wet ground on pump site/location. May need investigation about wet ground. FIELD_STRUCT_DESC: 8-inch steel pipe through levee, 2.0 feet below crown. Pump electrical box and control valve on waterward slope. Siphon breaker on landward slope. Service pole at landward toe. (App. No. 4302-Hemly) . FS Date: 8/6/2013

WS view: steel pipe and power conduit.

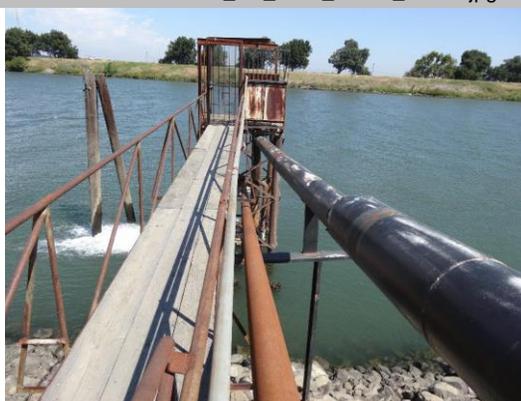
Photo 1 of 2 : UCIP\_SP\_2016\_41634\_29087.jpg

LM Start	<b>0.68</b>	Rating **	M	Issue No.	<b>44</b>
LM End	<b>0.68</b>	Issue Type +	En	Location *	LS
Category	Supplemental			GPS Latitude/Longitude	
				Start	End
Item	DWR UCIP Field Study			38.345113 °	38.345113 °
				-121.547789 °	-121.547789 °
DWR ID					
Comment Code					
Inspector Comment					
FS_ID:41634 DS_ID:18851 EP_NO: 7357 Repair Type: Non-Urgent Crossing Status: Found UCIP Comments: An abandoned 12-in steel pipe lying on LS levee slope should be removed. A buried concrete headwall found on LS levee slope should be checked for any pipe or connection. FIELD_STRUCT_DESC: 1 of 2 pipes. 8-inch pipe sleeved through 16-inch pipe, 4.2 feet below crown. 2-inch conduit through levee. (App. No. 7357-Green McKeown, Inc.). O&M Manual Sac 111, May 1959, Revision Year 2011. FS Date: 8/6/2013

WS view: pump structure on the stream, conduit, pipes, and walkway.

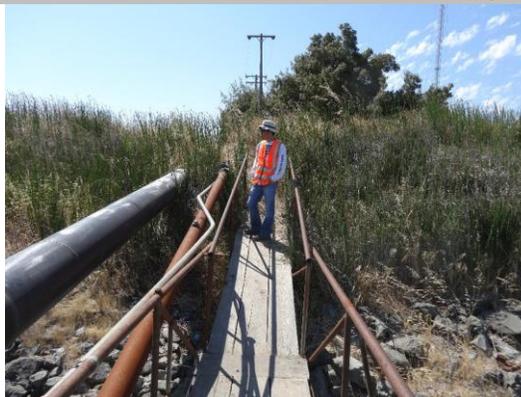
Photo 2 of 2 : UCIP\_SP\_2016\_41634\_29086.jpg

LM Start	<b>0.68</b>	Rating **	M	Issue No.	<b>44 (cont)</b>
LM End	<b>0.68</b>	Issue Type +	En	Location *	LS
Category	Supplemental			GPS Latitude/Longitude	
				Start	End
Item	DWR UCIP Field Study			38.345113 °	38.345113 °
				-121.547789 °	-121.547789 °
DWR ID					
Comment Code					
Inspector Comment					
FS_ID:41634 DS_ID:18851 EP_NO: 7357 Repair Type: Non-Urgent Crossing Status: Found UCIP Comments: An abandoned 12-in steel pipe lying on LS levee slope should be removed.A buried concrete headwall found on LS levee slope should be checked for any pipe or connection. FIELD_STRUCT_DESC: 1 of 2 pipes. 8-inch pipe sleeved through 16-inch pipe, 4.2 feet below crown. 2-inch conduit through levee. (App. No. 7357-Green McKeown, Inc.). O&M Manual Sac 111, May 1959, Revision Year 2011. FS Date: 8/6/2013

WS view: view towards levee crown from pump structure.

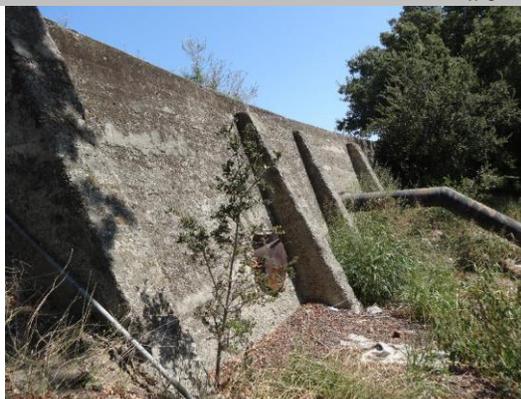
Photo 1 of 2 : UCIP\_SP\_2016\_17049\_29119.jpg

LM Start	<b>0.70</b>	Rating **	M	Issue No.	<b>42</b>
LM End	<b>0.70</b>	Issue Type +	En	Location *	LS
Category	Supplemental			GPS Latitude/Longitude	
				Start	End
Item	DWR UCIP Field Study			38.345036 °	38.345036 °
				-121.548141 °	-121.548141 °
DWR ID					
Comment Code					
Inspector Comment					
FS_ID:17049 DS_ID:18854 EP_NO: 1716 Repair Type: Non-Urgent Crossing Status: Found UCIP Comments: Not found- a 4-inch pipe on waterward shoulder but a 2-inch GI pipe found on landside slope. FIELD_STRUCT_DESC: Abandoned 18-inch drainpipe through levee, 4.5 feet below crown. (App. No. 1716-Green McKeown, Inc.). O&M Manual Sac 111, May 1959, Revision Year 2011. FS Date: 8/6/2013

LS view: concrete headwall and 2-inch conduit (left)

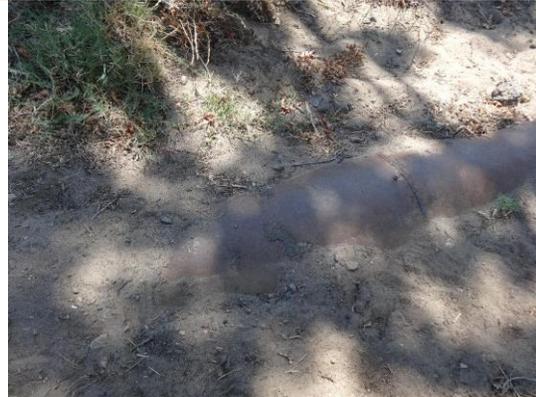
Photo 2 of 2 : UCIP\_SP\_2016\_17049\_29121.jpg

LM Start	0.70	Rating **	M	Issue No.	42 (cont)
LM End	0.70	Issue Type +	En	Location *	LS
Category	Supplemental			GPS Latitude/Longitude	
			Start	End	
Item	DWR UCIP Field Study			38.345036 °	38.345036 °
				-121.548141 °	-121.548141 °
DWR ID					
Comment Code					
Inspector Comment					
FS_ID:17049 DS_ID:18854 EP_NO: 1716 Repair Type: Non-Urgent Crossing Status: Found UCIP Comments: Not found- a 4-inch pipe on waterward shoulder but a 2-inch GI pipe found on landside slope. FIELD_STRUCT_DESC: Abandoned 18-inch drainpipe through levee, 4.5 feet below crown. (App. No. 1716-Green McKeown, Inc.). O&M Manual Sac 111, May 1959, Revision Year 2011. FS Date: 8/6/2013

LS view: 18-inch abandoned pipe on levee slope

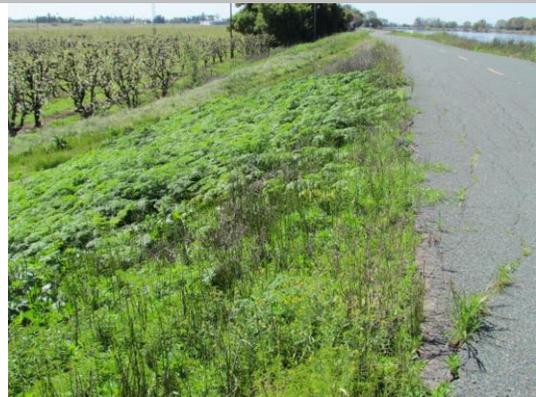
Photo 1 of 1 : SP\_2016\_RD0755\_177\_27\_20160321\_00027.jpg

LM Start	0.71	Rating **	U	Issue No.	27
LM End	0.86	Issue Type +	Ma	Location *	LS
Category	Earthen Levee			GPS Latitude/Longitude	
			Start	End	
Item	Vegetation			38.345032 °	38.344352 °
				-121.548230 °	-121.551020 °
DWR ID	DWR_RD0755_01_s_2016_27				
Comment Code					
V2 : Remove the wild growth other than native grasses from the levee slopes.					
Inspector Comment					
Remove the tall weeds from the landside levee slope.

Tall weed present on shoulder and slope taller than 15".

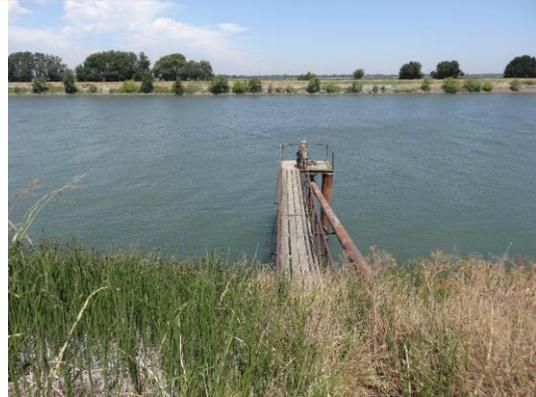
Photo 1 of 2 : UCIP\_SP\_2016\_17063\_29148.jpg

LM Start	<b>0.93</b>	Rating **	M	Issue No.	<b>43</b>
LM End	<b>0.93</b>	Issue Type +	En	Location *	LS
Category	Supplemental			GPS Latitude/Longitude	
				Start	End
Item	DWR UCIP Field Study			38.344103 °	38.344103 °
				-121.552119 °	-121.552119 °
DWR ID					
Comment Code					
Inspector Comment					
FS_ID:17063 DS_ID:18855 EP_NO: 11225 Repair Type: Non-Urgent Crossing Status: Found UCIP Comments: Abandoned pipe and pump. Service pole, power box lying on LS slope. FIELD_STRUCT_DESC: Abandoned 10-inch pipe and 1-inch conduit through levee, 5.6 feet below crown, pump on pile structure with walkway to pump. Abandoned service pole on landward slope. (ABO No. 11225- Wilson). O&M Manual Sac 111, May 1959, Revision Year 2011. FS Date: 8/6/2013

WS view: overview of pipe and pump structure.

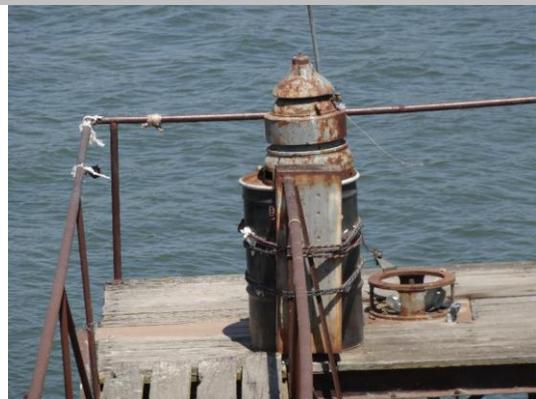
Photo 2 of 2 : UCIP\_SP\_2016\_17063\_29147.jpg

WS view: an abandoned pump

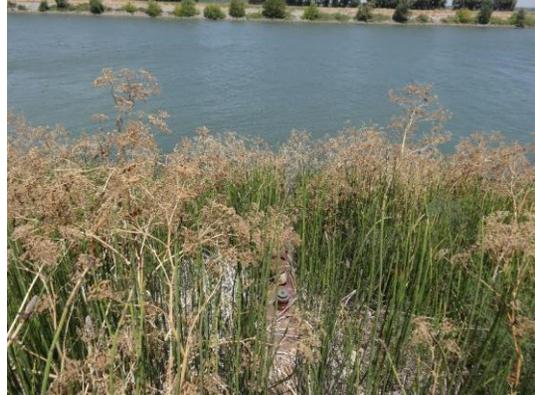
Photo 1 of 2 : UCIP\_SP\_2016\_46764\_29158.jpg

LM Start	<b>1.04</b>	Rating **	M	Issue No.	<b>45</b>
LM End	<b>1.04</b>	Issue Type +	En	Location *	LS
Category	Supplemental			GPS Latitude/Longitude	
				Start	End
Item	DWR UCIP Field Study			38.343625 °	38.343625 °
				-121.554145 °	-121.554145 °
DWR ID					
Comment Code					
Inspector Comment					
FS_ID:46764 DS_ID:18856 EP_NO: N/A Repair Type: Non-Urgent Crossing Status: Found UCIP Comments: Needs to be properly abandoned. FIELD_STRUCT_DESC: *ABANDONED* 12-inch pipe through levee, 5.0 feet below crown. Siphon breaker on WS, no pipe found on LS. (Cat. IVA-Wilson). O&M Manual Sac 111, May 1959, Revision Year 2011. FS Date: 8/6/2013

WS view: overview of steel pipe with siphon breaker on levee slope

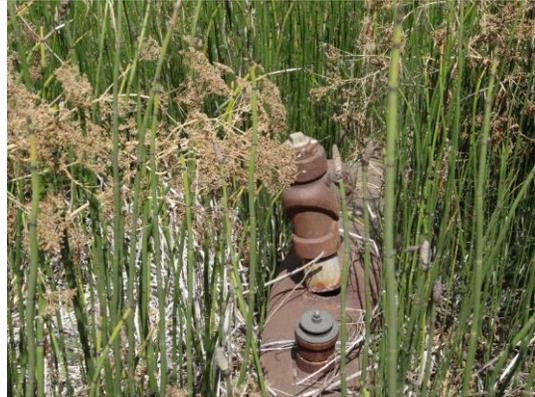
Photo 2 of 2 : UCIP\_SP\_2016\_46764\_29157.jpg

WS view: steel pipe with siphon breaker on levee slope

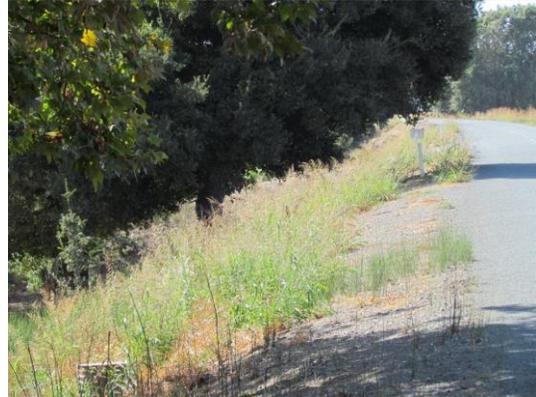
Photo 1 of 1 : SP\_2016\_RD0755\_177\_17\_20160223\_00005.jpg

LM Start	<b>1.11</b>	Rating **	U	Issue No.	<b>17</b>
LM End	<b>1.40</b>	Issue Type +	Ma	Location *	LS
Category	Earthen Levee		GPS Latitude/Longitude		
			Start	End	
Item	Vegetation		38.343300 °	38.341460 °	
			-121.555373 °	-121.559880 °	
DWR ID	DWR_RD0755_01_f_2015_17				
Comment Code					
V1 : Control annual grass and weeds on the levee slopes and easements.					
Inspector Comment					
Remove the tall weeds from the levee slope.

Unsatisfactory tall weed growth on the landside levee slope.

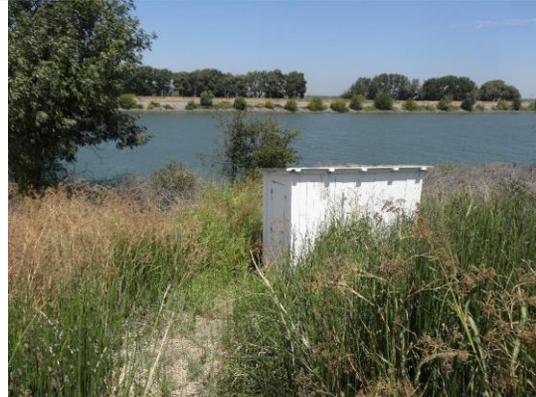
Photo 1 of 2 : UCIP\_SP\_2016\_17144\_29288.jpg

LM Start	<b>1.12</b>	Rating **	M	Issue No.	<b>41</b>
LM End	<b>1.12</b>	Issue Type +	En	Location *	LS
Category	Supplemental			GPS Latitude/Longitude	
				Start	End
Item	DWR UCIP Field Study			38.343305 °	38.343305 °
				-121.555538 °	-121.555538 °
DWR ID					
Comment Code					
Inspector Comment					
FS_ID:17144 DS_ID:18857 EP_NO: 11219 Repair Type: Non-Urgent Crossing Status: Found UCIP Comments: - requires cleaning of siphon breaker box. FIELD_STRUCT_DESC: 8-inch pipe through levee, 5.7 feet below crown. Siphon breaker inside CM Pipe riser on landside shoulder. Power pole on landside. Pump and power box in pump house on waterward slope. (ABO No. 11219- Elliott). O&M Manual Sac 111, May 1959, Revision Year 2011. FS Date: 8/6/2013

WS view: pump house on levee slope.

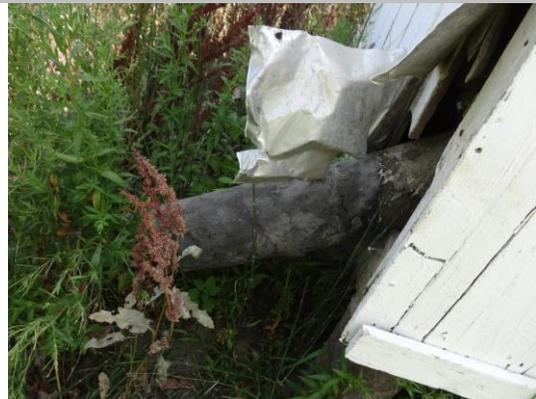
Photo 2 of 2 : UCIP\_SP\_2016\_17144\_29287.jpg

WS view: pipe daylight from pump house.

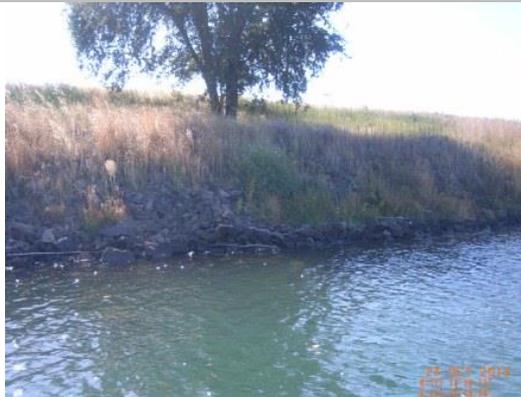
Photo 1 of 1 : SP\_2016\_RD0755\_177\_1\_20160223\_00001.jpg

LM Start	<b>1.24</b>	Rating **	M	Issue No.	<b>1</b>
LM End	<b>1.32</b>	Issue Type +	Ma	Location *	WS
Category	Supplemental			GPS Latitude/Longitude	
				Start	End

Item	2015 USACE Erosion Survey, DRAFT			38.343071 °	38.342426 °
				-121.557706 °	-121.559163 °
DWR ID	DWR_RD0755_01_s_2016_1				
Comment Code					
Inspector Comment					
2003 - Toe and lower slope eroding, rock in water and a few pieces on the slope; rock at upstream and downstream ends. 2005 - Looks a little worse. Two major holes with vertical banks and smaller intermittent pockets in between. Stone is present upstream, downstream, and at toe. 2008 - Repaired at both ends (50 ft of new stone) but middle remains unrepaired. 2011 - Site extended downstream to include new scour. 2013 - At the downstream end, behind tree, there is a new animal burrow. Tree has exposed roots. 2015: New rock placed at toe in middle of site, hole remains behind the tree. [2015 Site ID: SAC_35-4_L]

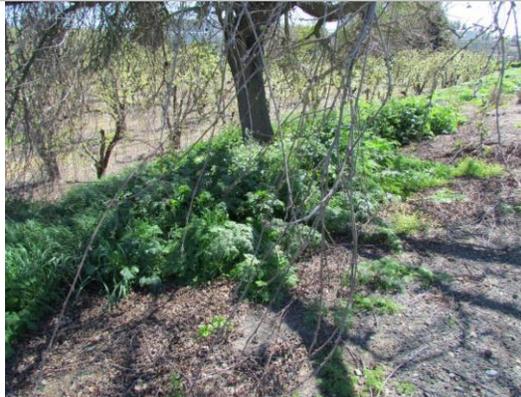
Photo 1 of 1 : SP\_2016\_RD0755\_177\_35\_20160321\_00028.jpg

LM Start	<b>1.42</b>	Rating **	U	Issue No.	<b>35</b>
LM End	<b>1.44</b>	Issue Type +	Ma	Location *	LS
Category	Earthen Levee			GPS Latitude/Longitude	
				Start	End
Item	Vegetation			38.341243 °	38.341012 °
				-121.560100 °	-121.560313 °
DWR ID	DWR_RD0755_01_s_2016_35				
Comment Code					
V2 : Remove the wild growth other than native grasses from the levee slopes.					
Inspector Comment					
Spray the tall weeds on the landside slope.

Tall weeds on the landside slope and shoulder.

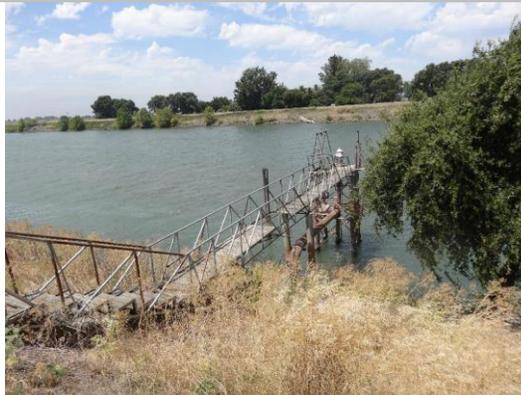
Photo 1 of 2 : UCIP\_SP\_2016\_17143\_29282.jpg

LM Start	<b>1.64</b>	Rating **	M	Issue No.	<b>40</b>
LM End	<b>1.64</b>	Issue Type +	En	Location *	LS
Category	Supplemental			GPS Latitude/Longitude	
				Start	End
Item	DWR UCIP Field Study			38.338715 °	38.338715 °
				-121.562560 °	-121.562560 °
DWR ID					
Comment Code					
Inspector Comment					
FS_ID:17143 DS_ID:18858 EP_NO: 11219 Repair Type: Non-Urgent Crossing Status: Found UCIP Comments: - Pump and walkway seem abandoned.- Power line is not connected with pump.- A pump house like structure found on LS levee toe. FIELD_STRUCT_DESC: 16-inch pipe through levee, 8.5 feet below crown. Pump on pile structure in stream. Walkway to pump. Siphon breaker and power pole on landward slope. (ABO No. 11219-Elliott). O&M Manual Sac 111, May 1959, Revision Year 2011. FS Date: 8/6/2013

WS view: Overview of walkway, pump structure, and pipe.

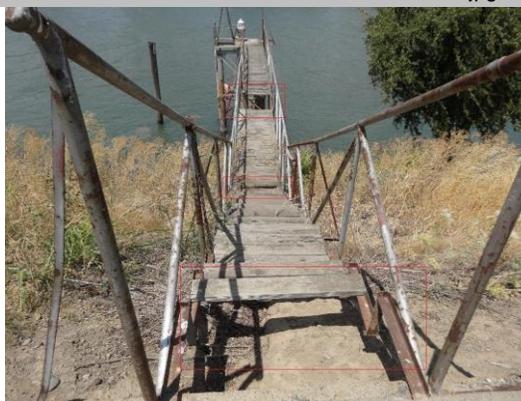
Photo 2 of 2 : UCIP\_SP\_2016\_17143\_29281.jpg

WS view: Abandoned walkway and pump structure
