**Flood Control Project Maintenance
Levee Inspections**
LMA District Cover Sheet
Spring 2017 Levee Inspection Results

Reclamation District No. 0755 Randall

Levee Inspection Report By Mile - Spring 2017

Waterway	Bank	Unit Miles	Inspection Start/End	Inspector
Unit No. 01 Sacramento River	Left	1.83	04/06/2017 04/06/2017	Herman Phillips

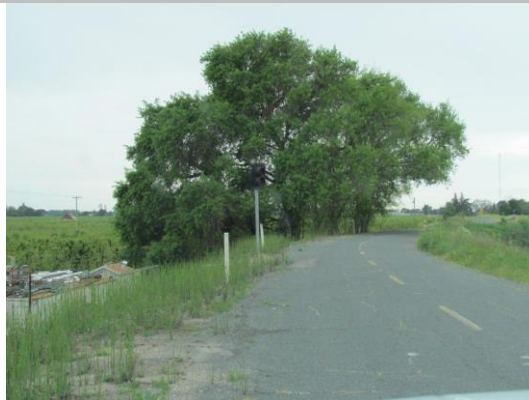
Photo 1 of 1 : SP_2017_RD0755_177_20_20170410_00032.jpg

LM Start	0.17	Rating **	A/W	Issue No.	20
LM End	0.59	Issue Type +	Ma	Location *	LS
Category	Earthen Levee			GPS Latitude/Longitude	
				Start	End
Item	Vegetation			38.346757 °	38.345423 °
				-121.538675 °	-121.546223 °
DWR ID	DWR_RD0755_01_f_2016_20				
Comment Code					
V2 : Remove the wild growth other than native grasses from the levee slopes.					
Inspector Comment					
The vegetation complies with standards but should be monitored.

RD 755 looking downstream from levee mile 0.17-0.59.

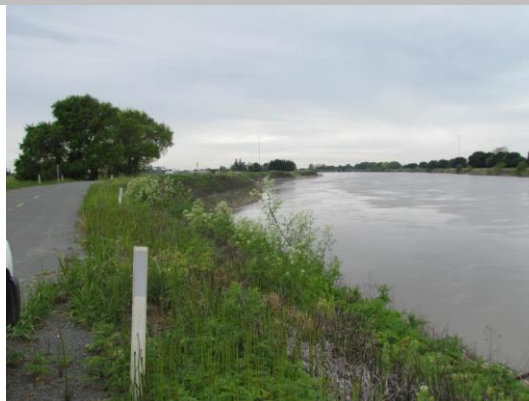
Photo 1 of 1 : SP_2017_RD0755_177_19_20170410_00031.jpg

LM Start	0.17	Rating **	U	Issue No.	19
LM End	1.12	Issue Type +	Ma	Location *	WS
Category	Earthen Levee			GPS Latitude/Longitude	
				Start	End
Item	Vegetation			38.346757 °	38.343328 °
				-121.538675 °	-121.555493 °
DWR ID	DWR_RD0755_01_f_2016_19				
Comment Code					
V2 : Remove the wild growth other than native grasses from the levee slopes.					
Inspector Comment					
The tall weeds on the waterside slope and shoulder should be removed.

RD 755 Levee mile 0.17-1.12 waterside looking downstream.

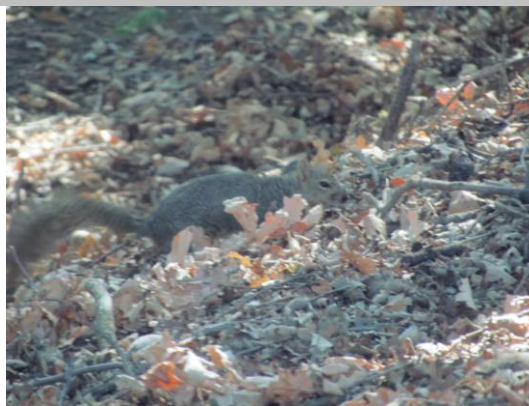
Photo 1 of 1 : SP_2017_RD0755_177_4_20170404_00002.jpg

LM Start	0.43	Rating **	M	Issue No.	4
LM End	1.77	Issue Type +	Ma	Location *	LS
Category	Earthen Levee			GPS Latitude/Longitude	
				Start	End
Item	Animal Control			38.345593 °	38.337197 °
				-121.543263 °	-121.564147 °
DWR ID	DWR_RD0755_01_f_2014_4				
Comment Code					
A1 : Exterminate rodents and backfill and compact or grout burrows.					
Inspector Comment					
There are bait stations along the landside levee slope; rodents are very active in this location near the walnut trees.

One of many active rodent observed during this inspection.

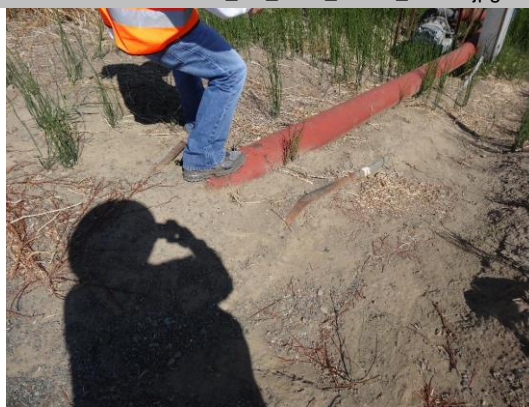
Photo 2 of 3 : UCIP_SP_2017_17123_29241.jpg

LM Start	0.43	Rating **	M	Issue No.	30
LM End	0.43	Issue Type +	En	Location *	LS
Category	Supplemental			GPS Latitude/Longitude	
				Start	End
Item	DWR UCIP Field Study			38.345640 °	38.345640 °
				-121.543277 °	-121.543277 °
DWR ID					
Comment Code					
Inspector Comment					
FS_ID:17123 DS_ID:18849 EP_NO: 4302 Repair Type: Non-Urgent Crossing Status: Found UCIP Comments: FBC about 2 feet.Power conduit also through the levee.Wet ground on pump site/location. May need investigation about wet ground. FIELD_STRUCT_DESC: 8-inch steel pipe through levee, 2.0 feet below crown. Pump electrical box and control valve on waterward slope. Siphon breaker on landward slope. Service pole at landward toe. (App. No. 4302-Hemly) . FS Date: 8/6/2013

WS view: steel pipe and power conduit.

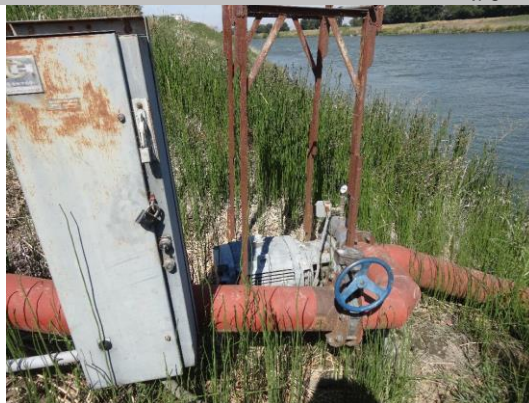
Photo 3 of 3 : UCIP_SP_2017_17123_29240.jpg

LM Start	0.43	Rating **	M	Issue No.	30 (cont)	
LM End	0.43	Issue Type +	En	Location *	LS	
Category	Supplemental			GPS Latitude/Longitude		
				Start		End
Item	DWR UCIP Field Study			38.345640 °		38.345640 °
				-121.543277 °		-121.543277 °
DWR ID						
Comment Code						
Inspector Comment						
FS_ID:17123 DS_ID:18849 EP_NO: 4302 Repair Type: Non-Urgent Crossing Status: Found UCIP Comments: FBC about 2 feet.Power conduit also through the leeve.Wet ground on pump site/location. May need investigation about wet ground. FIELD_STRUCT_DESC: 8-inch steel pipe through levee, 2.0 feet below crown. Pump electrical box and control valve on waterward slope. Siphon breaker on landward slope. Service pole at landward toe. (App. No. 4302-Hemly) . FS Date: 8/6/2013

WS view: pump, power switch box, butterfly valve and pipe.

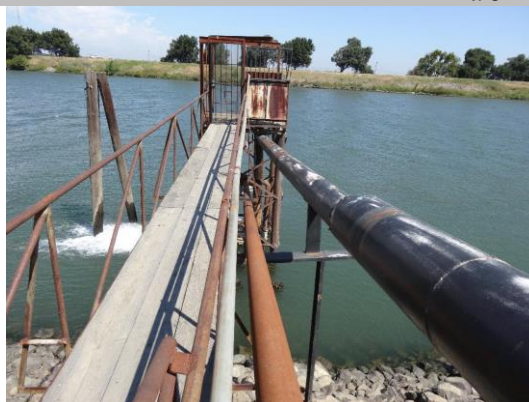
Photo 1 of 3 : UCIP_SP_2017_41634_29087.jpg

LM Start	0.68	Rating **	M	Issue No.	31
LM End	0.68	Issue Type +	En	Location *	LS
Category	Supplemental			GPS Latitude/Longitude	
				Start	End
Item	DWR UCIP Field Study			38.345113 °	38.345113 °
				-121.547789 °	-121.547789 °
DWR ID					
Comment Code					
Inspector Comment					
FS_ID:41634 DS_ID:18851 EP_NO: 7357 Repair Type: Non-Urgent Crossing Status: Found UCIP Comments: An abandoned 12-in steel pipe lying on LS levee slope should be removed.A buried concrete headwall found on LS levee slope should be checked for any pipe or connection. FIELD_STRUCT_DESC: 1 of 2 pipes. 8-inch pipe sleeved through 16-inch pipe, 4.2 feet below crown. 2-inch conduit through levee. (App. No. 7357-Green McKeown, Inc.). O&M Manual Sac 111, May 1959, Revision Year 2011. FS Date: 8/6/2013

WS view: pump structure on the stream, conduit, pipes, and walkway.

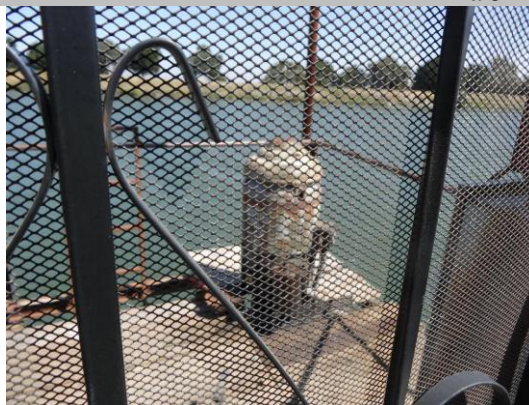
Photo 3 of 3 : UCIP_SP_2017_41634_29085.jpg

LM Start	0.68	Rating **	M	Issue No.	31 (cont)	
LM End	0.68	Issue Type +	En	Location *	LS	
Category	Supplemental			GPS Latitude/Longitude		
				Start		End
Item	DWR UCIP Field Study			38.345113 °		38.345113 °
				-121.547789 °		-121.547789 °
DWR ID						
Comment Code						
Inspector Comment						
FS_ID:41634 DS_ID:18851 EP_NO: 7357 Repair Type: Non-Urgent Crossing Status: Found UCIP Comments: An abandoned 12-in steel pipe lying on LS levee slope should be removed.A buried concrete headwall found on LS levee slope should be checked for any pipe or connection. FIELD_STRUCT_DESC: 1 of 2 pipes. 8-inch pipe sleeved through 16-inch pipe, 4.2 feet below crown. 2-inch conduit through levee. (App. No. 7357-Green McKeown, Inc.). O&M Manual Sac 111, May 1959, Revision Year 2011. FS Date: 8/6/2013

WS view: pump mounted on pump station/deck.

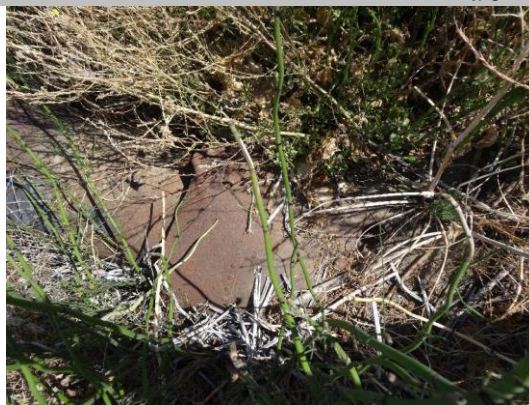
Photo 2 of 3 : UCIP_SP_2017_17145_29293.jpg

LM Start	0.70	Rating **	A/W	Issue No.	32
LM End	0.70	Issue Type +	Ma	Location *	LS
Category	Supplemental			GPS Latitude/Longitude	
				Start	End
Item	DWR UCIP LMA Responsibility			38.345057 °	38.345057 °
				-121.548050 °	-121.548050 °
DWR ID					
Comment Code					
Inspector Comment					
FS_ID:17145 DS_ID:18852 EP_NO: 11222 Repair Type: No Action Needed Crossing Status: Found UCIP Comments: It was working during field survey. A pump found 150 ft from the levee. Not sure whether the pump belong to this drainage system. FIELD_STRUCT_DESC: 16-inch steel drainpipe sleeved through a 24-inch steel pipe through levee, 8.0 feet below crown. (ABO No. 11222-Green McKeown, Inc.). O&M Manual Sac 111, May 1959, Revision Year 2011. FS Date: 8/6/2013

WS view: 16-inch pipe sleeved through 24-inch pipe.

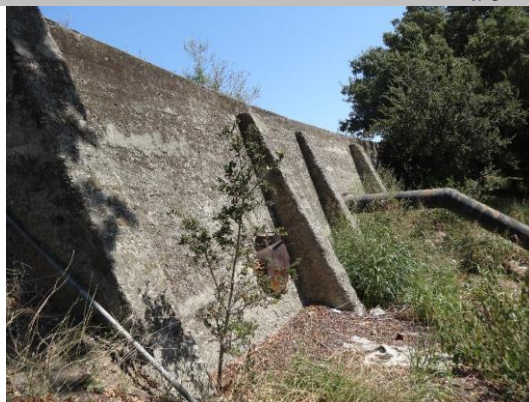
Photo 1 of 3 : UCIP_SP_2017_17049_29119.jpg

LM Start	0.70	Rating **	M	Issue No.	33
LM End	0.70	Issue Type +	Ma	Location *	LS
Category	Supplemental			GPS Latitude/Longitude	
				Start	End
Item	DWR UCIP LMA Responsibility			38.345036 °	38.345036 °
				-121.548141 °	-121.548141 °
DWR ID					
Comment Code					
Inspector Comment					
FS_ID:17049					
DS_ID:18854					
EP_NO: 1716					
Repair Type: Non-Urgent					
Crossing Status: Found					
UCIP Comments: Not found- a 4-inch pipe on waterward shoulder but a 2-inch GI pipe found on landside slope.					
FIELD_STRUCT_DESC: *ABANDONED* 18-inch drainpipe through levee, 4.5 feet below crown. (App. No. 1716-Green McKeown, Inc.).					
O&M Manual Sac 111, May 1959, Revision Year 2011.					
FS Date: 8/6/2013

LS view: concrete headwall and 2-inch conduit (left)

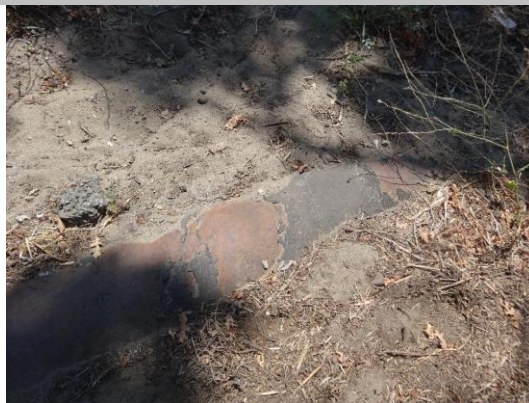
Photo 3 of 3 : UCIP_SP_2017_17049_29122.jpg

LM Start	0.70	Rating **	M	Issue No.	33 (cont)	
LM End	0.70	Issue Type +	Ma	Location *	LS	
Category	Supplemental			GPS Latitude/Longitude		
				Start	End	
Item	DWR UCIP LMA Responsibility			38.345036 °	38.345036 °	
				-121.548141 °	-121.548141 °	
DWR ID						
Comment Code						
Inspector Comment						
FS_ID:17049						
DS_ID:18854						
EP_NO: 1716						
Repair Type: Non-Urgent						
Crossing Status: Found						
UCIP Comments: Not found- a 4-inch pipe on waterward shoulder but a 2-inch GI pipe found on landside slope.						
FIELD_STRUCT_DESC: *ABANDONED* 18-inch drainpipe through levee, 4.5 feet below crown. (App. No. 1716-Green McKeown, Inc.).						
O&M Manual Sac 111, May 1959, Revision Year 2011.						
FS Date: 8/6/2013

LS view: exposed/daylight 18-inch abandoned pipe on levee slope

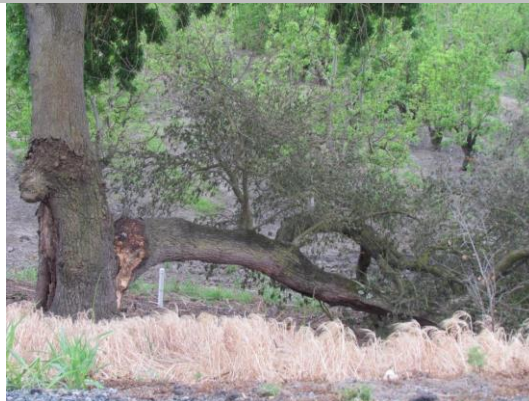
Photo 1 of 1 : SP_2017_RD0755_177_17_20170410_00033.jpg

LM Start	0.70	Rating **	U	Issue No.	17
LM End	0.70	Issue Type +	Ma	Location *	LS
Category	Earthen Levee			GPS Latitude/Longitude	
				Start	End
Item	Encroachments			38.345047 °	38.345047 °
				-121.548175 °	-121.548175 °
DWR ID	DWR_RD0755_01_s_2017_17				
Comment Code					
TR : Tree or limb					
Inspector Comment					
Cut up the broken tree branch and remove from levee section.

Broken tree limb on he landside levee slope and toe levee mile 0.70.

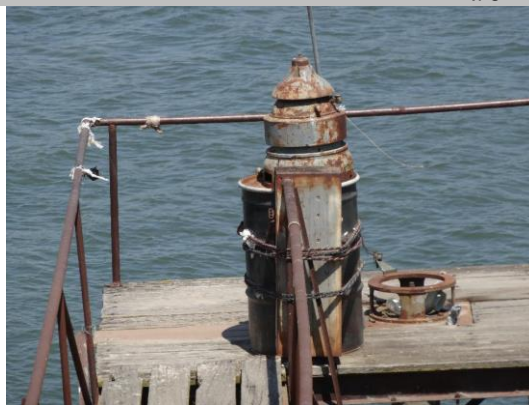
Photo 2 of 3 : UCIP_SP_2017_17063_29147.jpg

LM Start	0.93	Rating **	M	Issue No.	34
LM End	0.93	Issue Type +	En	Location *	LS
Category	Supplemental			GPS Latitude/Longitude	
				Start	End
Item	DWR UCIP Field Study			38.344103 °	38.344103 °
				-121.552119 °	-121.552119 °
DWR ID					
Comment Code					
Inspector Comment					
FS_ID:17063 DS_ID:18855 EP_NO: 11225 Repair Type: Non-Urgent Crossing Status: Found UCIP Comments: Abandoned pipe and pump.Service pole, power box lying on LS slope. FIELD_STRUCT_DESC: *ABANDONED* 10-inch pipe and 1-inch conduit through levee, 5.6 feet below crown, pump on pile structure with walkway to pump. Abandoned service pole on landward slope. (ABO No. 11225- Wilson).O&M Manual Sac 111, May 1959, Revision Year 2011. FS Date: 8/6/2013

WS view: an abandoned pump

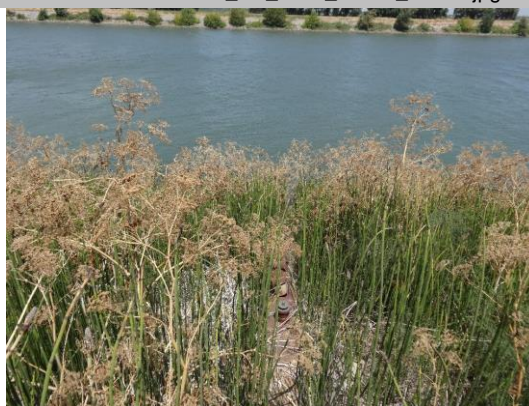
Photo 1 of 3 : UCIP_SP_2017_46764_29158.jpg

LM Start	1.04	Rating **	M	Issue No.	35
LM End	1.04	Issue Type +	En	Location *	LS
Category	Supplemental			GPS Latitude/Longitude	
				Start	End
Item	DWR UCIP Field Study			38.343625 °	38.343625 °
				-121.554145 °	-121.554145 °
DWR ID					
Comment Code					
Inspector Comment					
FS_ID:46764 DS_ID:18856 EP_NO: N/A Repair Type: Non-Urgent Crossing Status: Found UCIP Comments: Needs to be properly abandoned. FIELD_STRUCT_DESC: *ABANDONED* 12-inch pipe through levee, 5.0 feet below crown. Siphon breaker on WS, no pipe found on LS. (Cat. IVA-Wilson). O&M Manual Sac 111, May 1959, Revision Year 2011. FS Date: 8/6/2013

WS view: overview of steel pipe with siphon breaker on levee slope

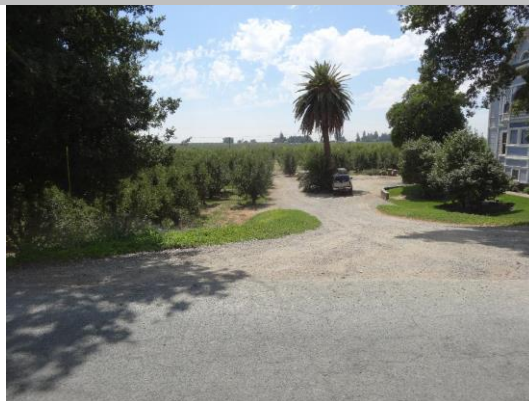
Photo 3 of 3 : UCIP_SP_2017_46764_29159.jpg

LM Start	1.04	Rating **	M	Issue No.	35 (cont)	
LM End	1.04	Issue Type +	En	Location *	LS	
Category	Supplemental			GPS Latitude/Longitude		
				Start	End	
Item	DWR UCIP Field Study			38.343625 °	38.343625 °	
				-121.554145 °	-121.554145 °	
DWR ID						
Comment Code						
Inspector Comment						
FS_ID:46764						
DS_ID:18856						
EP_NO: N/A						
Repair Type: Non-Urgent						
Crossing Status: Found						
UCIP Comments: Needs to be properly abandoned.						
FIELD_STRUCT_DESC: *ABANDONED* 12-inch pipe through levee,						
5.0 feet below crown. Siphon breaker on WS, no pipe found on LS.						
(Cat. IVA-Wilson). O&M Manual Sac 111, May 1959, Revision Year						
2011.						
FS Date: 8/6/2013

LS view: no pipe and pump found on LS.

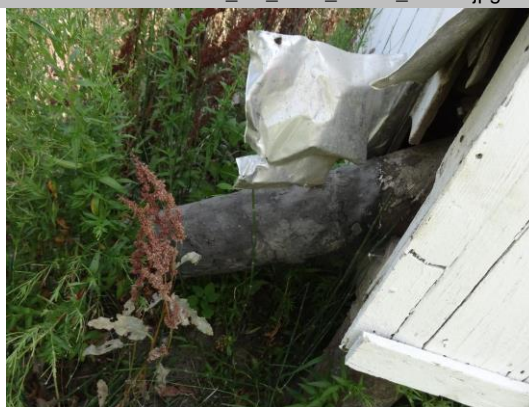
Photo 2 of 3 : UCIP_SP_2017_17144_29287.jpg

LM Start	1.12	Rating **	M	Issue No.	36
LM End	1.12	Issue Type +	En	Location *	WS
Category	Supplemental	GPS Latitude/Longitude			
		Start	End		
Item	DWR UCIP Field Study	38.343305°	38.343305°		
		-121.555538°	-121.555538°		
DWR ID					
Comment Code					
Inspector Comment					
FS_ID:17144 DS_ID:18857 EP_NO: 11219 Repair Type: Non-Urgent Crossing Status: Found UCIP Comments: - requires cleaning of siphon breaker box. FIELD_STRUCT_DESC: 8-inch pipe through levee, 5.7 feet below crown. Siphon breaker inside CM Pipe riser on landside shoulder. Power pole on landside. Pump and power box in pump house on waterward slope. (ABO No. 11219- Elliott). O&M Manual Sac 111, May 1959, Revision Year 2011. FS Date: 8/6/2013

WS view: pipe daylight from pump house.

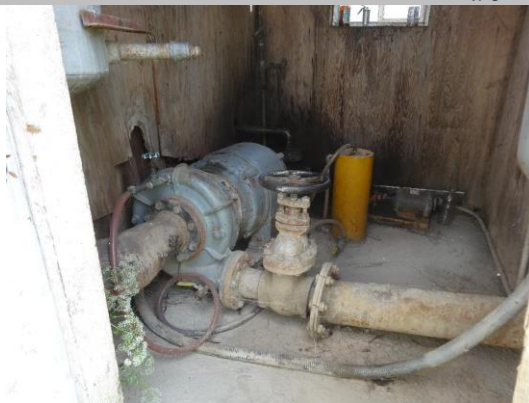
Photo 3 of 3 : UCIP_SP_2017_17144_29286.jpg

LM Start	1.12	Rating **	M	Issue No.	36 (cont)
LM End	1.12	Issue Type +	En	Location *	WS
Category	Supplemental			GPS Latitude/Longitude	
				Start	End
Item	DWR UCIP Field Study			38.343305 °	38.343305 °
				-121.555538 °	-121.555538 °
DWR ID					
Comment Code					
Inspector Comment					
FS_ID:17144					
DS_ID:18857					
EP_NO: 11219					
Repair Type: Non-Urgent					
Crossing Status: Found					
UCIP Comments: - requires cleaning of siphon breaker box.					
FIELD_STRUCT_DESC: 8-inch pipe through levee, 5.7 feet below crown. Siphon breaker inside CM Pipe riser on landside shoulder.Power pole on landside. Pump and power box in pump house on waterward slope. (ABO No. 11219- Elliott). O&M Manual Sac 111, May 1959, Revision Year 2011.					
FS Date: 8/6/2013

WS view: pumps, butterfly valve and pipe inside pump house.

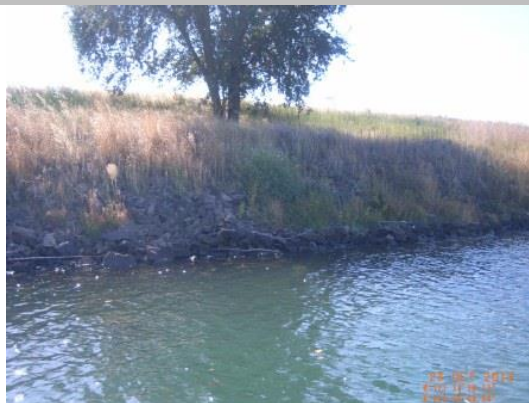
Photo 1 of 1 : SP_2017_RD0755_177_1_20170404_00001.jpg

Comment Code					
Inspector Comment					
2003 - Toe and lower slope eroding, rock in water and a few pieces on the slope; rock at upstream and downstream ends. 2005 - Looks a little worse. Two major holes with vertical banks and smaller intermittent pockets in between. Stone is present upstream, downstream, and at toe. 2008 - Repaired at both ends (50 ft of new stone) but middle remains unrepaired. 2011 - Site extended downstream to include new scour. 2013 - At the downstream end, behind tree, there is a new animal burrow. Tree has exposed roots. 2015: New rock placed at toe in middle of site, hole remains behind the tree. [2015 Site ID: SAC_35-4_L]

USACE 2013 Photo #1

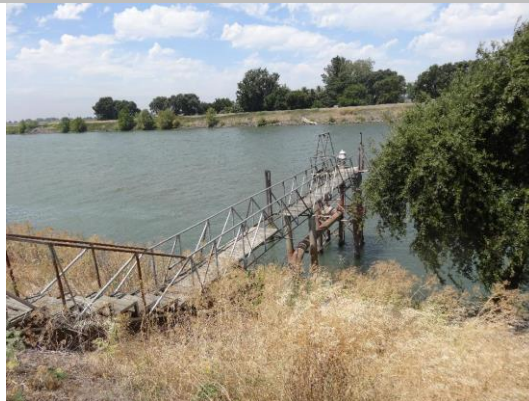
Photo 1 of 3 : UCIP_SP_2017_17143_29282.jpg

LM Start	1.64	Rating **	M	Issue No.	37
LM End	1.64	Issue Type +	En	Location *	LS
Category	Supplemental			GPS Latitude/Longitude	
				Start	End
Item	DWR UCIP Field Study			38.338715 °	38.338715 °
				-121.562560 °	-121.562560 °
DWR ID					
Comment Code					
Inspector Comment					
FS_ID:17143 DS_ID:18858 EP_NO: 11219 Repair Type: Non-Urgent Crossing Status: Found UCIP Comments: - Pump and walkway seem abandoned.- Power line is not connected with pump.- A pump house like structure found on LS levee toe. FIELD_STRUCT_DESC: 16-inch pipe through levee, 8.5 feet below crown. Pump on pile structure in stream. Walkway to pump. Siphon breaker and power pole on landward slope. (ABO No. 11219-Elliott). O&M Manual Sac 111, May 1959, Revision Year 2011. FS Date: 8/6/2013

WS view: Overview of walkway, pump structure, and pipe.

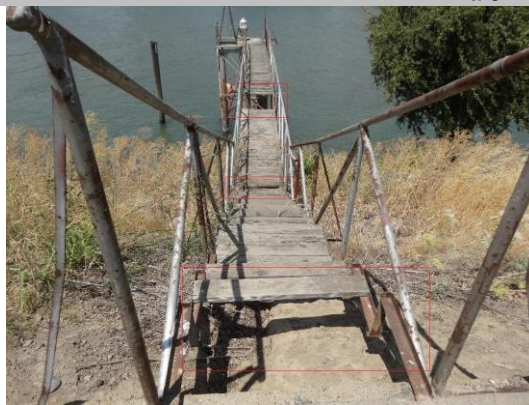
Photo 2 of 3 : UCIP_SP_2017_17143_29281.jpg

WS view: Abandoned walkway and pump structure

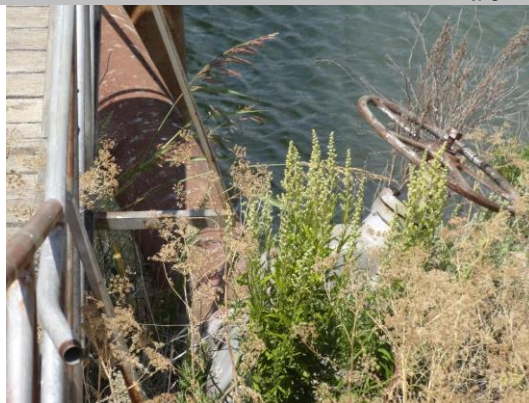
Photo 3 of 3 : UCIP_SP_2017_17143_29280.jpg

LM Start	1.64	Rating **	M	Issue No.	37 (cont)	
LM End	1.64	Issue Type +	En	Location *	LS	
Category	Supplemental			GPS Latitude/Longitude		
				Start		End
Item	DWR UCIP Field Study			38.338715 °		38.338715 °
				-121.562560 °		-121.562560 °
DWR ID						
Comment Code						
Inspector Comment						
FS_ID:17143 DS_ID:18858 EP_NO: 11219 Repair Type: Non-Urgent Crossing Status: Found UCIP Comments: - Pump and walkway seem abandoned.- Power line is not connected with pump.- A pump house like structure found on LS levee toe. FIELD_STRUCT_DESC: 16-inch pipe through levee, 8.5 feet below crown. Pump on pile structure in stream. Walkway to pump. Siphon breaker and power pole on landward slope. (ABO No. 11219-Elliott). O&M Manual Sac 111, May 1959, Revision Year 2011. FS Date: 8/6/2013

WS view: Pipe and butterfly/gate valve on levee slope.
