**Flood Control Project Maintenance
Levee Inspections**
LMA District Cover Sheet
Spring 2018 Levee Inspection Results

Reclamation District No. 0755 Randall

Spring 2018 Levee Inspection Results

Waterway			Bank	Unit Miles
Unit No. 01 Sacramento River			Left	1.83
	Spring (March - May)	Summer (June - August)	(September - November) Fall	Winter (December - February)
Unit Maintenance Rating (Fall Only)				
Date of Inspection	3/21/2018 - 3/21/2018			
DWR Inspector	Keith Millard			
Accompanied By

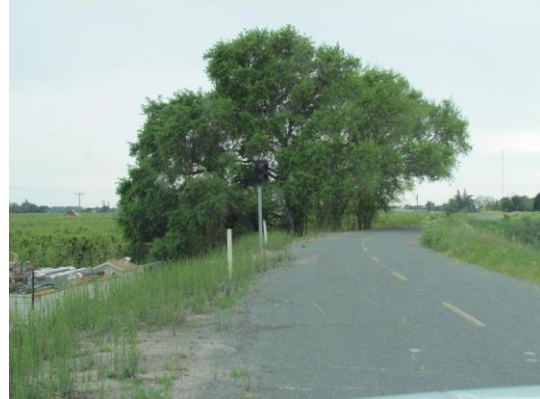
Photo 1 of 1 : SP_2018_RD0755_177_20_20180305_00009.jpg

LM Start	0.17	Rating **	M	Issue No.	20
LM End	1.05	Issue Type +	Ma	Location *	LS
Category	Earthen Levee			GPS Latitude/Longitude	
				Start	End
Item	Vegetation			38.346757 °	38.343581 °
				-121.538675 °	-121.554301 °
DWR ID	DWR_RD0755_01_f _ 2016_20				
Comment Code					
V2 : Remove the wild growth other than native grasses from the levee slopes.					
Inspector Comment					
The vegetation should be removed/managed to allow inspection of landside slope and toe.

RD 755 looking downstream from levee mile 0.17-0.59.

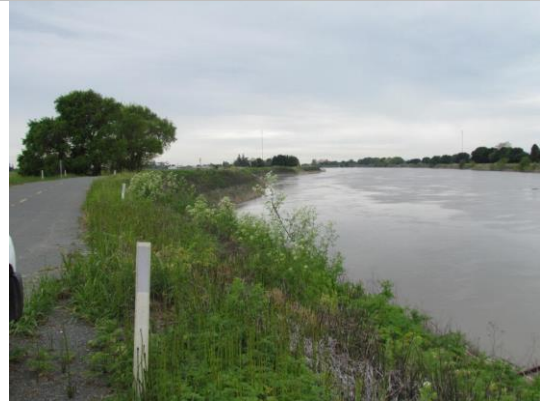
Photo 1 of 1 : SP_2018_RD0755_177_19_20180305_00008.jpg

LM Start	0.17	Rating **	M	Issue No.	19
LM End	1.84	Issue Type +	Ma	Location *	WS
Category	Earthen Levee			GPS Latitude/Longitude	
				Start	End
Item	Vegetation			38.346757 °	38.336409 °
				-121.538675 °	-121.564813 °
DWR ID	DWR_RD0755_01_f_2016_19				
Comment Code					
V2 : Remove the wild growth other than native grasses from the levee slopes.					
Inspector Comment					
The tall weeds on the waterside slope and should be removed/managed to allow inspection. Large cactus (Century Plants) at LM 1.07 should be removed.

RD 755 Levee mile 0.17-1.12 waterside looking downstream.

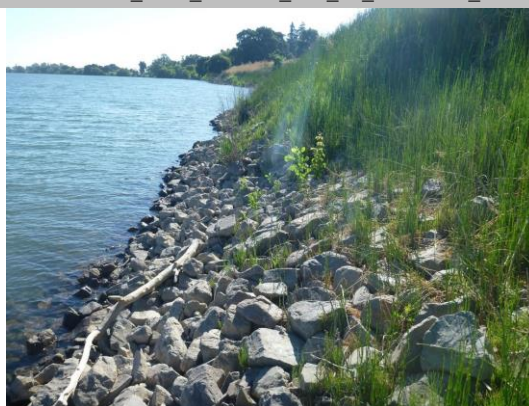
Photo 3 of 3 : SP_2018_RD0755_177_18_20180305_00007.jpg

Comment Code					
Inspector Comment					
<p>Levee Evaluation Comments</p> <p>Description: The damage consists of erosion of the lower waterside levee slope and bank approximately 27 feet in length along the east (left) bank of the Sacramento River. See attached pages for photos. Site location T06N R04E Section 28.</p> <p>Site ID No: 327</p> <p>Site Designation: LMA-154</p> <p>Repair Type: Erosion</p> <p>Rating: Area of Concern</p> <p>Field Date: 7/13/2017</p> <p>Notes: Pretty minor damage visible from the slope, site was originally identified by boat. Will look at again from waterside if there is time. Crown is a paved road. Original GPS was a little off, added correct point in start</p>

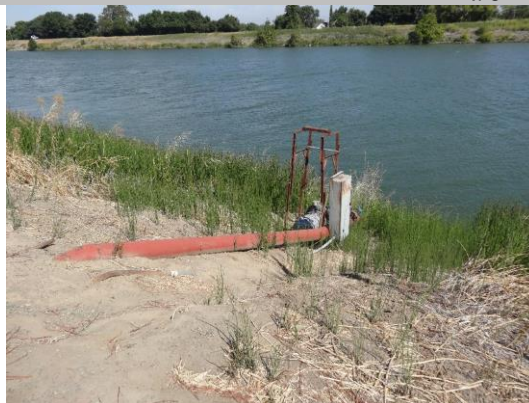
Photo 1 of 3 : UCIP_SP_2018_17123_29242.jpg

Comment Code					
Inspector Comment					
FS_ID:17123 DS_ID:18849 EP_NO: 4302 Repair Type: Non-Urgent Crossing Status: Found UCIP Comments: FBC about 2 feet.Power conduit also through the levee.Wet ground on pump site/location. May need investigation about wet ground. FIELD_STRUCT_DESC: 8-inch coated steel irrigation discharge pipe through the levee, 2 feet below the crown. Pump, electrical box, and control valve on the waterside (WS) slope. Siphon breaker on the landside (LS) slope. Service pole at the LS toe. (Plans for placing an 8-inch irrigation pipe and pump authorized under Permit No. 4302, 1963 - E. C. Hemly). [Additional Reference(s): DWR Levee Log, 2005, referenced as 4 feet below the crown]. FS Date: 8/6/2013

WS view: overview of pump and pipe.

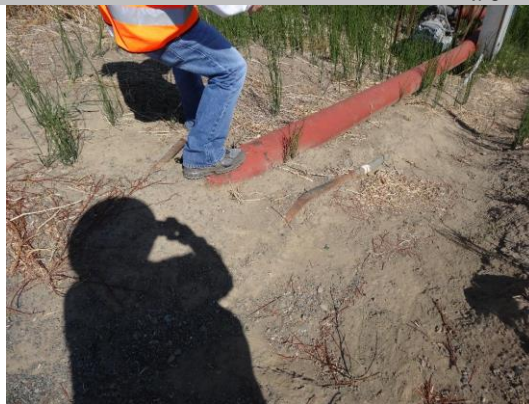
Photo 2 of 3 : UCIP_SP_2018_17123_29241.jpg

WS view: steel pipe and power conduit.

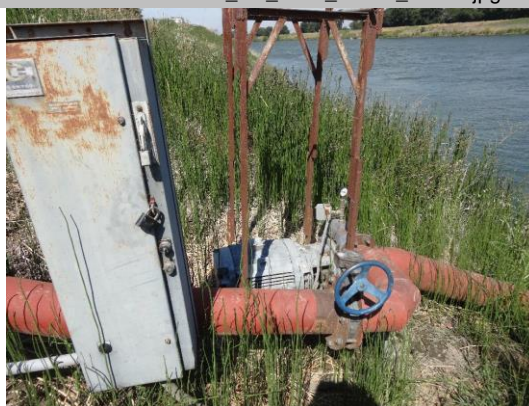
Photo 3 of 3 : UCIP_SP_2018_17123_29240.jpg

Comment Code						
Inspector Comment						
FS_ID:17123 DS_ID:18849 EP_NO: 4302 Repair Type: Non-Urgent Crossing Status: Found UCIP Comments: FBC about 2 feet.Power conduit also through the levee.Wet ground on pump site/location. May need investigation about wet ground. FIELD_STRUCT_DESC: 8-inch coated steel irrigation discharge pipe through the levee, 2 feet below the crown. Pump, electrical box, and control valve on the waterside (WS) slope. Siphon breaker on the landside (LS) slope. Service pole at the LS toe. (Plans for placing an 8-inch irrigation pipe and pump authorized under Permit No. 4302, 1963 - E. C. Hemly). [Additional Reference(s): DWR Levee Log, 2005, referenced as 4 feet below the crown]. FS Date: 8/6/2013

WS view: pump, power switch box, butterfly valve and pipe.

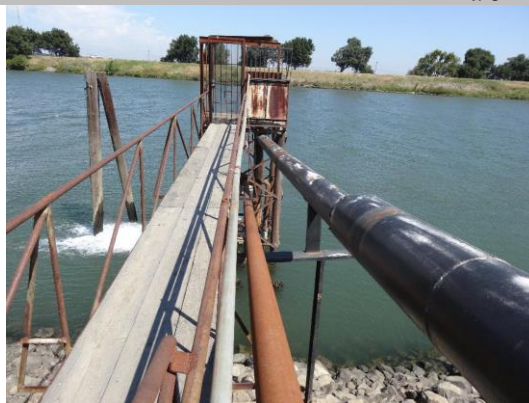
Photo 1 of 3 : UCIP_SP_2018_41634_29087.jpg

Comment Code					
Inspector Comment					
FS_ID:41634 DS_ID:18851 EP_NO: 7357 Repair Type: Non-Urgent Crossing Status: Found UCIP Comments: An abandoned 12-in steel pipe lying on LS levee slope should be removed.A buried concrete headwall found on LS levee slope should be checked for any pipe or connection. FIELD_STRUCT_DESC: 2 of 2: 8-inch pipe sleeved through a 16-inch irrigation discharge pipe of an unknown material through the levee, 4.2 feet below the crown. Pump on the waterside (WS). (Plans to install an additional pump on an existing stand and to connect the discharge pipe to the existing pipe through the levee authorized under Permit No. 7357, 1971 - Green and Keown Farms, Inc). [Additional Reference(s): DWR Levee Log, 2005, 14-inch outer pipe referenced]. FS Date: 8/6/2013

WS view: pump structure on the stream, conduit, pipes, and walkway.

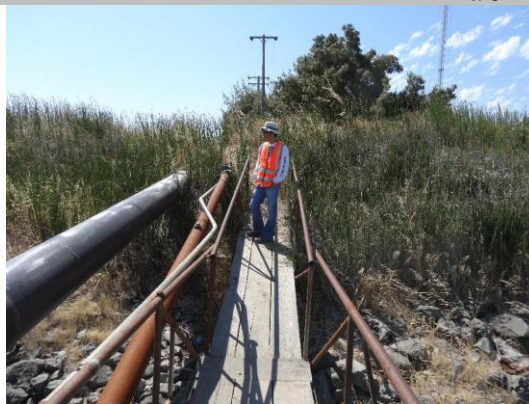
Photo 2 of 3 : UCIP_SP_2018_41634_29086.jpg

WS view: view towards levee crown from pump structure.

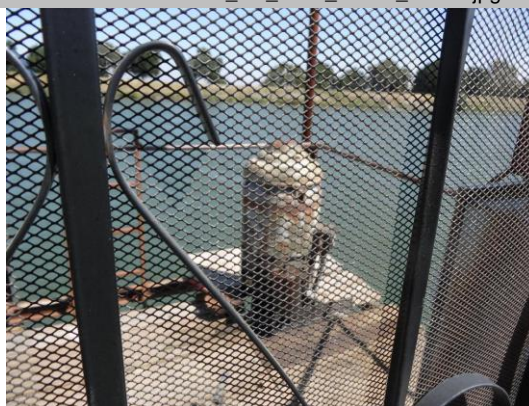
Photo 3 of 3 : UCIP_SP_2018_41634_29085.jpg

Comment Code						
Inspector Comment						
FS_ID:41634 DS_ID:18851 EP_NO: 7357 Repair Type: Non-Urgent Crossing Status: Found UCIP Comments: An abandoned 12-in steel pipe lying on LS levee slope should be removed.A buried concrete headwall found on LS levee slope should be checked for any pipe or connection. FIELD_STRUCT_DESC: 2 of 2: 8-inch pipe sleeved through a 16-inch irrigation discharge pipe of an unknown material through the levee, 4.2 feet below the crown. Pump on the waterside (WS). (Plans to install an additional pump on an existing stand and to connect the discharge pipe to the existing pipe through the levee authorized under Permit No. 7357, 1971 - Green and Keown Farms, Inc). [Additional Reference(s): DWR Levee Log, 2005, 14-inch outer pipe referenced]. FS Date: 8/6/2013

WS view: pump mounted on pump station/deck.

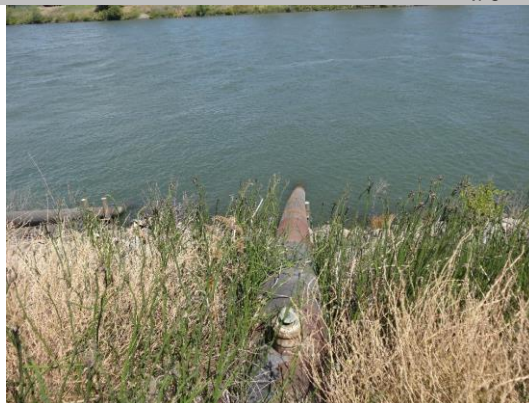
Photo 3 of 3 : UCIP_SP_2018_17145_29295.jpg

Comment Code						
Inspector Comment						
FS_ID:17145 DS_ID:18852 EP_NO: 11222 Repair Type: No Action Needed Crossing Status: Found UCIP Comments: It was working during field survey. A pump found 150 ft from the levee. Not sure whether the pump belong to this drainage system. FIELD_STRUCT_DESC: *ABANDONED* 16-inch steel drainage pipe sleeved through a 24-inch steel drainage pipe through the levee, invert elevation 8 feet below the crown. (Retention of a 12-inch drainage pipe sleeved through a 24-inch pipe through the levee, 8 feet below the crown, authorized under Automatic Board Order (ABO) issued as Permit No. 11222, 1975 - Green McKeown, Inc). [Additional Reference(s): DWR Levee Log, 2005, 12-inch inner pipe referenced. USACE Sacramento O&M Manual 111, May 1959, (RM 35.89)]. FS Date: 8/6/2013

WS view: 16-inch drainage pipe on levee slope.

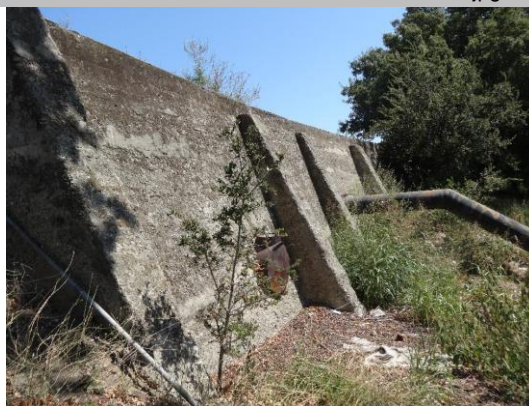
Photo 1 of 3 : UCIP_SP_2018_17049_29119.jpg

LM Start	0.70	Rating **	M	Issue No.	32
LM End	0.70	Issue Type +	Ma	Location *	
Category	Supplemental			GPS Latitude/Longitude	
				Start	End
Item	DWR UCIP LMA Responsibility			38.345036 °	38.345036 °
				-121.548141 °	-121.548141 °
DWR ID					
Comment Code					
Inspector Comment					
FS_ID:17049 DS_ID:18854 EP_NO: 1716 Repair Type: Non-Urgent Crossing Status: Found UCIP Comments: Not found- a 4-inch pipe on waterward shoulder but a 2-inch GI pipe found on landside slope. FIELD_STRUCT_DESC: *ABANDONED* 18-inch drainage pipe of an unknown material through the levee, invert elevation 4.5 feet below the crown. (Plans for the replacement of an existing pipe through the levee authorized under Permit No. 1716, 1952 - Reclamation District No. 755 [RD0755]). [Additional Reference(s): DWR Levee Log, 2005. USACE Sacramento O&M Manual 111, May 1959, (RM 35.88)]. FS Date: 8/6/2013

LS view: concrete headwall and 2-inch conduit (left)

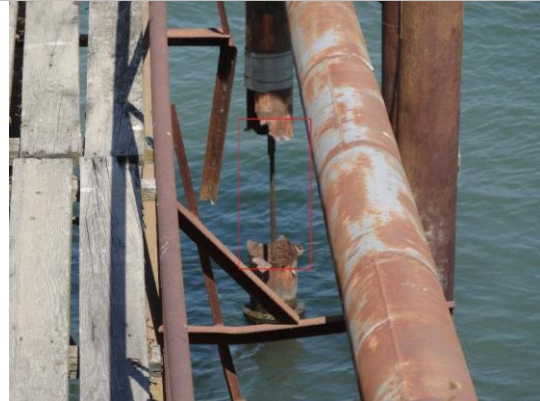
Photo 3 of 3 : UCIP_SP_2018_17063_29146.jpg

Comment Code						
Inspector Comment						
FS_ID:17063 DS_ID:18855 EP_NO: 11225 Repair Type: Non-Urgent Crossing Status: Found UCIP Comments: Abandoned pipe and pump.Service pole, power box lying on LS slope. FIELD_STRUCT_DESC: *ABANDONED* 10-inch irrigation discharge pipe of an unknown material and a 1-inch electrical conduit through the levee, invert elevation 5.6 feet below the crown. Pump on a pile structure with a walkway to the pump. Abandoned service pole on the landside (LS) slope. (Retention of a 10-inch pipe through the levee, 5.6 feet below the crown, pump on a pile structure with a walkway to the pump, and a service pole on the LS slope Automatic Board Order (ABO) issued as Permit No. 11225, 1975 - Helen D. Wilson). [Additional Reference(s): DWR Levee Log, 2005. USACE Sacramento O&M Manual 111, May 1959, (RM 35.66)]. FS Date: 8/6/2013

WS view: abandoned and discontinued vertical intake pipe

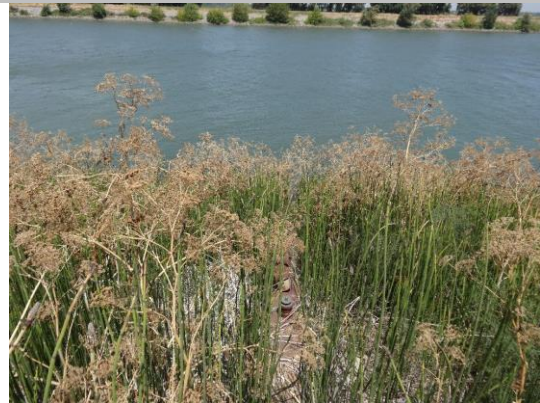
Photo 1 of 3 : UCIP_SP_2018_46764_29158.jpg

LM Start	1.04	Rating **	M	Issue No.	34	
LM End	1.04	Issue Type +	En	Location *		
Category	Supplemental			GPS Latitude/Longitude		
				Start	End	
Item	DWR UCIP Field Study			38.343625 °	38.343625 °	
				-121.554145 °	-121.554145 °	
DWR ID						
Comment Code						
Inspector Comment						
FS_ID:46764						
DS_ID:18856						
EP_NO: N/A						
Repair Type: Non-Urgent						
Crossing Status: Found						
UCIP Comments: Needs to be properly abandoned.						
FIELD_STRUCT_DESC: *ABANDONED* 12-inch pipe of an unknown material or purpose through the levee, invert elevation 5 feet below the crown. Siphon breaker on the waterside (WS). Pipe not found on the landside (LS). (Wilson). [Additional Reference(s): DWR Levee Log, 2005. USACE Sacramento O&M Manual 111, May 1959, (RM 35.55)].						
FS Date: 8/6/2013

WS view: overview of steel pipe with siphon breaker on levee slope

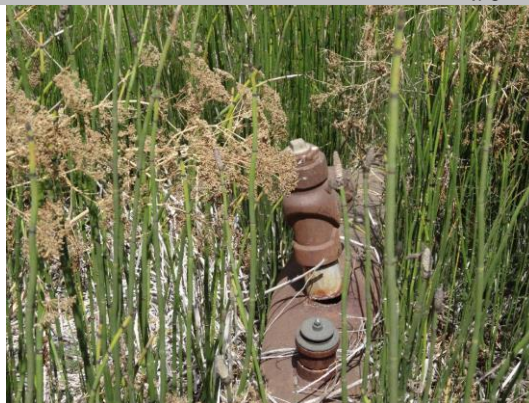
Photo 2 of 3 : UCIP_SP_2018_46764_29157.jpg

LM Start	1.04	Rating **	M	Issue No.	34 (cont)	
LM End	1.04	Issue Type +	En	Location *		
Category	Supplemental			GPS Latitude/Longitude		
				Start	End	
Item	DWR UCIP Field Study			38.343625 °	38.343625 °	
				-121.554145 °	-121.554145 °	
DWR ID						
Comment Code						
Inspector Comment						
FS_ID:46764						
DS_ID:18856						
EP_NO: N/A						
Repair Type: Non-Urgent						
Crossing Status: Found						
UCIP Comments: Needs to be properly abandoned.						
FIELD_STRUCT_DESC: *ABANDONED* 12-inch pipe of an unknown material or purpose through the levee, invert elevation 5 feet below the crown. Siphon breaker on the waterside (WS). Pipe not found on the landside (LS). (Wilson). [Additional Reference(s): DWR Levee Log, 2005. USACE Sacramento O&M Manual 111, May 1959, (RM 35.55)].						
FS Date: 8/6/2013

WS view: steel pipe with siphon breaker on levee slope

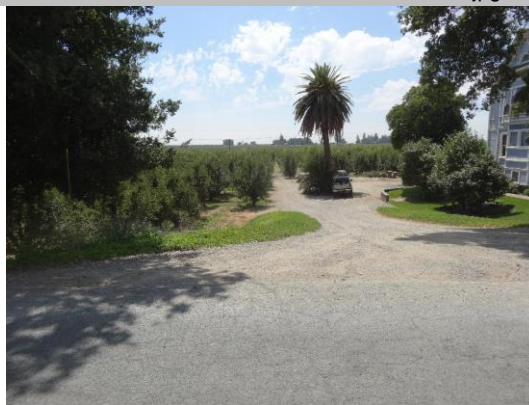
Photo 3 of 3 : UCIP_SP_2018_46764_29159.jpg

LS view: no pipe and pump found on LS.

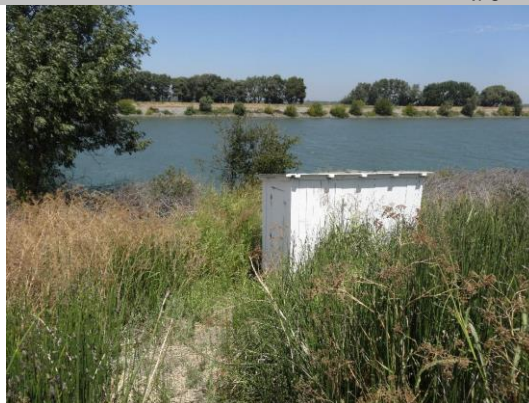
Photo 1 of 3 : UCIP_SP_2018_17144_29288.jpg

Comment Code					
Inspector Comment					
FS_ID:17144 DS_ID:18857 EP_NO: 11219 Repair Type: Non-Urgent Crossing Status: Found UCIP Comments: - requires cleaning of siphon breaker box. FIELD_STRUCT_DESC: 8-inch irrigation discharge pipe of an unknown material through the levee, invert elevation 5.7 feet below the crown. Siphon breaker in a corrugated metal pipe (CMP) riser on the landside (LS) shoulder. Power pole on the LS. Pump and power box in a pump house on the waterside (WS) slope. Electrical conduit through the levee at the same location. (Retention of an 8-inch pipe through the levee, 5.7 feet below the crown, and a pump in a pump house on the WS slope authorized under Automatic Board Order (ABO) issued as Permit No. 11219, 1975 - David J. Jr and Bonnie Elliott). [Additional Reference(s): DWR Levee Log, 2005. USACE Sacramento O&M Manual 111, May 1959, (RM 35.47)]. FS Date: 8/6/2013

WS view: pump house on levee slope.

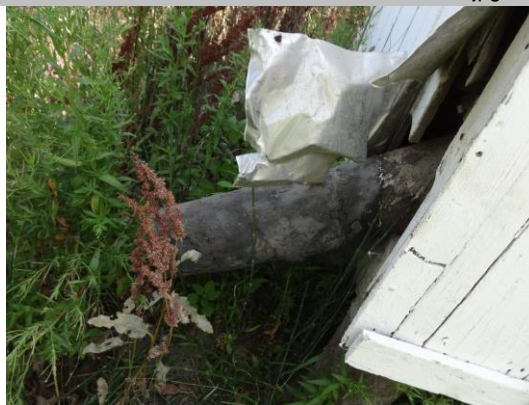
Photo 2 of 3 : UCIP_SP_2018_17144_29287.jpg

WS view: pipe daylight from pump house.

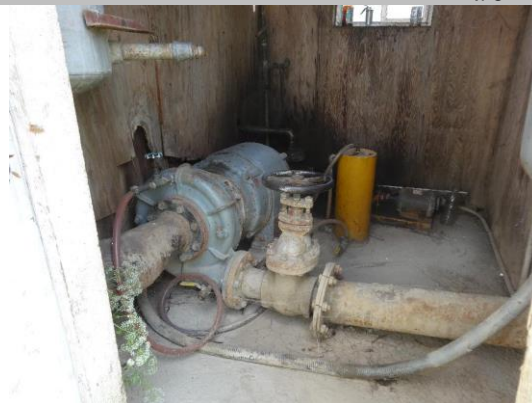
Photo 3 of 3 : UCIP_SP_2018_17144_29286.jpg

Comment Code						
Inspector Comment						
FS_ID:17144 DS_ID:18857 EP_NO: 11219 Repair Type: Non-Urgent Crossing Status: Found UCIP Comments: - requires cleaning of siphon breaker box. FIELD_STRUCT_DESC: 8-inch irrigation discharge pipe of an unknown material through the levee, invert elevation 5.7 feet below the crown. Siphon breaker in a corrugated metal pipe (CMP) riser on the landside (LS) shoulder. Power pole on the LS. Pump and power box in a pump house on the waterside (WS) slope. Electrical conduit through the levee at the same location. (Retention of an 8-inch pipe through the levee, 5.7 feet below the crown, and a pump in a pump house on the WS slope authorized under Automatic Board Order (ABO) issued as Permit No. 11219, 1975 - David J. Jr and Bonnie Elliott). [Additional Reference(s): DWR Levee Log, 2005. USACE Sacramento O&M Manual 111, May 1959, (RM 35.47)]. FS Date: 8/6/2013

WS view: pumps, butterfly valve and pipe inside pump house.

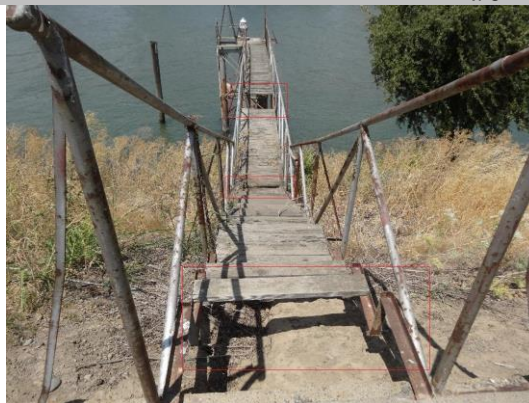
Photo 2 of 3 : UCIP_SP_2018_17143_29281.jpg

Comment Code						
Inspector Comment						
FS_ID:17143 DS_ID:18858 EP_NO: 11219 Repair Type: Non-Urgent Crossing Status: Found UCIP Comments: - Pump and walkway seem abandoned.- Power line is not connected with pump.- A pump house like structure found on LS levee toe. FIELD_STRUCT_DESC: 16-inch irrigation discharge pipe of an unknown material through the levee, invert elevation 8.5 feet below the crown. Pump on a pile structure in the river. Walkway to the pump. Siphon breaker and power pole on the landside (LS) slope. Electrical conduit through the levee at the same location. (Retention of a 14-inch pipe through the levee, 8.5 feet below the crown, a pump on a pile structure in the river, a walkway to the pump, and a siphon breaker on the LS slope authorized under Automatic Board Order (ABO) issued as Permit No. 11219, 1975 - David J. Jr and Bonnie Elliott). [Additional Reference(s): DWR Levee Log, 2005, 14-inch pipe referenced. USACE Sacramento O&M Manual 111, May 1959, (RM 35.02), 14-inch pipe referenced, incorrectly referenced in Reclamation District No. 551 (RD0551)]. FS Date: 8/6/2013

WS view: Abandoned walkway and pump structure

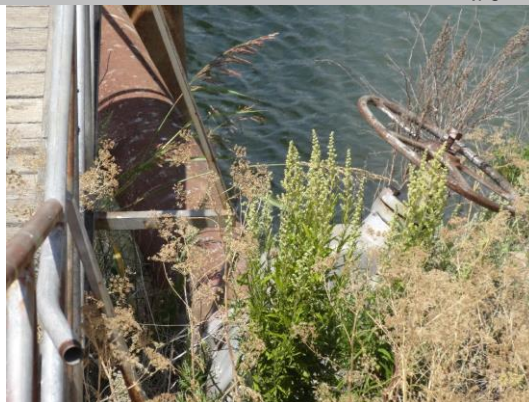
Photo 3 of 3 : UCIP_SP_2018_17143_29280.jpg

WS view: Pipe and butterfly/gate valve on levee slope.
