**Flood Control Project Maintenance
Levee Inspections**
LMA District Cover Sheet
Spring 2019 Levee Inspection Results

Reclamation District No. 0755 Randall

Levee Inspection Report By Mile - Spring 2019

Waterway	Bank	Unit Miles	Inspection Start/End	Inspector
Unit No. 01 Sacramento River	Left	1.83	03/15/2019 03/15/2019	David Julian

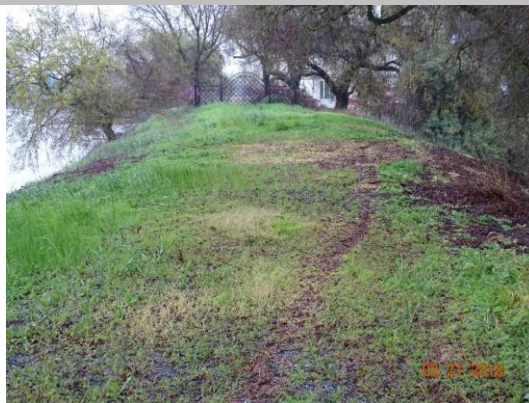
Photo 1 of 1 : SP_2019_RD0755_177_11_20190311_00001.jpg

LM Start	0.00	Rating **	M	Issue No.	11
LM End	0.17	Issue Type +	Ma	Location *	CR
Category	Earthen Levee			GPS Latitude/Longitude	
				Start	End
Item	Vegetation			38.347123 °	38.346773 °
				-121.537572 °	-121.538687 °
DWR ID	DWR_RD0755_01_s_2017_11				
Comment Code					
V9 : Keep the crown roadway free of vegetation.					
Inspector Comment					
Crown vegetation should be mowed to allow inspection.

Crown vegetation should be reduced.

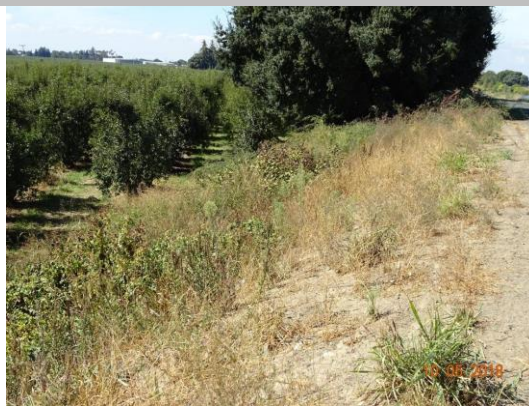
Photo 1 of 2 : SP_2019_RD0755_177_20_20190311_00008.jpg

LM Start	0.17	Rating **	M	Issue No.	20
LM End	0.85	Issue Type +	Ma	Location *	LS
Category	Earthen Levee			GPS Latitude/Longitude	
				Start	End
Item	Vegetation			38.346757 °	38.344390 °
				-121.538675 °	-121.550762 °
DWR ID	DWR_RD0755_01_f_2016_20				
Comment Code					
V2 : Remove the wild growth other than native grasses from the levee slopes.					
Inspector Comment					
The vegetation should be removed/managed to allow inspection of lanside slope and toe.

View looking downstream at vegetation on the land sideslope (October 2018).

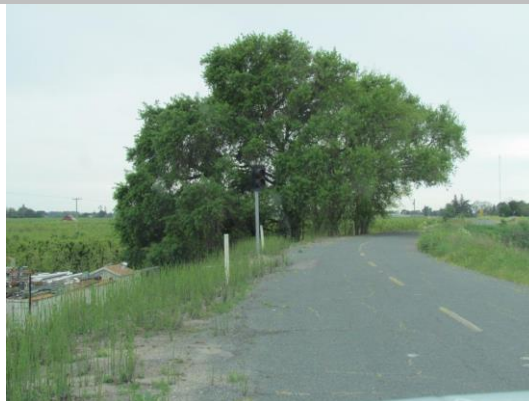
Photo 2 of 2 : SP_2019_RD0755_177_20_20190311_00009.jpg

RD 755 looking downstream from levee mile 0.17-0.59.

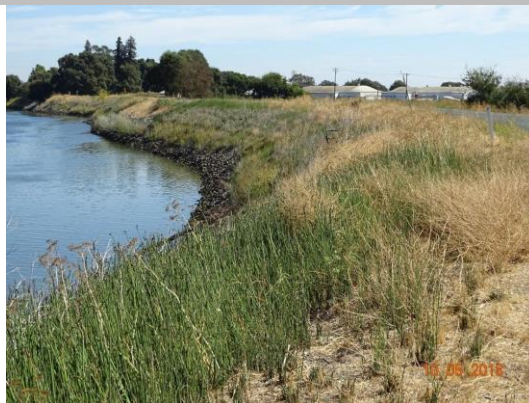
Photo 1 of 2 : SP_2019_RD0755_177_19_20190311_00006.jpg

LM Start	0.17	Rating **	M	Issue No.	19
LM End	1.84	Issue Type +	Ma	Location *	WS
Category	Earthen Levee			GPS Latitude/Longitude	
				Start	End
Item	Vegetation			38.346757 °	38.336409 °
				-121.538675 °	-121.564813 °
DWR ID	DWR_RD0755_01_f_2016_19				
Comment Code					
V2 : Remove the wild growth other than native grasses from the levee slopes.					
Inspector Comment					
The tall weeds on the waterside slope should be removed/managed to allow inspection. Large cactus (Century Plants) at LM 1.07 should also be removed.

View looking upstream at vegetation on the waterside slope (October 2018)

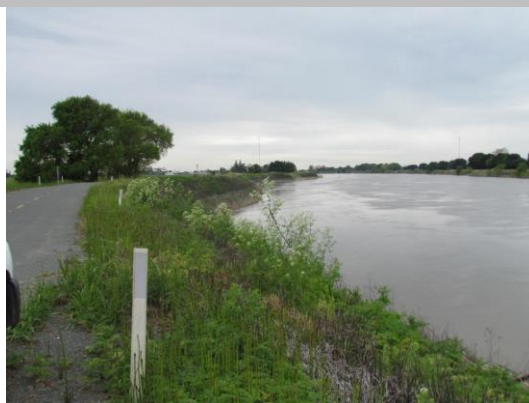
Photo 2 of 2 : SP_2019_RD0755_177_19_20190311_00007.jpg

RD 755 Levee mile 0.17-1.12 waterside looking downstream.

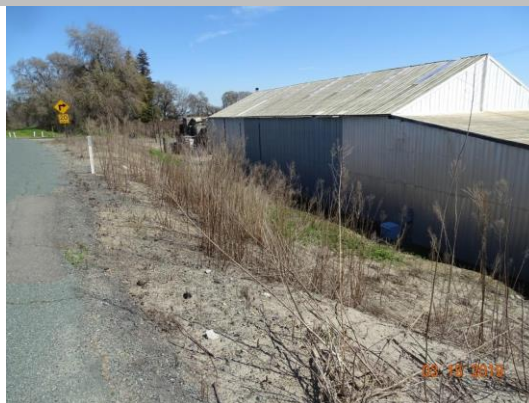
Photo 1 of 1 : SP_2019_RD0755_177_10_20190320_00049.jpg

LM Start	0.21	Rating **	M	Issue No.	10
LM End	0.21	Issue Type +	Ma	Location *	LS
Category	Earthen Levee			GPS Latitude/Longitude	
				Start	End
Item	Slope Stability			38.346428 °	38.346428 °
				-121.539400 °	-121.539400 °
DWR ID	DWR_RD0755_01_s_2019_10				
Comment Code					
S1 : Repair slope instability.					
Inspector Comment					
There is a 2" seperation between roadway and levee on the landside shoulder.

View looking upstream at small slip on the landside shoulder (Spring 2019).

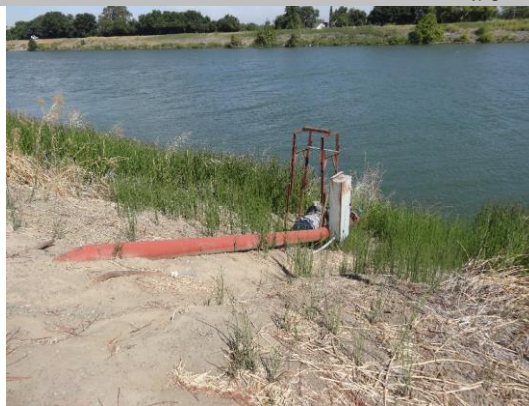
Photo 1 of 3 : UCIP_SP_2019_17123_29242.jpg

Comment Code						
Inspector Comment						
FS_ID:17123 DS_ID:18849 EP_NO: 4302 Repair Type: Non-Urgent Crossing Status: Found UCIP Comments: FBC about 2 feet.Power conduit also through the leeve.Wet ground on pump site/location. May need investigation about wet ground. FIELD_STRUCT_DESC: 8-inch coated steel irrigation discharge pipe through the levee, 2 feet below the crown. Pump, electrical box, and control valve on the waterside (WS) slope. Siphon breaker on the landside (LS) slope. Service pole at the LS toe. (Plans for placing an 8-inch irrigation pipe and pump authorized under Permit No. 4302, 1963 - E. C. Hemly). [Additional Reference(s): DWR Levee Log, 2005, referenced as 4 feet below the crown]. FS Date: 8/6/2013

WS view: overview of pump and pipe.

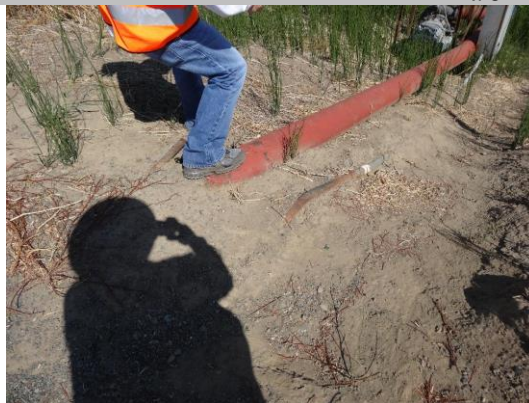
Photo 2 of 3 : UCIP_SP_2019_17123_29241.jpg

Comment Code						
Inspector Comment						
FS_ID:17123 DS_ID:18849 EP_NO: 4302 Repair Type: Non-Urgent Crossing Status: Found UCIP Comments: FBC about 2 feet.Power conduit also through the levee.Wet ground on pump site/location. May need investigation about wet ground. FIELD_STRUCT_DESC: 8-inch coated steel irrigation discharge pipe through the levee, 2 feet below the crown. Pump, electrical box, and control valve on the waterside (WS) slope. Siphon breaker on the landside (LS) slope. Service pole at the LS toe. (Plans for placing an 8-inch irrigation pipe and pump authorized under Permit No. 4302, 1963 - E. C. Hemly). [Additional Reference(s): DWR Levee Log, 2005, referenced as 4 feet below the crown]. FS Date: 8/6/2013

WS view: steel pipe and power conduit.

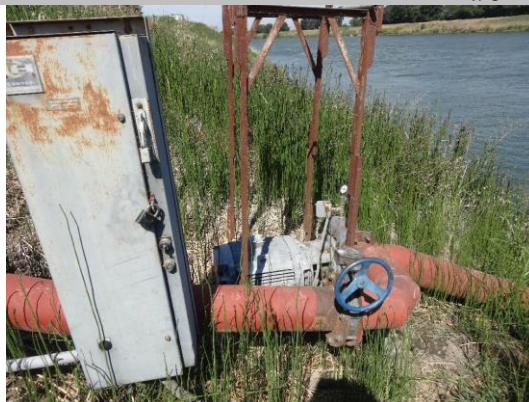
Photo 3 of 3 : UCIP_SP_2019_17123_29240.jpg

WS view: pump, power switch box, butterfly valve and pipe.

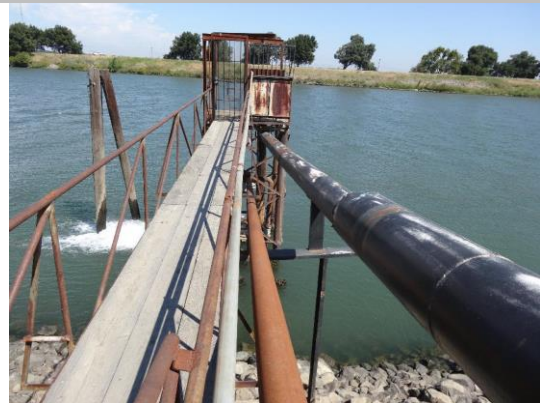
Photo 1 of 3 : UCIP_SP_2019_41634_29087.jpg

Comment Code					
Inspector Comment					
FS_ID:41634					
DS_ID:18851					
EP_NO: 7357					
Repair Type: Non-Urgent					
Crossing Status: Found					
UCIP Comments: An abandoned 12-in steel pipe lying on LS levee slope should be removed.A buried concrete headwall found on LS levee slope should be checked for any pipe or connection.					
FIELD_STRUCT_DESC: 2 of 2: 8-inch pipe sleeved through a 16-inch irrigation discharge pipe of an unknown material through the levee, 4.2 feet below the crown. Pump on the waterside (WS). (Plans to install an additional pump on an existing stand and to connect the discharge pipe to the existing pipe through the levee authorized under Permit No. 7357, 1971 - Green and Keown Farms, Inc). [Additional Reference(s): DWR Levee Log, 2005, 14-inch outer pipe referenced].					
FS Date: 8/6/2013

WS view: pump structure on the stream, conduit, pipes, and walkway.

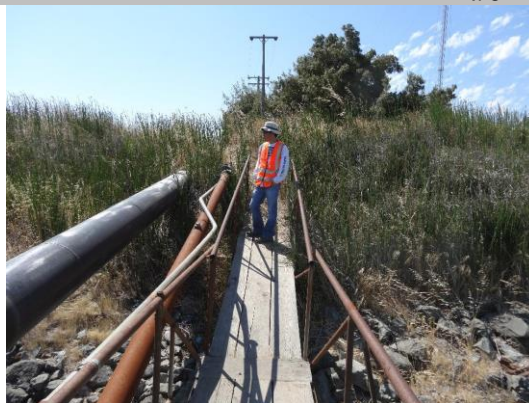
Photo 2 of 3 : UCIP_SP_2019_41634_29086.jpg

Comment Code						
Inspector Comment						
FS_ID:41634 DS_ID:18851 EP_NO: 7357 Repair Type: Non-Urgent Crossing Status: Found UCIP Comments: An abandoned 12-in steel pipe lying on LS levee slope should be removed.A buried concrete headwall found on LS levee slope should be checked for any pipe or connection. FIELD_STRUCT_DESC: 2 of 2: 8-inch pipe sleeved through a 16-inch irrigation discharge pipe of an unknown material through the levee, 4.2 feet below the crown. Pump on the waterside (WS). (Plans to install an additional pump on an existing stand and to connect the discharge pipe to the existing pipe through the levee authorized under Permit No. 7357, 1971 - Green and Keown Farms, Inc). [Additional Reference(s): DWR Levee Log, 2005, 14-inch outer pipe referenced]. FS Date: 8/6/2013

WS view: view towards levee crown from pump structure.

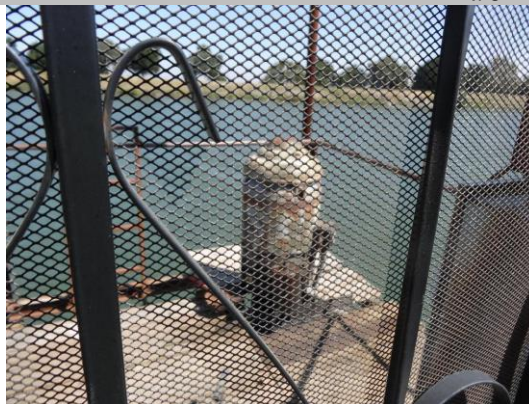
Photo 3 of 3 : UCIP_SP_2019_41634_29085.jpg

WS view: pump mounted on pump station/deck.

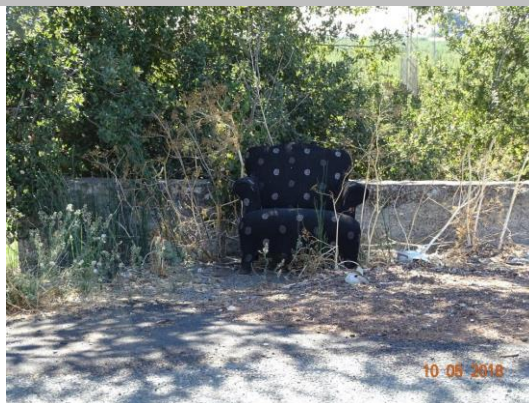
Photo 1 of 1 : SP_2019_RD0755_177_27_20190311_00017.jpg

Chair on the waterside (October 2018).

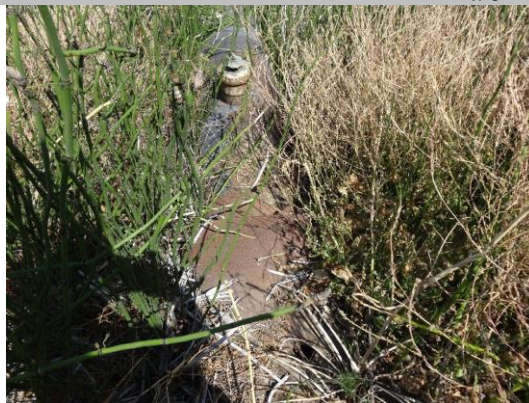
Photo 1 of 3 : UCIP_SP_2019_17145_29292.jpg

FS_ID:17145
DS_ID:18852
EP_NO: 11222
Repair Type: No Action Needed
Crossing Status: Found
UCIP Comments: It was working during field survey. A pump found 150 ft from the levee. Not sure whether the pump belong to this drainage system.
FIELD_STRUCT_DESC: *ABANDONED* 16-inch steel drainage pipe sleeved through a 24-inch steel drainage pipe through the levee, invert elevation 8 feet below the crown. (Retention of a 12-inch drainage pipe sleeved through a 24-inch pipe through the levee, 8 feet below the crown, authorized under Automatic Board Order (ABO) issued as Permit No. 11222, 1975 - Green McKeown, Inc). [Additional Reference(s): DWR Levee Log, 2005, 12-inch inner pipe referenced. USACE Sacramento O&M Manual 111, May 1959, (RM 35.89)].
FS Date: 8/6/2013

WS view: pipe and siphon breaker on levee slope

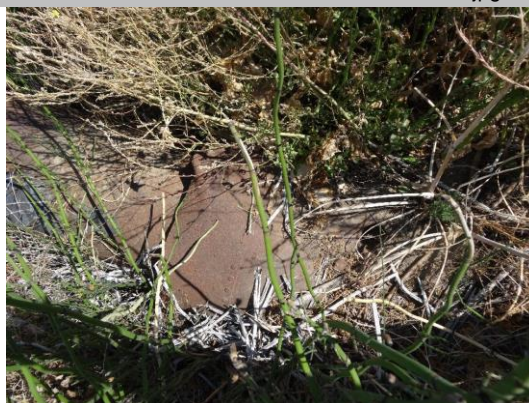
Photo 2 of 3 : UCIP_SP_2019_17145_29293.jpg

WS view: 16-inch pipe sleeved through 24-inch pipe.

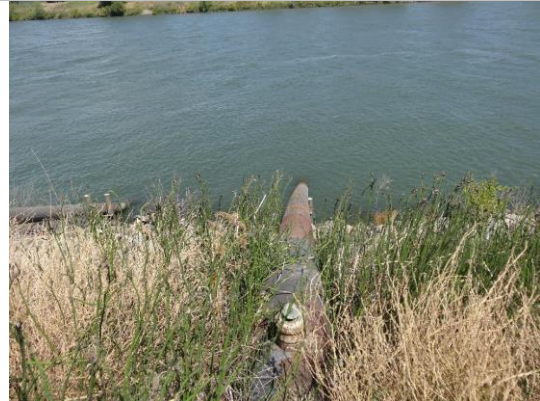
Photo 3 of 3 : UCIP_SP_2019_17145_29295.jpg

Comment Code						
Inspector Comment						
FS_ID:17145 DS_ID:18852 EP_NO: 11222 Repair Type: No Action Needed Crossing Status: Found UCIP Comments: It was working during field survey. A pump found 150 ft from the levee. Not sure whether the pump belong to this drainage system. FIELD_STRUCT_DESC: *ABANDONED* 16-inch steel drainage pipe sleeved through a 24-inch steel drainage pipe through the levee, invert elevation 8 feet below the crown. (Retention of a 12-inch drainage pipe sleeved through a 24-inch pipe through the levee, 8 feet below the crown, authorized under Automatic Board Order (ABO) issued as Permit No. 11222, 1975 - Green McKeown, Inc). [Additional Reference(s): DWR Levee Log, 2005, 12-inch inner pipe referenced. USACE Sacramento O&M Manual 111, May 1959, (RM 35.89)]. FS Date: 8/6/2013

WS view: 16-inch drainage pipe on levee slope.

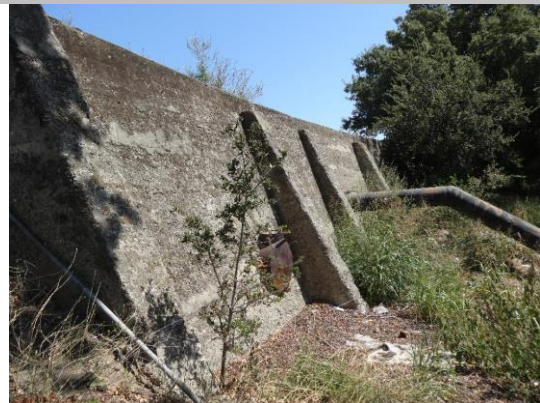
Photo 1 of 3 : UCIP_SP_2019_17049_29119.jpg

Comment Code						
Inspector Comment						
FS_ID:17049						
DS_ID:18854						
EP_NO: 1716						
Repair Type: Non-Urgent						
Crossing Status: Found						
UCIP Comments: Not found- a 4-inch pipe on waterward shoulder but a 2-inch GI pipe found on landside slope.						
FIELD_STRUCT_DESC: *ABANDONED* 18-inch drainage pipe of an unknown material through the levee, invert elevation 4.5 feet below the crown. (Plans for the replacement of an existing pipe through the levee authorized under Permit No. 1716, 1952 - Reclamation District No. 755 [RD0755]). [Additional Reference(s): DWR Levee Log, 2005. USACE Sacramento O&M Manual 111, May 1959, (RM 35.88)].						
FS Date: 8/6/2013

LS view: concrete headwall and 2-inch conduit (left)

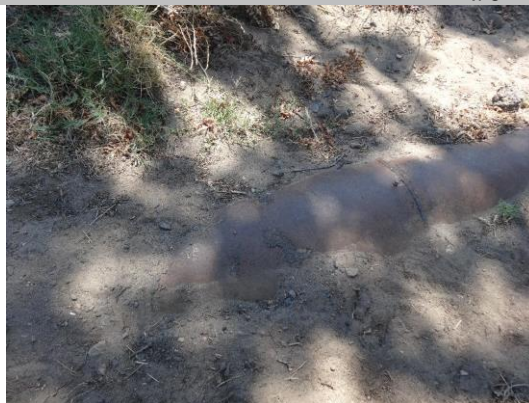
Photo 2 of 3 : UCIP_SP_2019_17049_29121.jpg

Comment Code						
Inspector Comment						
FS_ID:17049						
DS_ID:18854						
EP_NO: 1716						
Repair Type: Non-Urgent						
Crossing Status: Found						
UCIP Comments: Not found- a 4-inch pipe on waterward shoulder but a 2-inch GI pipe found on landside slope.						
FIELD_STRUCT_DESC: *ABANDONED* 18-inch drainage pipe of an unknown material through the levee, invert elevation 4.5 feet below the crown. (Plans for the replacement of an existing pipe through the levee authorized under Permit No. 1716, 1952 - Reclamation District No. 755 [RD0755]). [Additional Reference(s): DWR Levee Log, 2005. USACE Sacramento O&M Manual 111, May 1959, (RM 35.88)].						
FS Date: 8/6/2013

LS view: 18-inch abandoned pipe on levee slope

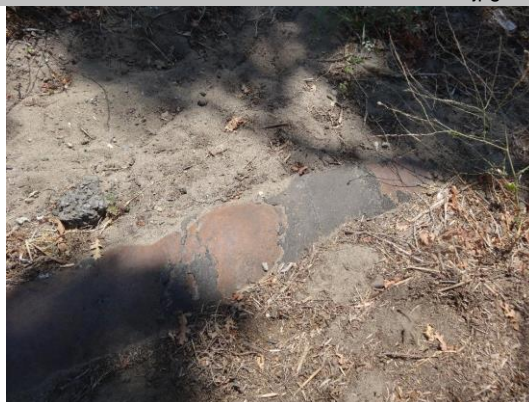
Photo 3 of 3 : UCIP_SP_2019_17049_29122.jpg

LS view: exposed/daylight 18-inch abandoned pipe on levee slope

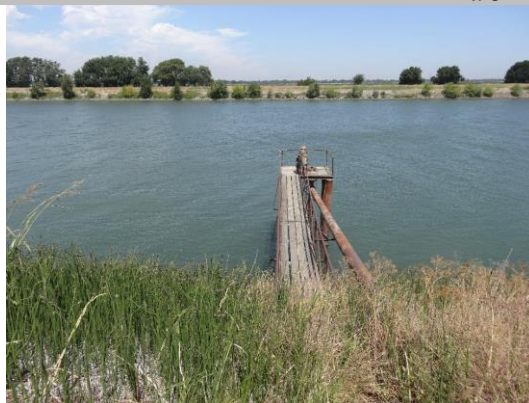
Photo 1 of 3 : UCIP_SP_2019_17063_29148.jpg

Comment Code					
Inspector Comment					
FS_ID:17063 DS_ID:18855 EP_NO: 11225 Repair Type: Non-Urgent Crossing Status: Found UCIP Comments: Abandoned pipe and pump.Service pole, power box lying on LS slope. FIELD_STRUCT_DESC: *ABANDONED* 10-inch irrigation discharge pipe of an unknown material and a 1-inch electrical conduit through the levee, invert elevation 5.6 feet below the crown. Pump on a pile structure with a walkway to the pump. Abandoned service pole on the landside (LS) slope. (Retention of a 10-inch pipe through the levee, 5.6 feet below the crown, pump on a pile structure with a walkway to the pump, and a service pole on the LS slope Automatic Board Order (ABO) issued as Permit No. 11225, 1975 - Helen D. Wilson). [Additional Reference(s): DWR Levee Log, 2005. USACE Sacramento O&M Manual 111, May 1959, (RM 35.66)]. FS Date: 8/6/2013

WS view: overview of pipe and pump structure.

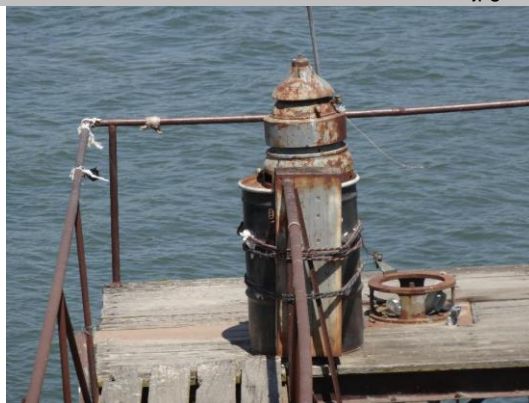
Photo 2 of 3 : UCIP_SP_2019_17063_29147.jpg

WS view: an abandoned pump

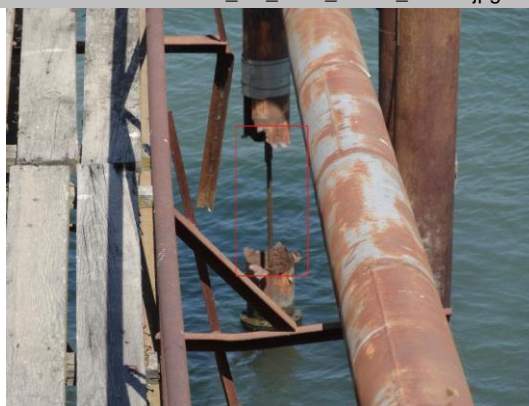
Photo 3 of 3 : UCIP_SP_2019_17063_29146.jpg

Comment Code					
Inspector Comment					
FS_ID:17063 DS_ID:18855 EP_NO: 11225 Repair Type: Non-Urgent Crossing Status: Found UCIP Comments: Abandoned pipe and pump.Service pole, power box lying on LS slope. FIELD_STRUCT_DESC: *ABANDONED* 10-inch irrigation discharge pipe of an unknown material and a 1-inch electrical conduit through the levee, invert elevation 5.6 feet below the crown. Pump on a pile structure with a walkway to the pump. Abandoned service pole on the landside (LS) slope. (Retention of a 10-inch pipe through the levee, 5.6 feet below the crown, pump on a pile structure with a walkway to the pump, and a service pole on the LS slope Automatic Board Order (ABO) issued as Permit No. 11225, 1975 - Helen D. Wilson). [Additional Reference(s): DWR Levee Log, 2005. USACE Sacramento O&M Manual 111, May 1959, (RM 35.66)]. FS Date: 8/6/2013

WS view: abandoned and discontinued vertical intake pipe

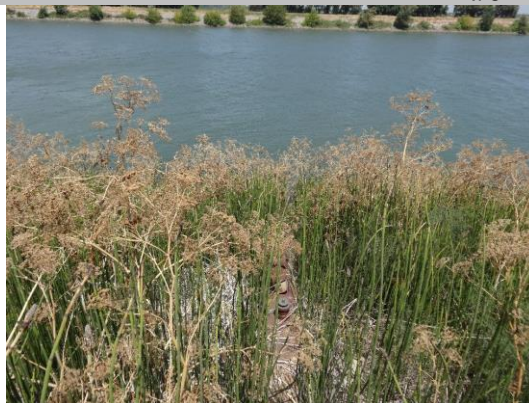
Photo 1 of 3 : UCIP_SP_2019_46764_29158.jpg

LM Start	1.04	Rating **	M	Issue No.	40	
LM End	1.04	Issue Type +	En	Location *		
Category	Supplemental			GPS Latitude/Longitude		
				Start	End	
Item	DWR UCIP Field Study			38.343625 °	38.343625 °	
				-121.554145 °	-121.554145 °	
DWR ID	18856					
Comment Code						
Inspector Comment						
FS_ID:46764						
DS_ID:18856						
EP_NO: N/A						
Repair Type: Non-Urgent						
Crossing Status: Found						
UCIP Comments: Needs to be properly abandoned.						
FIELD_STRUCT_DESC: *ABANDONED* 12-inch pipe of an unknown material or purpose through the levee, invert elevation 5 feet below the crown. Siphon breaker on the waterside (WS). Pipe not found on the landside (LS). (Wilson). [Additional Reference(s): DWR Levee Log, 2005. USACE Sacramento O&M Manual 111, May 1959, (RM 35.55)].						
FS Date: 8/6/2013

WS view: overview of steel pipe with siphon breaker on levee slope

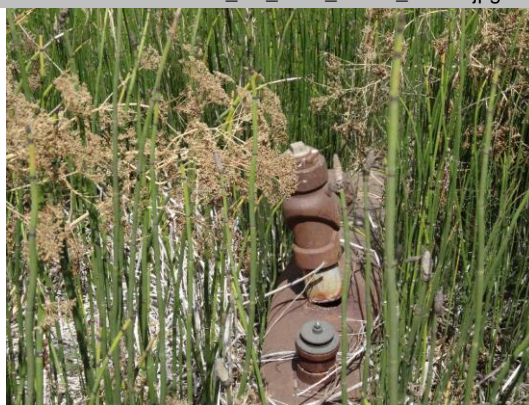
Photo 2 of 3 : UCIP_SP_2019_46764_29157.jpg

WS view: steel pipe with siphon breaker on levee slope

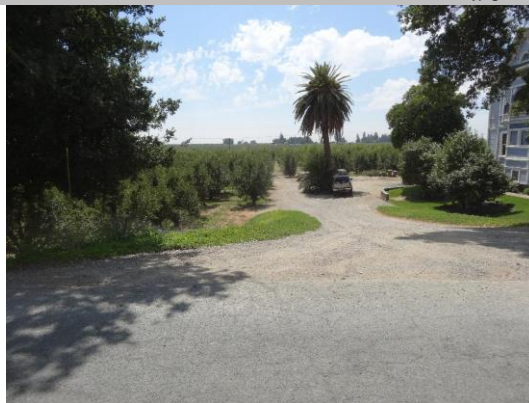
Photo 3 of 3 : UCIP_SP_2019_46764_29159.jpg

LM Start	1.04	Rating **	M	Issue No.	40 (cont)	
LM End	1.04	Issue Type +	En	Location *		
Category	Supplemental			GPS Latitude/Longitude		
				Start	End	
Item	DWR UCIP Field Study			38.343625 °	38.343625 °	
				-121.554145 °	-121.554145 °	
DWR ID	18856					
Comment Code						
Inspector Comment						
FS_ID:46764						
DS_ID:18856						
EP_NO: N/A						
Repair Type: Non-Urgent						
Crossing Status: Found						
UCIP Comments: Needs to be properly abandoned.						
FIELD_STRUCT_DESC: *ABANDONED* 12-inch pipe of an unknown material or purpose through the levee, invert elevation 5 feet below the crown. Siphon breaker on the waterside (WS). Pipe not found on the landside (LS). (Wilson). [Additional Reference(s): DWR Levee Log, 2005. USACE Sacramento O&M Manual 111, May 1959, (RM 35.55)].						
FS Date: 8/6/2013

LS view: no pipe and pump found on LS.

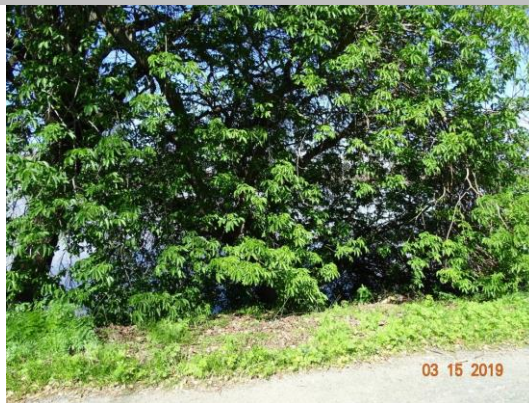
Photo 1 of 1 : SP_2019_RD0755_177_31_20190320_00048.jpg

View of tree at the top of the waterside shoulder (Spring 2019).

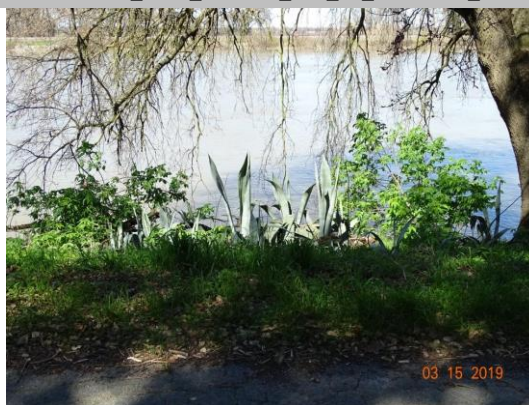
Photo 1 of 1 : SP_2019_RD0755_177_12_20190320_00047.jpg

LM Start	1.06	Rating **	M	Issue No.	12
LM End	1.06	Issue Type +	En	Location *	WS
Category	Earthen Levee			GPS Latitude/Longitude	
				Start	End
Item	Vegetation			38.343543 °	38.343543 °
				-121.554523 °	-121.554523 °
DWR ID	DWR_RD0755_01_s_2018_12				
Comment Code					
V6 : Landscaping					
Inspector Comment					
Remove cactus on waterside slope.

View of cactus at the top of the waterside slope (Spring 2019).

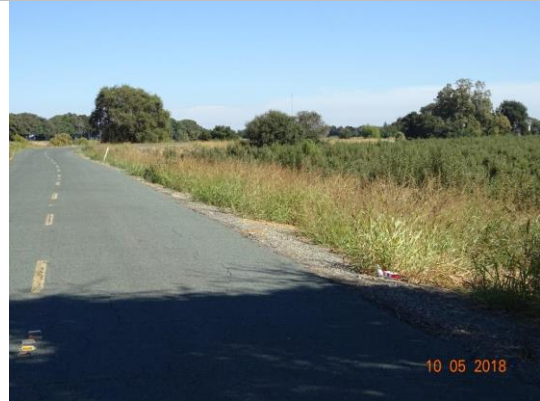
Photo 1 of 1 : SP_2019_RD0755_177_28_20190311_00018.jpg

View looking upstream at vegetation on the landside slope (October 2018).

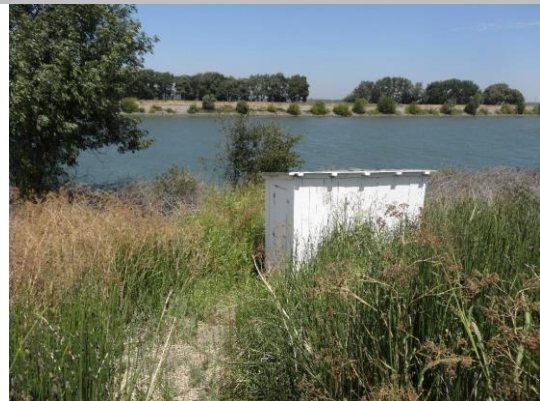
Photo 1 of 3 : UCIP_SP_2019_17144_29288.jpg

Comment Code					
Inspector Comment					
FS_ID:17144 DS_ID:18857 EP_NO: 11219 Repair Type: Non-Urgent Crossing Status: Found UCIP Comments: - requires cleaning of siphon breaker box. FIELD_STRUCT_DESC: 8-inch irrigation discharge pipe of an unknown material through the levee, invert elevation 5.7 feet below the crown. Siphon breaker in a corrugated metal pipe (CMP) riser on the landside (LS) shoulder. Power pole on the LS. Pump and power box in a pump house on the waterside (WS) slope. Electrical conduit through the levee at the same location. (Retention of an 8-inch pipe through the levee, 5.7 feet below the crown, and a pump in a pump house on the WS slope authorized under Automatic Board Order (ABO) issued as Permit No. 11219, 1975 - David J. Jr and Bonnie Elliott). [Additional Reference(s): DWR Levee Log, 2005. USACE Sacramento O&M Manual 111, May 1959, (RM 35.47)]. FS Date: 8/6/2013

WS view: pump house on levee slope.

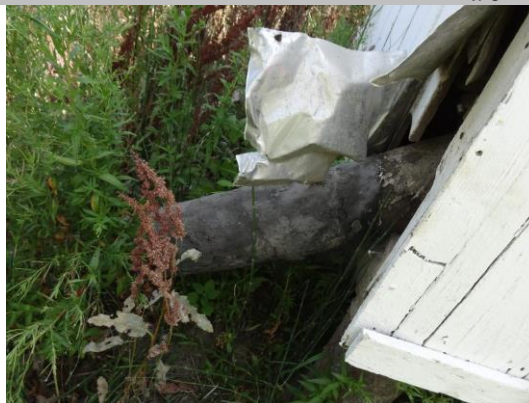
Photo 2 of 3 : UCIP_SP_2019_17144_29287.jpg

Comment Code						
Inspector Comment						
FS_ID:17144 DS_ID:18857 EP_NO: 11219 Repair Type: Non-Urgent Crossing Status: Found UCIP Comments: - requires cleaning of siphon breaker box. FIELD_STRUCT_DESC: 8-inch irrigation discharge pipe of an unknown material through the levee, invert elevation 5.7 feet below the crown. Siphon breaker in a corrugated metal pipe (CMP) riser on the landside (LS) shoulder. Power pole on the LS. Pump and power box in a pump house on the waterside (WS) slope. Electrical conduit through the levee at the same location. (Retention of an 8-inch pipe through the levee, 5.7 feet below the crown, and a pump in a pump house on the WS slope authorized under Automatic Board Order (ABO) issued as Permit No. 11219, 1975 - David J. Jr and Bonnie Elliott). [Additional Reference(s): DWR Levee Log, 2005. USACE Sacramento O&M Manual 111, May 1959, (RM 35.47)]. FS Date: 8/6/2013

WS view: pipe daylight from pump house.

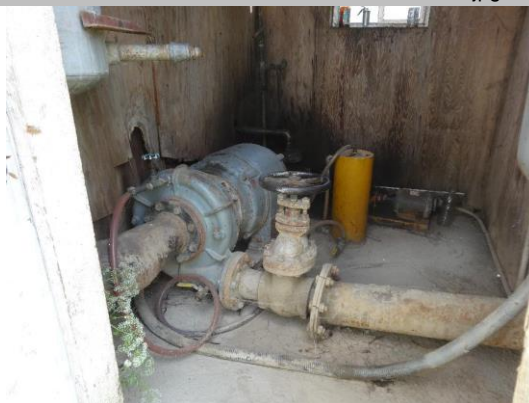
Photo 3 of 3 : UCIP_SP_2019_17144_29286.jpg

WS view: pumps, butterfly valve and pipe inside pump house.

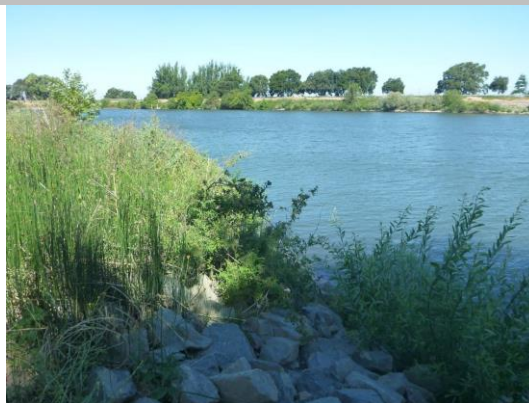
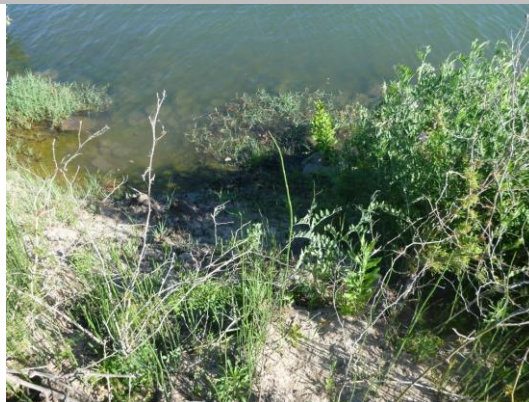
LM Start	1.23	Rating **	A/W	Issue No.	22
LM End	1.29	Issue Type +	Ma	Location *	WS
Category	Supplemental			GPS Latitude/Longitude	
				Start	End
Item	2017 Storm Damage			38.342992 °	38.342633 °
				-121.557572 °	-121.558622 °
DWR ID	DWR_RD0755_01_f_2017_22

Comment Code					
Inspector Comment					
Levee Evaluation Comments					
Description:The damage consists of erosion of the lower waterside levee slope and bank approximately 322 feet in length along the east (left) bank of the Sacramento River. See attached pages for photos.					
Site location T06N R04E Section 29.					
Site ID No:328					
Site Designation:LMA-155					
Repair Type: Erosion					
Rating:Area of Concern					
Field Date:7/13/2017					
Notes: Could not access most of the lower portion of the slope because of vegetation, but there was rip rap just downstream of the site. Looked like it may have been missing on part of the site. Erosion looked like it may be 1/2 the length reported. Crown is a paved road

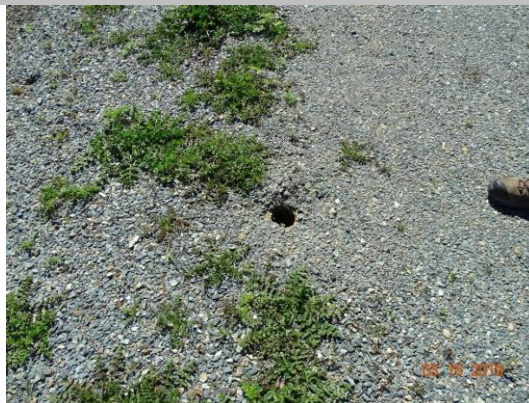
Photo 1 of 2 : SP_2019_RD0755_177_34_20190320_00045.jpg

View of 2 foot deep rodent hole on the landside of the crown (Spring 2019).

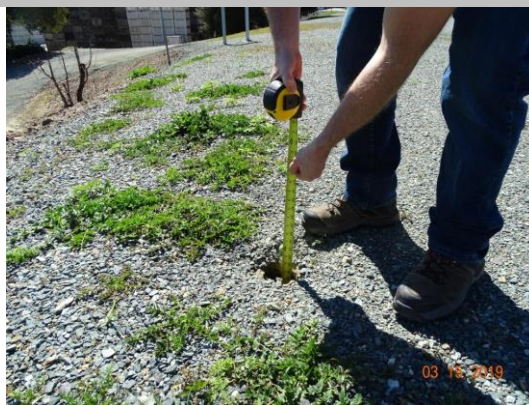
Photo 2 of 2 : SP_2019_RD0755_177_34_20190320_00046.jpg

Measuring tape showing rodent hole as being 2 feet deep on the landside of the crown (Spring 2019).

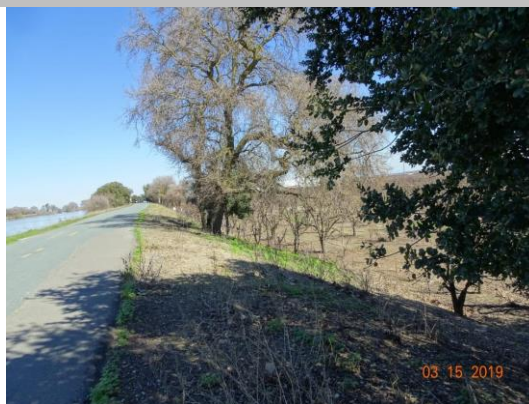
Photo 1 of 1 : SP_2019_RD0755_177_33_20190320_00043.jpg

LM Start	1.58	Rating **	M	Issue No.	33
LM End	1.72	Issue Type +	En	Location *	LS
Category	Earthen Levee			GPS Latitude/Longitude	
				Start	End
Item	Encroachments			38.339360 °	38.337767 °
				-121.561855 °	-121.563602 °
DWR ID	DWR_RD0755_01_s_2019_33				
Comment Code					
CR : Crops					
Inspector Comment					
Trees are on the landside slope.

View looking upstream at orchard trees at the landside toe (Spring 2019).

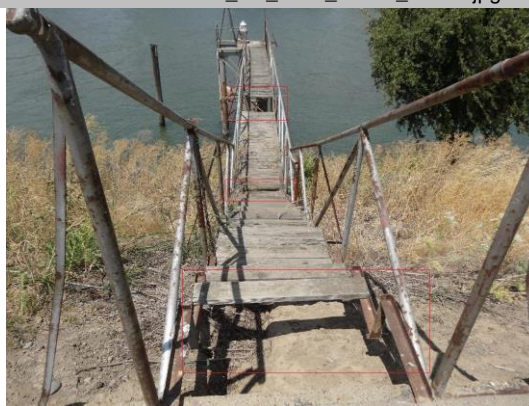
Photo 2 of 3 : UCIP_SP_2019_17143_29281.jpg

Comment Code						
Inspector Comment						
FS_ID:17143 DS_ID:18858 EP_NO: 11219 Repair Type: Non-Urgent Crossing Status: Found UCIP Comments: - Pump and walkway seem abandoned.- Power line is not connected with pump.- A pump house like structure found on LS levee toe. FIELD_STRUCT_DESC: 16-inch irrigation discharge pipe of an unknown material through the levee, invert elevation 8.5 feet below the crown. Pump on a pile structure in the river. Walkway to the pump. Siphon breaker and power pole on the landside (LS) slope. Electrical conduit through the levee at the same location. (Retention of a 14-inch pipe through the levee, 8.5 feet below the crown, a pump on a pile structure in the river, a walkway to the pump, and a siphon breaker on the LS slope authorized under Automatic Board Order (ABO) issued as Permit No. 11219, 1975 - David J. Jr and Bonnie Elliott). [Additional Reference(s): DWR Levee Log, 2005, 14-inch pipe referenced. USACE Sacramento O&M Manual 111, May 1959, (RM 35.02), 14-inch pipe referenced, incorrectly referenced in Reclamation District No. 551 (RD0551)]. FS Date: 8/6/2013

WS view: Abandoned walkway and pump structure

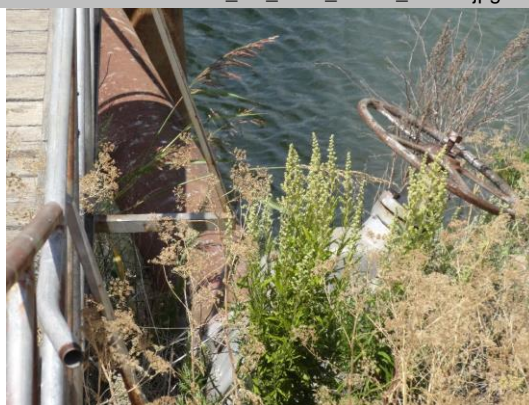
Photo 3 of 3 : UCIP_SP_2019_17143_29280.jpg

WS view: Pipe and butterfly/gate valve on levee slope.
