**Flood Control Project Maintenance
Levee Inspections**
LMA District Cover Sheet
Spring 2020 Levee Inspection Results

Reclamation District No. 0755 Randall

Spring 2020 Levee Inspection Results

Waterway			Bank	Unit Miles
Unit No. 01 Sacramento River			Left	1.83
	Spring (March - May)	Summer (June - August)	(September - November) Fall	Winter (December - February)
Unit Maintenance Rating (Fall Only)				
Date of Inspection	3/25/2020 - 3/25/2020			
DWR Inspector	David Julian			
Accompanied By

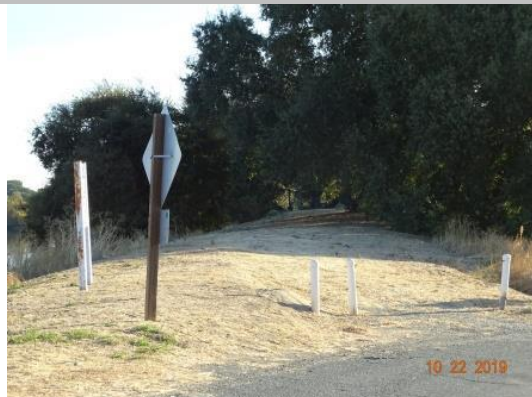
Photo 1 of 1 : SP_2020_RD0755_177_11_20200304_00002.jpg

View looking upstream at vegetation on the crown (Fall 2019).

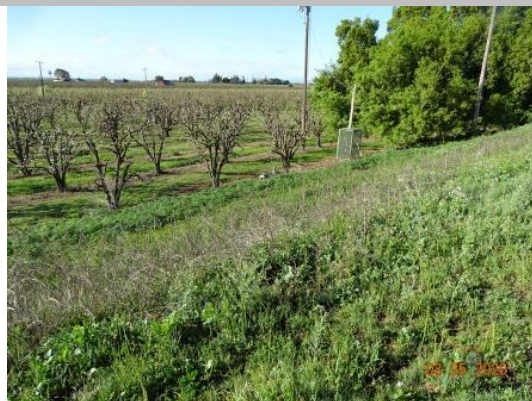
Photo 1 of 1 : SP_2020_RD0755_177_20_20200330_00068.jpg

LM Start	0.17	Rating **	M	Issue No.	20
LM End	0.78	Issue Type +	Ma	Location *	LS
Category	Earthen Levee			GPS Latitude/Longitude	
				Start	End
Item	Vegetation			38.346757 °	38.344749 °
				-121.538675 °	-121.549464 °
DWR ID	DWR_RD0755_01_f_2016_20				
Comment Code					
V2 : Remove the wild growth other than native grasses from the levee slopes.					
Inspector Comment					
The vegetation should be removed/managed to allow inspection of landside slope and toe.

View looking downstream at annual vegetation on the landside slope (Spring 2020).

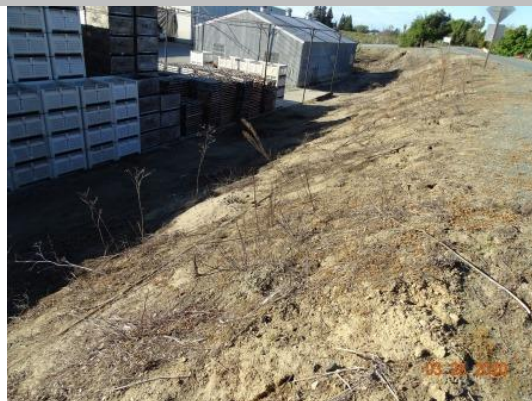
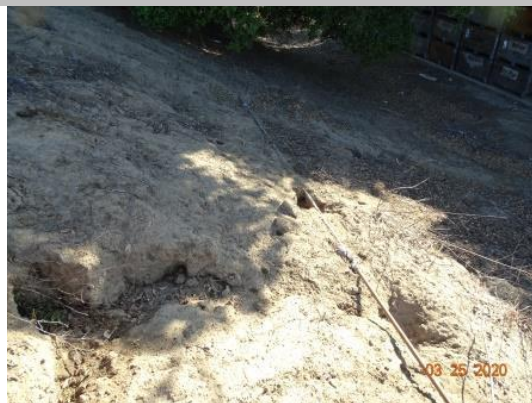
Photo 1 of 2 : SP_2020_RD0755_177_4_20200330_00069.jpg

LM Start	0.20	Rating **	M	Issue No.	4
LM End	1.77	Issue Type +	Ma	Location *	LS
Category	Earthen Levee			GPS Latitude/Longitude	
				Start	End
Item	Animal Control			38.346500 °	38.337197 °
				-121.539146 °	-121.564147 °
DWR ID	DWR_RD0755_01_f_2014_4				
Comment Code					
A1 : Exterminate rodents and backfill and compact or grout burrows.					
Inspector Comment					
Evidence of active rodents on landside slope near the walnut trees. No bait stations were observed.

View looking downstream at fresh animal hole on the landside slope (Spring 2020).

View a couple animal holes on the landside slope (Spring 2020).

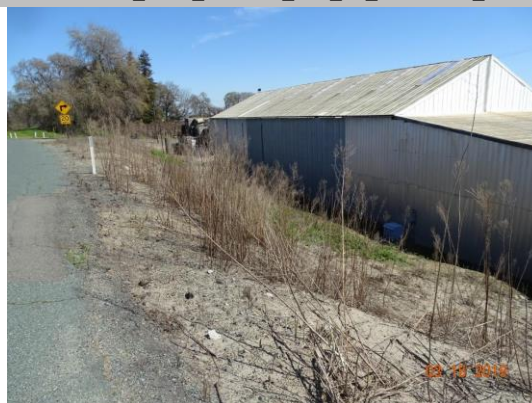
Photo 1 of 1 : SP_2020_RD0755_177_10_20200304_00001.jpg

LM Start	0.21	Rating **	M	Issue No.	10
LM End	0.21	Issue Type +	Ma	Location *	LS
Category	Earthen Levee			GPS Latitude/Longitude	
				Start	End
Item	Slope Stability			38.346428 °	38.346428 °
				-121.539400 °	-121.539400 °
DWR ID	DWR_RD0755_01_s_2019_10				
Comment Code					
S1 : Repair slope instability.					
Inspector Comment					
There is a 2" seperation between roadway and levee on the landside shoulder.

View looking upstream at small slip on the landside shoulder (Spring 2019).

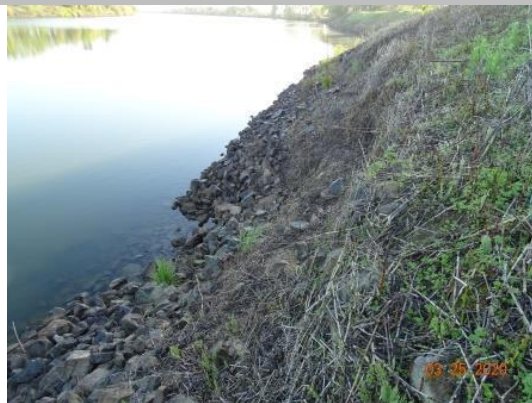
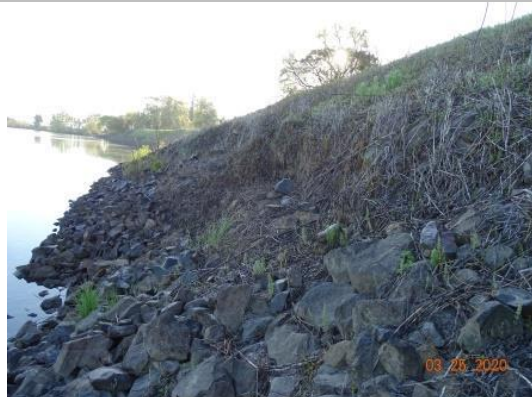
Photo 1 of 2 : SP_2020_RD0755_177_18_20200330_00064.jpg

LM Start	0.28	Rating **	U	Issue No.	18
LM End	0.28	Issue Type +	Ma	Location *	WS
Category	Earthen Levee			GPS Latitude/Longitude	
				Start	End
Item	Erosion / Bank Caving			38.346249 °	38.346331 °
				-121.540542 °	-121.540664 °
DWR ID	DWR_RD0755_01_s_2020_18				
Comment Code					
E2 : Schedule repair of erosion site prior to the next inspection.					
Inspector Comment					
This was a 2017 Storm Damage site. Damage consists of erosion of the lower waterside levee slope and bank approximately 27 feet in length. Site ID No:327 Site Designation:LMA-154 3/25/2020 Field Notes: Erosion is significant. At least 1' into waterside slope. No riprap present.

View looking upstream and slightly down at erosion into the waterside slope (Spring 2020).

View looking upstream and slightly up at erosion into the waterside slope (Spring 2020).

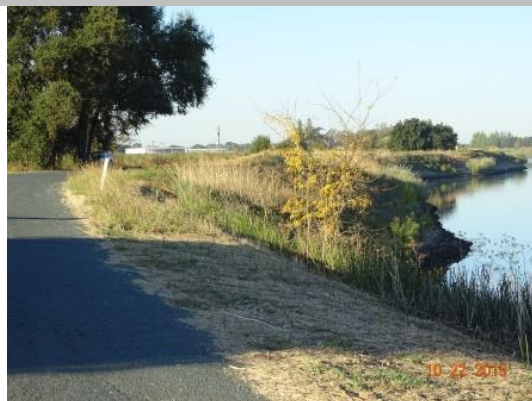
Photo 1 of 1 : SP_2020_RD0755_177_19_20200304_00008.jpg

LM Start	0.33	Rating **	M	Issue No.	19
LM End	1.84	Issue Type +	Ma	Location *	WS
Category	Earthen Levee			GPS Latitude/Longitude	
				Start	End
Item	Vegetation			38.346043 °	38.336409 °
				-121.541483 °	-121.564813 °
DWR ID	DWR RD0755 01 f 2016 19

View looking downstream at thick vegetation on the waterside slope (Fall 2019).

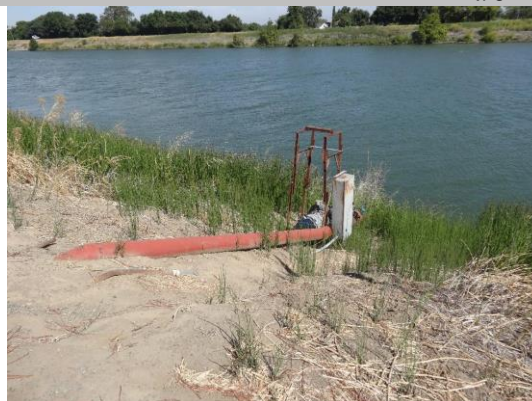
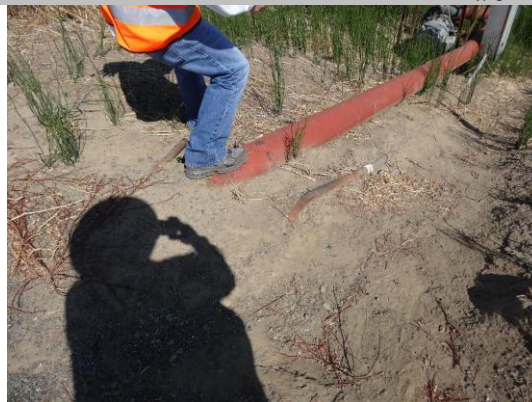
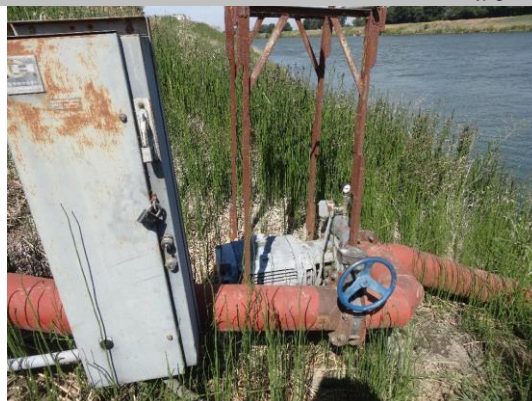
Comment Code					
Inspector Comment					
DS_ID:18849					
FS_ID:17123					
EP_NO: 4302					
Repair Type: Non-Urgent					
Crossing Status: Found					
UCIP Comments: FBC about 2 feet.Power conduit also through the levee.Wet ground on pump site/location. May need investigation about wet ground.					
FIELD_STRUCT_DESC: 8-inch coated steel irrigation discharge pipe through the levee, 2 feet below the crown. Pump, electrical box, and control valve on the waterside (WS) slope. Siphon breaker on the landside (LS) slope. Service pole at the LS toe. (Plans for placing an 8-inch irrigation pipe and pump authorized under Permit No. 4302, 1963 - E. C. Hemly). [Additional Reference(s): DWR Levee Log, 2005, referenced as 4 feet below the crown].					
FS Date: 8/6/2013

WS view: overview of pump and pipe.

WS view: steel pipe and power conduit.

WS view: pump, power switch box, butterfly valve and pipe.

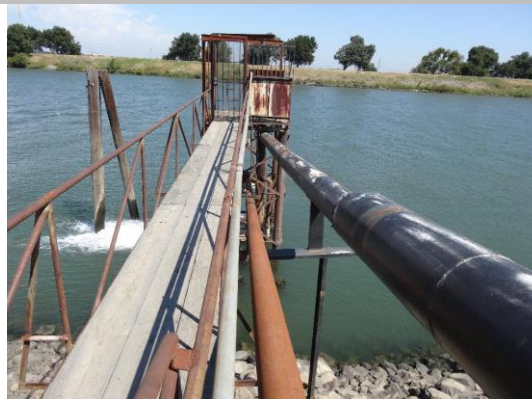
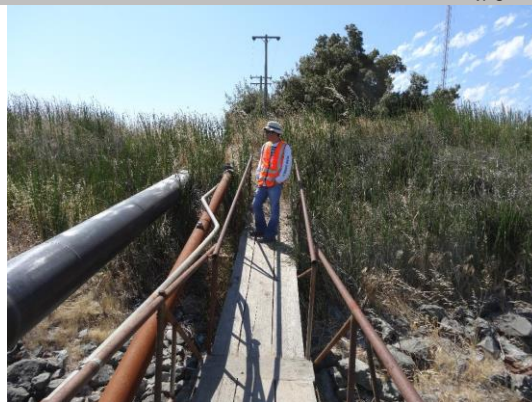
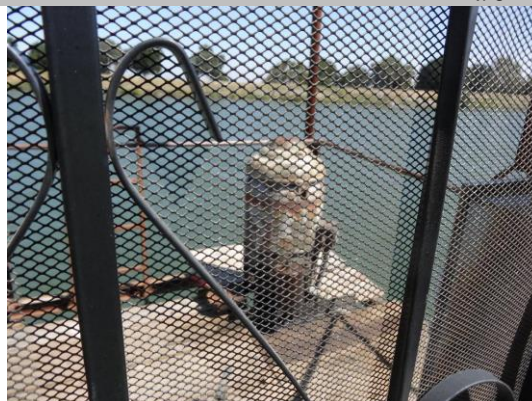
Comment Code						
Inspector Comment						
DS_ID:18851 FS_ID:41634 EP_NO: 7357 Repair Type: Non-Urgent Crossing Status: Found UCIP Comments: An abandoned 12-in steel pipe lying on LS levee slope should be removed.A buried concrete headwall found on LS levee slope should be checked for any pipe or connection. FIELD_STRUCT_DESC: 2 of 2: 8-inch pipe sleeved through a 16-inch irrigation discharge pipe of an unknown material through the levee, 4.2 feet below the crown. Pump on the waterside (WS). (Plans to install an additional pump on an existing stand and to connect the discharge pipe to the existing pipe through the levee authorized under Permit No. 7357, 1971 - Green and Keown Farms, Inc). [Additional Reference(s): DWR Levee Log, 2005, 14-inch outer pipe referenced]. FS Date: 8/6/2013

WS view: pump structure on the stream, conduit, pipes, and walkway.

WS view: view towards levee crown from pump structure.

WS view: pump mounted on pump station/deck.

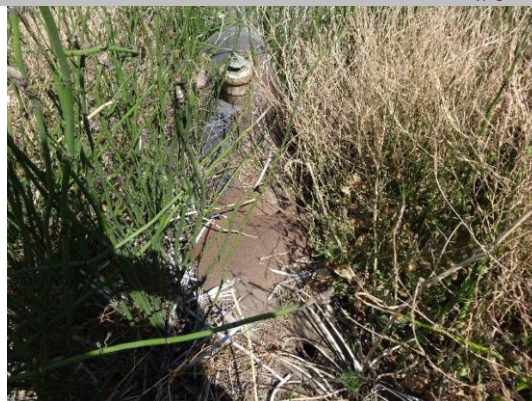
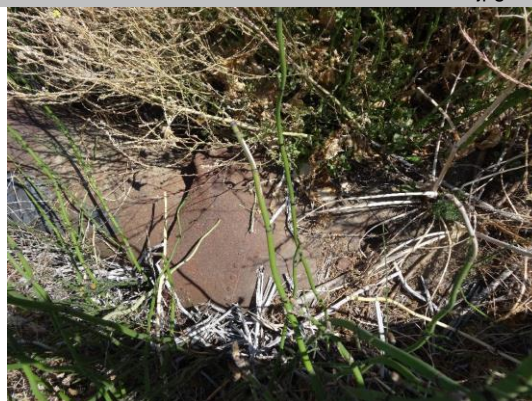
Comment Code					
Inspector Comment					
DS_ID:18852 FS_ID:17145 EP_NO: 11222 Repair Type: No Action Needed Crossing Status: Found UCIP Comments: It was working during field survey. A pump found 150 ft from the levee. Not sure whether the pump belong to this drainage system. FIELD_STRUCT_DESC: *ABANDONED* 16-inch steel drainage pipe sleeved through a 24-inch steel drainage pipe through the levee, invert elevation 8 feet below the crown. (Retention of a 12-inch drainage pipe sleeved through a 24-inch pipe through the levee, 8 feet below the crown, authorized under Automatic Board Order (ABO) issued as Permit No. 11222, 1975 - Green McKeown, Inc). [Additional Reference(s): DWR Levee Log, 2005, 12-inch inner pipe referenced. USACE Sacramento O&M Manual 111, May 1959, (RM 35.89)]. FS Date: 8/6/2013

WS view: pipe and siphon breaker on levee slope

WS view: 16-inch pipe sleeved through 24-inch pipe.

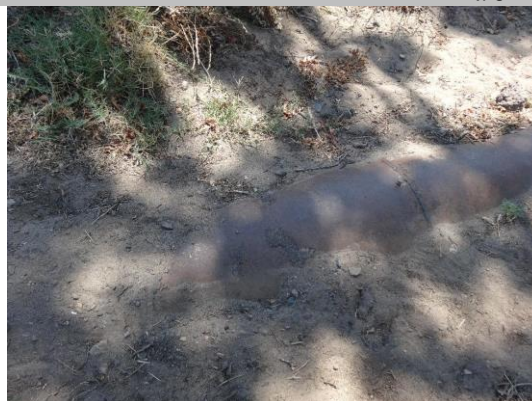
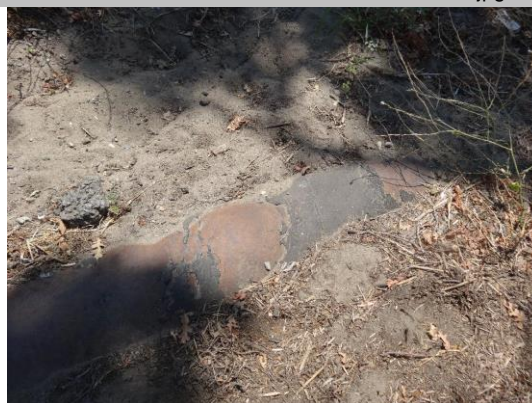
LS view: 18-inch abandoned pipe on levee slope

LS view: exposed/daylight 18-inch abandoned pipe on levee slope

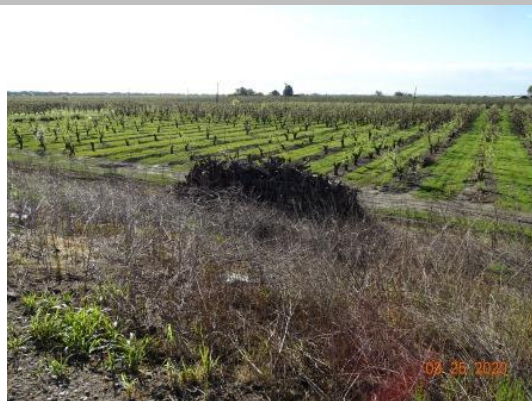
Photo 1 of 1 : SP_2020_RD0755_177_13_20200330_00066.jpg

LM Start	0.77	Rating **	U	Issue No.	13
LM End	0.77	Issue Type +	En	Location *	LS
Category	Earthen Levee			GPS Latitude/Longitude	
				Start	End
Item	Encroachments			38.344786 °	38.344786 °
				-121.549322 °	-121.549322 °
DWR ID	DWR_RD0755_01_s_2020_13				
Comment Code					
PR : Prunings					
Inspector Comment					
Remove large pruning pile on the landside toe.

View of large pruning pile on the landside toe (Spring 2020).

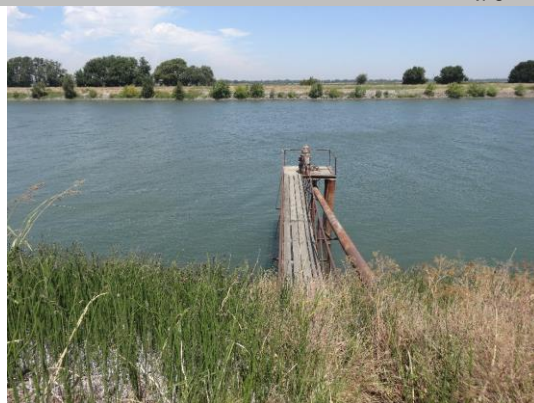
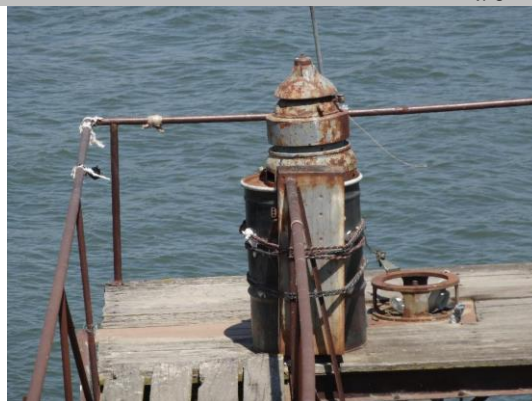
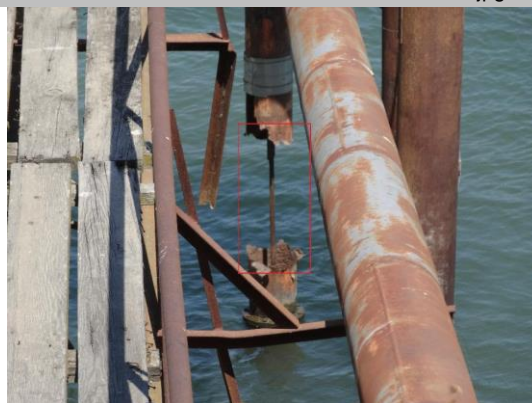
Comment Code					
Inspector Comment					
DS_ID:18855 FS_ID:17063 EP_NO: 11225 Repair Type: Non-Urgent Crossing Status: Found UCIP Comments: Abandoned pipe and pump.Service pole, power box lying on LS slope. FIELD_STRUCT_DESC: *ABANDONED* 10-inch irrigation discharge pipe of an unknown material and a 1-inch electrical conduit through the levee, invert elevation 5.6 feet below the crown. Pump on a pile structure with a walkway to the pump. Abandoned service pole on the landside (LS) slope. (Retention of a 10-inch pipe through the levee, 5.6 feet below the crown, pump on a pile structure with a walkway to the pump, and a service pole on the LS slope Automatic Board Order (ABO) issued as Permit No. 11225, 1975 - Helen D. Wilson). [Additional Reference(s): DWR Levee Log, 2005. USACE Sacramento O&M Manual 111, May 1959, (RM 35.66)]. FS Date: 8/6/2013

WS view: overview of pipe and pump structure.

WS view: an abandoned pump

WS view: abandoned and discontinued vertical intake pipe

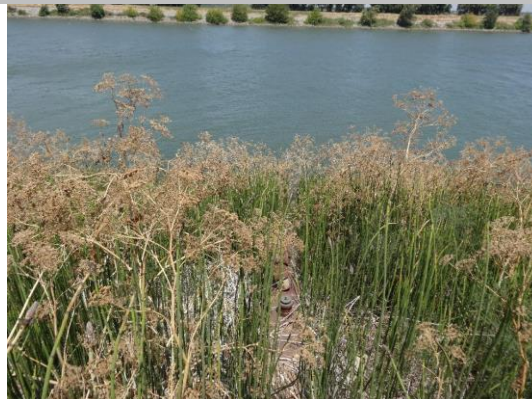
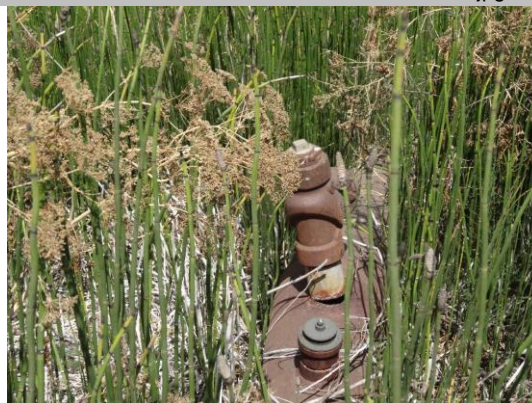
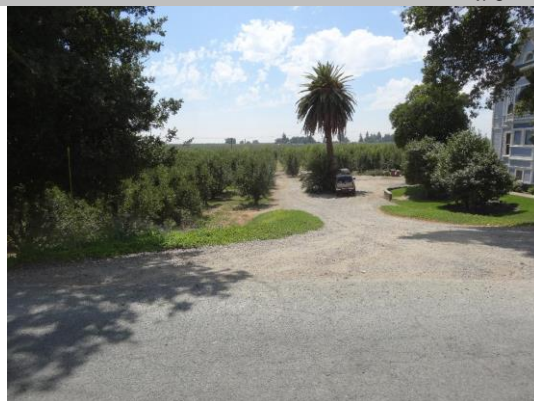
LM Start	1.04	Rating **	M	Issue No.	54
LM End	1.04	Issue Type +	En	Location *	
Category	Supplemental			GPS Latitude/Longitude	
				Start	End
Item	DWR UCIP Field Study			38.343625 °	38.343625 °
				-121.554145 °	-121.554145 °
DWR ID	18856				
Comment Code					
Inspector Comment					
DS_ID:18856 FS_ID:46764 EP_NO: N/A Repair Type: Non-Urgent Crossing Status: Found UCIP Comments: Needs to be properly abandoned. FIELD_STRUCT_DESC: *ABANDONED* 12-inch pipe of an unknown material or purpose through the levee, invert elevation 5 feet below the crown. Siphon breaker on the waterside (WS). Pipe not found on the landside (LS). (Wilson). [Additional Reference(s): DWR Levee Log, 2005. USACE Sacramento O&M Manual 111, May 1959, (RM 35.55)]. FS Date: 8/6/2013

WS view: overview of steel pipe with siphon breaker on levee slope

WS view: steel pipe with siphon breaker on levee slope

LS view: no pipe and pump found on LS.

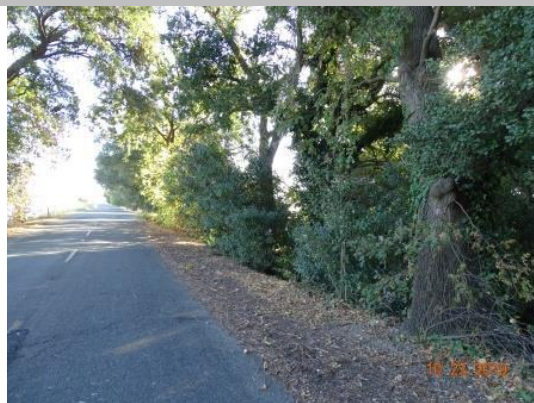
Photo 1 of 1 : SP_2020_RD0755_177_23_20200304_00013.jpg

LM Start	1.05	Rating **	M	Issue No.	23
LM End	1.08	Issue Type +	En	Location *	LS
Category	Earthen Levee			GPS Latitude/Longitude	
				Start	End
Item	Vegetation			38.343595 °	38.343487 °
				-121.554238 °	-121.554768 °
DWR ID	DWR_RD0755_01_s_2017_23				
Comment Code					
V6 : Landscaping					
Inspector Comment					
Ground vegetation, shrubs and trees should be maintained to allow inspection and access to landside slope and toe.

View looking upstream at landscaping on the landside slope (Fall 2019).

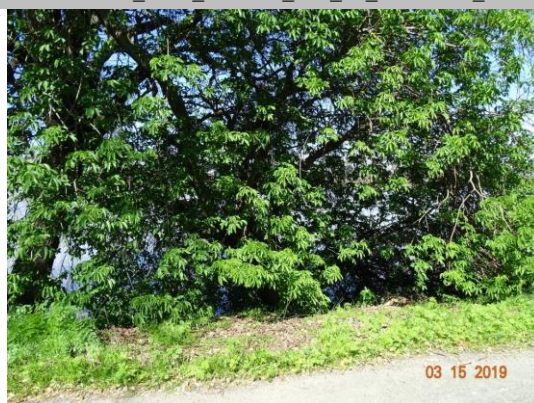
Photo 1 of 1 : SP_2020_RD0755_177_31_20200304_00020.jpg

LM Start	1.06	Rating **	M	Issue No.	31
LM End	1.06	Issue Type +	Ma	Location *	WS
Category	Earthen Levee			GPS Latitude/Longitude	
				Start	End
Item	Trim / Thin Trees			38.343542 °	38.343542 °
				-121.554487 °	-121.554487 °
DWR ID	DWR_RD0755_01_s_2019_31				
Comment Code					
T1 : Trim trees to at least five feet above ground level.					
Inspector Comment					
Trees are blocking visibility down waterside slope.

View of tree at the top of the waterside shoulder (Spring 2019).

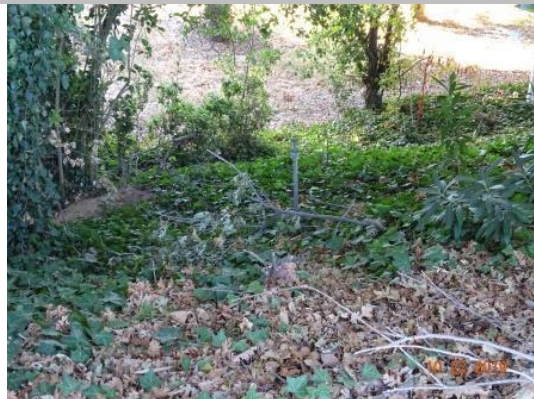
Photo 1 of 1 : SP_2020_RD0755_177_44_20200304_00028.jpg

View looking downslope at sprinkler emitter on the landside slope (Fall 2019).

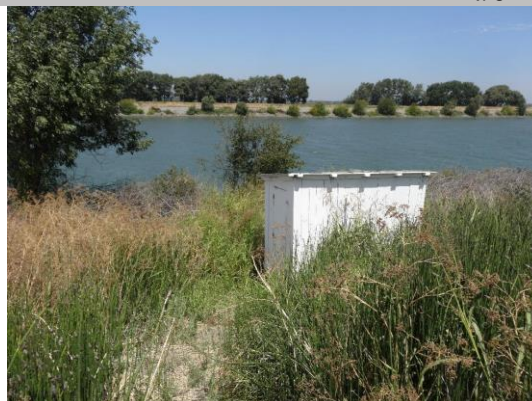
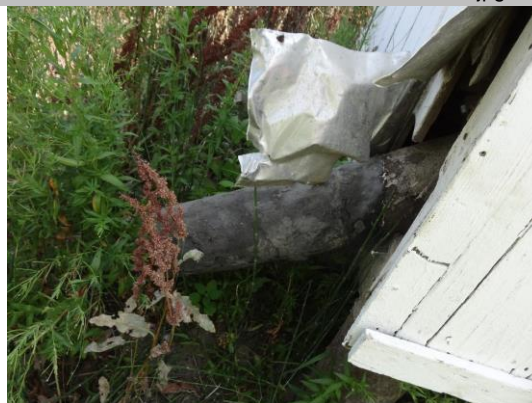
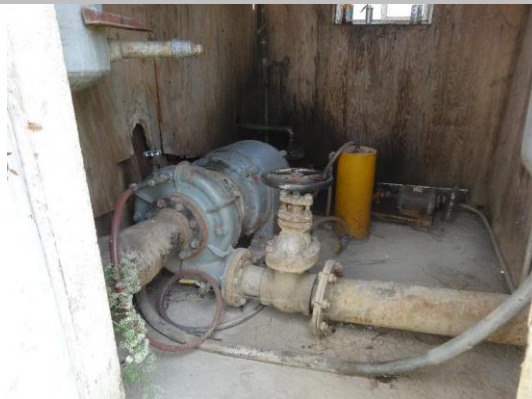
DS_ID:18857
FS_ID:17144
EP_NO: 11219
Repair Type: Non-Urgent
Crossing Status: Found
UCIP Comments: - requires cleaning of siphon breaker box.
FIELD_STRUCT_DESC: 8-inch irrigation discharge pipe of an unknown material through the levee, invert elevation 5.7 feet below the crown. Siphon breaker in a corrugated metal pipe (CMP) riser on the landside (LS) shoulder. Power pole on the LS. Pump and power box in a pump house on the waterside (WS) slope. Electrical conduit through the levee at the same location. (Retention of an 8-inch pipe through the levee, 5.7 feet below the crown, and a pump in a pump house on the WS slope authorized under Automatic Board Order (ABO) issued as Permit No. 11219, 1975 - David J. Jr and Bonnie Elliott). [Additional Reference(s): DWR Levee Log, 2005. USACE Sacramento O&M Manual 111, May 1959, (RM 35.47)].
FS Date: 8/6/2013

WS view: pump house on levee slope.

WS view: pipe daylight from pump house.

WS view: pumps, butterfly valve and pipe inside pump house.

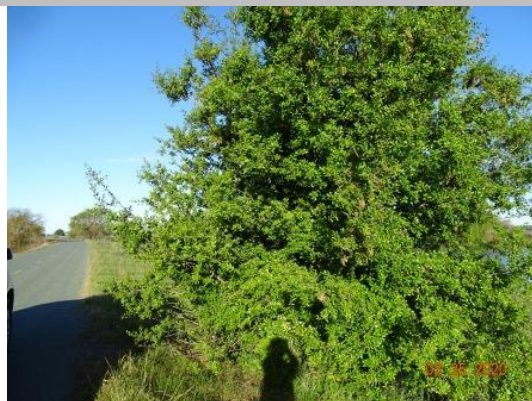
Photo 1 of 1 : SP_2020_RD0755_177_28_20200330_00067.jpg

View looking downstream at tree on the waterside slope (Spring 2020).

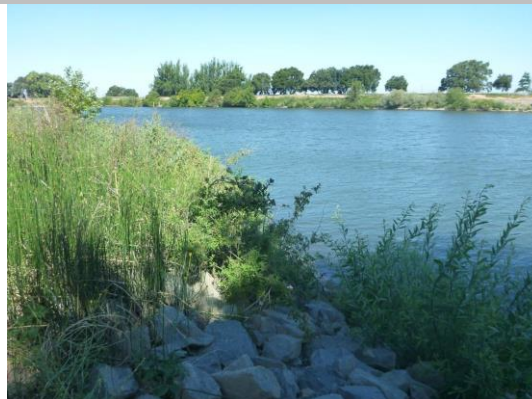
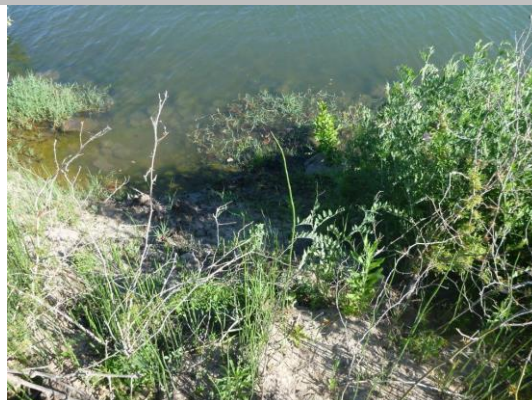
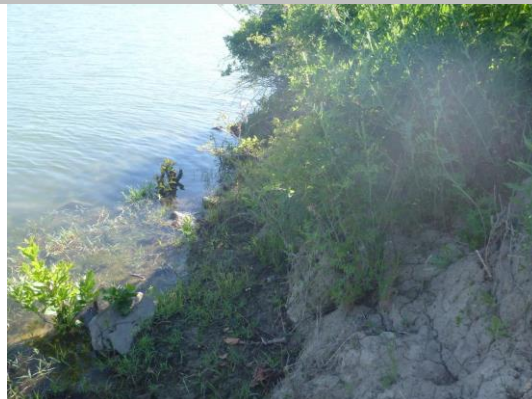
This was a 2017 Storm Damage site.
Damage consists of erosion of the lower waterside levee slope and bank approximately 322 feet in length.
Site ID No:328
Site Designation:LMA-155
3/25/2020 Field Notes:
Erosion is into berm and not prism. A boat survey would get a better look. Monitor.

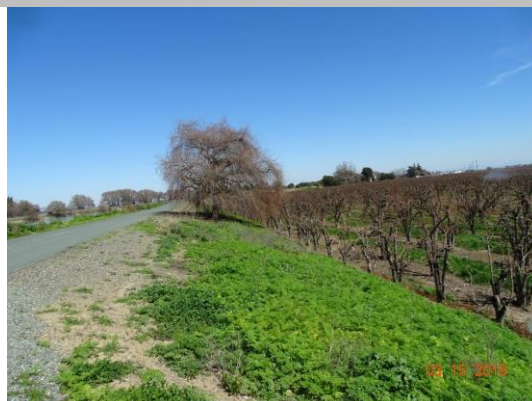
Photo 1 of 1 : SP_2020_RD0755_177_32_20200304_00021.jpg

View looking upstream at orchard trees on the base of the landside slope (Spring 2019).

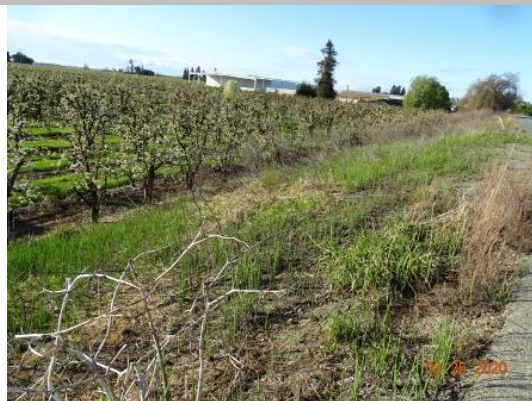
Photo 1 of 1 : SP_2020_RD0755_177_40_20200330_00071.jpg

View looking downstream at vegetation on the landside slope (Spring 2020).

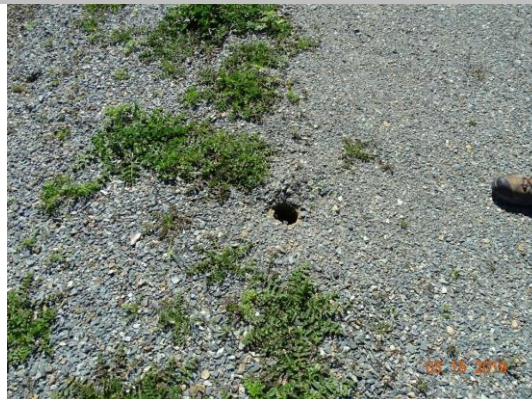
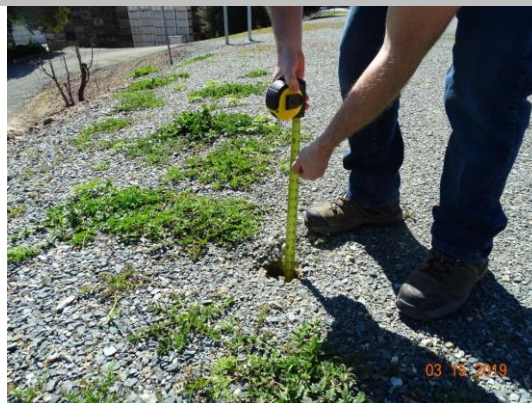
View of 2 foot deep rodent hole on the landside of the crown (Spring 2019).

Measuring tape showing rodent hole as being 2 feet deep on the landside of the crown (Spring 2019).

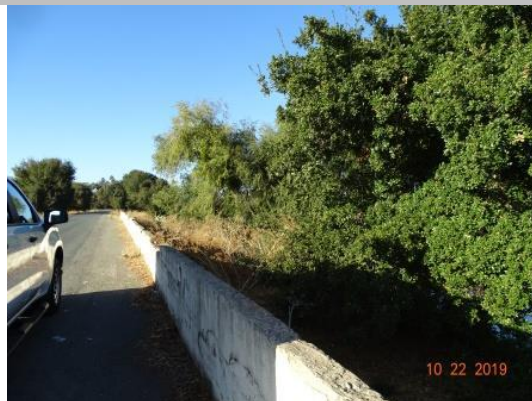
Photo 1 of 1 : SP_2020_RD0755_177_36_20200304_00026.jpg

View looking downstream at thick trees on the waterside slope (Fall 2019).

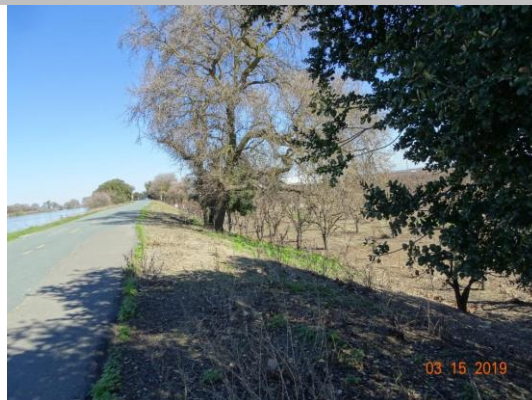
Photo 1 of 1 : SP_2020_RD0755_177_33_20200304_00022.jpg

View looking upstream at orchard trees at the landside toe (Spring 2019).

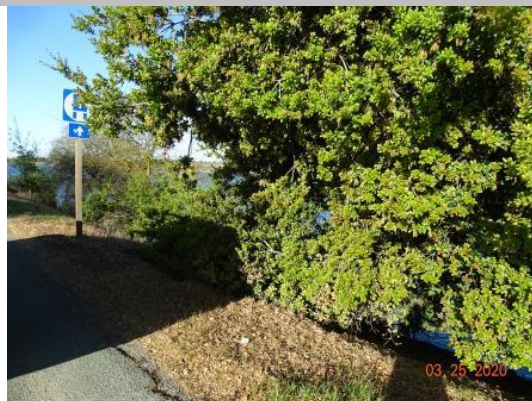
Photo 1 of 1 : SP_2020_RD0755_177_37_20200330_00072.jpg

View looking downstream of tree branches directly on waterside slope (Spring 2020).

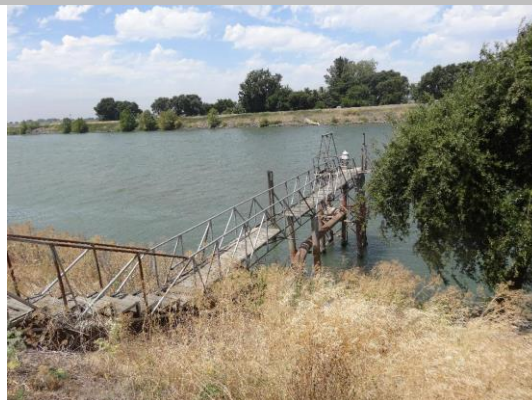
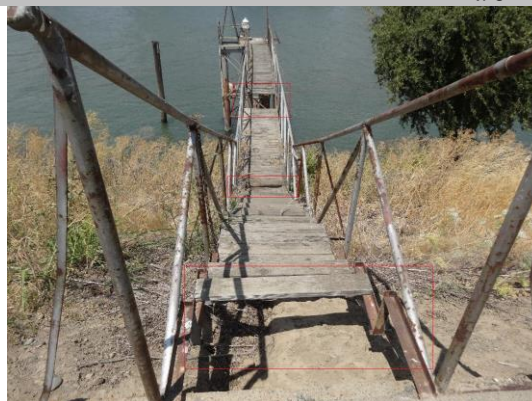
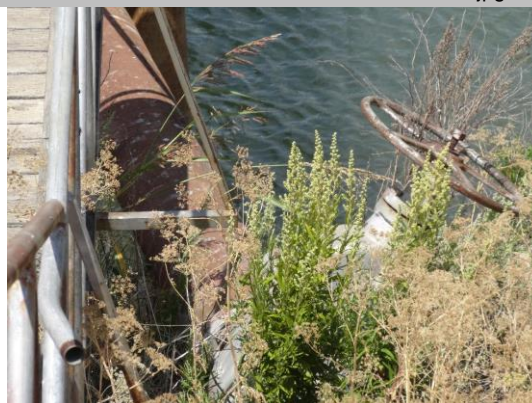
Comment Code						
Inspector Comment						
DS_ID:18858 FS_ID:17143 EP_NO: 11219 Repair Type: Non-Urgent Crossing Status: Found UCIP Comments: - Pump and walkway seem abandoned.- Power line is not connected with pump.- A pump house like structure found on LS levee toe. FIELD_STRUCT_DESC: 16-inch irrigation discharge pipe of an unknown material through the levee, invert elevation 8.5 feet below the crown. Pump on a pile structure in the river. Walkway to the pump. Siphon breaker and power pole on the landside (LS) slope. Electrical conduit through the levee at the same location. (Retention of a 14-inch pipe through the levee, 8.5 feet below the crown, a pump on a pile structure in the river, a walkway to the pump, and a siphon breaker on the LS slope authorized under Automatic Board Order (ABO) issued as Permit No. 11219, 1975 - David J. Jr and Bonnie Elliott). [Additional Reference(s): DWR Levee Log, 2005, 14-inch pipe referenced. USACE Sacramento O&M Manual 111, May 1959, (RM 35.02), 14-inch pipe referenced, incorrectly referenced in Reclamation District No. 551 (RD0551)]. FS Date: 8/6/2013

WS view: Overview of walkway, pump structure, and pipe.

WS view: Abandoned walkway and pump structure

WS view: Pipe and butterfly/gate valve on levee slope.

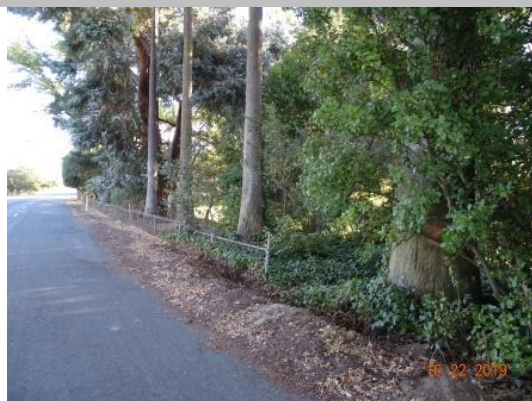
Photo 1 of 1 : SP_2020_RD0755_177_25_20200304_00017.jpg

View looking upstream at landscaping on the landside slope (Fall 2019).

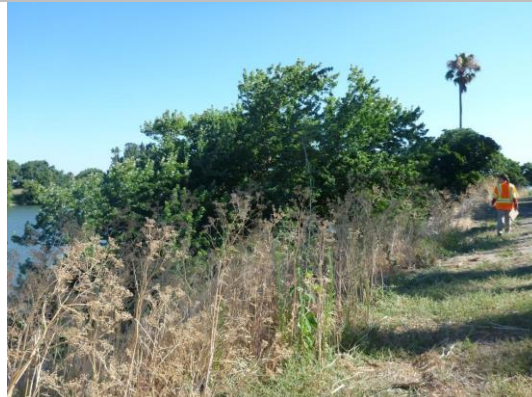
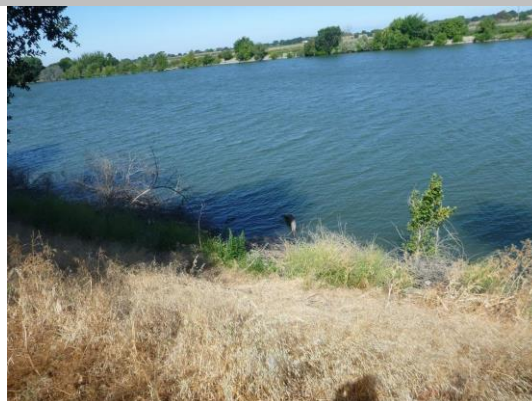
LM Start	1.73	Rating **	A/W	Issue No.	24
LM End	1.81	Issue Type +	Ma	Location *	
Category	Supplemental			GPS Latitude/Longitude	
				Start	End
Item	2017 Storm Damage			38.337758 °	38.336789 °
				-121.563856 °	-121.564739 °
DWR ID	LMA-156

Comment Code					
Inspector Comment					
Planned For Repair.					
Levee Evaluation Comments					
Description:The damage consists of erosion of the lower waterside levee slope and bank approximately 424 feet in length along the east (left) bank of the Sacramento River. See attached pages for photos.					
Site location T06N R04E Section 29.					
Site ID No:329					
Site Designation:LMA-156					
Repair Type: Erosion					
Rating:Serious					
Field Date:7/13/2017					
Notes: Crown is a paved road. Large LS berm on part. Good visibility here. Serious because erosion cut into prism significantly for a long distance and soils are very sandy here and WS slope is very steep.
