**Flood Control Project Maintenance  
Levee Inspections  
LMA District Cover Sheet**

**Reclamation District No. 0755 Randall**

**Levee Inspection Report By Mile - Spring 2021**

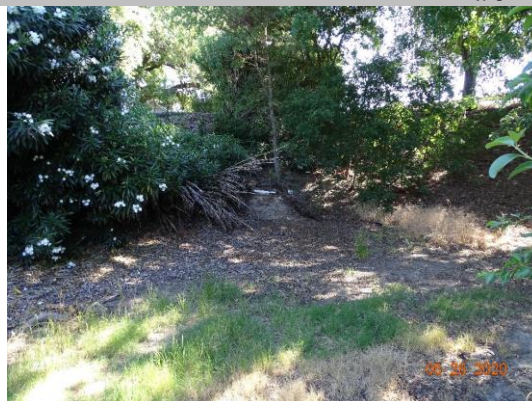
Photo 1 of 3 : UCIP\_SP\_2021\_57008\_84320.jpg

Comment Code						
Inspector Comment						
FS_ID:57008 DS_ID:18865 EP_NO: N/A Repair Type: Non-Urgent Crossing Status: Indicator Found UCIP Comments: 05/26/2020 Record updated to Non-Urgent. No permit has been identified authorizing pipe. Crossing appears abandoned. Unable to see pipe on either side of levee. Abandoned pump house on waterside. Former irrigation ditch begins at landside toe where water used to be pumped. PVC pipe debris in landside ditch. Coordinates of this crossing have bee updated. (O.Yakimov - DWR UCIP) 08/07/2013 No access. Iron gate on the levee. FIELD_STRUCT_DESC: 14-inch irrigation discharge pipe of an unknown material through the levee, invert elevation 4.2 feet below the crown. Pump house on the waterside slope, concrete standpipe and siphon breaker at LS toe. [Additional Reference(s): USACE Sacramento O&M Manual, Unit 111, May 1959, Revised 29 December 2016, (RM 36.60), listed as 14-inch pipe]. FS Date: 5/26/2020 8:45:30 AM

Land-Side: View of former irrigation ditch and LS slope covered with shrub

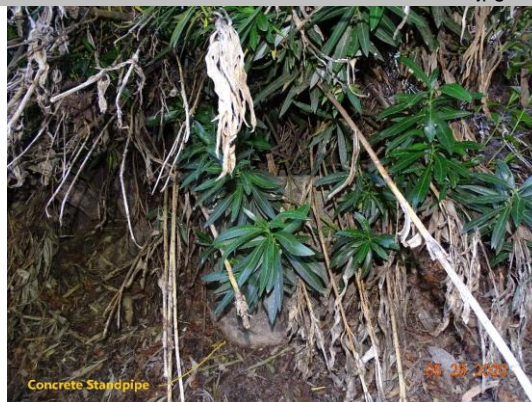
Photo 2 of 3 : UCIP\_SP\_2021\_57008\_84321.jpg

Land-Side: Concrete standpipe at levee toe covered with vegetation

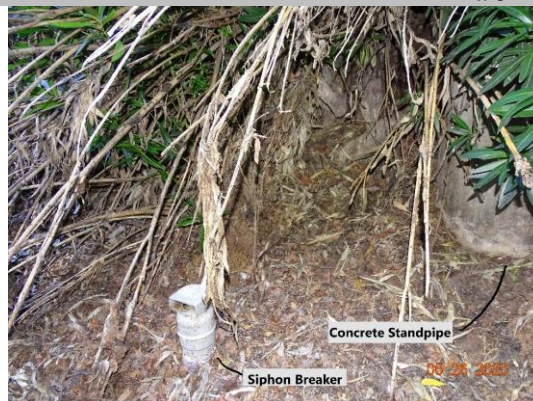
Photo 3 of 3 : UCIP\_SP\_2021\_57008\_84322.jpg

Land-Side: Concrete standpipe and siphon breaker at levee toe

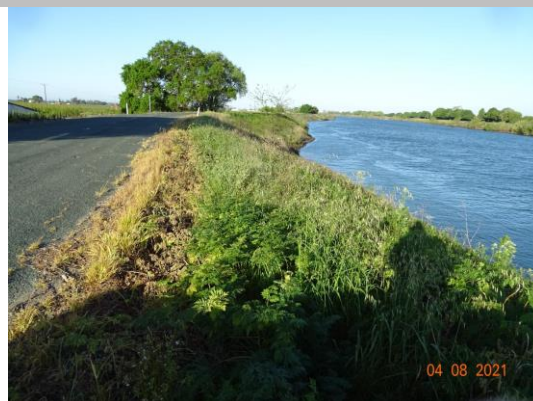
Photo 1 of 1 : SP\_2021\_RD0755\_177\_19\_20210408\_00080.jpg

LM Start	0.07	Rating **	M	Issue No.	42
LM End	0.15	Issue Type +	Ma	Location *	CR
Category	Earthen Levee			GPS Latitude/Longitude	
				Start	End
Item	Vegetation			38.347353 °	38.346885 °
				-121.537034 °	-121.538322 °
DWR ID	DWR_RD0755_01_s_2021_42				
Comment Code					
V9 : Keep the crown roadway free of vegetation.					
Inspector Comment

View looking downstream at vegetation on the waterside slope (Spring 2021).

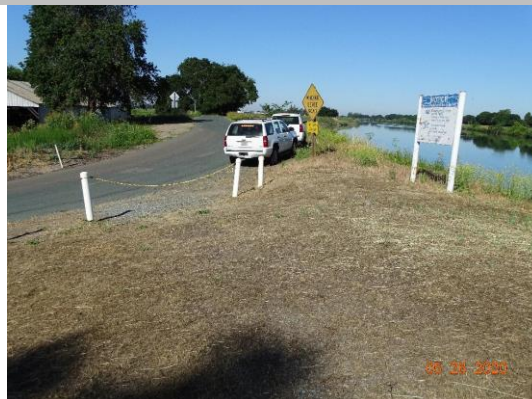
Photo 1 of 3 : UCIP\_SP\_2021\_57009\_84330.jpg

LM Start	0.16	Rating **	M	Issue No.	2	
LM End	0.16	Issue Type +	En	Location *		
Category	Supplemental			GPS Latitude/Longitude		
				Start		End
Item	DWR UCIP Field Study			38.346815 °		38.346815 °
				-121.538491 °		-121.538491 °
DWR ID	18860					
Comment Code						
Inspector Comment						
FS_ID:57009 DS_ID:18860 EP_NO: N/A Repair Type: Non-Urgent Crossing Status: Not Found UCIP Comments: 05/26/2020 Record updated to Non-Urgent. Crossing not found. No permit has been identified authorizing pipe. (O.Yakimov - DWR UCIP) FIELD_STRUCT_DESC: 6-inch pipe of an unknown material or purpose through the levee, at unknown depth. [Additional Reference(s): USACE Sacramento O&M Manual, Unit 111, May 1959, Revised 29 December 2016, (RM 36.51), listed as 6-inch pipe]. FS Date: 5/26/2020 9:06:25 AM

Top of Levee: View of levee crown at potential crossing looking downstream

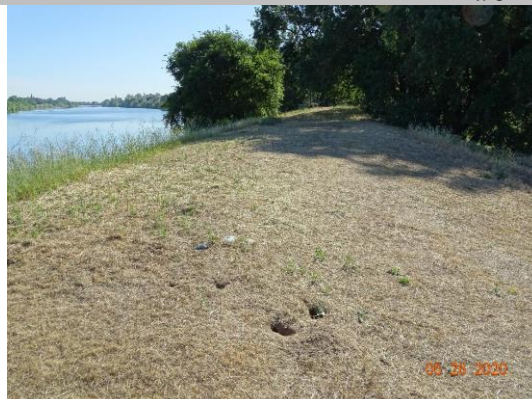
Photo 2 of 3 : UCIP\_SP\_2021\_57009\_84331.jpg

Top of Levee: View of levee crown at potential crossing looking upstream

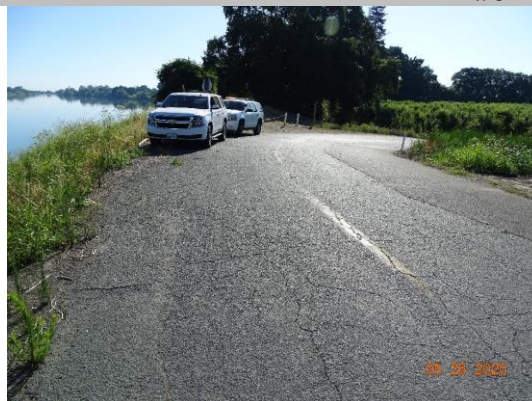
Photo 1 of 3 : UCIP\_SP\_2021\_57010\_84335.jpg

FS\_ID:57010  
DS\_ID:18848  
EP\_NO: 11221  
Repair Type: Urgent  
Crossing Status: Found  
UCIP Comments: 05/26/2020 Record updated to Urgent. Through holes in pipe on LS slope. Open end of electrical conduit without wires at LS toe next to abandoned service pole. These two could pose flood risk to landside. 14-inch to 12-inch pipe welded connection on LS shoulder. Ruined pile structure at riverbank, missing pump. Abandoned service pole at LS toe. Crossing appears abandoned. Need to have CVFPB review ABO and determine current owner. Coordinates of crossing have been updated. (O.Yakimov - DWR UCIP)  
FIELD\_STRUCT\_DESC: 14-inch irrigation discharge pipe of an unknown material through the levee, invert elevation 4.2 feet below the crown, 2-inch steel electrical conduit at same location. Pump on a pile structure in the river. Wooden stairs and walkway to the pump. 42-inch concrete standpipe and service pole at landside toe. (14-inch pipe [HLM 0.18] authorized under Automatic Board Order (ABO) issued as Permit No. 11221, 1975 - Greene and Hemly, Inc). [Additional Reference(s): DWR Levee Log, 2005 (HLM 0.18). USACE As-Built Drawing No. 50-04-2983, Sheet 14, RM 36.5, March 1954, listed as 12-inch pipe].

Top of Levee: View of levee crown looking upstream

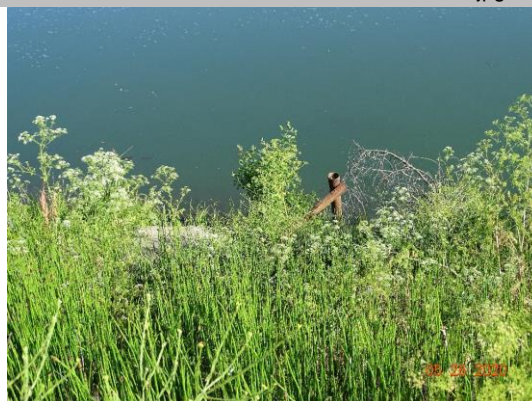
Photo 3 of 3 : UCIP\_SP\_2021\_57010\_84337.jpg

Water-Side: Signs of ruined pile structure on levee slope

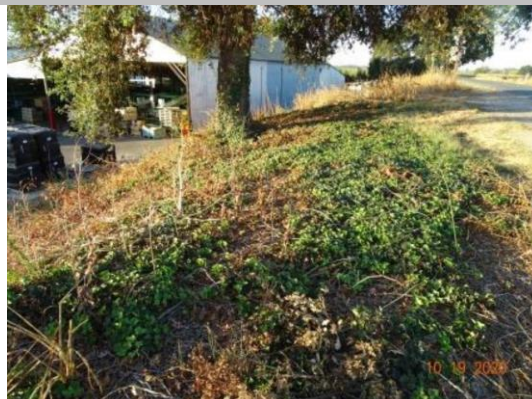
Photo 1 of 1 : SP\_2021\_RD0755\_177\_50\_20210301\_00022.jpg

LM Start	0.17	Rating **	M	Issue No.	50
LM End	0.17	Issue Type +	En	Location *	LS
Category	Earthen Levee			GPS Latitude/Longitude	
				Start	End
Item	Vegetation			38.346743 °	38.346743 °
				-121.538767 °	-121.538767 °
DWR ID	DWR_RD0755_01_f_2020_50				
Comment Code					
V6 : Landscaping					
Inspector Comment					
Ivy on the landside shoulder and slope.

View of ivy on the landside slope (Fall 2020).

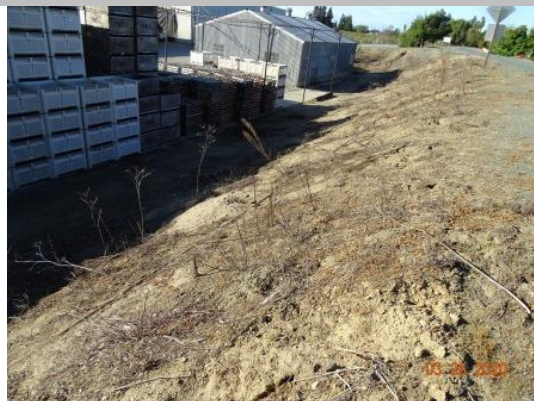
Photo 1 of 2 : SP\_2021\_RD0755\_177\_4\_20210301\_00001.jpg

LM Start	0.20	Rating **	M	Issue No.	4
LM End	0.92	Issue Type +	Ma	Location *	LS
Category	Earthen Levee			GPS Latitude/Longitude	
				Start	End
Item	Animal Control			38.346500 °	38.344130 °
				-121.539146 °	-121.552038 °
DWR ID	DWR_RD0755_01_f_2014_4				
Comment Code					
A3 : No rodents visible, but rodent burrows visible; need to backfill and compact or grout burrows.					
Inspector Comment					
Evidence of active rodents on landside slope near the walnut trees. No bait stations were observed.

View looking downstream at fresh animal hole on the landside slope (Spring 2020).

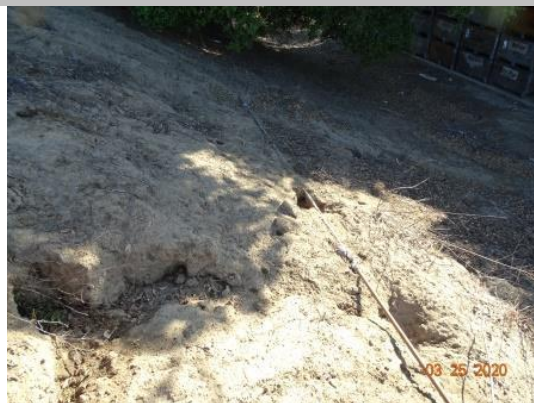
Photo 2 of 2 : SP\_2021\_RD0755\_177\_4\_20210301\_00002.jpg

View a couple animal holes on the landside slope (Spring 2020).

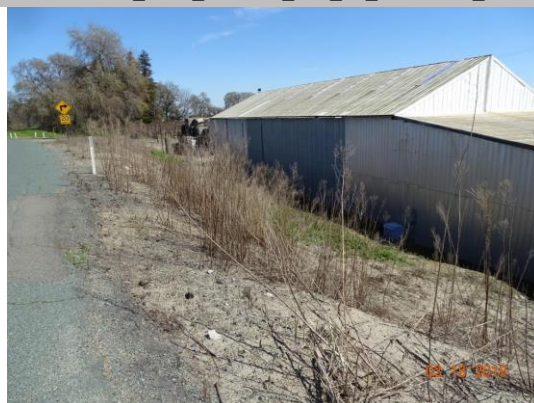
Photo 1 of 1 : SP\_2021\_RD0755\_177\_10\_20210301\_00003.jpg

LM Start	0.21	Rating **	M	Issue No.	10
LM End	0.21	Issue Type +	Ma	Location *	LS
Category	Earthen Levee			GPS Latitude/Longitude	
				Start	End
Item	Slope Stability			38.346428 °	38.346428 °
				-121.539400 °	-121.539400 °
DWR ID	DWR_RD0755_01_s_2019_10				
Comment Code					
S1 : Repair slope instability.					
Inspector Comment					
There is a 2" seperation between roadway and levee on the landside shoulder.

View looking upstream at small slip on the landside shoulder (Spring 2019).

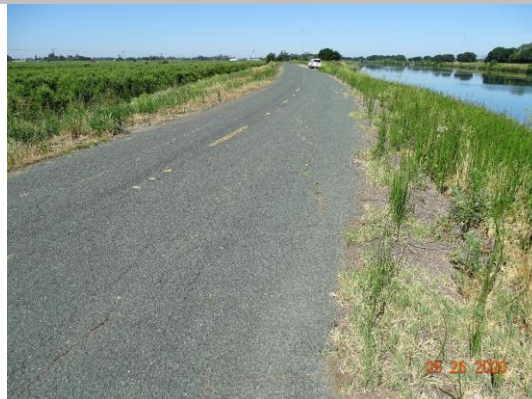
Photo 1 of 3 : UCIP\_SP\_2021\_57011\_84345.jpg

Comment Code						
Inspector Comment						
FS_ID:57011						
DS_ID:18866						
EP_NO: N/A						
Repair Type: Non-Urgent						
Crossing Status: Not Found						
UCIP Comments: 05/26/2020 Record updated to Non-Urgent. Crossing not found. No permit has been identified authorizing pipe. (O.Yakimov - DWR UCIP)						
FIELD_STRUCT_DESC: 12-inch irrigation discharge pipe of an unknown material through the levee, invert elevation 4.2 feet below the crown. Pump on the waterside (WS). [Additional Reference(s): USACE Sacramento O&M Manual, Unit 111, May 1959, Revised 29 December 2016, (RM 36.42), listed as 12-inch pipe].						
FS Date: 5/26/2020 10:12:22 AM

Top of Levee: View of levee crown at potential crossing looking downstream

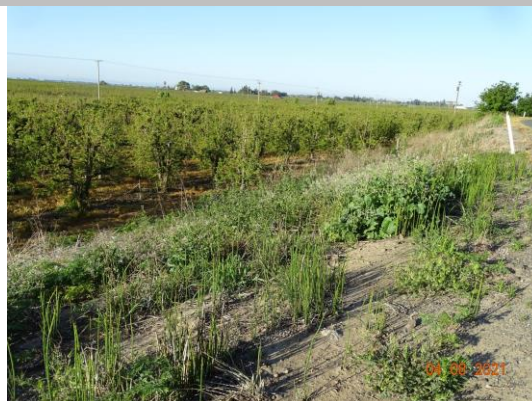
Photo 1 of 1 : SP\_2021\_RD0755\_177\_20\_20210408\_00081.jpg

View looking downstream at vegetation on the landside slope (Spring 2021).

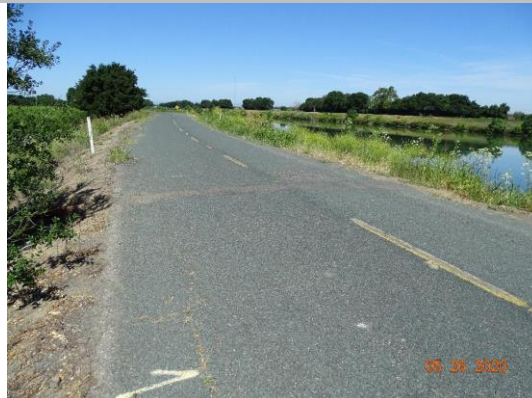
Photo 1 of 3 : UCIP\_SP\_2021\_57013\_84356.jpg

Comment Code						
Inspector Comment						
FS_ID:57013 DS_ID:18849 EP_NO: 4302 Repair Type: Non-Urgent Crossing Status: Found UCIP Comments: 05/26/2020 Record remains Non-Urgent. Pump is running, minor leak through pump sealing on WS slope observed. (O.Yakimov - DWR UCIP) 08/06/2013 FBC about 2 feet.Power conduit also through the levee.Wet ground on pump site/location. May need investigation about wet ground. FIELD_STRUCT_DESC: 8-inch coated steel irrigation discharge pipe through the levee, 2 feet below the crown. 2-inch electrical conduit through the levee at same location. Pump, electrical box, and control valve on the waterside (WS) slope. Siphon breaker on the landside (LS) shoulder. Pipe connected to two screen filters on LS. Service pole at the LS toe. (8-inch pipe [HLM 0.43] authorized under Permit No. 4302, 1963 - E. C. Hemly). [Additional Reference(s): DWR Levee Log, 2005 (HLM 0.44)]. FS Date: 5/26/2020 10:33:38 AM

Top of Levee: View on levee crown at the crossing looking downstream

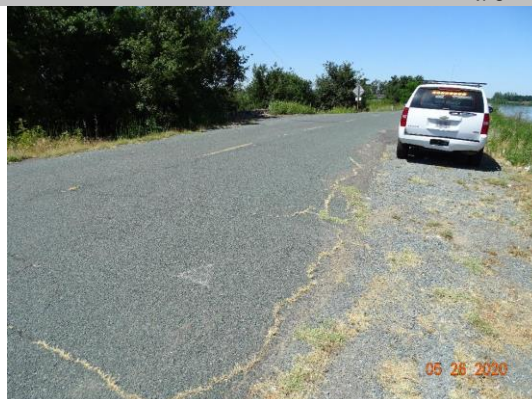
Photo 1 of 3 : UCIP\_SP\_2021\_57018\_84377.jpg

Comment Code						
Inspector Comment						
FS_ID:57018 DS_ID:18861 EP_NO: N/A Repair Type: Non-Urgent Crossing Status: Not Found UCIP Comments: 05/26/2020 Record updated from No Action Needed to Non-Urgent. Crossing not found. 12-inch pipe debris on LS slope, buried headwall at LS toe. No permit has been identified authorizing pipe. (O.Yakimov - DWR UCIP) 08/06/2013 Not found. FIELD_STRUCT_DESC: 12-inch irrigation discharge pipe of unknown material, at unknown depth. Pump and gate on landside. [Additional Reference(s): USACE Sacramento O&M Manual, Unit 111, May 1959, Revised 29 December 2016, (RM 36.01), listed as 12-inch pipe]. FS Date: 5/26/2020 12:43:14 PM

Top of Levee: View of levee crown at potential crossing looking downstream

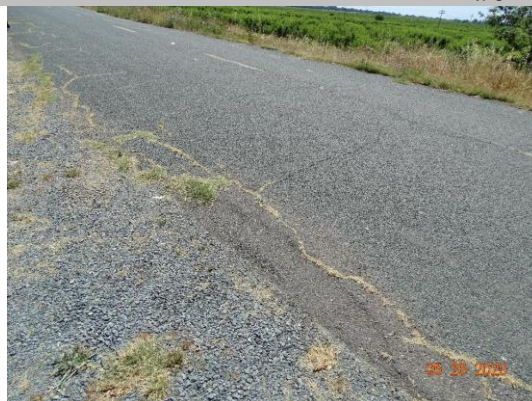
Photo 1 of 3 : UCIP\_SP\_2021\_57034\_84419.jpg

FS\_ID:57034  
DS\_ID:18850  
EP\_NO: 4637  
Repair Type: Non-Urgent  
Crossing Status: Found  
UCIP Comments: 05/26/2020 Record updated from No Action Needed to Non-Urgent. Pumping platform on pile structure in the river has been removed. Unable to find permit authorizing modifications to this crossing to sleeve 12-inch pipe through 16-inch pipe. (O.Yakimov - DWR UCIP)  
08/06/2013 12-inch steel pipe sleeved through 16 in steel pipe. Pump was running during field survey.  
FIELD\_STRUCT\_DESC: 12-inch pipe sleeved through a 16-inch coated steel irrigation discharge pipe through the levee, 5 feet below the crown. Pump on pumping platform of WS slope with stairs to the pump. Flow meter installed on 12-inch pipe. This crossing replaces 16-inch pipe (see DSID 25613). (Replacement of a portion of 16-inch pipe through the levee section authorized under Permit No. 4637, 1964 - Green and McKeown Farms, Inc). [Additional Reference(s): DWR Levee Log, 2005 (HLM 0.70). USACE Sacramento O&M Manual, Unit 111, May 1959, Revised 29 December 2016, (RM 35.90), listed as 14-inch pipe].

Top of Levee: View of levee crown at the crossing looking upstream

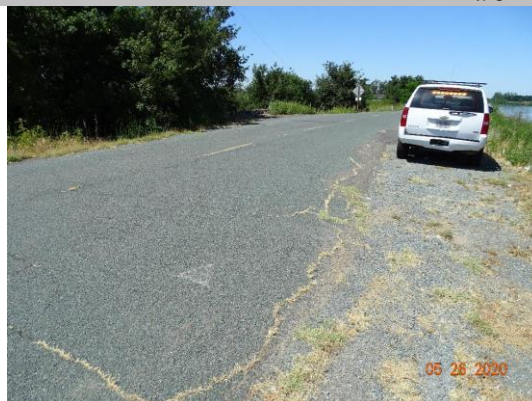
Photo 1 of 3 : UCIP\_SP\_2021\_57035\_84433.jpg

FS\_ID:57035  
DS\_ID:18851  
EP\_NO: 7357  
Repair Type: Non-Urgent  
Crossing Status: Found  
UCIP Comments: 05/26/2020 Record remains Non-Urgent. Pumping platform on pile structure in the river has been removed. No permit has been identified authorizing original 16-inch pipe. Annular space between 8-inch pipe and 16-inch pipe has been grouted. (O.Yakimov - DWR UCIP)  
08/06/2013 An abandoned 12-in steel pipe lying on LS levee slope should be removed. A buried concrete headwall found on LS levee slope should be checked for any pipe or connection.  
FIELD\_STRUCT\_DESC: 8-inch pipe and 2-inch electrical conduit sleeved through a 16-inch steel irrigation discharge pipe through the levee, 4.2 feet below the crown. Pump on pumping platform on WS slope with stairs to pump. (Additional pump installation on WS and sleeving 8-inch pipe through an existing 14-inch pipe authorized under Permit 7357, 1971 - Green and Keown Farms, Inc). [Additional Reference(s): DWR Levee Log, 2005, (HLM 0.70), 14-inch outer pipe referenced. USACE Sacramento O&M Manual, Unit 111, May 1959, Revised 29 December 2016, (RM 35.90), listed as 14-inch pipe].

Top of levee: View of levee crown looking downstream

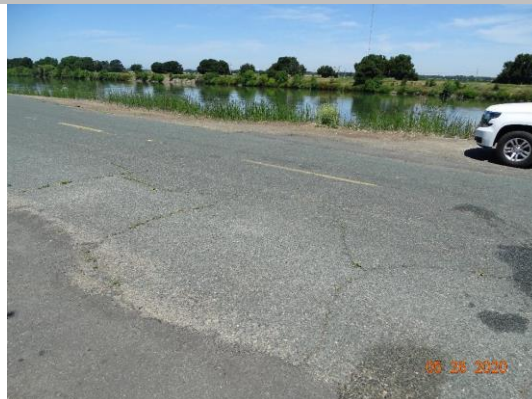
Photo 1 of 3 : UCIP\_SP\_2021\_57038\_84440.jpg

Comment Code						
Inspector Comment						
FS_ID:57038 DS_ID:18852 EP_NO: 11222 Repair Type: Non-Urgent Crossing Status: Found UCIP Comments: 05/26/2020 Record updated from No Action Needed to Non-Urgent. No permit has been identified authorizing pipe. Pipe was running during site visit pumping water to the waterside. (O.Yakimov - DWR UCIP) 08/06/2013 It was working during field survey. A pump found 150 ft from the levee. Not sure whether the pump belong to this drainage system. FIELD_STRUCT_DESC: 16-inch steel drainage pipe sleeved through a 24-inch steel drainage pipe through the levee, invert elevation 8 feet below the crown. Air vent installed on the pipe on WS slope. Concrete headwall on LS. (12-inch pipe sleeved through 24-inch pipe-inch pipe [HLM 0.71] authorized under Automatic Board Order (ABO) issued as Permit No. 11222, 1975 - Green McKeown, Inc). [Additional Reference(s): DWR Levee Log, 2005 (HLM 0.71), referenced as 12-inch pipe through 24-inch pipe. USACE Sacramento O&M Manual, Unit 111, May 1959, Revised 29 December 2016, (RM 35.89), listed as 24-inch pipe]. FS Date: 5/26/2020 3:00:07 PM

Top of Levee: View of levee crown looking downstream

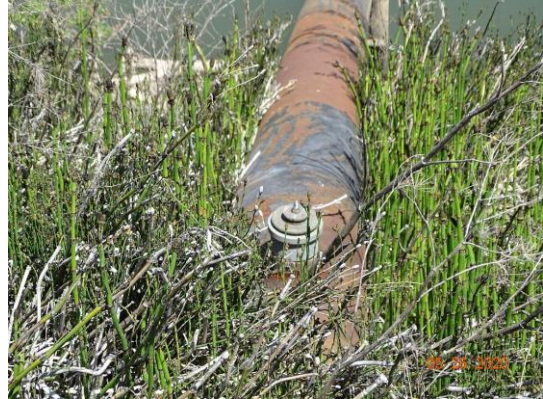
Photo 3 of 3 : UCIP\_SP\_2021\_57038\_84443.jpg

Water-Side: Pipe and air release valve on levee slope

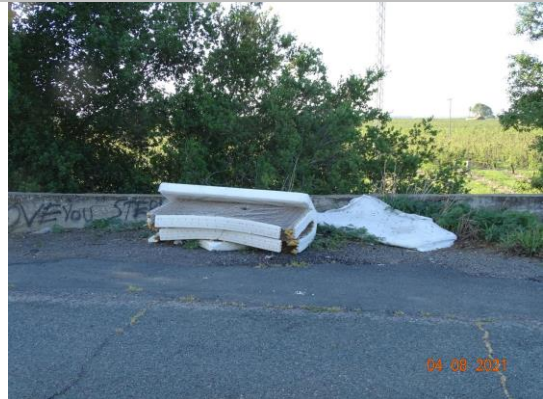
Photo 1 of 1 : SP\_2021\_RD0755\_177\_43\_20210408\_00082.jpg

View of discarded mattress on the landside hinge (Spring 2021).

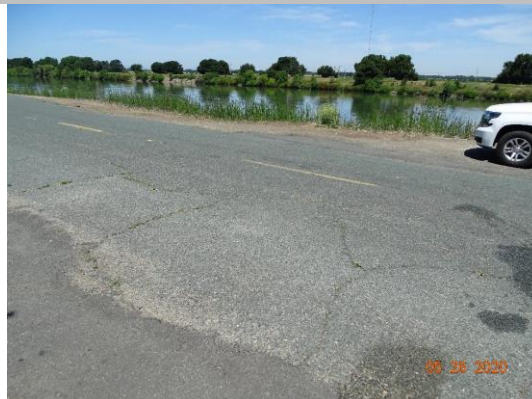
Photo 1 of 3 : UCIP\_SP\_2021\_57042\_84449.jpg

Comment Code						
Inspector Comment						
FS_ID:57042 DS_ID:18853 EP_NO: N/A Repair Type: Non-Urgent Crossing Status: Found UCIP Comments: 05/26/2020 Record updated from No Action Needed to Non-Urgent. Crossing appears abandoned: landside end filled with concrete and capped with a steel plate. Unauthorized encroachment recorded in Levee Log prior to 2011. (O.Yakimov - DWR UCIP)  FIELD_STRUCT_DESC: 30-inch pipe of an unknown material or purpose through the levee, 10.5 feet below the crown. Landside (LS) end filled with concrete and capped with a steel plate. Concrete headwall on the LS end. [Additional Reference(s): DWR Levee Log, 2005 (HLM 0.71)]. FS Date: 5/26/2020 3:47:43 PM

Top of Levee: View of levee crown looking downstream

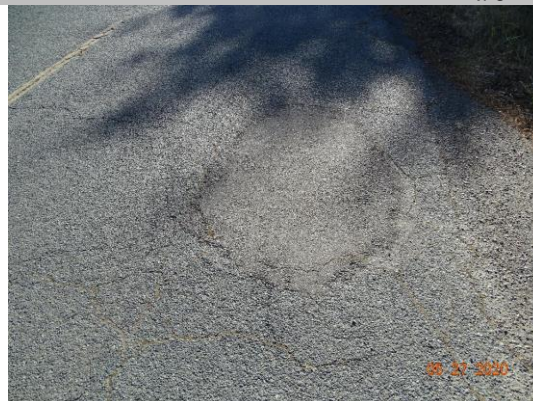
Photo 2 of 3 : UCIP\_SP\_2021\_57080\_84493.jpg

Top of Levee: Patch in road pavement within pipe alignment

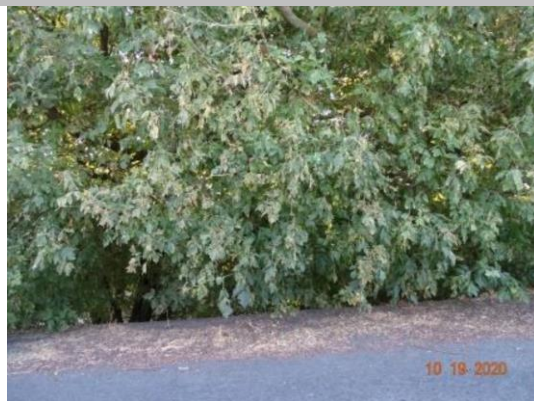
Photo 1 of 1 : SP\_2021\_RD0755\_177\_53\_20210301\_00023.jpg

View of thick trees on the landside slope (Fall 2020).

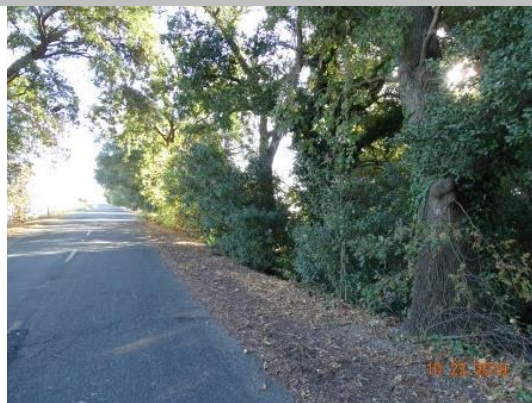
Photo 1 of 1 : SP\_2021\_RD0755\_177\_23\_20210301\_00010.jpg

View looking upstream at landscaping on the landside slope (Fall 2019).

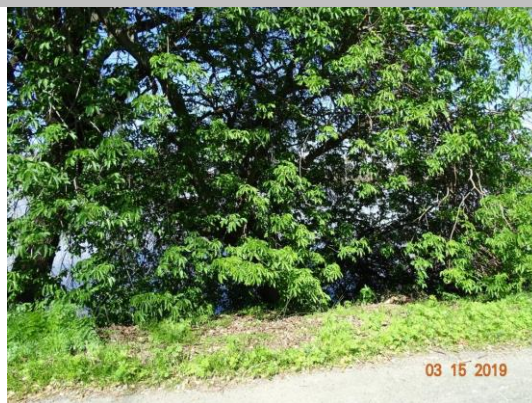
Photo 1 of 1 : SP\_2021\_RD0755\_177\_31\_20210301\_00016.jpg

View of tree at the top of the waterside shoulder (Spring 2019).

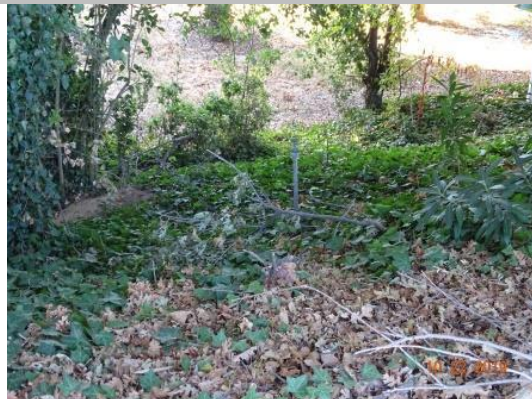
Photo 1 of 1 : SP\_2021\_RD0755\_177\_44\_20210301\_00021.jpg

View looking downslope at sprinkler emitter on the landside slope (Fall 2019).

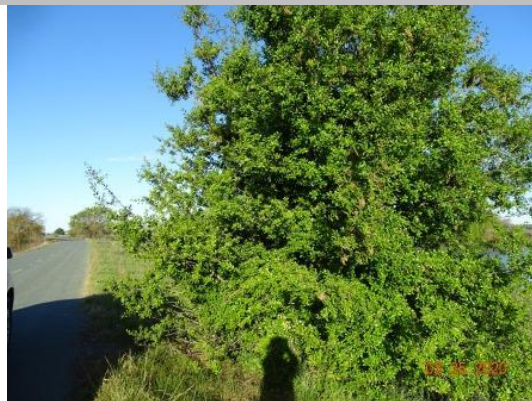
Photo 1 of 1 : SP\_2021\_RD0755\_177\_28\_20210301\_00015.jpg

View looking downstream at tree on the waterside slope (Spring 2020).

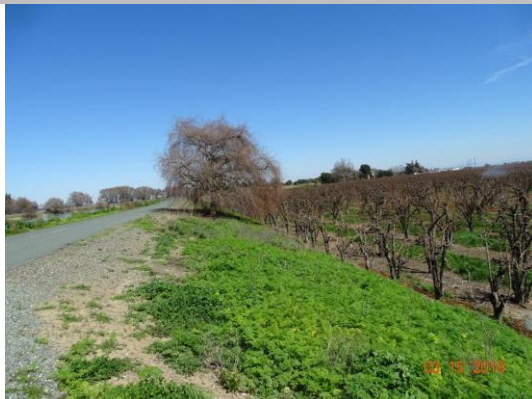
Photo 1 of 1 : SP\_2021\_RD0755\_177\_32\_20210301\_00017.jpg

View looking upstream at orchard trees on the base of the landside slope (Spring 2019).

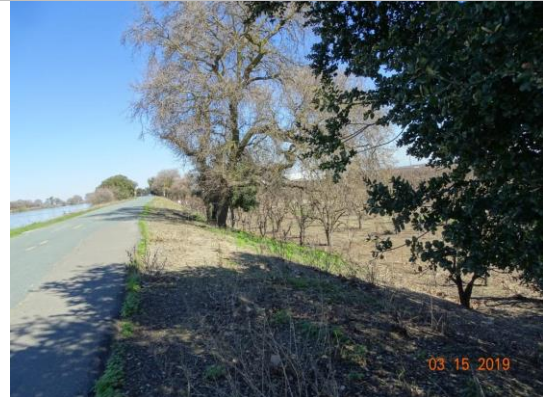
Photo 1 of 1 : SP\_2021\_RD0755\_177\_33\_20210301\_00018.jpg

View looking upstream at orchard trees at the landside toe (Spring 2019).

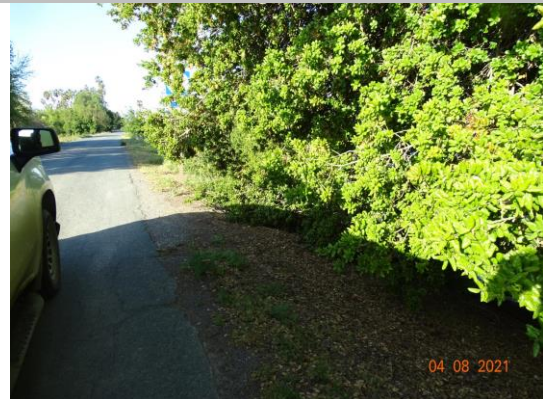
Photo 1 of 1 : SP\_2021\_RD0755\_177\_37\_20210408\_00083.jpg

View looking downstream at thick tree on the waterside slope (Spring 2021).

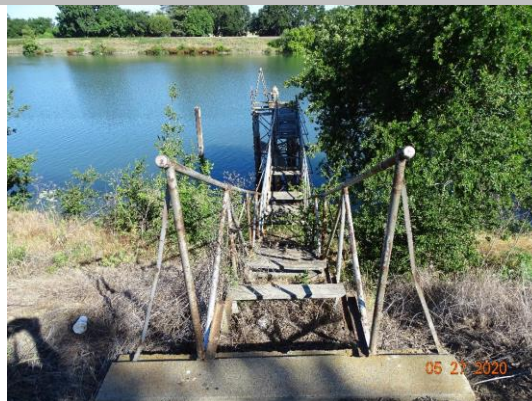
Photo 3 of 3 : UCIP\_SP\_2021\_57084\_84534.jpg

Water-Side: View of levee slope looking from crown. Abandoned pier on waterside

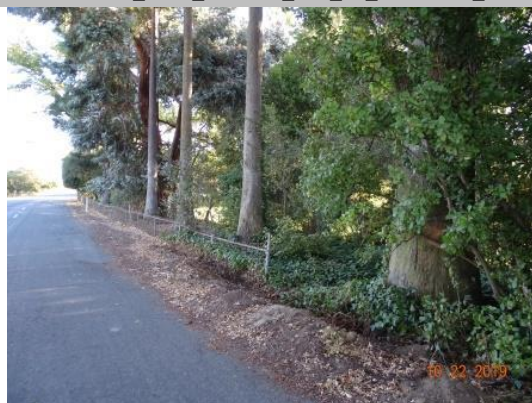
Photo 1 of 1 : SP\_2021\_RD0755\_177\_25\_20210301\_00014.jpg

View looking upstream at landscaping on the landside slope (Fall 2019).
