**Flood Control Project Maintenance
Levee Inspections
LMA District Cover Sheet**

Reclamation District No. 0755 Randall

**Flood Control Project Maintenance
Levee Inspections**

Levee Inspection Report By Mile - Spring 2022

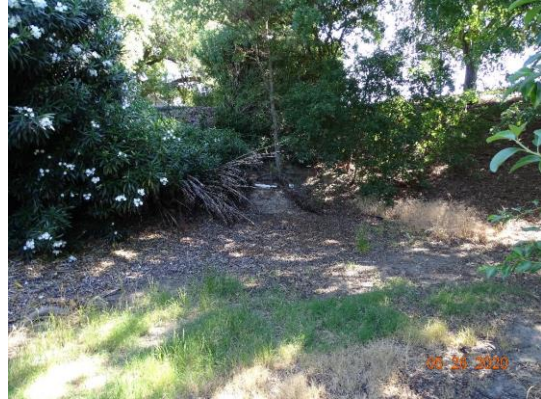
Photo 1 of 3 : UCIP_SP_2022_57008_84320.jpg

Comment Code						
Inspector Comment						
FS_ID:57008 DS_ID:18865 EP_NO: N/A Repair Type: Non-Urgent Crossing Status: Indicator Found UCIP Comments: 05/26/2020 Record updated to Non-Urgent. No permit has been identified authorizing pipe. Crossing appears abandoned. Unable to see pipe on either side of levee. Abandoned pump house on waterside. Former irrigation ditch begins at landside toe where water used to be pumped. PVC pipe debris in landside ditch. Coordinates of this crossing have bee updated. (O.Yakimov - DWR UCIP) 08/07/2013 No access. Iron gate on the levee. FIELD_STRUCT_DESC: 14-inch irrigation discharge pipe of an unknown material through the levee, invert elevation 4.2 feet below the crown. Pump house on the waterside slope, concrete standpipe and siphon breaker at LS toe. [Additional Reference(s): USACE Sacramento O&M Manual, Unit 111, May 1959, Revised 29 December 2016, (RM 36.60), listed as 14-inch pipe]. FS Date: 5/26/2020 8:45:30 AM

Land-Side: View of former irrigation ditch and LS slope covered with shrub

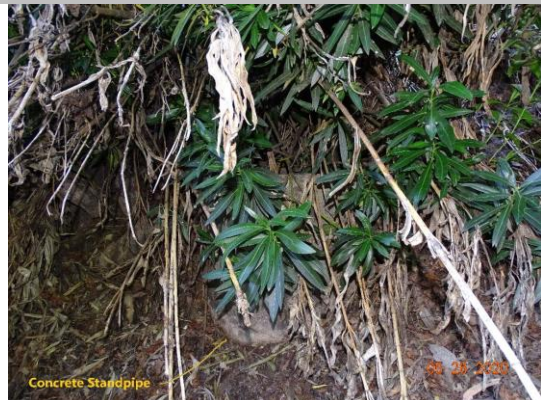
Photo 2 of 3 : UCIP_SP_2022_57008_84321.jpg

Land-Side: Concrete standpipe at levee toe covered with vegetation

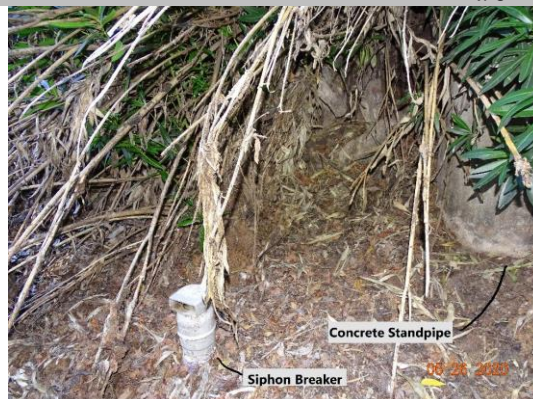
Photo 3 of 3 : UCIP_SP_2022_57008_84322.jpg

Land-Side: Concrete standpipe and siphon breaker at levee toe

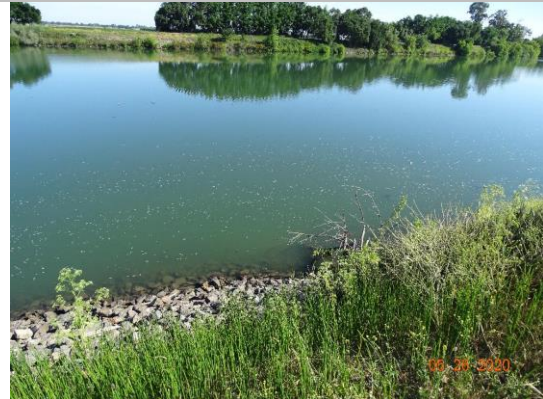
Photo 3 of 3 : UCIP_SP_2022_57009_84332.jpg

LM Start	0.16	Rating **	M	Issue No.	2	
LM End	0.16	Issue Type +	En	Location *		
Category	Supplemental			GPS Latitude/Longitude		
				Start		End
Item	DWR UCIP Field Study			38.346815 °		38.346815 °
				-121.538491 °		-121.538491 °
DWR ID	18860					
Comment Code						
Inspector Comment						
FS_ID:57009 DS_ID:18860 EP_NO: N/A Repair Type: Non-Urgent Crossing Status: Not Found UCIP Comments: 05/26/2020 Record updated to Non-Urgent. Crossing not found. No permit has been identified authorizing pipe. (O.Yakimov - DWR UCIP) FIELD_STRUCT_DESC: 6-inch pipe of an unknown material or purpose through the levee, at unknown depth. [Additional Reference(s): USACE Sacramento O&M Manual, Unit 111, May 1959, Revised 29 December 2016, (RM 36.51), listed as 6-inch pipe]. FS Date: 5/26/2020 9:06:25 AM

Water-Side: View of levee slope looking from crown

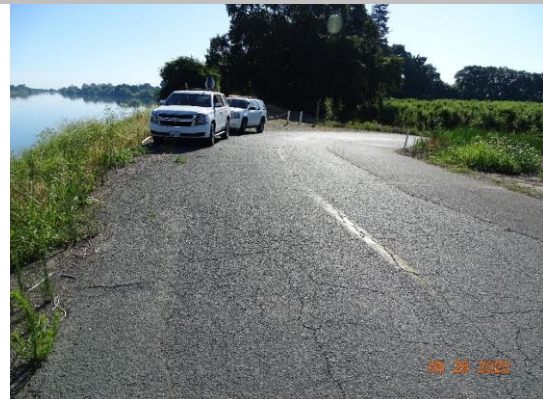
Photo 1 of 3 : UCIP_SP_2022_57010_84335.jpg

FS_ID:57010
DS_ID:18848
EP_NO: 11221
Repair Type: Urgent
Crossing Status: Found
UCIP Comments: 05/26/2020 Record updated to Urgent. Through holes in pipe on LS slope. Open end of electrical conduit without wires at LS toe next to abandoned service pole. These two could pose flood risk to landside. 14-inch to 12-inch pipe welded connection on LS shoulder. Ruined pile structure at riverbank, missing pump. Abandoned service pole at LS toe. Crossing appears abandoned. Need to have CVFPB review ABO and determine current owner. Coordinates of crossing have been updated. (O.Yakimov - DWR UCIP)
FIELD_STRUCT_DESC: 14-inch irrigation discharge pipe of an unknown material through the levee, invert elevation 4.2 feet below the crown, 2-inch steel electrical conduit at same location. Pump on a pile structure in the river. Wooden stairs and walkway to the pump. 42-inch concrete standpipe and service pole at landside toe. (14-inch pipe [HLM 0.18] authorized under Automatic Board Order (ABO) issued as Permit No. 11221, 1975 - Greene and Hemly, Inc). [Additional Reference(s): DWR Levee Log, 2005 (HLM 0.18). USACE As-Built Drawing No. 50-04-2983, Sheet 14, RM 36.5, March 1954, listed as 12-inch pipe].

Top of Levee: View of levee crown looking upstream

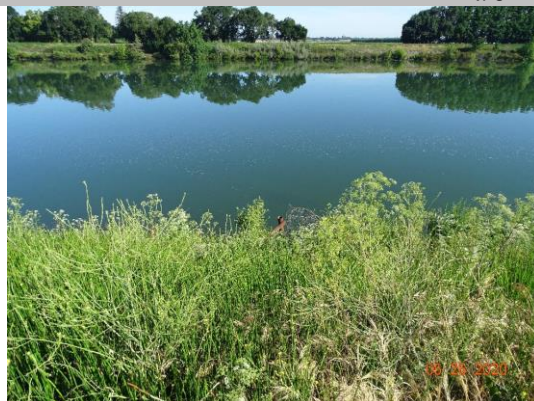
Photo 2 of 3 : UCIP_SP_2022_57010_84336.jpg

Water-Side: View of levee slope looking from crown

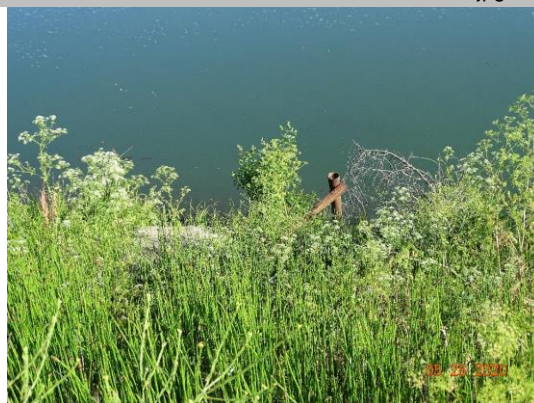
Photo 3 of 3 : UCIP_SP_2022_57010_84337.jpg

Water-Side: Signs of ruined pile structure on levee slope

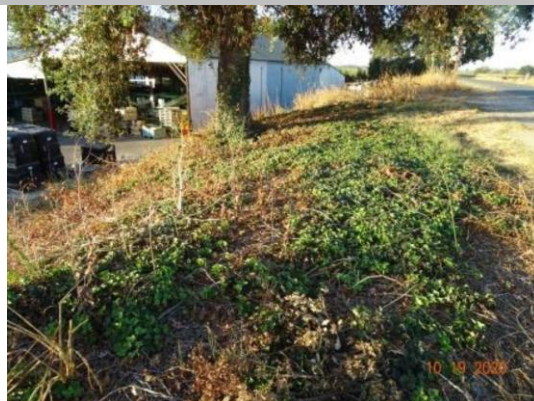
Photo 1 of 1 : SP_2022_RD0755_177_50_20220307_00017.jpg

LM Start	0.17	Rating **	M	Issue No.	50
LM End	0.17	Issue Type +	En	Location *	LS
Category	Earthen Levee			GPS Latitude/Longitude	
				Start	End
Item	Vegetation			38.346743 °	38.346743 °
				-121.538767 °	-121.538767 °
DWR ID	DWR_RD0755_01_f_2020_50				
Comment Code					
V6 : Landscaping					
Inspector Comment					
Ivy on the landside shoulder and slope.

View of ivy on the landside slope (Fall 2020).

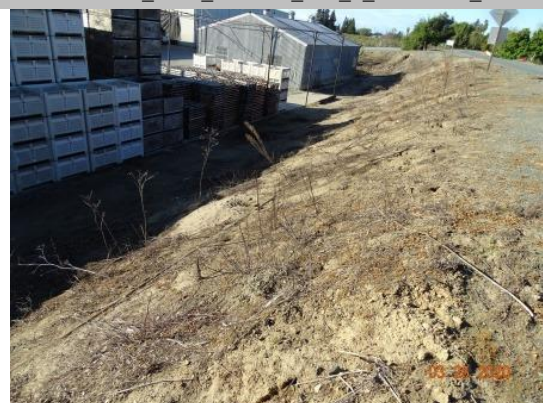
Photo 1 of 2 : SP_2022_RD0755_177_4_20220307_00001.jpg

View looking downstream at fresh animal hole on the landside slope (Spring 2020).

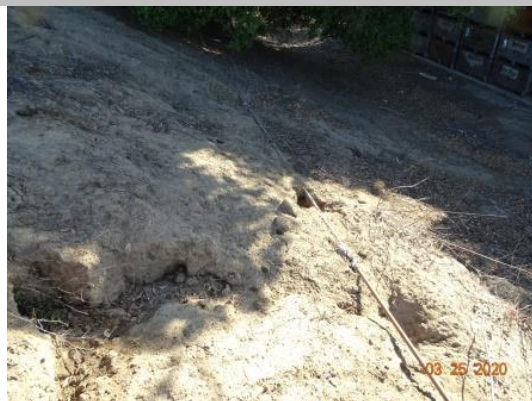
Photo 2 of 2 : SP_2022_RD0755_177_4_20220307_00002.jpg

View a couple animal holes on the landside slope (Spring 2020).

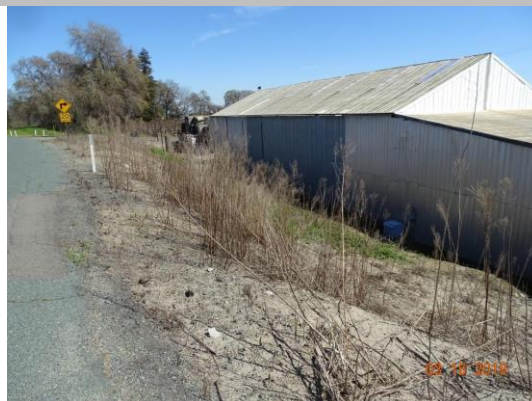
Photo 1 of 1 : SP_2022_RD0755_177_10_20220307_00003.jpg

LM Start	0.21	Rating **	M	Issue No.	10
LM End	0.21	Issue Type +	Ma	Location *	LS
Category	Earthen Levee			GPS Latitude/Longitude	
				Start	End
Item	Slope Stability			38.346428 °	38.346428 °
				-121.539400 °	-121.539400 °
DWR ID	DWR_RD0755_01_s_2019_10				
Comment Code					
S1 : Repair slope instability.					
Inspector Comment					
There is a 2" seperation between roadway and levee on the landside shoulder.

View looking upstream at small slip on the landside shoulder (Spring 2019).

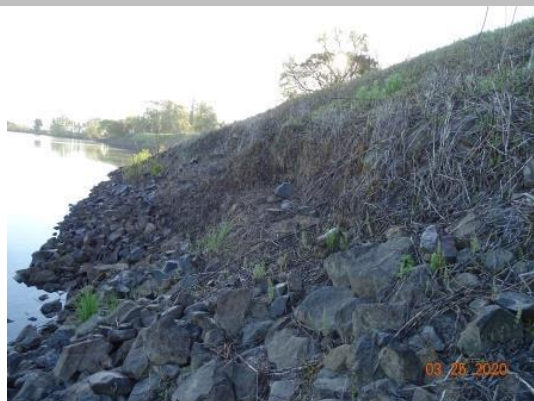
Photo 1 of 1 : SP_2022_RD0755_177_18_20220307_00005.jpg

LM Start	0.28	Rating **	U	Issue No.	18
LM End	0.28	Issue Type +	Ma	Location *	WS
Category	Earthen Levee			GPS Latitude/Longitude	
				Start	End
Item	Erosion / Bank Caving			38.346249 °	38.346331 °
				-121.540542 °	-121.540664 °
DWR ID	DWR RD0755 01 s 2020 18

This was a 2017 Storm Damage site.
Damage consists of erosion of the lower waterside levee slope and bank approximately 27 feet in length.
Site ID No:327
Site Designation:LMA-154
3/25/2020 Field Notes:
Erosion is significant. At least 1' into waterside slope. No riprap present.

View looking upstream and slightly up at erosion into the waterside slope (Spring 2020).

E2 : Schedule repair of erosion site prior to the next inspection.

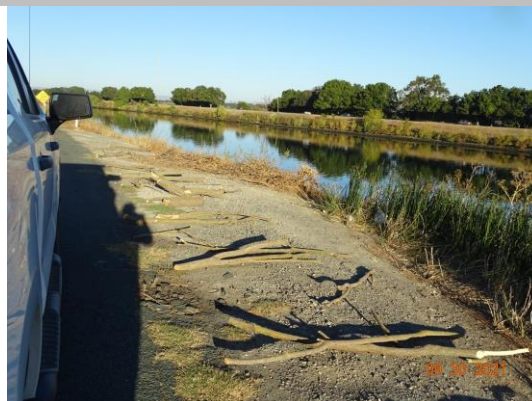
Photo 1 of 1 : SP_2022_RD0755_177_60_20220307_00023.jpg

View of branches placed across waterside turnout by LMA (Fall 2021).

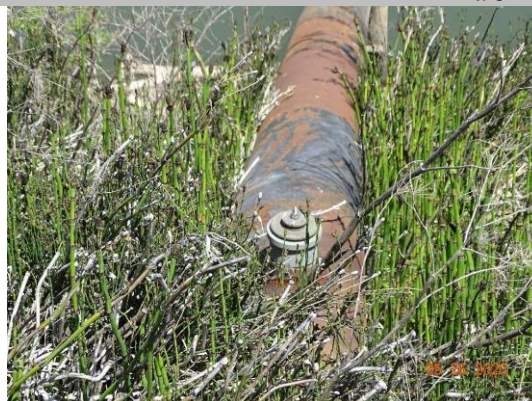
Photo 3 of 3 : UCIP_SP_2022_57038_84443.jpg

Water-Side: Pipe and air release valve on levee slope

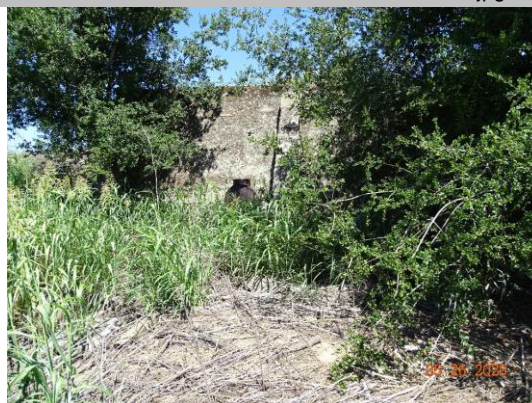
Photo 3 of 3 : UCIP_SP_2022_57042_84447.jpg

FS_ID:57042
DS_ID:18853
EP_NO: N/A
Repair Type: Non-Urgent
Crossing Status: Found
UCIP Comments: 05/26/2020 Record updated from No Action Needed to Non-Urgent. Crossing appears abandoned: landside end filled with concrete and capped with a steel plate. Unauthorized encroachment recorded in Levee Log prior to 2011. (O.Yakimov - DWR UCIP)

Overview of Levee: headwall on LS levee slope looking from landside berm

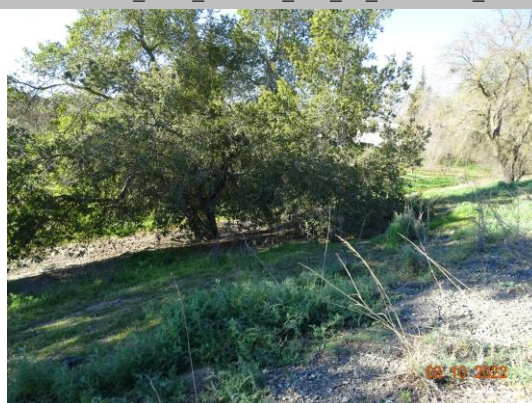
Photo 1 of 1 : SP_2022_RD0755_177_20_20220311_00078.jpg

View looking downstream at tree needing trimming on the landside slope (Spring 2022).

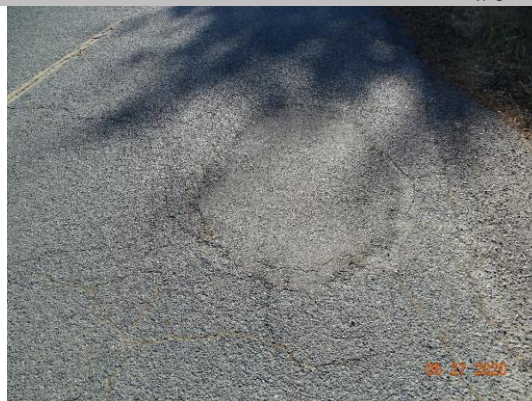
Photo 2 of 3 : UCIP_SP_2022_57080_84493.jpg

Top of Levee: Patch in road pavement within pipe alignment

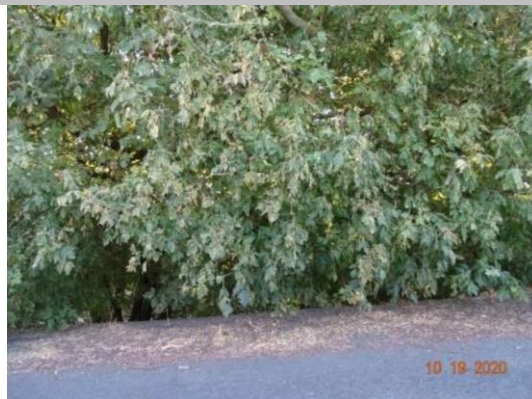
Photo 1 of 1 : SP_2022_RD0755_177_53_20220307_00019.jpg

View of thick trees on the landside slope (Fall 2020).

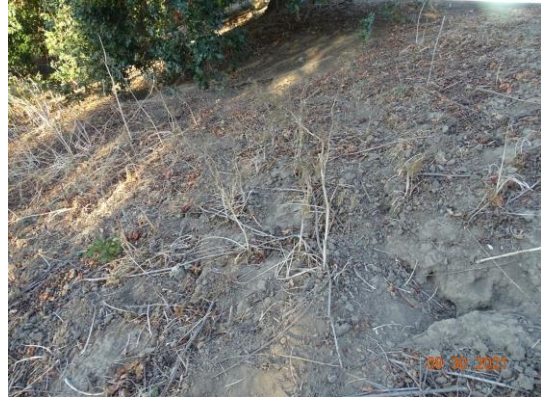
Photo 1 of 1 : SP_2022_RD0755_177_59_20220307_00022.jpg

View of animal holes in the landside slope (Fall 2021).

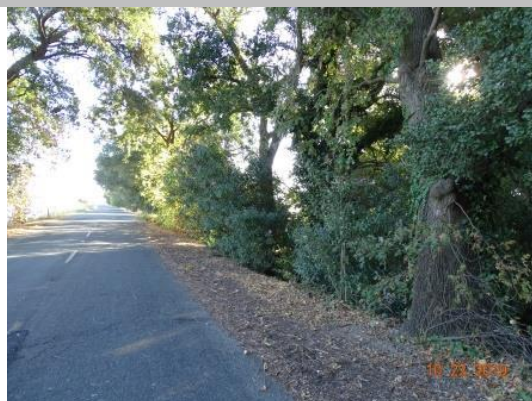
Photo 1 of 1 : SP_2022_RD0755_177_23_20220307_00008.jpg

View looking upstream at landscaping on the landside slope (Fall 2019).

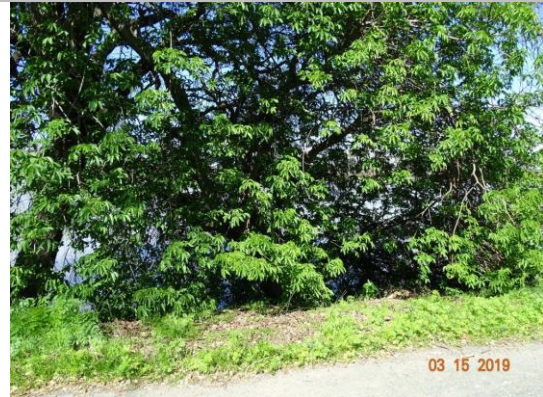
Photo 1 of 1 : SP_2022_RD0755_177_31_20220307_00011.jpg

View of tree at the top of the waterside shoulder (Spring 2019).

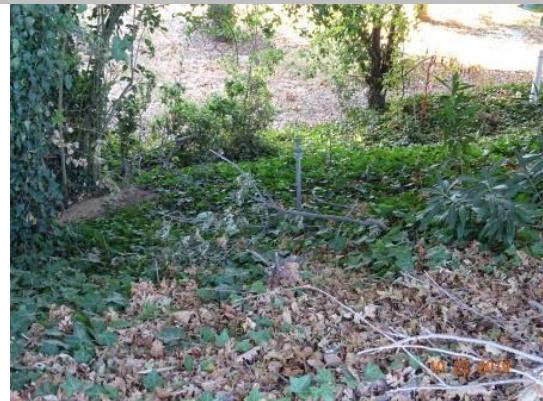
Photo 1 of 1 : SP_2022_RD0755_177_44_20220307_00016.jpg

View looking downslope at sprinkler emitter on the landside slope (Fall 2019).

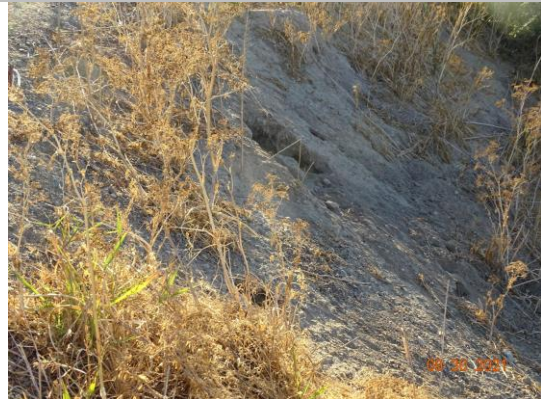
Photo 1 of 1 : SP_2022_RD0755_177_58_20220307_00021.jpg

View of animal hole in the landside slope (Fall 2021).

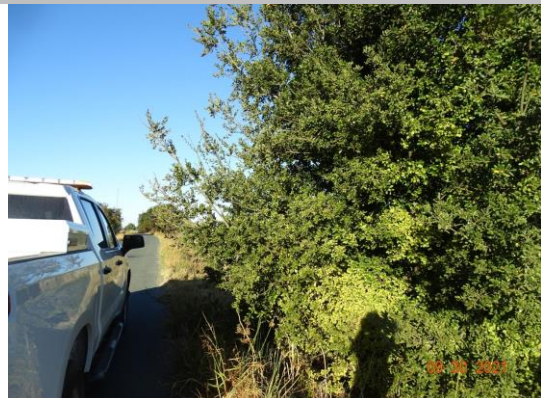
Photo 1 of 1 : SP_2022_RD0755_177_28_20220307_00010.jpg

View looking downstream at tree on the waterside slope (Fall 2021).

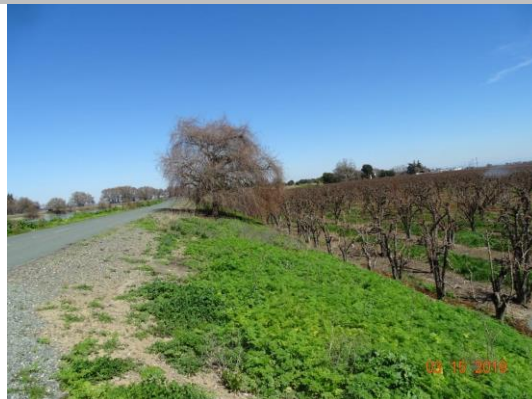
Photo 1 of 1 : SP_2022_RD0755_177_32_20220307_00012.jpg

View looking upstream at orchard trees on the base of the landside slope (Spring 2019).

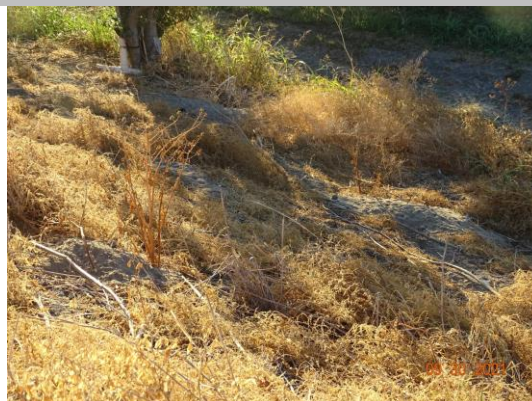
Photo 1 of 1 : SP_2022_RD0755_177_55_20220307_00020.jpg

View of animal holes in the landside slope (Fall 2021).

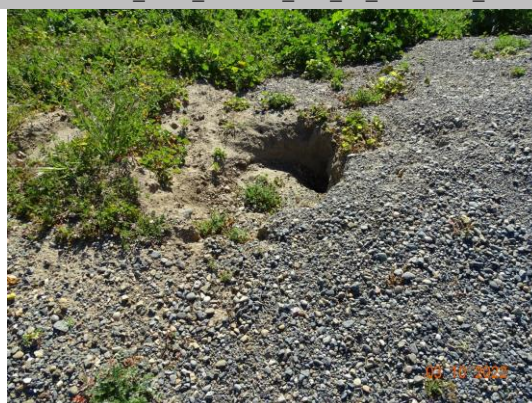
Photo 1 of 1 : SP_2022_RD0755_177_52_20220311_00079.jpg

View of animal hole in the landside slope (Spring 2022).

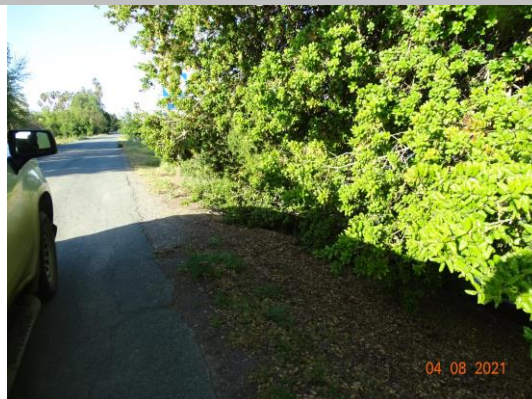
Photo 1 of 1 : SP_2022_RD0755_177_37_20220307_00015.jpg

View looking downstream at thick tree on the waterside slope (Spring 2021).

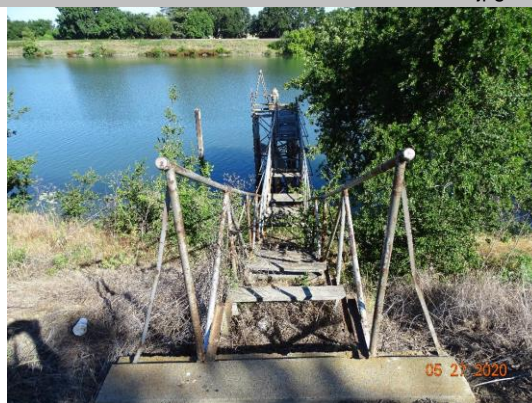
Photo 3 of 3 : UCIP_SP_2022_57084_84534.jpg

Water-Side: View of levee slope looking from crown. Abandoned pair on waterside
