**Flood Control Project Maintenance  
Levee Inspections**

**Levee Inspection Report By Mile - Spring 2023**

**Reclamation District No. 0755 Randall**

Waterway	Bank	Unit Miles	Inspection Start/End	Inspector
Unit No. 01 Sacramento River	Left	1.83	04/27/2023 04/27/2023	Saskia Donovan

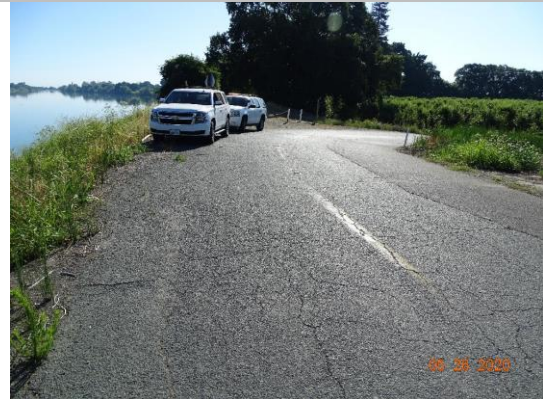
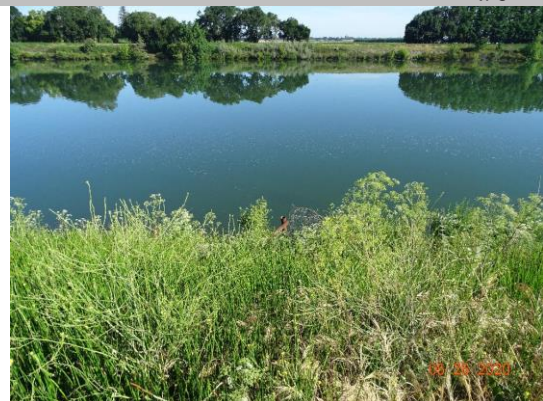
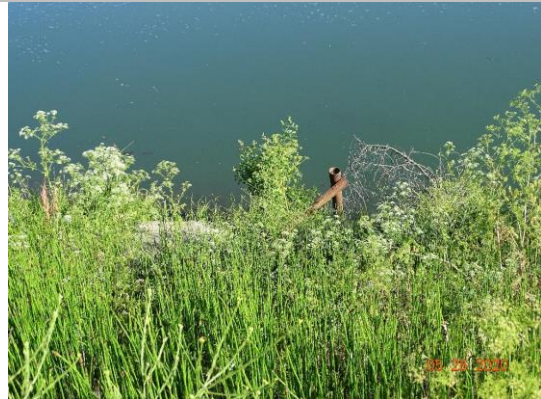
LM Start	0.17	Rating **	U	Issue No.	1
LM End	0.17	Issue Type +	En	Location *	
Category	Supplemental			GPS Latitude/Longitude	
				Start	End
Item	DWR UCIP Field Study			38.346783°	38.346783°
				-121.538834°	-121.538834°
DWR ID	18848

DS\_ID:18848  
FS\_ID:57010  
EP\_NO: 11221  
Repair Type: Urgent  
EVAL Issue: 1, Pipe Integrity  
Crossing Status: Found  
UCIP Comments: 05/26/2020 Record updated to Urgent. Through holes in pipe on LS slope. Open end of electrical conduit without wires at LS toe next to abandoned service pole. These two could pose flood risk to landside. 14-inch to 12-inch pipe welded connection on LS shoulder. Ruined pile structure at riverbank, missing pump. Abandoned service pole at LS toe. Crossing appears abandoned. Need to have CVFPB review ABO and determine current owner. Coordinates of crossing have been updated. (O.Yakimov - DWR UCIP)  
FIELD\_STRUCT\_DESC: 14-inch irrigation discharge pipe of an unknown material through the levee, invert elevation 4.2 feet below the crown, 2-inch steel electrical conduit at same location. Pump on a pile structure in the river. Wooden stairs and walkway to the pump. 42-inch concrete standpipe and service pole at landside toe. (14-inch pipe [HLM 0.18] authorized under Automatic Board Order (ABO) issued as Permit No. 11221, 1975 - Greene and Hemly, Inc). [Additional Reference(s): DWR Levee Log, 2005 (HLM 0.18). USACE As-Built Drawing No. 50-04-2983, Sheet 14, RM 36.5, March 1954, listed as 12-inch pipe].

Top of Levee: View of levee crown looking upstream

Water-Side: View of levee slope looking from crown

Water-Side: Signs of ruined pile structure on levee slope

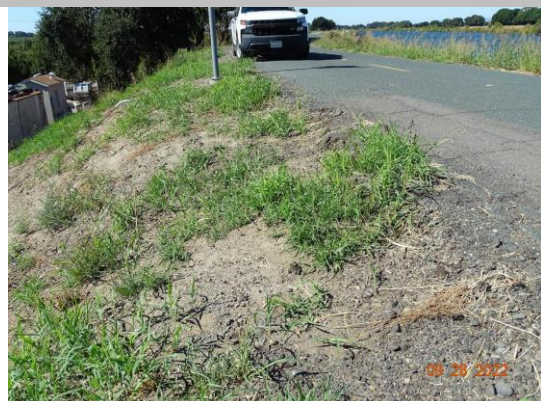
Photo 1 of 1 : SP\_2023\_RD0755\_177\_10\_20230206\_00002.jpg

LM Start	0.21	Rating **	M	Issue No.	10
LM End	0.21	Issue Type +	Ma	Location *	LS
Category	Earthen Levee			GPS Latitude/Longitude	
				Start	End
Item	Slope Stability			38.346428°	38.346428°
				-121.539400°	-121.539400°
DWR ID	DWR_RD0755_01_s_2019_10				
Comment Code					
S1 : Repair slope instability.					
Inspector Comment					
There is a 2" separation between roadway and levee on the landside shoulder.

View of the small slip on the LS shoulder (Fall 2022).

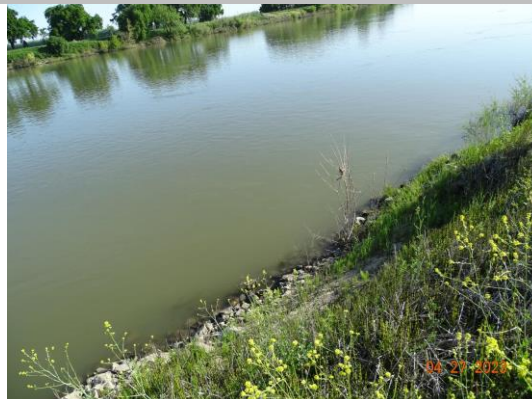
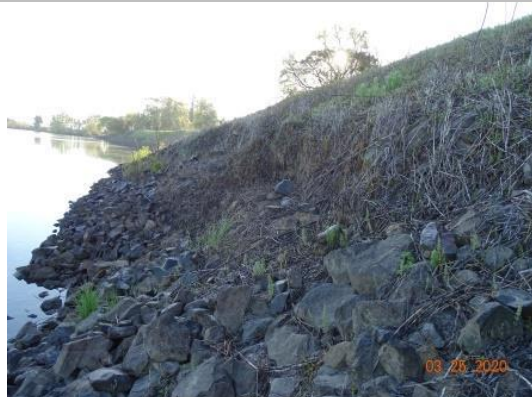
LM Start	0.28	Rating **	U	Issue No.	18
LM End	0.28	Issue Type +	Ma	Location *	WS
Category	Earthen Levee			GPS Latitude/Longitude	
				Start	End
Item	Erosion / Bank Caving			38.346249°	38.346331°
				-121.540542°	-121.540664°
DWR ID	DWR_RD0755_01_s _ 2020_18				
Comment Code					
E2 : Schedule repair of erosion site prior to the next inspection.					
Inspector Comment					
Fall 2022: Erosion repair is pending. This was a 2017 Storm Damage site.					
Damage consists of erosion of the lower waterside levee slope and bank approximately 27 feet in length.					
Site ID No:327					
Site Designation:LMA-154					
3/25/2020 Field Notes:					
Erosion is significant. At least 1' into waterside slope. No riprap present.

View of the WS erosion looking down the slope (Spring 2023).

View looking upstream and slightly up at erosion into the waterside slope (Spring 2020).

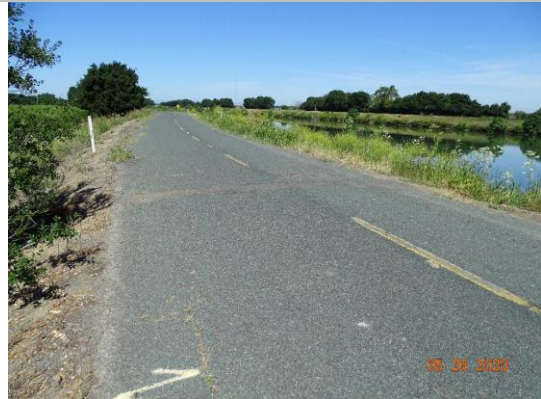
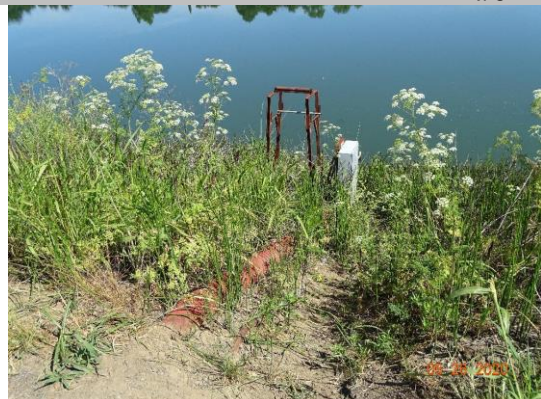
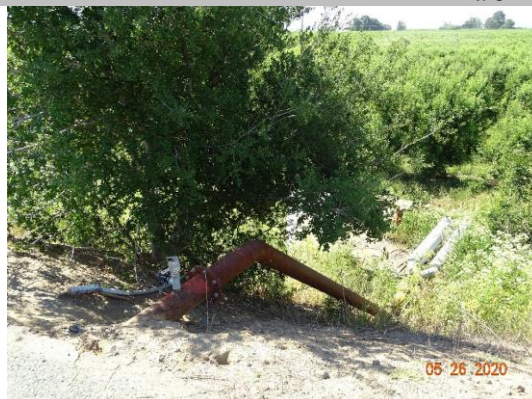
LM Start	0.43	Rating **	M	Issue No.	2	
LM End	0.43	Issue Type +	En	Location *		
Category	Supplemental			GPS Latitude/Longitude		
				Start	End	
Item	DWR UCIP Field Study			38.345640°	38.345640°	
				-121.543277°	-121.543277°	
DWR ID	18849

Comment Code						
Inspector Comment						
DS_ID:18849						
FS_ID:57013						
EP_NO: 4302						
Repair Type: Non-Urgent						
EVAL Issue: 11, Maintenance Compliance Issue						
Crossing Status: Found						
UCIP Comments: 05/26/2020 Record remains Non-Urgent. Pump is running, minor leak through pump sealing on WS slope observed. (O.Yakimov - DWR UCIP)						
08/06/2013 FBC about 2 feet.Power conduit also through the levee.Wet ground on pump site/location. May need investigation about wet ground.						
FIELD_STRUCT_DESC: 8-inch coated steel irrigation discharge pipe through the levee, 2 feet below the crown. 2-inch electrical conduit through the levee at same location. Pump, electrical box, and control valve on the waterside (WS) slope. Siphon breaker on the landside (LS) shoulder. Pipe connected to two screen filters on LS. Service pole at the LS toe. (8-inch pipe [HLM 0.43] authorized under Permit No. 4302, 1963 - E. C. Hemly). [Additional Reference(s): DWR Levee Log, 2005 (HLM 0.44)].

Top of Levee: View on levee crown at the crossing looking downstream

Water-Side: View of levee slope looking from crown

Land-Side: View of levee slope looking from crown

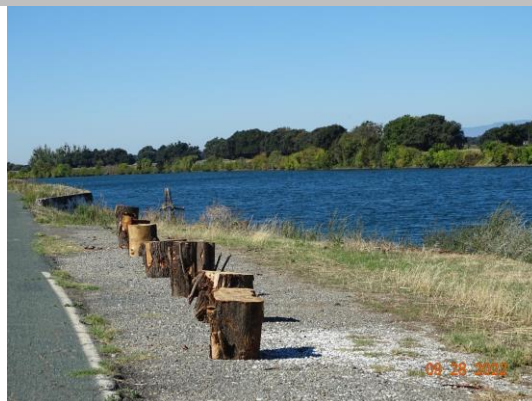
Photo 1 of 1 : SP\_2023\_RD0755\_177\_38\_20230206\_00009.jpg

LM Start	0.59	Rating **	A/W	Issue No.	38
LM End	0.59	Issue Type +	En	Location *	WS
Category	Earthen Levee			GPS Latitude/Longitude	
				Start	End
Item	Encroachments			38.345490 °	38.345490 °
				-121.546098 °	-121.546098 °
DWR ID	DWR_RD0755_01_f _ 2022_38				
Comment Code					
MISC : Miscellaneous					
Inspector Comment					
There are tree logs on the WS shoulder to prevent parking.

View of the logs on the WS shoulder (Fall 2022).

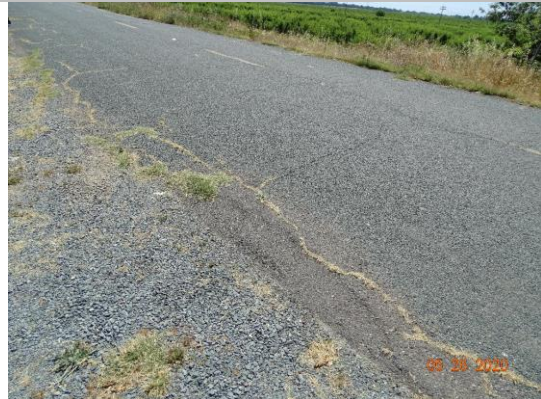
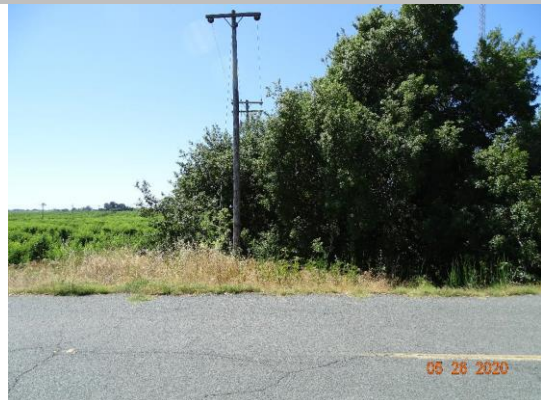
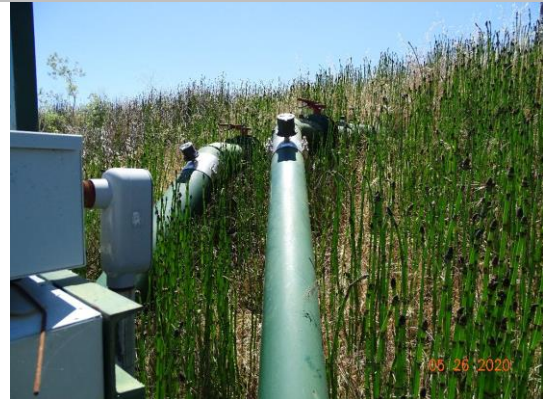
LM Start	0.68	Rating **	M	Issue No.	3	
LM End	0.68	Issue Type +	En	Location *		
Category	Supplemental			GPS Latitude/Longitude		
				Start	End	
Item	DWR UCIP Field Study			38.345113°	38.345113°	
				-121.547789°	-121.547789°	
DWR ID	18850

Comment Code						
Inspector Comment						
DS_ID:18850 FS_ID:57034 EP_NO: 4637 Repair Type: Non-Urgent EVAL Issue: 10, Unauthorized Modification or Non-Compliant Permit Crossing Status: Found UCIP Comments: 05/26/2020 Record updated from No Action Needed to Non-Urgent. Pumping platform on pile structure in the river has been removed. Unable to find permit authorizing modifications to this crossing to sleeve 12-inch pipe through 16-inch pipe. (O.Yakimov - DWR UCIP) 08/06/2013 12-inch steel pipe sleeved through 16 in steel pipe. Pump was running during field survey. FIELD_STRUCT_DESC: 12-inch pipe sleeved through a 16-inch coated steel irrigation discharge pipe through the levee, 5 feet below the crown. Pump on pumping platform of WS slope with stairs to the pump. Flow meter installed on 12-inch pipe. This crossing replaces 16-inch pipe (see DSID 25613). (Replacement of a portion of 16-inch pipe through the levee section authorized under Permit No. 4637, 1964 - Green and McKeown Farms, Inc). [Additional Reference(s): DWR Levee Log, 2005 (HLM 0.70). USACE Sacramento O&M Manual, Unit 111, May 1959, Revised 29 December 2016, (RM 35.90), listed as 14-inch pipe]. FS Date: 5/26/2020 8:27:31 AM

Top of Levee: View of levee crown at the crossing looking upstream

Land-Side: View of landside looking from crown

Water-Side: View of levee slope looking towards crown

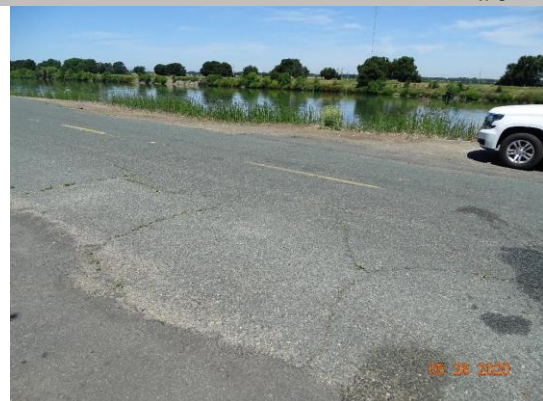
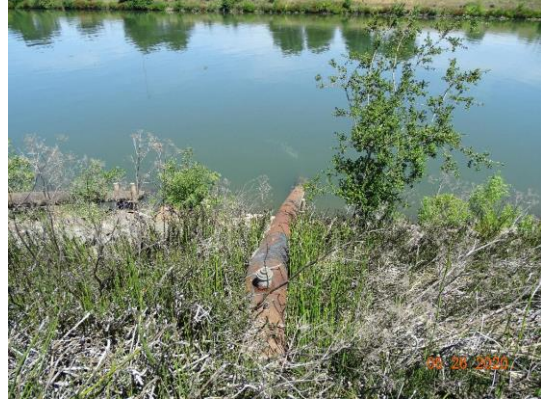
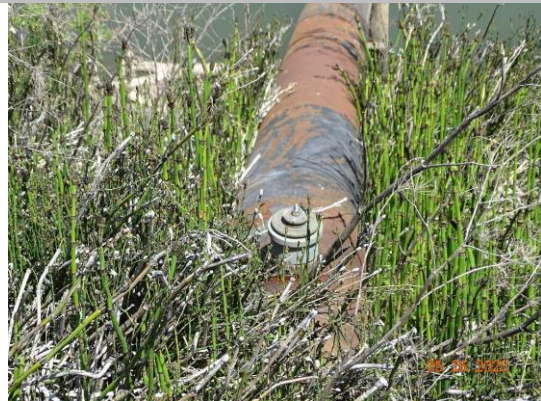
LM Start	<b>0.70</b>	Rating **	M	Issue No.	<b>5</b>
LM End	<b>0.70</b>	Issue Type +	Ma	Location *	
Category	Supplemental		GPS Latitude/Longitude		
			Start	End	
Item	DWR UCIP LMA Responsibility		38.345057°	38.345057°	
			-121.548050°	-121.548050°	
DWR ID	18852

DS\_ID:18852  
 FS\_ID:57038  
 EP\_NO: 11222  
 Repair Type: Non-Urgent  
 EVAL Issue:  
 Crossing Status: Found  
 UCIP Comments: 05/26/2020 Record updated from No Action Needed to Non-Urgent. No permit has been identified authorizing pipe. Pipe was running during site visit pumping water to the waterside. (O.Yakimov - DWR UCIP)  
 08/06/2013 It was working during field survey. A pump found 150 ft from the levee. Not sure whether the pump belong to this drainage system.  
 FIELD\_STRUCT\_DESC: 16-inch steel drainage pipe sleeved through a 24-inch steel drainage pipe through the levee, invert elevation 8 feet below the crown. Air vent installed on the pipe on WS slope. Concrete headwall on LS. (12-inch pipe sleeved through 24-inch pipe-inch pipe [HLM 0.71] authorized under Automatic Board Order (ABO) issued as Permit No. 11222, 1975 - Green McKeown, Inc). [Additional Reference(s): DWR Levee Log, 2005 (HLM 0.71), referenced as 12-inch pipe through 24-inch pipe. USACE Sacramento O&M Manual, Unit 111, May 1959, Revised 29 December 2016, (RM 35.89), listed as 24-inch pipe].

Top of Levee: View of levee crown looking downstream

Water-Side: View of levee slope looking from crown

Water-Side: Pipe and air release valve on levee slope

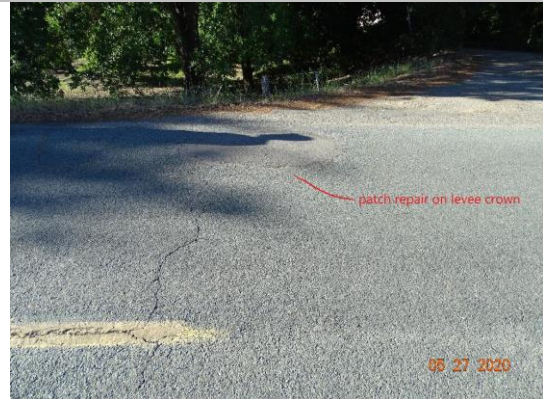
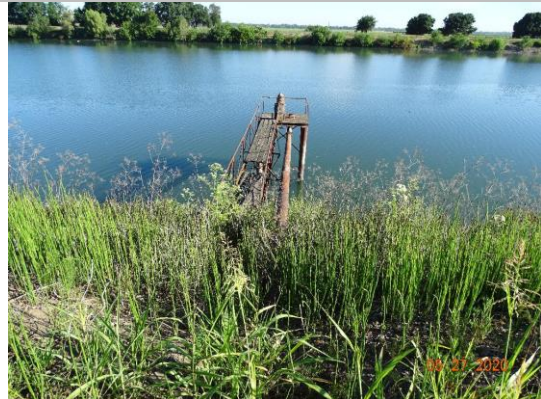
LM Start	0.93	Rating **	U	Issue No.	6
LM End	0.93	Issue Type +	En	Location *	
Category	Supplemental			GPS Latitude/Longitude	
				Start	End
Item	DWR UCIP Field Study			38.344103°	38.344103°
				-121.552119°	-121.552119°
DWR ID	18855

DS\_ID:18855  
FS\_ID:57080  
EP\_NO: 11225  
Repair Type: Urgent  
EVAL Issue: 1, Pipe Integrity  
Crossing Status: Found  
UCIP Comments: 05/27/2020 Record updated from Non-Urgent to Urgent. Through holes in pipe on waterside slope, sinkhole on WS shoulder measures 3'x3'x1'. Erosion continues to levee crown - road pavement. Asphalt patch repair on the crown. Knocked down service pole with electric box on LS slope. Crossing appears abandoned. Need to have CVFPB review ABO and determine current owner. (O.Yakimov - DWR UCIP)  
08/06/2013 Abandoned pipe and pump. Service pole, power box lying on LS slope.  
FIELD\_STRUCT\_DESC: 10-inch irrigation discharge pipe of an unknown material and a 1-inch electrical conduit through the levee, invert elevation 5.6 feet below the crown. Pump on a pile structure with a walkway to the pump. Abandoned service pole on the landside (LS) slope. (10-inch pipe [HLM 0.94] authorized under Automatic Board Order (ABO) issued as Permit No. 11225, 1975 - Helen D. Wilson). [Additional Reference(s): DWR Levee Log, 2005 (HLM 0.94). USACE Sacramento O&M Manual, Unit 111, May 1959, Revised 29 December 2016, (RM 35.66), listed as 10-inch pipe. USACE As-Built Drawing No. 50-04-2983, Sheet 13, downstream of Station 515+00, March 1954].

Top of Levee: View of levee crown looking across the road

Top of Levee: Patch in road pavement within pipe alignment

Water-Side: View of levee slope looking from crown

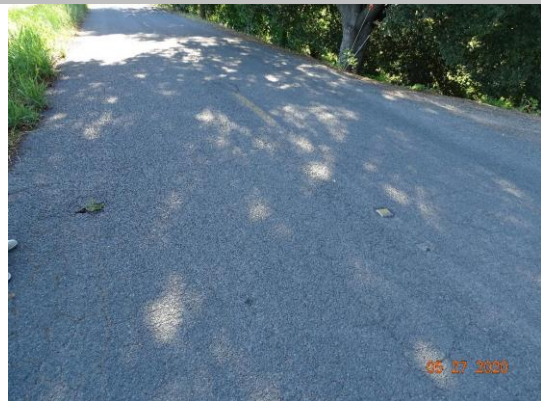
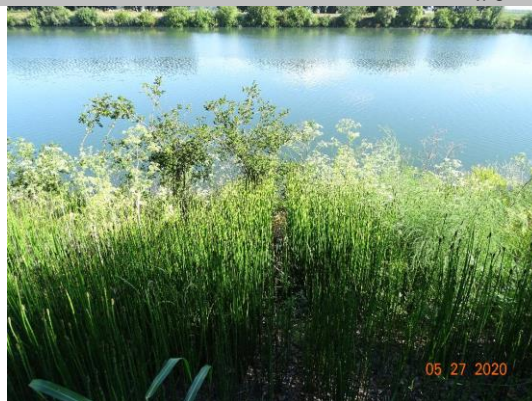
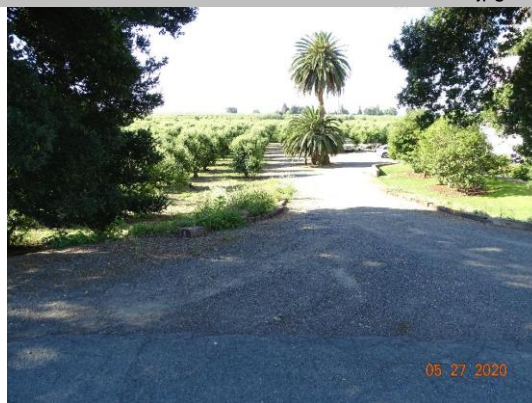
LM Start	<b>1.04</b>	Rating **	M	Issue No.	<b>7</b>
LM End	<b>1.04</b>	Issue Type +	En	Location *	
Category	Supplemental		GPS Latitude/Longitude		
			Start	End	
Item	DWR UCIP Field Study		38.343625°	38.343625°	
			-121.554145°	-121.554145°	
DWR ID	18856

DS\_ID:18856  
FS\_ID:57081  
EP\_NO: N/A  
Repair Type: Non-Urgent  
EVAL Issue: 6, Levee Damage or Threat for Levee Damage  
Crossing Status: Found  
UCIP Comments: 05/27/2020 Record remains Non-Urgent. A sinkhole is developing on levee crown closer to waterside hinge. The sinkhole is currently measuring 12"x18" in size. Was unable to locate pipe on landside slope. Crossing appears abandoned. No permit has been identified authorizing pipe. (O.Yakimov - DWR UCIP)  
08/06/2013 Needs to be properly abandoned.  
FIELD\_STRUCT\_DESC: 12-inch pipe of an unknown material or purpose through the levee, invert elevation 5 feet below the crown. Siphon breaker on the waterside (WS). Pipe not found on the landside (LS). [Additional Reference(s): DWR Levee Log, 2005 (HLM 1.05). USACE Sacramento O&M Manual, Unit 111, May 1959, Revised 29 December 2016, (RM 35.55), listed as 12-inch pipe].  
FS Date: 5/27/2020 7:33:53 AM

Top of Levee: View of levee crown looking upstream

Water-Side: View of levee slope looking from crown

Land-Side: View of levee slope looking from crown

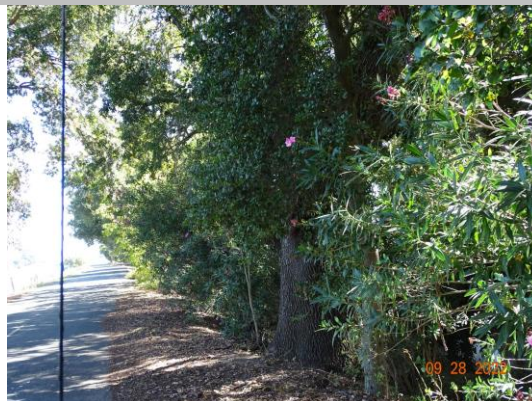
Photo 1 of 1 : SP\_2023\_RD0755\_177\_23\_20230206\_00005.jpg

LM Start	1.05	Rating **	M	Issue No.	23
LM End	1.08	Issue Type +	En	Location *	LS
Category	Earthen Levee			GPS Latitude/Longitude	
				Start	End
Item	Vegetation			38.343595°	38.343487°
				-121.554238°	-121.554768°
DWR ID	DWR_RD0755_01_s_2017_23				
Comment Code					
V6 : Landscaping					
Inspector Comment					
Ground vegetation, shrubs and trees should be maintained to allow inspection and access to landside slope and toe.

View of the landscaping on the LS slope (Fall 2022).

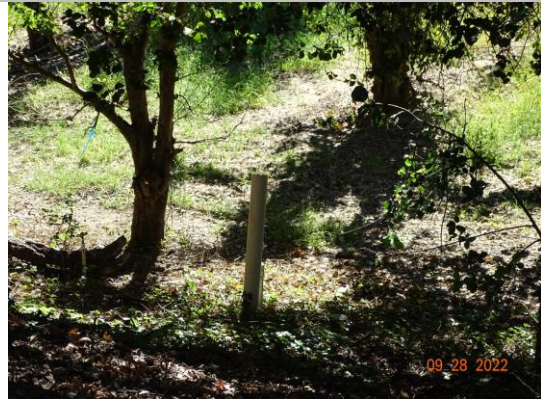
Photo 1 of 1 : SP\_2023\_RD0755\_177\_44\_20230206\_00010.jpg

View of the valve and sprinkler on the LS slope (Fall 2022).

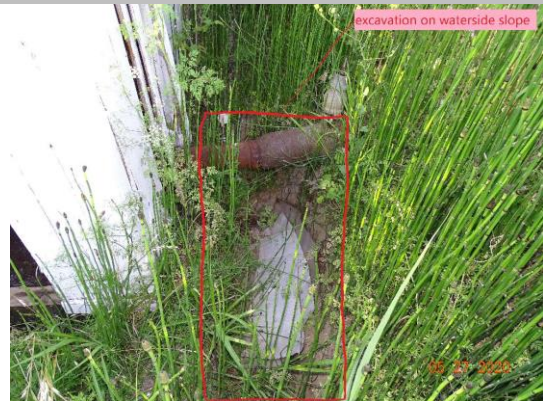
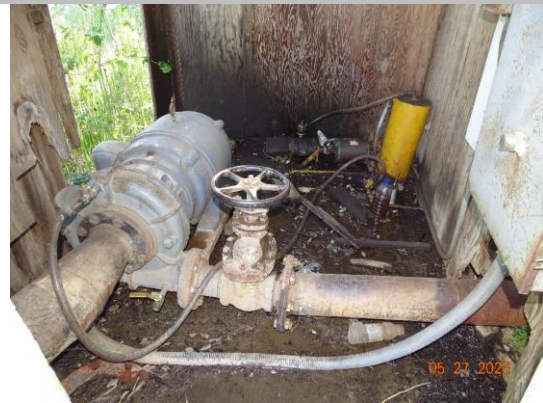
LM Start	1.12	Rating **	U	Issue No.	8	
LM End	1.12	Issue Type +	En	Location *		
Category	Supplemental			GPS Latitude/Longitude		
				Start	End	
Item	DWR UCIP Field Study			38.343305°	38.343305°	
				-121.555538°	-121.555538°	
DWR ID	18857

Comment Code						
Inspector Comment						
DS_ID:18857 FS_ID:57083 EP_NO: 11219 Repair Type: Urgent EVAL Issue: 2a, Levee Integrity Crossing Status: Found UCIP Comments: 05/27/2020 Record updated from Non-Urgent to Urgent. Unauthorized 8'x3'x3' excavation between pump house and WS levee slope was observed. Excavation exposes 8-inch pipe cut-off that was welded to a 6-inch pipe going towards pump house. Pump is running, minor water leaks from pump in pump house observed. CMP riser on LS shoulder is filled with soil and debris. No permit has been identified authorizing pipe. (O.Yakimov - DWR UCIP) 08/06/2013 requires cleaning of siphon breaker box. FIELD_STRUCT_DESC: 8-inch irrigation discharge pipe of an unknown material through the levee, invert elevation 5.7 feet below the crown. Siphon breaker in a 26-inch corrugated metal pipe (CMP) riser on the landside (LS) shoulder. Power pole on the LS. Pump and power box in a pump house on the waterside (WS) slope. Electrical conduit through the levee at the same location. (8-inch pipe [HLM 1.13] authorized under Automatic Board Order (ABO) issued as Permit No. 11219, 1975 - David J. Jr and Bonnie Elliott). [Additional Reference(s): DWR Levee Log, 2005 (HLM 1.13). USACE Sacramento O&M Manual, Unit 111, May 1959, Revised 29 December 2016, (RM 35.47), listed as 8-inch pipe]. FS Date: 5/27/2020 9:09:23 AM

Land-Side: Soil and debris inside of CMP riser

Water-Side: 8'x3'x3' excavation between pump house and levee slope to expose pipe

Water-Side: View inside of pump house

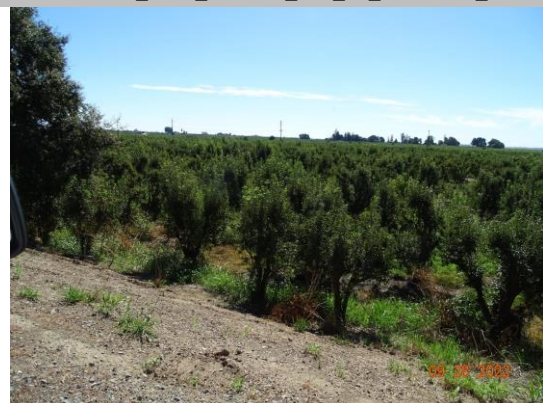
Photo 1 of 1 : SP\_2023\_RD0755\_177\_32\_20230206\_00007.jpg

LM Start	1.18	Rating **	M	Issue No.	32
LM End	1.43	Issue Type +	En	Location *	LS
Category	Earthen Levee			GPS Latitude/Longitude	
				Start	End
Item	Encroachments			38.343133°	38.341108°
				-121.556565°	-121.560220°
DWR ID	DWR_RD0755_01_s_2019_32				
Comment Code					
CR : Crops					
Inspector Comment					
Orchard trees are on the landside slope.

View of the orchard along the LS toe (Fall 2022).

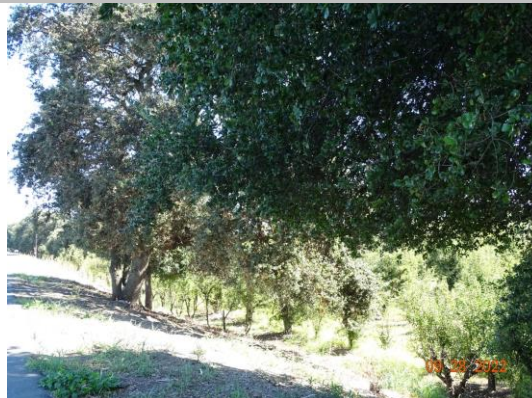
Photo 1 of 1 : SP\_2023\_RD0755\_177\_33\_20230206\_00008.jpg

LM Start	1.58	Rating **	M	Issue No.	33
LM End	1.72	Issue Type +	En	Location *	LS
Category	Earthen Levee			GPS Latitude/Longitude	
				Start	End
Item	Encroachments			38.339360°	38.337767°
				-121.561855°	-121.563602°
DWR ID	DWR_RD0755_01_s_2019_33				
Comment Code					
CR : Crops					
Inspector Comment					
Pear trees are on the landside slope.

View of the trees along the LS toe (Fall 2022).

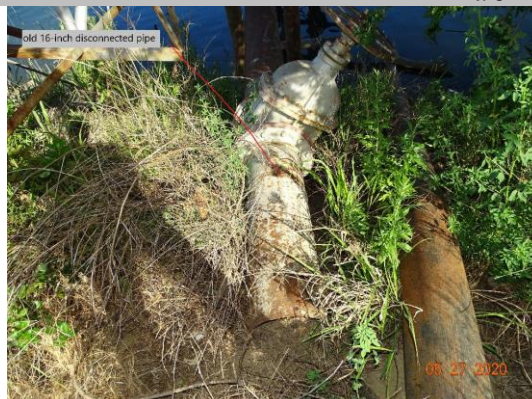
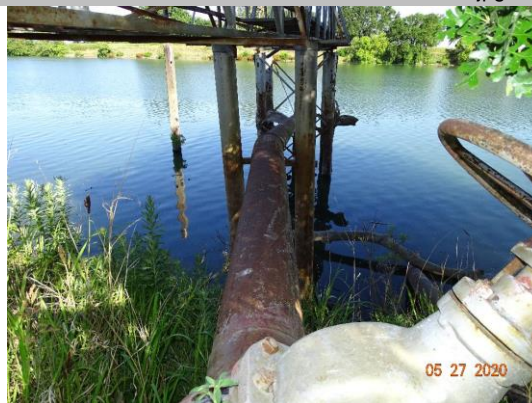
DS\_ID:18858  
FS\_ID:57084  
EP\_NO: 11219  
Repair Type: Non-Urgent  
EVAL Issue: 10, Unauthorized Modification or Non-Compliant Permit  
Crossing Status: Found  
UCIP Comments: 05/27/2020 Record remains Non-Urgent. 14-inch supply pipe segment on waterside cut off between closure device and levee shoulder and replaced with 12-inch pipe from WS shoulder to riverbank. Pump house with a pump at LS toe was built. 8-inch pipe daylights in this pump house. Pump on pile structure in the river and walkway to the pump have been abandoned. 2-inch electrical conduit through the levee has open end with no wires on LS shoulder - should be abandoned properly. Need to have CVFPB review ABO and determine current owner. (O.Yakimov - DWR UCIP)  
08/06/2013 Pump and walkway seem abandoned.- Power line is not connected with pump.- A pump house like structure found on LS levee toe.  
FIELD\_STRUCT\_DESC: 14-inch irrigation discharge pipe of an unknown material through the levee, invert elevation 8.5 feet below the crown. Pump house at landside levee toe. Siphon breaker and power pole on the landside (LS) slope. 2-inch electrical conduit through the levee at the same location. Pump on pile structure in the river and walkway to the pump have been abandoned. (14-inch pipe [HLM 1.65] authorized under Automatic Board Order (ABO) issued as Permit No. 11219, 1975 - David J. Jr and Bonnie Elliott). [Additional Reference(s): DWR Levee Log, 2005 (HLM 1.65). USACE Sacramento O&M Manual, Unit 111, May 1959, Revised 29 December 2016, (RM35.02), 14-inch pipe referenced in RD0551. USACE As-Built Drawing No. 50-4-2983, Sheet 11, page 15, March 1954. USACE As-Built Drawing No. 06-13-1100, Sheet 12, near 'L' 1283+75, January 1933].

Water-Side: View of levee slope looking from crown. Abandoned pipe on waterside

Water-Side: 16-inch supply pipe has been cut off between levee slope and shut off device

Water-Side: Abandoned 16-inch supply pipe under walkway and pumping pier on riverbank

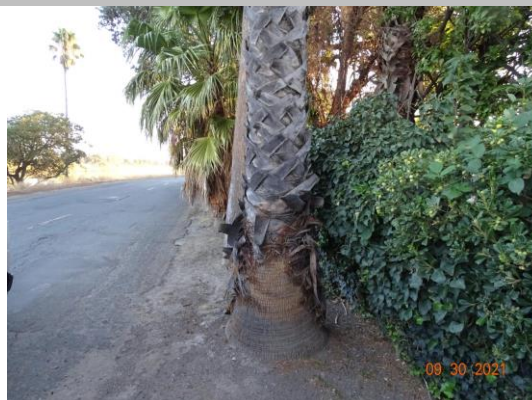
Photo 1 of 1 : SP\_2023\_RD0755\_177\_25\_20230206\_00006.jpg

LM Start	1.73	Rating **	U	Issue No.	25
LM End	1.84	Issue Type +	En	Location *	LS
Category	Earthen Levee			GPS Latitude/Longitude	
				Start	End
Item	Vegetation			38.337688°	38.336437°
				-121.563738°	-121.564800°
DWR ID	DWR_RD0755_01_f_2017_25				
Comment Code					
V6 : Landscaping					
Inspector Comment					
Landscaping on the landside should be maintained to allow inspection and access to levee slope and toe.

View looking upstream at landscaping on the landside slope (Fall 2021).
