**Flood Control Project Maintenance  
Levee Inspections**

**Maintenance Issue Types Only, Levee Inspection Report By Mile - Fall 2014**

**Reclamation District No. 0755 Randall**

Waterway	Bank	Unit Miles	Inspection Start/End	Inspector
Unit No. 01 Sacramento River	Left	1.83	10/29/2014 10/29/2014	Herman Phillips

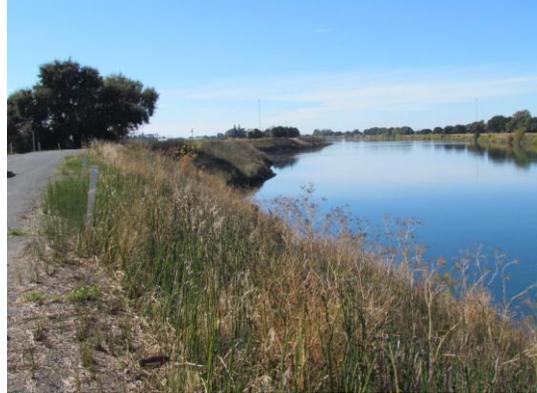
Photo 1 of 1 : FA\_2014\_RD0755\_177\_2\_20141124\_00003.jpg

LM Start	<b>0.18</b>	Rating **	U	Issue No.	<b>2</b>
LM End	<b>0.59</b>	Issue Type +	Ma	Location *	WS
Category	Earthen Levee		GPS Latitude/Longitude		
			Start	End	
Item	Vegetation		38.346768 °	38.345555 °	
			-121.538667 °	-121.545965 °	
DWR ID	DWR_RD0755_01_f_2014_2				
Action/Comments					
Control annual grass and weeds on the levee slopes and easements. Inspector Comments: Control the wild growth on the waterside levee slope.

Looking downstream from levee mile 0.18 along the waterside at unwanted tall weeds blocking the view of the waterside slope.

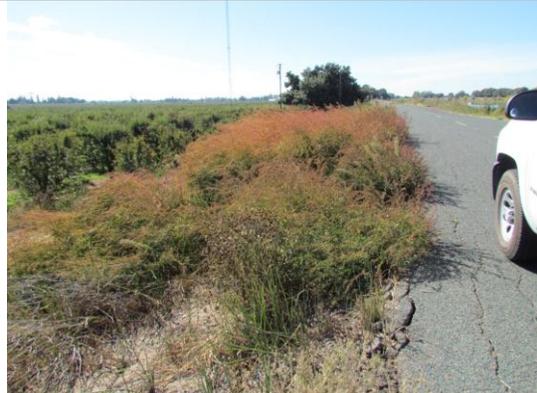
Photo 1 of 1 : FA\_2014\_RD0755\_177\_11\_20141124\_00002.jpg

LM Start	<b>0.64</b>	Rating **	U	Issue No.	<b>11</b>
LM End	<b>0.92</b>	Issue Type +	Ma	Location *	LS
Category	Earthen Levee		GPS Latitude/Longitude		
			Start	End	
Item	Vegetation		38.345383 °	38.344197 °	
			-121.546740 °	-121.551710 °	
DWR ID	DWR_RD0755_01_f_2014_11				
Action/Comments					
Control annual grass and weeds on the levee slopes and easements. Inspector Comments: Remove the unwanted tall weeds from the levee section.

Looking downstream from levee mile 0.64 at unwanted tall weeds on the landside levee shoulder and slope.

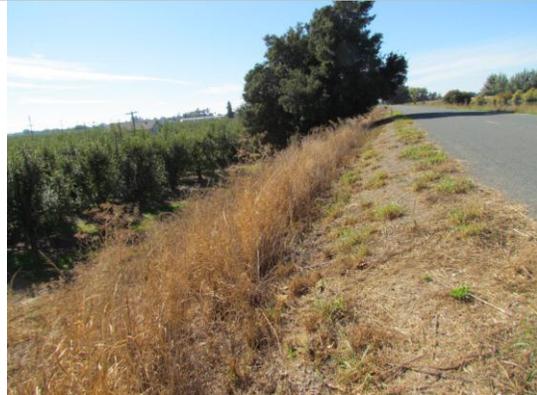
Photo 1 of 1 : FA\_2014\_RD0755\_177\_7\_20141124\_00004.jpg

LM Start	<b>1.14</b>	Rating **	<b>U</b>	Issue No.	<b>7</b>
LM End	<b>1.26</b>	Issue Type +	<b>Ma</b>	Location *	<b>LS</b>
Category	Earthen Levee		GPS Latitude/Longitude		
			Start	End	
Item	Vegetation		38.343302 °	38.342810 °	
			-121.555538 °	-121.557687 °	
DWR ID	DWR_RD0755_01_f_2014_7				
Action/Comments					
Control annual grass and weeds on the levee slopes and easements. Inspector Comments: Remove tall weeds from the landside levee slope.

Tall weeds on slope and toe landside.
