**Flood Control Project Maintenance
Levee Inspections**

Maintenance Issue Types Only, Levee Inspection Report By Mile - Fall 2015

Reclamation District No. 0755 Randall

Waterway	Bank	Unit Miles	Inspection Start/End	Inspector
Unit No. 01 Sacramento River	Left	1.83	10/14/2015 10/14/2015	Herman Phillips

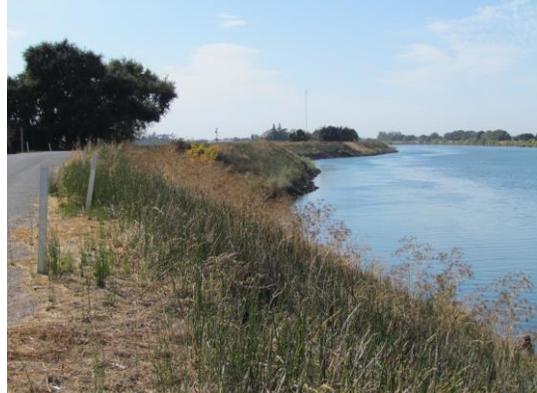
Photo 1 of 1 : FA_2015_RD0755_177_9_20151014_00006.jpg

LM Start	0.17	Rating **	U	Issue No.	9
LM End	1.82	Issue Type +	Ma	Location *	WS
Category	Earthen Levee		GPS Latitude/Longitude		
			Start	End	
Item	Vegetation		38.346752 °	38.336687 °	
			-121.538672 °	-121.564615 °	
DWR ID	DWR_RD0755_01_f_2015_9				
Action/Comments					
Control annual grass and weeds on the levee slopes and easements. Inspector Comments: Remove the unsatisfactory tall weeds from the waterside levee slope.

RD 755 Waterside levee mile 0.17-1.82 levee slope covered with tall weeds such as sweet anise, snap grass and other unsatisfactory weed growth.

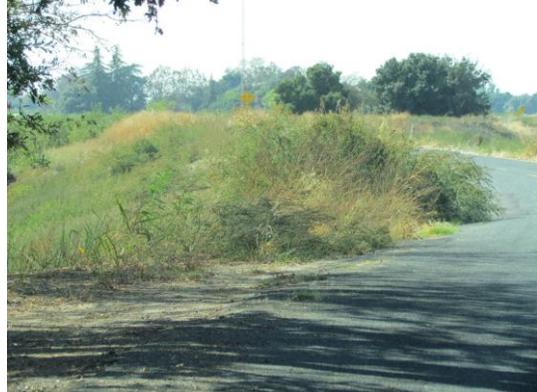
Photo 1 of 1 : FA_2015_RD0755_177_11_20151014_00007.jpg

LM Start	0.26	Rating **	U	Issue No.	11
LM End	0.86	Issue Type +	Ma	Location *	LS
Category	Earthen Levee		GPS Latitude/Longitude		
			Start	End	
Item	Vegetation		38.346322 °	38.344352 °	
			-121.540168 °	-121.551018 °	
DWR ID	DWR_RD0755_01_f_2015_11				
Action/Comments					
Control annual grass and weeds on the levee slopes and easements. Inspector Comments: Remove the tall weeds from the landside levee slope and toe.

Looking downstream landside levee mile 0.26-0.86 slope covered with tall weeds.

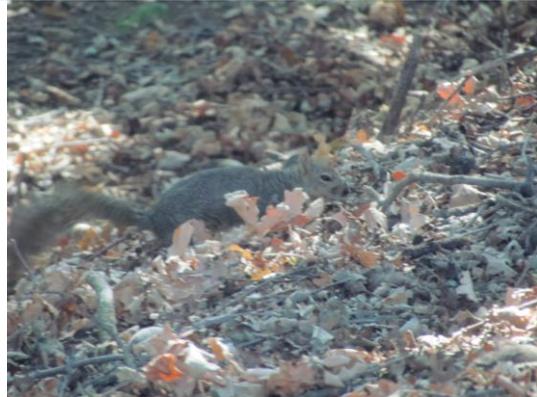
Photo 1 of 1 : FA_2015_RD0755_177_4_20151014_00008.jpg

LM Start	0.43	Rating **	M	Issue No.	4
LM End	1.77	Issue Type +	Ma	Location *	LS
Category	Earthen Levee		GPS Latitude/Longitude		
			Start	End	
Item	Animal Control		38.345593 °	38.337197 °	
			-121.543263 °	-121.564147 °	
DWR ID	DWR_RD0755_01_f_2014_4				
Action/Comments					
Exterminate rodents and backfill and compact or grout burrows. Inspector Comments: There are bait station along the landside levee slope rodents are very active in this location near the walnut trees.

One of many active rodent observed during this inspection.

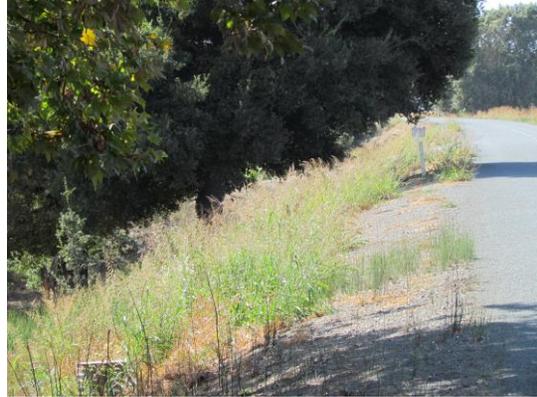
Photo 1 of 1 : FA_2015_RD0755_177_17_20151014_00009.jpg

LM Start	1.11	Rating **	U	Issue No.	17
LM End	1.42	Issue Type +	Ma	Location *	LS
Category	Earthen Levee		GPS Latitude/Longitude		
			Start	End	
Item	Vegetation		38.343300 °	38.341243 °	
			-121.555373 °	-121.560098 °	
DWR ID	DWR_RD0755_01_f_2015_17				
Action/Comments					
Control annual grass and weeds on the levee slopes and easements. Inspector Comments: Remove the tall weeds from the levee slope.

Unsatisfactory tall weed growth on the landside levee slope.

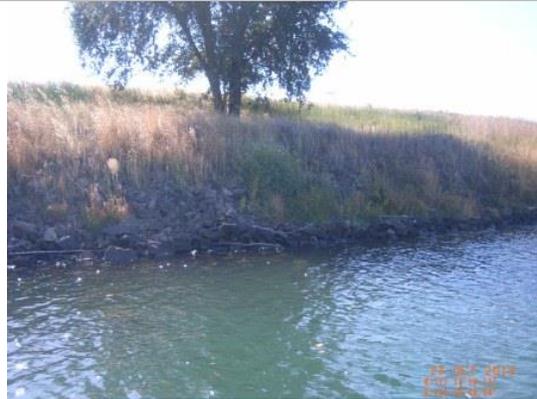
Photo 1 of 1 : USACE2013A_SAC_35-4_L_7.jpg

LM Start	1.24	Rating **	M	Issue No.	1
LM End	1.32	Issue Type +	Ma	Location *	WS
Category	Supplemental		GPS Latitude/Longitude		
			Start	End	
Item	2015 USACE Erosion Survey, DRAFT		38.343071 °	38.342426 °	
			-121.557706 °	-121.559163 °	
DWR ID					
Action/Comments					
Inspector Comments: 2003 - Toe and lower slope eroding, rock in water and a few pieces on the slope; rock at upstream and downstream ends. 2005 - Looks a little worse. Two major holes with vertical banks and smaller intermittent pockets in between. Stone is present upstream, downstream, and at toe. 2008 - Repaired at both ends (50 ft of new stone) but middle remains unrepaired. 2011 - Site extended downstream to include new scour. 2013 - At the downstream end, behind tree, there is a new animal burrow. Tree has exposed roots. 2015: New rock placed at toe in middle of site, hole remains behind the tree. [2015 Site ID: SAC_35-4_L]
