**Flood Control Project Maintenance
Levee Inspections**

Maintenance Issue Types Only, Levee Inspection Report By Mile - Spring 2015

Reclamation District No. 0755 Randall

Waterway	Bank	Unit Miles	Inspection Start/End	Inspector
Unit No. 01 Sacramento River	Left	1.83	04/16/2015 04/16/2015	Herman Phillips

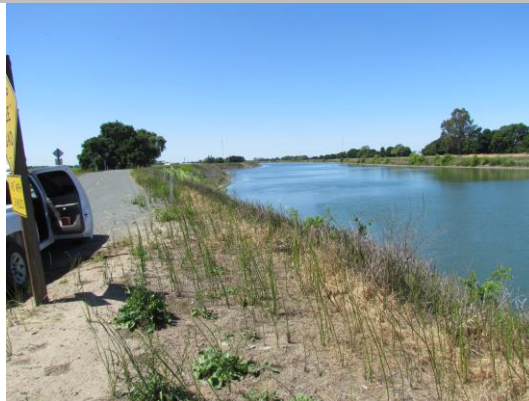
Photo 1 of 1 : SP_2015_RD0755_177_2_20150601_00011.jpg

LM Start	0.17	Rating **	U	Issue No.	2
LM End	0.62	Issue Type +	Ma	Location *	WS
Category	Earthen Levee			GPS Latitude/Longitude	
				Start	End
Item	Vegetation			38.346768 °	38.345415 °
				-121.538667 °	-121.546663 °
DWR ID	DWR_RD0755_01_f_2014_2				
Action/Comments					
Control annual grass and weeds on the levee slopes and easements. Inspector Comments: Control the wild growth on the waterside levee slope.

Looking downstream along the waterside shoulder at tall snap grass and other weeds on the slope.

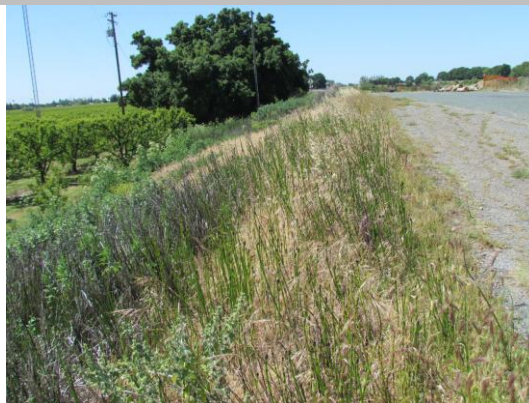
Photo 1 of 1 : SP_2015_RD0755_177_11_20150601_00012.jpg

LM Start	0.62	Rating **	U	Issue No.	11
LM End	0.90	Issue Type +	Ma	Location *	LS
Category	Earthen Levee			GPS Latitude/Longitude	
				Start	End
Item	Vegetation			38.345383 °	38.344197 °
				-121.546740 °	-121.551710 °
DWR ID	DWR_RD0755_01_f_2014_11				
Action/Comments					
Control annual grass and weeds on the levee slopes and easements. Inspector Comments: Remove the unwanted tall weeds from the levee section.

Looking downstream at tall weeds on the landside levee shoulder and slope.

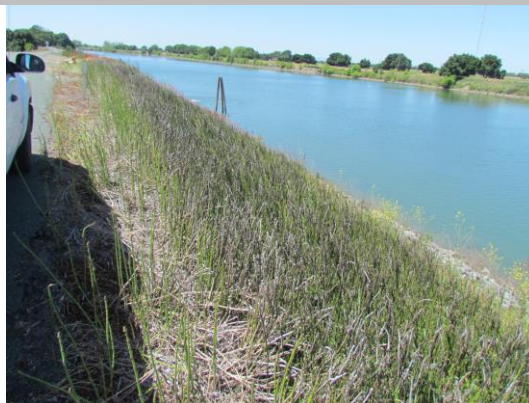
Photo 1 of 1 : SP_2015_RD0755_177_22_20150601_00010.jpg

LM Start	0.64	Rating **	U	Issue No.	22
LM End	0.87	Issue Type +	Ma	Location *	WS
Category	Earthen Levee			GPS Latitude/Longitude	
				Start	End
Item	Vegetation			38.345315 °	38.344330 °
				-121.547092 °	-121.551032 °
DWR ID	DWR_RD0755_01_s_2015_22				
Action/Comments					
Control annual grass and weeds on the levee slopes and easements. Inspector Comments: Snap grasses on waterward levee section unacceptable growth.

Looking downstream at tall snap grasses covering the waterward levee slope.

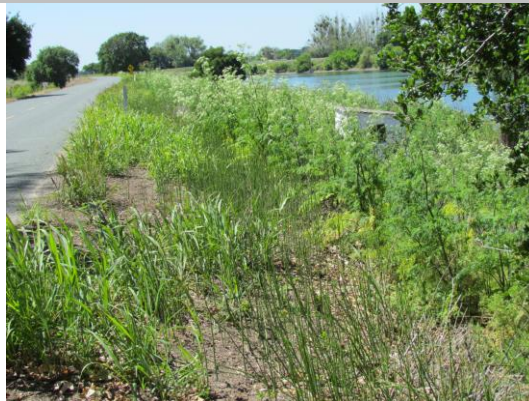
Photo 1 of 1 : SP_2015_RD0755_177_25_20150601_00009.jpg

LM Start	1.11	Rating **	U	Issue No.	25
LM End	1.57	Issue Type +	Ma	Location *	WS
Category	Earthen Levee			GPS Latitude/Longitude	
				Start	End
Item	Vegetation			38.343418 °	38.339530 °
				-121.555315 °	-121.561800 °
DWR ID	DWR_RD0755_01_s_2015_25				
Action/Comments					
Control annual grass and weeds on the levee slopes and easements. Inspector Comments: Control the wild growth on the waterside levee slope.

Looking downstream from the waterside shoulder at unacceptable tall weeds covering the waterward slope.
