**Flood Control Project Maintenance
Levee Inspections**

Maintenance Issue Types Only, Levee Inspection Report By Mile - Spring 2016

Reclamation District No. 0755 Randall

Waterway	Bank	Unit Miles	Inspection Start/End	Inspector
Unit No. 01 Sacramento River	Left	1.83	03/17/2016 03/17/2016	Herman Phillips

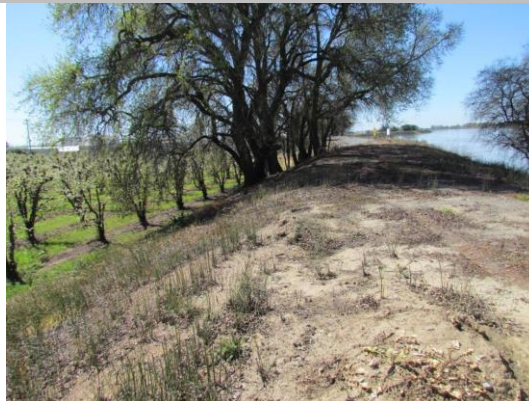
Photo 1 of 1 : SP_2016_RD0755_177_19_20160321_00024.jpg

LM Start	0.11	Rating **	A	Issue No.	19
LM End	0.19	Issue Type +	Ma	Location *	LS
Category	Earthen Levee			GPS Latitude/Longitude	
				Start	End
Item	Vegetation			38.347080 °	38.346577 °
				-121.537630 °	-121.539075 °
DWR ID	DWR_RD0755_01_s_2016_19				
Comment Code					
V1 : Control annual grass and weeds on the levee slopes and easements.					
Inspector Comment					
Looking downstream st the landside slope form levee mile 0.11 the slope has been sprayed at this location.

Looking downstream from levee mile 0.11 landside slope.

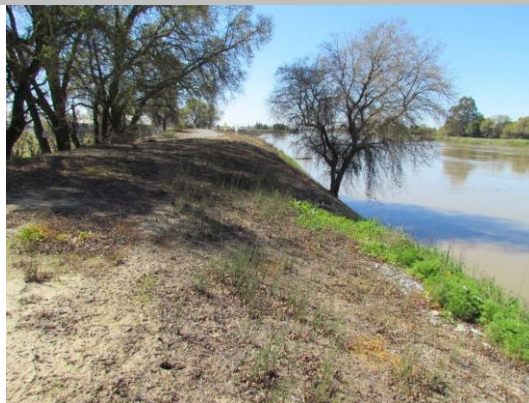
Photo 1 of 1 : SP_2016_RD0755_177_38_20160321_00025.jpg

LM Start	0.11	Rating **	A	Issue No.	38
LM End	0.17	Issue Type +	Ma	Location *	WS
Category	Earthen Levee			GPS Latitude/Longitude	
				Start	End
Item	Vegetation			38.347080 °	38.346745 °
				-121.537630 °	-121.538750 °
DWR ID	DWR_RD0755_01_s_2016_38				
Comment Code					
V1 : Control annual grass and weeds on the levee slopes and easements.					
Inspector Comment					
This section along the waterside appears to have been sprayed.

Looking downstream from levee mile 0.11 waterside slope to levee mile 0.17.

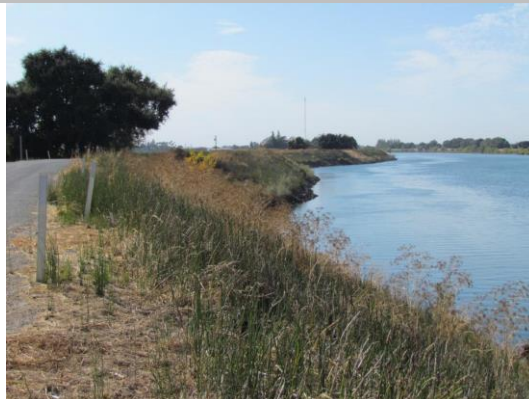
Photo 1 of 1 : SP_2016_RD0755_177_9_20160223_00003.jpg

LM Start	0.17	Rating **	U	Issue No.	9
LM End	1.82	Issue Type +	Ma	Location *	WS
Category	Earthen Levee			GPS Latitude/Longitude	
				Start	End
Item	Vegetation			38.346752 °	38.336687 °
				-121.538672 °	-121.564615 °
DWR ID	DWR_RD0755_01_f_2015_9				
Comment Code					
V1 : Control annual grass and weeds on the levee slopes and easements.					
Inspector Comment					
Remove the unsatisfactory tall weeds from the waterside levee slope.

RD 755 Waterside levee mile 0.17-1.82 levee slope covered with tall weeds such as sweet anise, snap grass and other unsatisfactory weed growth.

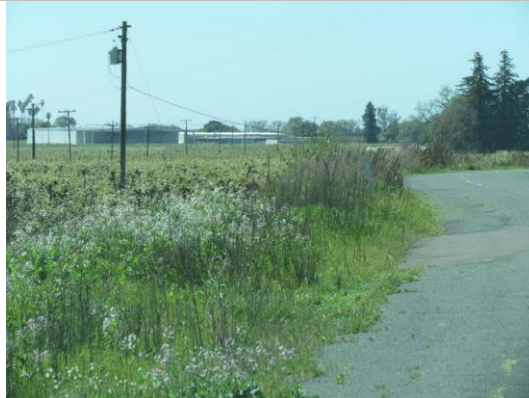
Photo 1 of 1 : SP_2016_RD0755_177_24_20160321_00026.jpg

LM Start	0.25	Rating **	U	Issue No.	24
LM End	0.51	Issue Type +	Ma	Location *	LS
Category	Earthen Levee			GPS Latitude/Longitude	
				Start	End
Item	Vegetation			38.346262 °	38.345668 °
				-121.540047 °	-121.544744 °
DWR ID	DWR_RD0755_01_s_2016_24				
Comment Code					
V1 : Control annual grass and weeds on the levee slopes and easements.					
Inspector Comment					
Tall weed growth on the landside shoulder and slope need spraying.

Looking at tall weeds along the landside levee shoulder and slope.

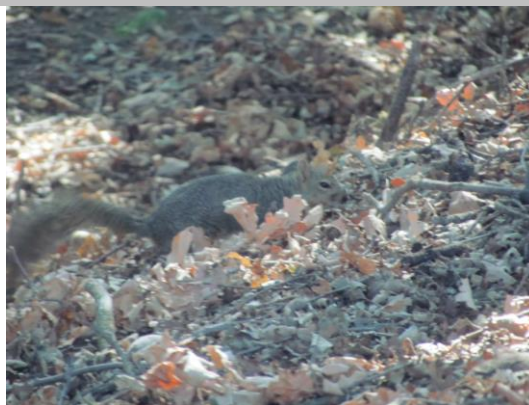
Photo 1 of 1 : SP_2016_RD0755_177_4_20160223_00002.jpg

LM Start	0.43	Rating **	M	Issue No.	4
LM End	1.77	Issue Type +	Ma	Location *	LS
Category	Earthen Levee			GPS Latitude/Longitude	
				Start	End
Item	Animal Control			38.345593 °	38.337197 °
				-121.543263 °	-121.564147 °
DWR ID	DWR_RD0755_01_f_2014_4				
Comment Code					
A1 : Exterminate rodents and backfill and compact or grout burrows.					
Inspector Comment					
There are bait station along the landside levee slope rodents are very active in this location near the walnut trees.

One of many active rodent observed during this inspection.

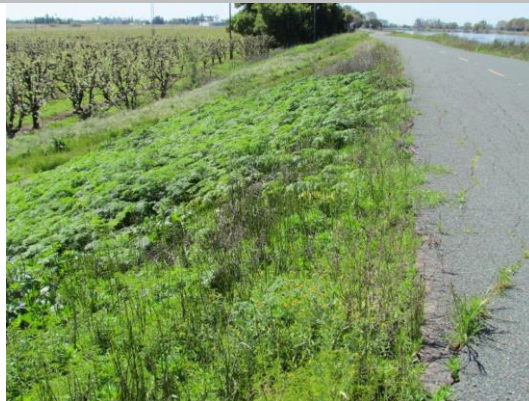
Photo 1 of 1 : SP_2016_RD0755_177_27_20160321_00027.jpg

LM Start	0.71	Rating **	U	Issue No.	27
LM End	0.86	Issue Type +	Ma	Location *	LS
Category	Earthen Levee			GPS Latitude/Longitude	
				Start	End
Item	Vegetation			38.345032 °	38.344352 °
				-121.548230 °	-121.551020 °
DWR ID	DWR_RD0755_01_s_2016_27				
Comment Code					
V2 : Remove the wild growth other than native grasses from the levee slopes.					
Inspector Comment					
Remove the tall weeds from the landside levee slope.

Tall weed present on shoulder and slope taller than 15".

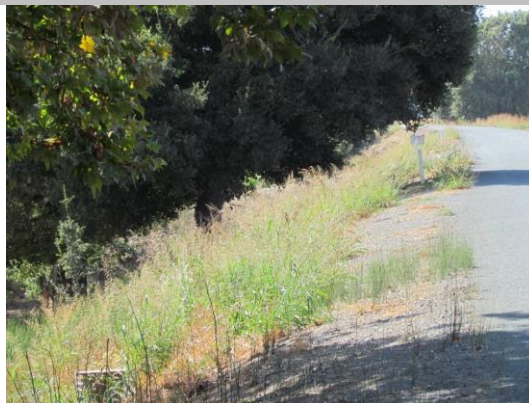
Photo 1 of 1 : SP_2016_RD0755_177_17_20160223_00005.jpg

LM Start	1.11	Rating **	U	Issue No.	17
LM End	1.40	Issue Type +	Ma	Location *	LS
Category	Earthen Levee			GPS Latitude/Longitude	
				Start	End
Item	Vegetation			38.343300 °	38.341460 °
				-121.555373 °	-121.559880 °
DWR ID	DWR_RD0755_01_f_2015_17				
Comment Code					
V1 : Control annual grass and weeds on the levee slopes and easements.					
Inspector Comment					
Remove the tall weeds from the levee slope.

Unsatisfactory tall weed growth on the landside levee slope.

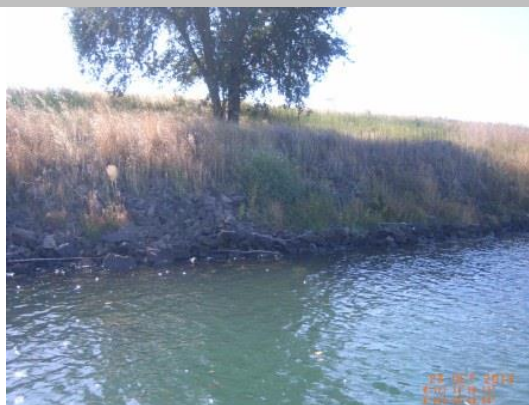
Photo 1 of 1 : SP_2016_RD0755_177_1_20160223_00001.jpg

LM Start	1.24	Rating **	M	Issue No.	1
LM End	1.32	Issue Type +	Ma	Location *	WS
Category	Supplemental			GPS Latitude/Longitude	
				Start	End
Item	2015 USACE Erosion Survey, DRAFT			38.343071 °	38.342426 °
				-121.557706 °	-121.559163 °
DWR ID	DWR_RD0755_01_s_2016_1

Comment Code					
Inspector Comment					
2003 - Toe and lower slope eroding, rock in water and a few pieces on the slope; rock at upstream and downstream ends. 2005 - Looks a little worse. Two major holes with vertical banks and smaller intermittent pockets in between. Stone is present upstream, downstream, and at toe. 2008 - Repaired at both ends (50 ft of new stone) but middle remains unrepaired. 2011 - Site extended downstream to include new scour. 2013 - At the downstream end, behind tree, there is a new animal burrow. Tree has exposed roots. 2015: New rock placed at toe in middle of site, hole remains behind the tree. [2015 Site ID: SAC_35-4_L]

USACE 2013 Photo #1

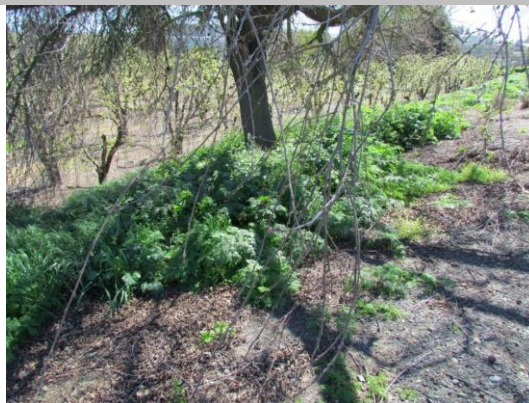
Photo 1 of 1 : SP_2016_RD0755_177_35_20160321_00028.jpg

LM Start	1.42	Rating **	U	Issue No.	35
LM End	1.44	Issue Type +	Ma	Location *	LS
Category	Earthen Levee			GPS Latitude/Longitude	
				Start	End
Item	Vegetation			38.341243 °	38.341012 °
				-121.560100 °	-121.560313 °
DWR ID	DWR_RD0755_01_s _ 2016_35				
Comment Code					
V2 : Remove the wild growth other than native grasses from the levee slopes.					
Inspector Comment					
Spray the tall weeds on the landside slope.

Tall weeds on the landside slope and shoulder.
