**Flood Control Project Maintenance  
Levee Inspections**

## Maintenance Issue Types Only, Levee Inspection Report By Mile - Spring 2017

### Reclamation District No. 0755 Randall

Waterway	Bank	Unit Miles	Inspection Start/End	Inspector
Unit No. 01 Sacramento River	Left	1.83	04/06/2017 04/06/2017	Herman Phillips

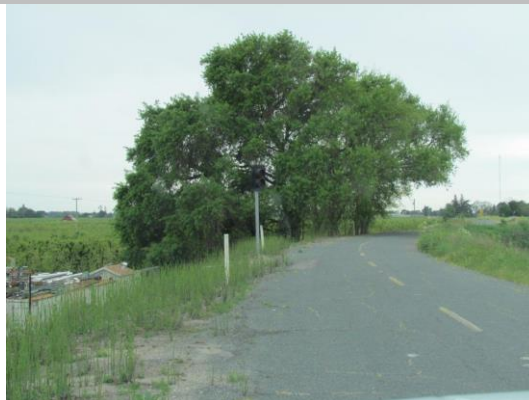
Photo 1 of 1 : SP\_2017\_RD0755\_177\_20\_20170410\_00032.jpg

LM Start	0.17	Rating **	A/W	Issue No.	20
LM End	0.59	Issue Type +	Ma	Location *	LS
Category	Earthen Levee		GPS Latitude/Longitude		
			Start	End	
Item	Vegetation		38.346757 °	38.345423 °	
			-121.538675 °	-121.546223 °	
DWR ID	DWR_RD0755_01_f_2016_20				
Comment Code					
V2 : Remove the wild growth other than native grasses from the levee slopes.					
Inspector Comment					
The vegetation complies with standards but should be monitored.

RD 755 looking downstream from levee mile 0.17-0.59.

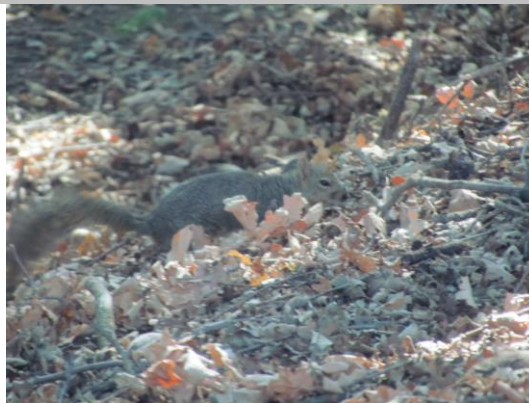
Photo 1 of 1 : SP\_2017\_RD0755\_177\_4\_20170404\_00002.jpg

LM Start	0.43	Rating **	M	Issue No.	4
LM End	1.77	Issue Type +	Ma	Location *	LS
Category	Earthen Levee			GPS Latitude/Longitude	
				Start	End
Item	Animal Control			38.345593 °	38.337197 °
				-121.543263 °	-121.564147 °
DWR ID	DWR_RD0755_01_f_2014_4				
Comment Code					
A1 : Exterminate rodents and backfill and compact or grout burrows.					
Inspector Comment					
There are bait stations along the landside levee slope; rodents are very active in this location near the walnut trees.

One of many active rodent observed during this inspection.

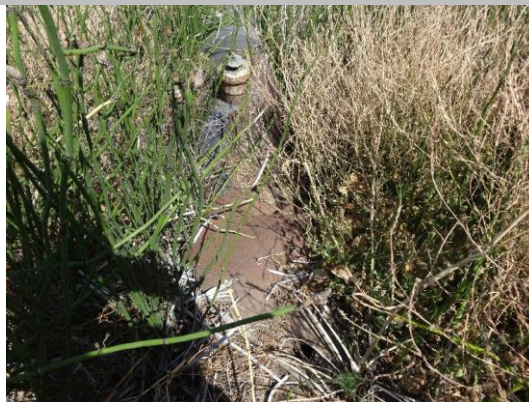
Photo 1 of 3 : UCIP\_SP\_2017\_17145\_29292.jpg

LM Start	0.70	Rating **	A/W	Issue No.	32
LM End	0.70	Issue Type +	Ma	Location *	LS
Category	Supplemental			GPS Latitude/Longitude	
				Start	End
Item	DWR UCIP LMA Responsibility			38.345057 °	38.345057 °
				-121.548050 °	-121.548050 °
DWR ID					
Comment Code					
Inspector Comment					
FS_ID:17145 DS_ID:18852 EP_NO: 11222 Repair Type: No Action Needed Crossing Status: Found UCIP Comments: It was working during field survey. A pump found 150 ft from the levee. Not sure whether the pump belong to this drainage system. FIELD_STRUCT_DESC: 16-inch steel drainpipe sleeved through a 24-inch steel pipe through levee, 8.0 feet below crown. (ABO No. 11222-Green McKeown, Inc.). O&M Manual Sac 111, May 1959, Revision Year 2011. FS Date: 8/6/2013

WS view: pipe and siphon breaker on levee slope

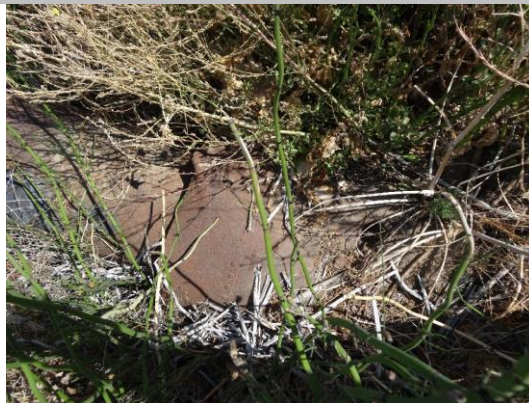
Photo 2 of 3 : UCIP\_SP\_2017\_17145\_29293.jpg

LM Start	0.70	Rating **	A/W	Issue No.	32 (cont)
LM End	0.70	Issue Type +	Ma	Location *	LS
Category	Supplemental			GPS Latitude/Longitude	
				Start	End
Item	DWR UCIP LMA Responsibility			38.345057 °	38.345057 °
				-121.548050 °	-121.548050 °
DWR ID					
Comment Code					
Inspector Comment					
FS_ID:17145 DS_ID:18852 EP_NO: 11222 Repair Type: No Action Needed Crossing Status: Found UCIP Comments: It was working during field survey. A pump found 150 ft from the levee. Not sure whether the pump belong to this drainage system. FIELD_STRUCT_DESC: 16-inch steel drainpipe sleeved through a 24-inch steel pipe through levee, 8.0 feet below crown. (ABO No. 11222-Green McKeown, Inc.). O&M Manual Sac 111, May 1959, Revision Year 2011. FS Date: 8/6/2013

WS view: 16-inch pipe sleeved through 24-inch pipe.

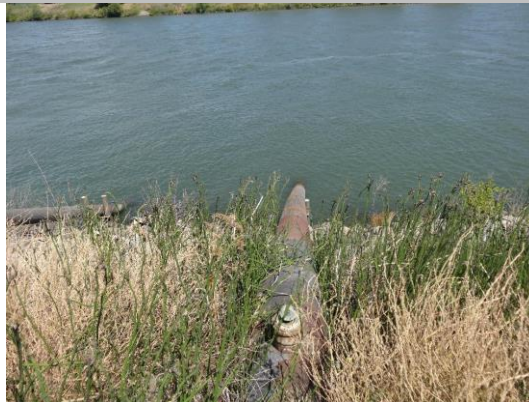
Photo 3 of 3 : UCIP\_SP\_2017\_17145\_29295.jpg

WS view: 16-inch drainage pipe on levee slope.

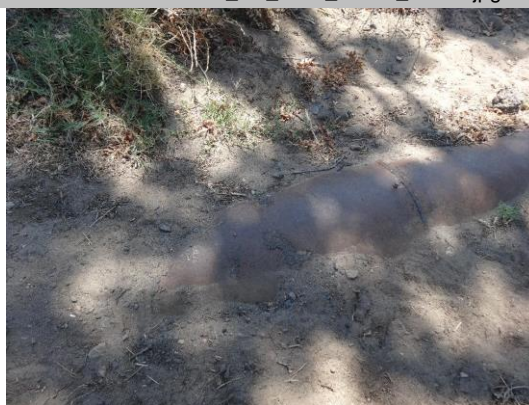
Photo 2 of 3 : UCIP\_SP\_2017\_17049\_29121.jpg

LS view: 18-inch abandoned pipe on levee slope

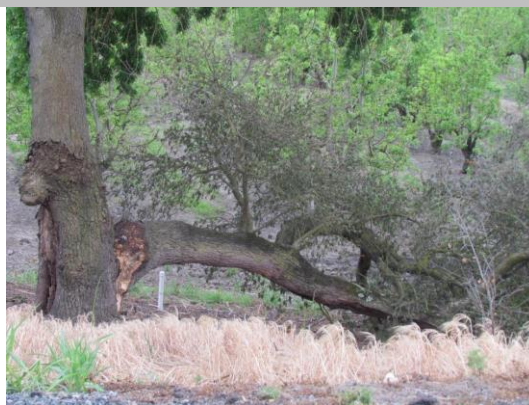
Photo 1 of 1 : SP\_2017\_RD0755\_177\_17\_20170410\_00033.jpg

LM Start	0.70	Rating **	U	Issue No.	17
LM End	0.70	Issue Type +	Ma	Location *	LS
Category	Earthen Levee			GPS Latitude/Longitude	
				Start	End
Item	Encroachments			38.345047 °	38.345047 °
				-121.548175 °	-121.548175 °
DWR ID	DWR_RD0755_01_s_2017_17				
Comment Code					
TR : Tree or limb					
Inspector Comment					
Cut up the broken tree branch and remove from levee section.

Broken tree limb on he landside levee slope and toe levee mile 0.70.

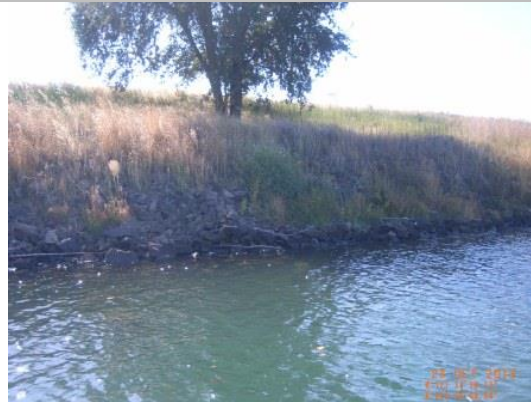
Photo 1 of 1 : SP\_2017\_RD0755\_177\_1\_20170404\_00001.jpg

LM Start	1.24	Rating **	M	Issue No.	1
LM End	1.32	Issue Type +	Ma	Location *	WS
Category	Supplemental			GPS Latitude/Longitude	
				Start	End
Item	2015 USACE Erosion Survey, DRAFT			38.343071 °	38.342426 °
				-121.557706 °	-121.559163 °
DWR ID	DWR_RD0755_01_f_2016_1

Comment Code					
Inspector Comment					
2003 - Toe and lower slope eroding, rock in water and a few pieces on the slope; rock at upstream and downstream ends. 2005 - Looks a little worse. Two major holes with vertical banks and smaller intermittent pockets in between. Stone is present upstream, downstream, and at toe. 2008 - Repaired at both ends (50 ft of new stone) but middle remains unrepaired. 2011 - Site extended downstream to include new scour. 2013 - At the downstream end, behind tree, there is a new animal burrow. Tree has exposed roots. 2015: New rock placed at toe in middle of site, hole remains behind the tree. [2015 Site ID: SAC_35-4_L]

USACE 2013 Photo #1
