**Flood Control Project Maintenance  
Levee Inspections**

## Maintenance Issue Types Only, Levee Inspection Report By Mile - Spring 2018

### Reclamation District No. 0755 Randall

Waterway	Bank	Unit Miles	Inspection Start/End	Inspector
Unit No. 01 Sacramento River	Left	1.83	03/21/2018 03/21/2018	Keith Millard

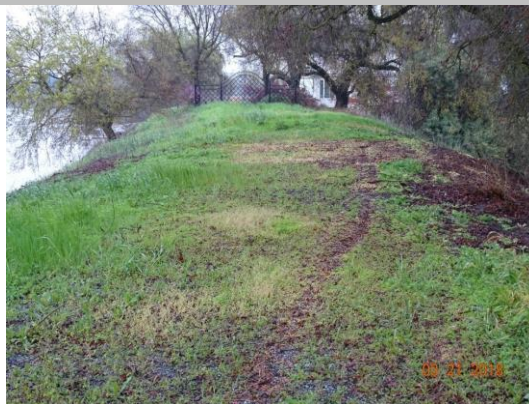
Photo 1 of 1 : SP\_2018\_RD0755\_177\_11\_20180321\_00047.jpg

LM Start	0.00	Rating **	M	Issue No.	11
LM End	0.17	Issue Type +	Ma	Location *	CR
Category	Earthen Levee			GPS Latitude/Longitude	
				Start	End
Item	Vegetation			38.347123 °	38.346773 °
				-121.537572 °	-121.538687 °
DWR ID	DWR_RD0755_01_s_2017_11				
Comment Code					
V9 : Keep the crown roadway free of vegetation.					
Inspector Comment					
Crown vegetation should be mowed to allow inspection.

Crown vegetation should be reduced.

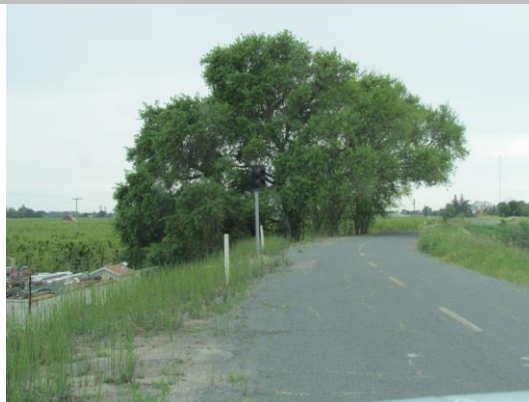
Photo 1 of 1 : SP\_2018\_RD0755\_177\_20\_20180305\_00009.jpg

LM Start	0.17	Rating **	M	Issue No.	20
LM End	1.05	Issue Type +	Ma	Location *	LS
Category	Earthen Levee			GPS Latitude/Longitude	
				Start	End
Item	Vegetation			38.346757 °	38.343581 °
				-121.538675 °	-121.554301 °
DWR ID	DWR_RD0755_01_f_2016_20				
Comment Code					
V2 : Remove the wild growth other than native grasses from the levee slopes.					
Inspector Comment					
The vegetation should be removed/managed to allow inspection of lanside slope and toe.

RD 755 looking downstream from levee mile 0.17-0.59.

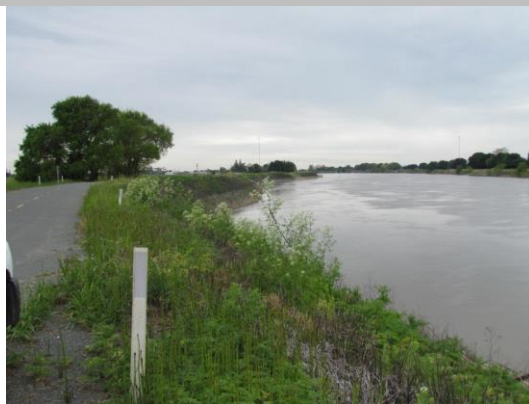
Photo 1 of 1 : SP\_2018\_RD0755\_177\_19\_20180305\_00008.jpg

LM Start	0.17	Rating **	M	Issue No.	19
LM End	1.84	Issue Type +	Ma	Location *	WS
Category	Earthen Levee			GPS Latitude/Longitude	
				Start	End
Item	Vegetation			38.346757 °	38.336409 °
				-121.538675 °	-121.564813 °
DWR ID	DWR_RD0755_01_f_2016_19				
Comment Code					
V2 : Remove the wild growth other than native grasses from the levee slopes.					
Inspector Comment					
The tall weeds on the waterside slope and should be removed/managed to allow inspection. Large cactus (Century Plants) at LM 1.07 should be removed.

RD 755 Levee mile 0.17-1.12 waterside looking downstream.

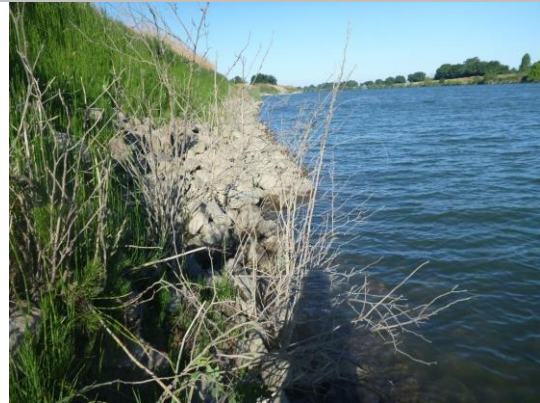
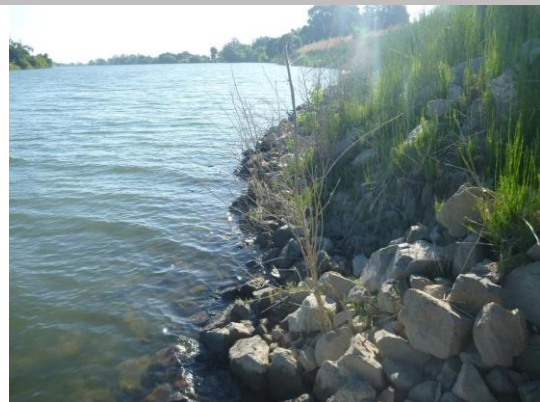
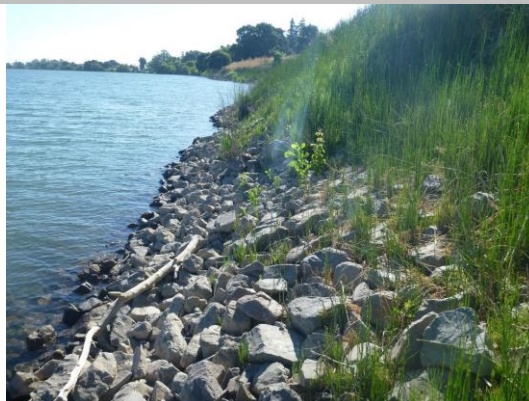
Item	2017 Storm Damage			38.346249 °	38.346331 °
				-121.540542 °	-121.540664 °
DWR ID	DWR_RD0755_01_f_2017_18				
Comment Code					
Inspector Comment					
<p>Levee Evaluation Comments</p> <p>Description: The damage consists of erosion of the lower waterside levee slope and bank approximately 27 feet in length along the east (left) bank of the Sacramento River. See attached pages for photos. Site location T06N R04E Section 28.</p> <p>Site ID No: 327</p> <p>Site Designation: LMA-154</p> <p>Repair Type: Erosion</p> <p>Rating: Area of Concern</p> <p>Field Date: 7/13/2017</p> <p>Notes: Pretty minor damage visible from the slope, site was originally identified by boat. Will look at again from waterside if there is time. Crown is a paved road. Original GPS was a little off, added correct point in start</p>

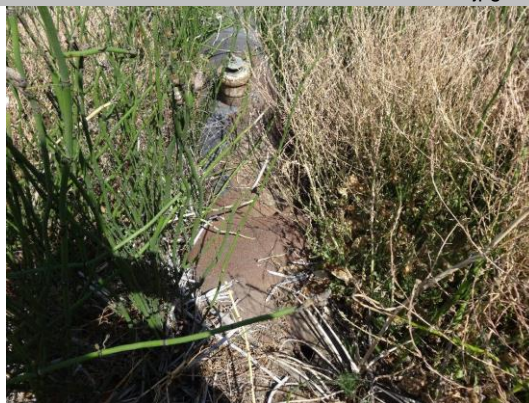
Photo 1 of 3 : UCIP\_SP\_2018\_17145\_29292.jpg

FS\_ID:17145  
DS\_ID:18852  
EP\_NO: 11222  
Repair Type: No Action Needed  
Crossing Status: Found  
UCIP Comments: It was working during field survey. A pump found 150 ft from the levee. Not sure whether the pump belong to this drainage system.  
FIELD\_STRUCT\_DESC: \*ABANDONED\* 16-inch steel drainage pipe sleeved through a 24-inch steel drainage pipe through the levee, invert elevation 8 feet below the crown. (Retention of a 12-inch drainage pipe sleeved through a 24-inch pipe through the levee, 8 feet below the crown, authorized under Automatic Board Order (ABO) issued as Permit No. 11222, 1975 - Green McKeown, Inc). [Additional Reference(s): DWR Levee Log, 2005, 12-inch inner pipe referenced. USACE Sacramento O&M Manual 111, May 1959, (RM 35.89)].  
FS Date: 8/6/2013

WS view: pipe and siphon breaker on levee slope

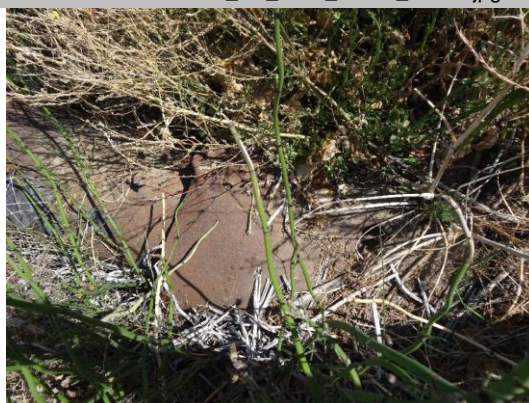
Photo 2 of 3 : UCIP\_SP\_2018\_17145\_29293.jpg

WS view: 16-inch pipe sleeved through 24-inch pipe.

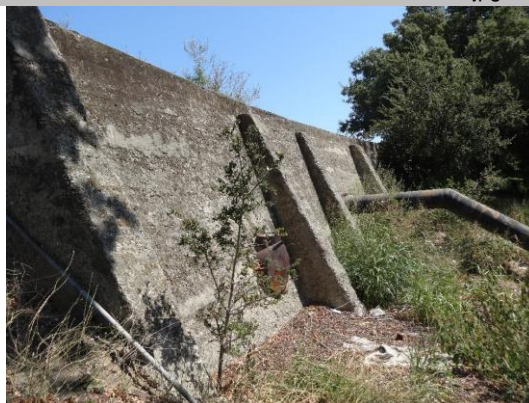
Photo 1 of 3 : UCIP\_SP\_2018\_17049\_29119.jpg

LM Start	0.70	Rating **	M	Issue No.	32	
LM End	0.70	Issue Type +	Ma	Location *		
Category	Supplemental			GPS Latitude/Longitude		
				Start	End	
Item	DWR UCIP LMA Responsibility			38.345036 °	38.345036 °	
				-121.548141 °	-121.548141 °	
DWR ID						
Comment Code						
Inspector Comment						
FS_ID:17049 DS_ID:18854 EP_NO: 1716 Repair Type: Non-Urgent Crossing Status: Found UCIP Comments: Not found- a 4-inch pipe on waterward shoulder but a 2-inch GI pipe found on landside slope. FIELD_STRUCT_DESC: *ABANDONED* 18-inch drainage pipe of an unknown material through the levee, invert elevation 4.5 feet below the crown. (Plans for the replacement of an existing pipe through the levee authorized under Permit No. 1716, 1952 - Reclamation District No. 755 [RD0755]). [Additional Reference(s): DWR Levee Log, 2005. USACE Sacramento O&M Manual 111, May 1959, (RM 35.88)]. FS Date: 8/6/2013

LS view: concrete headwall and 2-inch conduit (left)

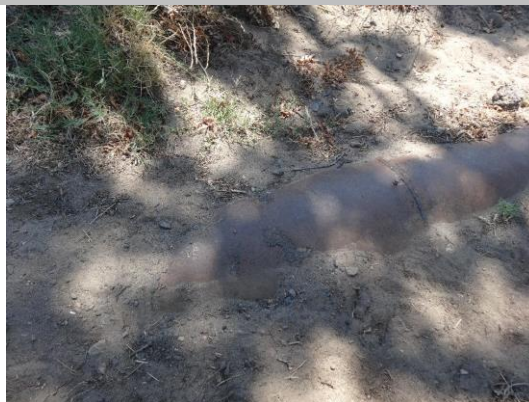
Photo 2 of 3 : UCIP\_SP\_2018\_17049\_29121.jpg

LS view: 18-inch abandoned pipe on levee slope

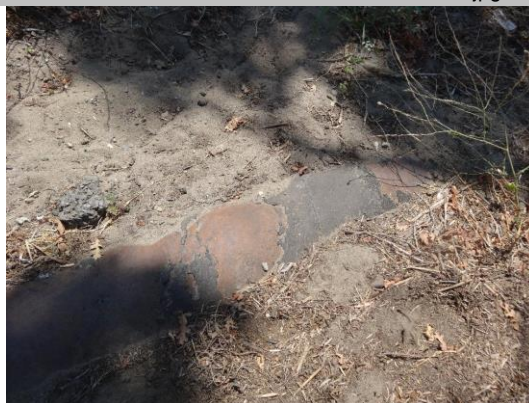
Photo 3 of 3 : UCIP\_SP\_2018\_17049\_29122.jpg

Comment Code						
Inspector Comment						
FS_ID:17049 DS_ID:18854 EP_NO: 1716 Repair Type: Non-Urgent Crossing Status: Found UCIP Comments: Not found- a 4-inch pipe on waterward shoulder but a 2-inch GI pipe found on landside slope. FIELD_STRUCT_DESC: *ABANDONED* 18-inch drainage pipe of an unknown material through the levee, invert elevation 4.5 feet below the crown. (Plans for the replacement of an existing pipe through the levee authorized under Permit No. 1716, 1952 - Reclamation District No. 755 [RD0755]). [Additional Reference(s): DWR Levee Log, 2005. USACE Sacramento O&M Manual 111, May 1959, (RM 35.88)]. FS Date: 8/6/2013

LS view: exposed/daylight 18-inch abandoned pipe on levee slope

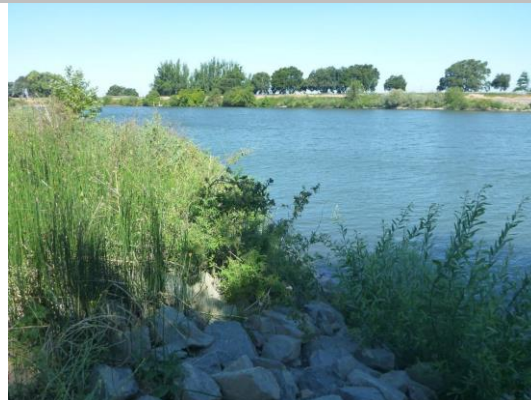
Photo 1 of 3 : SP\_2018\_RD0755\_177\_22\_20180305\_00010.jpg

Comment Code					
Inspector Comment					
<p><b>Levee Evaluation Comments</b>            Description: The damage consists of erosion of the lower waterside levee slope and bank approximately 322 feet in length along the east (left) bank of the Sacramento River. See attached pages for photos.            Site location T06N R04E Section 29.            Site ID No: 328            Site Designation: LMA-155            Repair Type: Erosion            Rating: Area of Concern            Field Date: 7/13/2017            Notes: Could not access most of the lower portion of the slope because of vegetation, but there was rip rap just downstream of the site. Looked like it may have been missing on part of the site. Erosion looked like it may be 1/2 the length reported. Crown is a paved road</p>

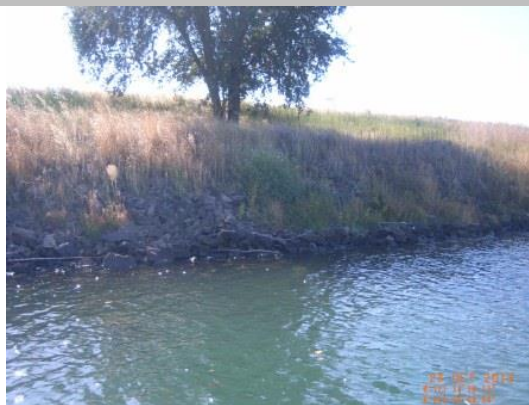
Photo 1 of 1 : SP\_2018\_RD0755\_177\_1\_20180305\_00001.jpg

Comment Code					
Inspector Comment					
2003 - Toe and lower slope eroding, rock in water and a few pieces on the slope; rock at upstream and downstream ends. 2005 - Looks a little worse. Two major holes with vertical banks and smaller intermittent pockets in between. Stone is present upstream, downstream, and at toe. 2008 - Repaired at both ends (50 ft of new stone) but middle remains unrepaired. 2011 - Site extended downstream to include new scour. 2013 - At the downstream end, behind tree, there is a new animal burrow. Tree has exposed roots. 2015: New rock placed at toe in middle of site, hole remains behind the tree. [2015 Site ID: SAC_35-4_L]

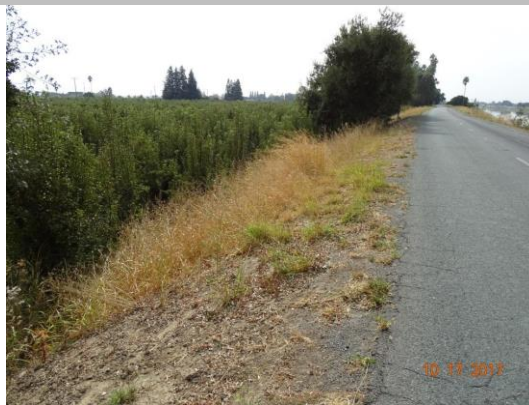
Photo 1 of 1 : SP\_2018\_RD0755\_177\_13\_20180305\_00004.jpg

LM Start	1.59	Rating **	M	Issue No.	13
LM End	1.73	Issue Type +	Ma	Location *	LS
Category	Earthen Levee			GPS Latitude/Longitude	
				Start	End
Item	Vegetation			38.339210 °	38.337755 °
				-121.562058 °	-121.563666 °
DWR ID	DWR_RD0755_01_f_2017_13				
Comment Code					
V2 : Remove the wild growth other than native grasses from the levee slopes.					
Inspector Comment

Vegetation on landside should be maintained to allow inspection and access to slope and toe.

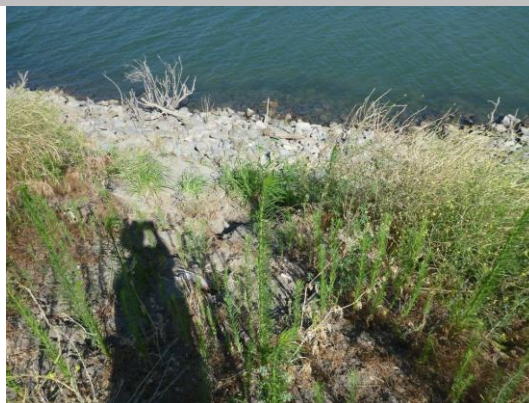
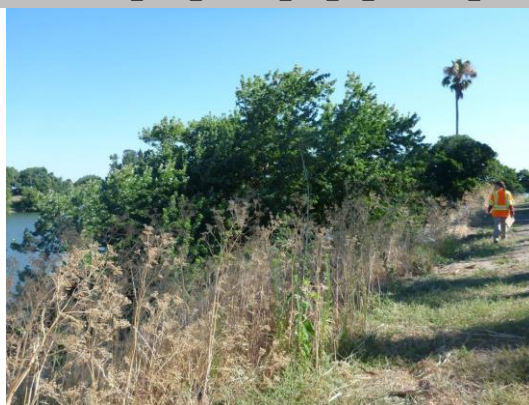
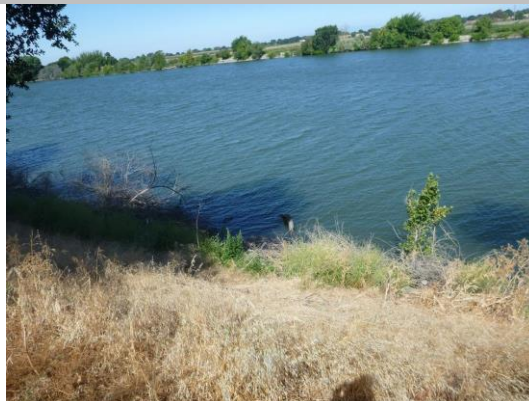
Comment Code					
Inspector Comment					
Levee Evaluation Comments					
Description:The damage consists of erosion of the lower waterside levee slope and bank approximately 424 feet in length along the east (left) bank of the Sacramento River. See attached pages for photos. Site location T06N R04E Section 29.					
Site ID No:329					
Site Designation:LMA-156					
Repair Type: Erosion					
Rating:Serious					
Field Date:7/13/2017					
Notes: Crown is a paved road. Large LS berm on part. Good visibility here. Serious because erosion cut into prism significantly for a long distance and soils are very sandy here and WS slope is very steep.
