**Flood Control Project Maintenance  
Levee Inspections**

## Maintenance Issue Types Only, Levee Inspection Report By Mile - Spring 2019

### Reclamation District No. 0755 Randall

Waterway	Bank	Unit Miles	Inspection Start/End	Inspector
Unit No. 01 Sacramento River	Left	1.83	03/15/2019 03/15/2019	David Julian

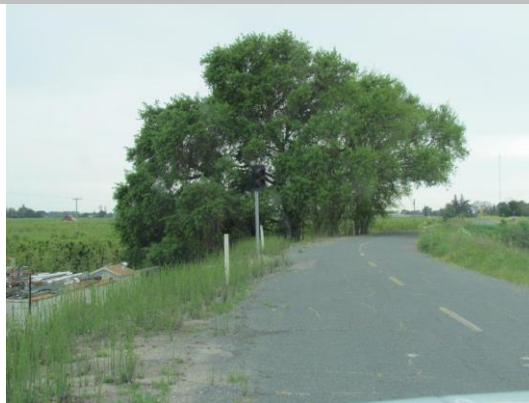
Photo 2 of 2 : SP\_2019\_RD0755\_177\_20\_20190311\_00009.jpg

RD 755 looking downstream from levee mile 0.17-0.59.

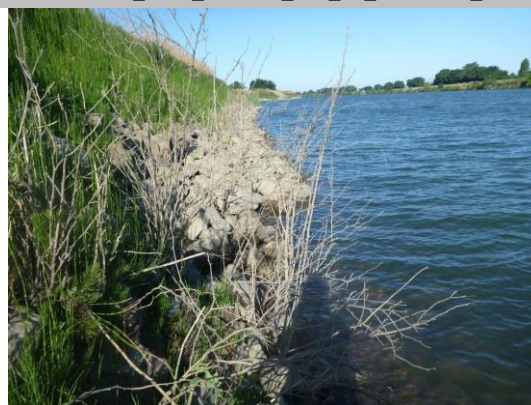
Photo 1 of 3 : SP\_2019\_RD0755\_177\_18\_20190311\_00003.jpg

Comment Code					
Inspector Comment					
Levee Evaluation Comments					
Description:The damage consists of erosion of the lower waterside levee slope and bank approximately 27 feet in length along the east (left) bank of the Sacramento River. See attached pages for photos.					
Site location T06N R04E Section 28.					
Site ID No:327					
Site Designation:LMA-154					
Repair Type: Erosion					
Rating:Area of Concern					
Field Date:7/13/2017					
Notes: Pretty minor damage visible from the slope, site was originally identified by boat. Will look at again from waterside if there is time.					
Crown is a paved road. Original GPS was a little off, added correct point in start

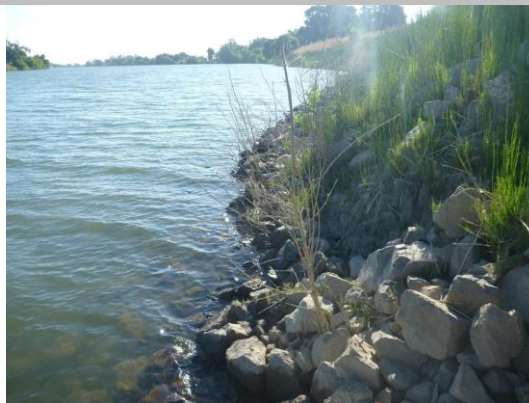
Photo 2 of 3 : SP\_2019\_RD0755\_177\_18\_20190311\_00004.jpg

Comment Code					
Inspector Comment					
Levee Evaluation Comments					
Description:The damage consists of erosion of the lower waterside levee slope and bank approximately 27 feet in length along the east (left) bank of the Sacramento River. See attached pages for photos.					
Site location T06N R04E Section 28.					
Site ID No:327					
Site Designation:LMA-154					
Repair Type: Erosion					
Rating:Area of Concern					
Field Date:7/13/2017					
Notes: Pretty minor damage visible from the slope, site was originally identified by boat. Will look at again from waterside if there is time.					
Crown is a paved road. Original GPS was a little off, added correct point in start

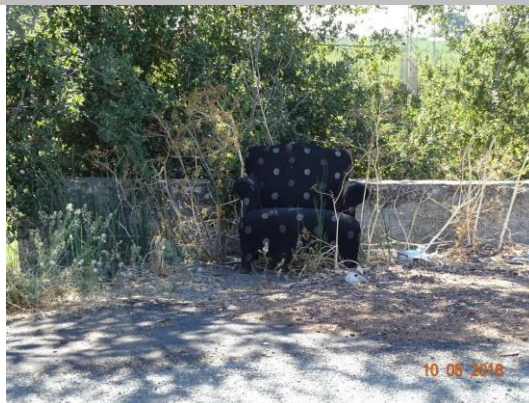
Photo 1 of 1 : SP\_2019\_RD0755\_177\_27\_20190311\_00017.jpg

LM Start	0.69	Rating **	M	Issue No.	27
LM End	0.69	Issue Type +	Ma	Location *	LS
Category	Earthen Levee			GPS Latitude/Longitude	
				Start	End
Item	Encroachments			38.345070 °	38.345070 °
				-121.547985 °	-121.547985 °
DWR ID	DWR_RD0755_01_f_2018_27				
Comment Code					
GA : Garbage					
Inspector Comment					
Remove chair from the landside shoulder.

Chair on the waterside (October 2018).

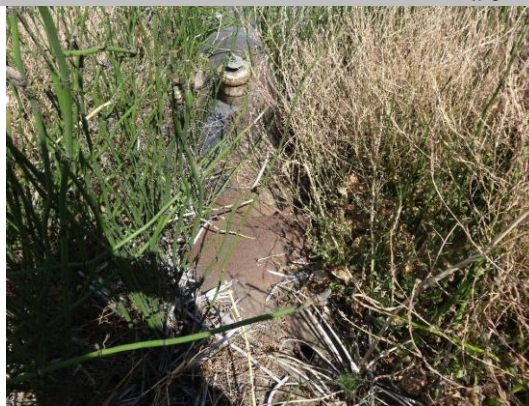
Photo 1 of 3 : UCIP\_SP\_2019\_17145\_29292.jpg

Comment Code					
Inspector Comment					
FS_ID:17145 DS_ID:18852 EP_NO: 11222 Repair Type: No Action Needed Crossing Status: Found UCIP Comments: It was working during field survey. A pump found 150 ft from the levee. Not sure whether the pump belong to this drainage system. FIELD_STRUCT_DESC: *ABANDONED* 16-inch steel drainage pipe sleeved through a 24-inch steel drainage pipe through the levee, invert elevation 8 feet below the crown. (Retention of a 12-inch drainage pipe sleeved through a 24-inch pipe through the levee, 8 feet below the crown, authorized under Automatic Board Order (ABO) issued as Permit No. 11222, 1975 - Green McKeown, Inc). [Additional Reference(s): DWR Levee Log, 2005, 12-inch inner pipe referenced. USACE Sacramento O&M Manual 111, May 1959, (RM 35.89)]. FS Date: 8/6/2013

WS view: pipe and siphon breaker on levee slope

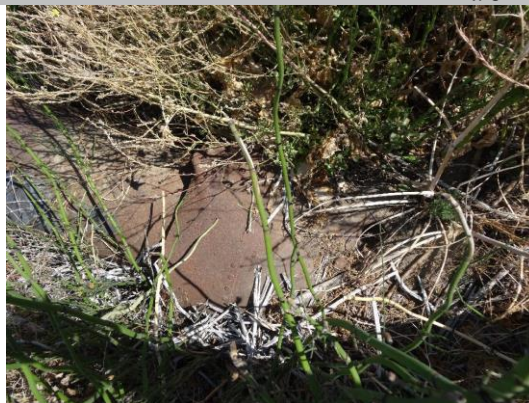
Photo 2 of 3 : UCIP\_SP\_2019\_17145\_29293.jpg

Comment Code						
Inspector Comment						
FS_ID:17145 DS_ID:18852 EP_NO: 11222 Repair Type: No Action Needed Crossing Status: Found UCIP Comments: It was working during field survey. A pump found 150 ft from the levee. Not sure whether the pump belong to this drainage system. FIELD_STRUCT_DESC: *ABANDONED* 16-inch steel drainage pipe sleeved through a 24-inch steel drainage pipe through the levee, invert elevation 8 feet below the crown. (Retention of a 12-inch drainage pipe sleeved through a 24-inch pipe through the levee, 8 feet below the crown, authorized under Automatic Board Order (ABO) issued as Permit No. 11222, 1975 - Green McKeown, Inc). [Additional Reference(s): DWR Levee Log, 2005, 12-inch inner pipe referenced. USACE Sacramento O&M Manual 111, May 1959, (RM 35.89)]. FS Date: 8/6/2013

WS view: 16-inch pipe sleeved through 24-inch pipe.

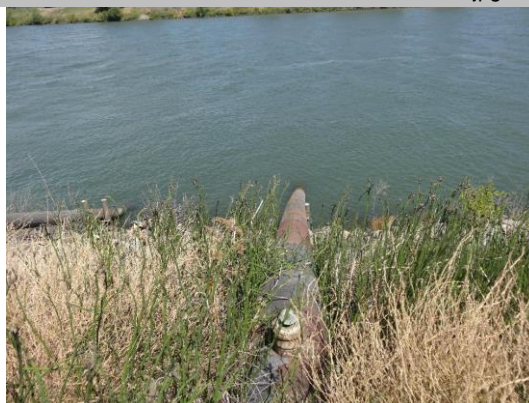
Photo 3 of 3 : UCIP\_SP\_2019\_17145\_29295.jpg

WS view: 16-inch drainage pipe on levee slope.

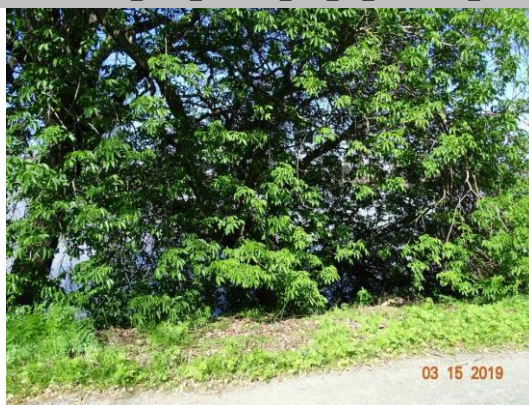
Photo 1 of 1 : SP\_2019\_RD0755\_177\_31\_20190320\_00048.jpg

LM Start	1.06	Rating **	M	Issue No.	31
LM End	1.06	Issue Type +	Ma	Location *	WS
Category	Earthen Levee			GPS Latitude/Longitude	
				Start	End
Item	Trim / Thin Trees			38.343542 °	38.343542 °
				-121.554487 °	-121.554487 °
DWR ID	DWR_RD0755_01_s_2019_31				
Comment Code					
T1 : Trim trees to at least five feet above ground level.					
Inspector Comment					
Trees are blocking visibility down waterside slope.

View of tree at the top of the waterside shoulder (Spring 2019).

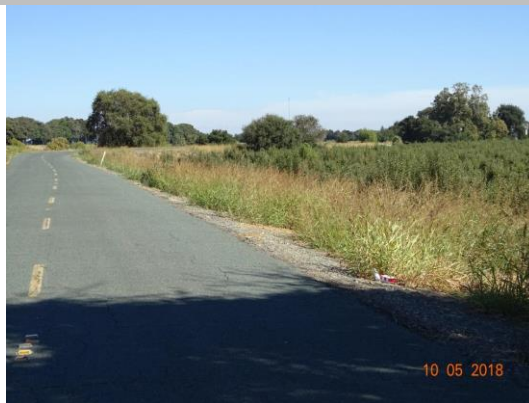
Photo 1 of 1 : SP\_2019\_RD0755\_177\_28\_20190311\_00018.jpg

LM Start	1.12	Rating **	M	Issue No.	28	
LM End	1.42	Issue Type +	Ma	Location *	LS	
Category	Earthen Levee			GPS Latitude/Longitude		
				Start		End
Item	Vegetation			38.343300 °		38.341237 °
				-121.555507 °		-121.560113 °
DWR ID	DWR_RD0755_01_s_2017_28					
Comment Code						
V1 : Control annual grass and weeds on the levee slopes and easements.						
Inspector Comment						
Remove vegetation from the landside slope.

View looking upstream at vegetation on the landside slope (October 2018).

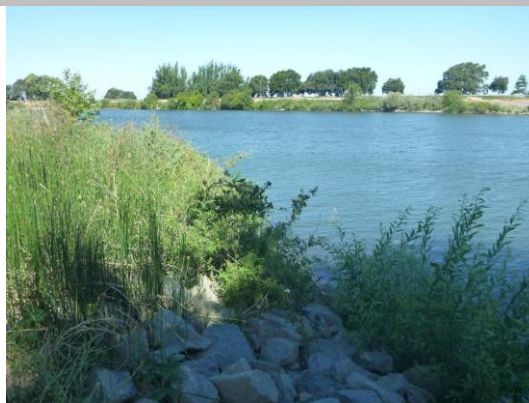
Photo 1 of 3 : SP\_2019\_RD0755\_177\_22\_20190311\_00010.jpg

Comment Code					
Inspector Comment					
Levee Evaluation Comments					
Description:The damage consists of erosion of the lower waterside levee slope and bank approximately 322 feet in length along the east (left) bank of the Sacramento River. See attached pages for photos.					
Site location T06N R04E Section 29.					
Site ID No:328					
Site Designation:LMA-155					
Repair Type: Erosion					
Rating:Area of Concern					
Field Date:7/13/2017					
Notes: Could not access most of the lower portion of the slope because of vegetation, but there was rip rap just downstream of the site. Looked like it may have been missing on part of the site. Erosion looked like it may be 1/2 the length reported. Crown is a paved road

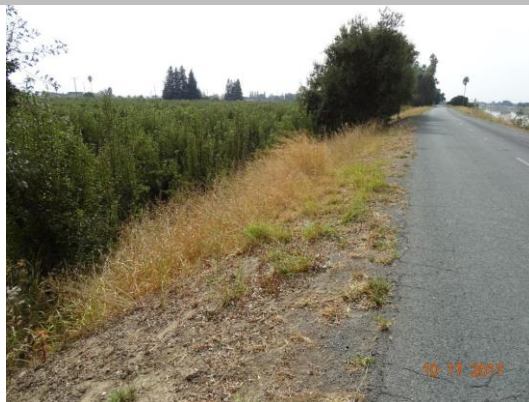
Photo 1 of 1 : SP\_2019\_RD0755\_177\_13\_20190311\_00002.jpg

LM Start	1.59	Rating **	M	Issue No.	13
LM End	1.73	Issue Type +	Ma	Location *	LS
Category	Earthen Levee			GPS Latitude/Longitude	
				Start	End
Item	Vegetation			38.339210 °	38.337755 °
				-121.562058 °	-121.563666 °
DWR ID	DWR_RD0755_01_f_2018_13				
Comment Code					
V2 : Remove the wild growth other than native grasses from the levee slopes.					
Inspector Comment

Vegetation on landside should be maintained to allow inspection and access to slope and toe.

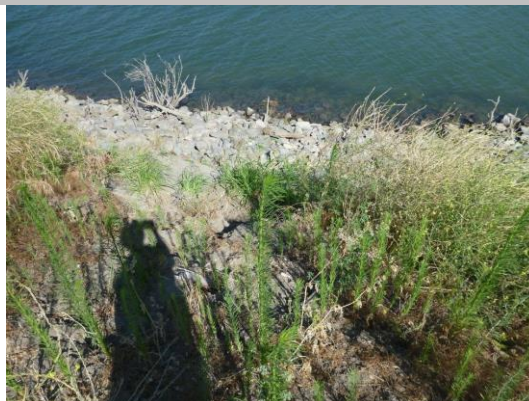
Photo 1 of 3 : SP\_2019\_RD0755\_177\_24\_20190311\_00013.jpg

Comment Code					
Inspector Comment					
Levee Evaluation Comments					
Description:The damage consists of erosion of the lower waterside levee slope and bank approximately 424 feet in length along the east (left) bank of the Sacramento River. See attached pages for photos. Site location T06N R04E Section 29. Site ID No:329 Site Designation:LMA-156 Repair Type: Erosion Rating:Serious Field Date:7/13/2017 Notes: Crown is a paved road. Large LS berm on part. Good visibility here. Serious because erosion cut into prism significantly for a long distance and soils are very sandy here and WS slope is very steep.					
LM Start	1.73	Rating **	A/W	Issue No.	24 (cont)
LM End	1.81	Issue Type +	Ma	Location *

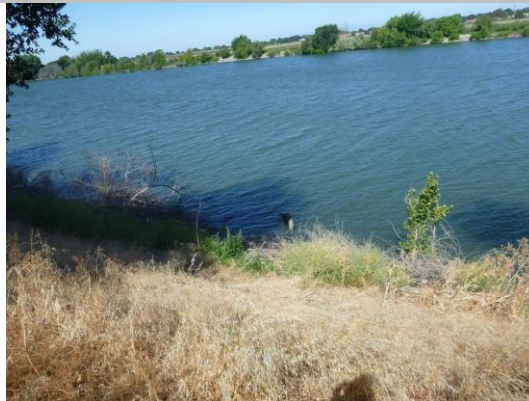
Photo 3 of 3 : SP\_2019\_RD0755\_177\_24\_20190311\_00015.jpg

Comment Code					
Inspector Comment					
Levee Evaluation Comments					
Description:The damage consists of erosion of the lower waterside levee slope and bank approximately 424 feet in length along the east (left) bank of the Sacramento River. See attached pages for photos.					
Site location T06N R04E Section 29.					
Site ID No:329					
Site Designation:LMA-156					
Repair Type: Erosion					
Rating:Serious					
Field Date:7/13/2017					
Notes: Crown is a paved road. Large LS berm on part. Good visibility here. Serious because erosion cut into prism significantly for a long distance and soils are very sandy here and WS slope is very steep.
