**Flood Control Project Maintenance
Levee Inspections**

Maintenance Issue Types Only, Levee Inspection Report By Mile - Spring 2020

Reclamation District No. 0755 Randall

Waterway	Bank	Unit Miles	Inspection Start/End	Inspector
Unit No. 01 Sacramento River	Left	1.83	03/25/2020 03/25/2020	David Julian

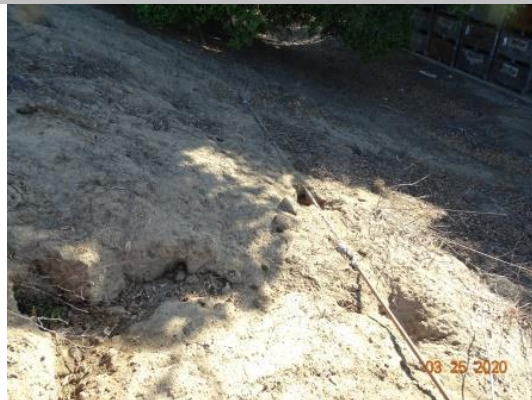
Photo 2 of 2 : SP_2020_RD0755_177_4_20200330_00070.jpg

LM Start	0.20	Rating **	M	Issue No.	4 (cont)
LM End	1.77	Issue Type +	Ma	Location *	LS
Category	Earthen Levee			GPS Latitude/Longitude	
				Start	End
Item	Animal Control			38.346500 °	38.337197 °
				-121.539146 °	-121.564147 °
DWR ID	DWR_RD0755_01_f_2014_4

View a couple animal holes on the landside slope (Spring 2020).

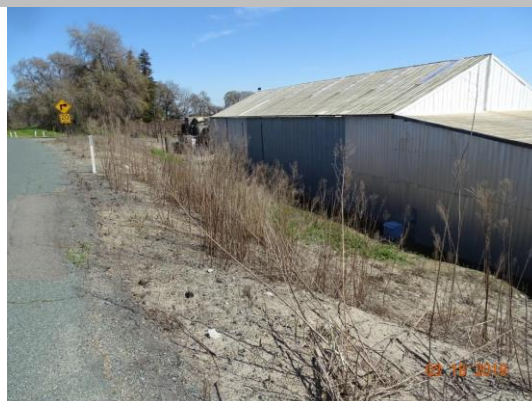
Photo 1 of 1 : SP_2020_RD0755_177_10_20200304_00001.jpg

LM Start	0.21	Rating **	M	Issue No.	10
LM End	0.21	Issue Type +	Ma	Location *	LS
Category	Earthen Levee			GPS Latitude/Longitude	
				Start	End
Item	Slope Stability			38.346428 °	38.346428 °
				-121.539400 °	-121.539400 °
DWR ID	DWR_RD0755_01_s_2019_10				
Comment Code					
S1 : Repair slope instability.					
Inspector Comment					
There is a 2" seperation between roadway and levee on the landside shoulder.

View looking upstream at small slip on the landside shoulder (Spring 2019).

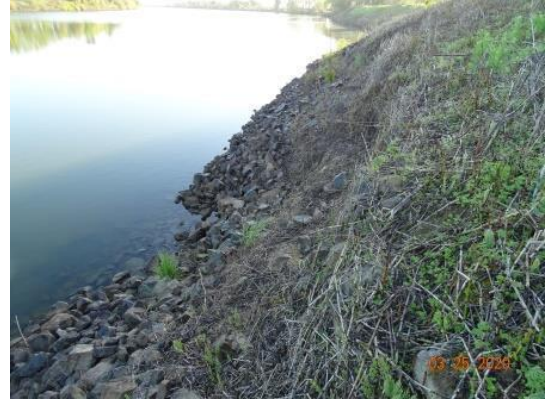
Photo 1 of 2 : SP_2020_RD0755_177_18_20200330_00064.jpg

LM Start	0.28	Rating **	U	Issue No.	18
LM End	0.28	Issue Type +	Ma	Location *	WS
Category	Earthen Levee			GPS Latitude/Longitude	
				Start	End
Item	Erosion / Bank Caving			38.346249 °	38.346331 °
				-121.540542 °	-121.540664 °
DWR ID	DWR_RD0755_01_s_2020_18				
Comment Code					
E2 : Schedule repair of erosion site prior to the next inspection.					
Inspector Comment					
This was a 2017 Storm Damage site. Damage consists of erosion of the lower waterside levee slope and bank approximately 27 feet in length. Site ID No:327 Site Designation:LMA-154 3/25/2020 Field Notes: Erosion is significant. At least 1' into waterside slope. No riprap present.

View looking upstream and slightly down at erosion into the waterside slope (Spring 2020).

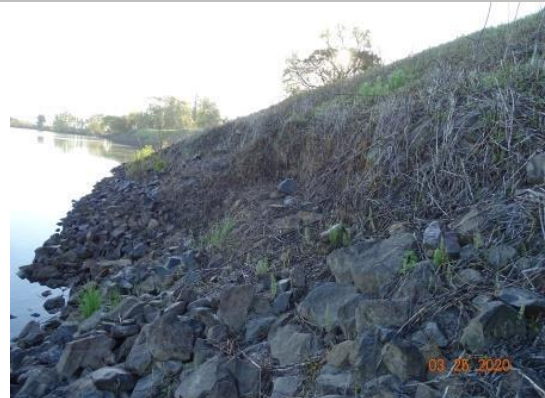
Photo 2 of 2 : SP_2020_RD0755_177_18_20200330_00065.jpg

View looking upstream and slightly up at erosion into the waterside slope (Spring 2020).

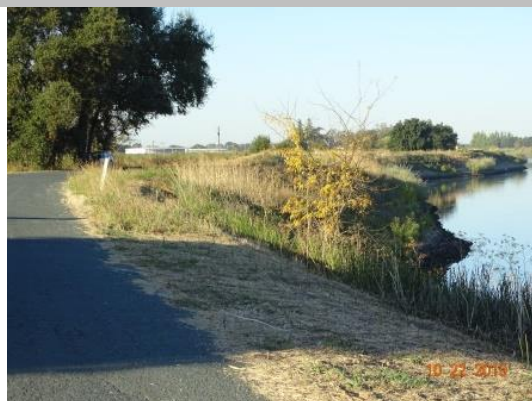
Photo 1 of 1 : SP_2020_RD0755_177_19_20200304_00008.jpg

LM Start	0.33	Rating **	M	Issue No.	19
LM End	1.84	Issue Type +	Ma	Location *	WS
Category	Earthen Levee			GPS Latitude/Longitude	
				Start	End
Item	Vegetation			38.346043 °	38.336409 °
				-121.541483 °	-121.564813 °
DWR ID	DWR_RD0755_01_f_2016_19				
Comment Code					
V2 : Remove the wild growth other than native grasses from the levee slopes.					
Inspector Comment					
The tall weeds on the waterside slope should be removed/managed to allow inspection. Large cactus (Century Plants) at LM 1.07 should also be removed.

View looking downstream at thick vegetation on the waterside slope (Fall 2019).

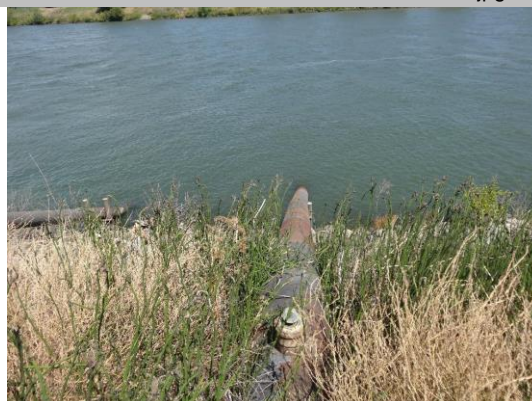
Photo 3 of 3 : UCIP_SP_2020_17145_29295.jpg

WS view: 16-inch drainage pipe on levee slope.

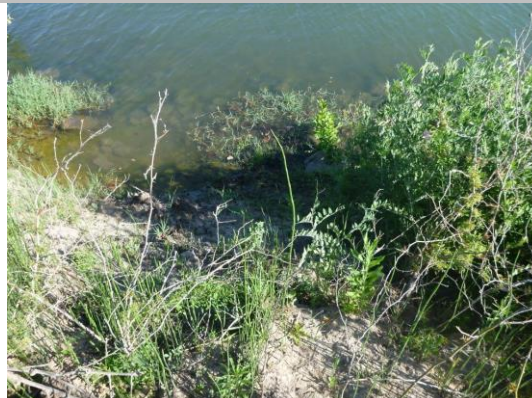
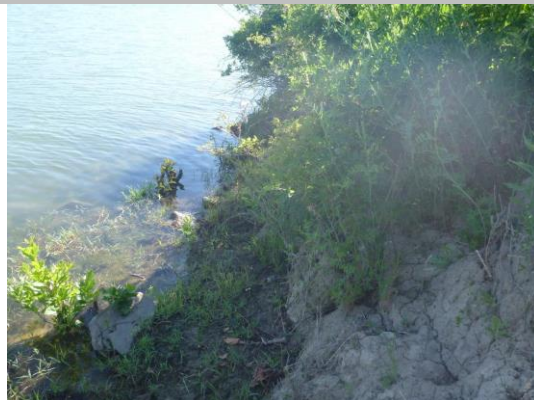
LM Start	1.23	Rating **	A/W	Issue No.	22
LM End	1.29	Issue Type +	Ma	Location *	WS
Category	Earthen Levee			GPS Latitude/Longitude	
				Start	End
Item	Erosion / Bank Caving			38.342992 °	38.342633 °
				-121.557572 °	-121.558622 °
DWR ID	LMA-155				
Comment Code					
E1 : Note and monitor erosion site.					
Inspector Comment					
This was a 2017 Storm Damage site. Damage consists of erosion of the lower waterside levee slope and bank approximately 322 feet in length. Site ID No:328 Site Designation:LMA-155 3/25/2020 Field Notes: Erosion is into berm and not prism. A boat survey would get a better look. Monitor.

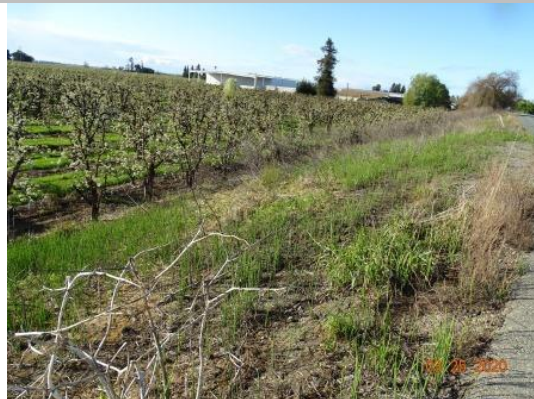
Photo 1 of 1 : SP_2020_RD0755_177_40_20200330_00071.jpg

LM Start	1.32	Rating **	M	Issue No.	40
LM End	1.42	Issue Type +	Ma	Location *	LS
Category	Earthen Levee			GPS Latitude/Longitude	
				Start	End
Item	Vegetation			38.342274 °	38.341170 °
				-121.559014 °	-121.560208 °
DWR ID	DWR_RD0755_01_f_2019_40				
Comment Code					
V1 : Control annual grass and weeds on the levee slopes and easements.					
Inspector Comment

View looking downstream at vegetation on the landside slope (Spring 2020).

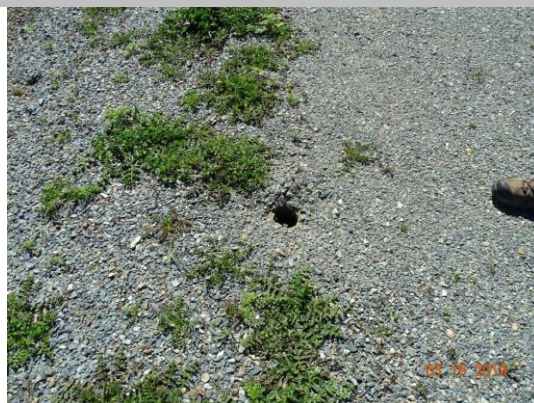
Photo 1 of 2 : SP_2020_RD0755_177_34_20200304_00023.jpg

LM Start	1.42	Rating **	M	Issue No.	34
LM End	1.42	Issue Type +	Ma	Location *	CR
Category	Earthen Levee			GPS Latitude/Longitude	
				Start	End
Item	Animal Control			38.341205 °	38.341205 °
				-121.560122 °	-121.560122 °
DWR ID	DWR_RD0755_01_s_2019_34				
Comment Code					
A1 : Exterminate rodents and backfill and compact or grout burrows.					
Inspector Comment					
Multiple rodent holes are on the crown, including one that was 2' deep.

View of 2 foot deep rodent hole on the landside of the crown (Spring 2019).

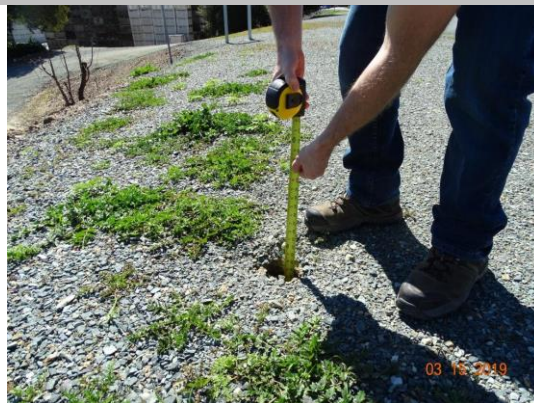
Photo 2 of 2 : SP_2020_RD0755_177_34_20200304_00024.jpg

Measuring tape showing rodent hole as being 2 feet deep on the landside of the crown (Spring 2019).

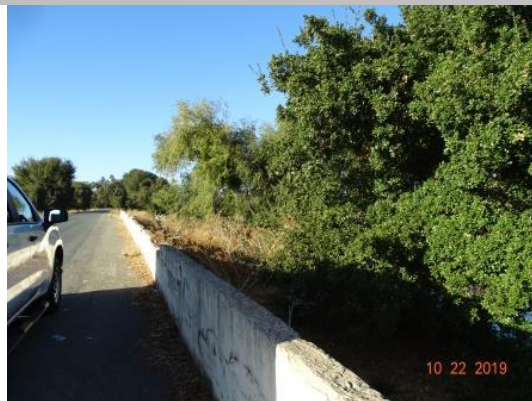
Photo 1 of 1 : SP_2020_RD0755_177_36_20200304_00026.jpg

LM Start	1.53	Rating **	U	Issue No.	36
LM End	1.53	Issue Type +	Ma	Location *	WS
Category	Earthen Levee			GPS Latitude/Longitude	
				Start	End
Item	Trim / Thin Trees			38.339867 °	38.339867 °
				-121.561397 °	-121.561397 °
DWR ID	DWR_RD0755_01_f_2019_36				
Comment Code					
T2 : Thin trees to allow visibility of the ground and room to flood fight.					
Inspector Comment

View looking downstream at thick trees on the waterside slope (Fall 2019).

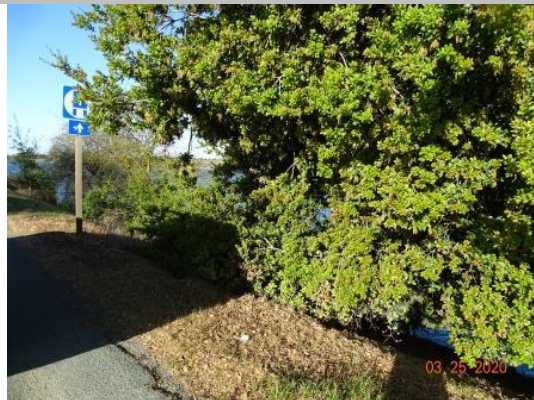
Photo 1 of 1 : SP_2020_RD0755_177_37_20200330_00072.jpg

LM Start	1.61	Rating **	U	Issue No.	37
LM End	1.61	Issue Type +	Ma	Location *	WS
Category	Earthen Levee			GPS Latitude/Longitude	
				Start	End
Item	Trim / Thin Trees			38.339030 °	38.339030 °
				-121.562232 °	-121.562232 °
DWR ID	DWR_RD0755_01_f_2019_37				
Comment Code					
T2 : Thin trees to allow visibility of the ground and room to flood fight.					
Inspector Comment

View looking downstream of tree branches directly on waterside slope (Spring 2020).

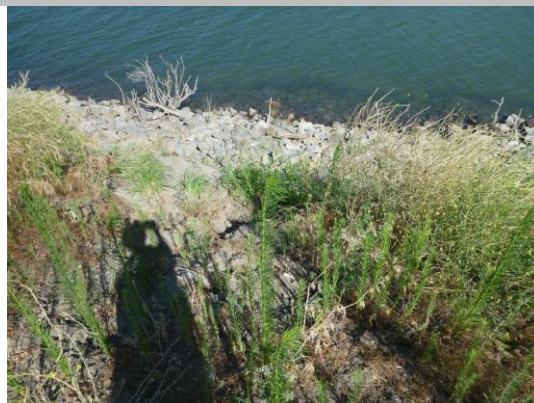
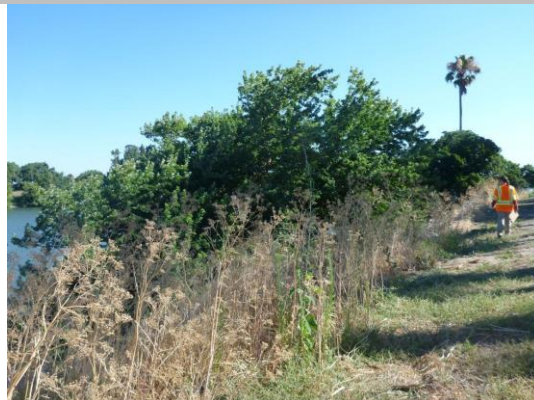
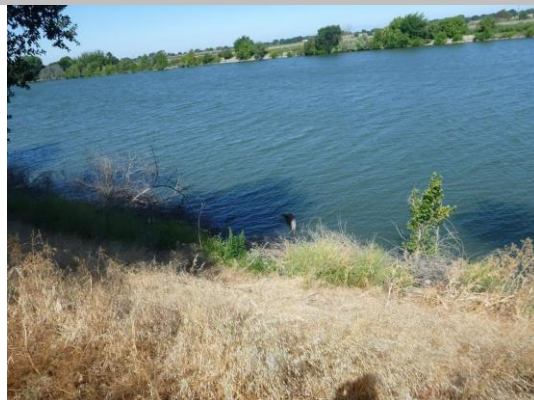
Comment Code					
Inspector Comment					
Planned For Repair.					
Levee Evaluation Comments					
Description:The damage consists of erosion of the lower waterside levee slope and bank approximately 424 feet in length along the east (left) bank of the Sacramento River. See attached pages for photos.					
Site location T06N R04E Section 29.					
Site ID No:329					
Site Designation:LMA-156					
Repair Type: Erosion					
Rating:Serious					
Field Date:7/13/2017					
Notes: Crown is a paved road. Large LS berm on part. Good visibility here. Serious because erosion cut into prism significantly for a long distance and soils are very sandy here and WS slope is very steep.
