**Flood Control Project Maintenance
Levee Inspections**

Maintenance Issue Types Only, Levee Inspection Report By Mile - Spring 2021

Reclamation District No. 0755 Randall

Waterway	Bank	Unit Miles	Inspection Start/End	Inspector
Unit No. 01 Sacramento River	Left	1.83	04/08/2021 04/08/2021	David Julian

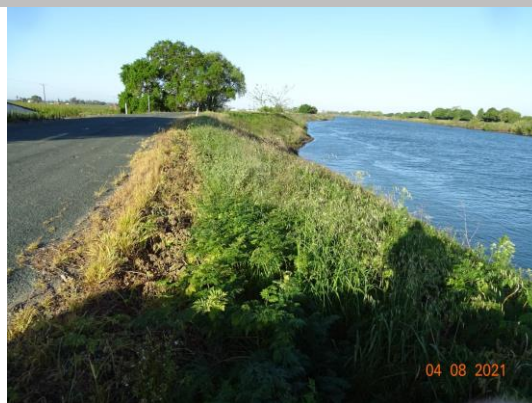
Photo 1 of 1 : SP_2021_RD0755_177_19_20210408_00080.jpg

LM Start	0.07	Rating **	M	Issue No.	19
LM End	1.73	Issue Type +	Ma	Location *	WS
Category	Earthen Levee			GPS Latitude/Longitude	
				Start	End
Item	Vegetation			38.347353 °	38.337654 °
				-121.537034 °	-121.563779 °
DWR ID	DWR_RD0755_01_f_2016_19				
Comment Code					
V1 : Control annual grass and weeds on the levee slopes and easements.					
Inspector Comment					
Large cactus (Century Plants) at LM 1.07 should also be removed.

View looking downstream at vegetation on the waterside slope (Spring 2021).

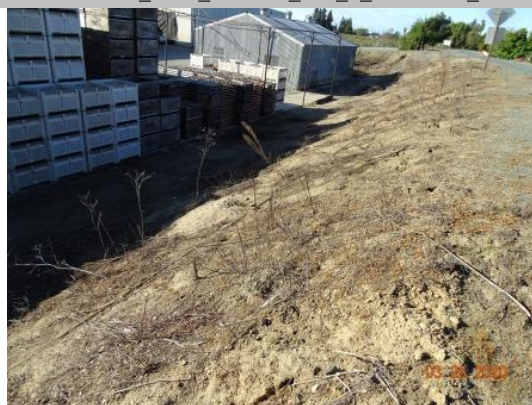
Photo 1 of 2 : SP_2021_RD0755_177_4_20210301_00001.jpg

LM Start	0.20	Rating **	M	Issue No.	4
LM End	0.92	Issue Type +	Ma	Location *	LS
Category	Earthen Levee			GPS Latitude/Longitude	
				Start	End
Item	Animal Control			38.346500 °	38.344130 °
				-121.539146 °	-121.552038 °
DWR ID	DWR_RD0755_01_f_2014_4				
Comment Code					
A3 : No rodents visible, but rodent burrows visible; need to backfill and compact or grout burrows.					
Inspector Comment					
Evidence of active rodents on landside slope near the walnut trees. No bait stations were observed.

View looking downstream at fresh animal hole on the landside slope (Spring 2020).

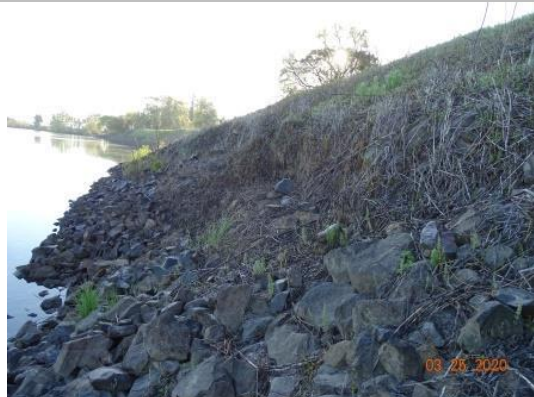
Photo 1 of 1 : SP_2021_RD0755_177_18_20210301_00006.jpg

LM Start	0.28	Rating **	U	Issue No.	18
LM End	0.28	Issue Type +	Ma	Location *	WS
Category	Earthen Levee			GPS Latitude/Longitude	
				Start	End
Item	Erosion / Bank Caving			38.346249 °	38.346331 °
				-121.540542 °	-121.540664 °
DWR ID	DWR_RD0755_01_s _ 2020_18				
Comment Code					
E2 : Schedule repair of erosion site prior to the next inspection.					
Inspector Comment					
This was a 2017 Storm Damage site. Damage consists of erosion of the lower waterside levee slope and bank approximately 27 feet in length. Site ID No:327 Site Designation:LMA-154 3/25/2020 Field Notes: Erosion is significant. At least 1' into waterside slope. No riprap present.

View looking upstream and slightly up at erosion into the waterside slope (Spring 2020).

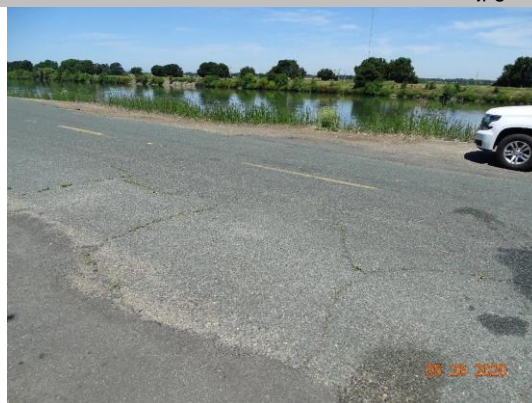
Photo 1 of 3 : UCIP_SP_2021_57038_84440.jpg

Comment Code						
Inspector Comment						
FS_ID:57038						
DS_ID:18852						
EP_NO: 11222						
Repair Type: Non-Urgent						
Crossing Status: Found						
UCIP Comments: 05/26/2020 Record updated from No Action Needed to Non-Urgent. No permit has been identified authorizing pipe. Pipe was running during site visit pumping water to the waterside. (O.Yakimov - DWR UCIP)						
08/06/2013 It was working during field survey. A pump found 150 ft from the levee. Not sure whether the pump belong to this drainage system.						
FIELD_STRUCT_DESC: 16-inch steel drainage pipe sleeved through a 24-inch steel drainage pipe through the levee, invert elevation 8 feet below the crown. Air vent installed on the pipe on WS slope. Concrete headwall on LS. (12-inch pipe sleeved through 24-inch pipe-inch pipe [HLM 0.71] authorized under Automatic Board Order (ABO) issued as Permit No. 11222, 1975 - Green McKeown, Inc). [Additional Reference(s): DWR Levee Log, 2005 (HLM 0.71), referenced as 12-inch pipe through 24-inch pipe. USACE Sacramento O&M Manual, Unit 111, May 1959, Revised 29 December 2016, (RM 35.89), listed as 24-inch pipe].

Top of Levee: View of levee crown looking downstream

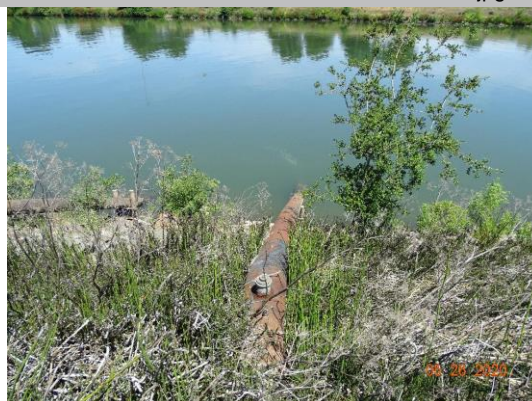
Photo 2 of 3 : UCIP_SP_2021_57038_84442.jpg

Water-Side: View of levee slope looking from crown

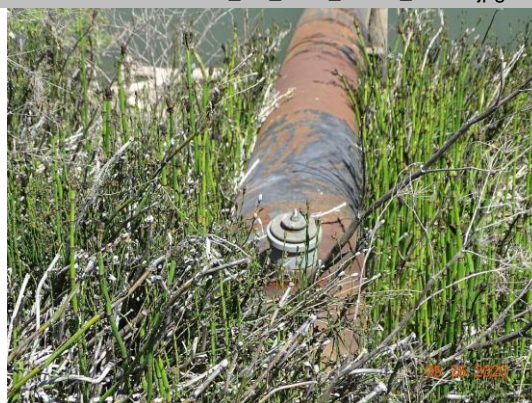
Photo 3 of 3 : UCIP_SP_2021_57038_84443.jpg

Water-Side: Pipe and air release valve on levee slope

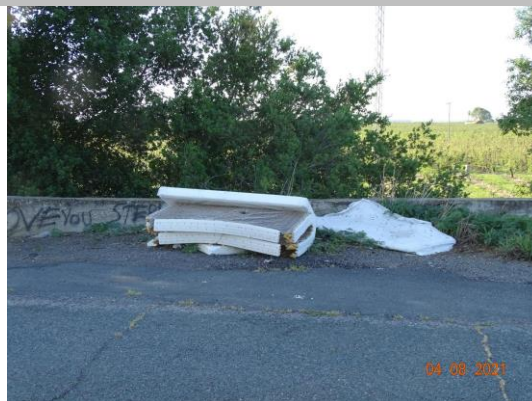
Photo 1 of 1 : SP_2021_RD0755_177_43_20210408_00082.jpg

LM Start	0.70	Rating **	M	Issue No.	43
LM End	0.70	Issue Type +	Ma	Location *	LS
Category	Earthen Levee			GPS Latitude/Longitude	
				Start	End
Item	Encroachments			38.345083 °	38.345083 °
				-121.548068 °	-121.548068 °
DWR ID	DWR_RD0755_01_s_2021_43				
Comment Code					
GA : Garbage					
Inspector Comment					
Remove discarded mattresses.

View of discarded mattress on the landside hinge (Spring 2021).

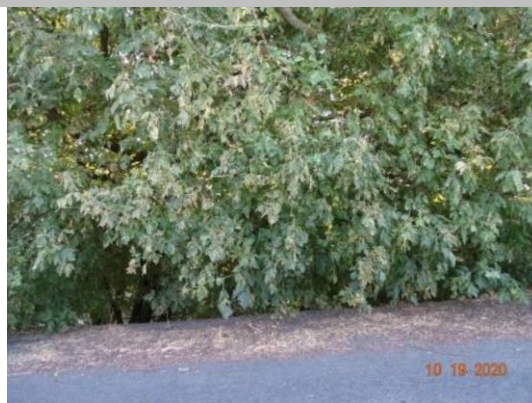
Photo 1 of 1 : SP_2021_RD0755_177_53_20210301_00023.jpg

LM Start	0.99	Rating **	U	Issue No.	53
LM End	0.99	Issue Type +	Ma	Location *	LS
Category	Earthen Levee			GPS Latitude/Longitude	
				Start	End
Item	Trim / Thin Trees			38.343850 °	38.343850 °
				-121.553150 °	-121.553150 °
DWR ID	DWR_RD0755_01_f_2020_53				
Comment Code					
T1 : Trim trees to at least five feet above ground level.					
Inspector Comment

View of thick trees on the landside slope (Fall 2020).

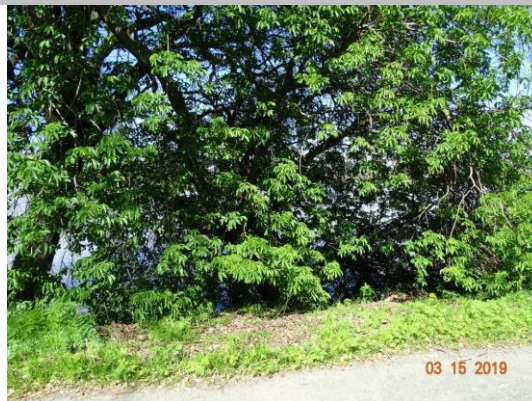
Photo 1 of 1 : SP_2021_RD0755_177_31_20210301_00016.jpg

LM Start	1.06	Rating **	M	Issue No.	31
LM End	1.06	Issue Type +	Ma	Location *	WS
Category	Earthen Levee			GPS Latitude/Longitude	
				Start	End
Item	Trim / Thin Trees			38.343542 °	38.343542 °
				-121.554487 °	-121.554487 °
DWR ID	DWR_RD0755_01_s_2019_31				
Comment Code					
T1 : Trim trees to at least five feet above ground level.					
Inspector Comment					
Trees are blocking visibility down waterside slope.

View of tree at the top of the waterside shoulder (Spring 2019).

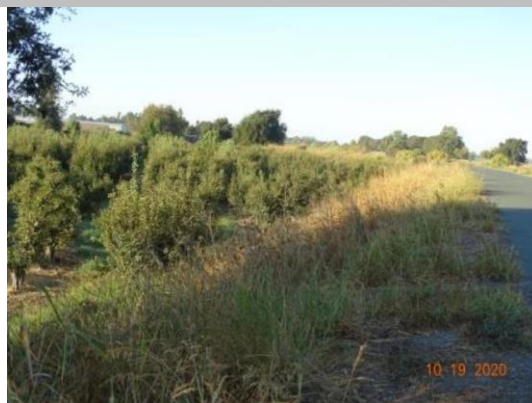
Photo 1 of 1 : SP_2021_RD0755_177_54_20210301_00024.jpg

LM Start	1.11	Rating **	M	Issue No.	54
LM End	1.76	Issue Type +	Ma	Location *	LS
Category	Earthen Levee			GPS Latitude/Longitude	
				Start	End
Item	Vegetation			38.343345 °	38.337423 °
				-121.555430 °	-121.564028 °
DWR ID	DWR_RD0755_01_f_2020_54				
Comment Code					
V1 : Control annual grass and weeds on the levee slopes and easements.					
Inspector Comment

View looking downstream at annual vegetation on the landside slope (Fall 2020).

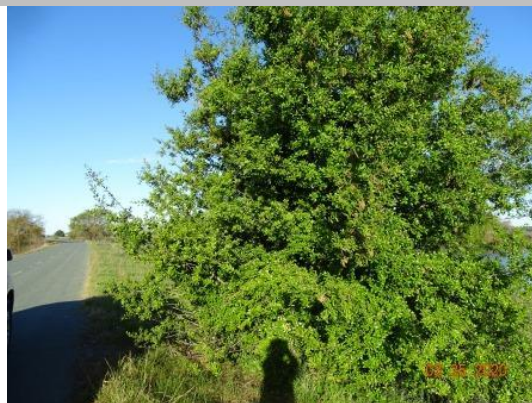
Photo 1 of 1 : SP_2021_RD0755_177_28_20210301_00015.jpg

LM Start	1.18	Rating **	M	Issue No.	28
LM End	1.18	Issue Type +	Ma	Location *	WS
Category	Earthen Levee			GPS Latitude/Longitude	
				Start	End
Item	Trim / Thin Trees			38.343072 °	38.343072 °
				-121.556532 °	-121.556532 °
DWR ID	DWR_RD0755_01_f_2019_28				
Comment Code					
T2 : Thin trees to allow visibility of the ground and room to flood fight.					
Inspector Comment

View looking downstream at tree on the waterside slope (Spring 2020).

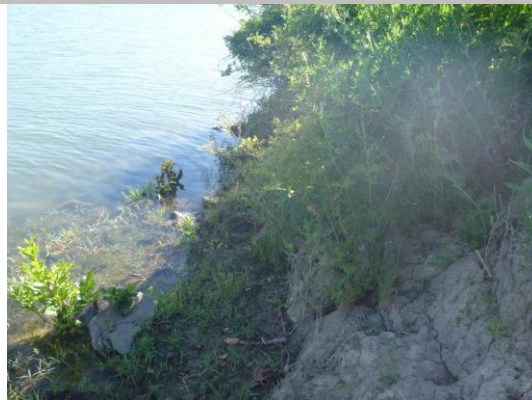
Photo 1 of 1 : SP_2021_RD0755_177_22_20210301_00009.jpg

LM Start	1.23	Rating **	A/W	Issue No.	22
LM End	1.29	Issue Type +	Ma	Location *	WS
Category	Earthen Levee			GPS Latitude/Longitude	
				Start	End
Item	Erosion / Bank Caving			38.342992 °	38.342633 °
				-121.557572 °	-121.558622 °
DWR ID	LMA-155				
Comment Code					
E1 : Note and monitor erosion site.					
Inspector Comment					
This was a 2017 Storm Damage site. Damage consists of erosion of the lower waterside levee slope and bank approximately 322 feet in length. Site ID No:328 Site Designation:LMA-155 6/18/2020 Field Notes: Erosion is into berm and not prism.

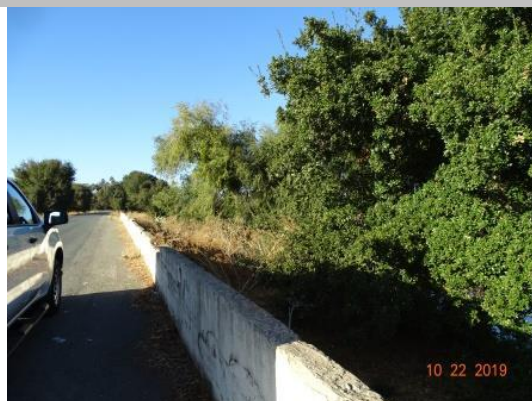
Photo 1 of 1 : SP_2021_RD0755_177_36_20210301_00019.jpg

LM Start	1.53	Rating **	U	Issue No.	36
LM End	1.53	Issue Type +	Ma	Location *	WS
Category	Earthen Levee			GPS Latitude/Longitude	
				Start	End
Item	Trim / Thin Trees			38.339867 °	38.339867 °
				-121.561397 °	-121.561397 °
DWR ID	DWR_RD0755_01_f_2019_36				
Comment Code					
T2 : Thin trees to allow visibility of the ground and room to flood fight.					
Inspector Comment

View looking downstream at thick trees on the waterside slope (Fall 2019).

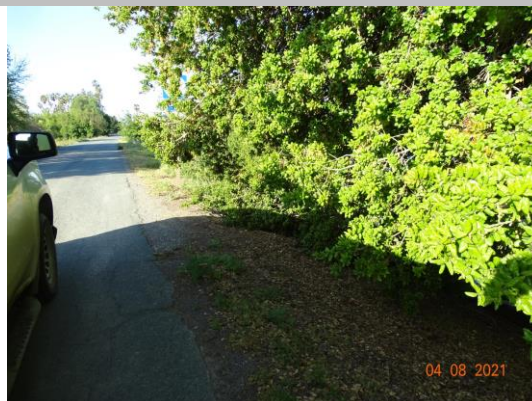
Photo 1 of 1 : SP_2021_RD0755_177_37_20210408_00083.jpg

LM Start	1.61	Rating **	U	Issue No.	37
LM End	1.61	Issue Type +	Ma	Location *	WS
Category	Earthen Levee			GPS Latitude/Longitude	
				Start	End
Item	Trim / Thin Trees			38.339030 °	38.339030 °
				-121.562232 °	-121.562232 °
DWR ID	DWR_RD0755_01_f_2019_37				
Comment Code					
T2 : Thin trees to allow visibility of the ground and room to flood fight.					
Inspector Comment

View looking downstream at thick tree on the waterside slope (Spring 2021).

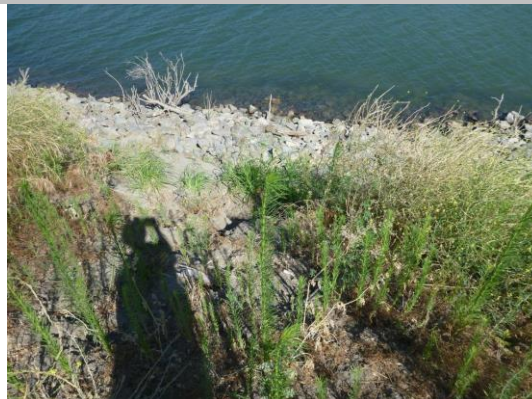
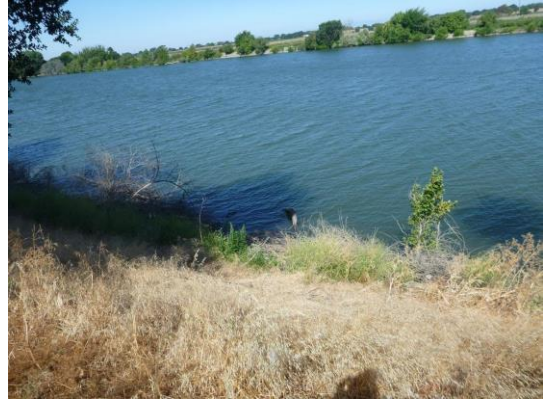
Comment Code					
Inspector Comment					
Planned For Repair.					
Levee Evaluation Comments					
Description:The damage consists of erosion of the lower waterside levee slope and bank approximately 424 feet in length along the east (left) bank of the Sacramento River. See attached pages for photos.					
Site location T06N R04E Section 29.					
Site ID No:329					
Site Designation:LMA-156					
Repair Type: Erosion					
Rating:Serious					
Field Date:7/13/2017					
Notes: Crown is a paved road. Large LS berm on part. Good visibility here. Serious because erosion cut into prism significantly for a long distance and soils are very sandy here and WS slope is very steep.
