**Flood Control Project Maintenance  
Levee Inspections**

**Maintenance Issue Types Only, Levee Inspection Report By Mile - Spring 2022**

**Reclamation District No. 0755 Randall**

Waterway	Bank	Unit Miles	Inspection Start/End	Inspector
Unit No. 01 Sacramento River	Left	1.83	03/11/2022 03/11/2022	David Julian

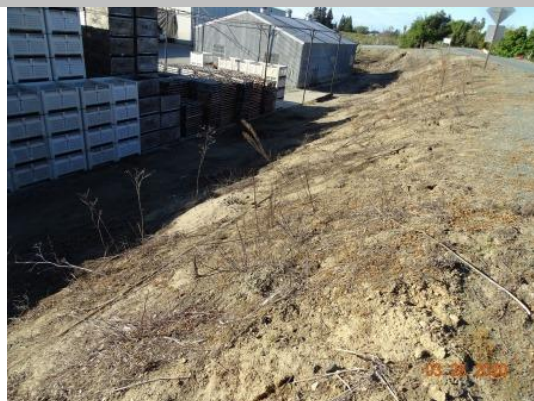
Photo 1 of 2 : SP\_2022\_RD0755\_177\_4\_20220307\_00001.jpg

LM Start	0.20	Rating **	M	Issue No.	4
LM End	0.92	Issue Type +	Ma	Location *	LS
Category	Earthen Levee			GPS Latitude/Longitude	
				Start	End
Item	Animal Control			38.346500 °	38.344130 °
				-121.539146 °	-121.552038 °
DWR ID	DWR_RD0755_01_f_2014_4				
Comment Code					
A3 : No rodents visible, but rodent burrows visible; need to backfill and compact or grout burrows.					
Inspector Comment					
Evidence of active rodents on landside slope. LMA has started baiting.

View looking downstream at fresh animal hole on the landside slope (Spring 2020).

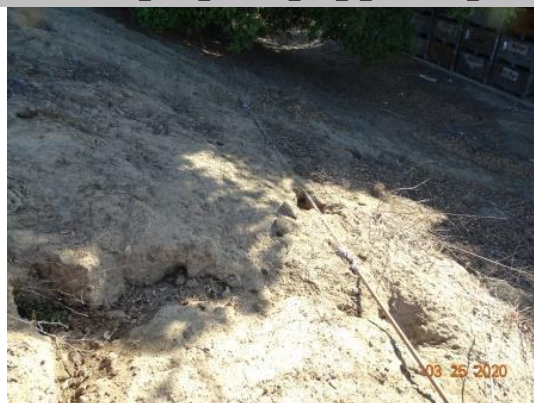
Photo 2 of 2 : SP\_2022\_RD0755\_177\_4\_20220307\_00002.jpg

LM Start	<b>0.20</b>	Rating **	M	Issue No.	<b>4 (cont)</b>
LM End	<b>0.92</b>	Issue Type +	Ma	Location *	LS

View a couple animal holes on the landside slope (Spring 2020).

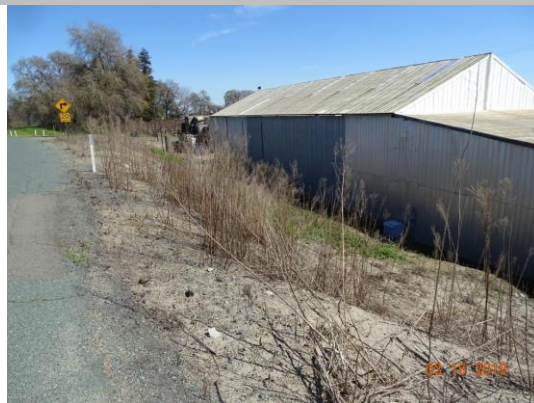
Photo 1 of 1 : SP\_2022\_RD0755\_177\_10\_20220307\_00003.jpg

LM Start	0.21	Rating **	M	Issue No.	10	
LM End	0.21	Issue Type +	Ma	Location *	LS	
Category	Earthen Levee			GPS Latitude/Longitude		
				Start		End
Item	Slope Stability			38.346428 °		38.346428 °
				-121.539400 °		-121.539400 °
DWR ID	DWR_RD0755_01_s_2019_10					
Comment Code						
S1 : Repair slope instability.						
Inspector Comment						
There is a 2" seperation between roadway and levee on the landside shoulder.

View looking upstream at small slip on the landside shoulder (Spring 2019).

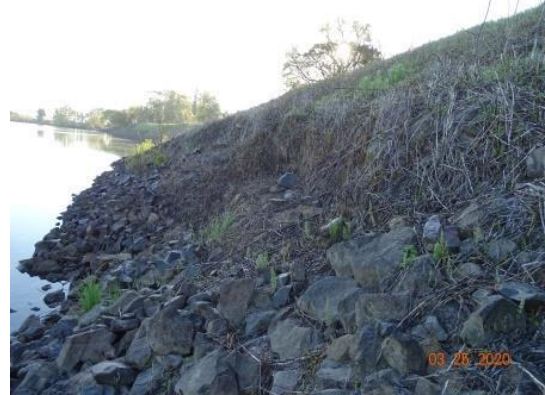
Photo 1 of 1 : SP\_2022\_RD0755\_177\_18\_20220307\_00005.jpg

LM Start	0.28	Rating **	U	Issue No.	18
LM End	0.28	Issue Type +	Ma	Location *	WS
Category	Earthen Levee			GPS Latitude/Longitude	
				Start	End
Item	Erosion / Bank Caving			38.346249 °	38.346331 °
				-121.540542 °	-121.540664 °
DWR ID	DWR_RD0755_01_s_2020_18				
Comment Code					
E2 : Schedule repair of erosion site prior to the next inspection.					
Inspector Comment					
This was a 2017 Storm Damage site. Damage consists of erosion of the lower waterside levee slope and bank approximately 27 feet in length. Site ID No:327 Site Designation:LMA-154 3/25/2020 Field Notes: Erosion is significant. At least 1' into waterside slope. No riprap present.

View looking upstream and slightly up at erosion into the waterside slope (Spring 2020).

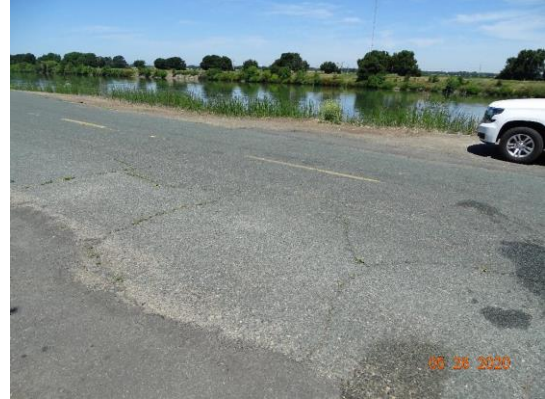
Photo 1 of 3 : UCIP\_SP\_2022\_57038\_84440.jpg

Comment Code					
Inspector Comment					
FS_ID:57038 DS_ID:18852 EP_NO: 11222 Repair Type: Non-Urgent Crossing Status: Found UCIP Comments: 05/26/2020 Record updated from No Action Needed to Non-Urgent. No permit has been identified authorizing pipe. Pipe was running during site visit pumping water to the waterside. (O.Yakimov - DWR UCIP) 08/06/2013 It was working during field survey. A pump found 150 ft from the levee. Not sure whether the pump belong to this drainage system. FIELD_STRUCT_DESC: 16-inch steel drainage pipe sleeved through a 24-inch steel drainage pipe through the levee, invert elevation 8 feet below the crown. Air vent installed on the pipe on WS slope. Concrete headwall on LS. (12-inch pipe sleeved through 24-inch pipe-inch pipe [HLM 0.71] authorized under Automatic Board Order (ABO) issued as Permit No. 11222, 1975 - Green McKeown, Inc). [Additional Reference(s): DWR Levee Log, 2005 (HLM 0.71), referenced as 12-inch pipe through 24-inch pipe. USACE Sacramento O&M Manual, Unit 111, May 1959, Revised 29 December 2016, (RM 35.89), listed as 24-inch pipe]. FS Date: 5/26/2020 3:00:07 PM

Top of Levee: View of levee crown looking downstream

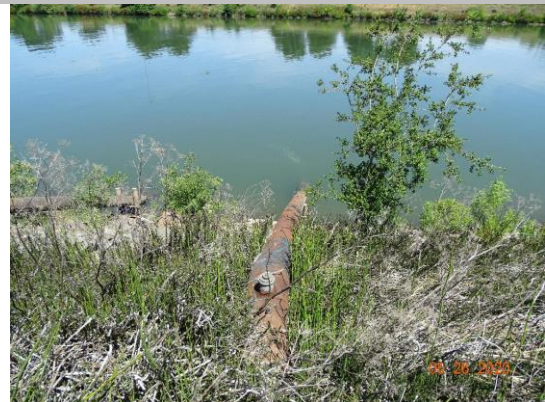
Photo 2 of 3 : UCIP\_SP\_2022\_57038\_84442.jpg

Water-Side: View of levee slope looking from crown

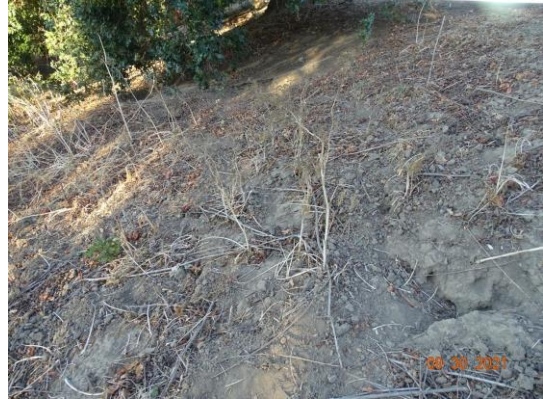
Photo 1 of 1 : SP\_2022\_RD0755\_177\_59\_20220307\_00022.jpg

LM Start	1.01	Rating **	M	Issue No.	59
LM End	1.01	Issue Type +	Ma	Location *	LS
Category	Earthen Levee			GPS Latitude/Longitude	
				Start	End
Item	Animal Control			38.343726 °	38.343726 °
				-121.553526 °	-121.553526 °
DWR ID	DWR_RD0755_01_f _ 2021_59				
Comment Code					
A1 : Exterminate rodents and backfill and compact or grout burrows.					
Inspector Comment

View of animal holes in the landside slope (Fall 2021).

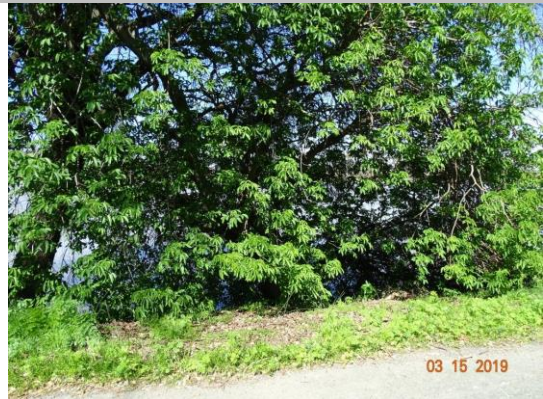
Photo 1 of 1 : SP\_2022\_RD0755\_177\_31\_20220307\_00011.jpg

LM Start	1.06	Rating **	M	Issue No.	31
LM End	1.06	Issue Type +	Ma	Location *	WS
Category	Earthen Levee			GPS Latitude/Longitude	
				Start	End
Item	Trim / Thin Trees			38.343542 °	38.343542 °
				-121.554487 °	-121.554487 °
DWR ID	DWR_RD0755_01_s_2019_31				
Comment Code					
T1 : Trim and thin trees to at least five feet above ground level to allow visibility of the ground and room to flood fight.					
Inspector Comment					
Trees are blocking visibility down waterside slope.

View of tree at the top of the waterside shoulder (Spring 2019).

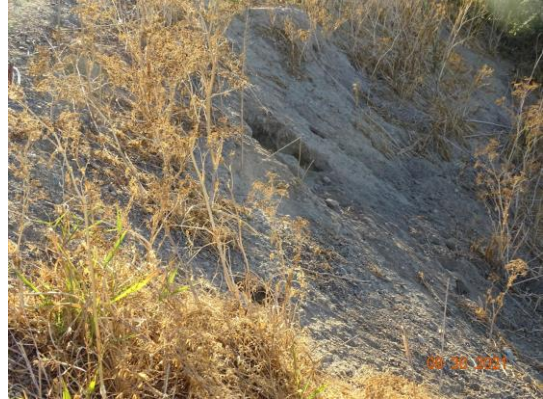
Photo 1 of 1 : SP\_2022\_RD0755\_177\_58\_20220307\_00021.jpg

LM Start	1.17	Rating **	M	Issue No.	58
LM End	1.17	Issue Type +	Ma	Location *	LS
Category	Earthen Levee			GPS Latitude/Longitude	
				Start	End
Item	Animal Control			38.343087 °	38.343087 °
				-121.556488 °	-121.556488 °
DWR ID	DWR_RD0755_01_f_2021_58				
Comment Code					
A1 : Exterminate rodents and backfill and compact or grout burrows.					
Inspector Comment

View of animal hole in the landside slope (Fall 2021).

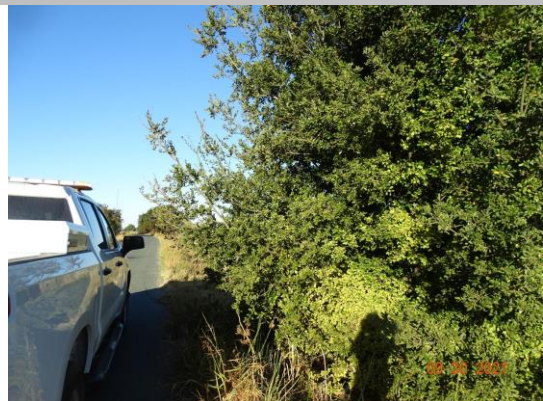
Photo 1 of 1 : SP\_2022\_RD0755\_177\_28\_20220307\_00010.jpg

LM Start	1.18	Rating **	U	Issue No.	28
LM End	1.18	Issue Type +	Ma	Location *	WS
Category	Earthen Levee			GPS Latitude/Longitude	
				Start	End
Item	Trim / Thin Trees			38.343072 °	38.343072 °
				-121.556532 °	-121.556532 °
DWR ID	DWR_RD0755_01_f_2019_28				
Comment Code					
T1 : Trim and thin trees to at least five feet above ground level to allow visibility of the ground and room to flood fight.					
Inspector Comment

View looking downstream at tree on the waterside slope (Fall 2021).

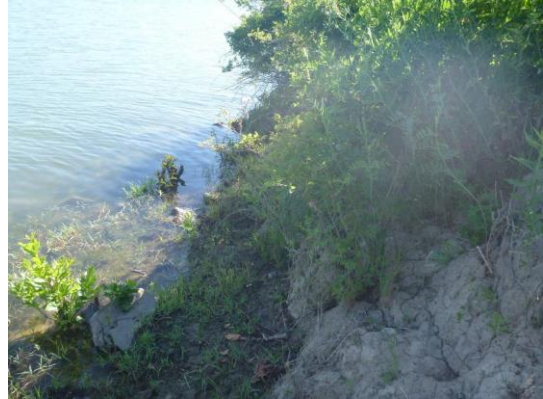
Photo 1 of 1 : SP\_2022\_RD0755\_177\_22\_20220307\_00007.jpg

LM Start	1.23	Rating **	A/W	Issue No.	22
LM End	1.29	Issue Type +	Ma	Location *	WS
Category	Earthen Levee			GPS Latitude/Longitude	
				Start	End
Item	Erosion / Bank Caving			38.342992 °	38.342633 °
				-121.557572 °	-121.558622 °
DWR ID	LMA-155				
Comment Code					
E1 : Note and monitor erosion site.					
Inspector Comment					
This was a 2017 Storm Damage site. Damage consists of erosion of the lower waterside levee slope and bank approximately 322 feet in length. Site ID No:328 Site Designation:LMA-155 6/18/2020 Field Notes: Erosion is into berm and not prism.

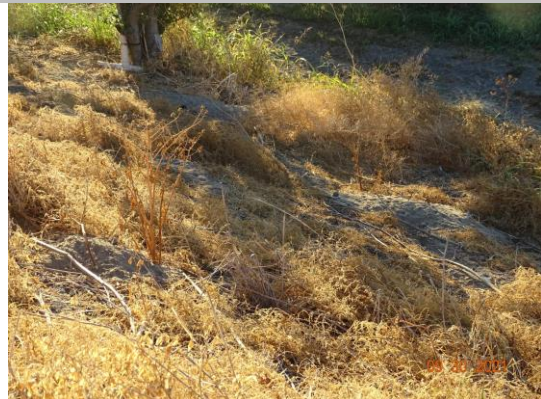
Photo 1 of 1 : SP\_2022\_RD0755\_177\_55\_20220307\_00020.jpg

LM Start	1.29	Rating **	U	Issue No.	55
LM End	1.29	Issue Type +	Ma	Location *	LS
Category	Earthen Levee			GPS Latitude/Longitude	
				Start	End
Item	Animal Control			38.342526 °	38.342526 °
				-121.558481 °	-121.558481 °
DWR ID	DWR_RD0755_01_f_2021_55				
Comment Code					
A1 : Exterminate rodents and backfill and compact or grout burrows.					
Inspector Comment					
Multiple fresh rodent holes.

View of animal holes in the landside slope (Fall 2021).

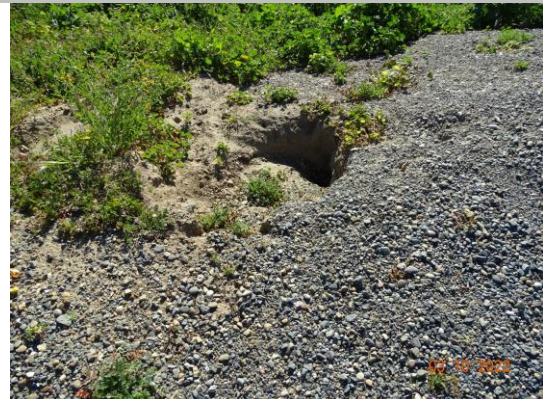
Photo 1 of 1 : SP\_2022\_RD0755\_177\_52\_20220311\_00079.jpg

LM Start	1.49	Rating **	M	Issue No.	52
LM End	1.49	Issue Type +	Ma	Location *	LS
Category	Earthen Levee			GPS Latitude/Longitude	
				Start	End
Item	Animal Control			38.340326 °	38.340326 °
				-121.560948 °	-121.560948 °
DWR ID	DWR_RD0755_01_f_2021_52				
Comment Code					
A1 : Exterminate rodents and backfill and compact or grout burrows.					
Inspector Comment

View of animal hole in the landside slope (Spring 2022).

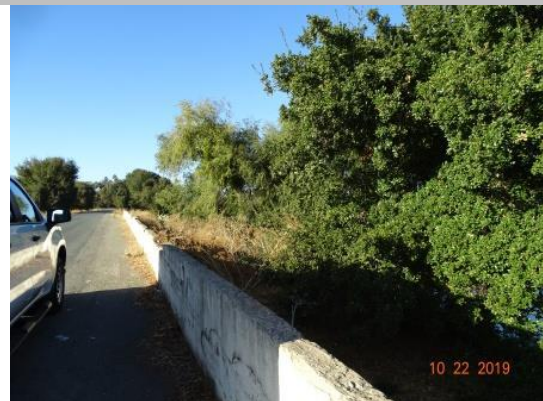
Photo 1 of 1 : SP\_2022\_RD0755\_177\_36\_20220307\_00014.jpg

LM Start	1.55	Rating **	U	Issue No.	36
LM End	1.55	Issue Type +	Ma	Location *	WS
Category	Earthen Levee			GPS Latitude/Longitude	
				Start	End
Item	Trim / Thin Trees			38.339689 °	38.339689 °
				-121.561576 °	-121.561576 °
DWR ID	DWR_RD0755_01_f_2019_36				
Comment Code					
T1 : Trim and thin trees to at least five feet above ground level to allow visibility of the ground and room to flood fight.					
Inspector Comment

View looking downstream at thick trees on the waterside slope (Fall 2019).

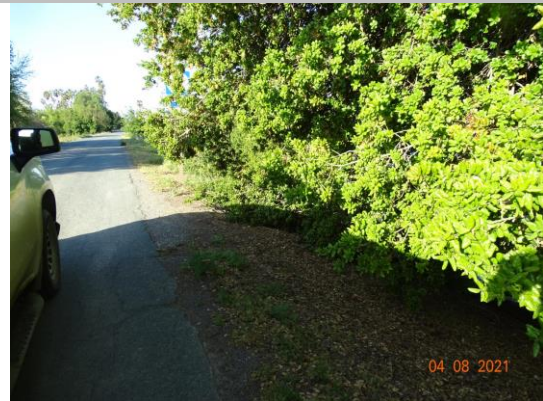
Photo 1 of 1 : SP\_2022\_RD0755\_177\_37\_20220307\_00015.jpg

LM Start	1.61	Rating **	U	Issue No.	37
LM End	1.61	Issue Type +	Ma	Location *	WS
Category	Earthen Levee			GPS Latitude/Longitude	
				Start	End
Item	Trim / Thin Trees			38.339030 °	38.339030 °
				-121.562232 °	-121.562232 °
DWR ID	DWR_RD0755_01_f _ 2019_37				
Comment Code					
T1 : Trim and thin trees to at least five feet above ground level to allow visibility of the ground and room to flood fight.					
Inspector Comment

View looking downstream at thick tree on the waterside slope (Spring 2021).
