**Flood Control Project Maintenance
Levee Inspections**

Maintenance Issue Types Only, Levee Inspection Report By Mile - Spring 2023

Reclamation District No. 0755 Randall

Waterway	Bank	Unit Miles	Inspection Start/End	Inspector
Unit No. 01 Sacramento River	Left	1.83	04/27/2023 04/27/2023	Saskia Donovan

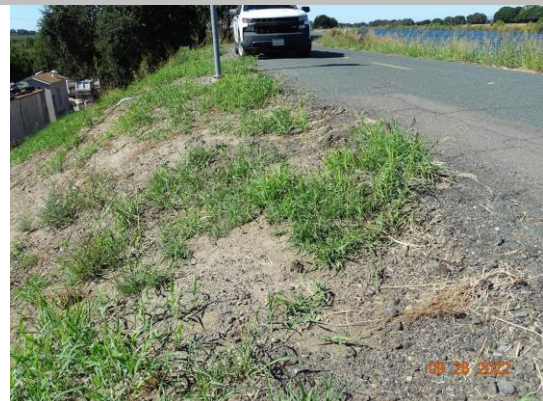
Photo 1 of 1 : SP_2023_RD0755_177_10_20230206_00002.jpg

LM Start	0.21	Rating **	M	Issue No.	10
LM End	0.21	Issue Type +	Ma	Location *	LS
Category	Earthen Levee			GPS Latitude/Longitude	
				Start	End
Item	Slope Stability			38.346428°	38.346428°
				-121.539400°	-121.539400°
DWR ID	DWR_RD0755_01_s_2019_10				
Comment Code					
S1 : Repair slope instability.					
Inspector Comment					
There is a 2" separation between roadway and levee on the landside shoulder.

View of the small slip on the LS shoulder (Fall 2022).

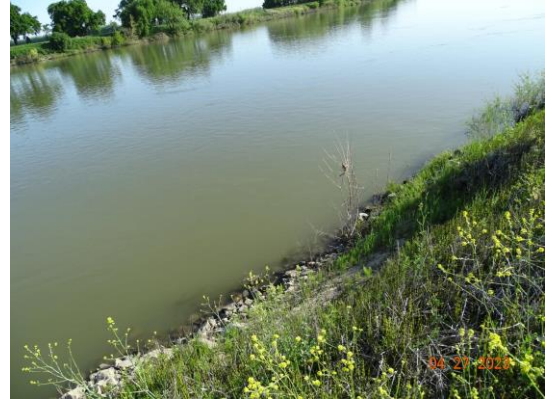
Photo 1 of 2 : SP_2023_RD0755_177_18_20230510_00035.jpg

LM Start	0.28	Rating **	U	Issue No.	18
LM End	0.28	Issue Type +	Ma	Location *	WS
Category	Earthen Levee			GPS Latitude/Longitude	
				Start	End
Item	Erosion / Bank Caving			38.346249°	38.346331°
				-121.540542°	-121.540664°
DWR ID	DWR_RD0755_01_s_2020_18				
Comment Code					
E2 : Schedule repair of erosion site prior to the next inspection.					
Inspector Comment					
Fall 2022: Erosion repair is pending. This was a 2017 Storm Damage site.					
Damage consists of erosion of the lower waterside levee slope and bank approximately 27 feet in length.					
Site ID No:327					
Site Designation:LMA-154					
3/25/2020 Field Notes:					
Erosion is significant. At least 1' into waterside slope. No riprap present.

View of the WS erosion looking down the slope (Spring 2023).

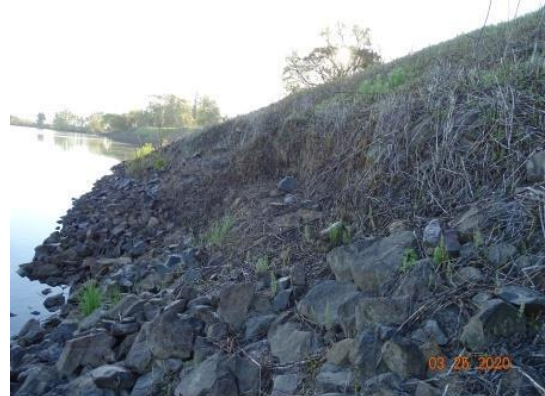
Photo 2 of 2 : SP_2023_RD0755_177_18_20230206_00003.jpg

View looking upstream and slightly up at erosion into the waterside slope (Spring 2020).

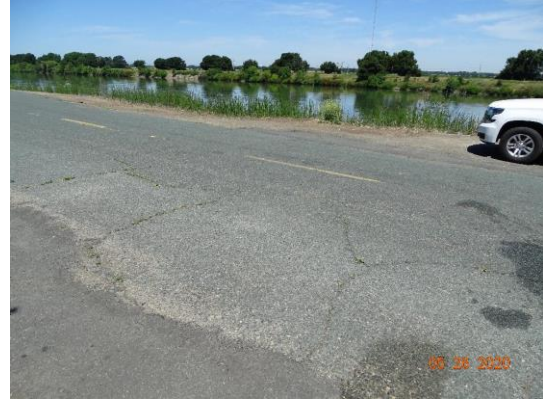
Photo 1 of 3 : UCIP_SP_2023_57038_84440.jpg

Comment Code					
Inspector Comment					
DS_ID:18852 FS_ID:57038 EP_NO: 11222 Repair Type: Non-Urgent EVAL Issue: Crossing Status: Found UCIP Comments: 05/26/2020 Record updated from No Action Needed to Non-Urgent. No permit has been identified authorizing pipe. Pipe was running during site visit pumping water to the waterside. (O.Yakimov - DWR UCIP) 08/06/2013 It was working during field survey. A pump found 150 ft from the levee. Not sure whether the pump belong to this drainage system. FIELD_STRUCT_DESC: 16-inch steel drainage pipe sleeved through a 24-inch steel drainage pipe through the levee, invert elevation 8 feet below the crown. Air vent installed on the pipe on WS slope. Concrete headwall on LS. (12-inch pipe sleeved through 24-inch pipe-inch pipe [HLM 0.71] authorized under Automatic Board Order (ABO) issued as Permit No. 11222, 1975 - Green McKeown, Inc). [Additional Reference(s): DWR Levee Log, 2005 (HLM 0.71), referenced as 12-inch pipe through 24-inch pipe. USACE Sacramento O&M Manual, Unit 111, May 1959, Revised 29 December 2016, (RM 35.89), listed as 24-inch pipe]. FS Date: 5/26/2020 3:00:07 PM

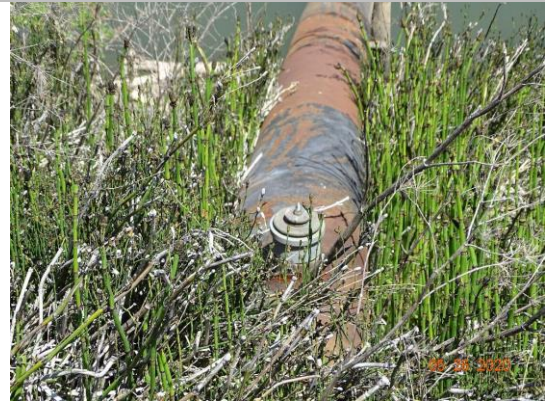
Photo 3 of 3 : UCIP_SP_2023_57038_84443.jpg

Water-Side: Pipe and air release valve on levee slope

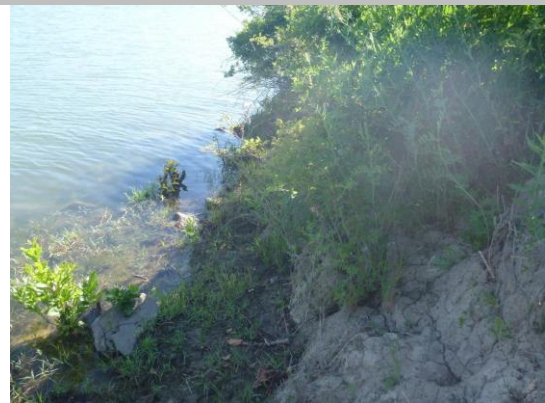
Photo 1 of 1 : SP_2023_RD0755_177_22_20230206_00004.jpg

E1 : Note and monitor erosion site.

This was a 2017 Storm Damage site.
Damage consists of erosion of the lower waterside levee slope and bank approximately 322 feet in length.
Site ID No:328
Site Designation:LMA-155
6/18/2020 Field Notes:
Erosion is into berm and not prism.
