**Flood Control Project Maintenance
Levee Inspections**

Fall 2009 Levee Maintenance Deficiency Summary Report

Reclamation District No. 0765 Glide

Levee Inspection Report By Mile - Fall 2009

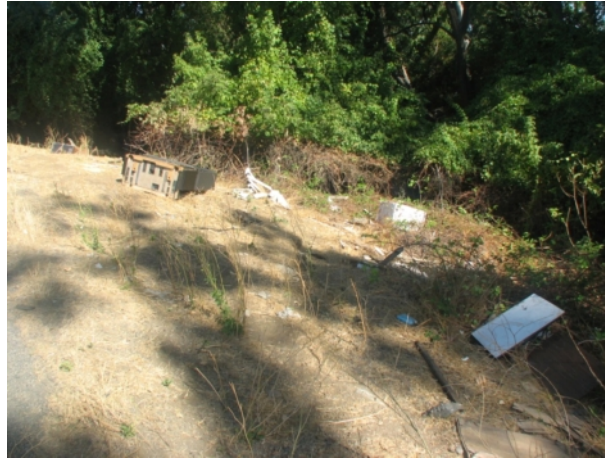
richard_20090922_1.jpg

Levee Mile Report Line	24
Start Levee Mile	1.69
End Levee Mile	1.69
Location	Water Side
Category	Earthen Levee
Item	Encroachments

Looking upstream at garbage on waterside slope.

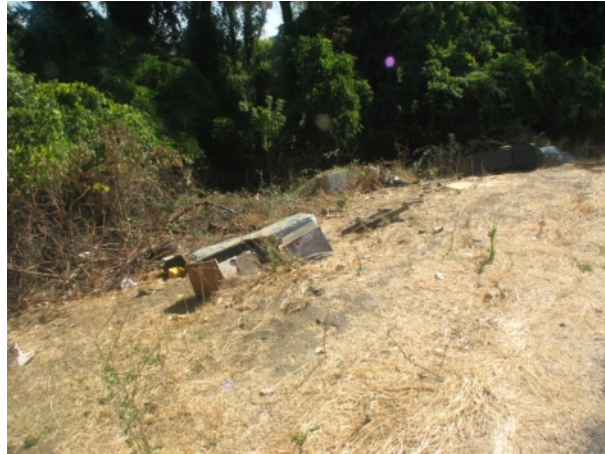
richard_20090922_2.jpg

Levee Mile Report Line	24
Start Levee Mile	1.69
End Levee Mile	1.69
Location	Water Side
Category	Earthen Levee
Item	Encroachments

Looking downstream at garbage on waterside slope.
