**Flood Control Project Maintenance
Levee Inspections**

Fall 2012 Levee Maintenance Deficiency Summary Report

Reclamation District No. 0765 Glide

Waterway			Bank	Unit Miles
Unit No. 01 Sacramento River			Right	1.74
	Spring (March - May)	Summer (June - August)	(September - November) Fall	Winter (December - February)
Unit Maintenance Rating (Fall Only)			U	
Date of Inspection	03/13/2012 - 03/13/2012		11/27/2012 - 11/27/2012	
DWR Inspector	Richard Willoughby		Richard Willoughby	
Accompanied By	Dave Chestnut RD765		Dave Chestnut RD765

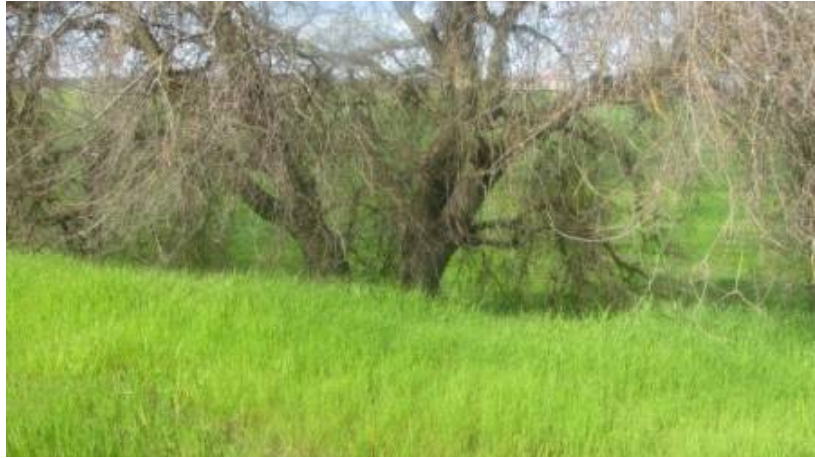
Levee Mile Report Line	7
Start Levee Mile	0.12
End Levee Mile	0.19
Location	Land Side
Category	Earthen Levee
Item	Trim / Thin Trees

Looking west at trees on landside toe.

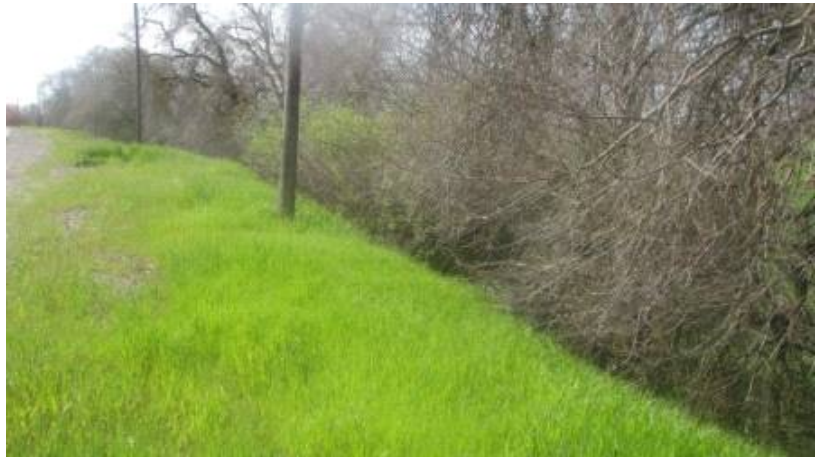
Levee Mile Report Line	7
Start Levee Mile	0.12
End Levee Mile	0.19
Location	Land Side
Category	Earthen Levee
Item	Trim / Thin Trees

Looking downstream (south) at trees on landside slope & toe.

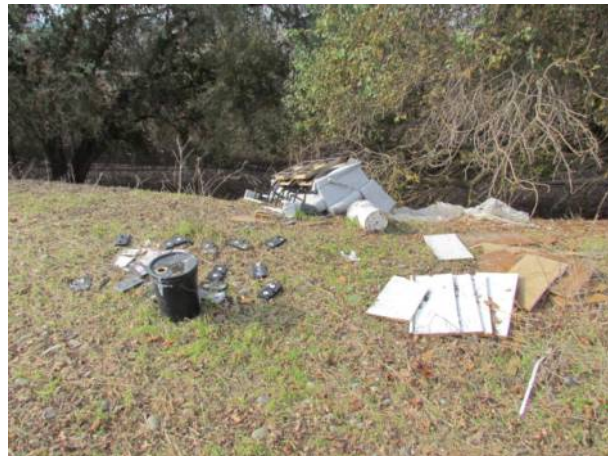
Levee Mile Report Line	10
Start Levee Mile	0.19
End Levee Mile	0.19
Location	Land Side
Category	Earthen Levee
Item	Encroachments

Looking west at garbage on landside slope.

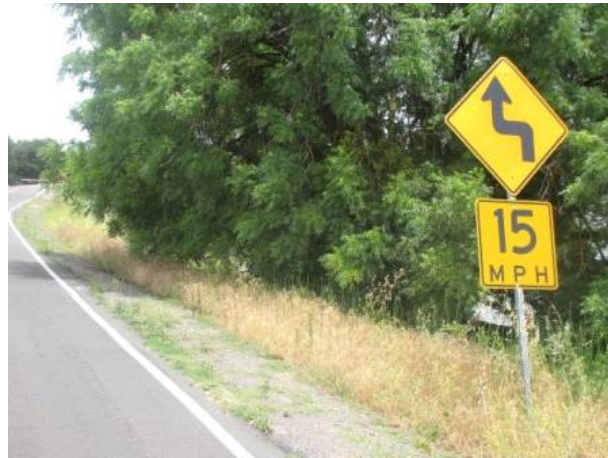
Levee Mile Report Line	12
Start Levee Mile	0.25
End Levee Mile	0.28
Location	Water Side
Category	Earthen Levee
Item	Trim / Thin Trees

Looking northeast at overgrown trees on waterside slope.

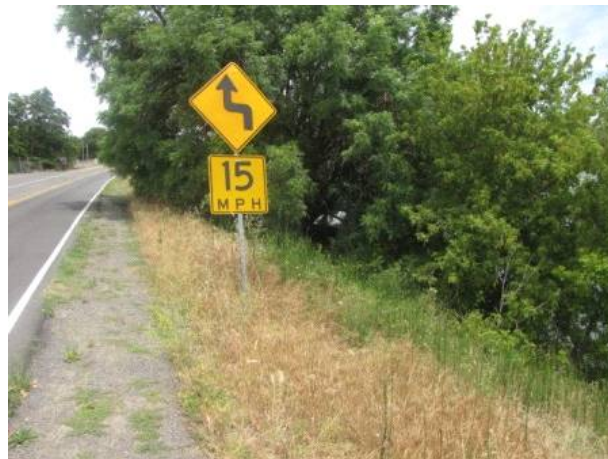
Levee Mile Report Line	12
Start Levee Mile	0.25
End Levee Mile	0.28
Location	Water Side
Category	Earthen Levee
Item	Trim / Thin Trees

Looking north at dense trees on waterside slope from fall 2010 inspection.

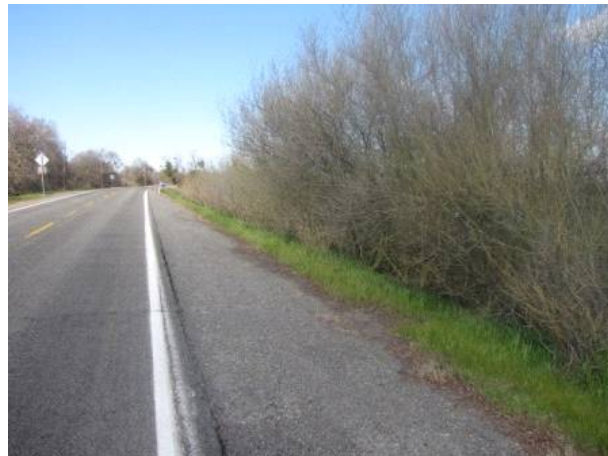
Levee Mile Report Line	12
Start Levee Mile	0.25
End Levee Mile	0.28
Location	Water Side
Category	Earthen Levee
Item	Trim / Thin Trees

Looking upstream (north) at dense vegetation and trees from 2011 spring inspection.

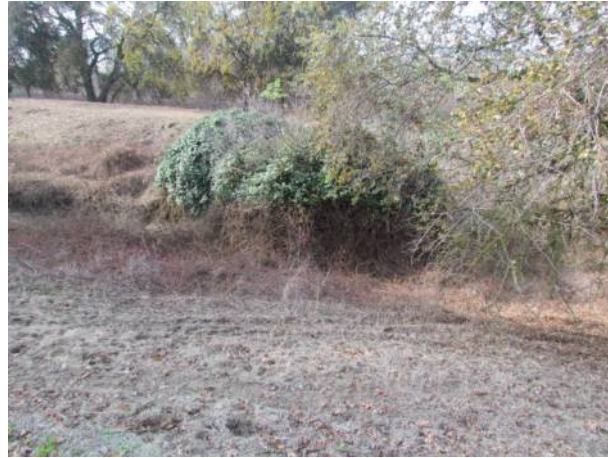
Levee Mile Report Line	17
Start Levee Mile	0.41
End Levee Mile	0.41
Location	Land Side
Category	Earthen Levee
Item	Vegetation

Looking west at dense berryvines on landside toe.

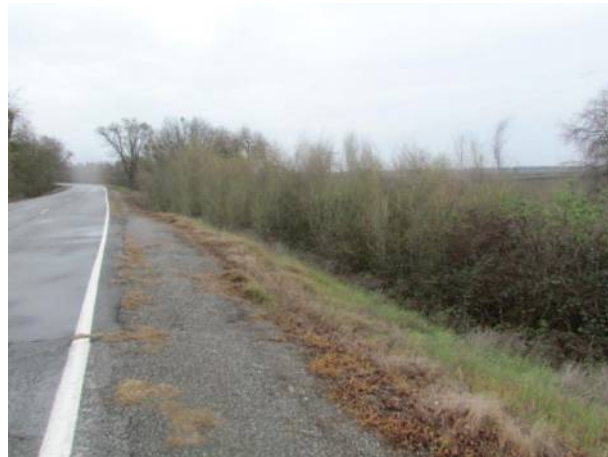
Levee Mile Report Line	18
Start Levee Mile	0.43
End Levee Mile	0.47
Location	Land Side
Category	Earthen Levee
Item	Trim / Thin Trees

Looking southwest at dense vegetation on landside slope and toe.

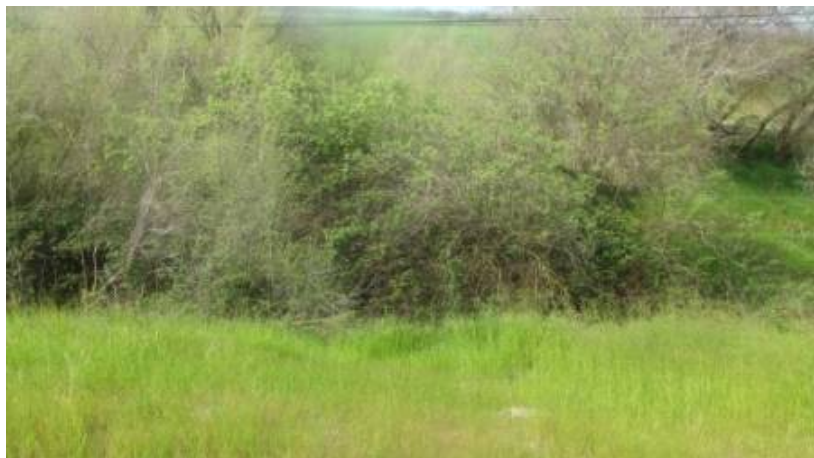
Levee Mile Report Line	19
Start Levee Mile	0.48
End Levee Mile	0.50
Location	Land Side
Category	Earthen Levee
Item	Vegetation

Looking northwest at trees on landside toe from 2010 fall inspection.

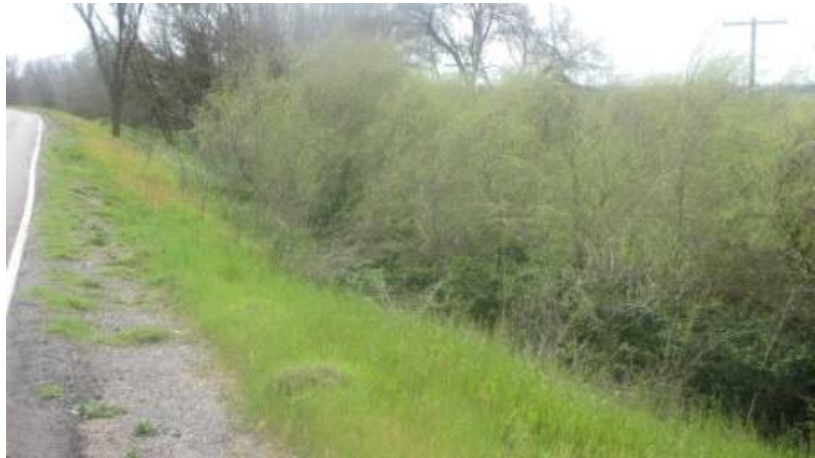
Levee Mile Report Line	19
Start Levee Mile	0.48
End Levee Mile	0.50
Location	Land Side
Category	Earthen Levee
Item	Vegetation

Looking downstream (south) at trees on landside slope & toe.

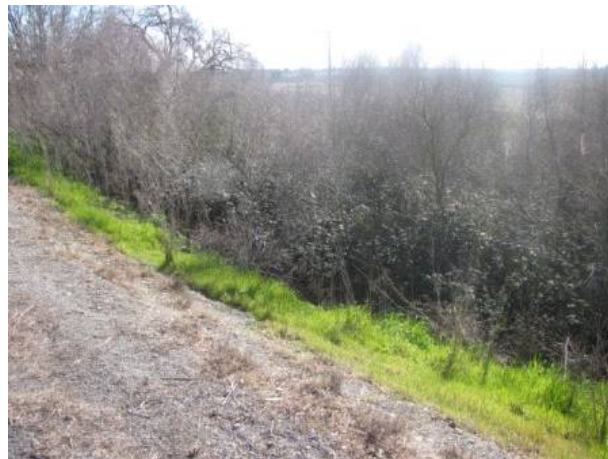
Levee Mile Report Line	19
Start Levee Mile	0.48
End Levee Mile	0.50
Location	Land Side
Category	Earthen Levee
Item	Vegetation

Looking downstream (southwest) at dense vegetation on landside slope.

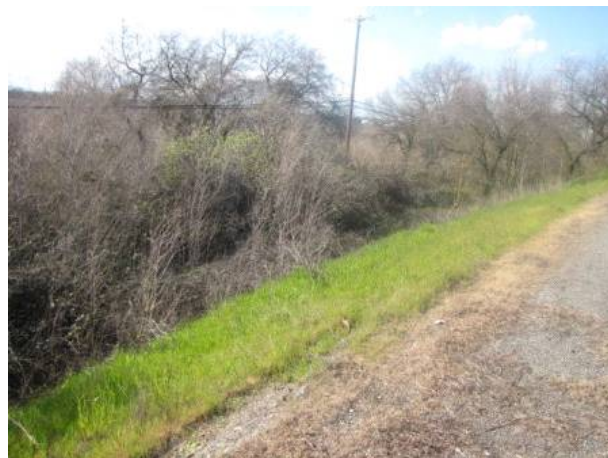
Levee Mile Report Line	19
Start Levee Mile	0.48
End Levee Mile	0.50
Location	Land Side
Category	Earthen Levee
Item	Vegetation

Looking upstream (northwest) at dense vegetation on landside slope.

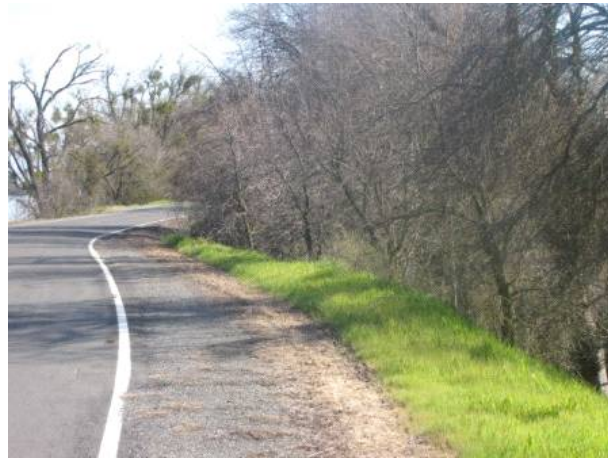
Levee Mile Report Line	27
Start Levee Mile	0.87
End Levee Mile	0.99
Location	Land Side
Category	Earthen Levee
Item	Trim / Thin Trees
Looking downstream (south) at dense trees on landside slope and toe.	
richard_f_20121101_622.jpg

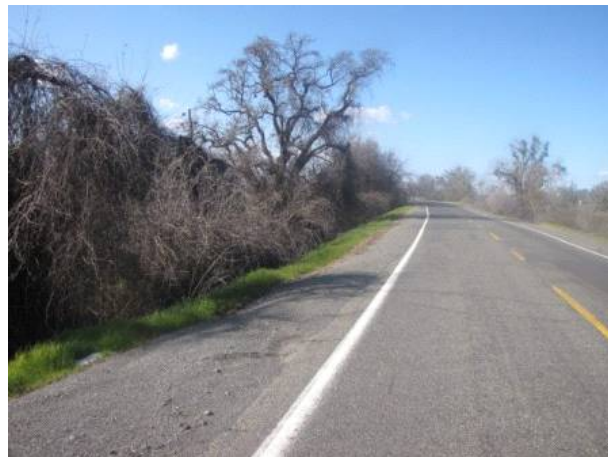
Levee Mile Report Line	27
Start Levee Mile	0.87
End Levee Mile	0.99
Location	Land Side
Category	Earthen Levee
Item	Trim / Thin Trees
Looking upstream (north) at dense trees on landside slope and toe.	
richard_f_20121101_623.jpg

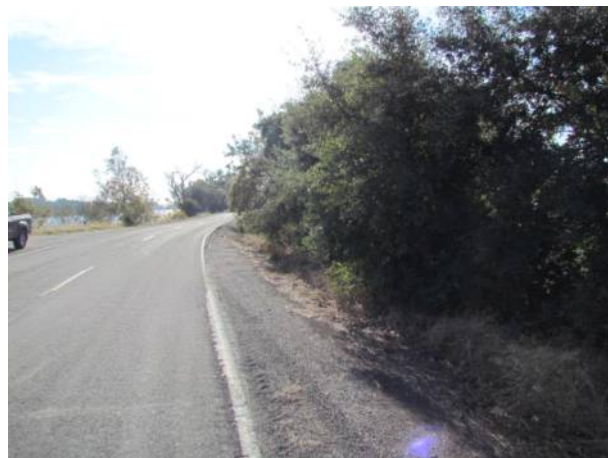
Levee Mile Report Line	27
Start Levee Mile	0.87
End Levee Mile	0.99
Location	Land Side
Category	Earthen Levee
Item	Trim / Thin Trees
Looking south at dense trees on landside shoulder and slope. (November 2011)	
richard_f_20121101_624.jpg

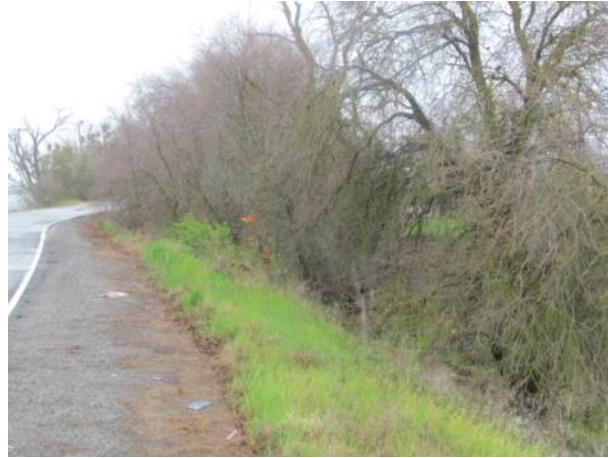
Levee Mile Report Line	27
Start Levee Mile	0.87
End Levee Mile	0.99
Location	Land Side
Category	Earthen Levee
Item	Trim / Thin Trees

Looking southwest at dense trees on landside slope and toe spring 2012.

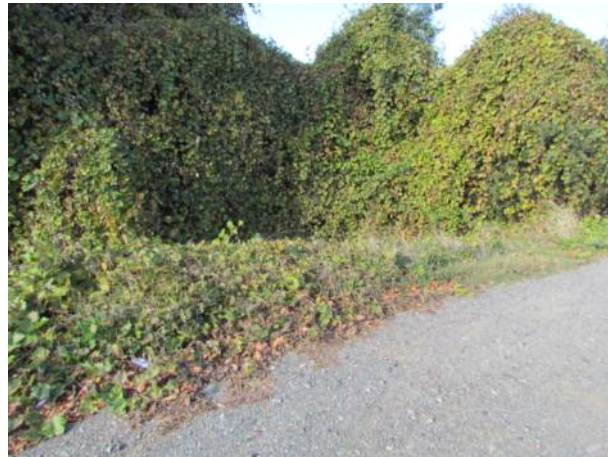
Levee Mile Report Line	28
Start Levee Mile	0.97
End Levee Mile	0.97
Location	Land Side
Category	Earthen Levee
Item	Vegetation

Looking west at dense berryvines and wildroses on landside shoulder and slope. (November 2011)

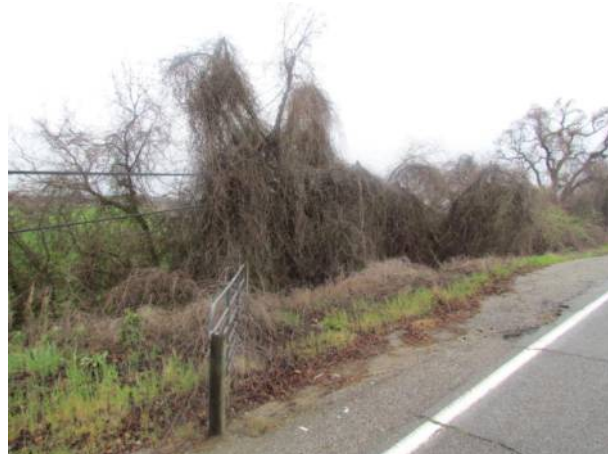
Levee Mile Report Line	28
Start Levee Mile	0.97
End Levee Mile	0.97
Location	Land Side
Category	Earthen Levee
Item	Vegetation

Looking northwest at vines on landside toe spring 2012.

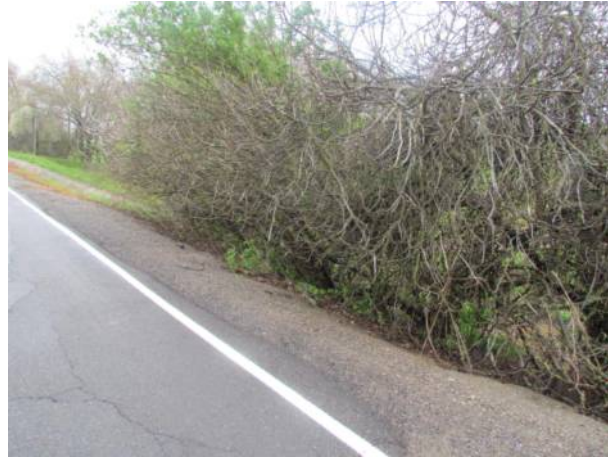
Levee Mile Report Line	30
Start Levee Mile	1.02
End Levee Mile	1.02
Location	Land Side
Category	Earthen Levee
Item	Vegetation

Looking southwest at fig trees and other trees on landside slope and toe.

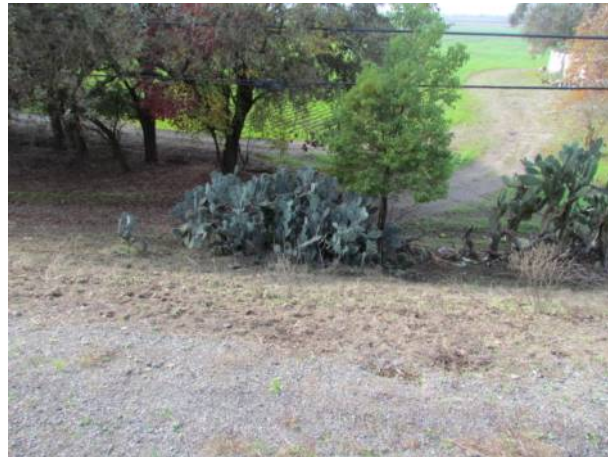
Levee Mile Report Line	31
Start Levee Mile	1.04
End Levee Mile	1.04
Location	Land Side
Category	Earthen Levee
Item	Vegetation

Looking west at cactus at landside toe.

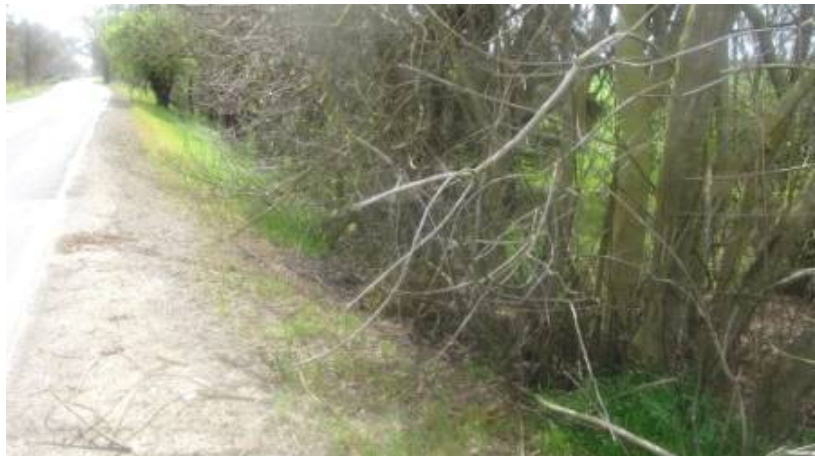
Levee Mile Report Line	32
Start Levee Mile	1.08
End Levee Mile	1.08
Location	Land Side
Category	Earthen Levee
Item	Trim / Thin Trees

Looking downstream (south) at trees on landside slope & toe from 2010 fall inspection.

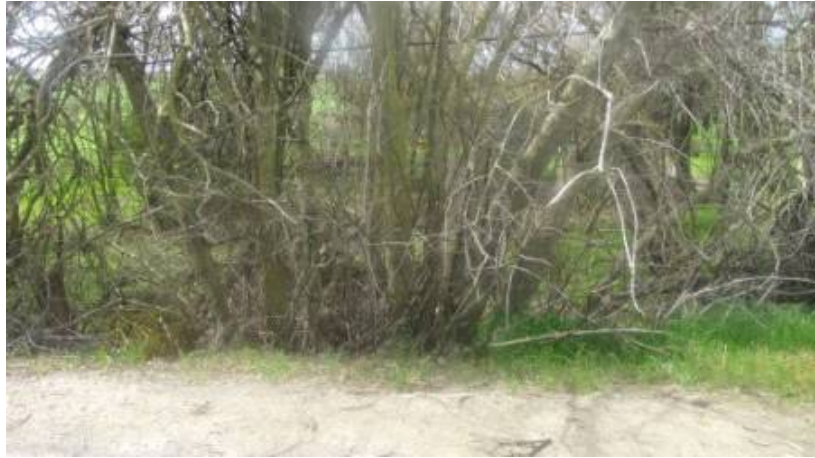
Levee Mile Report Line	32
Start Levee Mile	1.08
End Levee Mile	1.08
Location	Land Side
Category	Earthen Levee
Item	Trim / Thin Trees

Looking west at trees on landside slope & toe.

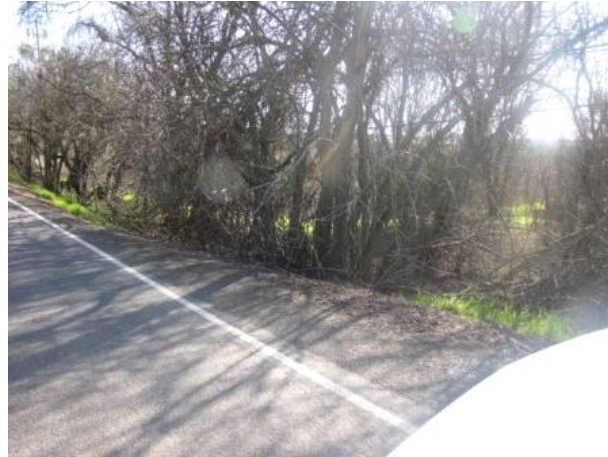
Levee Mile Report Line	32
Start Levee Mile	1.08
End Levee Mile	1.08
Location	Land Side
Category	Earthen Levee
Item	Trim / Thin Trees

Looking downstream (southwest) at dense trees on landside slope and toe.

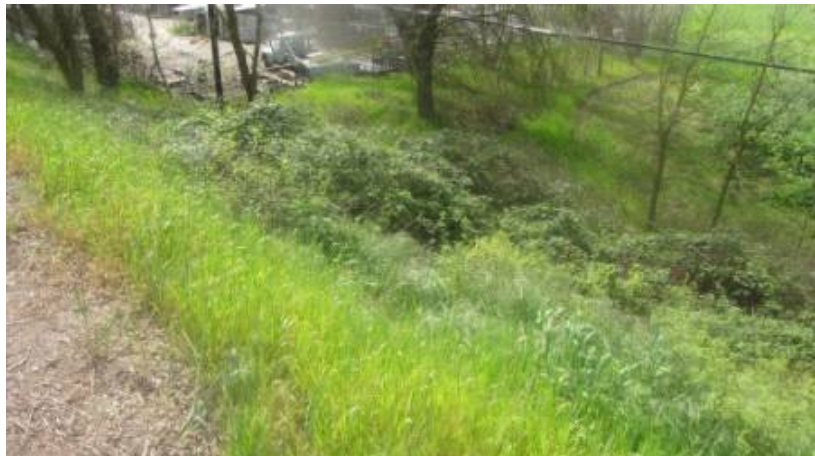
Levee Mile Report Line	34
Start Levee Mile	1.15
End Levee Mile	1.15
Location	Land Side
Category	Earthen Levee
Item	Vegetation

Looking downstream (southwest) at wild roses on landside slope & toe.

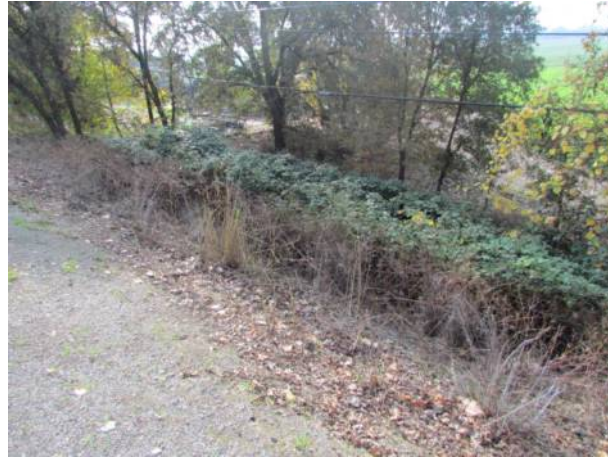
Looking southwest at dense vegetation on landside slope and toe.

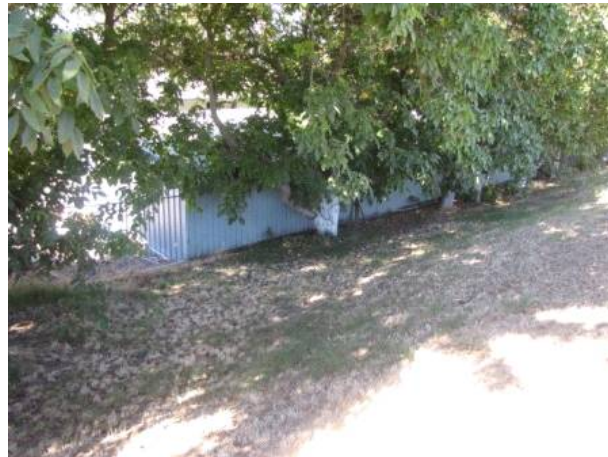
Levee Mile Report Line	37
Start Levee Mile	1.19
End Levee Mile	1.22
Location	Land Side
Category	Earthen Levee
Item	Encroachments

Looking northwest at buildings along landside toe.

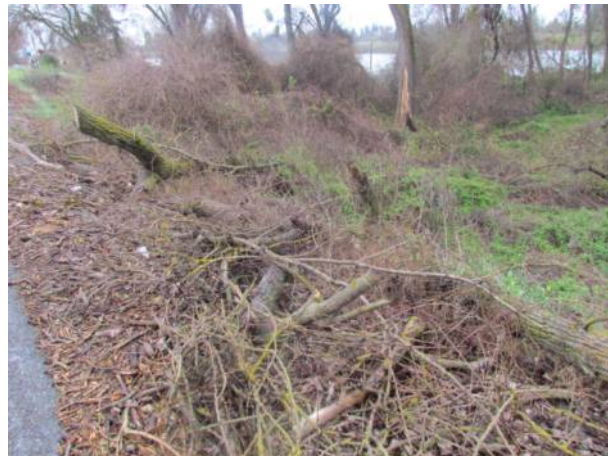
Levee Mile Report Line	39
Start Levee Mile	1.33
End Levee Mile	1.33
Location	Water Side
Category	Earthen Levee
Item	Encroachments

DWR ID: DWR_RD0765_01_s_2012_26										
39	1.33	1.33	Earthen Levee	Encroachments	WS	M En	TR : Tree or limb Inspector Comments: Downed tree on waterside slope.	38.485245 ° -121.552807 °	38.485245 ° -121.552807 °	20 Y
DWR ID: DWR_RD0765_01_s_2012_20										
40	1.36	1.36	Earthen Levee	Vegetation	WS	U Ma	V2 : Remove the wild growth other than native grasses from the levee slopes.	38.484877 ° -121.552540 °	38.484877 ° -121.552540 °	7 Y
DWR ID: DWR_RD0765_01_s_2012_7										
41	1.41	1.41	Earthen Levee	Trim / Thin Trees	WS	M Ma	T1 : Trim trees to at least five feet above ground level.	38.484316 ° -121.552115 °	38.484316 ° -121.552115 °	4 Y
DWR ID: DWR_RD0765_01_s_2012_4										
42	1.44	1.47	Earthen Levee	Trim / Thin Trees	WS	U Ma	T2 : Thin trees to allow visibility of the ground and room to flood fight.	38.483925 ° -121.551845 °	38.483530 ° -121.551587 °	5 Y
DWR ID: DWR_RD0765_01_s_2012_5

Looking northeast at tree limbs on waterside slope.

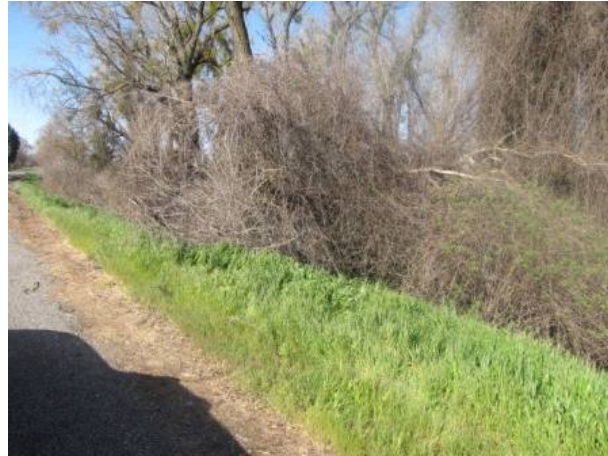
Looking upstream (north) at dense vegetation on waterside slope.

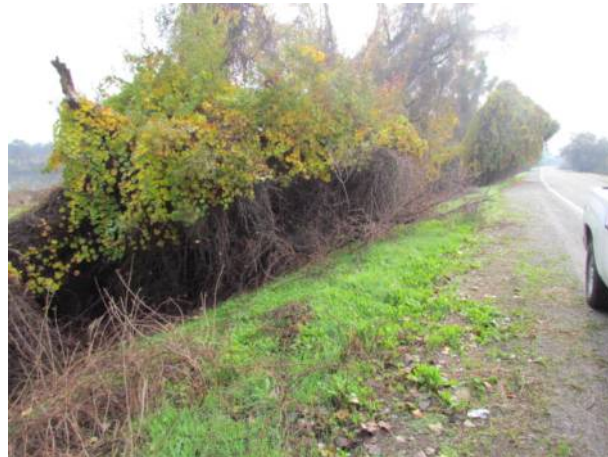
Levee Mile Report Line	40
Start Levee Mile	1.36
End Levee Mile	1.36
Location	Water Side
Category	Earthen Levee
Item	Vegetation

Looking southeast at dense vegetation on waterside slope. (Fall Inspection 2012)

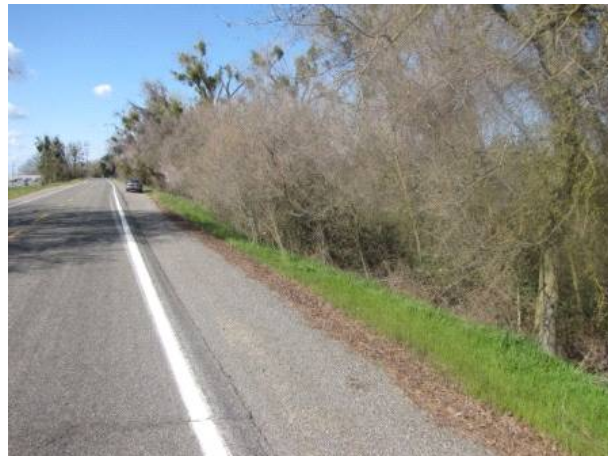
Levee Mile Report Line	42
Start Levee Mile	1.44
End Levee Mile	1.47
Location	Water Side
Category	Earthen Levee
Item	Trim / Thin Trees

Looking upstream (north) at dense trees on waterside slope.

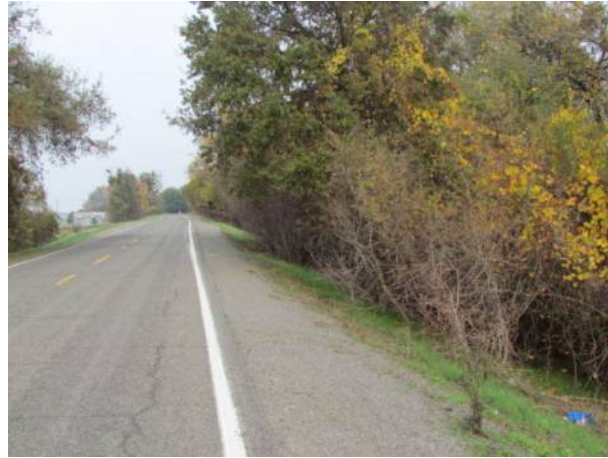
Looking north at dense vegetation on waterside slope. (Fall Inspection 2012)

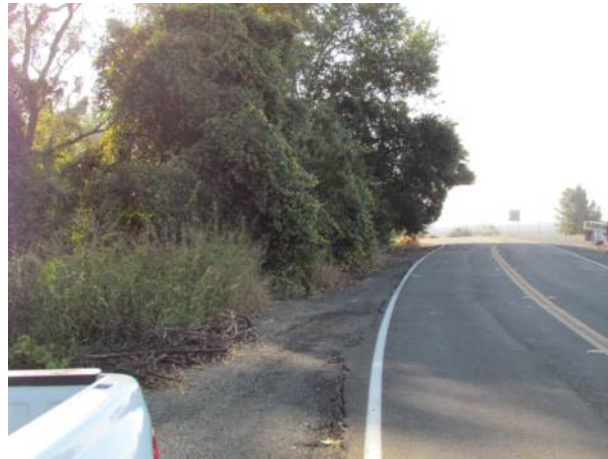
Levee Mile Report Line	45
Start Levee Mile	1.52
End Levee Mile	1.73
Location	Water Side
Category	Earthen Levee
Item	Vegetation

Looking south at dense trees and vegetation on waterside slope. (November 2011)

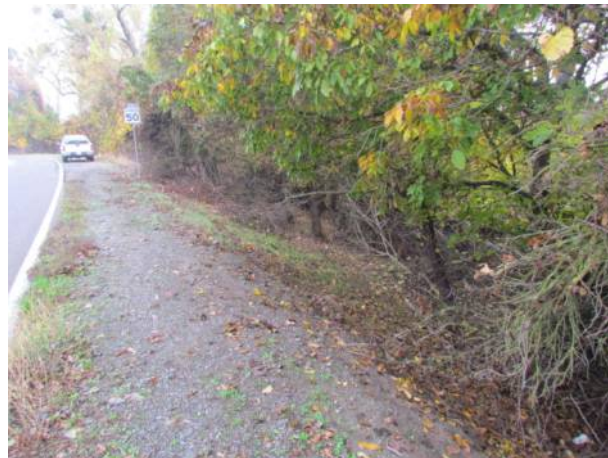
Levee Mile Report Line	45
Start Levee Mile	1.52
End Levee Mile	1.73
Location	Water Side
Category	Earthen Levee
Item	Vegetation

Looking north at dense vegetation on waterside slope.

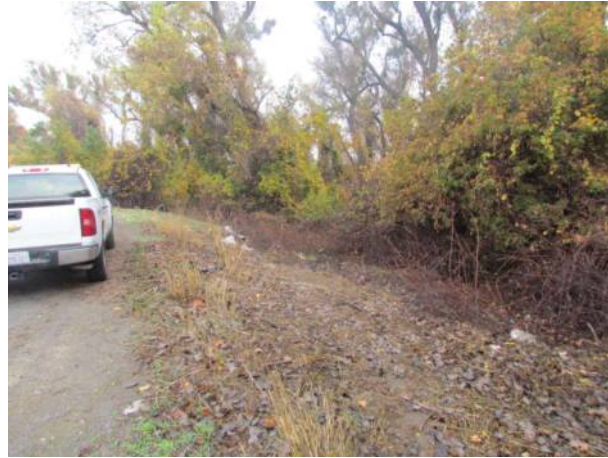
Looking northeast at dense vegetation on waterside slope.

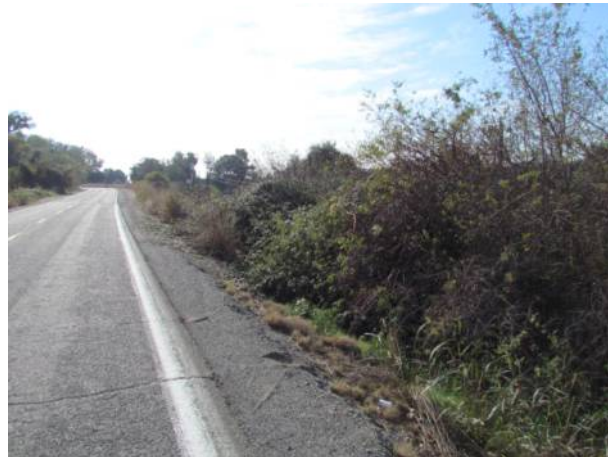
Levee Mile Report Line	46
Start Levee Mile	1.54
End Levee Mile	1.63
Location	Land Side
Category	Earthen Levee
Item	Vegetation

Looking south at dense vegetation on landside shoulder and slope. (November 2011)

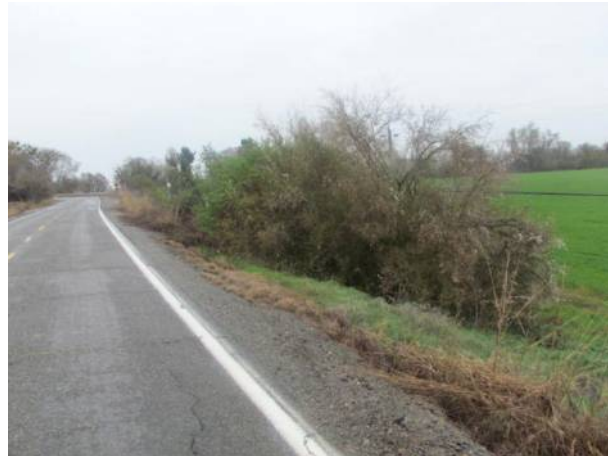
Levee Mile Report Line	46
Start Levee Mile	1.54
End Levee Mile	1.63
Location	Land Side
Category	Earthen Levee
Item	Vegetation

Looking south at dense vegetation on landside slope and toe spring 2012.

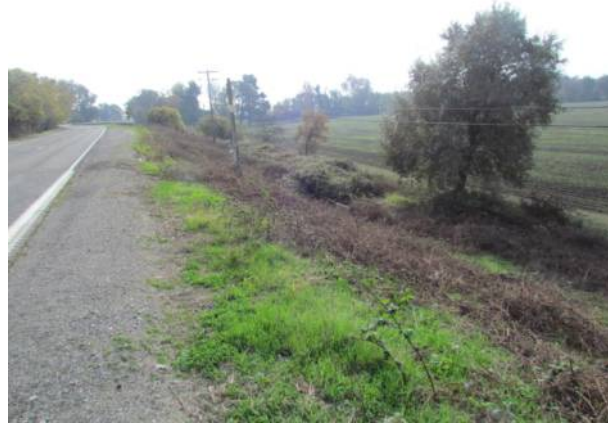
Looking southwest at vegetation on landside slope and toe. (Fall Inspection 2012)

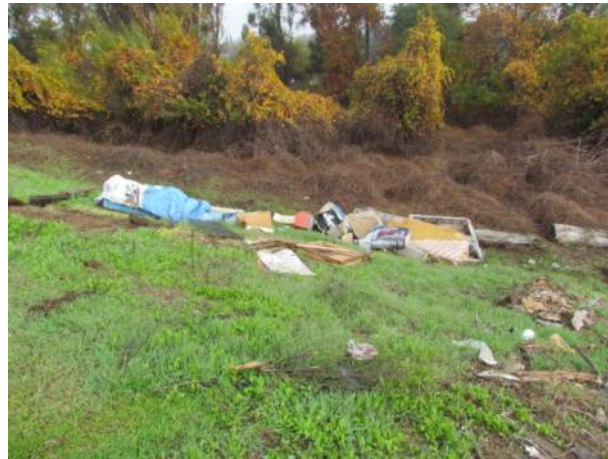
Levee Mile Report Line	47
Start Levee Mile	1.54
End Levee Mile	1.54
Location	Water Side
Category	Earthen Levee
Item	Encroachments

Looking northeast at garbage on waterside slope.

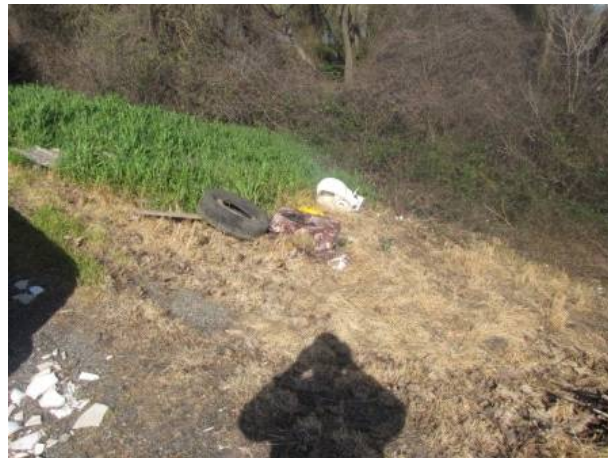
Levee Mile Report Line	48
Start Levee Mile	1.69
End Levee Mile	1.69
Location	Water Side
Category	Earthen Levee
Item	Encroachments

Looking northeast at garbage on waterside slope. (May 2011)

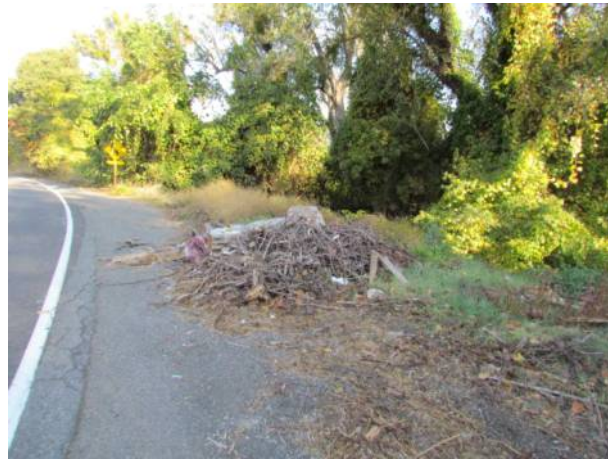
Looking north at garbage and pruning pile on waterside shoulder. (November 2011)

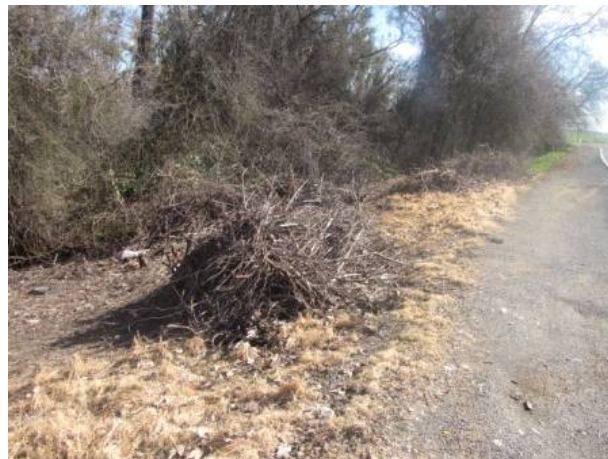
Levee Mile Report Line	49
Start Levee Mile	1.70
End Levee Mile	1.70
Location	Water Side
Category	Earthen Levee
Item	Encroachments

49	1.70	1.70	Earthen Levee	Encroachments	WSA/W Ma	PR : Prunings	Inspector Comments: Landowner burned pruning pile.	38.480632 ° -121.549543 °	38.480632 ° -121.549543 °	13 Y
DWR ID: DWR_RD0765_01_s_2012_13

Looking southeast at pruning piles on waterside shoulder & slope.
