**Flood Control Project Maintenance
Levee Inspections**

Fall 2015 Levee Maintenance Deficiency Summary Report

Reclamation District No. 0765 Glide

Waterway			Bank	Unit Miles
Unit No. 01 Sacramento River			Right	1.72
	Spring (March - May)	Summer (June - August)	(September - November) Fall	Winter (December - February)
Unit Maintenance Rating (Fall Only)			U	
Date of Inspection	04/23/2015 - 04/23/2015		09/25/2015 - 09/25/2015	
DWR Inspector	Richard Willoughby		Richard Willoughby	
Accompanied By	Everett Lovejoy RD 765		Everett Lovejoy RD 765

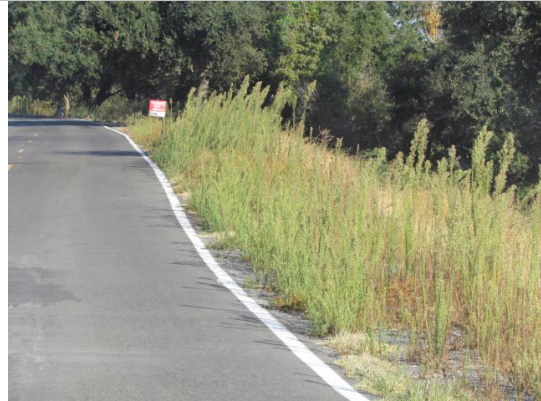
Photo 1 of 2 : FA_2015_RD0765_211_59_20150925_00065.jpg

Looking south at typical view of vegetation on waterward slope.

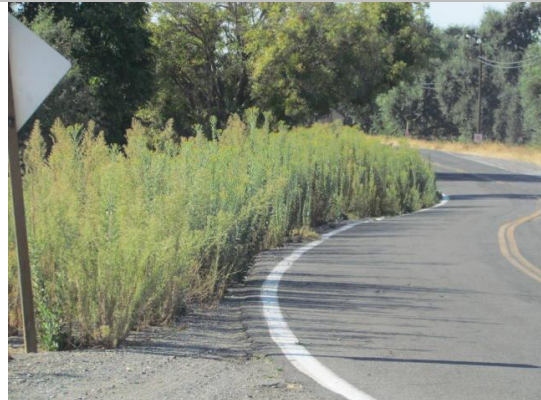
Photo 2 of 2 : FA_2015_RD0765_211_59_20150925_00066.jpg

Looking north at typical view of vegetation on waterward slope.

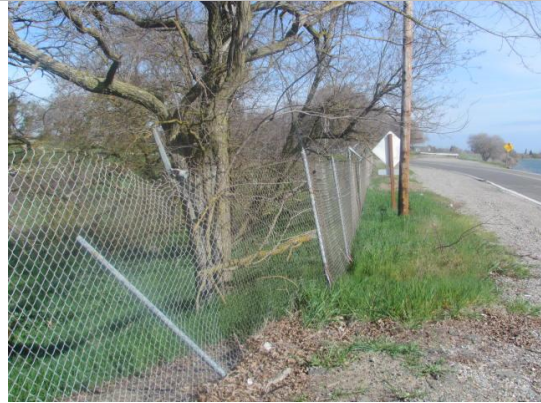
Photo 1 of 1 : FA_2015_RD0765_211_3_20150914_00001.jpg

Looking north (upstream) at trees on landside slope.

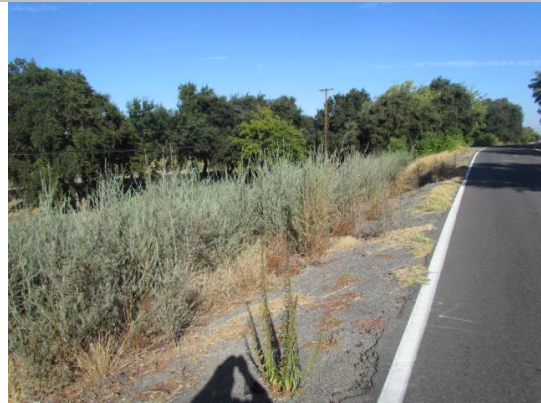
Photo 1 of 2 : FA_2015_RD0765_211_61_20150925_00067.jpg

LM Start	0.08	Rating **	U	Issue No.	61
LM End	1.15	Issue Type +	Ma	Location *	LS
Category	Earthen Levee			GPS Latitude/Longitude	
				Start	End
Item	Vegetation			38.501832 °	38.487471 °
				-121.560301 °	-121.554125 °
DWR ID	DWR_RD0765_01_f_2015_61				
Action/Comments					
Remove the wild growth other than native grasses from the levee slopes.

Looking south at typical view of vegetation on landward slope.

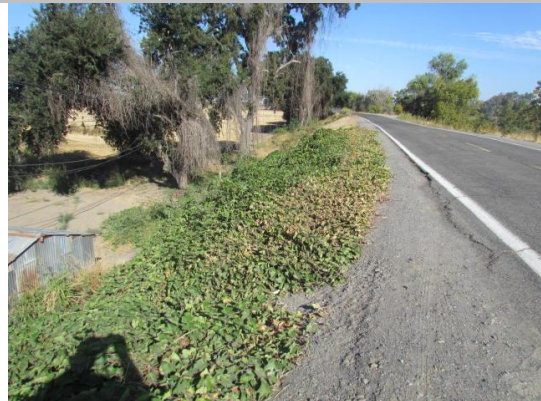
Photo 2 of 2 : FA_2015_RD0765_211_61_20150925_00068.jpg

LM Start	0.08	Rating **	U	Issue No.	61 (cont)
LM End	1.15	Issue Type +	Ma	Location *	LS

Looking north at typical view of vegetation on landward slope.

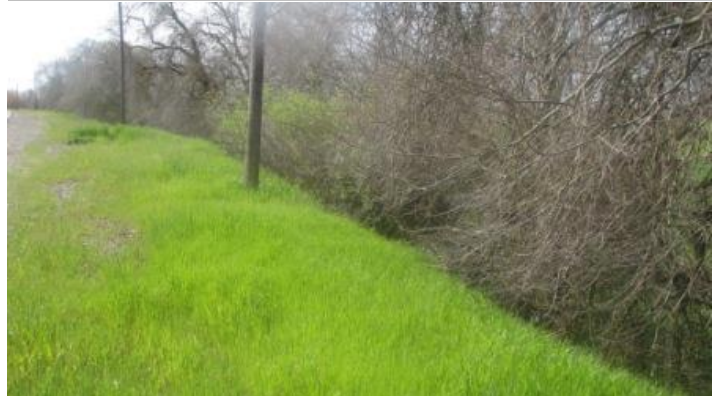
Photo 1 of 2 : FA_2015_RD0765_211_28_20150914_00025.jpg

Looking downstream (south) at trees on landside slope & toe.

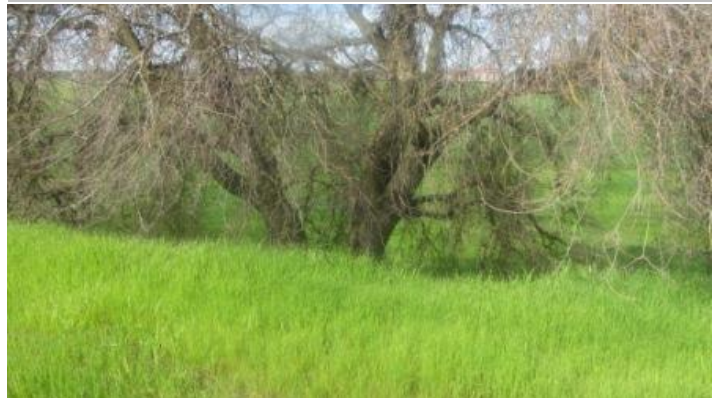
Photo 2 of 2 : FA_2015_RD0765_211_28_20150914_00026.jpg

LM Start	0.12	Rating **	M	Issue No.	28 (cont)
LM End	0.19	Issue Type +	Ma	Location *	LS

Looking west at trees on landside toe.

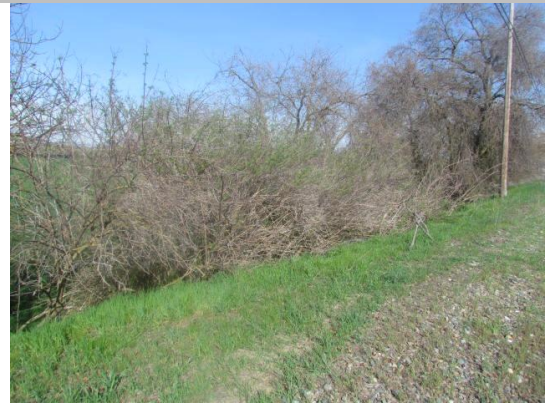
Photo 1 of 1 : FA_2015_RD0765_211_22_20150914_00022.jpg

Looking northwest at dense vegetation on landside slope.

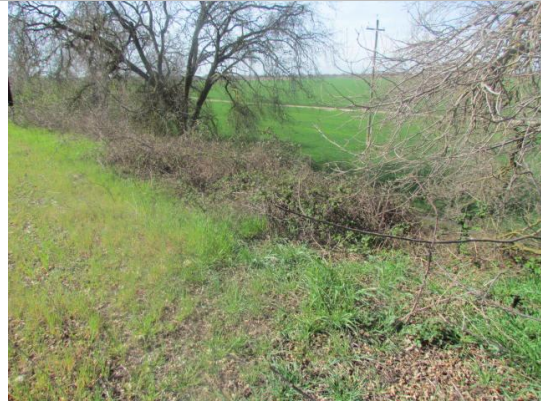
Photo 1 of 1 : FA_2015_RD0765_211_49_20150914_00047.jpg

Looking at wild berryvines or wild roses on landside slope and toe.

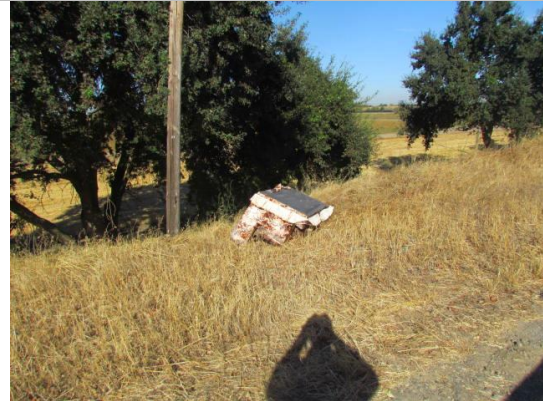
Photo 1 of 1 : FA_2015_RD0765_211_62_20150925_00069.jpg

Looking westly at garbage on landward shoulder.

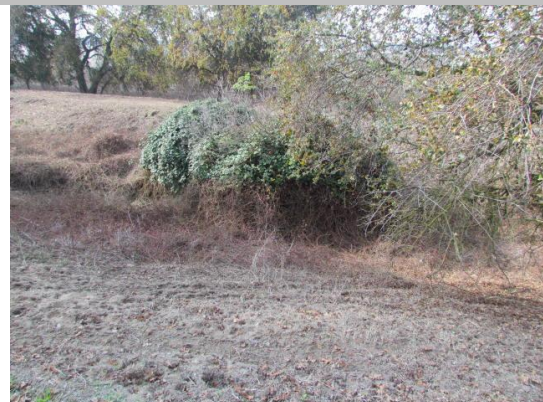
Photo 1 of 1 : FA_2015_RD0765_211_47_20150914_00045.jpg

Looking west at dense berryvines on landside toe.

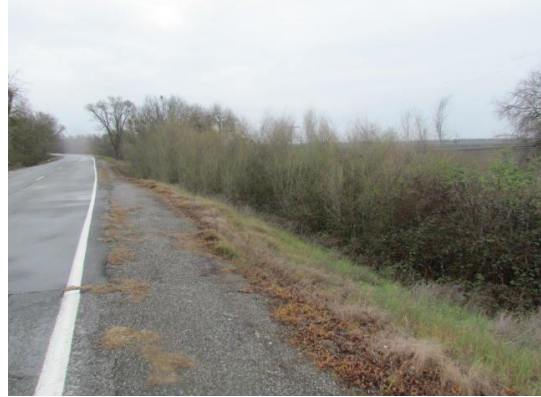
Photo 1 of 1 : FA_2015_RD0765_211_32_20150914_00033.jpg

Looking southwest at dense vegetation on landside slope and toe.

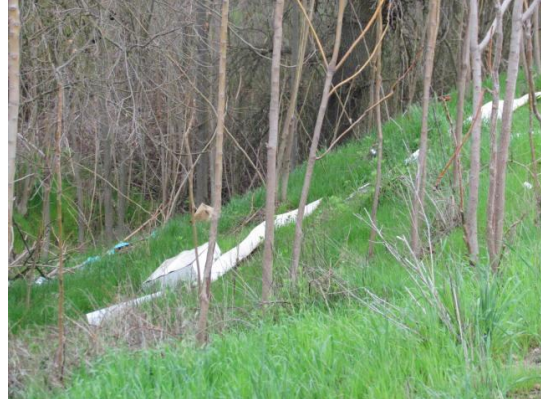
Photo 1 of 2 : FA_2015_RD0765_211_55_20150914_00056.jpg

LM Start	0.47	Rating **	A/W	Issue No.	55
LM End	0.47	Issue Type +	Ma	Location *	LS
Category	Earthen Levee			GPS Latitude/Longitude	
				Start	End
Item	Encroachments			38.496235 °	38.496235 °
				-121.559796 °	-121.559796 °
DWR ID	DWR_RD0765_01_f_2013_55				
Action/Comments					
Garbage					
Inspector Comments: Trash dumped on landside slope.

Looking northwest at garbage on landside slope.

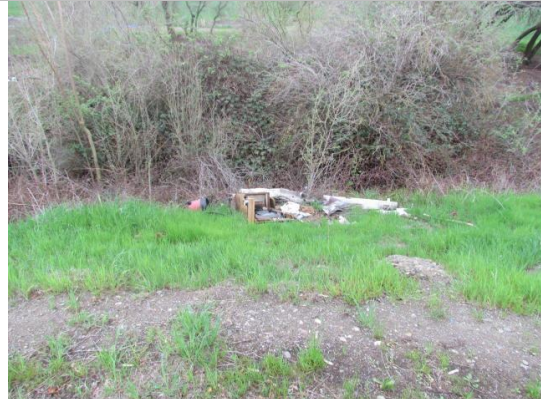
Photo 2 of 2 : FA_2015_RD0765_211_55_20150914_00057.jpg

LM Start	0.47	Rating **	A/W	Issue No.	55 (cont)
LM End	0.47	Issue Type +	Ma	Location *	LS

Looking west at garbage on landside slope.

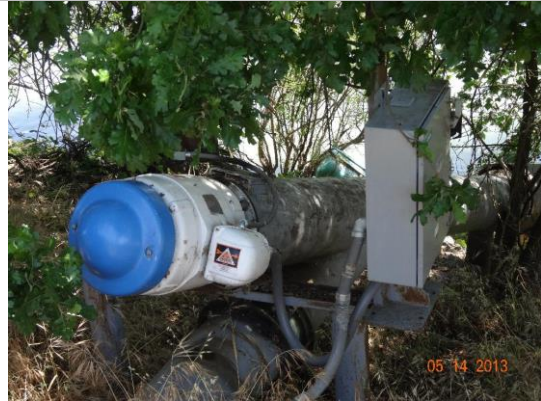
Photo 1 of 3 : UCIP_FA_2015_3668.jpg

LM Start	0.54	Rating **	M	Issue No.	63
LM End	0.54	Issue Type +	En	Location *	LS
Category	Supplemental			GPS Latitude/Longitude	
				Start	End
Item	DWR UCIP Field Study			38.495374 °	38.495374 °
				-121.559262 °	-121.559262 °
DWR ID					
Action/Comments					
Inspector Comments: FS_ID:44403					
DS_ID:21138					
EP_NO: 3314					
FS_HLM: 0.54					
Repair Type: Non-Urgent					
Crossing Status: Found

Close up of slant pump and control panel on waterward side.

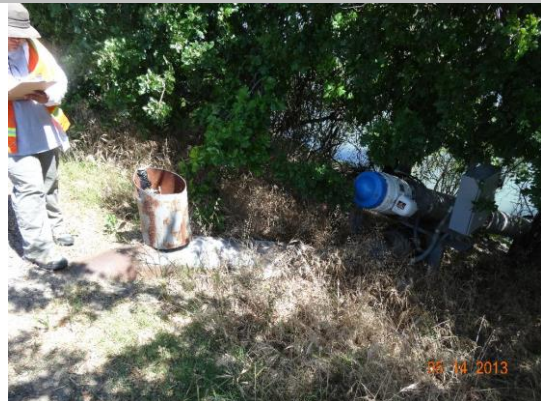
Photo 2 of 3 : UCIP_FA_2015_3669.jpg

Siphon breaker encased in steel casing located on waterward side.

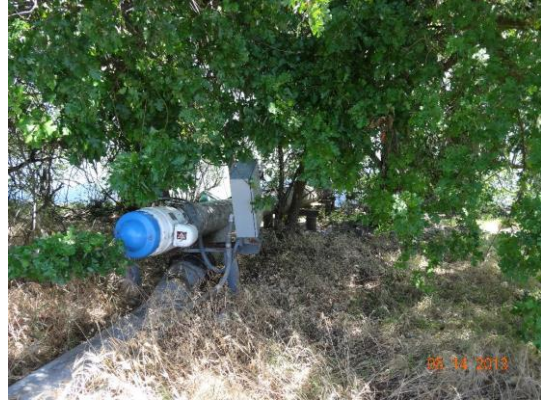
Photo 3 of 3 : UCIP_FA_2015_3670.jpg

LM Start	0.54	Rating **	M	Issue No.	63 (cont)	
LM End	0.54	Issue Type +	En	Location *	LS	
Category	Supplemental			GPS Latitude/Longitude		
				Start		End
Item	DWR UCIP Field Study			38.495374 °		38.495374 °
				-121.559262 °		-121.559262 °
DWR ID						
Action/Comments						
Inspector Comments: FS_ID:44403						
DS_ID:21138						
EP_NO: 3314						
FS_HLM: 0.54						
Repair Type: Non-Urgent						
Crossing Status: Found

View of waterward side--pipe, pump, control panels, and electrical conduit.

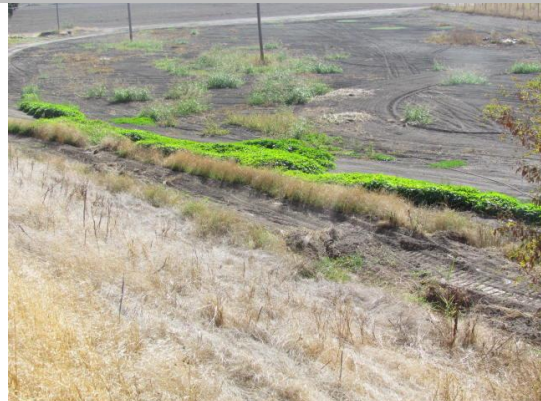
Photo 1 of 3 : FA_2015_RD0765_211_56_20150914_00058.jpg

LM Start	0.54	Rating **	A/W	Issue No.	56
LM End	0.70	Issue Type +	En	Location *	LS
Category	Earthen Levee			GPS Latitude/Longitude	
				Start	End
Item	Encroachments			38.495350 °	38.493303 °
				-121.559300 °	-121.557620 °
DWR ID	DWR_RD0765_01_f_2013_56				
Action/Comments					
Ditch					
Inspector Comments: Irrigation ditch at landward toe.

Looking southwest at irrigation ditch filled in.

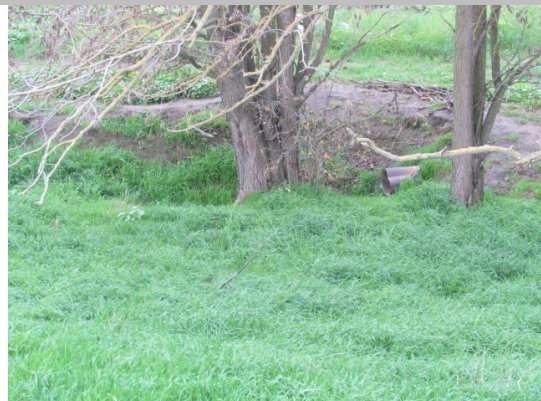
Photo 2 of 3 : FA_2015_RD0765_211_56_20150914_00059.jpg

LM Start	0.54	Rating **	A/W	Issue No.	56 (cont)
LM End	0.70	Issue Type +	En	Location *	LS

Looking west at irrigation ditch at landward toe.

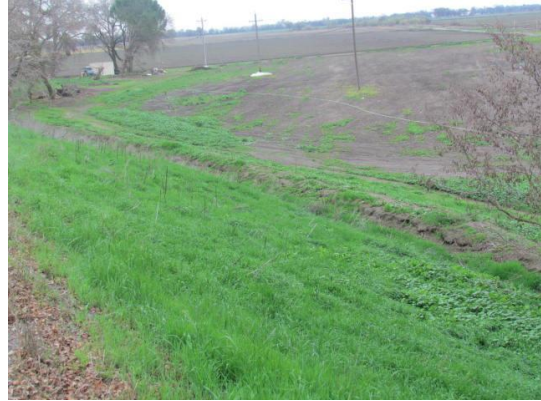
Photo 3 of 3 : FA_2015_RD0765_211_56_20150914_00060.jpg

Looking southwest at irrigation ditch running along landward toe.

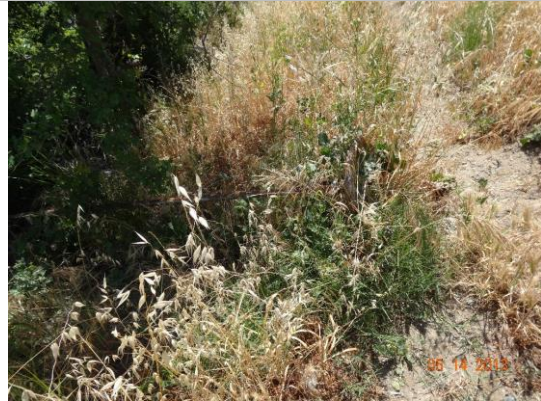
Photo 1 of 2 : UCIP_FA_2015_3671.jpg

LM Start	0.94	Rating **	M	Issue No.	64
LM End	0.94	Issue Type +	En	Location *	LS
Category	Supplemental			GPS Latitude/Longitude	
				Start	End
Item	DWR UCIP Field Study			38.490192 °	38.490192 °
				-121.555628 °	-121.555628 °
DWR ID					
Action/Comments					
Inspector Comments: FS_ID:44404					
DS_ID:21139					
EP_NO: 653					
FS_HLM: 0.953					
Repair Type: Non-Urgent					
Crossing Status: Found					
UCIP Comments: Dense vegetation on landward side limits visual inspection of potential leaks. Recommend clearing slope of vegetation.					
FIELD_STRUCT_DESC: 16-inch steel pipe through the levee, 14.3 feet below the crown. Pump on the landward side. Gate valve on the waterward slope. (USACE-1959). This entry matches the Drainage or Irrigation Structure referenced in O&M manual (RM 50.29).					
FS Date: 05/14/2013

View of waterward side--dense vegetation limits inspection.

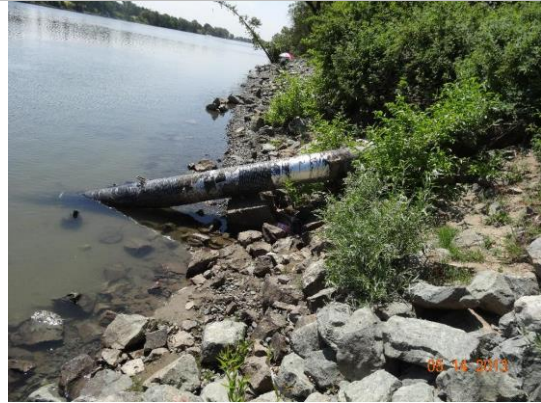
Photo 2 of 2 : UCIP_FA_2015_3672.jpg

Action/Comments					
Inspector Comments: FS_ID:44404 DS_ID:21139 EP_NO: 653 FS_HLM: 0.953 Repair Type: Non-Urgent Crossing Status: Found UCIP Comments: Dense vegetation on landward side limits visual inspection of potential leaks. Recommend clearing slope of vegetation. FIELD_STRUCT_DESC: 16-inch steel pipe through the levee, 14.3 feet below the crown. Pump on the landward side. Gate valve on the waterward slope. (USACE-1959). This entry matches the Drainage or Irrigation Structure referenced in O&M manual (RM 50.29). FS Date: 05/14/2013

Pipe section visible at waterward toe.

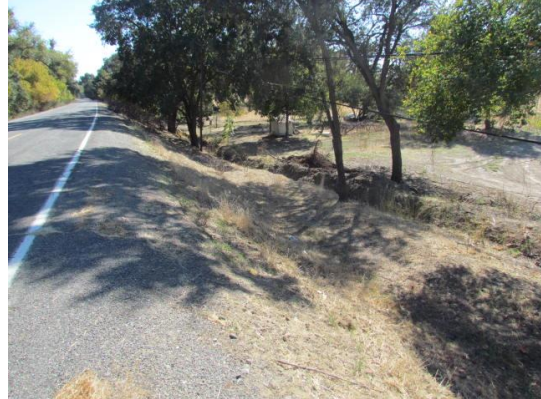
Photo 1 of 1 : FA_2015_RD0765_211_51_20150914_00049.jpg

Looking southwest at irrigation ditch on landward toe.

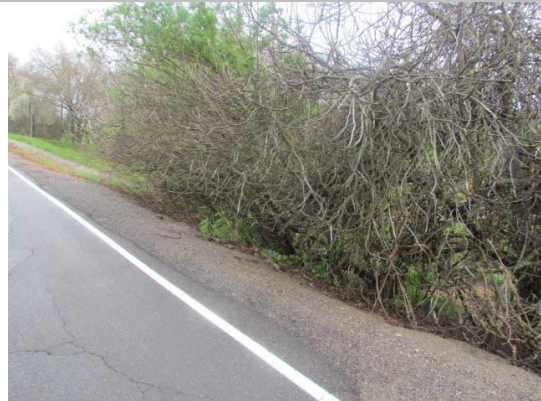
Photo 1 of 1 : FA_2015_RD0765_211_40_20150914_00043.jpg

Looking southwest at fig trees and other trees on landside slope and toe.

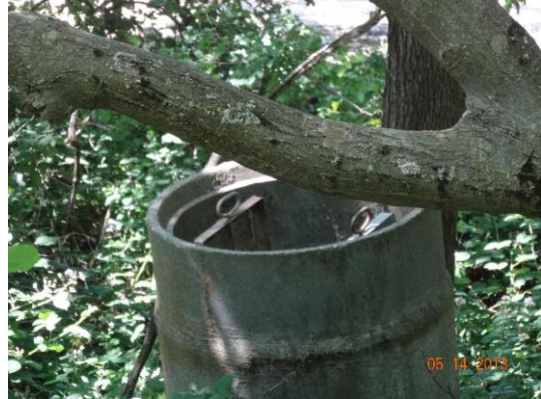
Photo 1 of 3 : UCIP_FA_2015_3837.jpg

Inspector Comments: FS_ID:44407
 DS_ID:21140
 EP_NO: N/A
 FS_HLM: 1.127
 Repair Type: Non-Urgent
 Crossing Status: Indicator Found
 UCIP Comments: Dense vegetation on waterward and landward slopes limit visual inspection of potential leaks along pipe alignment. Recommend having owner clear vegetation along slopes.
 FIELD_STRUCT_DESC: 6-inch steel pipe through the levee, 18.8 feet below the crown. Concrete standpipe on the LS toe. Pump on WS slope. This entry matches the Drainage or Irrigation Structure referenced in O&M manual (RM 50.15).
 FS Date: 04/09/2015

Concrete standpipe with 2 gates inside located on landward side.

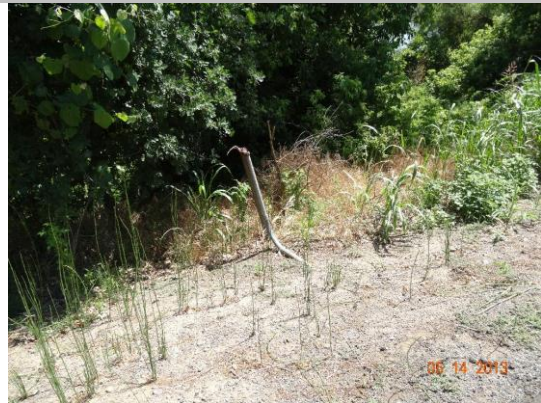
Photo 2 of 3 : UCIP_FA_2015_3838.jpg

Conduits disconnected and damaged on waterward side.

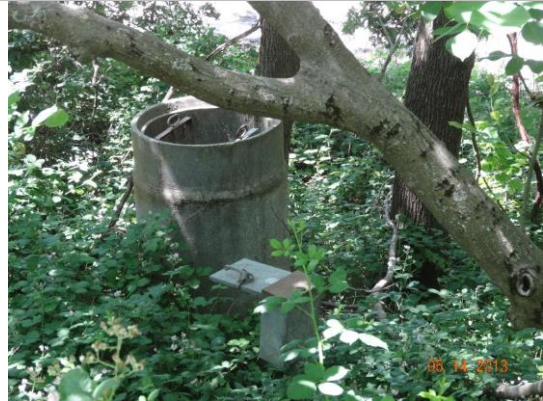
Photo 3 of 3 : UCIP_FA_2015_3839.jpg

LM Start	1.11	Rating **	M	Issue No.	65 (cont)
LM End	1.11	Issue Type +	En	Location *	LS
Category	Supplemental			GPS Latitude/Longitude	
				Start	End
Item	DWR UCIP Field Study			38.487917 °	38.487917 °
				-121.554405 °	-121.554405 °
DWR ID					
Action/Comments					
Inspector Comments: FS_ID:44407					
DS_ID:21140					
EP_NO: N/A					
FS_HLM: 1.127					
Repair Type: Non-Urgent					
Crossing Status: Indicator Found

Overview of landward side--concrete standpipe and control panel located at toe.

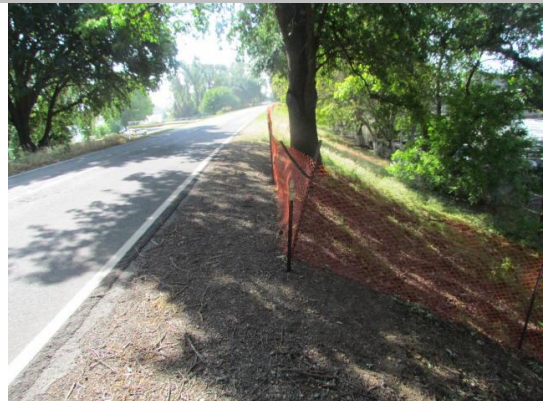
Photo 1 of 2 : FA_2015_RD0765_211_54_20150914_00054.jpg

Looking south at temporary fence on landward slope.

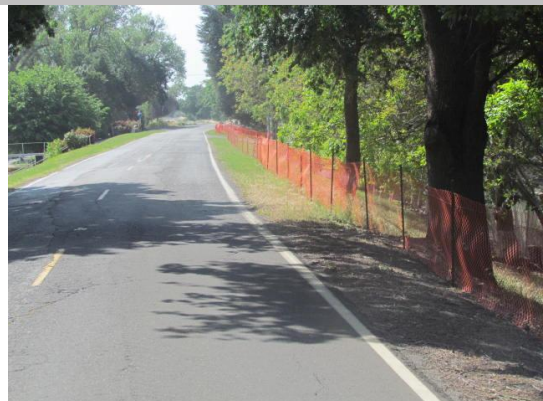
Photo 2 of 2 : FA_2015_RD0765_211_54_20150914_00055.jpg

Looking south at temporary fence on landward shoulder.

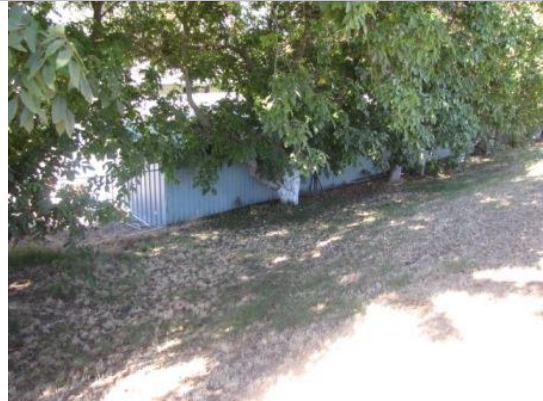
Photo 1 of 1 : FA_2015_RD0765_211_43_20150914_00044.jpg

Looking northwest at buildings along landside toe.

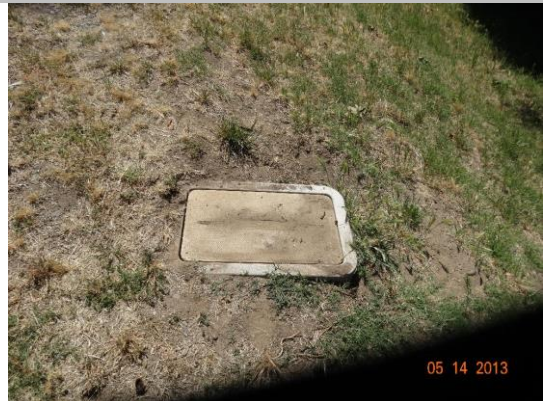
Photo 1 of 2 : UCIP_FA_2015_5803.jpg

LM Start	1.20	Rating **	M	Issue No.	66
LM End	1.20	Issue Type +	En	Location *	LS
Category	Supplemental			GPS Latitude/Longitude	
				Start	End
Item	DWR UCIP Field Study			38.486830 °	38.486830 °
				-121.553698 °	-121.553698 °
DWR ID					
Action/Comments					
Inspector Comments: FS_ID:43203 DS_ID:24660 EP_NO: N/A FS_HLM: 1.21 Repair Type: Non-Urgent Crossing Status: Indicator Found UCIP Comments: Unable to confirm details of crossing. Need to contact owner to determine additional details about crossing and permit issued. FIELD_STRUCT_DESC: PG&E utility service box on landward shoulder. FS Date: 05/14/2013

Utility box located on landward side.

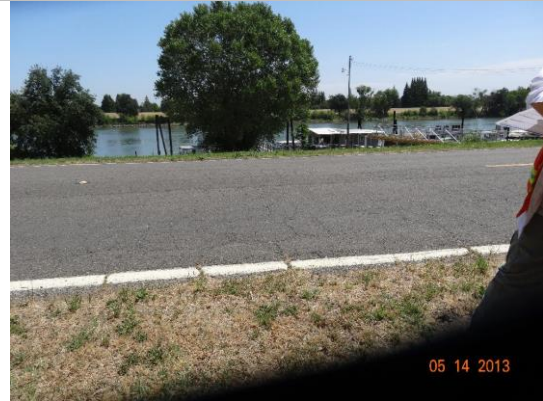
Photo 2 of 2 : UCIP_FA_2015_6077.jpg

LM Start	1.20	Rating **	M	Issue No.	66 (cont)	
LM End	1.20	Issue Type +	En	Location *	LS	
Category	Supplemental			GPS Latitude/Longitude		
				Start	End	
Item	DWR UCIP Field Study			38.486830 °	38.486830 °	
				-121.553698 °	-121.553698 °	
DWR ID						
Action/Comments						
Inspector Comments: FS_ID:43203						
DS_ID:24660						
EP_NO: N/A						
FS_HLM: 1.21						
Repair Type: Non-Urgent						
Crossing Status: Indicator Found						
UCIP Comments: Unable to confirm details of crossing. Need to contact owner to determine additional details about crossing and permit issued.						
FIELD_STRUCT_DESC: PG&E utility service box on landward shoulder.						
FS Date: 05/14/2013

View of levee crown and waterward side.

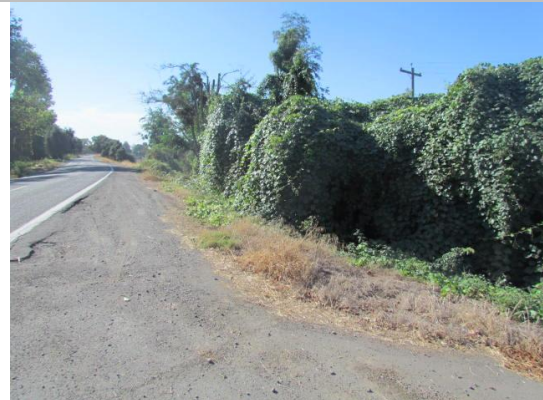
Photo 1 of 3 : FA_2015_RD0765_211_33_20150925_00070.jpg

Looking south from LM 1.28 at typical view of vegetation on landward slope.

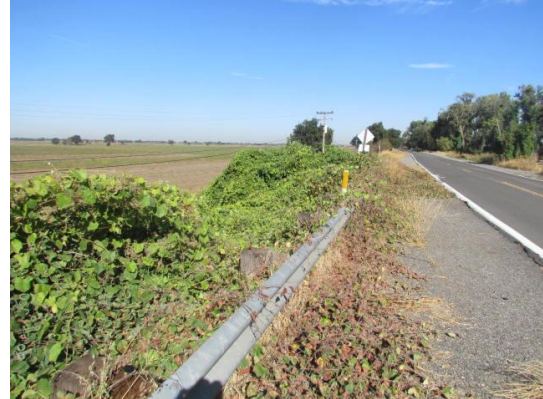
Photo 2 of 3 : FA_2015_RD0765_211_33_20150925_00071.jpg

Looking north from LM. 1.65 at dense vegetation on landward slope.

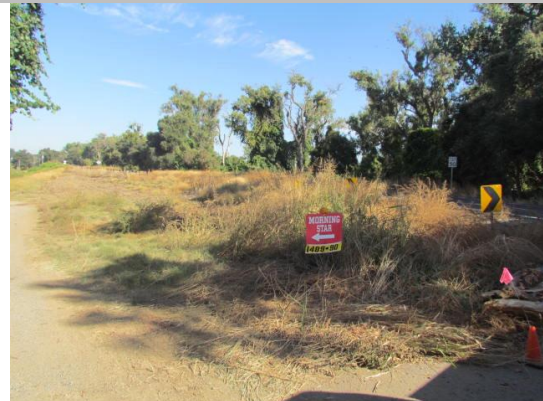
Photo 3 of 3 : FA_2015_RD0765_211_33_20150925_00072.jpg

Looking northeast from LM 1.71 at typical view of vegetation on landward slope.

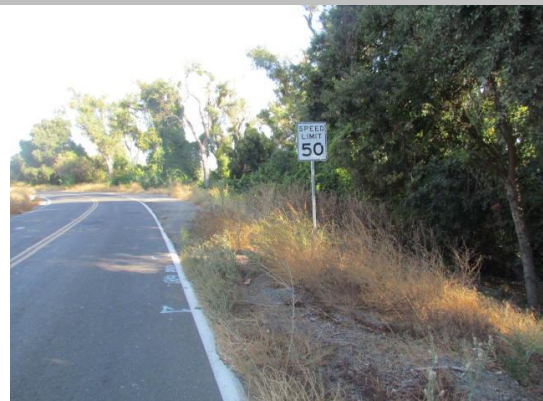
Photo 1 of 2 : FA_2015_RD0765_211_39_20150925_00073.jpg

Looking north from LM 1.70 at typical view of vegetation on waterward slope.

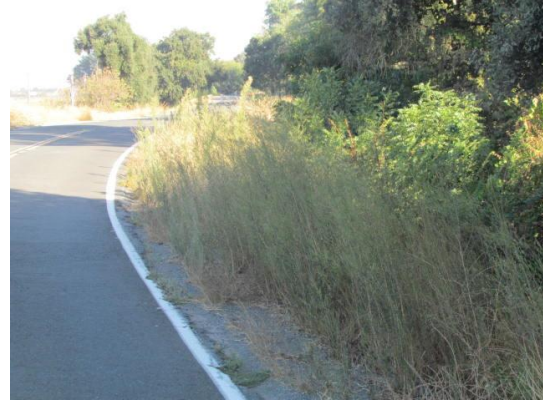
Photo 2 of 2 : FA_2015_RD0765_211_39_20150925_00074.jpg

Looking northeast from LM 1.29 at typical view of vegetation on waterward slope.

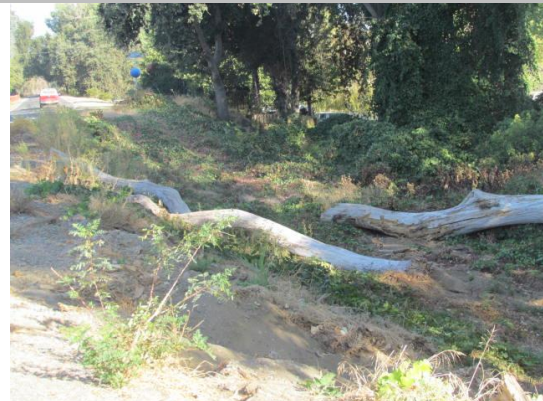
Photo 1 of 2 : FA_2015_RD0765_211_7_20150925_00075.jpg

Looking at several tree branches on waterward slope and berm.

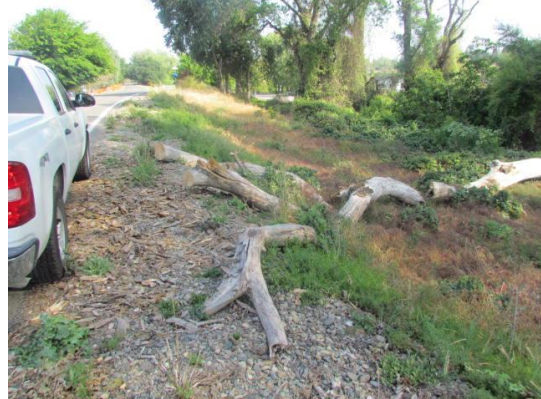
Photo 2 of 2 : FA_2015_RD0765_211_7_20150914_00007.jpg

Looking north at down tree across waterward slope.

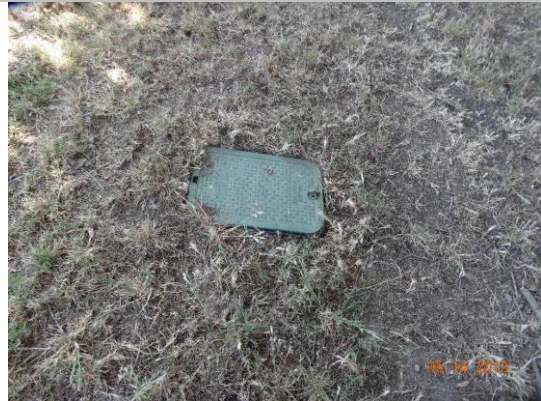
Photo 1 of 1 : UCIP_FA_2015_6076.jpg

LM Start	1.37	Rating **	M	Issue No.	67
LM End	1.37	Issue Type +	En	Location *	WS
Category	Supplemental			GPS Latitude/Longitude	
				Start	End
Item	DWR UCIP Field Study			38.484656 °	38.484656 °
				-121.552362 °	-121.552362 °
DWR ID					
Action/Comments					
Inspector Comments: FS_ID:39022					
DS_ID:24661					
EP_NO: N/A					
FS_HLM: 1.38					
Repair Type: Non-Urgent					
Crossing Status: Indicator Found					
UCIP Comments: Need to contact owner to determine if crossing goes through levee.					
FIELD_STRUCT_DESC: 3 inch irrigation line through levee at unknown depth. Service box located on landward shoulder.					
FS Date: 05/14/2013

Utility box located on landward shoulder.

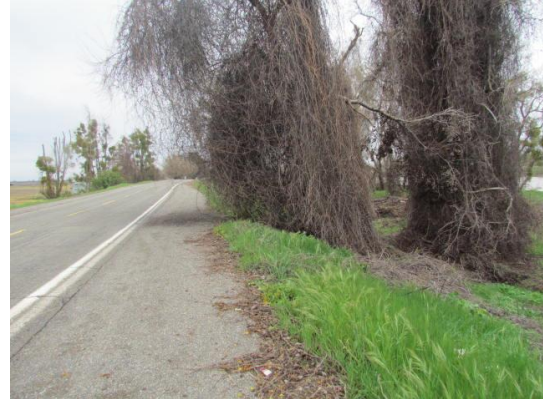
Photo 1 of 1 : FA_2015_RD0765_211_4_20150914_00002.jpg

Looking north at untrimmed trees on waterward slope.

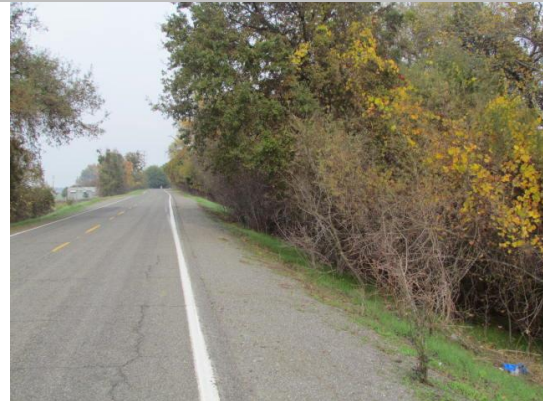
Photo 1 of 2 : FA_2015_RD0765_211_5_20150914_00003.jpg

Looking north at dense vegetation on waterside slope. (Fall Inspection 2012)

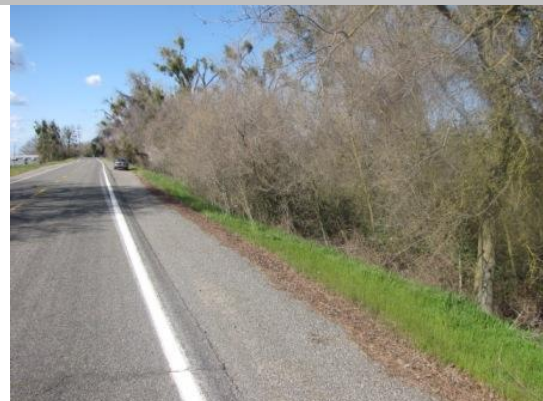
Photo 2 of 2 : FA_2015_RD0765_211_5_20150914_00004.jpg

Looking upstream (north) at dense trees on waterside slope.

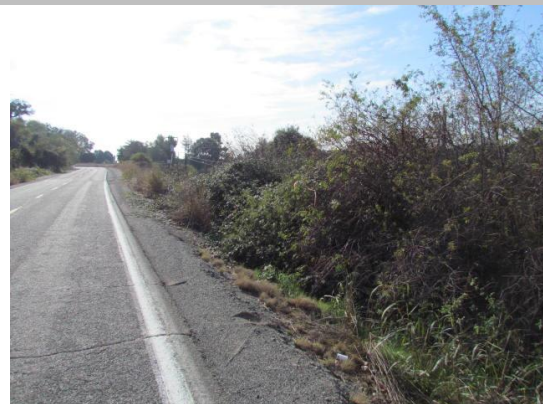
Photo 1 of 6 : FA_2015_RD0765_211_29_20150914_00027.jpg

Looking south at dense vegetation on landside shoulder and slope.
(November 2011)

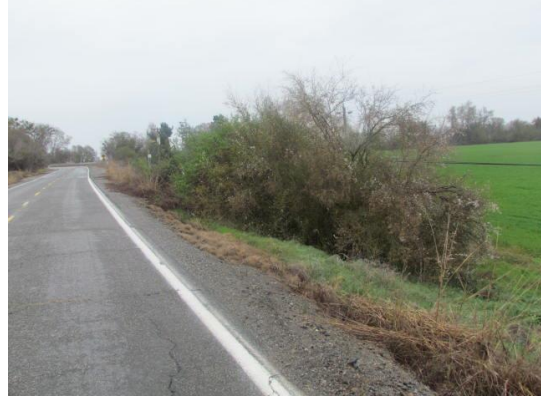
Photo 2 of 6 : FA_2015_RD0765_211_29_20150914_00028.jpg

Looking south at dense vegetation on landside slope and toe spring 2012.

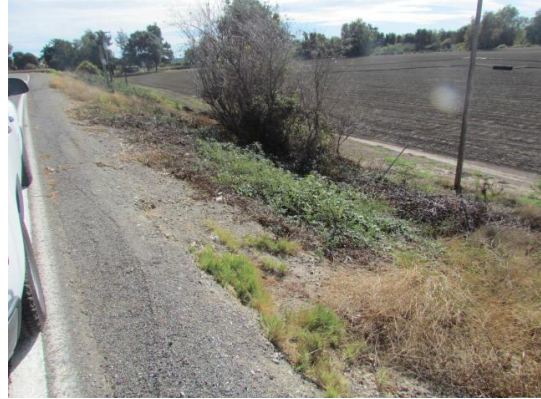
Photo 3 of 6 : FA_2015_RD0765_211_29_20150914_00029.jpg

Looking south at moderate vegetation on landward slope and toe. (Fall 2014)

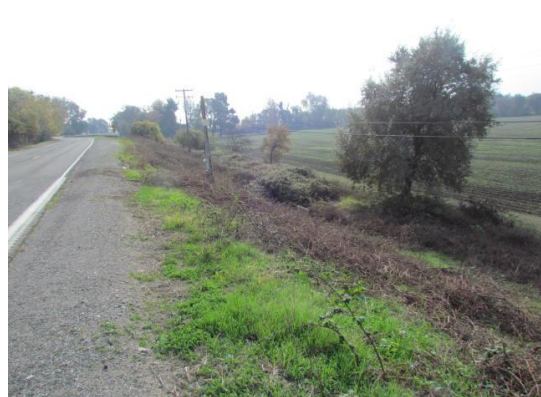
Photo 4 of 6 : FA_2015_RD0765_211_29_20150914_00030.jpg

Looking southwest at vegetation on landside slope and toe. (Fall Inspection 2012)

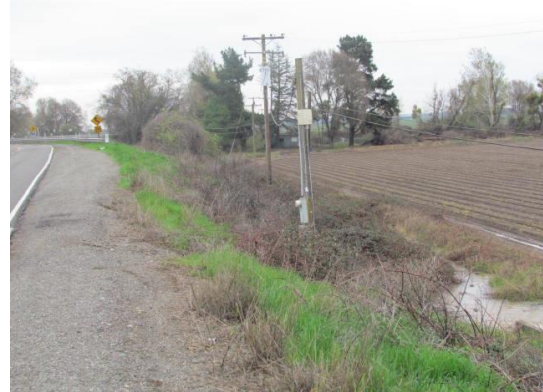
Photo 5 of 6 : FA_2015_RD0765_211_29_20150914_00031.jpg

Looking southwest at berryvines on landside slope.

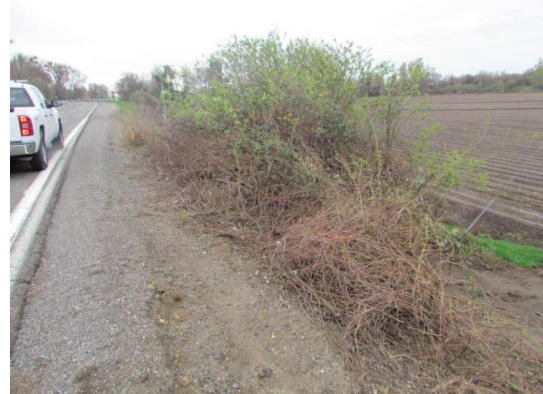
Photo 6 of 6 : FA_2015_RD0765_211_29_20150914_00032.jpg

Looking southwest at vegetation on landside slope.

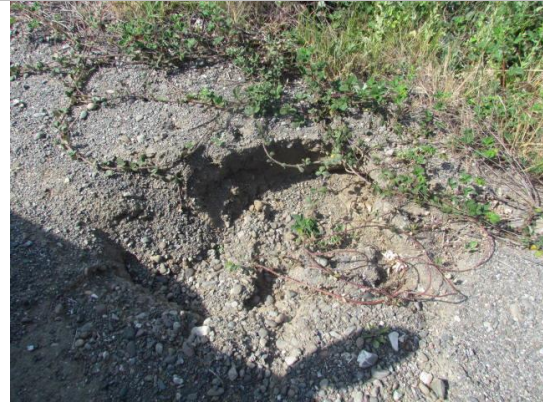
Photo 1 of 2 : FA_2015_RD0765_211_57_20150914_00061.jpg

Looking east at caving on landward shoulder.

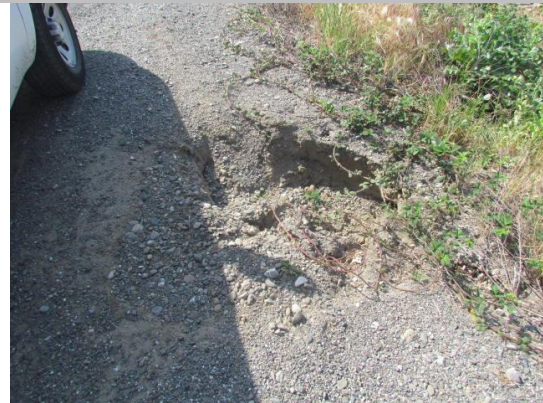
Photo 2 of 2 : FA_2015_RD0765_211_57_20150914_00062.jpg

Looking south at caving on landward shoulder.

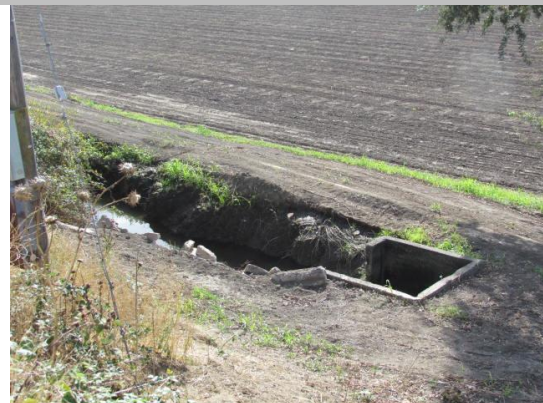
Photo 1 of 2 : FA_2015_RD0765_211_60_20150914_00063.jpg

Looking southwest at irrigation ditch at landward toe. (Fall 2014)

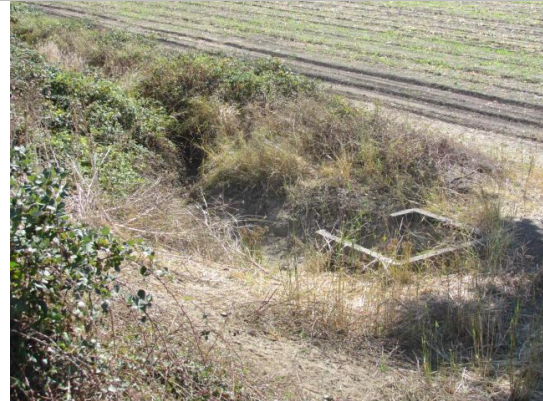
Photo 2 of 2 : FA_2015_RD0765_211_60_20150914_00064.jpg

Looking southwest at irrigation ditch on landward toe.

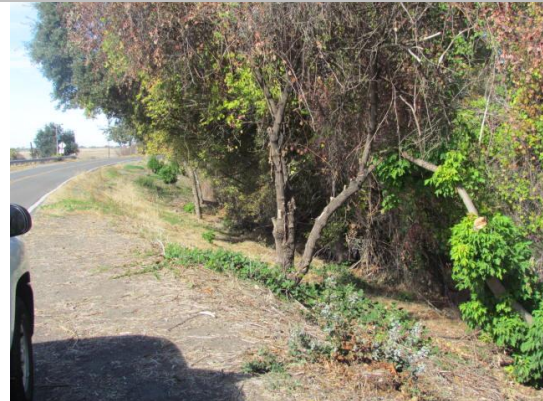
Photo 1 of 1 : FA_2015_RD0765_211_53_20150914_00052.jpg

Looking north at trimmed trees on waterward slope. (Fall 2014)

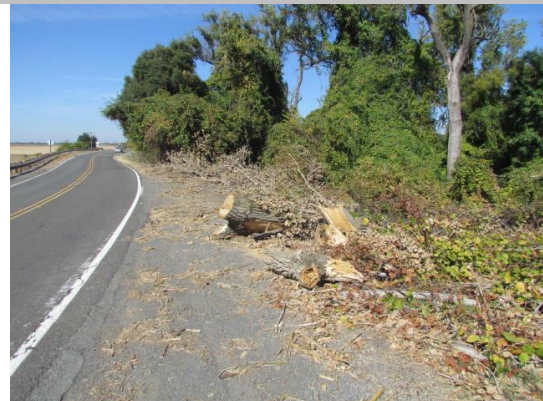
Photo 1 of 3 : FA_2015_RD0765_211_13_20150914_00013.jpg

Looking northeast at tree limbs on waterward slope.

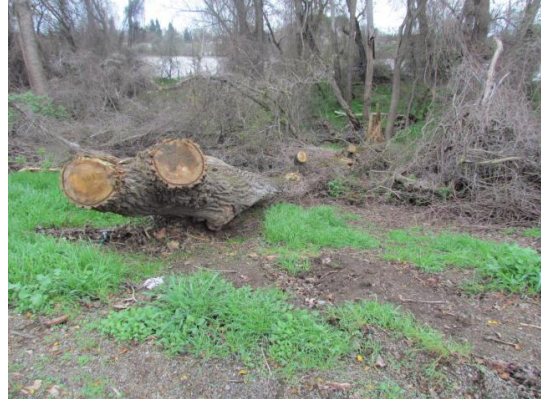
Photo 2 of 3 : FA_2015_RD0765_211_13_20150914_00014.jpg

Looking east at large tree limb on waterward slope.

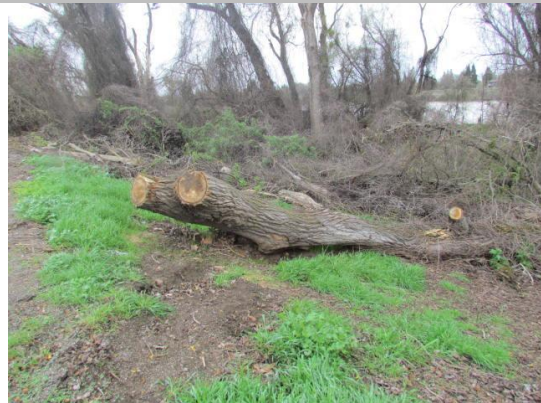
Photo 3 of 3 : FA_2015_RD0765_211_13_20150914_00015.jpg

Looking north at large tree limb on waterward slope.

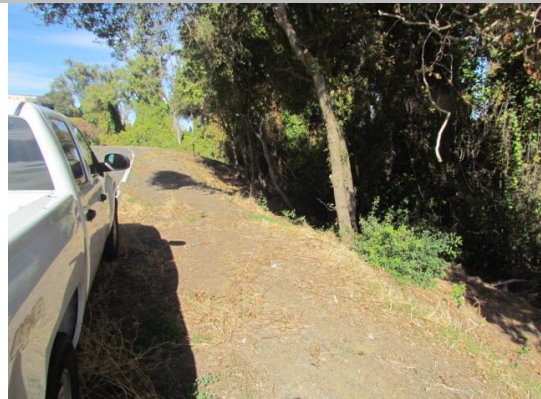
Photo 1 of 1 : FA_2015_RD0765_211_52_20150914_00050.jpg

Looking north (upstream) at trimmed trees on landward slope. (Fall 2014)

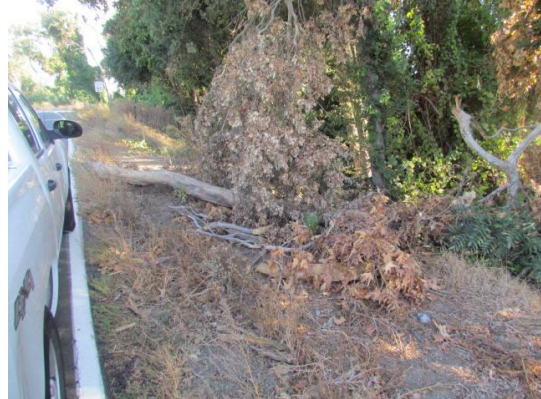
Photo 1 of 2 : FA_2015_RD0765_211_20_20150925_00076.jpg

Looking northeast at broken and cracked tree branches on waterward slope.

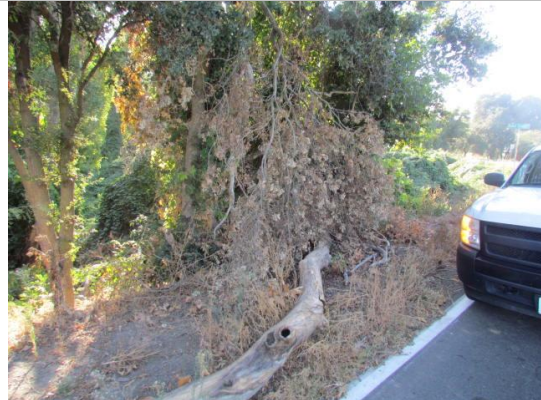
Photo 2 of 2 : FA_2015_RD0765_211_20_20150925_00077.jpg

Looking south at broken and cracked tree branches on waterward slope.
