**Flood Control Project Maintenance  
Levee Inspections**

**Fall 2016 Levee Maintenance Deficiency Summary Report**

**Reclamation District No. 0765 Glide**

Waterway			Bank	Unit Miles
Unit No. 01 Sacramento River			Right	1.72
	Spring (March - May)	Summer (June - August)	(September - November) Fall	Winter (December - February)
Unit Maintenance Rating (Fall Only)			<b>U</b>	
Date of Inspection	3/8/2016 - 3/8/2016		9/7/2016 - 9/7/2016	
DWR Inspector	Richard Willoughby		Richard Willoughby	
Accompanied By	Everett Lovejoy RD 765		Everett Lovejoy RD 765

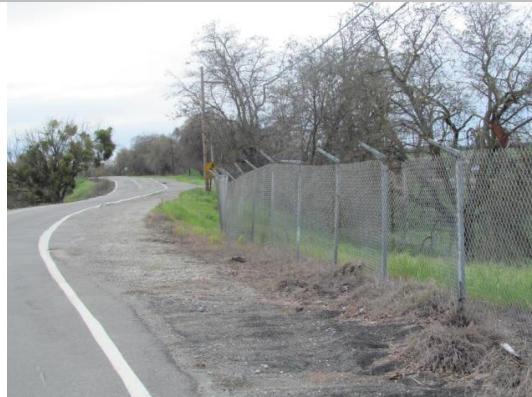
Photo 1 of 1 : FA\_2016\_RD0765\_211\_12\_20160907\_00011.jpg

Looking southwest at fence along landward shoulder.

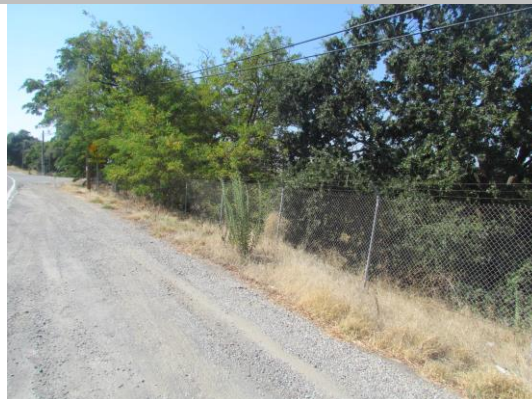
Photo 1 of 2 : FA\_2016\_RD0765\_211\_3\_20160909\_00063.jpg

LM Start	0.05	Rating **	U	Issue No.	3
LM End	0.05	Issue Type +	Ma	Location *	LS
Category	Earthen Levee			GPS Latitude/Longitude	
				Start	End
Item	Trim / Thin Trees			38.502253 °	38.502253 °
				-121.560192 °	-121.560192 °
DWR ID	DWR_RD0765_01_s_2012_3				
Comment Code					
T1 : Trim trees to at least five feet above ground level.					
Inspector Comment					
Trees blocking view of landward slope.

Looking southwest at untrimmed trees on landward slope.(Fall 2016)

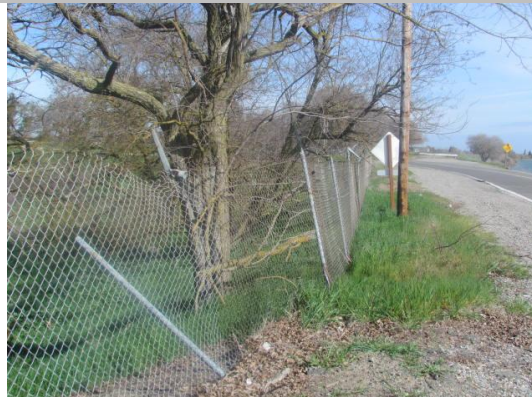
Photo 2 of 2 : FA\_2016\_RD0765\_211\_3\_20160907\_00003.jpg

Looking north (upstream) at trees on landside slope. (Spring 2016)

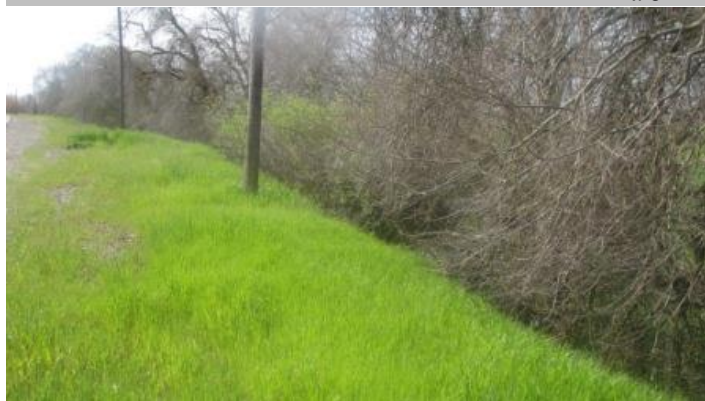
Photo 1 of 2 : FA\_2016\_RD0765\_211\_28\_20160907\_00019.jpg

Looking downstream (south) at trees on landside slope &amp; toe.

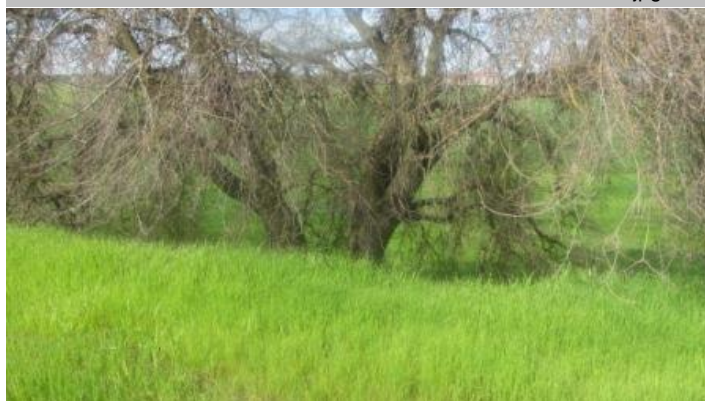
Photo 2 of 2 : FA\_2016\_RD0765\_211\_28\_20160907\_00020.jpg

Looking west at trees on landside toe.

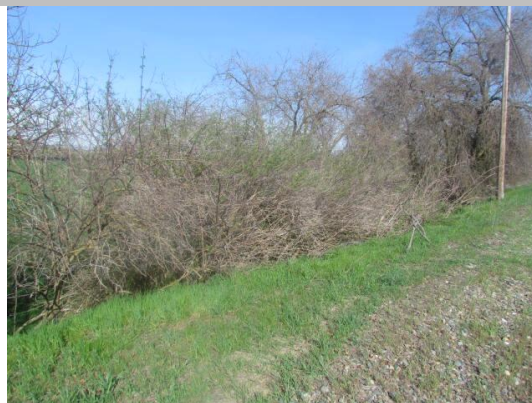
Photo 1 of 1 : FA\_2016\_RD0765\_211\_22\_20160907\_00016.jpg

Looking northwest at dense vegetation on landside slope.

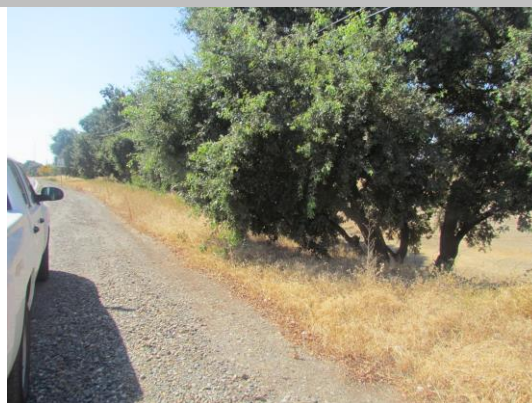
Photo 1 of 1 : FA\_2016\_RD0765\_211\_14\_20160909\_00064.jpg

LM Start	0.18	Rating **	U	Issue No.	14
LM End	0.34	Issue Type +	Ma	Location *	LS
Category	Earthen Levee			GPS Latitude/Longitude	
				Start	End
Item	Trim / Thin Trees			38.500343 °	38.498032 °
				-121.560507 °	-121.560337 °
DWR ID	DWR_RD0765_01_s_2012_14				
Comment Code					
T1 : Trim trees to at least five feet above ground level.					
Inspector Comment

Looking southwest at untrimmed trees on landward slope.

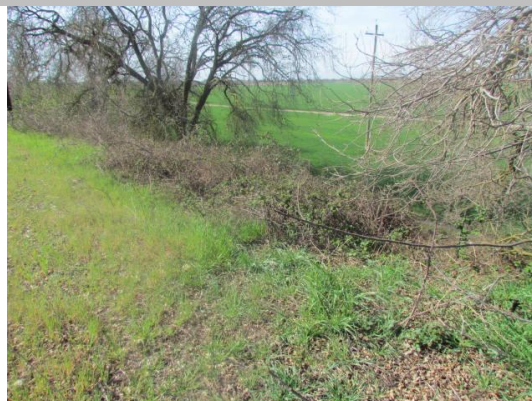
Photo 1 of 1 : FA\_2016\_RD0765\_211\_49\_20160907\_00030.jpg

Looking at wild berryvines or wild roses on landside slope and toe.

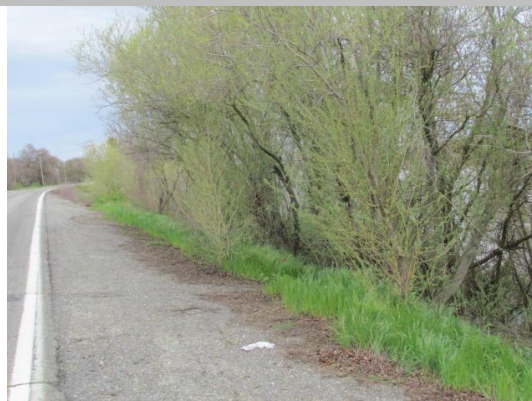
Photo 1 of 1 : FA\_2016\_RD0765\_211\_11\_20160907\_00010.jpg

LM Start	0.25	Rating **	U	Issue No.	11
LM End	0.27	Issue Type +	Ma	Location *	WS
Category	Earthen Levee			GPS Latitude/Longitude	
				Start	End
Item	Trim / Thin Trees			38.499405 °	38.499042 °
				-121.560445 °	-121.560430 °
DWR ID	DWR_RD0765_01_s_2012_11				
Comment Code					
T3 : Trim and thin trees to allow visibility of the ground and room to flood fight.					
Inspector Comment					
Trees shall be trimmed and thinned on waterward slope.

Looking southwest at trees along landward shoulder and slope.

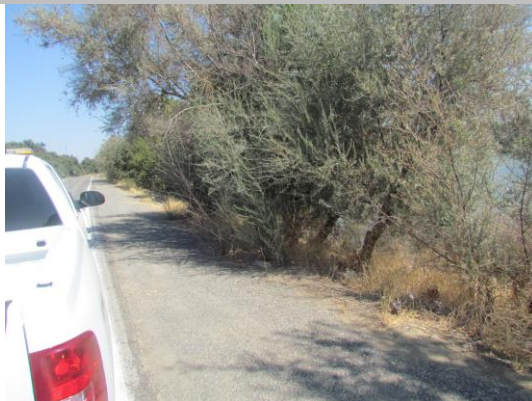
Photo 1 of 2 : FA\_2016\_RD0765\_211\_23\_20160909\_00065.jpg

Looking northeast at untrimmed trees on waterward shoulder. (Fall 2016)

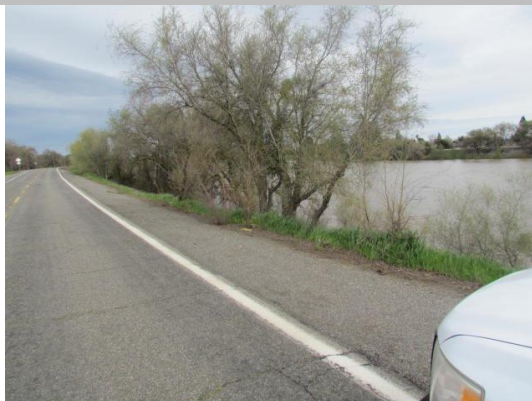
Photo 2 of 2 : FA\_2016\_RD0765\_211\_23\_20160907\_00017.jpg

Looking northeast at trees along waterward shoulder and slope. (Spring 2016)

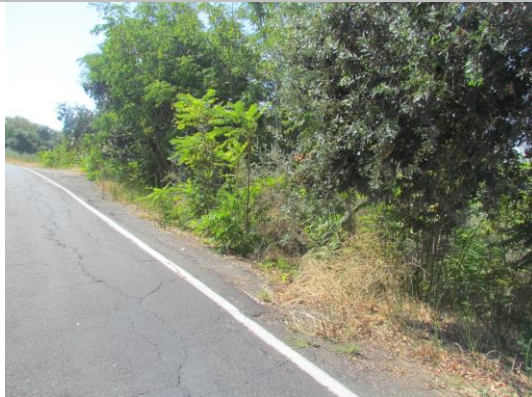
Photo 1 of 1 : FA\_2016\_RD0765\_211\_47\_20160909\_00066.jpg

Looking southwest at dense vegetation on landward shoulder and slope.

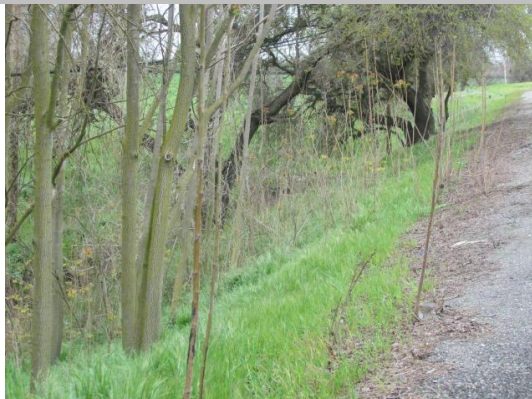
Photo 1 of 2 : FA\_2016\_RD0765\_211\_32\_20160907\_00023.jpg

LM Start	0.43	Rating **	U	Issue No.	32
LM End	0.46	Issue Type +	Ma	Location *	LS
Category	Earthen Levee			GPS Latitude/Longitude	
				Start	End
Item	Trim / Thin Trees			38.496792 °	38.496321 °
				-121.560026 °	-121.559842 °
DWR ID	DWR_RD0765_01_s_2012_32				
Comment Code					
T3 : Trim and thin trees to allow visibility of the ground and room to flood fight.					
Inspector Comment					
New saplings should be removed.

Looking northwest at trees (saplings) on landward slope.

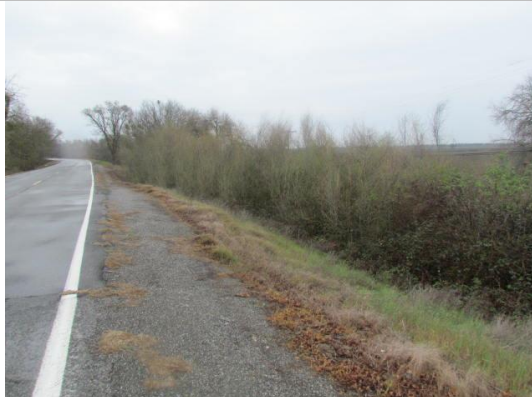
Photo 2 of 2 : FA\_2016\_RD0765\_211\_32\_20160907\_00024.jpg

Looking southwest at dense vegetation on landside slope and toe. (2015)

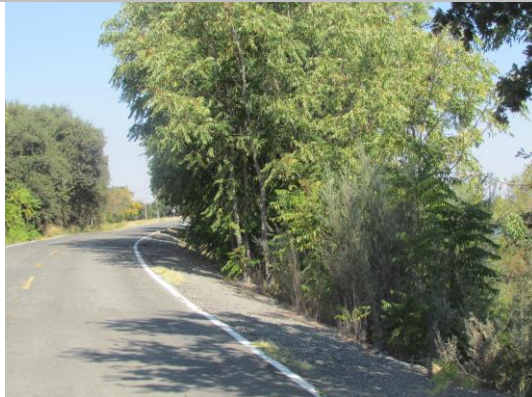
Photo 1 of 2 : FA\_2016\_RD0765\_211\_24\_20160909\_00067.jpg

Looking northeast at large cluster of trees on waterward slope. (Fall 2016)

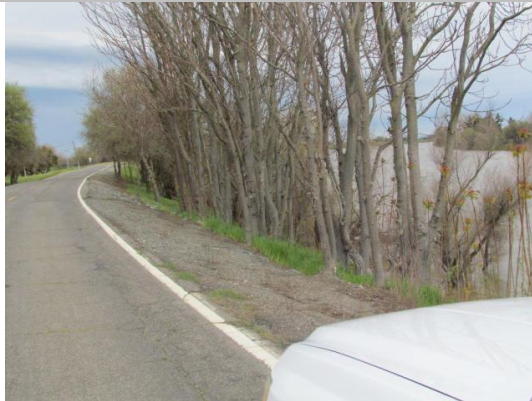
Photo 2 of 2 : FA\_2016\_RD0765\_211\_24\_20160907\_00018.jpg

Looking northeast at cluster of trees on waterward slope. (Spring 2016)

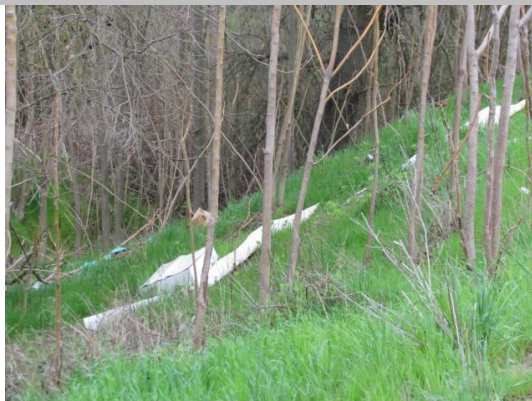
Photo 1 of 2 : FA\_2016\_RD0765\_211\_55\_20160907\_00035.jpg

LM Start	0.47	Rating **	A/W	Issue No.	55
LM End	0.47	Issue Type +	Ma	Location *	LS
Category	Earthen Levee			GPS Latitude/Longitude	
				Start	End
Item	Encroachments			38.496235 °	38.496235 °
				-121.559796 °	-121.559796 °
DWR ID	DWR_RD0765_01_f_2013_55				
Comment Code					
GA : Garbage					
Inspector Comment					
Trash dumped on landside slope.

Looking northwest at garbage on landside slope.

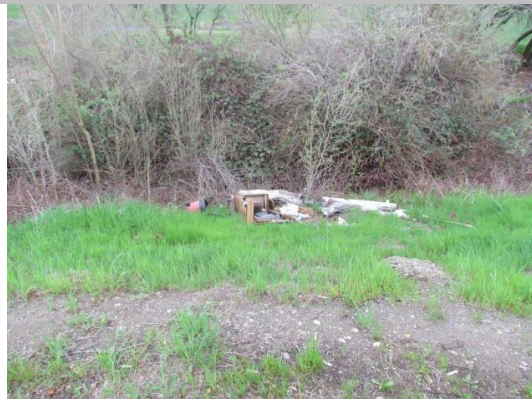
Photo 2 of 2 : FA\_2016\_RD0765\_211\_55\_20160907\_00036.jpg

Looking west at garbage on landside slope.

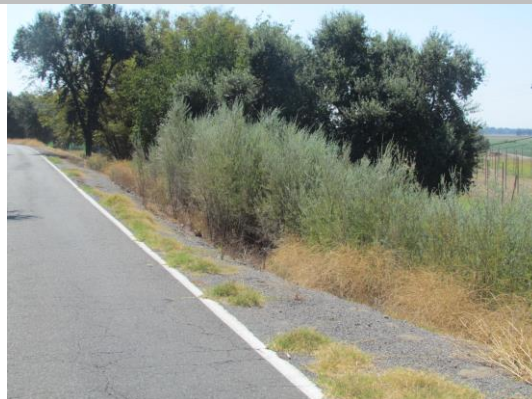
Photo 1 of 2 : FA\_2016\_RD0765\_211\_59\_20160909\_00068.jpg

LM Start	0.48	Rating **	U	Issue No.	59
LM End	0.48	Issue Type +	Ma	Location *	LS
Category	Earthen Levee			GPS Latitude/Longitude	
				Start	End
Item	Vegetation			38.496053 °	38.496053 °
				-121.559690 °	-121.559690 °
DWR ID	DWR_RD0765_01_s_2016_59				
Comment Code					
V2 : Remove the wild growth other than native grasses from the levee slopes.					
Inspector Comment					
Dense vegetation on landward slope.

Looking northwest at dense vegetation on landward slope. (Fall 2016)

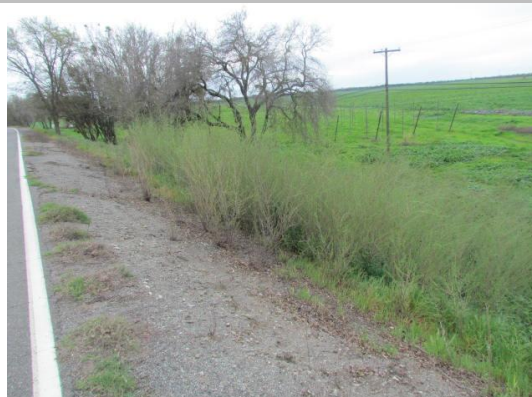
Photo 2 of 2 : FA\_2016\_RD0765\_211\_59\_20160907\_00045.jpg

Looking northwest at dense vegetation on landward slope. (Spring 2016)

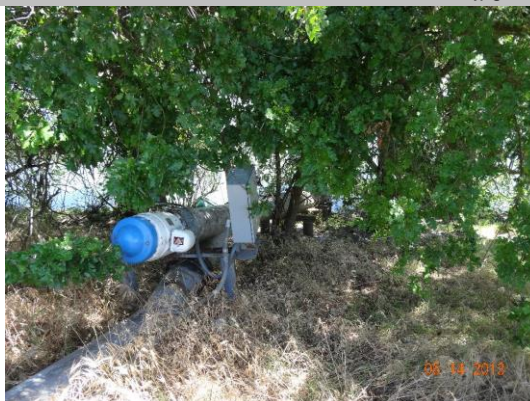
Photo 1 of 2 : UCIP\_FA\_2016\_44403\_60815.jpg

Comment Code						
Inspector Comment						
FS_ID:44403						
DS_ID:21138						
EP_NO: 3314						
Repair Type: Non-Urgent						
Crossing Status: Found						
UCIP Comments: Dense vegetation limit's the ability to determine condition of landward slope for potential leaks associated with crossing. Recommend having owner clear slope to be able to properly inspect slopes for leaks.						
FIELD_STRUCT_DESC: 16-inch steel pipe hthrough the levee, 4.0 feet below the crown. Cutoff wall around pipe at center of levee. Slant pump on the waterward slope, with 22-inch inlet pipe extending from channel. 16-inch pipe connects to 12-inch steel pipe at landward shoulder, extending to concrete standpipe discharge outlet at the toe. Cobble revetment on waterward slope. (Permit No. 3314-1960)						
FS Date: 5/14/2013

View of waterward side--pipe, pump, control panels, and electrical conduit.

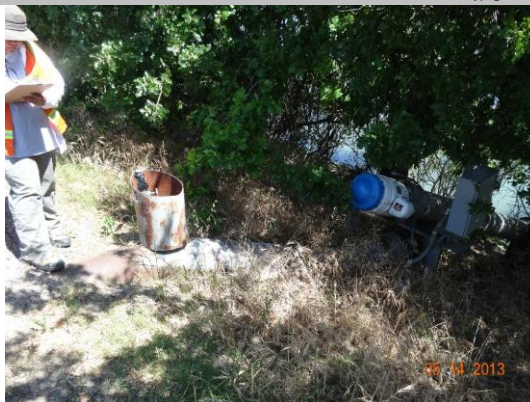
Photo 2 of 2 : UCIP\_FA\_2016\_44403\_60814.jpg

Siphon breaker encased in steel casing located on waterward side.

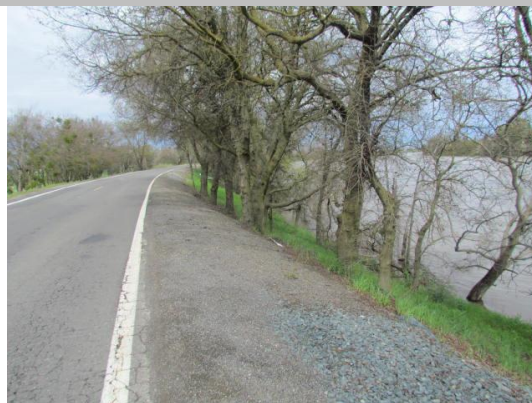
Photo 1 of 1 : FA\_2016\_RD0765\_211\_10\_20160907\_00009.jpg

Looking northeast at trees on waterward slope.

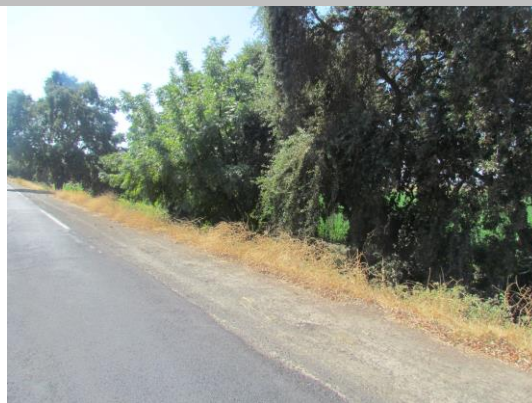
Photo 1 of 1 : FA\_2016\_RD0765\_211\_36\_20160909\_00069.jpg

Looking northwest at untrimmed trees on landward slope.

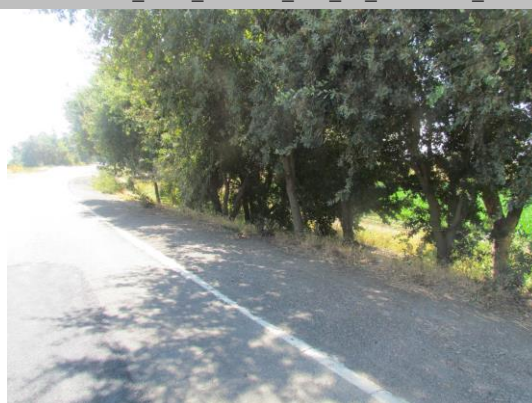
Photo 1 of 1 : FA\_2016\_RD0765\_211\_17\_20160909\_00070.jpg

LM Start	0.86	Rating **	U	Issue No.	17
LM End	0.98	Issue Type +	Ma	Location *	LS
Category	Earthen Levee			GPS Latitude/Longitude	
				Start	End
Item	Trim / Thin Trees			38.491283 °	38.489771 °
				-121.556360 °	-121.555451 °
DWR ID	DWR_RD0765_01_s_2012_17				
Comment Code					
T1 : Trim trees to at least five feet above ground level.					
Inspector Comment					
Untrimmed trees on landward slope.

Looking northwest at untrimmed trees on landward slope.

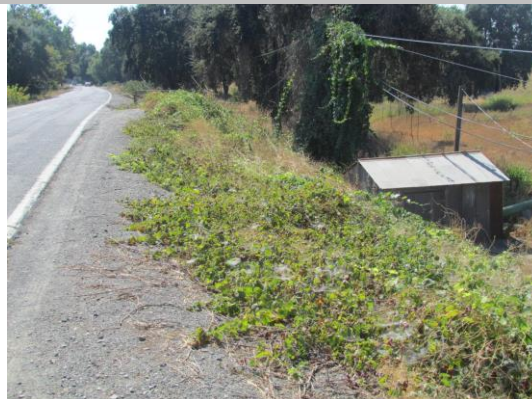
Photo 1 of 1 : FA\_2016\_RD0765\_211\_61\_20160909\_00071.jpg

Looking south at dense wildroses on landward slope.

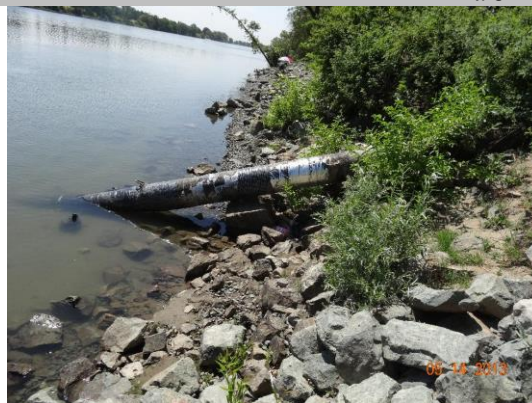
Photo 1 of 2 : UCIP\_FA\_2016\_44404\_60819.jpg

LM Start	0.95	Rating **	M	Issue No.	69
LM End	0.95	Issue Type +	En	Location *	LS
Category	Supplemental			GPS Latitude/Longitude	
				Start	End
Item	DWR UCIP Field Study			38.490192 °	38.490192 °
				-121.555628 °	-121.555628 °
DWR ID					
Comment Code					
Inspector Comment					
FS_ID:44404					
DS_ID:21139					
EP_NO: 653					
Repair Type: Non-Urgent					
Crossing Status: Found					
UCIP Comments: Dense vegetation on landward side limits visual inspection of potential leaks. Recommend clearing slope of vegetation.					
FIELD_STRUCT_DESC: 16-inch steel pipe through the levee, 14.3 feet below the crown. Pump on the landward side. Gate valve on the waterward slope. (USACE-1959). This entry matches the Drainage or Irrigation Structure referenced in O&M manual (RM 50.29).					
FS Date: 5/14/2013

Pipe section visible at waterward toe.

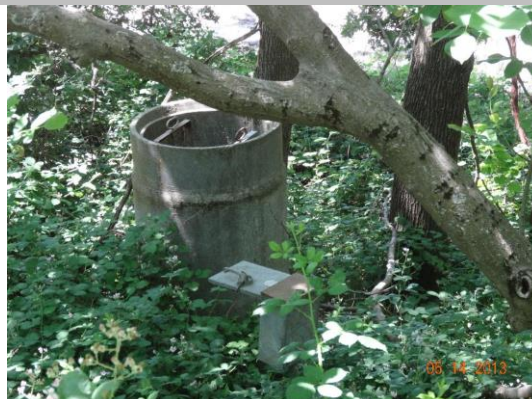
Photo 1 of 2 : UCIP\_FA\_2016\_44407\_73022.jpg

FS\_ID:44407  
DS\_ID:21140  
EP\_NO: N/A  
Repair Type: Non-Urgent  
Crossing Status: Indicator Found  
UCIP Comments: Dense vegetation on waterward and landward slopes limit visual inspection of potential leaks along pipe alignment. Recommend having owner clear vegetation along slopes.  
FIELD\_STRUCT\_DESC: 6-inch steel pipe through the levee, 18.8 feet below the crown. Concrete standpipe on the LS toe. Pump on WS slope. This entry matches the Drainage or Irrigation Structure referenced in O&M manual (RM 50.15).  
FS Date: 4/9/2015

Overview of landward side--concrete standpipe and control panel located at toe.

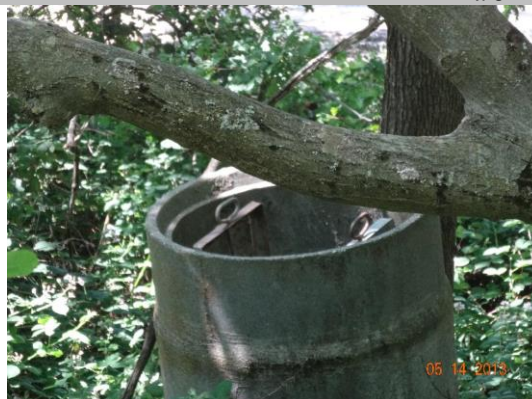
Photo 2 of 2 : UCIP\_FA\_2016\_44407\_73021.jpg

Concrete standpipe with 2 gates inside located on landward side.

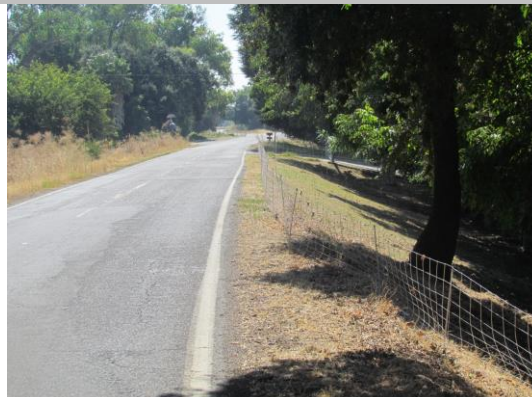
Photo 1 of 3 : FA\_2016\_RD0765\_211\_54\_20160909\_00075.jpg

Looking south at fencing for goats on landward slope. (Fall 2016)

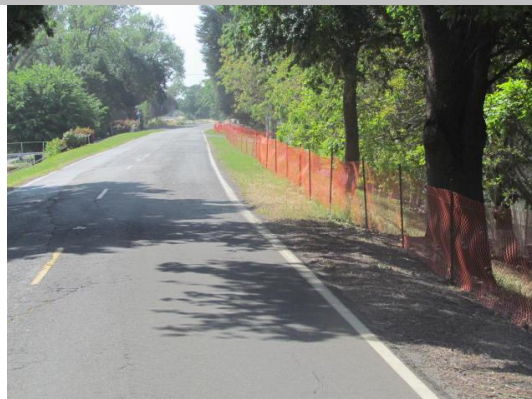
Photo 2 of 3 : FA\_2016\_RD0765\_211\_54\_20160907\_00034.jpg

Looking south at temporary fence on landward shoulder. (Spring 2016)

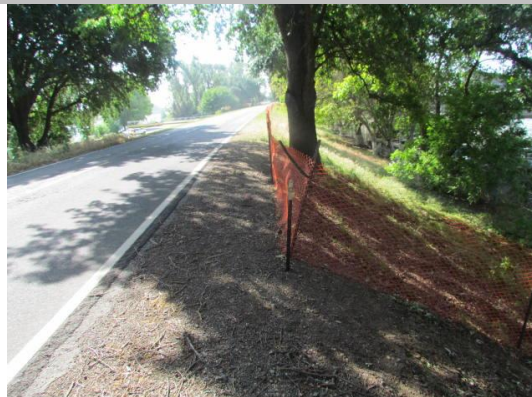
Photo 3 of 3 : FA\_2016\_RD0765\_211\_54\_20160907\_00033.jpg

Looking south at temporary fence on landward slope. (Spring 2016)

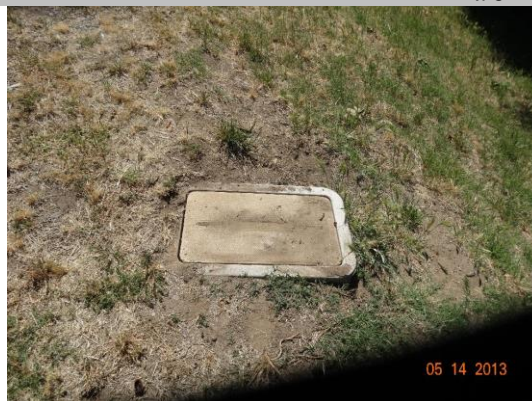
Photo 1 of 2 : UCIP\_FA\_2016\_43203\_71214.jpg

FS\_ID:43203  
DS\_ID:24660  
EP\_NO: N/A  
Repair Type: Non-Urgent  
Crossing Status: Indicator Found  
UCIP Comments: Unable to confirm details of crossing. Need to contact owner to determine additional details about crossing and permit issued.  
FIELD\_STRUCT\_DESC: PG&E utility service box on landward shoulder.  
FS Date: 5/14/2013

Utility box located on landward side.

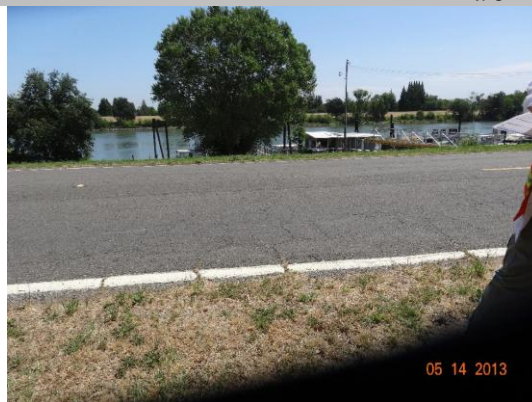
Photo 2 of 2 : UCIP\_FA\_2016\_43203\_71213.jpg

View of levee crown and waterward side.

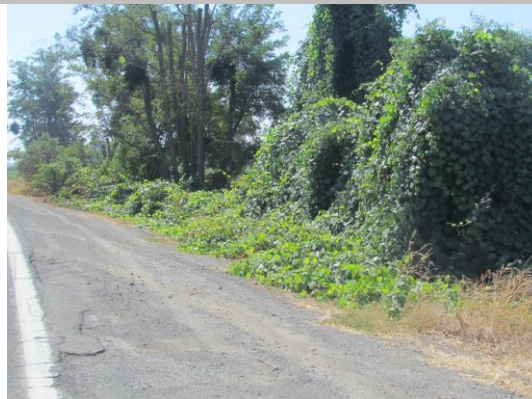
Photo 1 of 2 : FA\_2016\_RD0765\_211\_33\_20160909\_00076.jpg

Looking west at dense vegetation (grapevines) on landward slope. (Fall 2016)

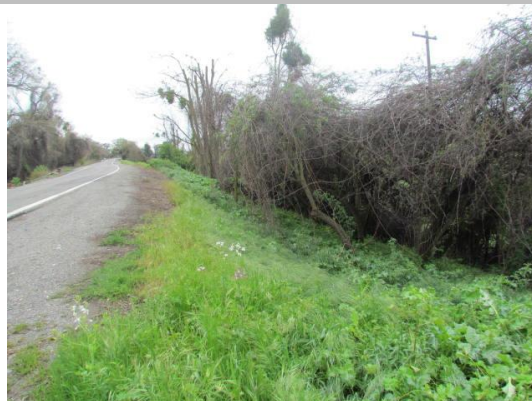
Photo 2 of 2 : FA\_2016\_RD0765\_211\_33\_20160907\_00026.jpg

Looking west at dense vegetation on landward toe.

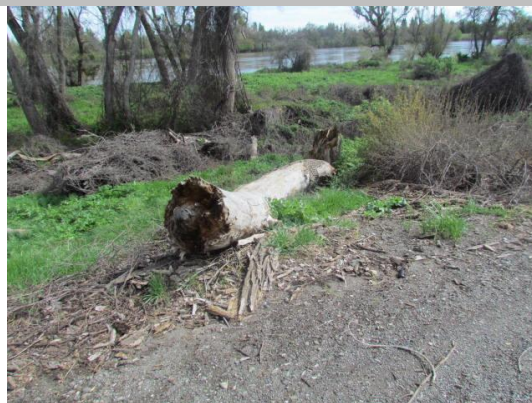
Photo 1 of 4 : FA\_2016\_RD0765\_211\_7\_20160907\_00005.jpg

Looking southeast at branch on waterward slope.

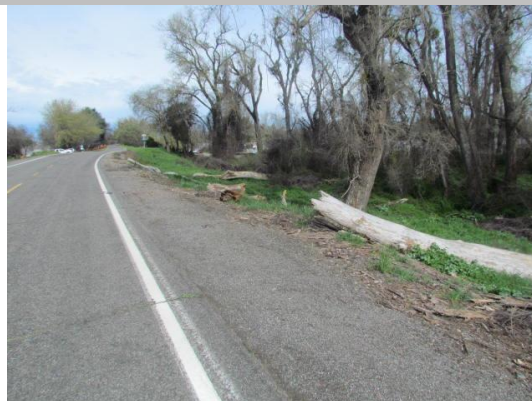
Photo 2 of 4 : FA\_2016\_RD0765\_211\_7\_20160907\_00006.jpg

Looking northeast at tree limbs on waterward slope.

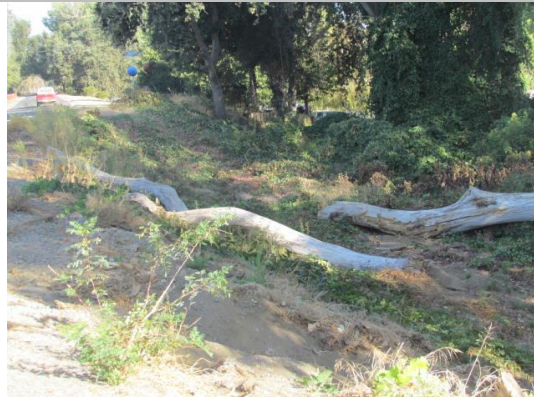
Photo 3 of 4 : FA\_2016\_RD0765\_211\_7\_20160907\_00007.jpg

Looking at several tree branches on waterward slope and berm.(2015)

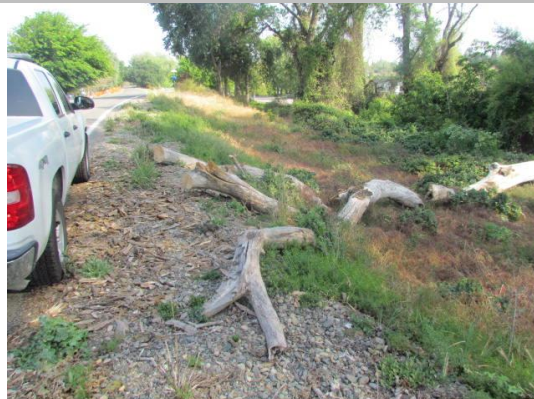
Photo 4 of 4 : FA\_2016\_RD0765\_211\_7\_20160907\_00008.jpg

Looking north at down tree across waterward slope.(2015)

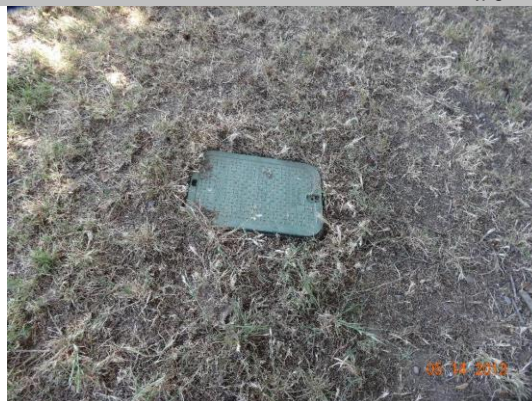
Photo 1 of 1 : UCIP\_FA\_2016\_39022\_71212.jpg

LM Start	1.37	Rating **	M	Issue No.	66
LM End	1.37	Issue Type +	En	Location *	WS
Category	Supplemental			GPS Latitude/Longitude	
				Start	End
Item	DWR UCIP Field Study			38.484656 °	38.484656 °
				-121.552362 °	-121.552362 °
DWR ID					
Comment Code					
Inspector Comment					
FS_ID:39022 DS_ID:24661 EP_NO: N/A Repair Type: Non-Urgent Crossing Status: Indicator Found UCIP Comments: Need to contact owner to determine if crossing goes through levee. FIELD_STRUCT_DESC: 3 inch irrigation line through levee at unknown depth. Service box located on landward shoulder. FS Date: 5/14/2013

Utility box located on landward shoulder.

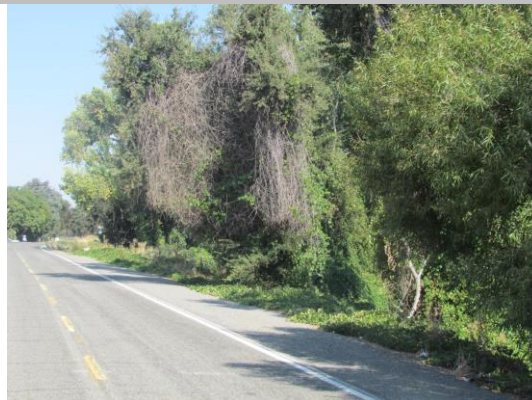
Photo 1 of 3 : FA\_2016\_RD0765\_211\_4\_20160909\_00078.jpg

Looking northeast at untrimmed trees and other vegetation on waterward slope. (Fall 2016)

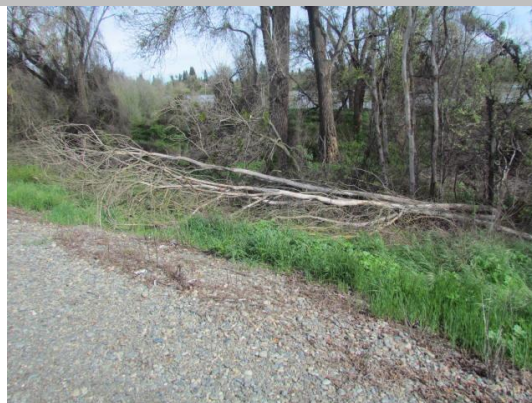
Photo 1 of 1 : FA\_2016\_RD0765\_211\_64\_20160907\_00050.jpg

Looking at fallen tree on waterward slope and toe.

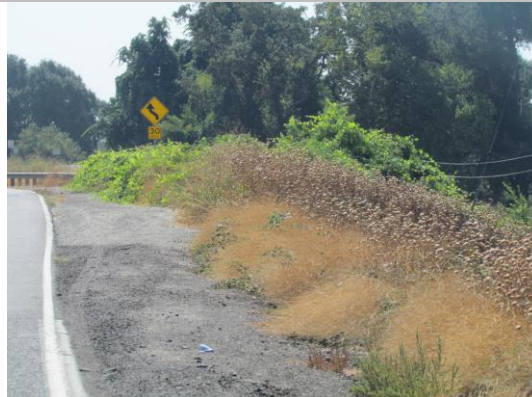
Photo 2 of 3 : FA\_2016\_RD0765\_211\_29\_20160909\_00080.jpg

Looking southwest at dense berry vines and other vegetation on landward slope. (Fall 2016)

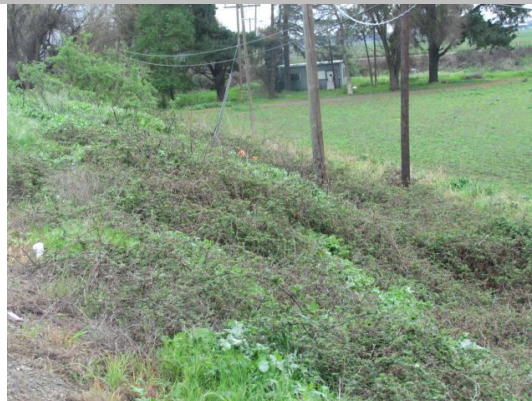
Photo 3 of 3 : FA\_2016\_RD0765\_211\_29\_20160907\_00022.jpg

Looking southwest at ground cover on landward slope. (Spring 2016)

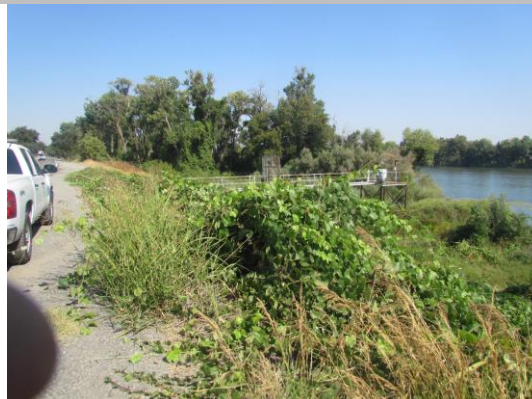
Photo 1 of 2 : FA\_2016\_RD0765\_211\_48\_20160909\_00082.jpg

Looking northeast at vines on waterward slope.

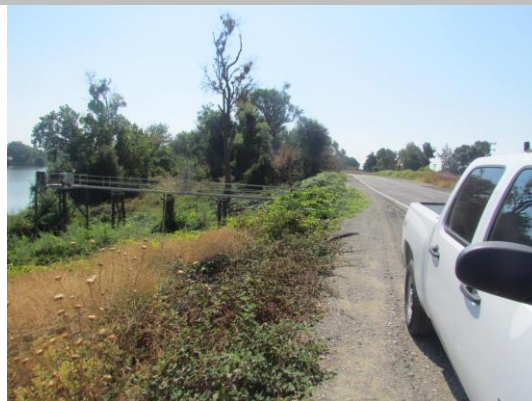
Photo 2 of 2 : FA\_2016\_RD0765\_211\_48\_20160909\_00083.jpg

Looking southeast at vines on waterward slope.

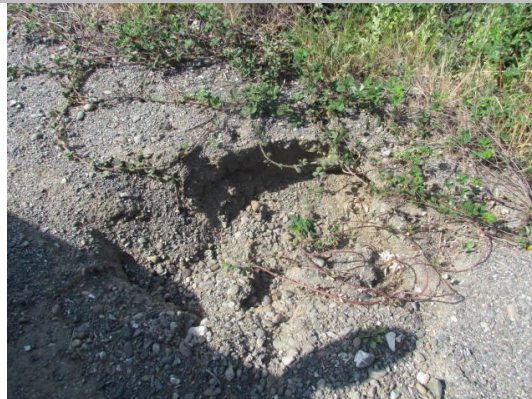
Photo 1 of 7 : FA\_2016\_RD0765\_211\_57\_20160907\_00037.jpg

LM Start	1.55	Rating **	U	Issue No.	57
LM End	1.55	Issue Type +	Ma	Location *	LS
Category	Earthen Levee			GPS Latitude/Longitude	
				Start	End
Item	Erosion / Bank Caving			38.482327 °	38.482327 °
				-121.550848 °	-121.550848 °
DWR ID	DWR_RD0765_01_s_2015_57				
Comment Code					
E2 : Schedule repair of erosion site prior to the next inspection.					
Inspector Comment					
Caving greater than one inch deep and greater that three inches in length on landward shoulder. Caving has grew to 3ft deep, 3ft wide and 10ft long. Erosion starting to undermine toward crown of levee.

Looking east at caving on landward shoulder.

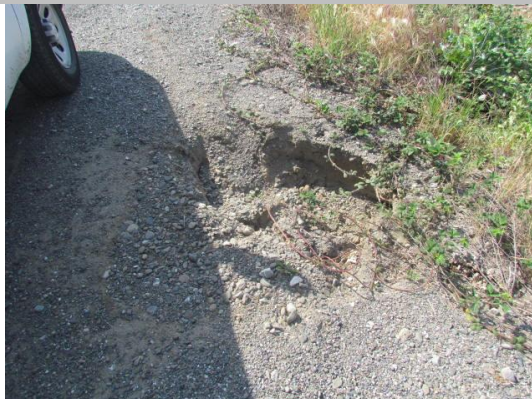
Photo 2 of 7 : FA\_2016\_RD0765\_211\_57\_20160907\_00038.jpg

LM Start	1.55	Rating **	U	Issue No.	57 (cont)	
LM End	1.55	Issue Type +	Ma	Location *	LS	
Category	Earthen Levee			GPS Latitude/Longitude		
				Start		End
Item	Erosion / Bank Caving			38.482327 °		38.482327 °
				-121.550848 °		-121.550848 °
DWR ID	DWR_RD0765_01_s_2015_57					
Comment Code						
E2 : Schedule repair of erosion site prior to the next inspection.						
Inspector Comment						
Caving greater than one inch deep and greater that three inches in length on landward shoulder. Caving has grew to 3ft deep, 3ft wide and 10ft long. Erosion starting to undermine toward crown of levee.

Looking south at caving on landward shoulder.

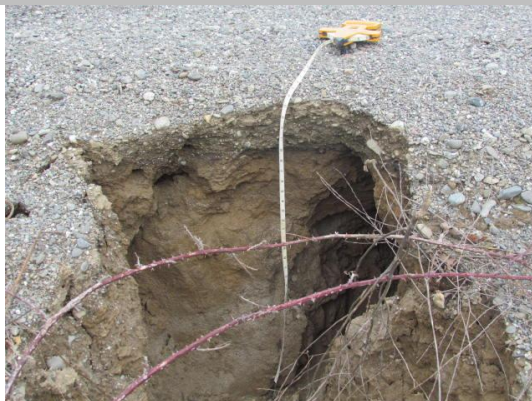
Photo 3 of 7 : FA\_2016\_RD0765\_211\_57\_20160907\_00039.jpg

Looking east at large hole on landward shoulder and slope.

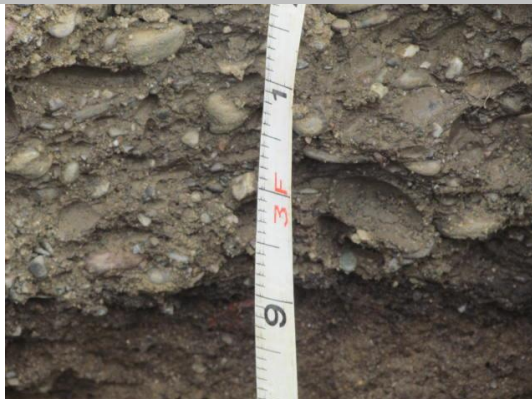
Photo 4 of 7 : FA\_2016\_RD0765\_211\_57\_20160907\_00040.jpg

Looking depth of hole on landward shoulder and slope.

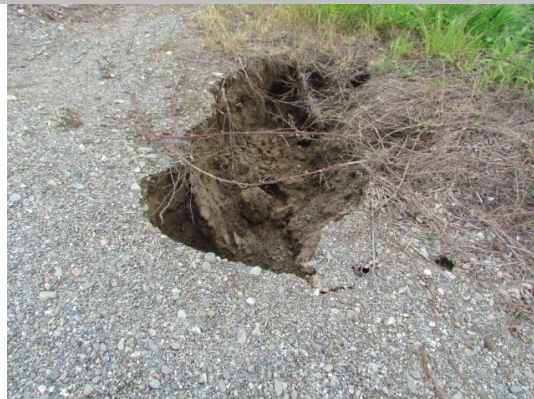
LM Start	1.55	Rating **	U	Issue No.	57 (cont)	
LM End	1.55	Issue Type +	Ma	Location *	LS	
Category	Earthen Levee			GPS Latitude/Longitude		
				Start	End	
Item	Erosion / Bank Caving			38.482327 °	38.482327 °	
				-121.550848 °	-121.550848 °	
DWR ID	DWR_RD0765_01_s_2015_57					
Comment Code						
E2 : Schedule repair of erosion site prior to the next inspection.						
Inspector Comment						
Caving greater than one inch deep and greater than three inches in length on landward shoulder. Caving has grown to 3ft deep, 3ft wide and 10ft long. Erosion starting to undermine toward crown of levee.

Looking southwest at large hole on landward shoulder and slope.

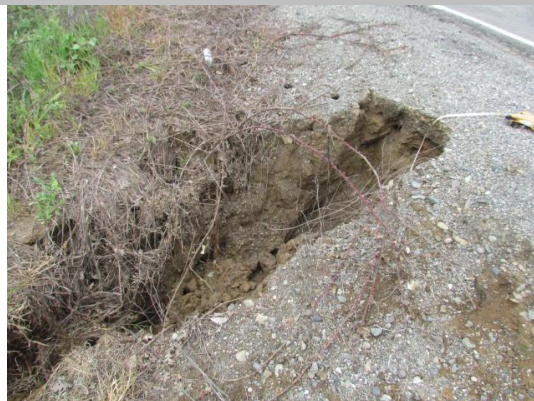
Looking north at hole on landward shoulder and slope.

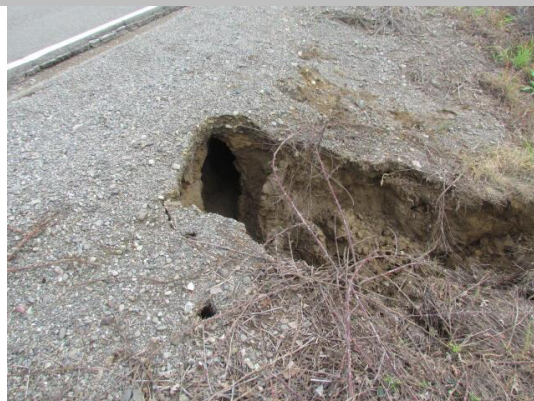
Looking south at large hole on landward shoulder and slope.

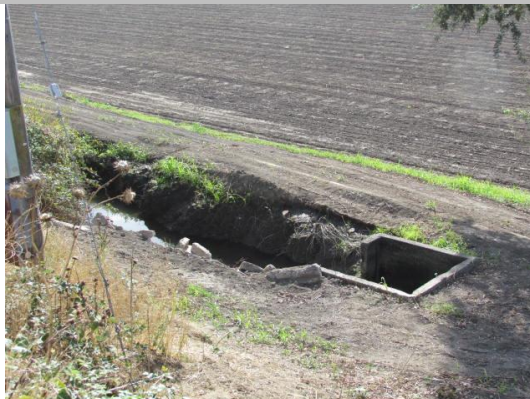
Photo 1 of 2 : FA\_2016\_RD0765\_211\_60\_20160907\_00046.jpg

Looking southwest at irrigation ditch at landward toe. (Fall 2014)

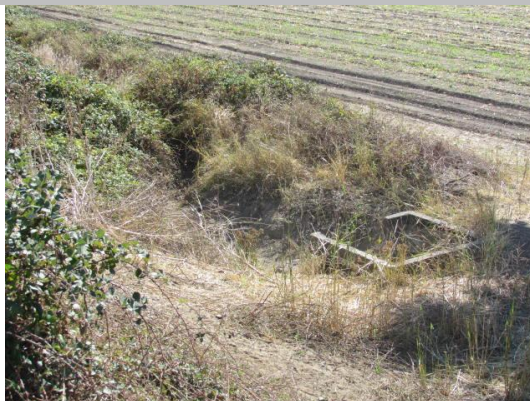
Photo 2 of 2 : FA\_2016\_RD0765\_211\_60\_20160907\_00047.jpg

Looking southwest at irrigation ditch on landward toe.

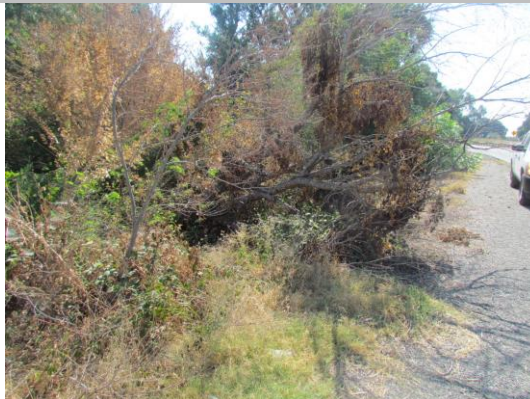
Photo 1 of 2 : FA\_2016\_RD0765\_211\_39\_20160909\_00084.jpg

Looking north at fallen tree on waterward slope.
