**Flood Control Project Maintenance  
Levee Inspections**

**Fall 2017 Levee Maintenance Deficiency Summary Report**

**Reclamation District No. 0765 Glide**

Waterway			Bank	Unit Miles
Unit No. 01 Sacramento River			Right	1.72
	Spring (March - May)	Summer (June - August)	(September - November) Fall	Winter (December - February)
Unit Maintenance Rating (Fall Only)			<b>U</b>	
Date of Inspection	3/13/2017 - 3/13/2017		9/5/2017 - 9/5/2017	
DWR Inspector	Richard Willoughby		Dave Torres	
Accompanied By	Everett Lovejoy RD 765		David Dickson RD765

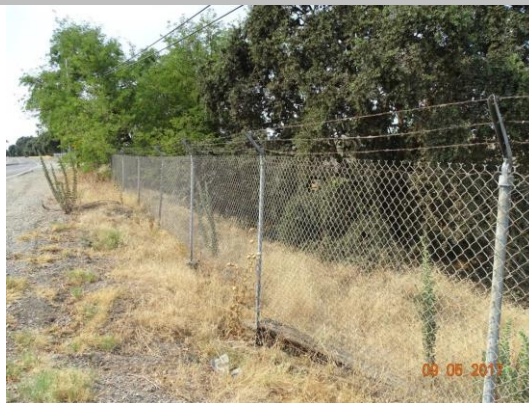
Photo 1 of 1 : FA\_2017\_RD0765\_211\_12\_20170919\_00073.jpg

Looking southwest at the fence on the landside slope.

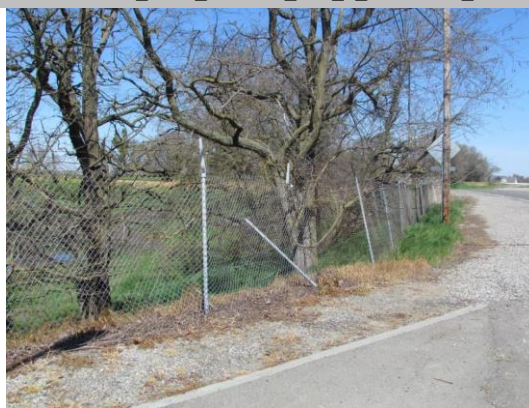
Photo 1 of 3 : FA\_2017\_RD0765\_211\_3\_20170901\_00001.jpg

LM Start	0.05	Rating **	U	Issue No.	3
LM End	0.05	Issue Type +	Ma	Location *	LS
Category	Earthen Levee			GPS Latitude/Longitude	
				Start	End
Item	Trim / Thin Trees			38.502253 °	38.502253 °
				-121.560192 °	-121.560192 °
DWR ID	DWR_RD0765_01_s_2012_3				
Comment Code					
T1 : Trim trees to at least five feet above ground level.					
Inspector Comment					
Trees blocking view of landward slope.

Looking north at untrimmed trees along landward slope. (Spring 2017)

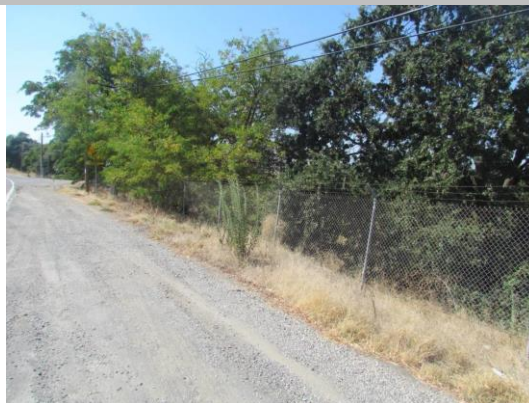
Photo 2 of 3 : FA\_2017\_RD0765\_211\_3\_20170901\_00002.jpg

Looking southwest at untrimmed trees on landward slope.(Fall 2016)

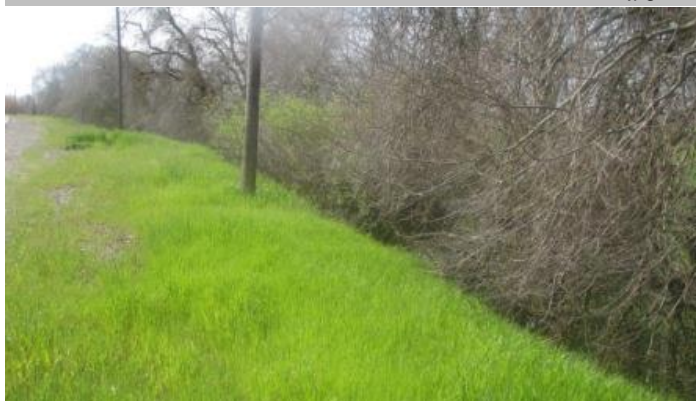
Photo 1 of 2 : FA\_2017\_RD0765\_211\_28\_20170901\_00028.jpg

LM Start	0.12	Rating **	M	Issue No.	28
LM End	0.25	Issue Type +	Ma	Location *	LS
Category	Earthen Levee			GPS Latitude/Longitude	
				Start	End
Item	Trim / Thin Trees			38.501215 °	38.499421 °
				-121.560432 °	-121.560471 °
DWR ID	DWR_RD0765_01_s_2012_28				
Comment Code					
T3 : Trim and thin trees to allow visibility of the ground and room to flood fight.					
Inspector Comment

Looking downstream (south) at trees on landside slope &amp; toe.

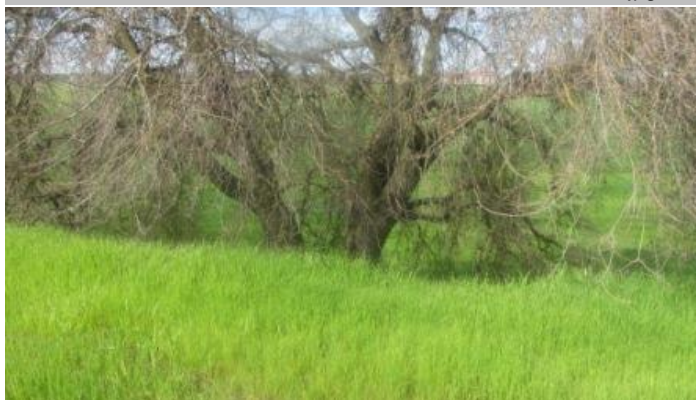
Photo 2 of 2 : FA\_2017\_RD0765\_211\_28\_20170901\_00029.jpg

Looking west at trees on landside toe.

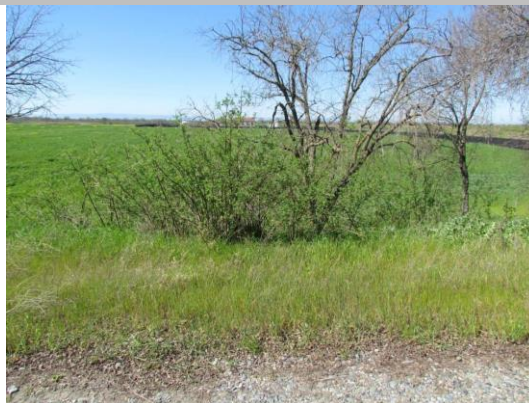
Photo 1 of 1 : FA\_2017\_RD0765\_211\_22\_20170901\_00019.jpg

Looking west at moderate veg on landward slope.

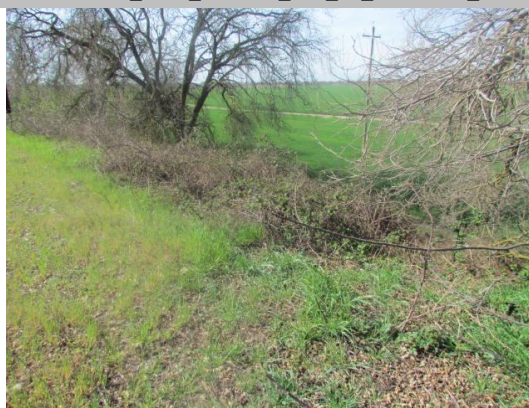
Photo 1 of 1 : FA\_2017\_RD0765\_211\_49\_20170901\_00049.jpg

LM Start	0.24	Rating **	M	Issue No.	49
LM End	0.24	Issue Type +	Ma	Location *	LS
Category	Earthen Levee			GPS Latitude/Longitude	
				Start	End
Item	Vegetation			38.499530 °	38.499530 °
				-121.560490 °	-121.560490 °
DWR ID	DWR_RD0765_01_s_2013_49				
Comment Code					
V2 : Remove the wild growth other than native grasses from the levee slopes.					
Inspector Comment					
Control wild berryvines on landside slope.

Looking at wild berryvines or wild roses on landside slope and toe.

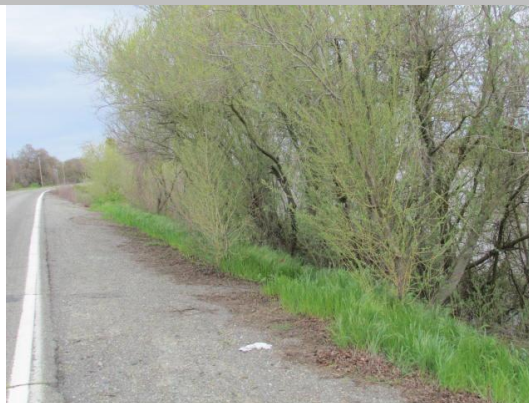
Photo 1 of 1 : FA\_2017\_RD0765\_211\_11\_20170901\_00013.jpg

LM Start	0.25	Rating **	U	Issue No.	11
LM End	0.27	Issue Type +	Ma	Location *	WS
Category	Earthen Levee			GPS Latitude/Longitude	
				Start	End
Item	Trim / Thin Trees			38.499405 °	38.499042 °
				-121.560445 °	-121.560430 °
DWR ID	DWR_RD0765_01_s_2012_11				
Comment Code					
T3 : Trim and thin trees to allow visibility of the ground and room to flood fight.					
Inspector Comment					
Trees shall be trimmed and thinned on waterward slope.

Looking southwest at trees along landward shoulder and slope.

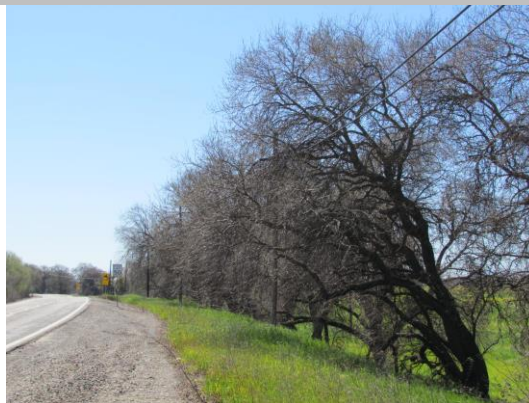
Photo 1 of 2 : FA\_2017\_RD0765\_211\_14\_20170901\_00016.jpg

Looking southwest at untrimmed trees on landward slope. (Spring 2017)

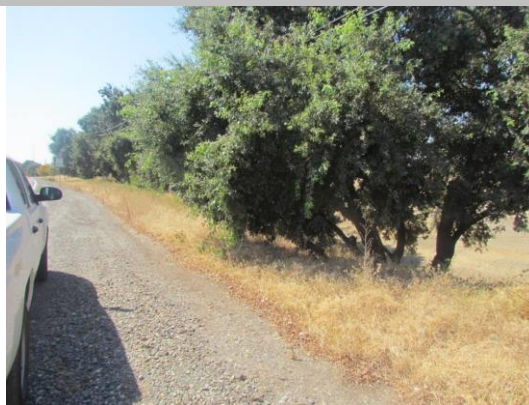
Photo 2 of 2 : FA\_2017\_RD0765\_211\_14\_20170901\_00017.jpg

Looking southwest at untrimmed trees on landward slope. (Fall 2016)

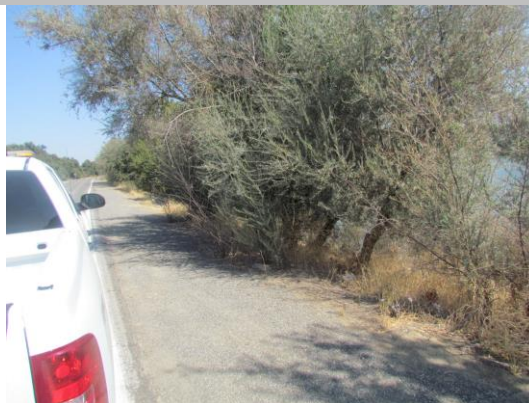
Photo 1 of 2 : FA\_2017\_RD0765\_211\_23\_20170901\_00020.jpg

Looking northeast at untrimmed trees on waterward shoulder. (Fall 2016)

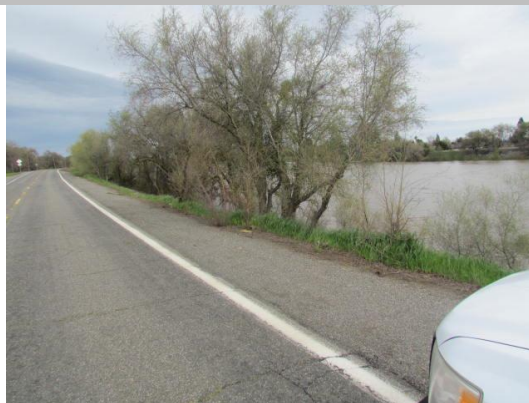
Photo 2 of 2 : FA\_2017\_RD0765\_211\_23\_20170901\_00021.jpg

Looking northeast at trees along waterward shoulder and slope. (Spring 2016)

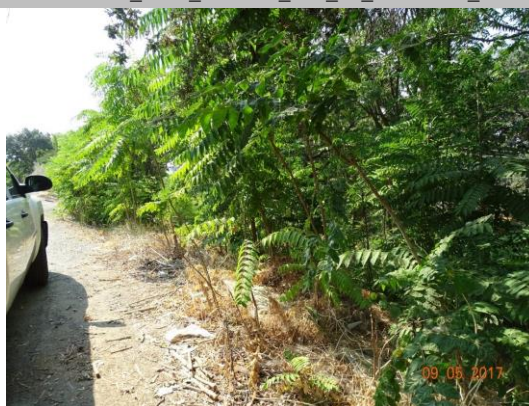
Photo 1 of 3 : FA\_2017\_RD0765\_211\_47\_20170919\_00081.jpg

Looking south at the landside slope.

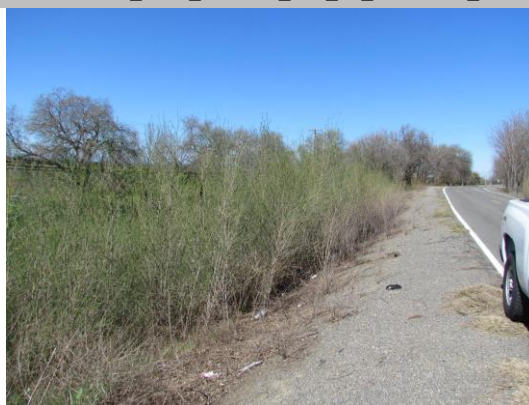
Photo 2 of 3 : FA\_2017\_RD0765\_211\_47\_20170901\_00045.jpg

Looking north at dense willows on landward slope. (Spring 2017)

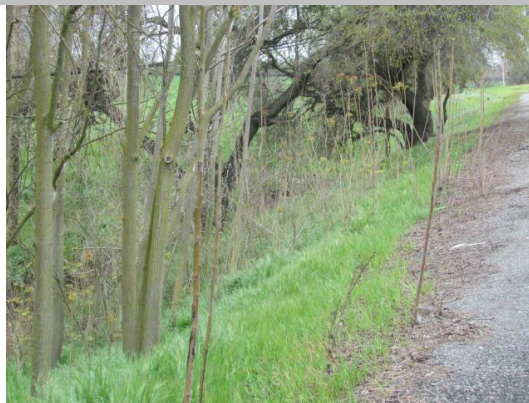
Photo 1 of 2 : FA\_2017\_RD0765\_211\_32\_20170901\_00034.jpg

Looking northwest at trees (saplings) on landward slope.

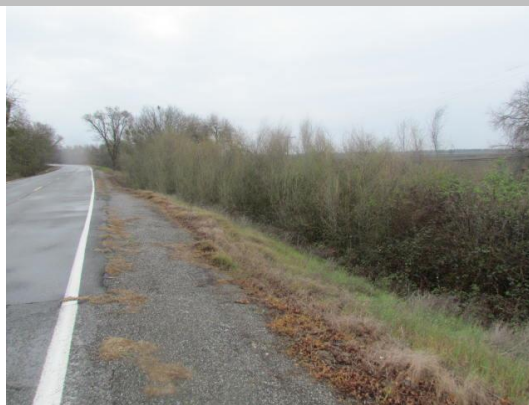
Photo 2 of 2 : FA\_2017\_RD0765\_211\_32\_20170901\_00035.jpg

Looking southwest at dense vegetation on landside slope and toe. (2015)

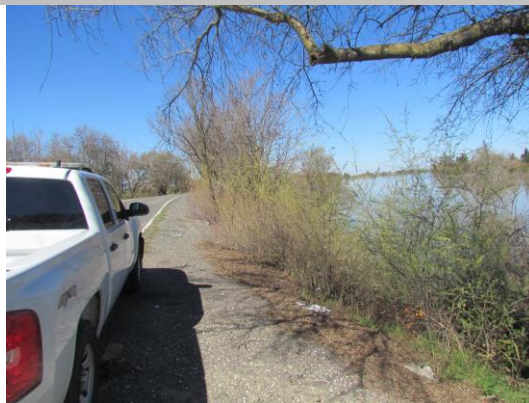
Photo 1 of 4 : FA\_2017\_RD0765\_211\_24\_20170901\_00022.jpg

Looking north at willows and other veg. on waterward slope. (Spring 2017)

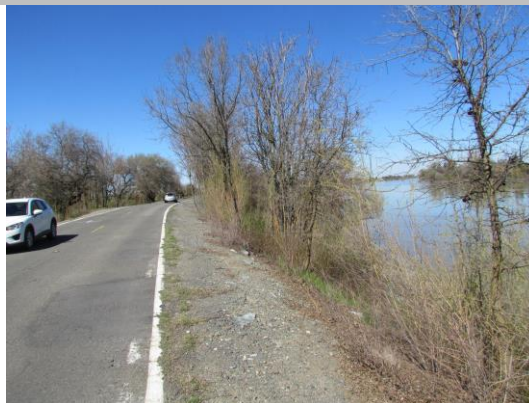
Photo 2 of 4 : FA\_2017\_RD0765\_211\_24\_20170901\_00023.jpg

Looking north at dense veg on waterward slope. (Spring 2017)

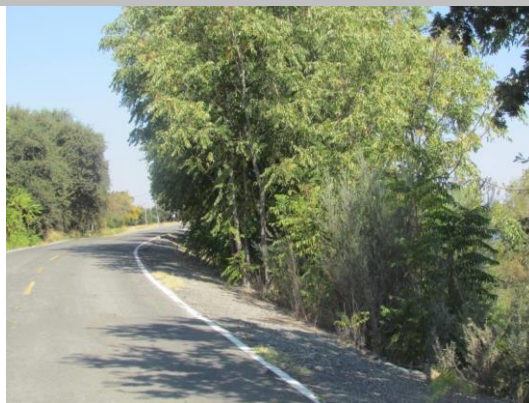
Photo 3 of 4 : FA\_2017\_RD0765\_211\_24\_20170901\_00024.jpg

Looking northeast at large cluster of trees on waterward slope. (Fall 2016)

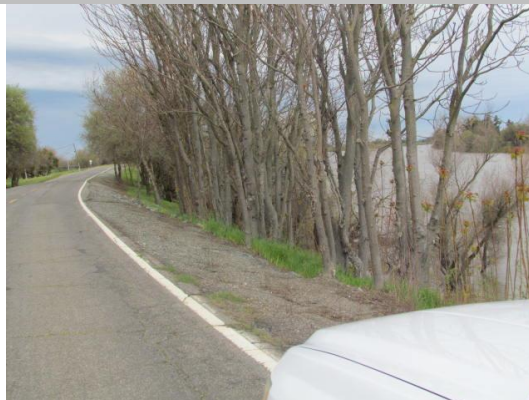
Photo 4 of 4 : FA\_2017\_RD0765\_211\_24\_20170901\_00025.jpg

Looking northeast at cluster of trees on waterward slope. (Spring 2016)

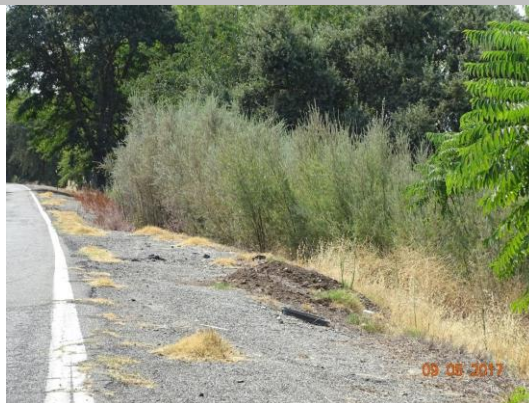
Photo 1 of 2 : FA\_2017\_RD0765\_211\_59\_20170919\_00083.jpg

Looking south at the landside slope.

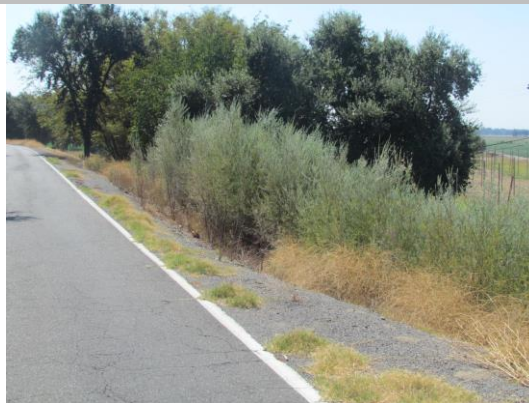
Photo 2 of 2 : FA\_2017\_RD0765\_211\_59\_20170901\_00058.jpg

Looking northwest at dense vegetation on landward slope. (Fall 2016)

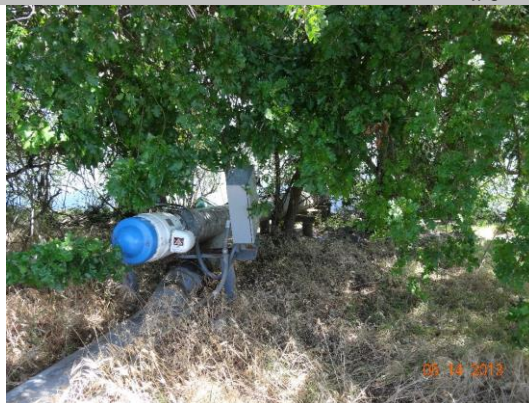
Photo 1 of 3 : UCIP\_FA\_2017\_44403\_60815.jpg

Comment Code					
Inspector Comment					
FS_ID:44403 DS_ID:21138 EP_NO: 3314 Repair Type: Non-Urgent Crossing Status: Found UCIP Comments: Dense vegetation limit's the ability to determine condition of landward slope for potential leaks associated with crossing. Recommend having owner clear slope to be able to properly inspect slopes for leaks. FIELD_STRUCT_DESC: 16-inch steel pipe through the levee, 4.0 feet below the crown. Cutoff wall around pipe at center of levee. Slant pump on the waterward slope, with 22-inch inlet pipe extending from channel. 16-inch pipe connects to 12-inch steel pipe at landward shoulder, extending to concrete standpipe discharge outlet at the toe. Cobble revetment on waterward slope. (Permit No. 3314-1960) FS Date: 5/14/2013

View of waterward side--pipe, pump, control panels, and electrical conduit.

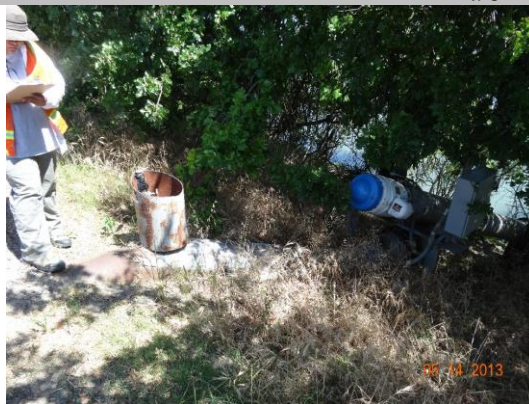
Photo 2 of 3 : UCIP\_FA\_2017\_44403\_60814.jpg

Siphon breaker encased in steel casing located on waterward side.

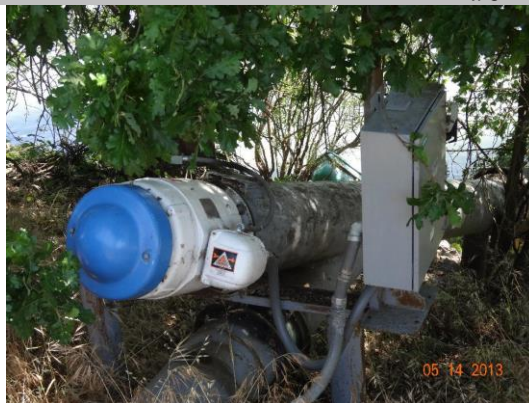
Photo 3 of 3 : UCIP\_FA\_2017\_44403\_60813.jpg

Comment Code						
Inspector Comment						
FS_ID:44403 DS_ID:21138 EP_NO: 3314 Repair Type: Non-Urgent Crossing Status: Found UCIP Comments: Dense vegetation limit's the ability to determine condition of landward slope for potential leaks associated with crossing. Recommend having owner clear slope to be able to properly inspect slopes for leaks. FIELD_STRUCT_DESC: 16-inch steel pipe through the levee, 4.0 feet below the crown. Cutoff wall around pipe at center of levee. Slant pump on the waterward slope, with 22-inch inlet pipe extending from channel. 16-inch pipe connects to 12-inch steel pipe at landward shoulder, extending to concrete standpipe discharge outlet at the toe. Cobble revetment on waterward slope. (Permit No. 3314-1960) FS Date: 5/14/2013

Close up of slant pump and control panel on waterward side.

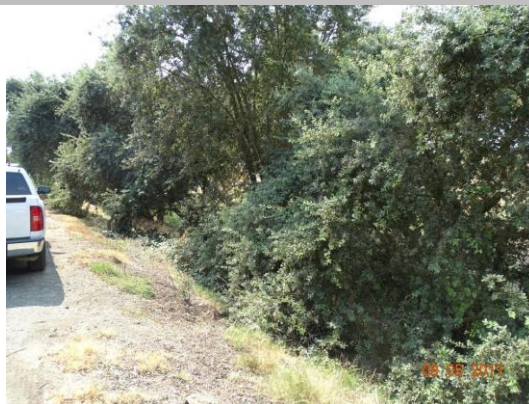
Photo 1 of 1 : FA\_2017\_RD0765\_211\_34\_20170919\_00080.jpg

Looking south at landside slope.

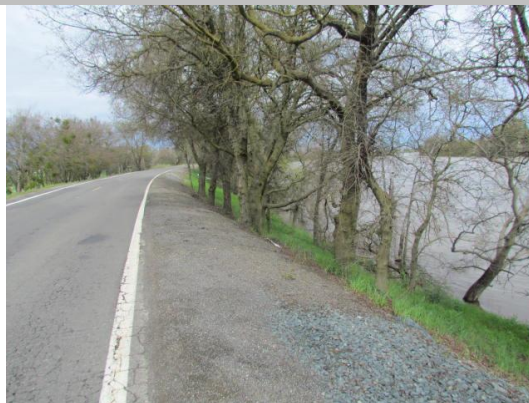
Photo 1 of 1 : FA\_2017\_RD0765\_211\_10\_20170901\_00012.jpg

Looking northeast at trees on waterward slope.

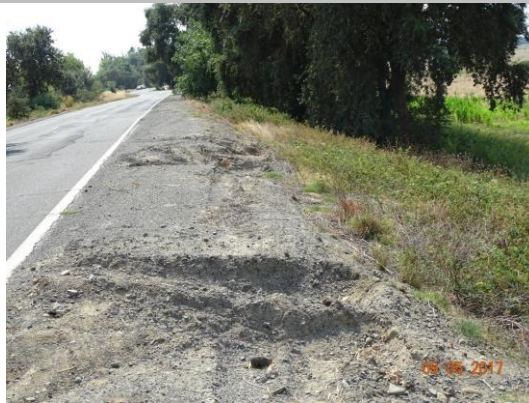
Photo 1 of 2 : FA\_2017\_RD0765\_211\_68\_20170919\_00084.jpg

LM Start	0.75	Rating **	M	Issue No.	68
LM End	0.75	Issue Type +	Ma	Location *	LS
Category	Earthen Levee			GPS Latitude/Longitude	
				Start	End
Item	Slope Stability			38.492705 °	38.492705 °
				-121.557193 °	-121.557193 °
DWR ID	DWR_RD0765_01_s_2017_68				
Comment Code					
S3 : Repair the levee slope damaged by vehicle traffic and prevent access where possible.					
Inspector Comment					
Damage caused by a truck.

Looking south on landside slope.

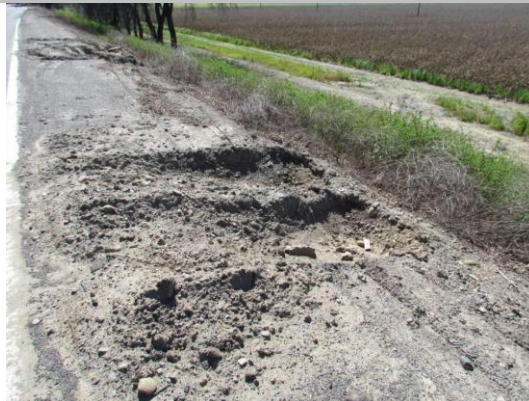
Photo 2 of 2 : FA\_2017\_RD0765\_211\_68\_20170901\_00069.jpg

Looking south at levee damage caused by vehicle traffic. (Spring 2017)

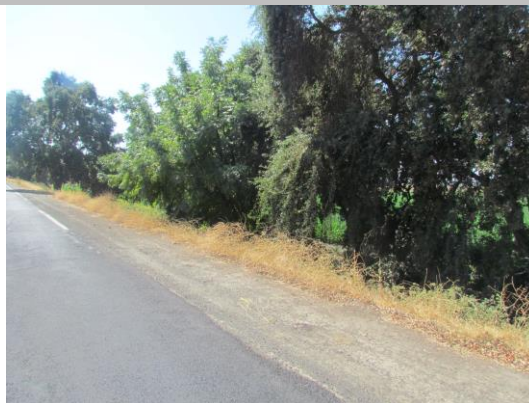
Photo 1 of 1 : FA\_2017\_RD0765\_211\_36\_20170901\_00038.jpg

Looking northwest at untrimmed trees on landward slope.

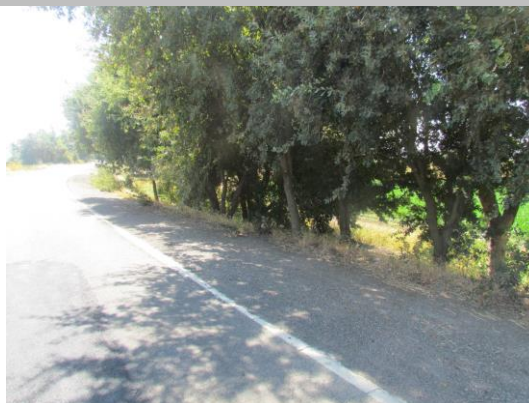
Photo 1 of 1 : FA\_2017\_RD0765\_211\_17\_20170901\_00018.jpg

Looking northwest at untrimmed trees on landward slope.

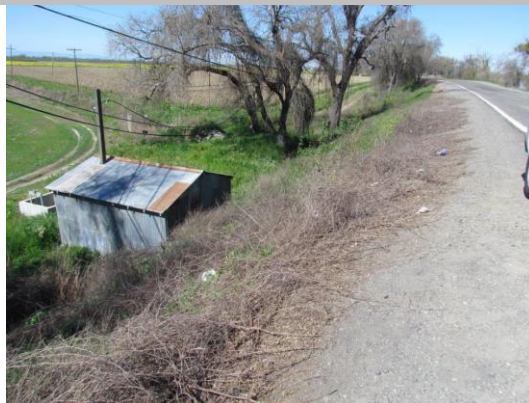
Photo 1 of 3 : FA\_2017\_RD0765\_211\_61\_20170901\_00062.jpg

Looking northwest at dense dead berryvines on landward slope. (Spring 2017)

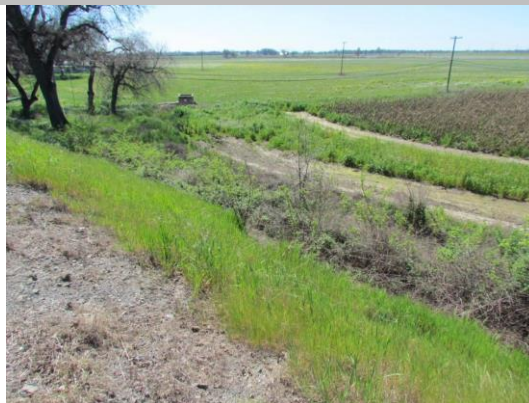
Photo 2 of 3 : FA\_2017\_RD0765\_211\_61\_20170901\_00063.jpg

Looking west at berryvine at bottom half of landward slope. (Spring 2017)

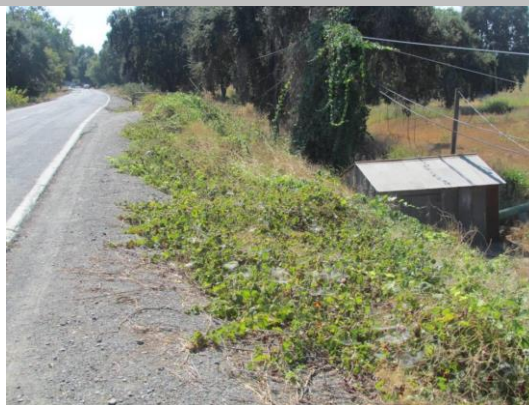
Photo 3 of 3 : FA\_2017\_RD0765\_211\_61\_20170901\_00064.jpg

Looking south at dense wildroses on landward slope. (Fall 2016)

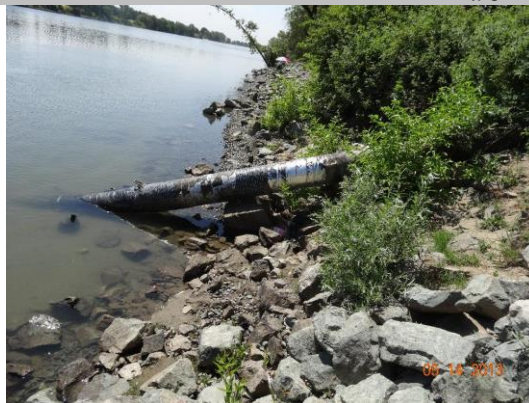
Photo 1 of 3 : UCIP\_FA\_2017\_44404\_60819.jpg

LM Start	0.95	Rating **	M	Issue No.	70
LM End	0.95	Issue Type +	En	Location *	
Category	Supplemental			GPS Latitude/Longitude	
				Start	End
Item	DWR UCIP Field Study			38.490192 °	38.490192 °
				-121.555628 °	-121.555628 °
DWR ID					
Comment Code					
Inspector Comment					
FS_ID:44404 DS_ID:21139 EP_NO: 653 Repair Type: Non-Urgent Crossing Status: Found UCIP Comments: Dense vegetation on landward side limits visual inspection of potential leaks. Recommend clearing slope of vegetation. FIELD_STRUCT_DESC: 16-inch steel pipe through the levee, 14.3 feet below the crown. Pump on the landward side. Gate valve on the waterward slope. (USACE-1959). This entry matches the Drainage or Irrigation Structure referenced in O&M manual (RM 50.29). FS Date: 5/14/2013

Pipe section visible at waterward toe.

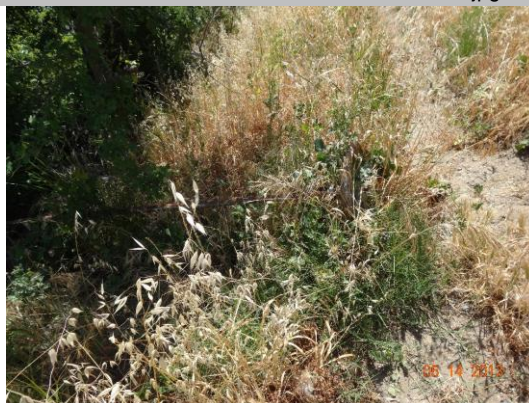
Photo 2 of 3 : UCIP\_FA\_2017\_44404\_60818.jpg

View of waterward side--dense vegetation limits inspection.

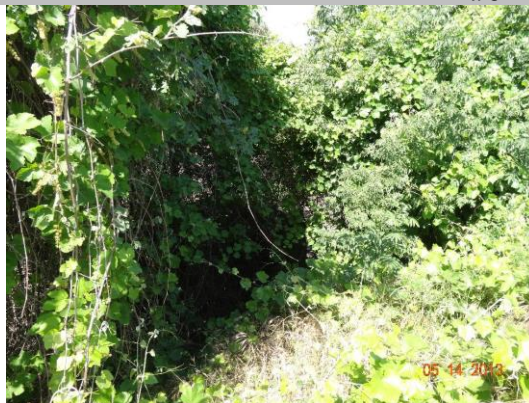
Photo 3 of 3 : UCIP\_FA\_2017\_44404\_60821.jpg

LM Start	0.95	Rating **	M	Issue No.	70 (cont)	
LM End	0.95	Issue Type +	En	Location *		
Category	Supplemental			GPS Latitude/Longitude		
				Start	End	
Item	DWR UCIP Field Study			38.490192 °	38.490192 °	
				-121.555628 °	-121.555628 °	
DWR ID						
Comment Code						
Inspector Comment						
FS_ID:44404 DS_ID:21139 EP_NO: 653 Repair Type: Non-Urgent Crossing Status: Found UCIP Comments: Dense vegetation on landward side limits visual inspection of potential leaks. Recommend clearing slope of vegetation. FIELD_STRUCT_DESC: 16-inch steel pipe through the levee, 14.3 feet below the crown. Pump on the landward side. Gate valve on the waterward slope. (USACE-1959). This entry matches the Drainage or Irrigation Structure referenced in O&M manual (RM 50.29). FS Date: 5/14/2013

View of landward side--dense vegetation limits inspection.

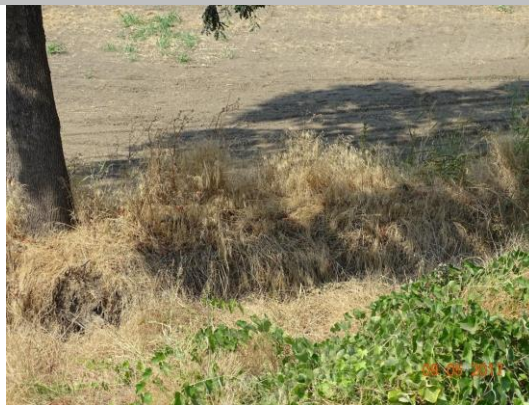
Photo 1 of 2 : FA\_2017\_RD0765\_211\_51\_20170919\_00082.jpg

Looking northwest at the irrigation ditch on the landside toe.

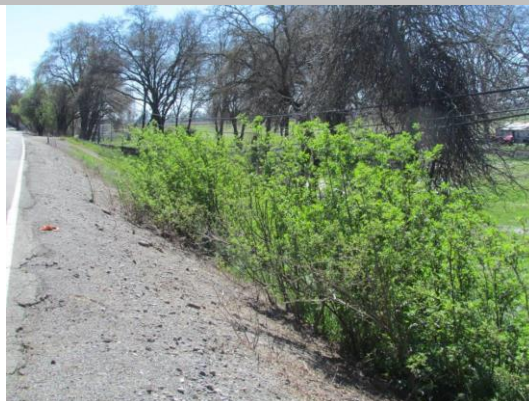
Photo 1 of 2 : FA\_2017\_RD0765\_211\_40\_20170901\_00042.jpg

Looking south at new growth on landward slope. (Spring 2017)

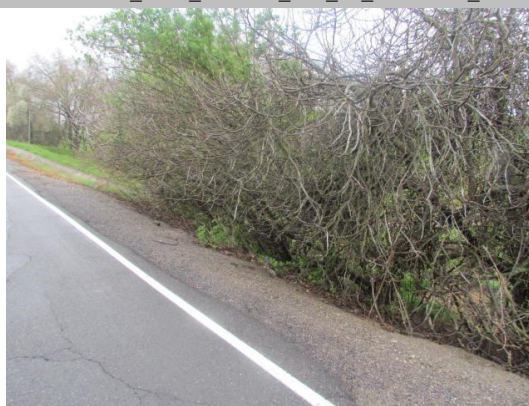
Photo 2 of 2 : FA\_2017\_RD0765\_211\_40\_20170901\_00043.jpg

Looking southwest at fig trees and other trees on landside slope and toe.  
(Fall 2016)

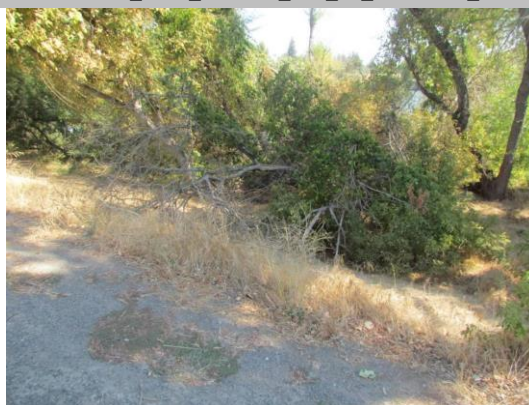
Photo 1 of 1 : FA\_2017\_RD0765\_211\_58\_20170901\_00057.jpg

Looking northeast at fallen tree on waterward slope.

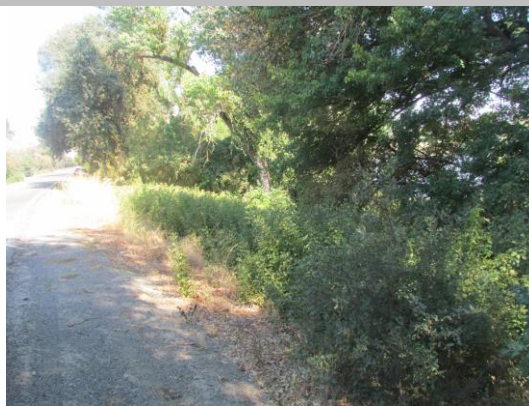
Photo 1 of 1 : FA\_2017\_RD0765\_211\_65\_20170901\_00066.jpg

Looking north at wildroses and untrimmed trees on waterward shoulder and slope.

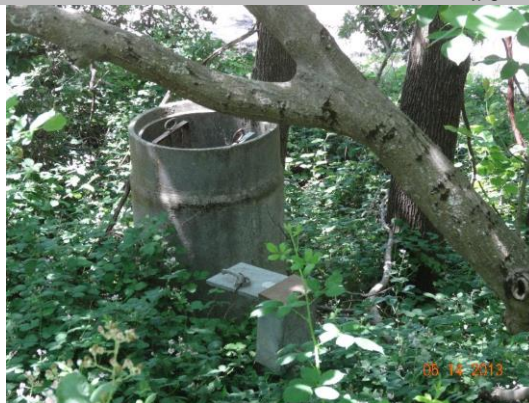
Photo 1 of 3 : UCIP\_FA\_2017\_44407\_73022.jpg

LM Start	1.12	Rating **	M	Issue No.	71	
LM End	1.12	Issue Type +	En	Location *		
Category	Supplemental			GPS Latitude/Longitude		
				Start	End	
Item	DWR UCIP Field Study			38.487917 °	38.487917 °	
				-121.554405 °	-121.554405 °	
DWR ID						
Comment Code						
Inspector Comment						
FS_ID:44407						
DS_ID:21140						
EP_NO: N/A						
Repair Type: Non-Urgent						
Crossing Status: Indicator Found						
UCIP Comments: Dense vegetation on waterward and landward slopes						
limit visual inspection of potential leaks along pipe alignment.						
Recommend having owner clear vegetation along slopes.						
FIELD_STRUCT_DESC: 6-inch steel pipe through the levee, 18.8 feet						
below the crown. Concrete standpipe on the LS toe. Pump on WS						
slope. This entry matches the Drainage or Irrigation Structure						
referenced in O&M manual (RM 50.15).						
FS Date: 4/9/2015

Overview of landward side--concrete standpipe and control panel located at toe.

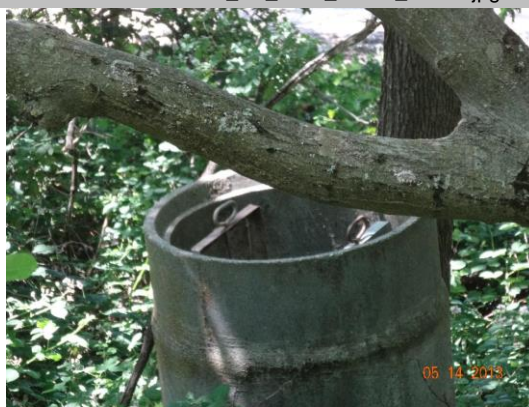
Photo 2 of 3 : UCIP\_FA\_2017\_44407\_73021.jpg

Concrete standpipe with 2 gates inside located on landward side.

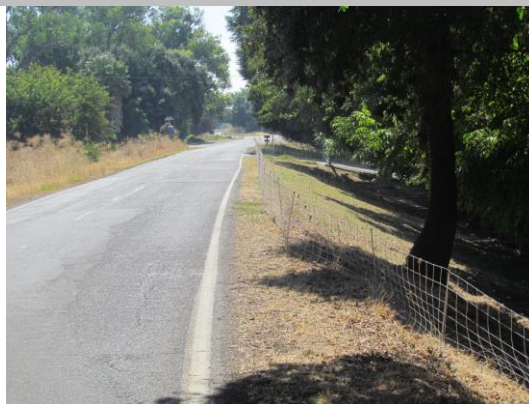
Photo 1 of 3 : FA\_2017\_RD0765\_211\_54\_20170901\_00054.jpg

Looking south at fencing for goats on landward slope. (Fall 2016)

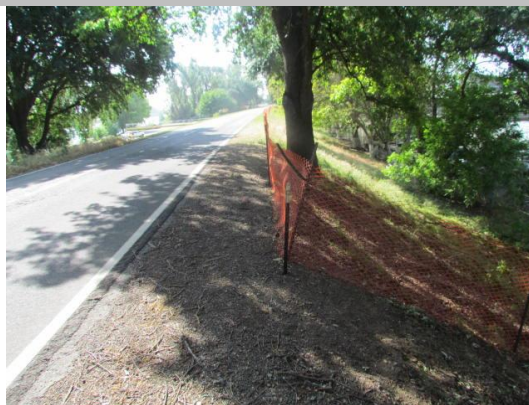
Photo 3 of 3 : FA\_2017\_RD0765\_211\_54\_20170901\_00056.jpg

Looking south at temporary fence on landward slope. (Spring 2016)

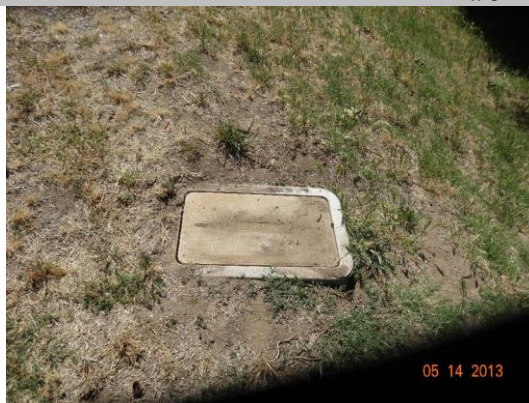
Photo 1 of 2 : UCIP\_FA\_2017\_43203\_71214.jpg

LM Start	1.20	Rating **	M	Issue No.	72
LM End	1.20	Issue Type +	En	Location *	
Category	Supplemental			GPS Latitude/Longitude	
				Start	End
Item	DWR UCIP Field Study			38.486830 °	38.486830 °
				-121.553698 °	-121.553698 °
DWR ID					
Comment Code					
Inspector Comment					
FS_ID:43203 DS_ID:24660 EP_NO: N/A Repair Type: Non-Urgent Crossing Status: Indicator Found UCIP Comments: Unable to confirm details of crossing. Need to contact owner to determine additional details about crossing and permit issued. FIELD_STRUCT_DESC: PG&E utility service box on landward shoulder. FS Date: 5/14/2013

Utility box located on landward side.

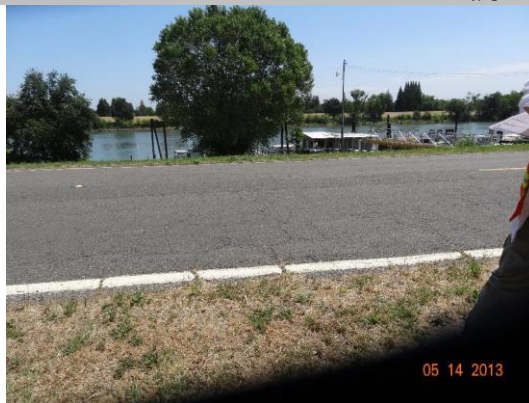
Photo 2 of 2 : UCIP\_FA\_2017\_43203\_71213.jpg

View of levee crown and waterward side.

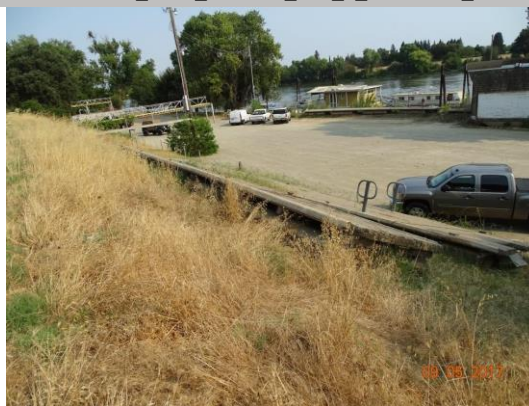
Photo 1 of 1 : FA\_2017\_RD0765\_211\_2\_20170919\_00071.jpg

Looking north at the waterside slope.

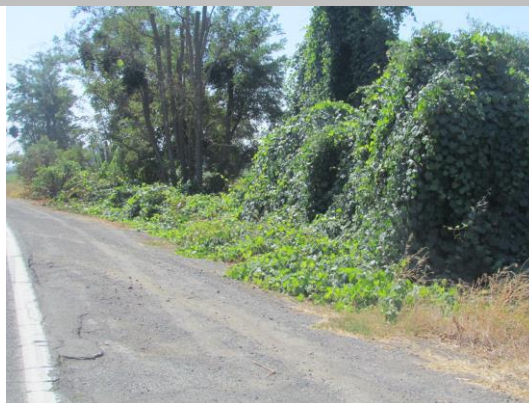
Photo 3 of 3 : FA\_2017\_RD0765\_211\_33\_20170901\_00037.jpg

Looking west at dense vegetation (grapevines) on landward slope. (Fall 2016)

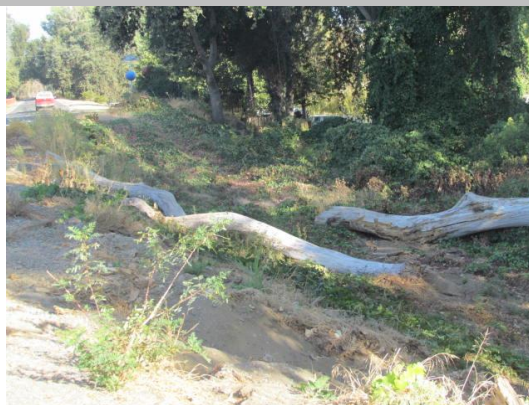
Photo 3 of 4 : FA\_2017\_RD0765\_211\_7\_20170901\_00010.jpg

Looking at several tree branches on waterward slope and berm.(2015)

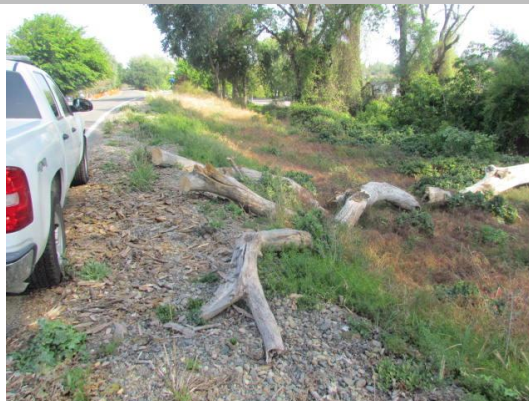
Photo 4 of 4 : FA\_2017\_RD0765\_211\_7\_20170901\_00011.jpg

Looking north at down tree across waterward slope.(2015)

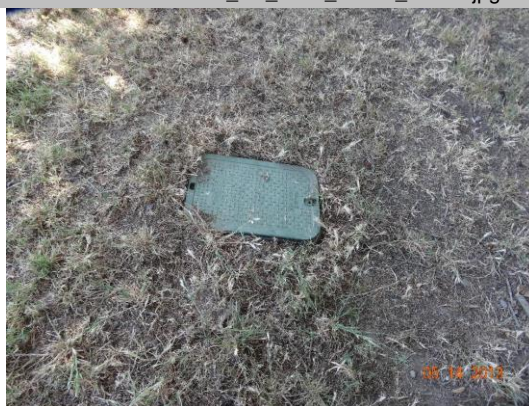
Photo 1 of 1 : UCIP\_FA\_2017\_39022\_71212.jpg

Utility box located on landward shoulder.

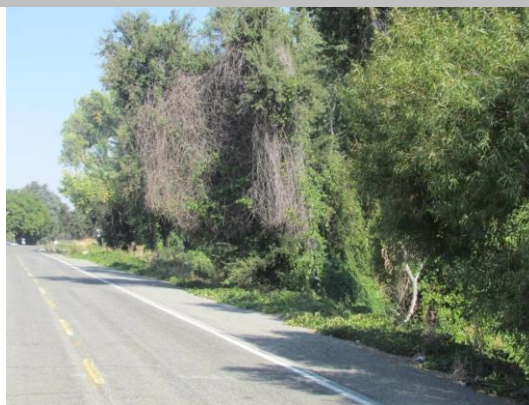
Photo 1 of 3 : FA\_2017\_RD0765\_211\_4\_20170901\_00004.jpg

Looking northeast at untrimmed trees and other vegetation on waterward slope. (Fall 2016)

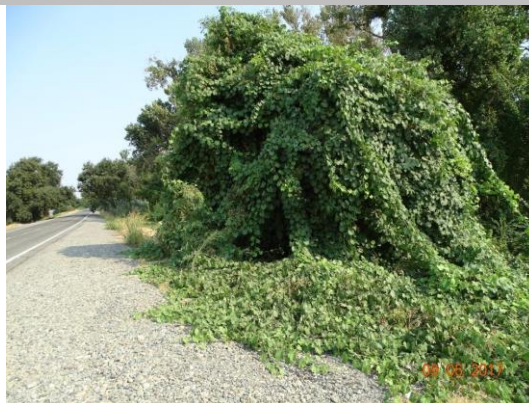
Photo 1 of 2 : FA\_2017\_RD0765\_211\_50\_20170919\_00076.jpg

Looking northwest on waterside slope.

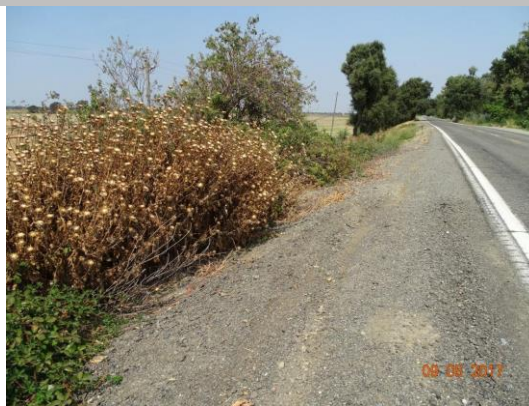
Photo 1 of 5 : FA\_2017\_RD0765\_211\_29\_20170919\_00078.jpg

Looking northwest at the landside slope.

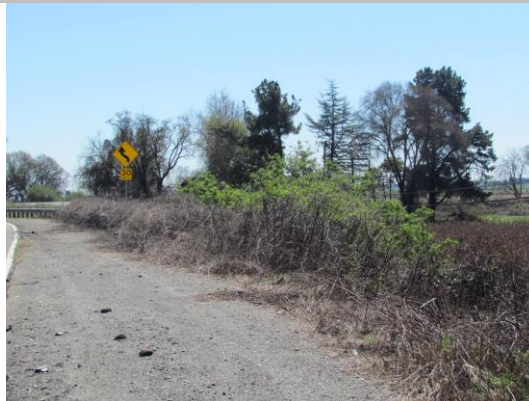
Photo 2 of 5 : FA\_2017\_RD0765\_211\_29\_20170901\_00030.jpg

Looking southwest at dead vines and other veg on landward slope.  
(Spring 2017)

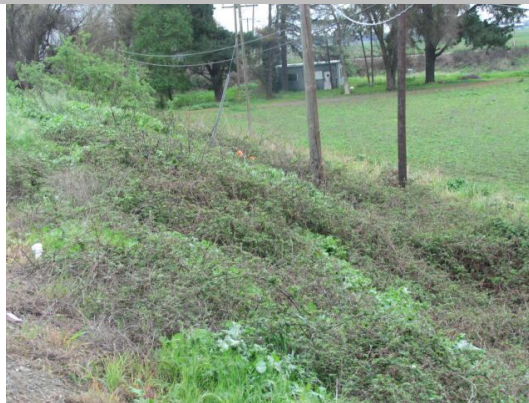
Photo 5 of 5 : FA\_2017\_RD0765\_211\_29\_20170901\_00033.jpg

Looking southwest at ground cover on landward slope. (Spring 2016)

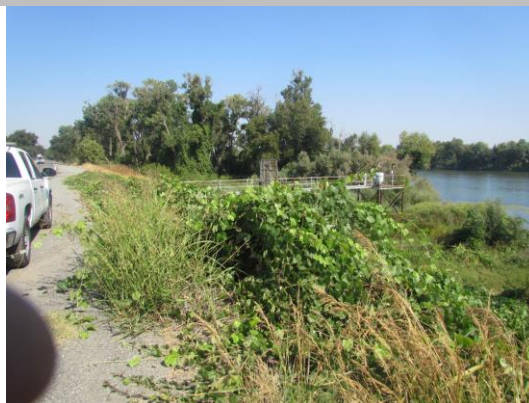
Photo 3 of 3 : FA\_2017\_RD0765\_211\_48\_20170901\_00048.jpg

Looking northeast at vines on waterward slope. (Fall 2016)

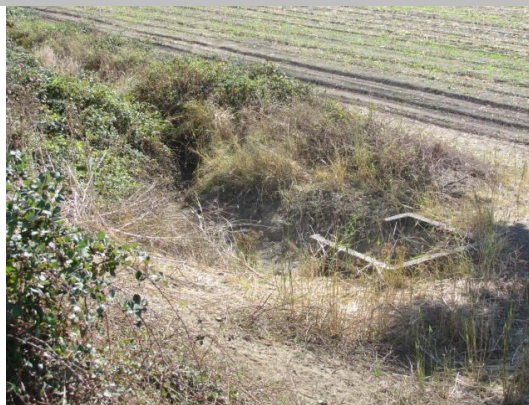
Photo 2 of 2 : FA\_2017\_RD0765\_211\_60\_20170901\_00061.jpg

Looking southwest at irrigation ditch on landward toe.

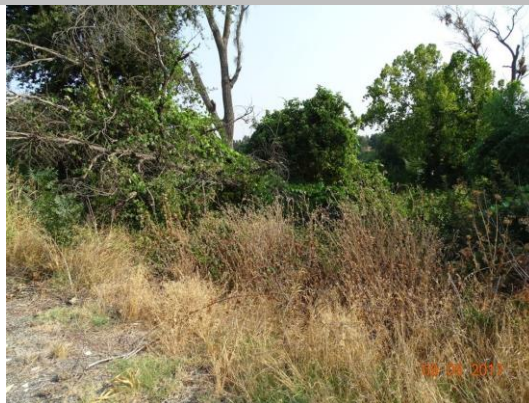
Photo 1 of 1 : FA\_2017\_RD0765\_211\_1\_20170919\_00070.jpg

Looking north at the downed tree.

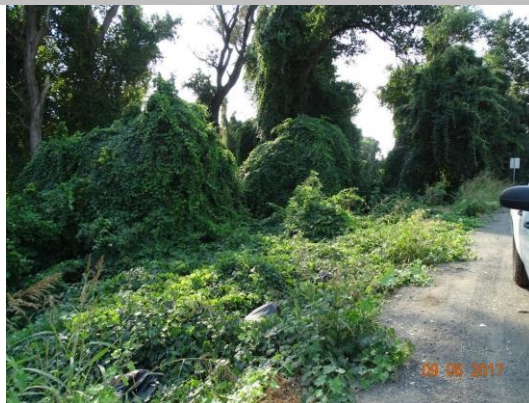
Photo 1 of 2 : FA\_2017\_RD0765\_211\_25\_20170919\_00085.jpg

Looking southeast at waterside slope.

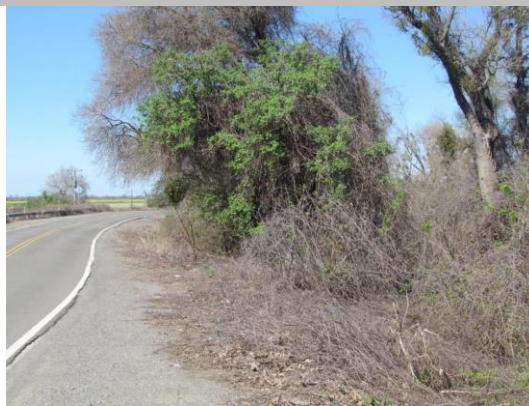
Photo 1 of 2 : FA\_2017\_RD0765\_211\_53\_20170901\_00052.jpg

Looking north at dense untrimmed trees on waterward slope. (Spring 2017)

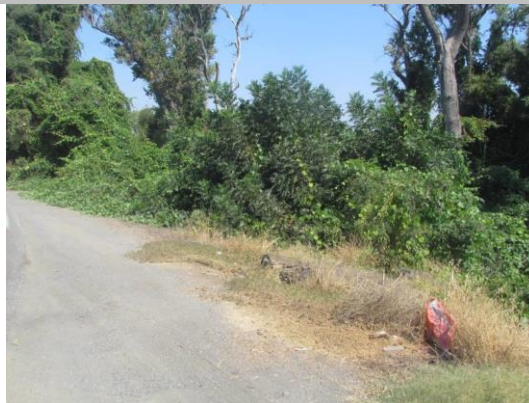
Photo 2 of 2 : FA\_2017\_RD0765\_211\_53\_20170901\_00053.jpg

Looking north at dense vegetation on waterward slope. (Fall 2016)

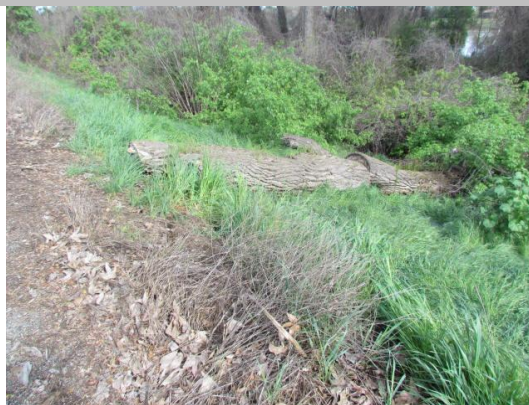
Photo 2 of 2 : FA\_2017\_RD0765\_211\_13\_20170901\_00015.jpg

Looking northwest at large tree limb on waterward slope.
