**Flood Control Project Maintenance
Levee Inspections**

Fall 2018 Levee Maintenance Deficiency Summary Report

**Flood Control Project Maintenance
Levee Inspections****LMA District Cover Sheet****Fall 2018 Levee Inspection Results****Reclamation District No. 0765 Glide**

Reclamation District No. 0765 Glide

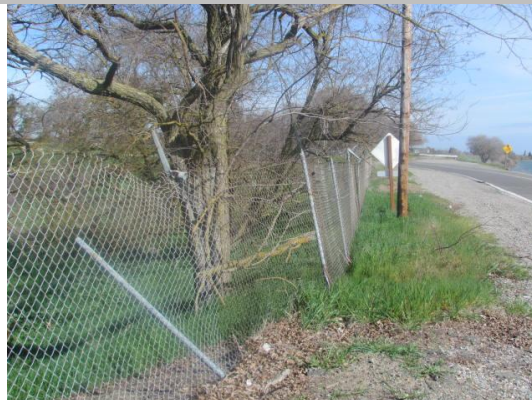
Photo 3 of 3 : FA_2018_RD0765_211_3_20180910_00005.jpg

LM Start	0.05	Rating **	M	Issue No.	3 (cont)	
LM End	0.05	Issue Type +	Ma	Location *	LS	
Category	Earthen Levee			GPS Latitude/Longitude		
				Start		End
Item	Trim / Thin Trees			38.502253 °		38.502253 °
				-121.560192 °		-121.560192 °
DWR ID	DWR_RD0765_01_s _ 2012_3					
Comment Code						
T1 : Trim trees to at least five feet above ground level.						
Inspector Comment						
Trees blocking view of landside slope.

Looking north (upstream) at trees on landside slope. (Spring 2016)

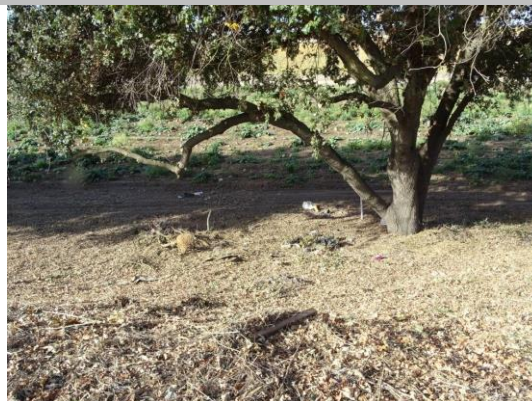
Photo 1 of 1 : FA_2018_RD0765_211_57_20181101_00093.jpg

LM Start	0.28	Rating **	A/W	Issue No.	57
LM End	0.28	Issue Type +	Ma	Location *	LS
Category	Earthen Levee			GPS Latitude/Longitude	
				Start	End
Item	Encroachments			38.498988 °	38.498988 °
				-121.560473 °	-121.560473 °
DWR ID	DWR_RD0765_01_s_2018_57				
Comment Code					
DE : Debris					
Inspector Comment

View of trash on levee. Fall 2018

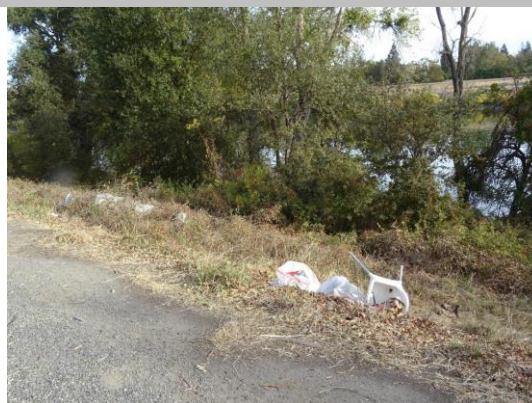
Photo 1 of 1 : FA_2018_RD0765_211_30_20181101_00092.jpg

LM Start	0.79	Rating **	M	Issue No.	30
LM End	0.79	Issue Type +	Ma	Location *	WS
Category	Earthen Levee			GPS Latitude/Longitude	
				Start	End
Item	Encroachments			38.492247 °	38.492247 °
				-121.556872 °	-121.556872 °
DWR ID	DWR_RD0765_01_f_2018_30				
Comment Code					
DE : Debris					
Inspector Comment					
Sofa and debris dumped on slope.

View of debris dumped on slope. Fall 2018

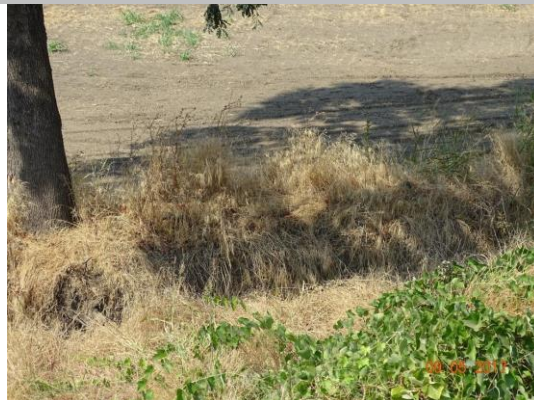
Photo 1 of 2 : FA_2018_RD0765_211_51_20180910_00059.jpg

LM Start	0.96	Rating **	M	Issue No.	51
LM End	1.02	Issue Type +	En	Location *	LS
Category	Earthen Levee			GPS Latitude/Longitude	
				Start	End
Item	Encroachments			38.489949 °	38.489230 °
				-121.555544 °	-121.555168 °
DWR ID	DWR_RD0765_01_s_2013_51				
Comment Code					
DT : Ditch					
Inspector Comment					
Ditch has been in place for several years. Most of the ditch appears to be outside the 15 foot right-of-way.

Looking northwest at the irrigation ditch on the landside toe.

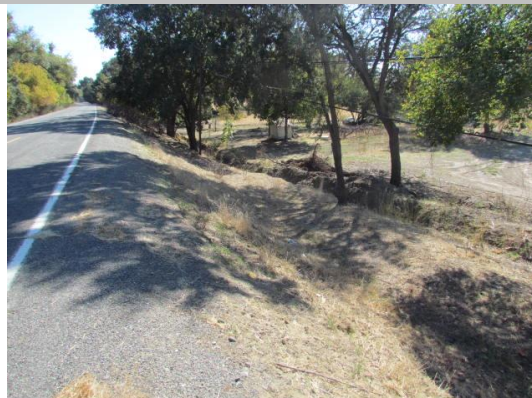
Photo 2 of 2 : FA_2018_RD0765_211_51_20180910_00060.jpg

Looking southwest at irrigation ditch on landward toe.

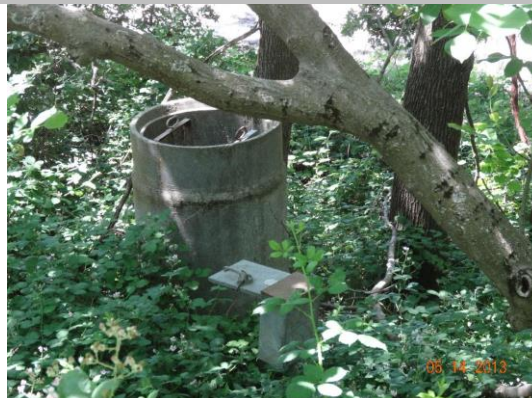
Photo 1 of 3 : UCIP_FA_2018_44407_73022.jpg

Comment Code					
Inspector Comment					
FS_ID:44407					
DS_ID:21140					
EP_NO: N/A					
Repair Type: Non-Urgent					
Crossing Status: Indicator Found					
UCIP Comments: Dense vegetation on waterward and landward slopes limit visual inspection of potential leaks along pipe alignment.					
Recommend having owner clear vegetation along slopes.					
FIELD_STRUCT_DESC: 6-inch steel pipe of unknown purpose through the levee, 18.8 feet below the crown. Concrete standpipe on the landise (LS) toe. Pump located on the waterside (WS) slope. [Additional					
Reference(s): USACE Sacramento O&M Manual Unit No. 114, April 1959, (river mile (RM) 50.15)]					
FS Date: 4/9/2015

Overview of landward side--concrete standpipe and control panel located at toe.

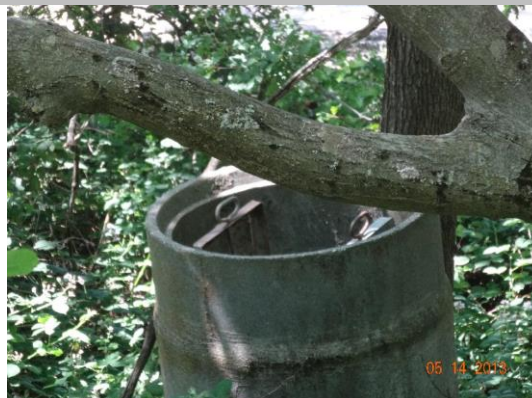
Photo 2 of 3 : UCIP_FA_2018_44407_73021.jpg

Concrete standpipe with 2 gates inside located on landward side.

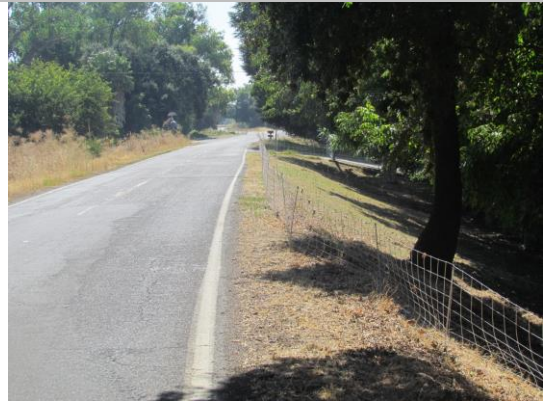
LM Start	1.16	Rating **	M	Issue No.	54 (cont)
LM End	1.26	Issue Type +	En	Location *	LS

Looking south at fencing for goats on landward slope. (Fall 2016)

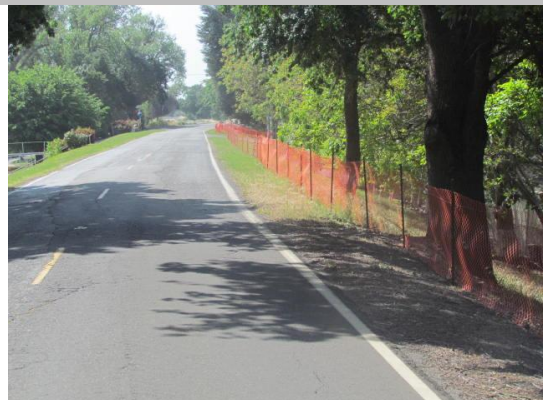
Looking south at temporary fence on landward shoulder. (Spring 2016)

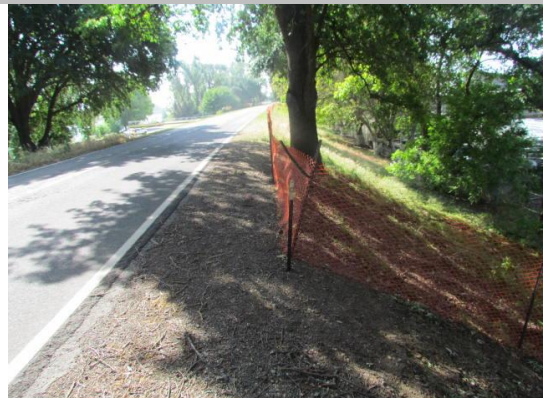
Looking south at temporary fence on landward slope. (Spring 2016)

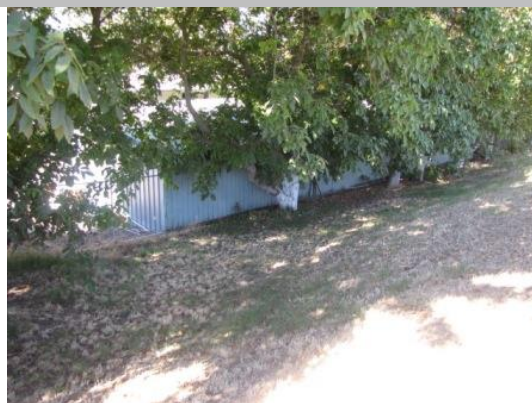
Photo 1 of 1 : FA_2018_RD0765_211_43_20180910_00048.jpg

Looking northwest at buildings along landside toe.

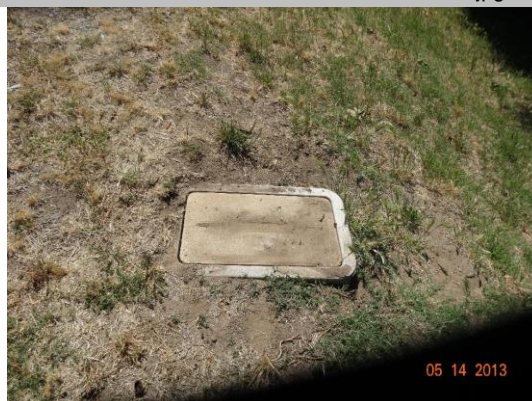
Photo 1 of 2 : UCIP_FA_2018_43203_71214.jpg

LM Start	1.20	Rating **	M	Issue No.	72
LM End	1.20	Issue Type +	En	Location *	
Category	Supplemental			GPS Latitude/Longitude	
				Start	End
Item	DWR UCIP Field Study			38.486830 °	38.486830 °
				-121.553698 °	-121.553698 °
DWR ID	24660				
Comment Code					
Inspector Comment					
FS_ID:43203 DS_ID:24660 EP_NO: N/A Repair Type: Non-Urgent Crossing Status: Indicator Found UCIP Comments: Unable to confirm details of crossing. Need to contact owner to determine additional details about crossing and permit issued. FIELD_STRUCT_DESC: PG&E utility service box located on the landside shoulder. FS Date: 5/14/2013

Utility box located on landward side.

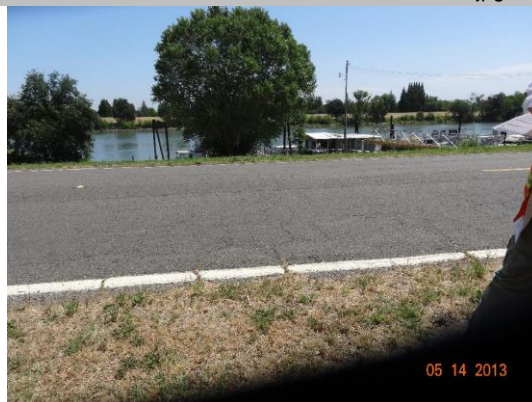
Photo 2 of 2 : UCIP_FA_2018_43203_71213.jpg

View of levee crown and waterward side.

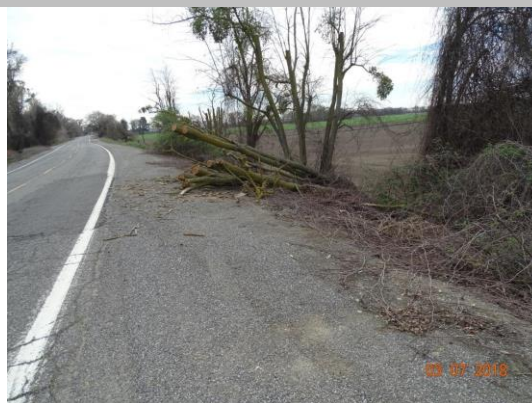
Photo 1 of 1 : FA_2018_RD0765_211_26_20180910_00030.jpg

Encroachment downed tree landside looking south.

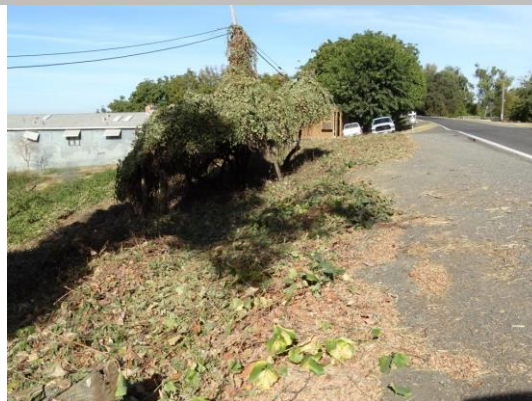
Photo 1 of 1 : FA_2018_RD0765_211_49_20181101_00097.jpg

View of prunings left on slope. Fall 2018

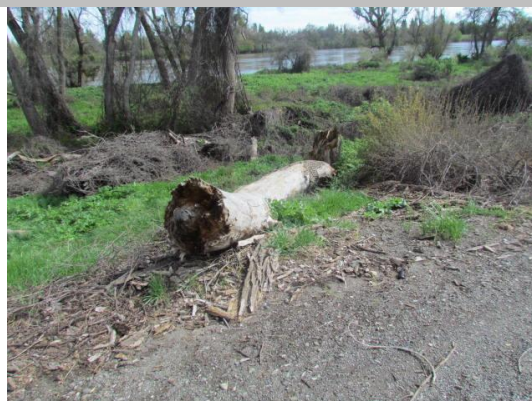
Photo 1 of 4 : FA_2018_RD0765_211_7_20180910_00010.jpg

Looking southeast at branch on waterward slope.

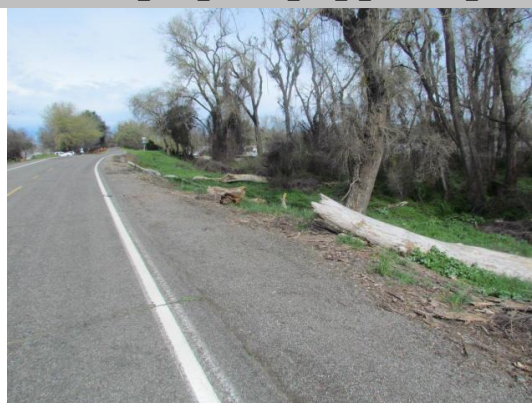
Photo 2 of 4 : FA_2018_RD0765_211_7_20180910_00011.jpg

Looking northeast at tree limbs on waterward slope.

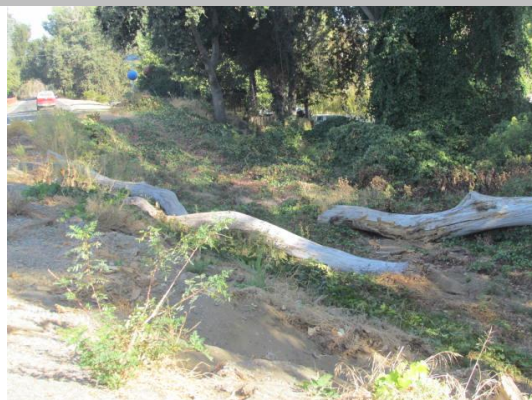
Photo 3 of 4 : FA_2018_RD0765_211_7_20180910_00012.jpg

Looking at several tree branches on waterward slope and berm.(2015)

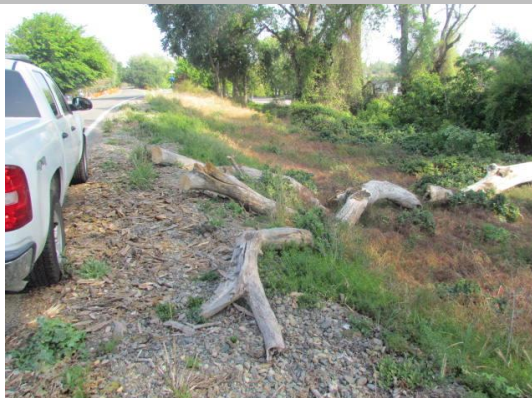
Photo 4 of 4 : FA_2018_RD0765_211_7_20180910_00013.jpg

Looking north at down tree across waterward slope.(2015)

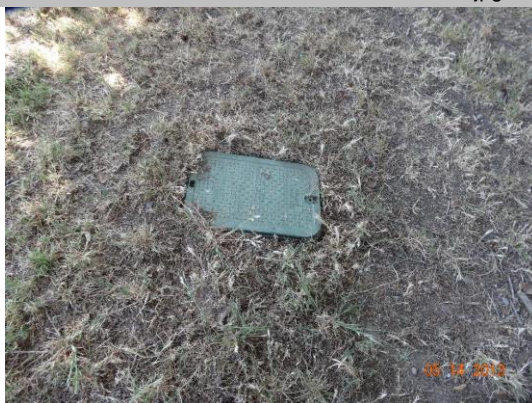
Photo 1 of 1 : UCIP_FA_2018_39022_71212.jpg

LM Start	1.37	Rating **	M	Issue No.	73
LM End	1.37	Issue Type +	En	Location *	
Category	Supplemental			GPS Latitude/Longitude	
				Start	End
Item	DWR UCIP Field Study			38.484656 °	38.484656 °
				-121.552362 °	-121.552362 °
DWR ID	24661				
Comment Code					
Inspector Comment					
FS_ID:39022 DS_ID:24661 EP_NO: N/A Repair Type: Non-Urgent Crossing Status: Indicator Found UCIP Comments: Need to contact owner to determine if crossing goes through levee. FIELD_STRUCT_DESC: 3-inch irrigation line through levee at unknown depth. Service box located on landside (LS) shoulder. FS Date: 5/14/2013

Utility box located on landward shoulder.

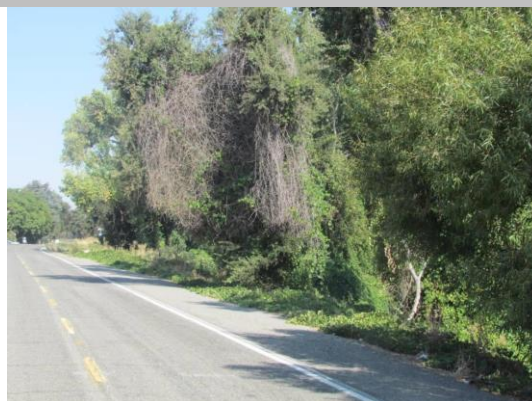
Photo 1 of 3 : FA_2018_RD0765_211_4_20180910_00006.jpg

Looking northeast at untrimmed trees and other vegetation on waterward slope. (Fall 2016)

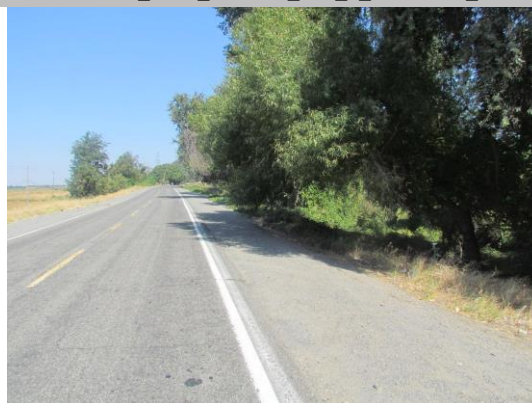
Photo 2 of 3 : FA_2018_RD0765_211_4_20180910_00007.jpg

Looking northeast at untrimmed trees on waterward slope. (Spring 2016)

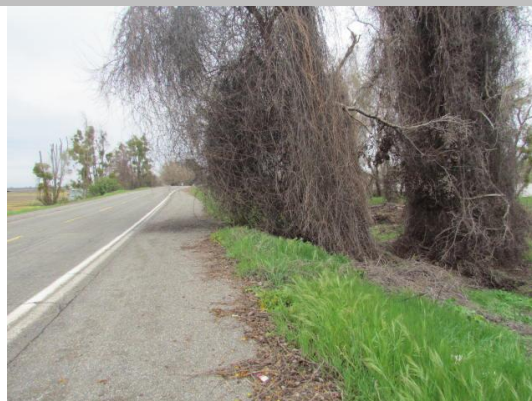
Photo 3 of 3 : FA_2018_RD0765_211_4_20180910_00008.jpg

Looking north at untrimmed trees on waterward slope. (Spring 2016)

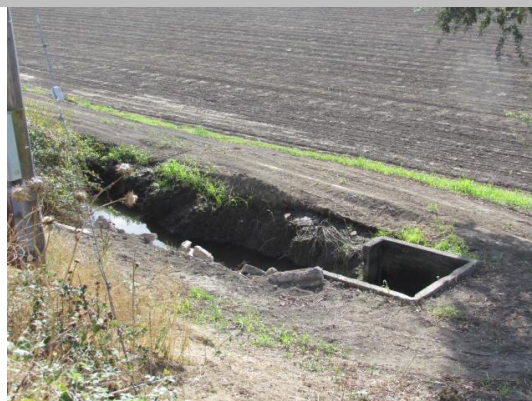
Photo 1 of 2 : FA_2018_RD0765_211_60_20180910_00068.jpg

Looking southwest at irrigation ditch at landward toe. (Fall 2014)

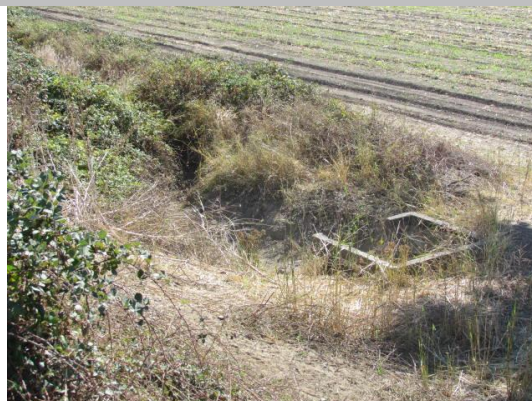
Photo 2 of 2 : FA_2018_RD0765_211_60_20180910_00069.jpg

Looking southwest at irrigation ditch on landward toe.

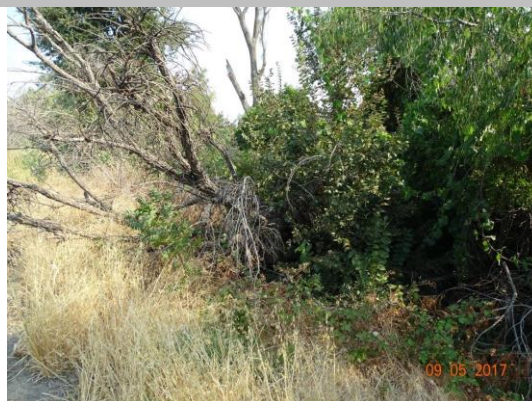
Photo 1 of 1 : FA_2018_RD0765_211_39_20180910_00045.jpg

LM Start	1.59	Rating **	M	Issue No.	39
LM End	1.59	Issue Type +	Ma	Location *	WS
Category	Earthen Levee			GPS Latitude/Longitude	
				Start	End
Item	Encroachments			38.481798 °	38.481798 °
				-121.550449 °	-121.550449 °
DWR ID	DWR_RD0765_01_f_2016_39				
Comment Code					
TR : Tree or limb					
Inspector Comment					
Downed tree on waterside slope.

Looking north at the waterside slope.

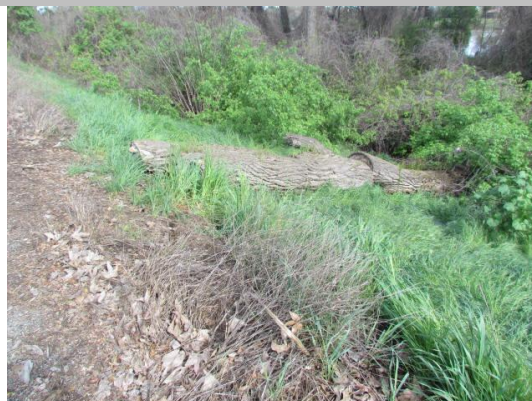
Photo 2 of 2 : FA_2018_RD0765_211_13_20180910_00018.jpg

Looking northwest at large tree limb on waterward slope.
